Attachment E

Natural Resources Assessments, Mack Point & Sears Island

Hydrographic and Marine Geophysical Site Characterization Surveys

Mack Point and Sears Island

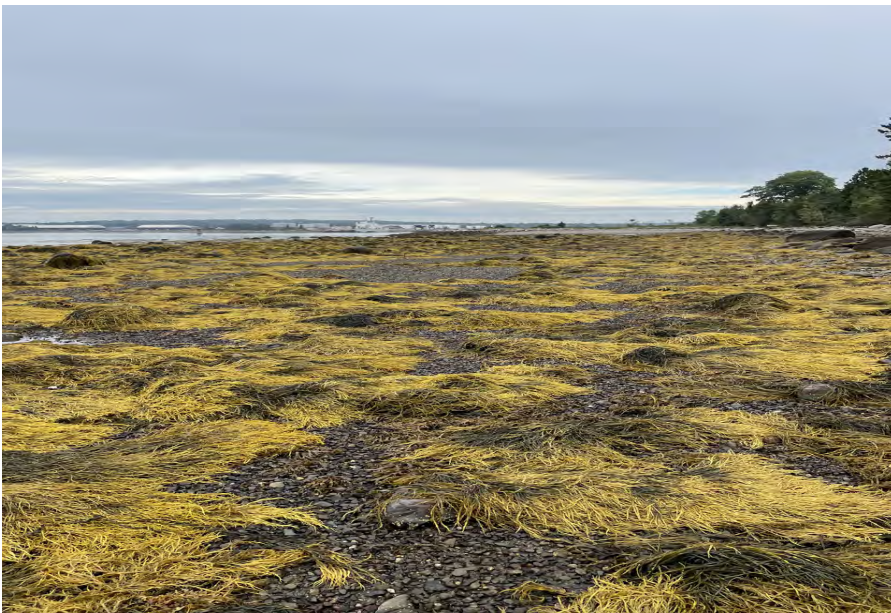
Photo 8. Mid intertidal substrate dominated by cobble, gravel and coarse sand with scattered boulders at Sears Island south of jetty. September 2023.

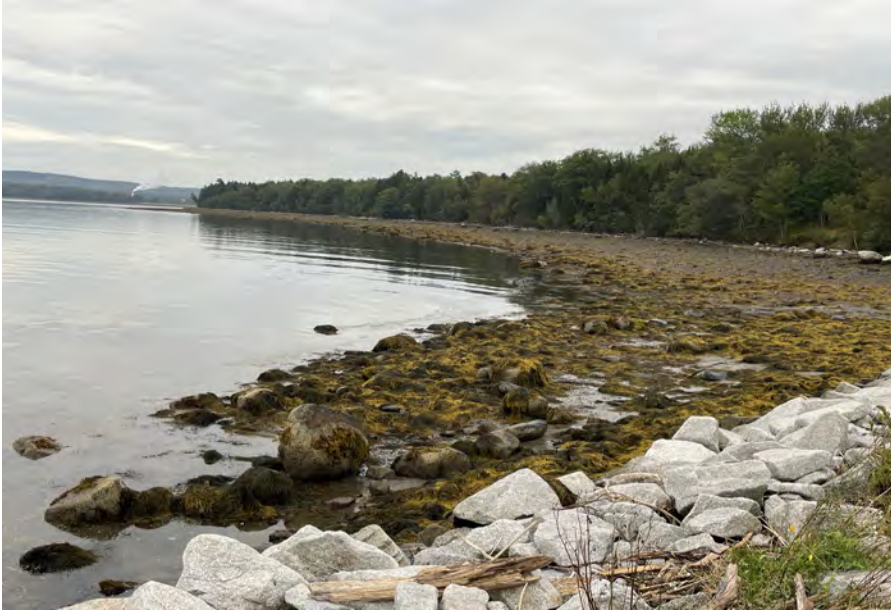
Photo 9. Boulder and cobble with scattered gravel, sand, and silt in the mid intertidal at Sears Island north of jetty. September 2023.

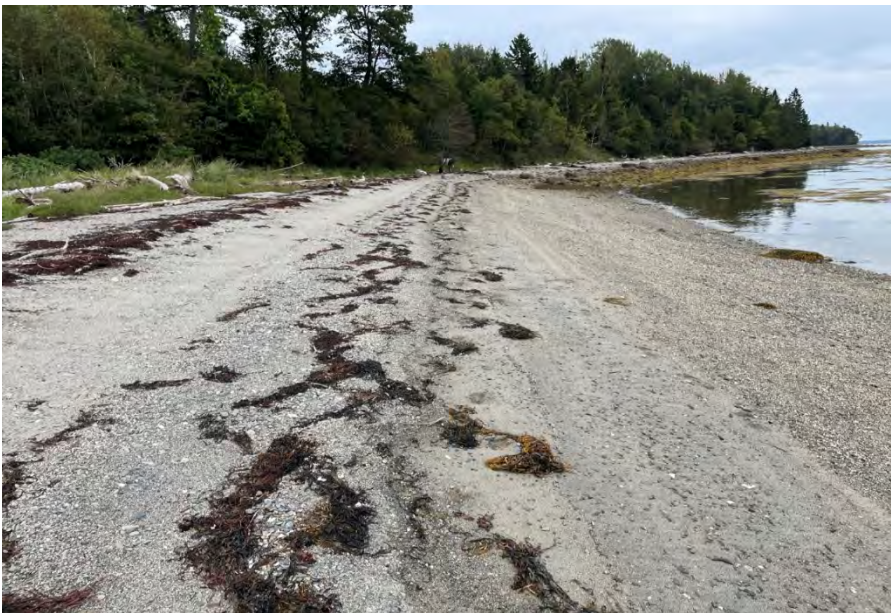
Photo 10. Coarse sand and gravel south of the jetty in the mid intertidal at Sears Island. September 2023.

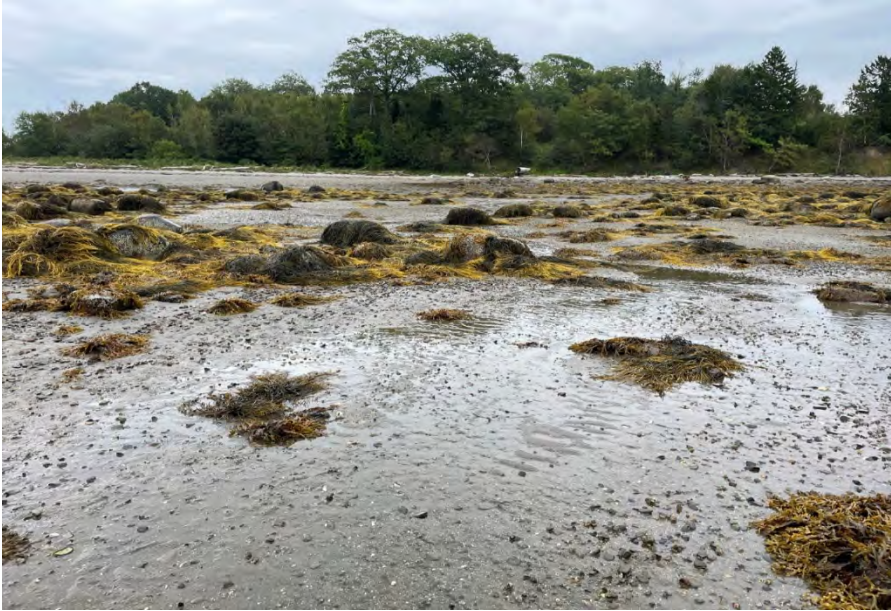
Photo 11. Scattered macroalgae on boulders in the finer grained substrate present in the mid intertidal at Sears Island south of jetty. September 2023.

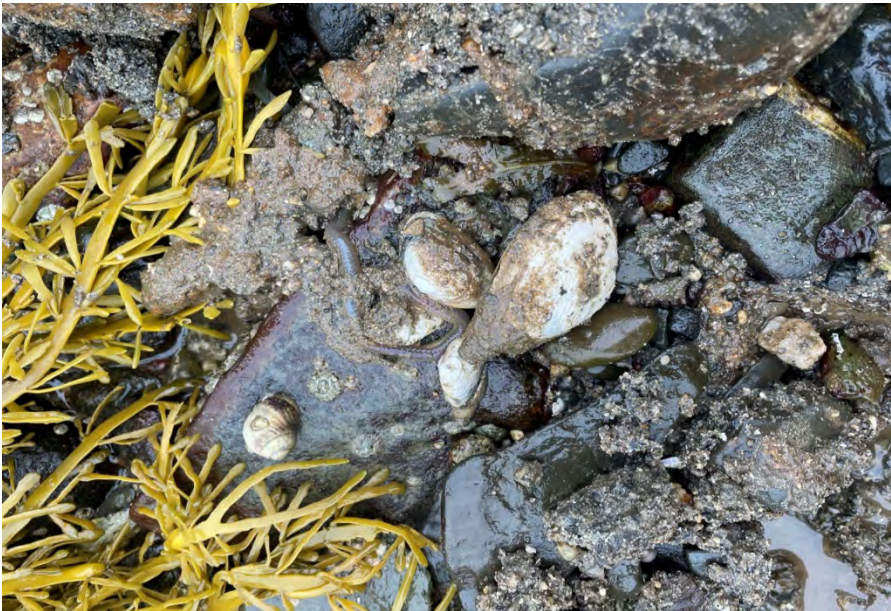
Photo 12. Soft-shell clams were common within this finer grained substrate in the mid intertidal at Sears Island. September 2023.

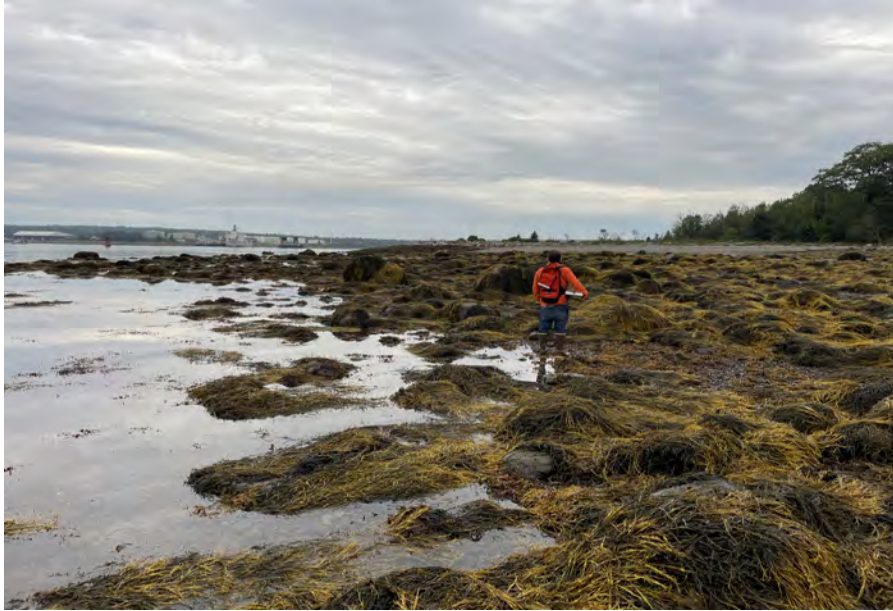
Photo 13. Boulders and cobble in the mid intertidal embedded in the gravel, sand, and silt at Sears Island south of jetty. September 2023.

The mid intertidal substrate at Sears Island is primarily mixed coarse and fines (cobble and gravel dominated with areas of sand/silt and scattered boulders in the upper mid intertidal). Mixed coarse and fines, boulder and cobble with scattered gravel, sand, and silt dominate the lower portions of the mid intertidal (Appendix D: Photos 9). Macroalgae is abundant in these substrate types and consists of knotted wrack (*Ascophyllum nodosum*) and rockweed (*Fucus vesiculosus*). Just south of the jetty, the substrate in the mid intertidal is primarily mixed coarse and fines (coarse sand and gravel) (Appendix D: Photo 10). Macroalgae is scattered in this finer grained substrate (Appendix D: Photo 11). Several areas of finer sediments are present within the dominant coarser grained areas, mostly associated with areas of freshwater discharge from the adjacent upland. Soft-shell clams (*Mya arenaria*) were common within this finer grained substrate (Appendix D: Photo 12). Excavation of survey quadrats revealed marine clay approximately 4 inches below the sediment surface in some areas. The boulders and cobble in this tidal zone are mostly embedded in the gravel, sand, and silt (Appendix D: Photo 13) (Figure 3).

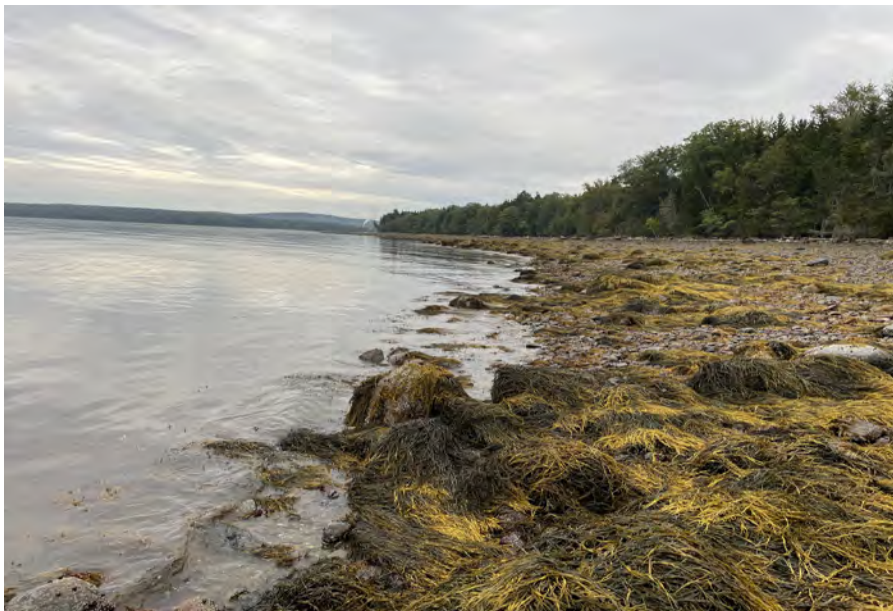
Photo 14. Low intertidal dominated by boulder and cobble and abundant macroalgae (knotted wrack and rockweed) at Sears Island north of jetty. September 2023.

The low intertidal at Sears Island is dominated by mixed coarse and fines, boulder, and cobble and abundant macroalgae (knotted wrack and rockweed) (Appendix D: Photo 14). Excavation of survey quadrats revealed marine clay approximately 4 inches below the sediment surface in some areas. The boulders and cobble in this tidal zone are mostly embedded in the gravel, sand, and silt (Figure 3).

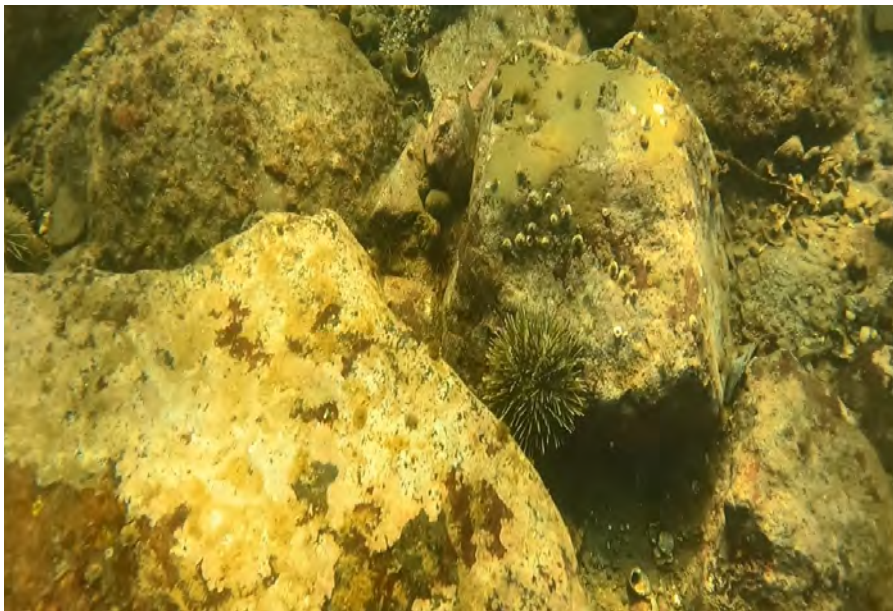
Photo 16. Green sea urchins and crustose coralline algae at Sears Island. December 2023.

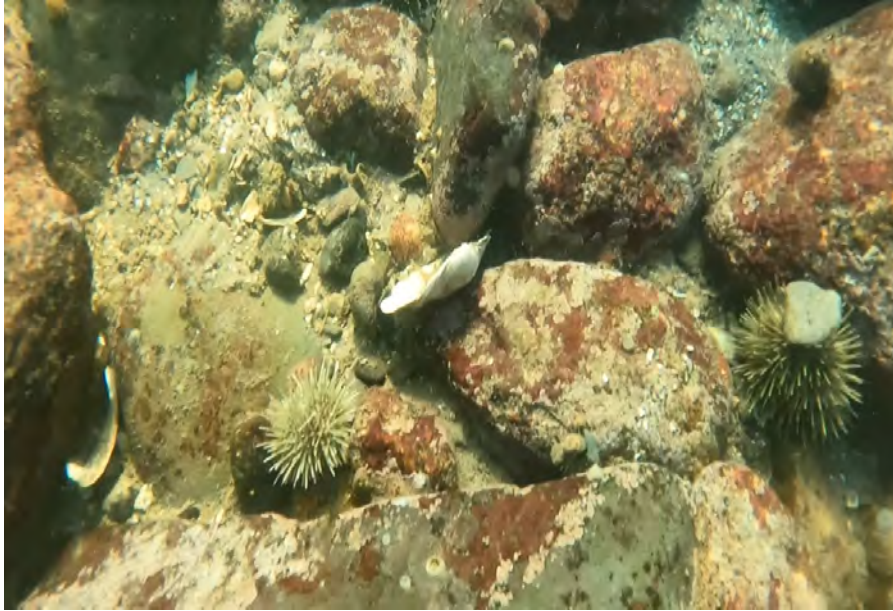
Photo 17. Green sea urchins and crustose coralline algae at Sears Island. December 2023.

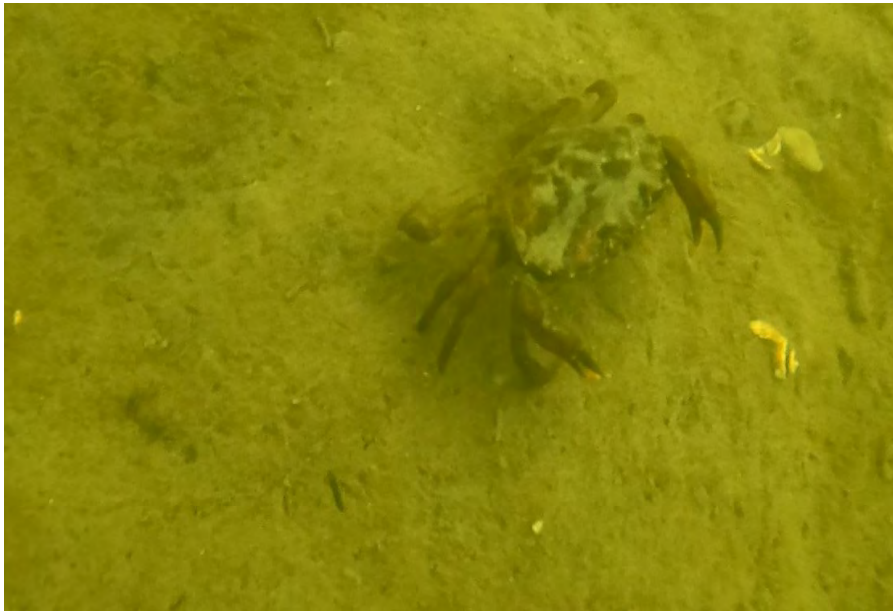
Photo 18. Green crab in shallow subtidal at Sears Island. August 2022.

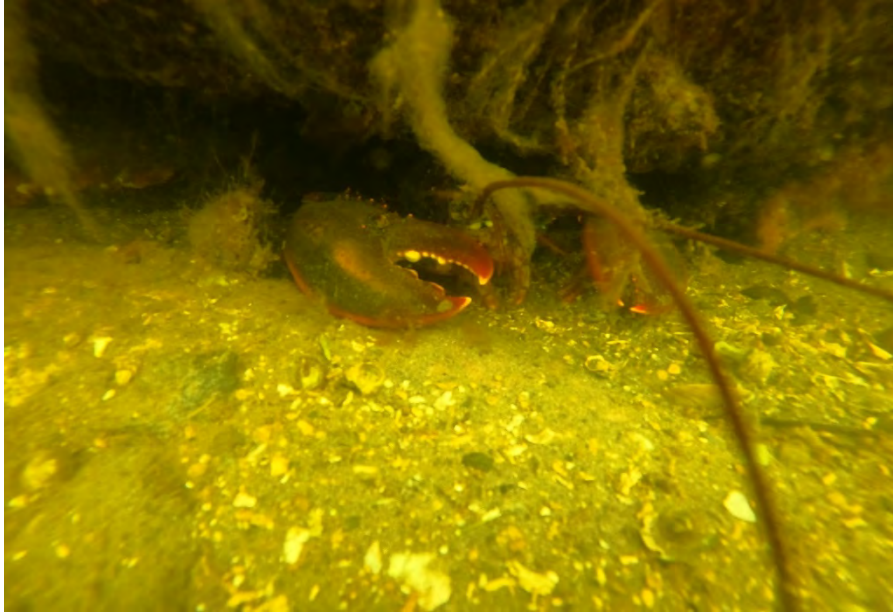
Photo 19. Lobster at Sears Island. August 2022.

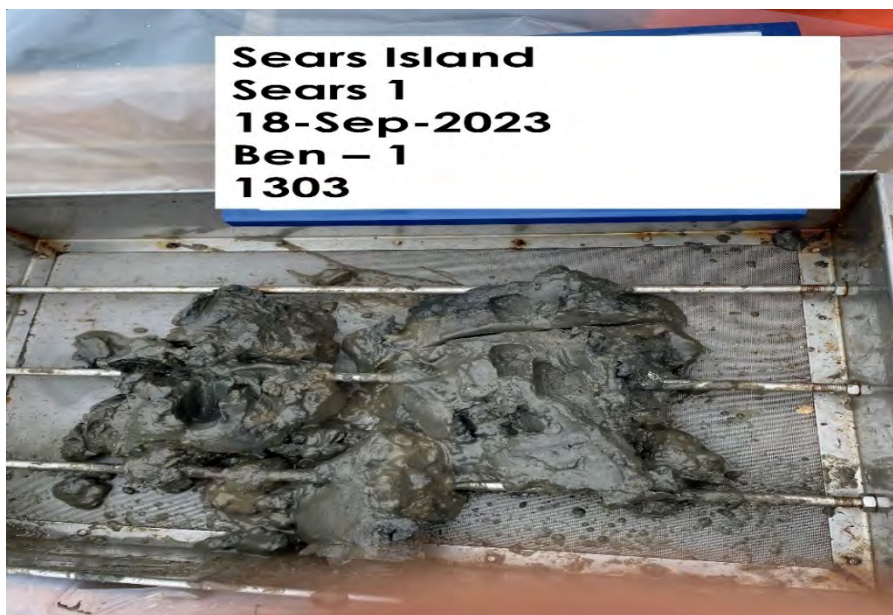
Photo 20. Sears Island Benthic Sample 1. September 2023.

On September 18, 2023, Stantec collected five grab samples from subtidal areas with unconsolidated sediments (Figure 2). The sediments in the five grab samples consisted of olive silt and fine sand (Appendix D: Photos 20–24). Macroinvertebrate samples from the sediment grabs were sent for sorting, enumeration, and speciation to Haley Ward, which is a qualified Maine taxonomic laboratory. Identified species, total number of individuals, individuals per meter squared, species richness (number of species), species evenness (a description of the relative abundance across species in a sample), Shannon-Weiner Index, and functional groups present for each sample per the methods in Ward (1999a) are presented in Appendix E.

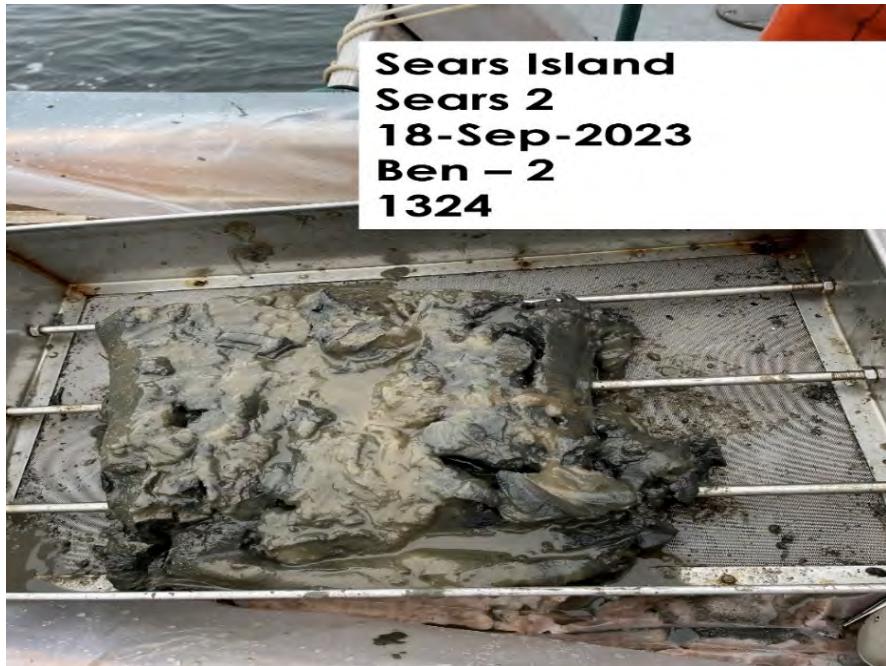
Photo 21. Sears Island Benthic Sample 2. September 2023.

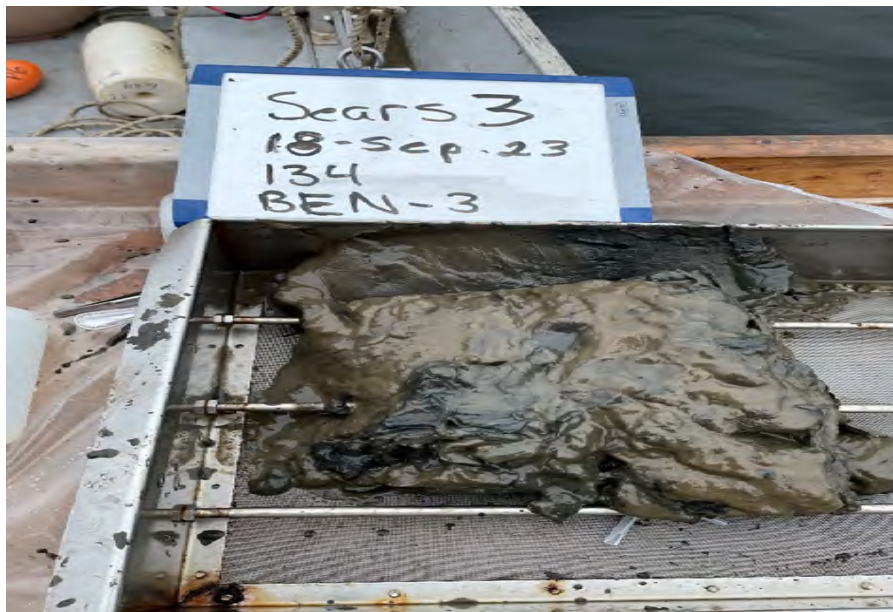
Photo 22. Sears Island Benthic Sample 3. September 2023.

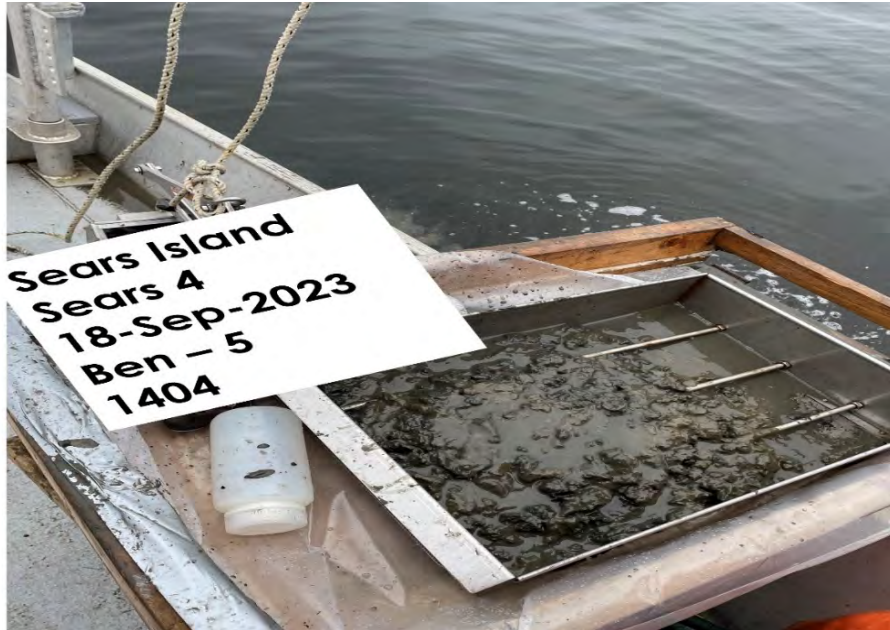
Photo 23. Sears Island Benthic Sample 5. September 2023.

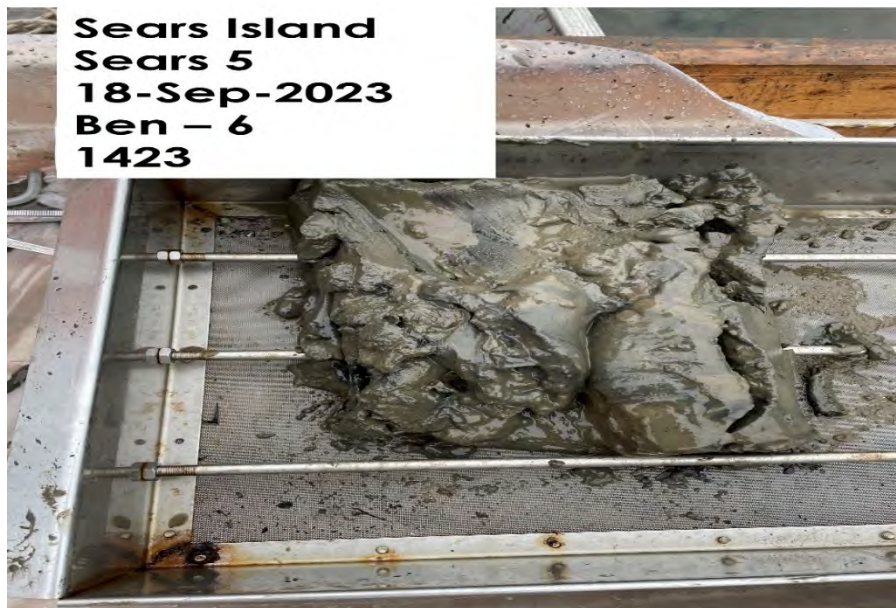
Photo 24. Sears Island Benthic Sample 6. September 2023.

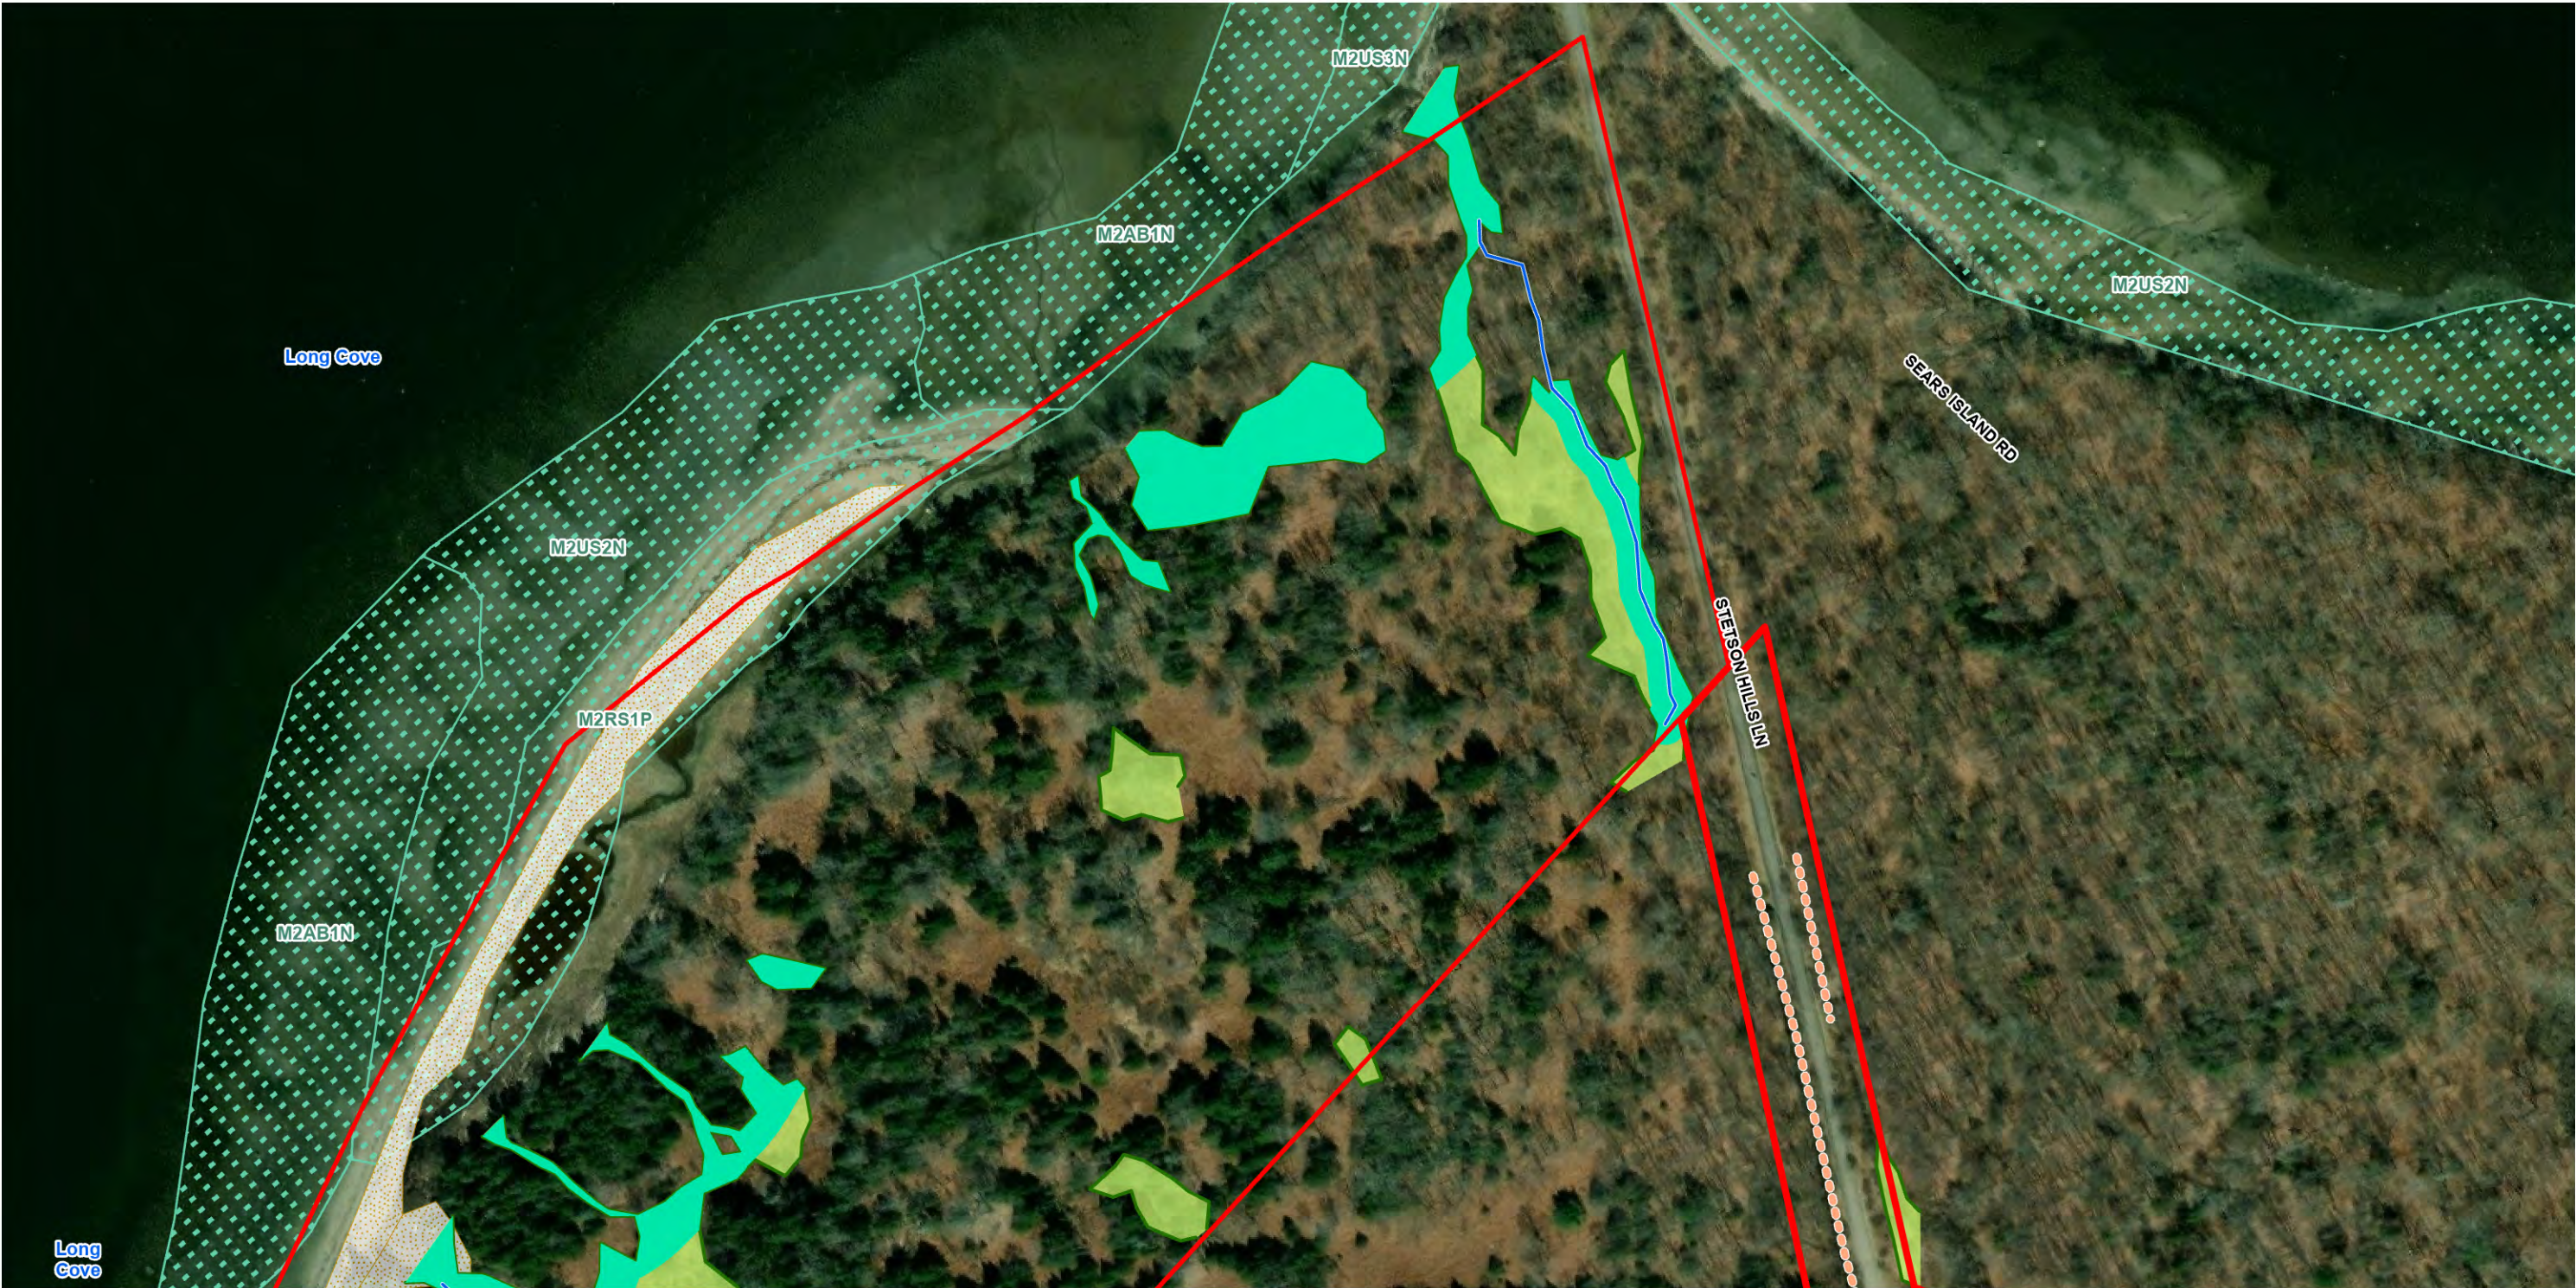
Figure 2: Natural Resources Map

Wetland Resources Delineated by VHB in August/September 2023

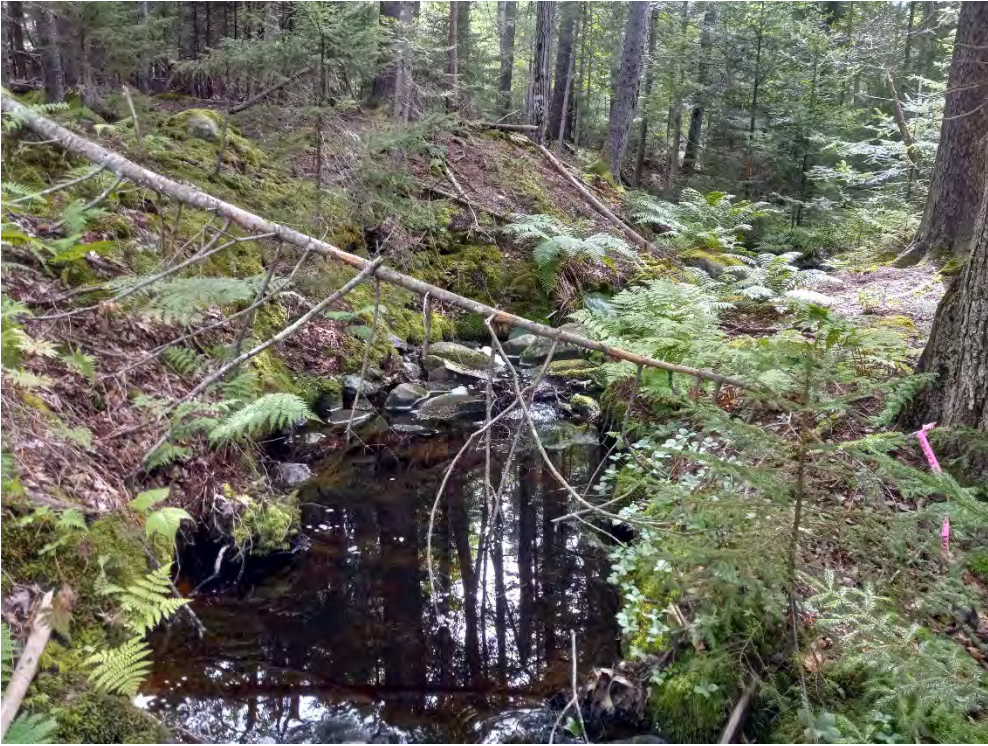
Photo No: 1	
Photo Date: 8-16-23	
Description: Perennial stream Perennial stream in northern portion of site where it enters the Study Area along its eastern boundary.

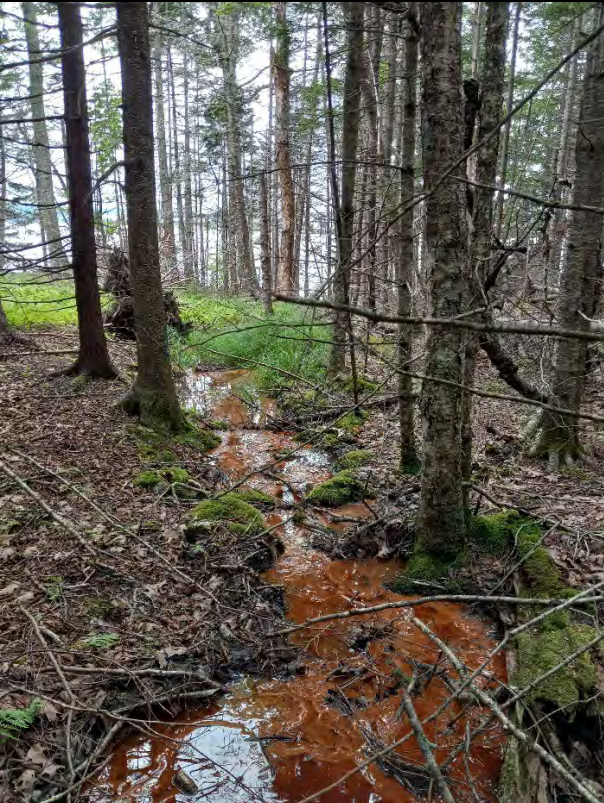
Photo No: 2	
Photo Date: 8-23-23	
Description: Intermittent stream Representative photo of intermittent stream in north-central portion of the study area where it flows west and exits the Study Area.

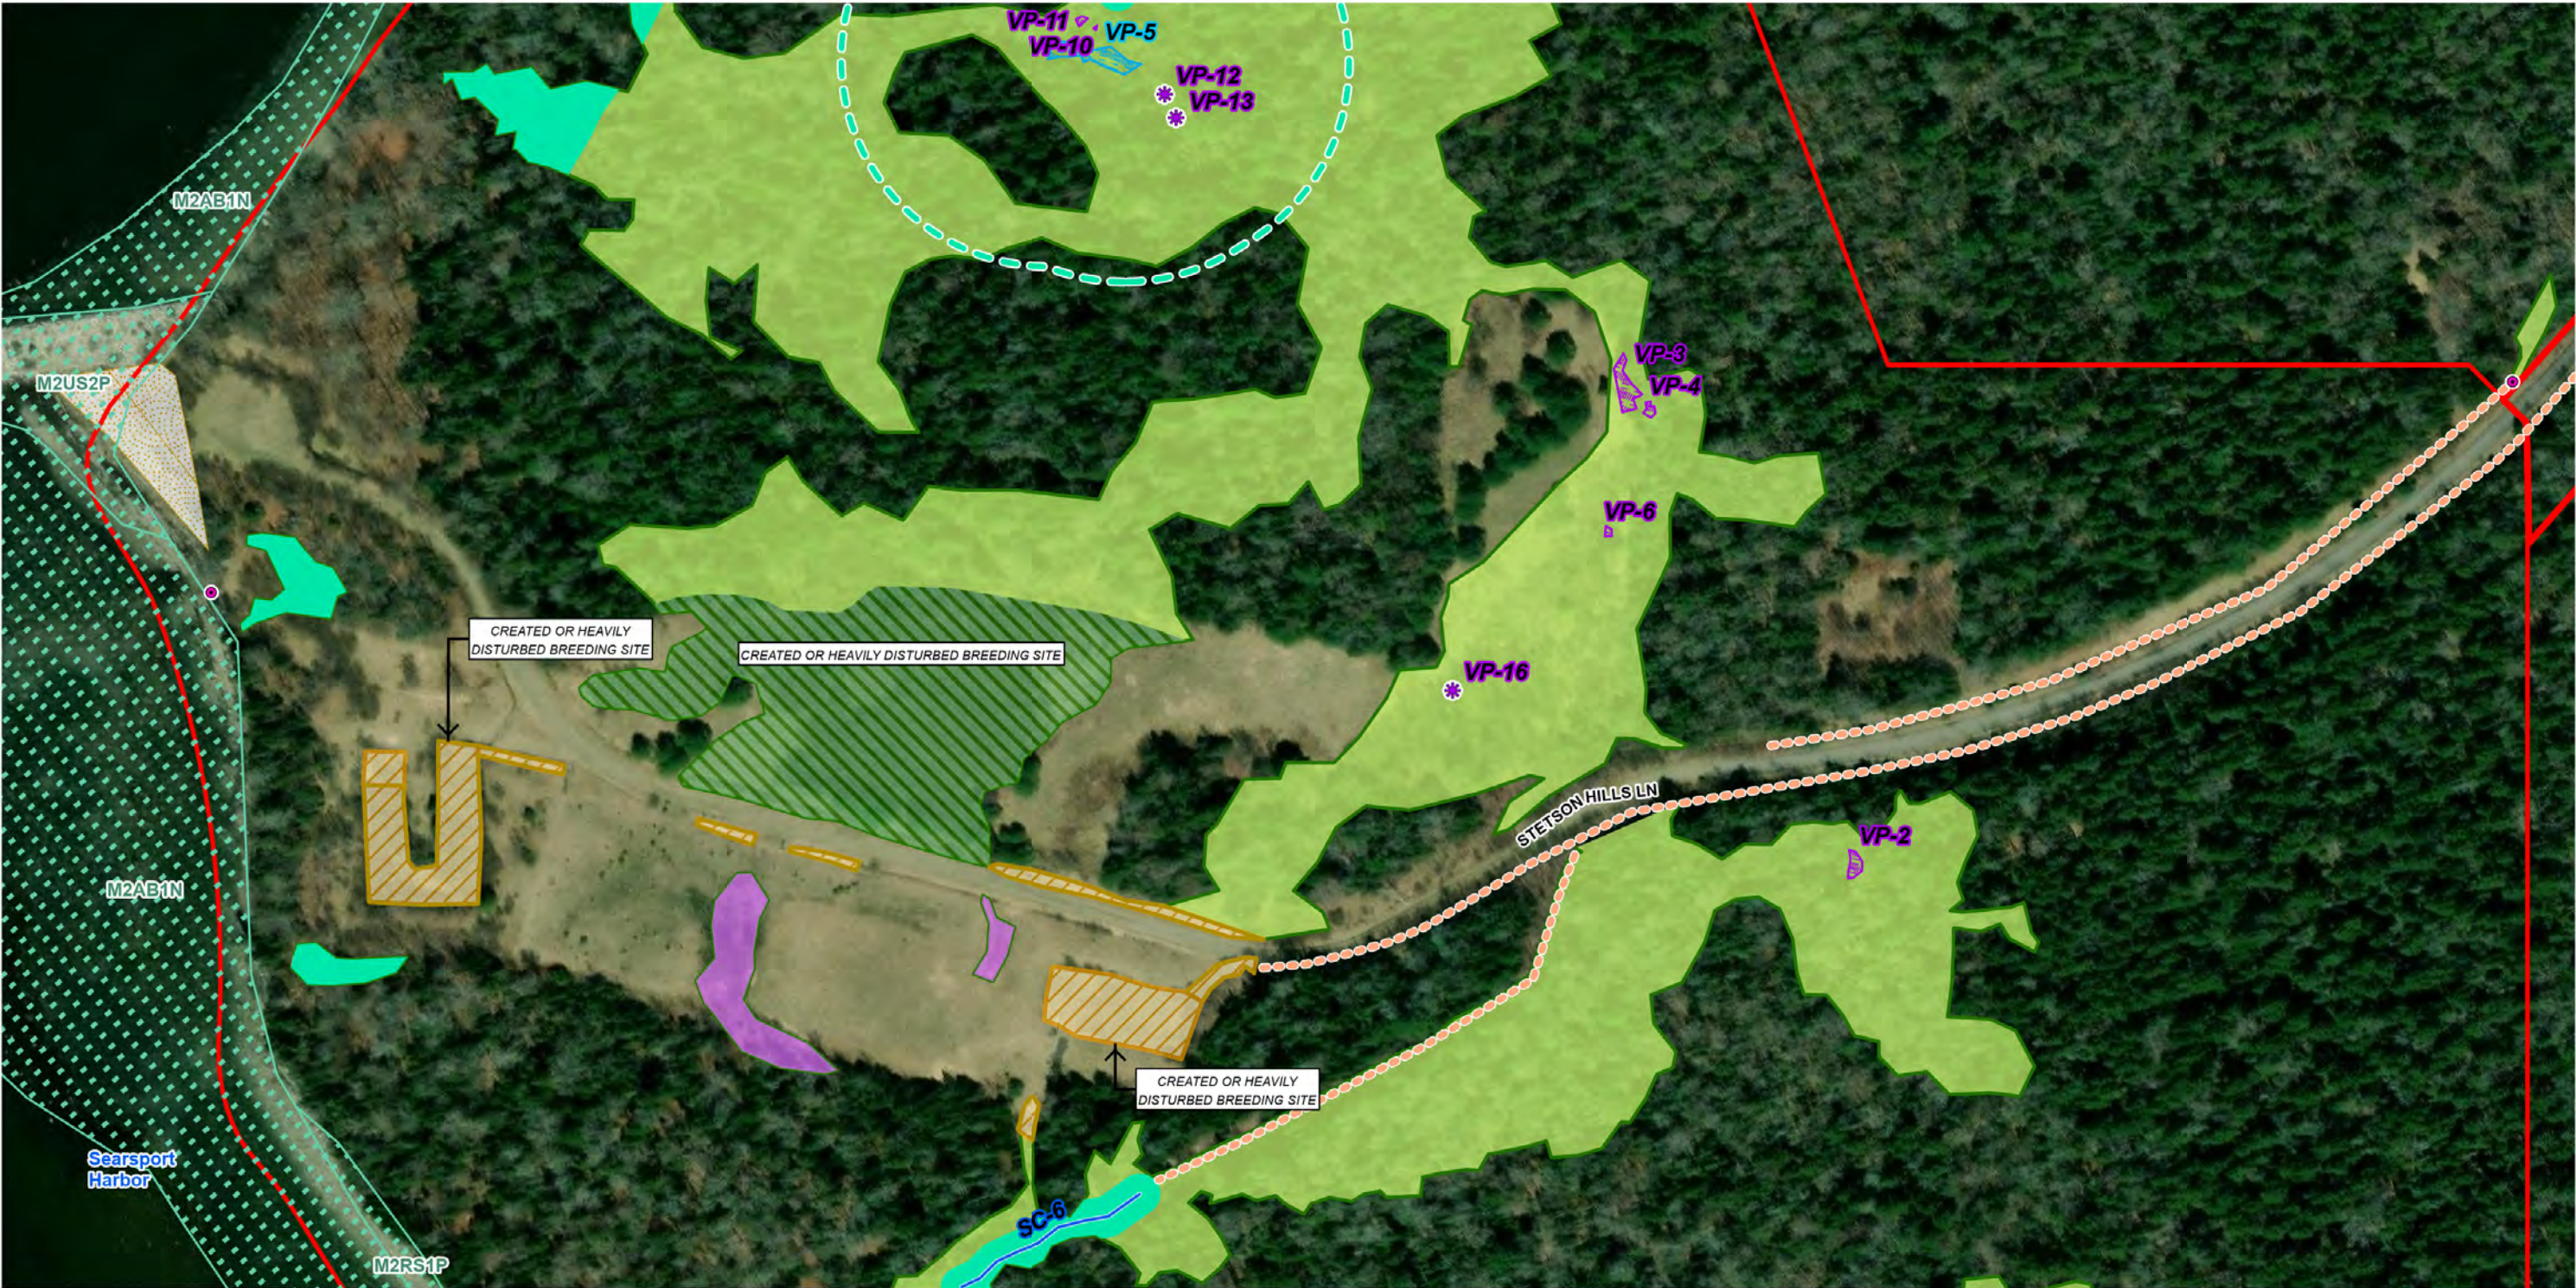
Wetland Resources Delineated by VHB in August/September 2023 and April 2024. Vernal pools surveyed in April and May 2024. **DRAFT**

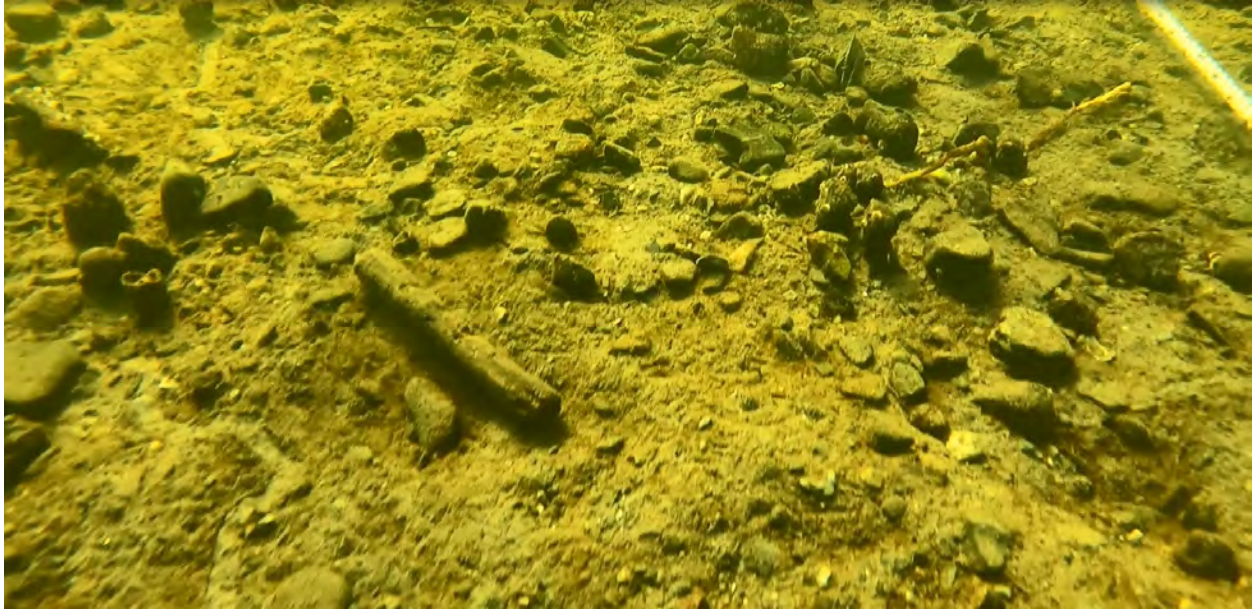
Photo 1. Silty sands with scattered, gravel, cobble, and boulders at Sears Island. September 2023.

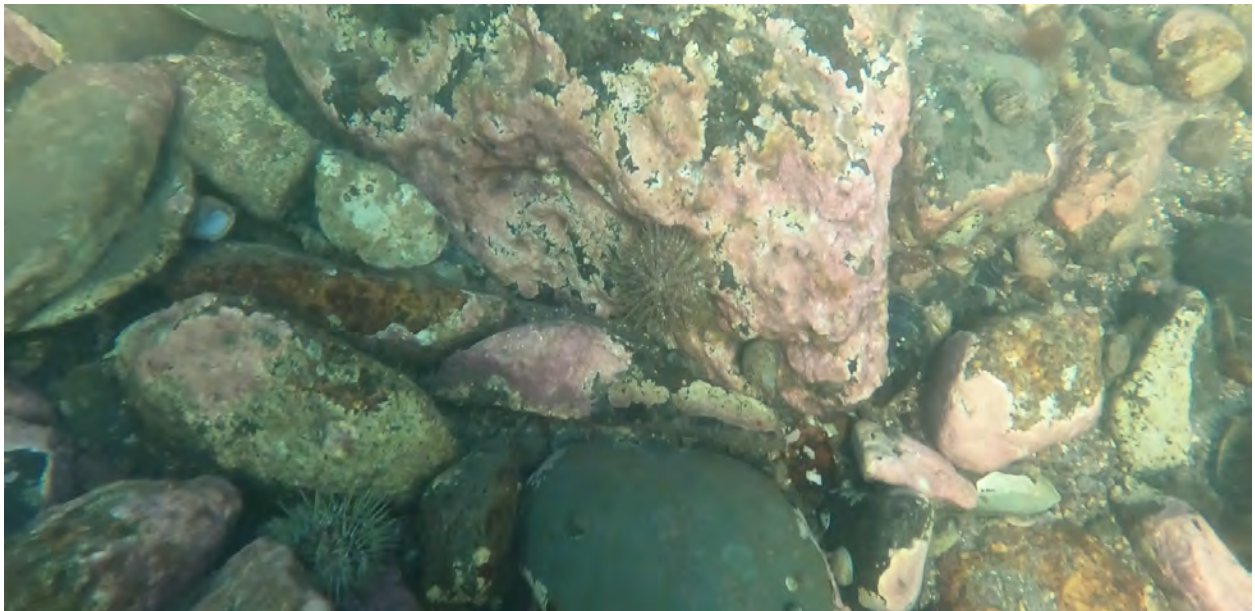
Photo 2. Boulders and cobble with crustose coralline algae due to urchin grazing at Sears Island. September 2023.

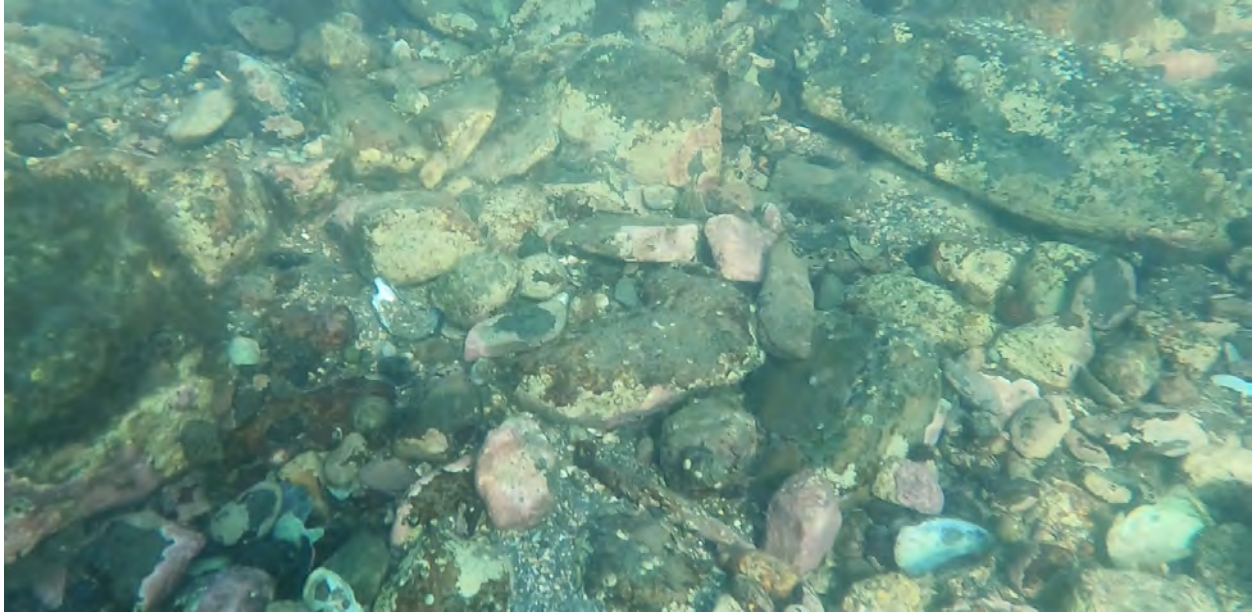
Photo 3. Boulders and cobble with crustose coralline algae due to urchin grazing at Sears Island. September 2023.

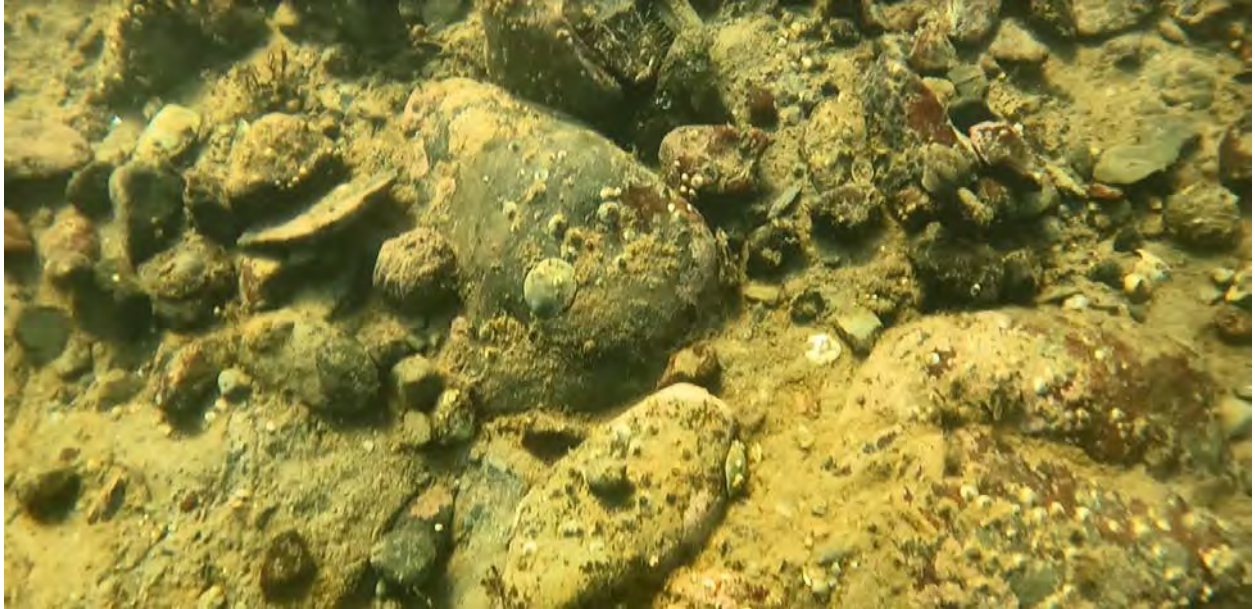
Photo 1. Sandy silt with cobble and gravel substrate at Sears Island. December 2023.

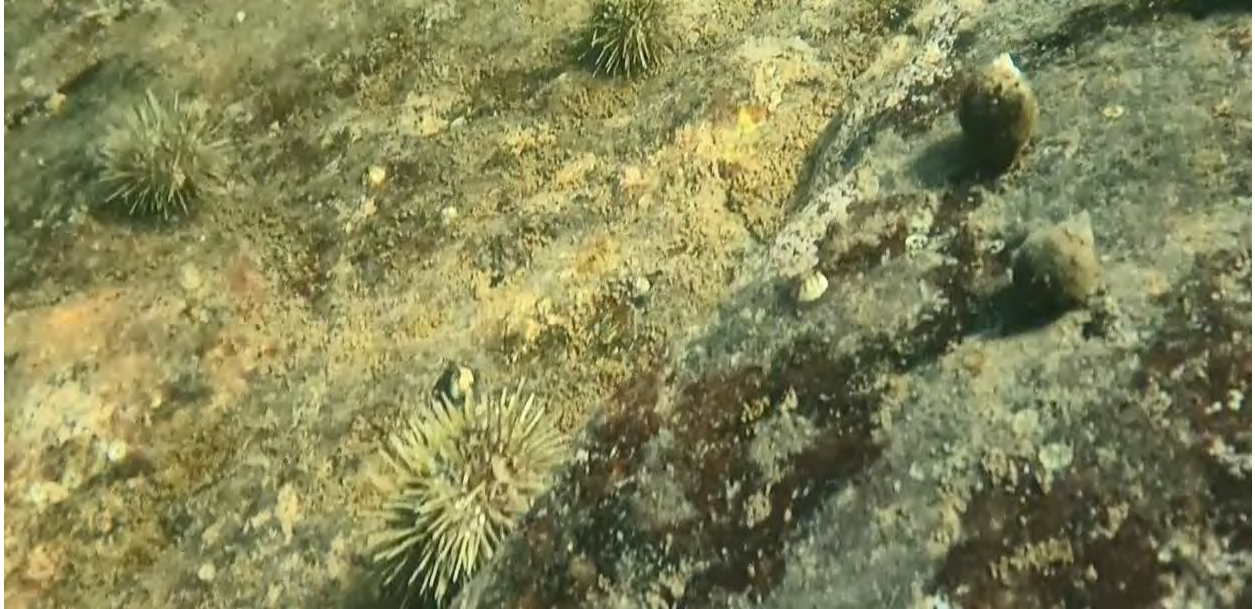
Photo 5. Green sea urchins, common periwinkles, and northern rock barnacles on a boulder in the shallow subtidal at Sears Island. December 2023.

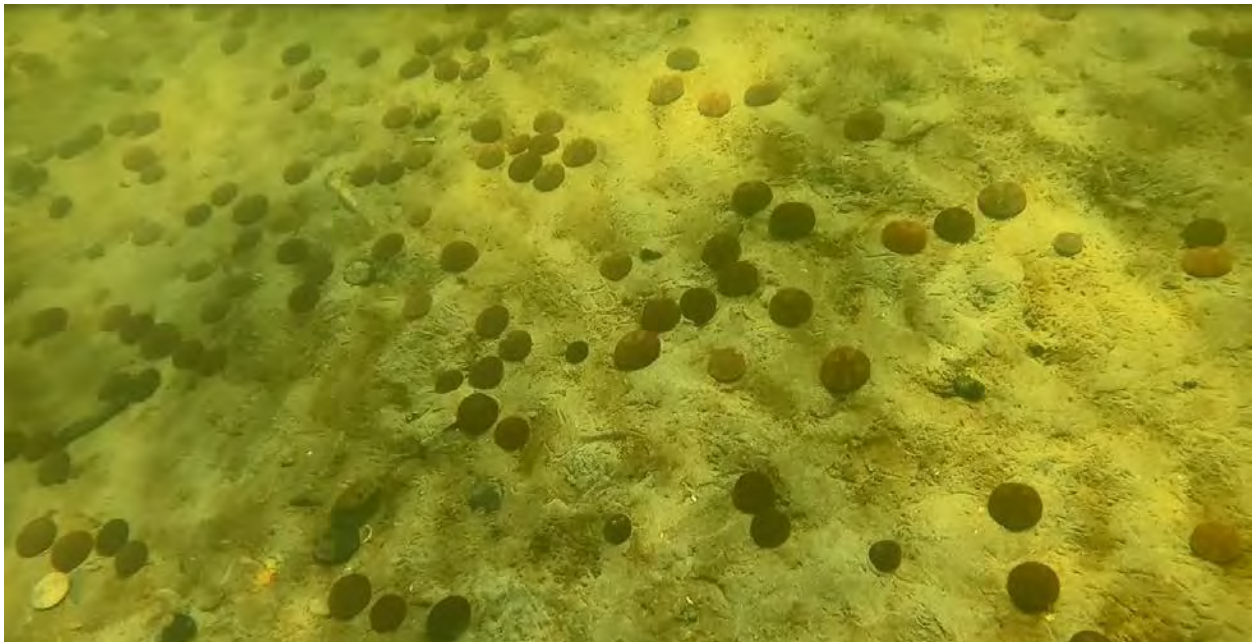
Photo 6. Sand dollars in the sandy silty substrate in the shallow subtidal at Sear Island. December 2023.
