Attachment E

Natural Resources Assessments, Mack Point & Sears Island

Hydrographic and Marine Geophysical Site Characterization Surveys

Mack Point and Sears Island

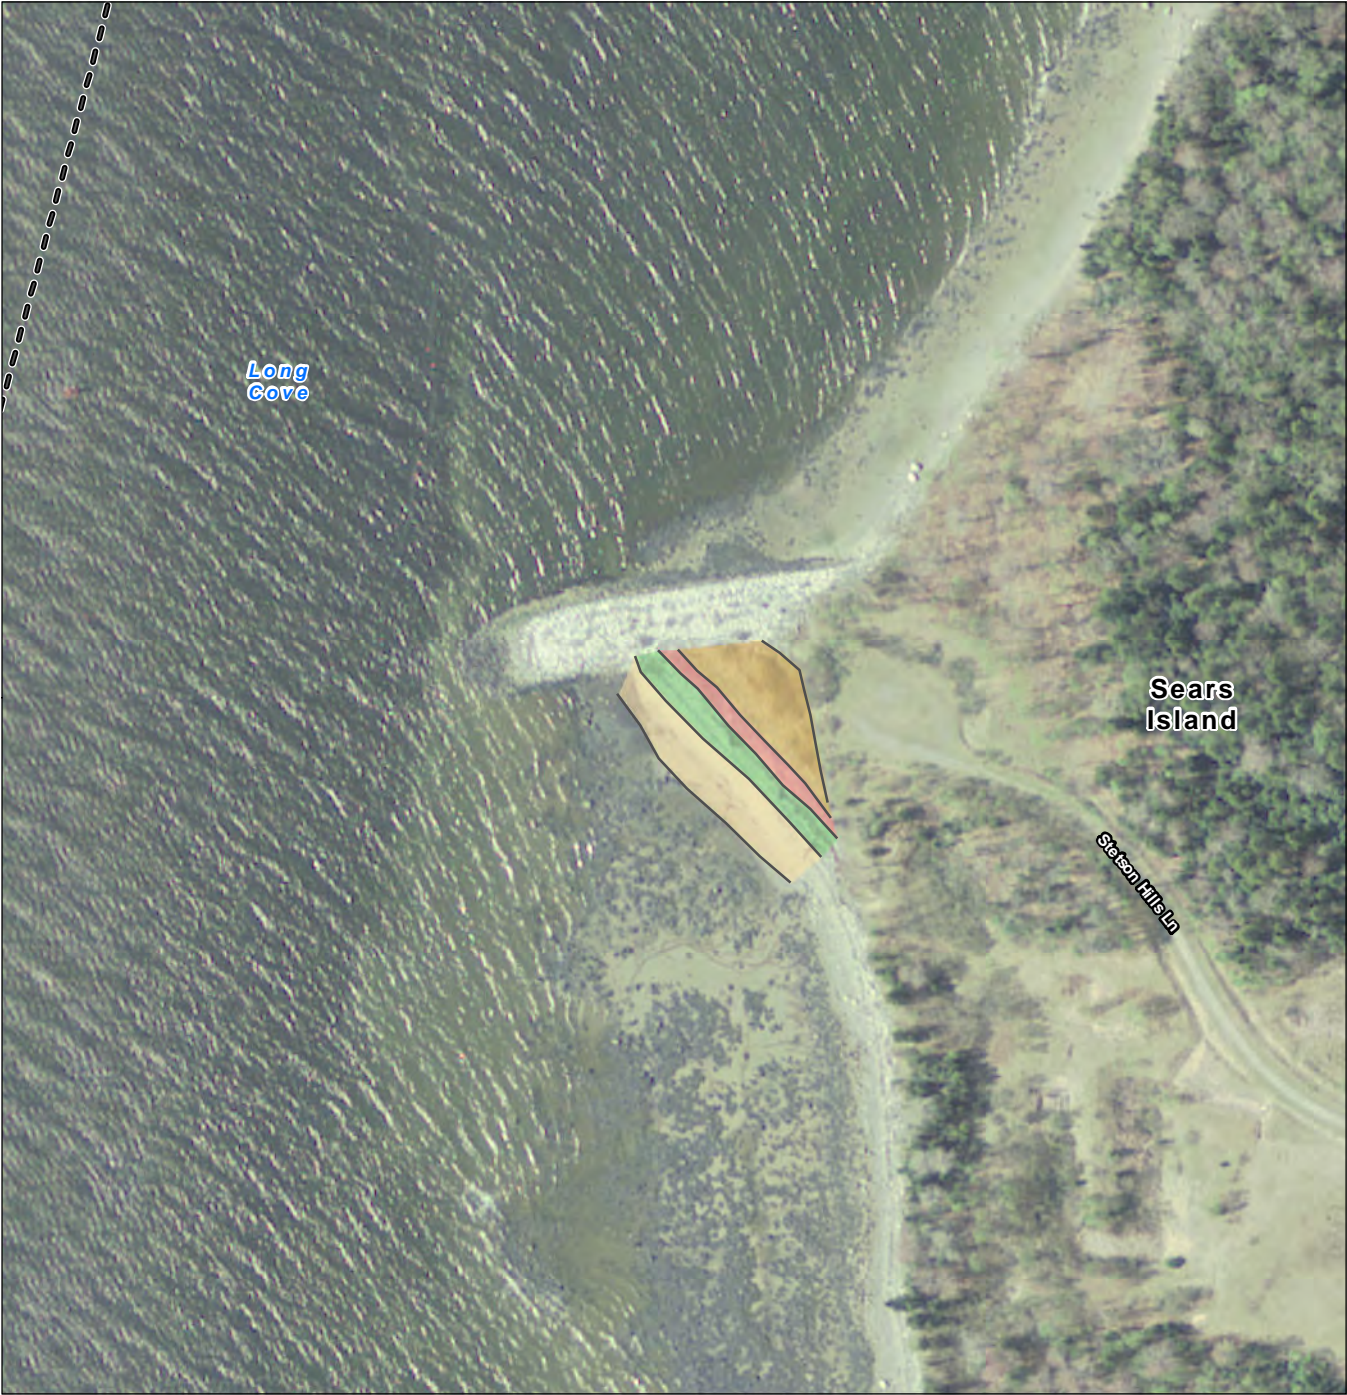
- Coastal Sand Dune Features**
- Back Dune Trough
 - Dune Ridge
 - Frontal Dune Berm
 - Beach

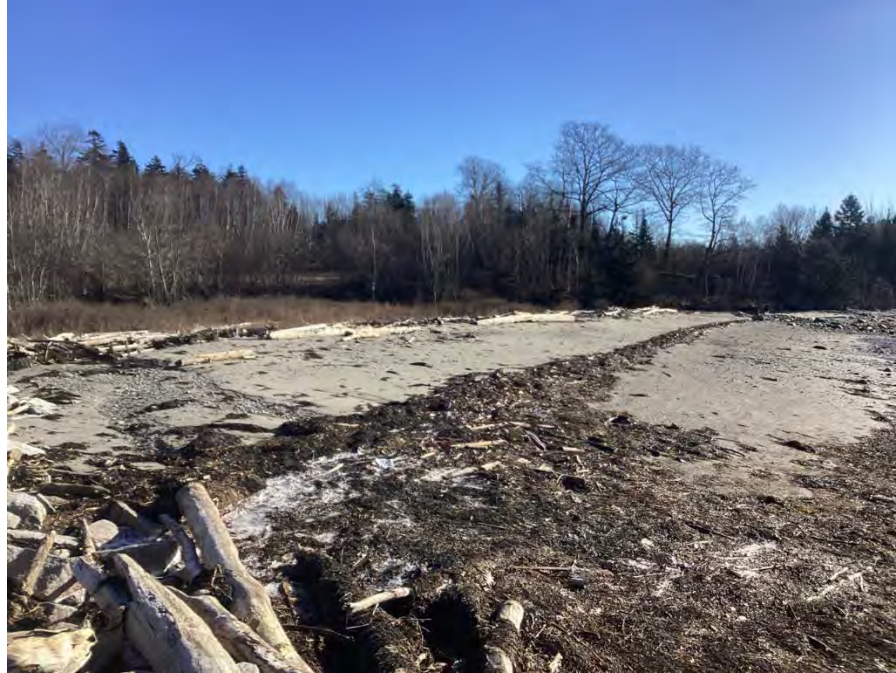
Photo 1. Coastal sand dune system, including beach and berm, view to the south from jetty. Stantec. December 22, 2023.

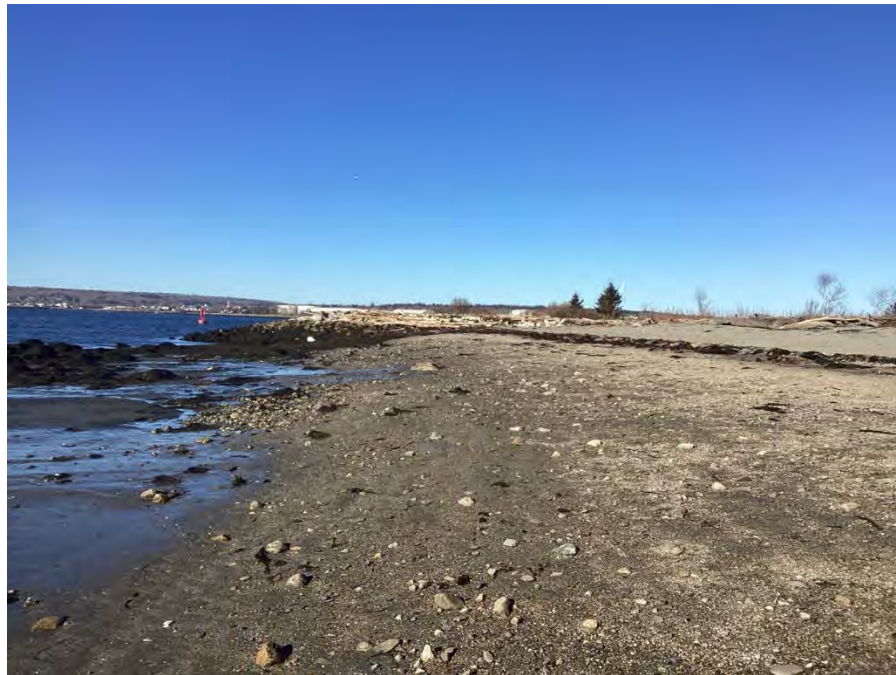
Photo 2. Low beach area, view to the north. Stantec. December 22, 2023.

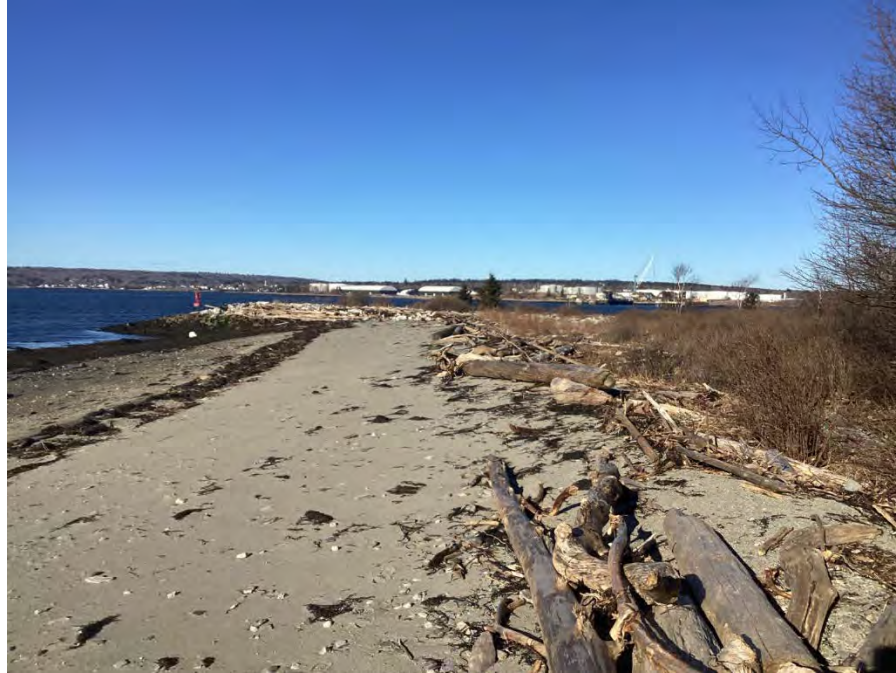
Photo 3. Dune berm and frontal dune ridge, view to the north. Stantec. December 22, 2023.

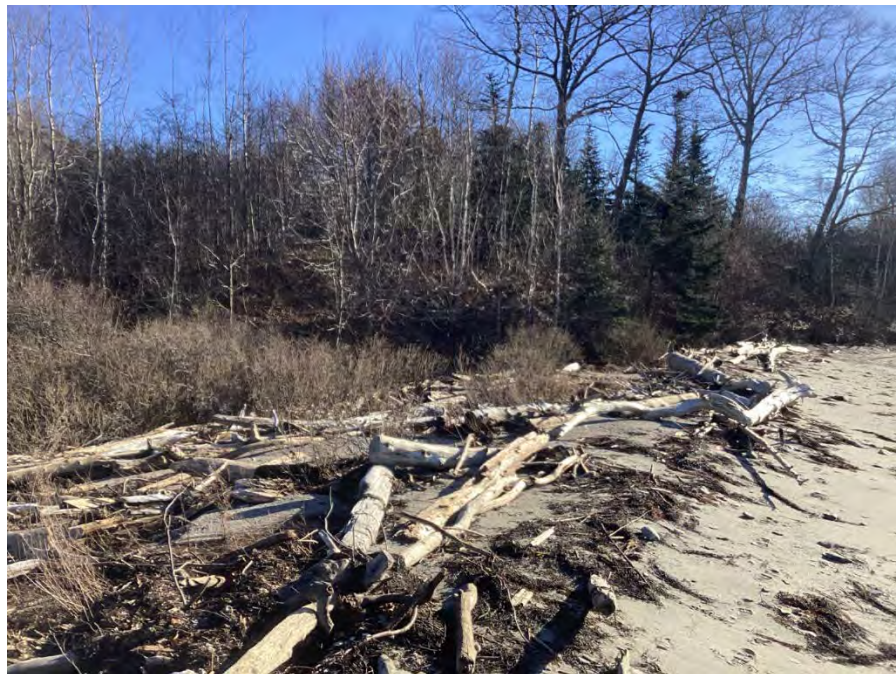
Photo 4. Frontal dune ridge with accumulation of wrack debris, view to the southeast. Stantec. December 22, 2023.

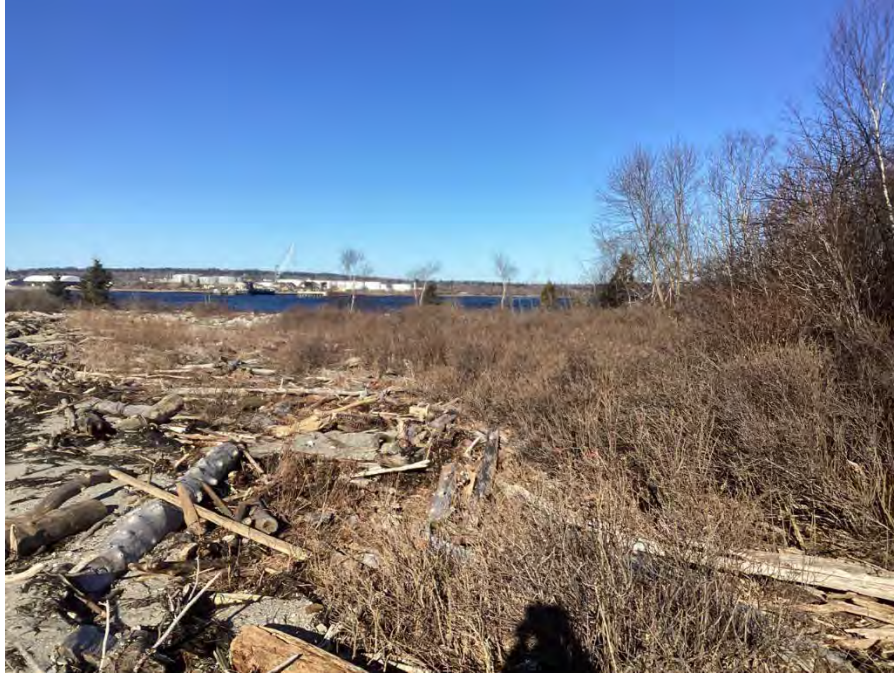
Photo 5. Back dune trough area dominated by beach rose, view to the north. Stantec. December 22, 2023.

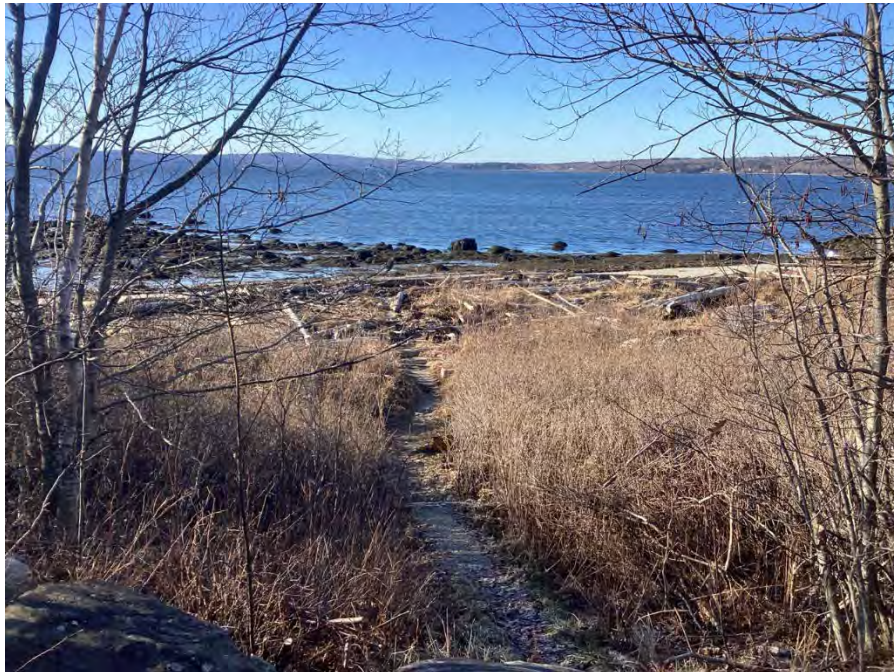
Photo 6. Back dune trough area dominated by beach rose, view to the west. Stantec. December 22, 2023.

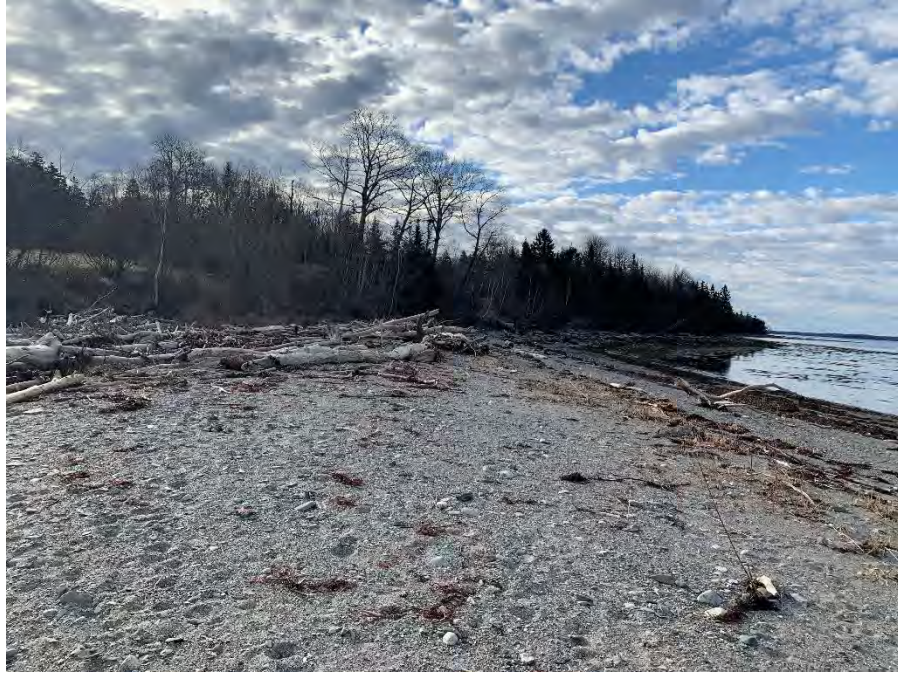
Photo 7. Additional debris present on sand dune due to winter storms. Stantec. April 2, 2024.

A site visit was conducted on April 2, 2024, to verify winter storms had not modified the dune. The survey found little had changed since the December 2023 survey, with the exception of some additional debris accumulation (Photos 7 and 8).

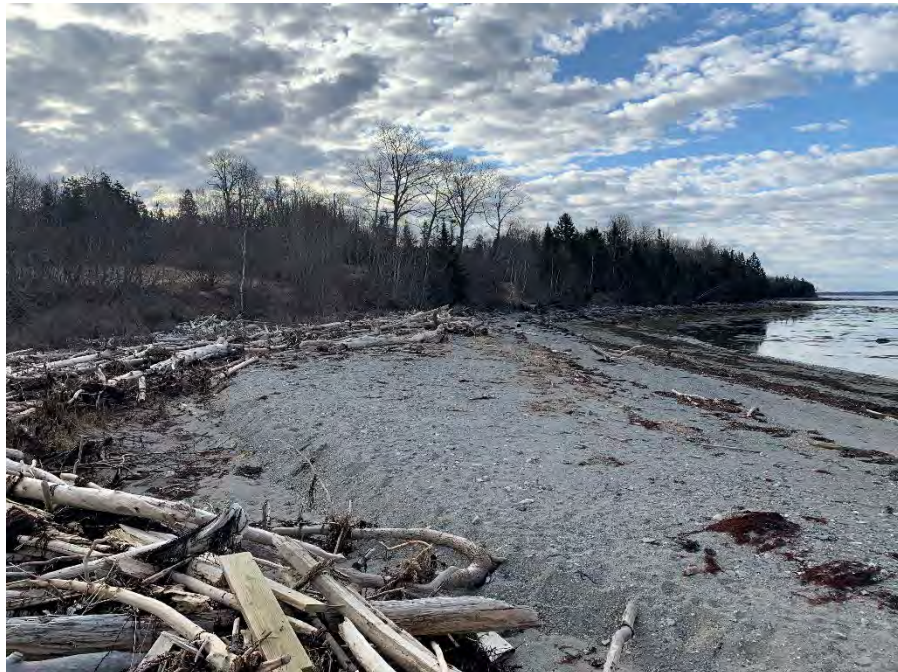
Photo 8. Additional debris present on sand dune due to winter storms. Stantec. April 2, 2024.
