### Technical Report 16-15

#### *Advanced Bridge Safety Initiative: Phase 2*

#### *Task 3- Instrumentation During Live Load Testing and Load Rating of Five Reinforced Concrete Slab Bridges*

*May 2016*

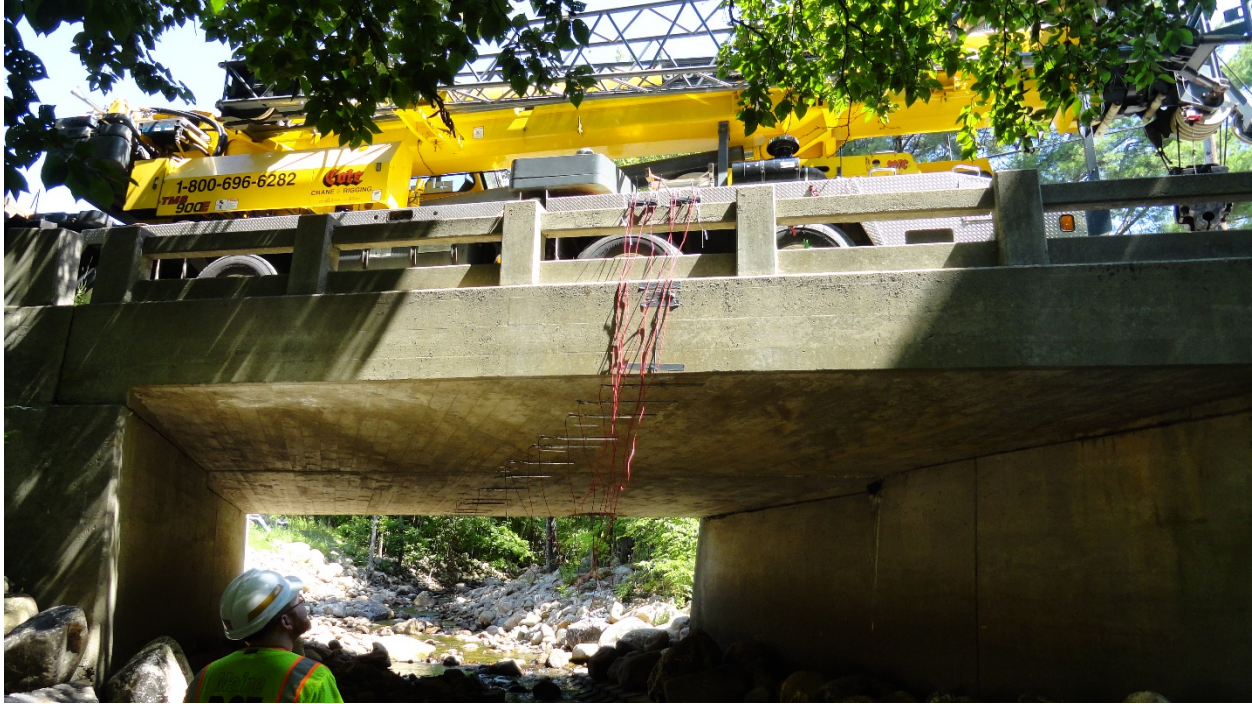
Figure 7: Weld No. 5361 general condition

The highest measured strain recorded from the live load test of Weld No. 5361 was  $34 \mu\epsilon$ , which is low relative to the other four bridges tested. While the bridge has the longest clear span of all tested slabs at 360 in, the 19 in thick structural slab was likely stiffened by the additional 3 in concrete wearing surface noted on the plans. A review of the load rating analysis performed by the MaineDOT using input values from a load rating conducted independently by a consultant showed the main reinforcing steel as 1.25 in diameter bars spaced at 7.75 in on center, giving a steel area of  $1.9 \text{ in}^2/\text{ft}$ . The MaineDOT load rating conducted per *SlabRate* yielded an HL-93 inventory rating of 0.91. However, the plans indicate #11, 1.25 in square bars with a cross-sectional area of  $1.56 \text{ in}^2$  each. Further, the bar spacing of 7.75 shown on the plans is along the 30 degree skew, and the actual bar spacing parallel to the span is 6.71 in. Therefore, the actual

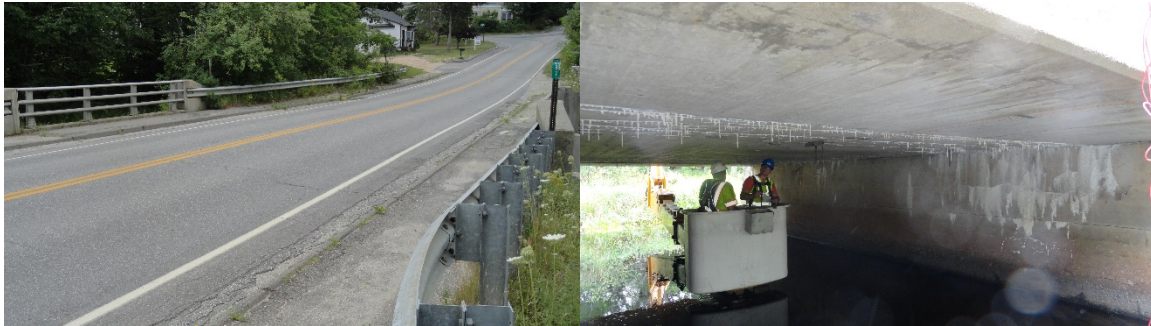
Figure 14: Penobscot No. 3297 overall configuration with sidewalks and new/ old/ new underneath

effectively transfer shear and could transfer significant longitudinal bending. Consistent with the MaineDOT load ratings and the uncertainty of load transfer across the joint, the initial FE models ignored the new sections of slab and conservatively treated the old portion of the slab as an independent structure. The general condition is shown in Figure 14, with the stelactites indicating the two joints between new/ old/ and new sections.

The original portion is on average 24.25 ft wide, and has an average thickness of gravel of approximately 17 in on top of the slab and below the asphalt wearing surface. The concrete compressive strength was assumed to be 4 ksi, which corresponds to an elastic modulus of 3600 ksi, likely a reasonable or conservatively higher value.
