# Maine Coastal Program Coastal Zone Management Act Federal Consistency Submission Form

| Project/Activity Name:<br>Bolt Hill Substation Project | | |
| Federal Agency:<br>U.S. Army Corps of Engineers | | |

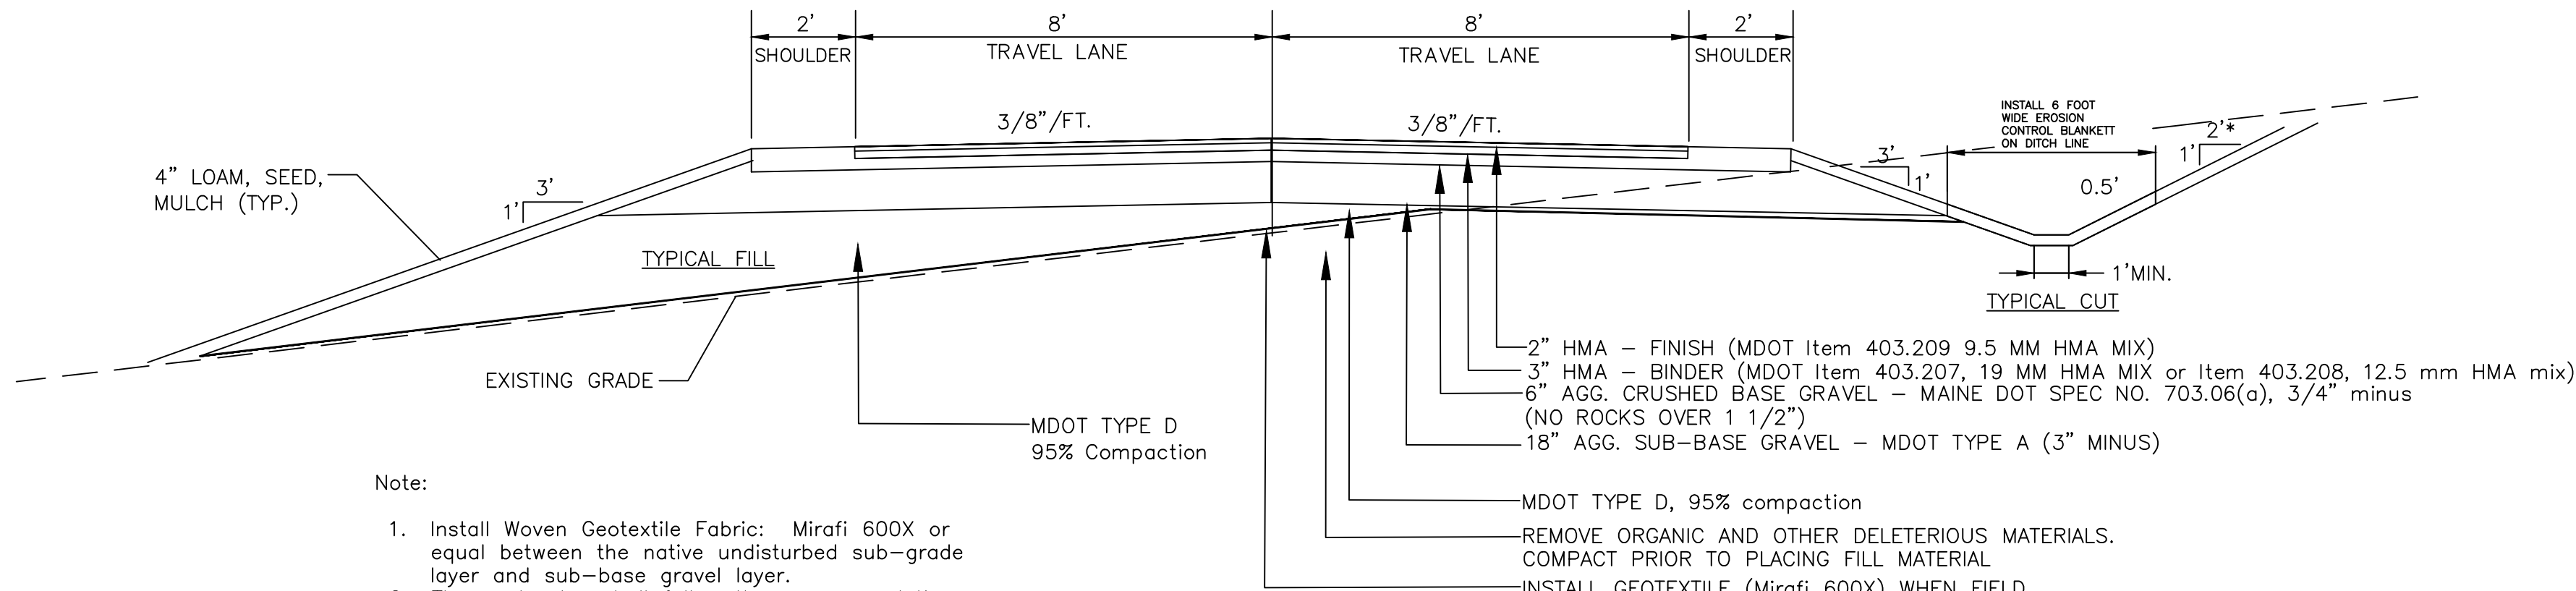
- Note:
1. Install Woven Geotextile Fabric: Mirafi 600X or equal between the native undisturbed sub-grade layer and sub-base gravel layer.
  2. The contractor shall follow the recommendations of the SW Cole Geotechnical Report completed for the Bolt Hill Substation project in Eliot, Maine, dated May 22, 2023.
  3. Remove unsuitable soils minimum of 12 inches. Replace with compacted MDOT Type D Subgrade fill on top of geotextile.

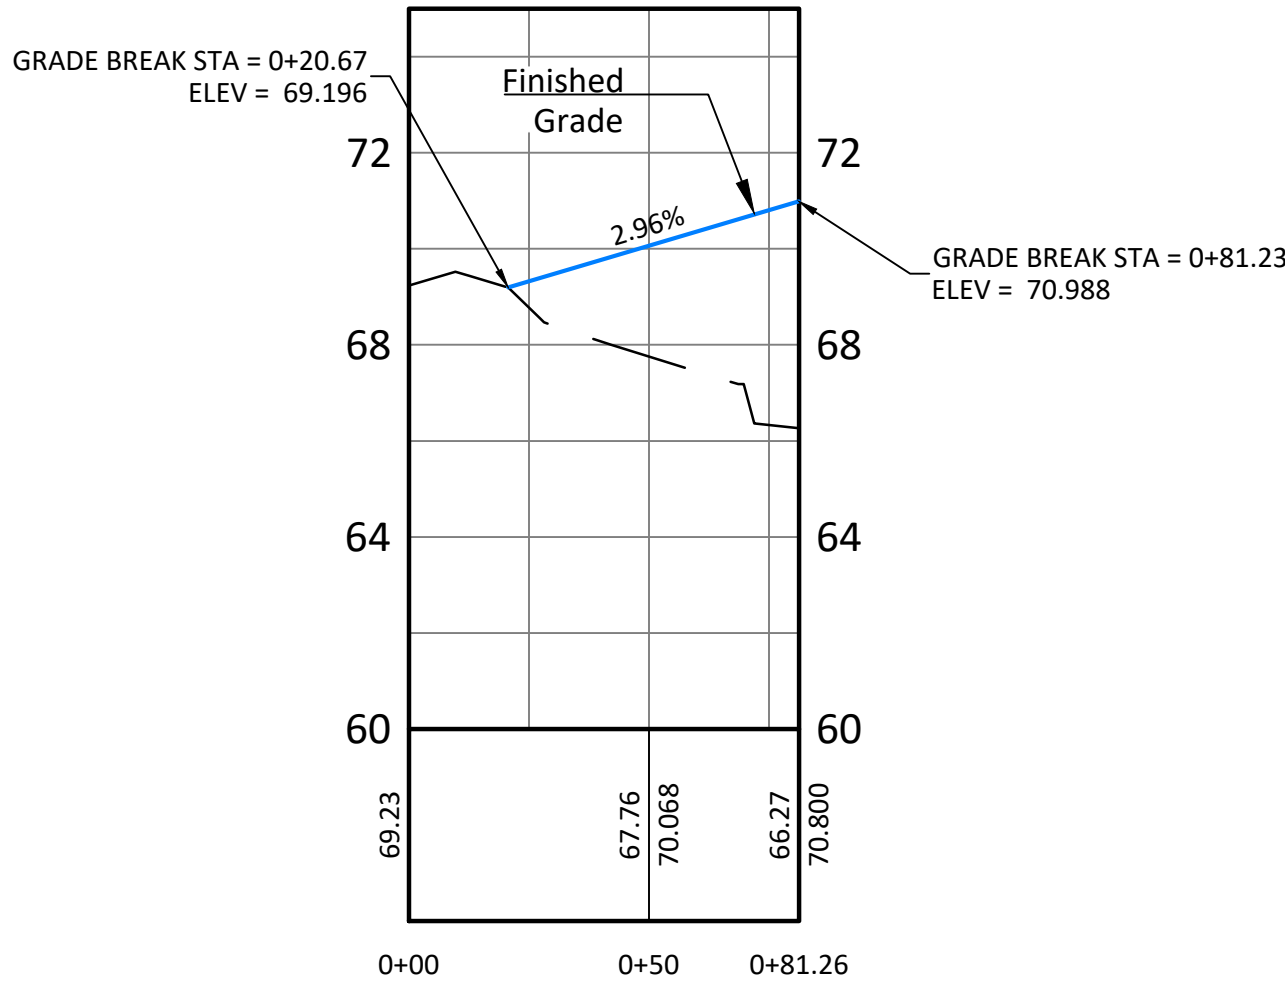
Access Drive West Side PROFILE

Scale:  
1"=40' Horizontal  
1"=4' Vertical

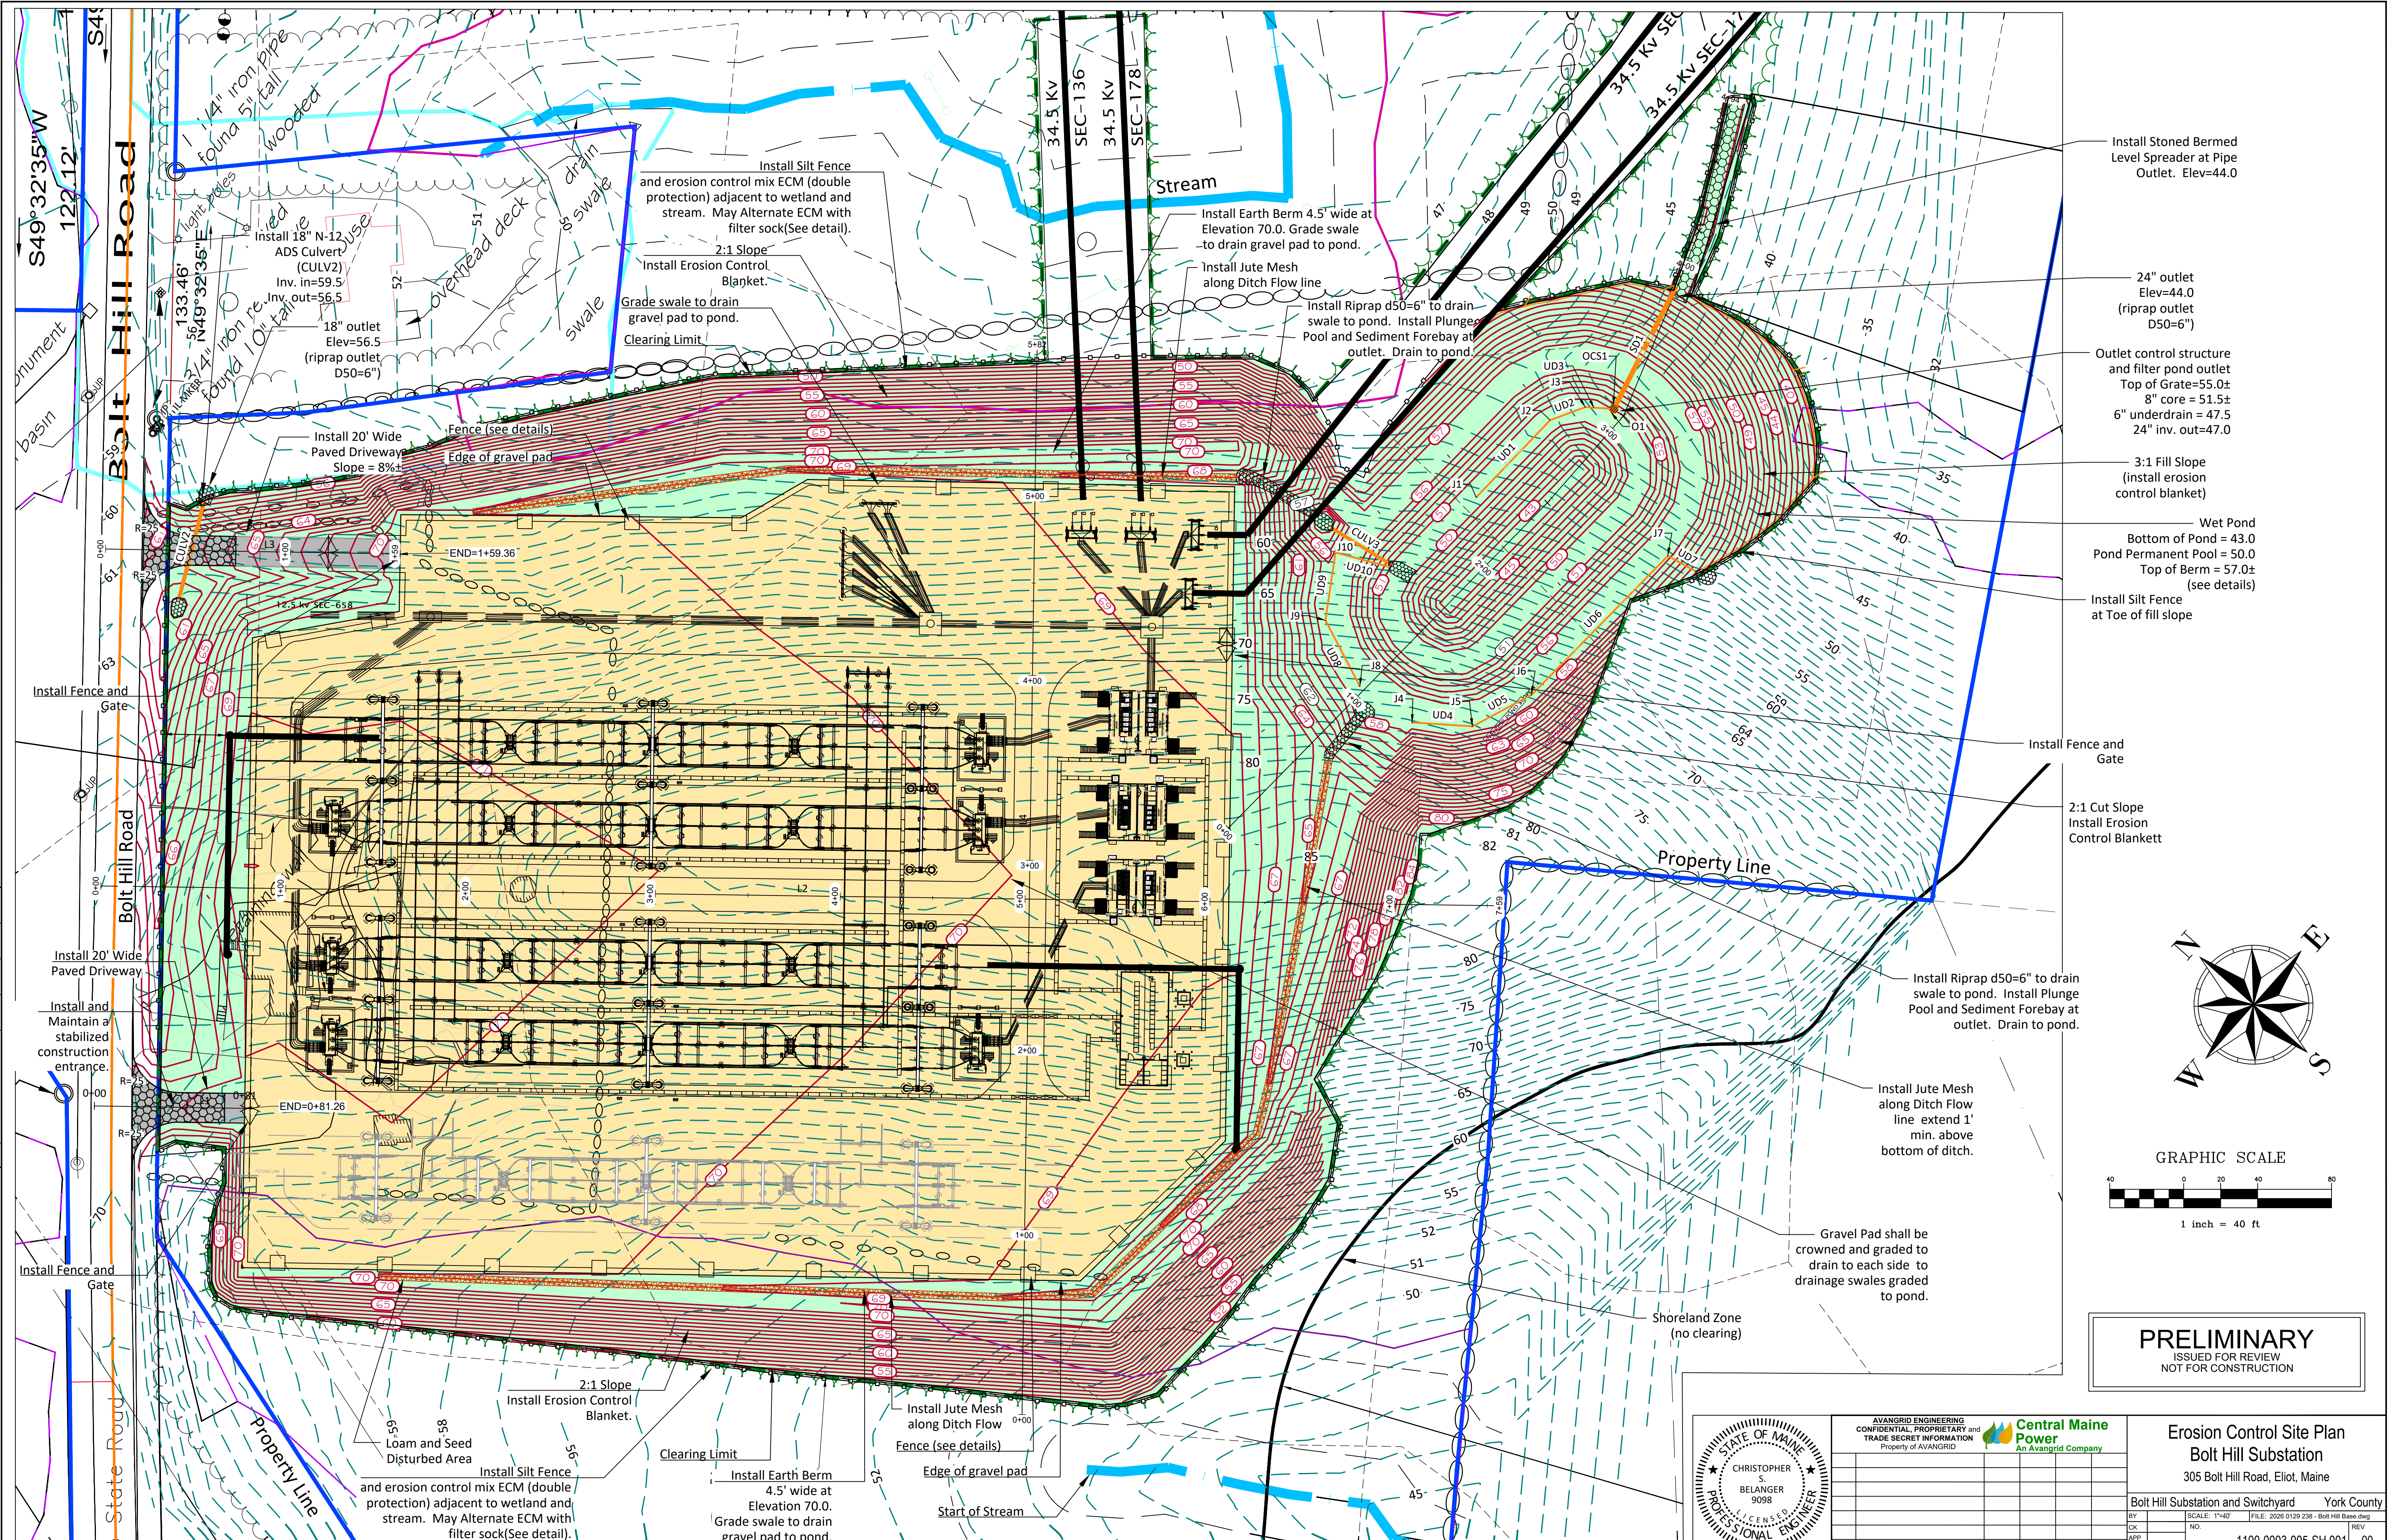
- Install Stoned Bermed Level Spreader at Pipe Outlet. Elev=44.0
- 24" outlet Elev=44.0 (riprap outlet D50=6")
- Outlet control structure and filter pond outlet Top of Gate=55.0± 8" core = 51.5± 6" underdrain = 47.5 24" inv. out=47.0
- 3:1 Fill Slope (install erosion control blanket)
- Wet Pond Bottom of Pond = 43.0 Pond Permanent Pool = 50.0 Top of Berm = 57.0± (see details)
- Install Silt Fence at Toe of fill slope

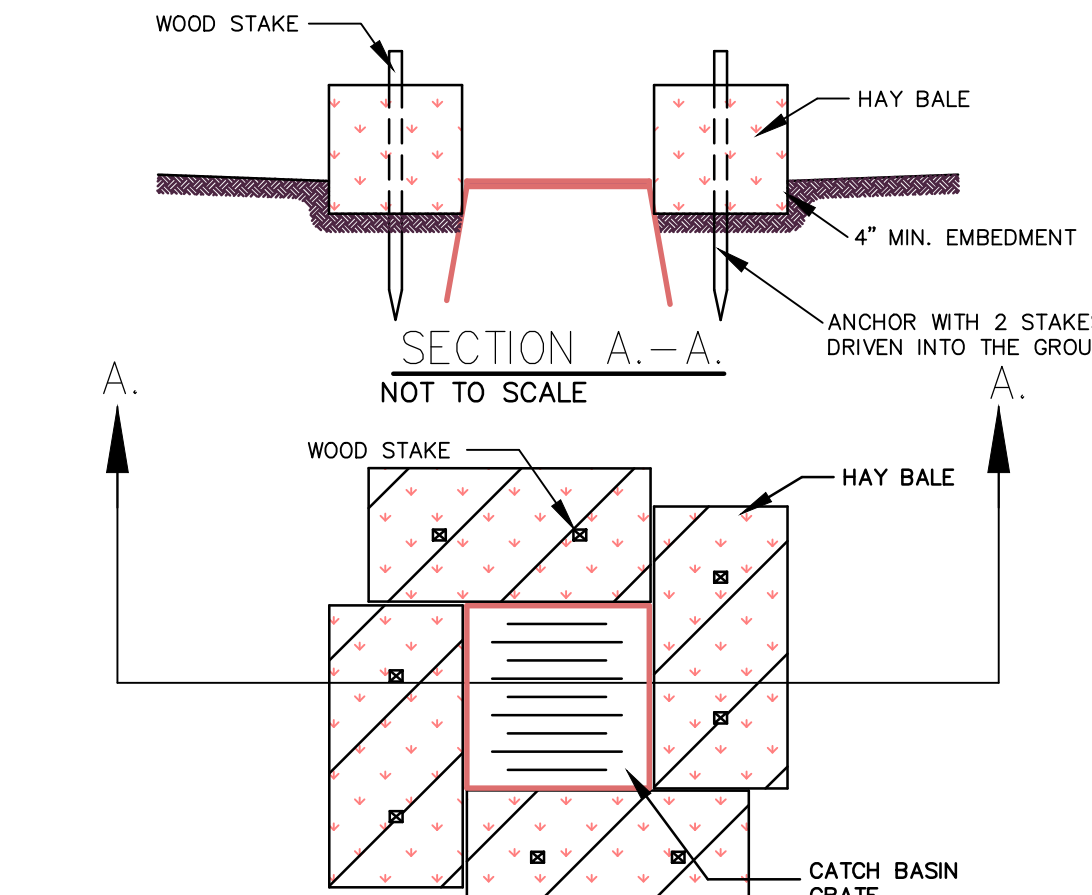
CATCH BASIN HAY BALE BARRIER DETAIL

2. INSPECTION SHOULD BE FREQUENT AND REPAIR OR REPLACEMENT MADE PROMPTLY AS NEEDED. CHECK AFTER EACH RAINFALL.

3. BARRIERS SHOULD BE REMOVED WHEN THEY HAVE SERVED THEIR USEFULNESS, BUT NOT BEFORE THE UPSLOPE AREAS HAVE BEEN PERMANENTLY STABILIZED.

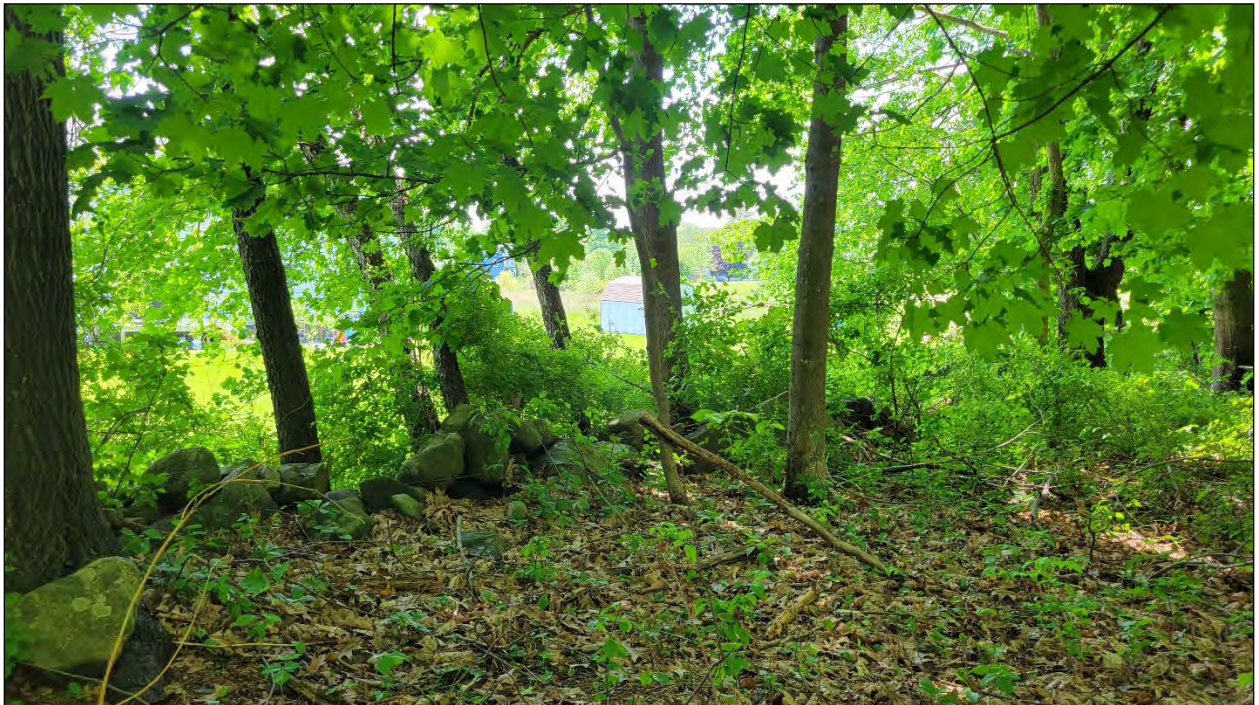
**Figure 9. View south of remnant stone wall in SA-03.**

SA-03 and SA-04 were both identified as possibly sensitive for precontact archaeological materials, SA-03 on the basis of soils and slope and SA-04 on the basis of the nearby perennial Spinney Creek. No archaeological sensitivity was identified for SA-03. The terrain is generally sloping, with no definable landforms present and a wet, uneven surface, making it unlikely that a precontact site is present. Although a remnant stone wall was observed in the eastern portion of SA-03, no other postcontact remains were present. **Figure 8** shows representative conditions in SA-03, while **Figure 9** shows the remnant stone wall feature.

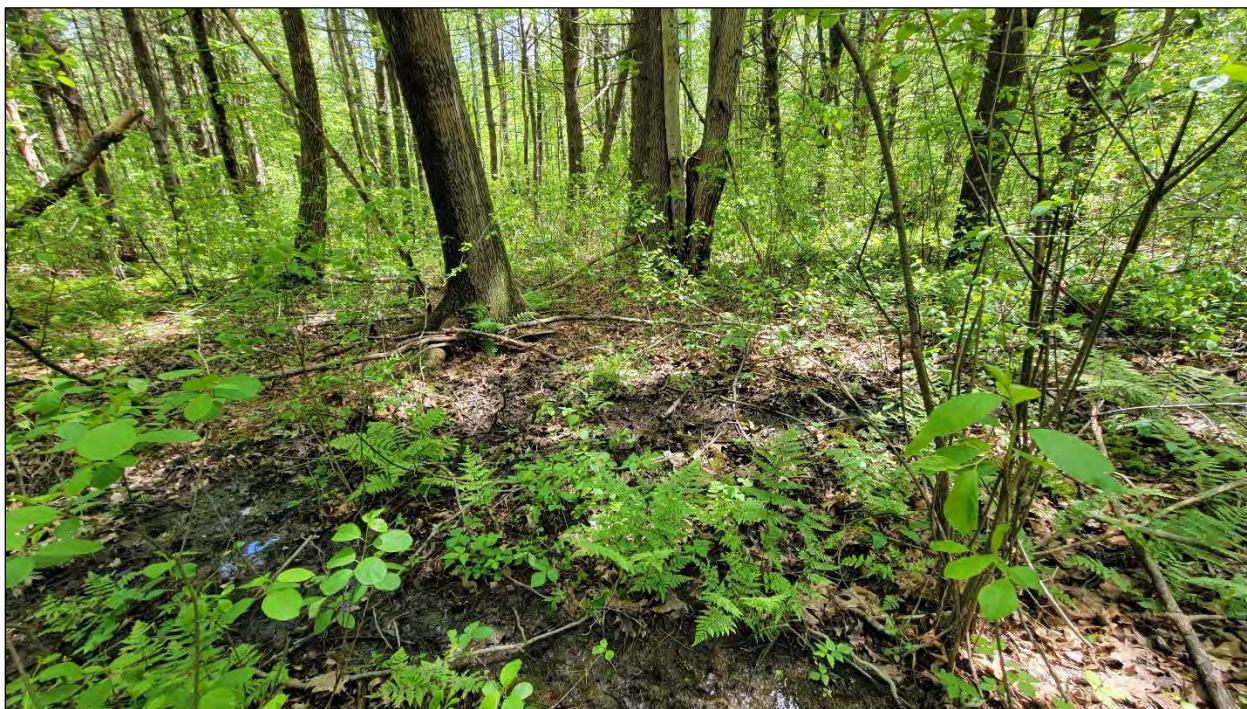
**Figure 11. View south from within SA-04 showing seasonal wetland conditions.**

Pedestrian inspection of SA-04 found it to be a low lying area with a hummocked and spongy ground surface suggesting seasonal wetland conditions, making it unlikely that a precontact site is present. **Figure 10** and **Figure 11** show the conditions encountered in SA-04.

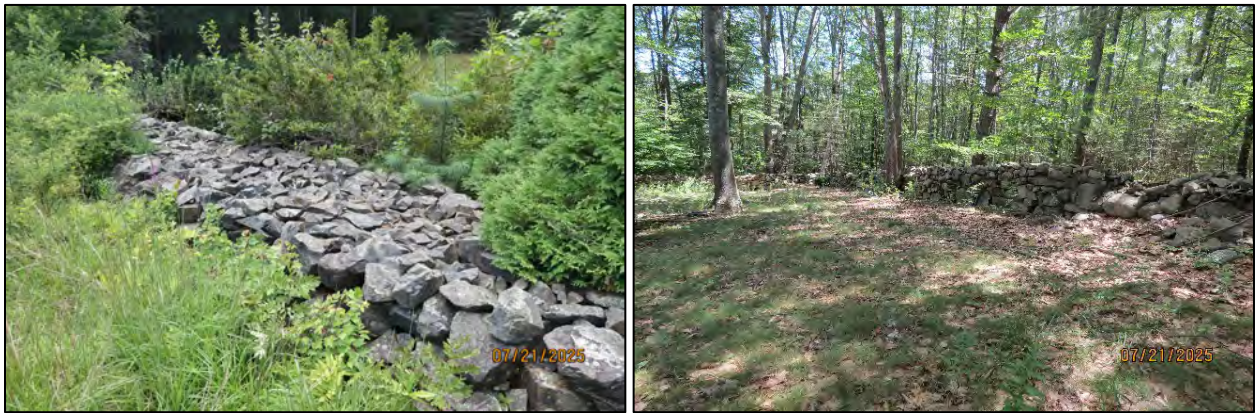
Figure 3. Northeastern retaining wall, facing north (left); southeastern boundary wall, facing northeast (right).

The stone walls consist of cut stones and field stones, and are constructed within the interior of the parcel and along its borders. The stone walls along the northeastern and southwestern boundaries of the parcel were constructed for use as retaining walls (**Figure 3**). The stone wall on the southeastern boundary of the property appears to be constructed as a property boundary marker (**Figure 3**). The stone walls within the interior of the parcel appear to have been constructed for decorative purposes and are associated with a previously existing garden.

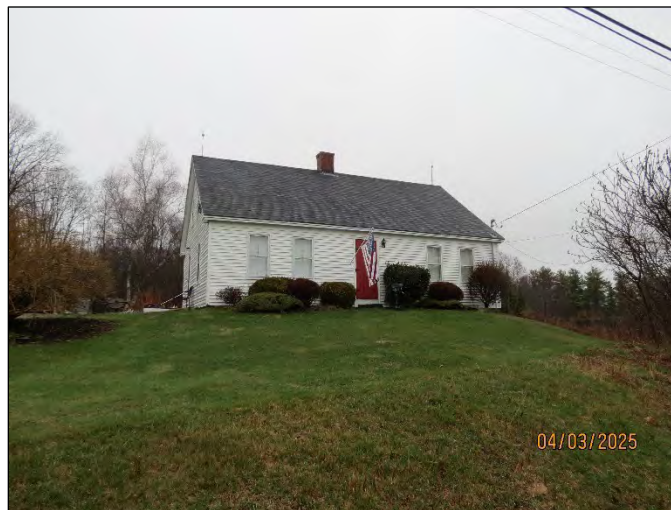
Figure 6. View of 325 Bolt Hill Road, an example of the Cape Cod style.

The Cape Cod style first gained widespread popularity in New England in the late eighteenth century. The basic eighteenth-century form remained in consistent use into the mid-nineteenth century. Cape Cod-style homes are typically modestly sized, one-and-a-half stories, and covered by a side-gabled roof with or without dormers (**Figure 6**). A central masonry chimney heats the building's small interior space. The Cape Cod style emphasizes symmetry through rectangular plans, central entrances, and double fenestration. Cape Cod homes can be categorized as half, three-quarter, or full Cape, depending on a floorplan's size. Exterior walls are typically clad with wooden shingles or wooden siding. The Cape Cod style gained renewed popularity in the 1940s. Developers created several small suburban houses meant for post-World War II families. Many variations were inspired by the earlier Cape Cod and Colonial Revival houses (Baker 1994).

- Symmetry;
- Rectangular plans;
- Central entrances and double fenestration;
- Side-gabled roofs with steep slopes; and
- Minimal exterior ornamentation (McAlester 2013).

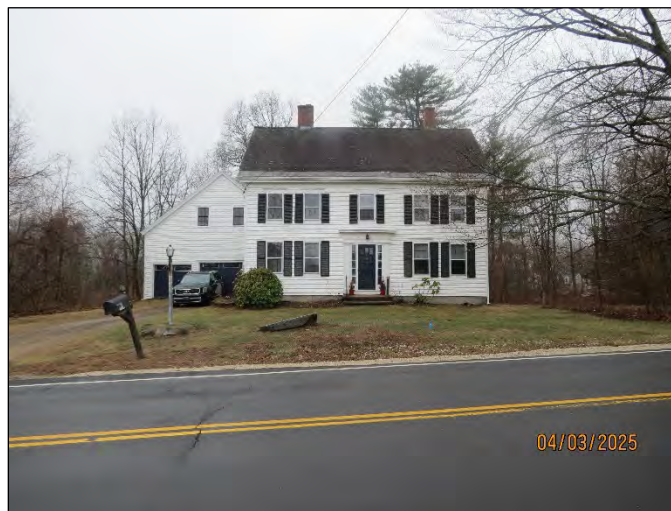
Figure 7. View of 1019 State Road, an example of the Colonial Revival style.

The Colonial Revival style was one of the most popular architectural styles in the United States in the late nineteenth to mid-twentieth centuries (**Figure 7**). In the aftermath of the Civil War, the United States sought a unified national identity. The style referenced buildings with patriotic, early American associations, including Independence Hall, Washington's Headquarters at Newburgh, and Mount Vernon (Rhoads 1976). The American Centennial Exposition of 1876 in Philadelphia sparked interest in the nation's colonial heritage. The 1893 World's Columbian Exposition in Chicago further promoted Classical Revival and Colonial Revival styles (Brandt 2009).

- Strict symmetry;
- Central entry, sometimes with a pedimented frontispiece supported by pilasters or slim columns;
- Palladian windows or paired double-hung sash windows; and
- Classical details (McAlester 2013).

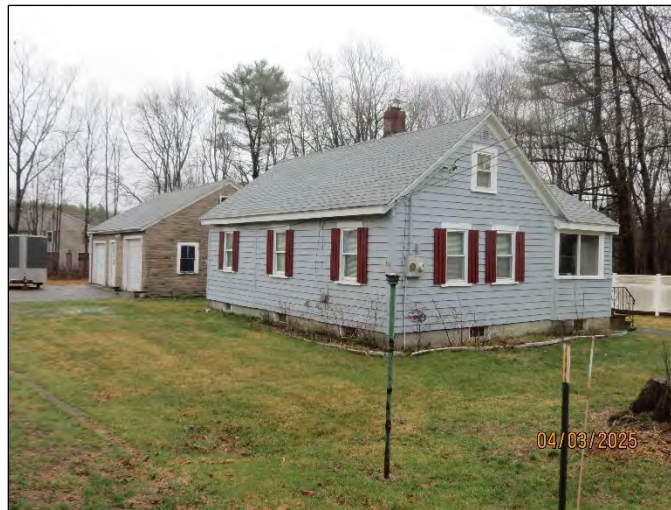
Figure 8. View of 226 Bolt Hill Road, an example of the Minimal Traditional style.

The Minimal Traditional architectural style is a simple style that originated during the years of the Great Depression and continued into the post-World War II era (McAlester 2013). Minimal Traditional houses are styled with minimal decoration/ornamentation, are small, and have a simple rectilinear footprint (**Figure 8**). Roofs are typically side-gabled with a cross gable at the entryway and have little to no overhang of the gables and eaves.

- Concrete foundations;
- Minimal ornamentation and decoration;
- Side-gable roof with entrances under a cross gable, sometimes with an integrated porch entryway;
- Sash windows with shutters (functional and non-functional);
- Garages are typically free-standing outbuildings (MHPC 2008).

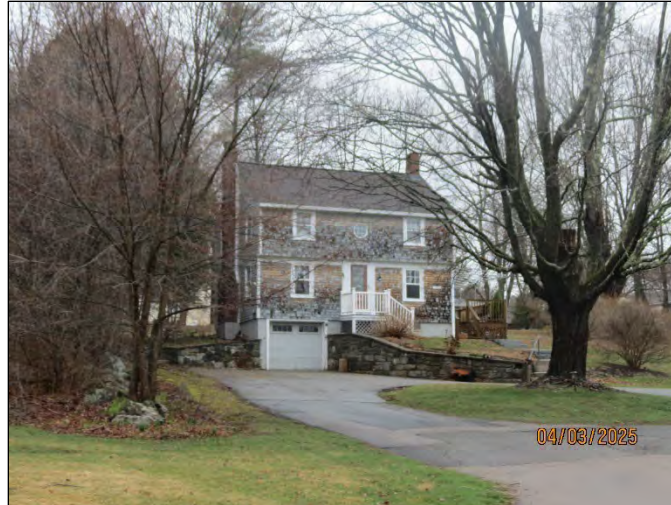
Figure 9. View of 1048 State Road, an example of the Neo-Colonial style.

- Concrete foundations;
- Moderately pitched side-gable roofs with overhanging eaves, closed soffits, and asphalt shingles;
- Clapboard, wooden shingle, or brick veneer siding with changes in cladding materials to articulate stories;
- Small garages made to minimize visual impact (MHPC 2008).

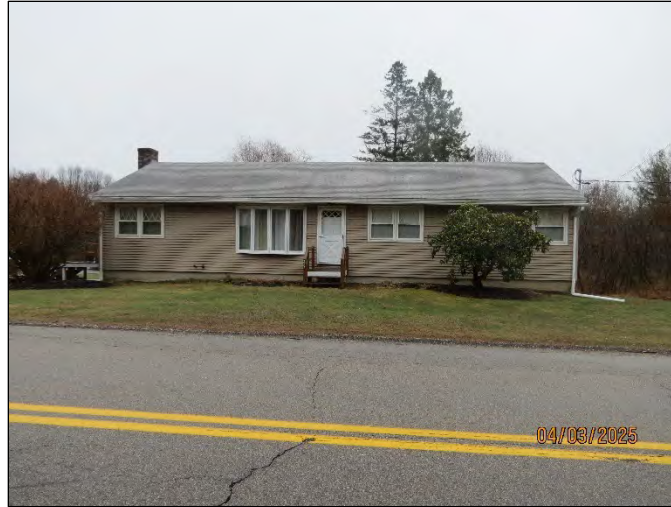
Figure 10. View of 322 Bolt Hill Road, an example of the Ranch style.

- Single story;
- Emphasis on horizontality;
- Low-pitched roofs with deep set eaves;
- Rectangular, L-shaped, or U-shaped plan;
- Attached garages;
- Modest stylistic details; and
- Picture windows (McAlester 2013).

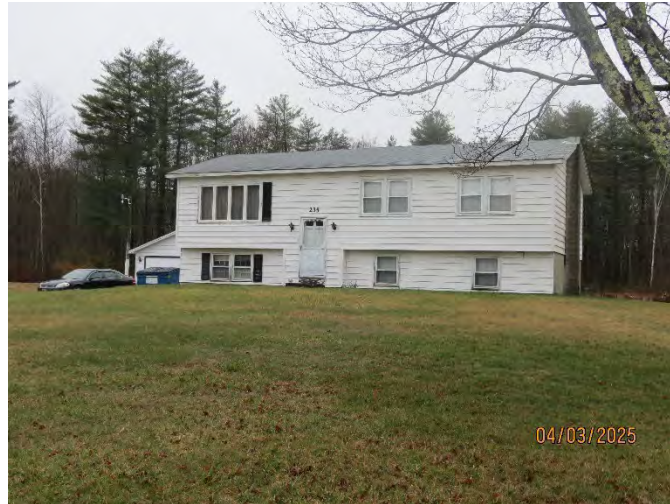
Figure 11. View of 235 Bolt Hill Road, an example of the Split Level style.

- Multilevel, staggered living spaces;
- Low-pitched roof with deep-set eaves;
- Rectangular or L-shaped plan;
- Asymmetry;
- Integrated garage; and
- Minimal decoration.

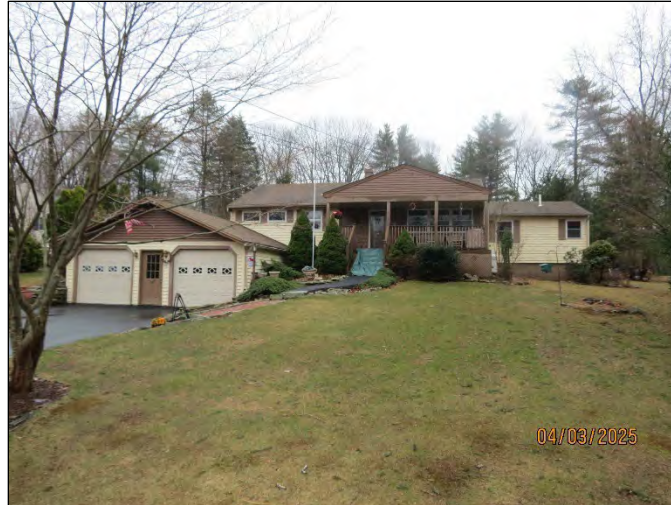
Figure 12. View of 17 Leach Road, an example of the Vernacular style.

- Balloon frame or concrete-block masonry construction;
- Simple geometric plans;
- One to three stories;
- Minimal exterior ornamentation;
- Original siding replaced with vinyl or cement board;
- Designs maximizing use of the environment and site (McAlester 2013).

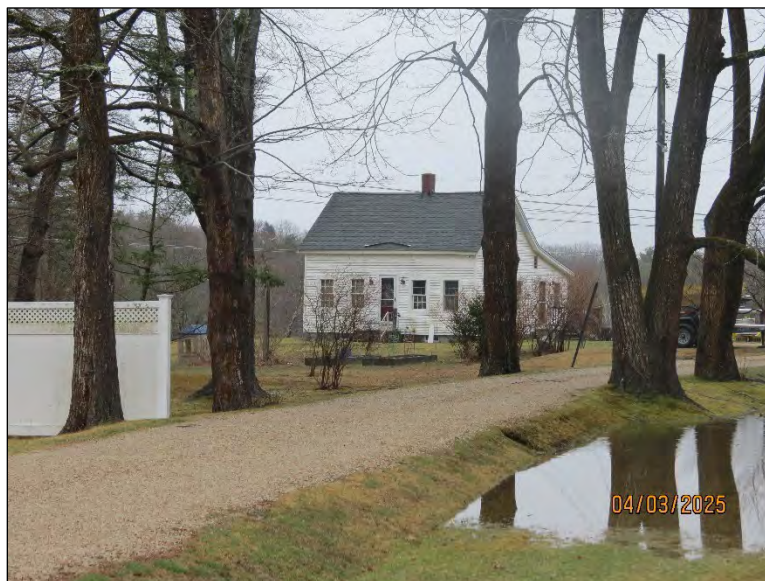
224 Bolt Hill Road is southwest of the project site. The building is a one-and-a-half-story Vernacular dwelling built ca. 1830 (**Figure 13** and **Figure 14**). The building is set at-grade on a concrete-block foundation. The main entryway is on the northern facade, and an additional entryway is on the western elevation. The exterior consists of vinyl siding. Fenestration includes double-hung sash windows. The side-gabled roof is covered with asphalt shingles. A deck extends off of the southern elevation. A modern storage shed is adjacent to the building. The building is in good condition.

Figure 13. View of 224 Bolt Hill Road, facing southeast.

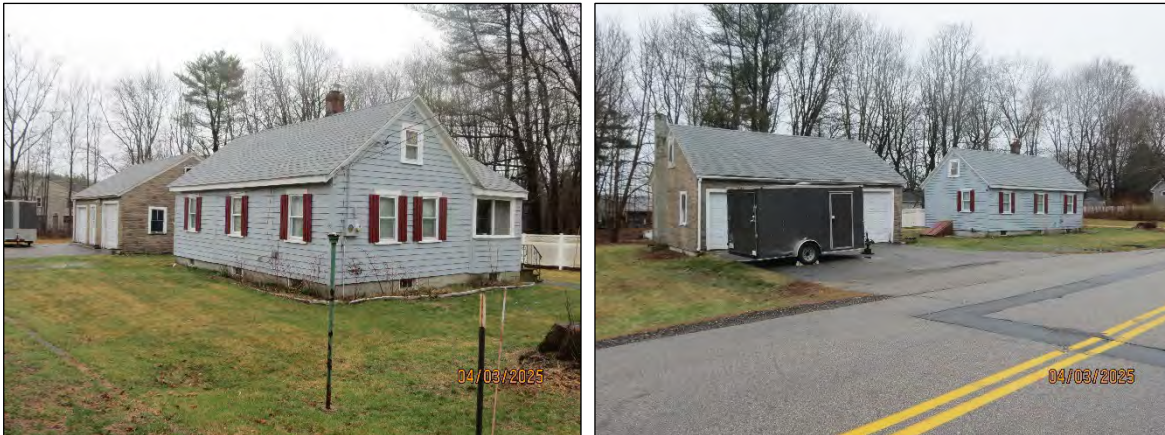
226 Bolt Hill Road is southwest of the project site. The building is a one-story Minimal Traditional dwelling built ca. 1941 (**Figure 15** and **Figure 16**). The building is set at-grade on a concrete foundation. An enclosed porch entryway (likely a later addition) is on the southeastern facade. The exterior consists of clapboard siding. Fenestration includes double-hung sash windows. The cross-gabled roof is covered with asphalt shingles. A two-bay garage with masonry exterior is northeast of the building. The garage has a single-leaf entry on the northwestern facade, double-hung sash windows, and a side-gabled roof covered with asphalt shingles. The building and garage are in good condition.

**Figure 15. View of 226 Bolt Hill Road, facing east (left) and facing south (right).**

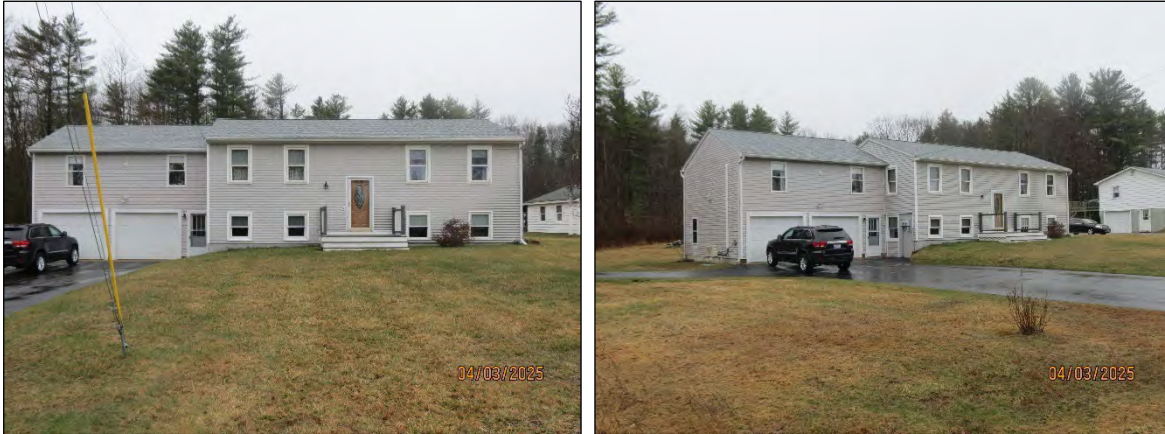
231 Bolt Hill Road is southwest of the project site. The building is a one-story Split Level dwelling built ca. 1978 (**Figure 17** and **Figure 18**). The building is set on a concrete foundation. The main entryway is on the southeastern facade. The exterior consists of vinyl siding. Fenestration includes double-hung sash windows of varying size. The side-gabled roof is covered with asphalt shingles. A two-bay, under-house garage is on the western portion of the building. A raised deck extends off the northwestern elevation. The building is in excellent condition.

Figure 17. View of 231 Bolt Hill Road, facing northwest (left) and facing north (right).

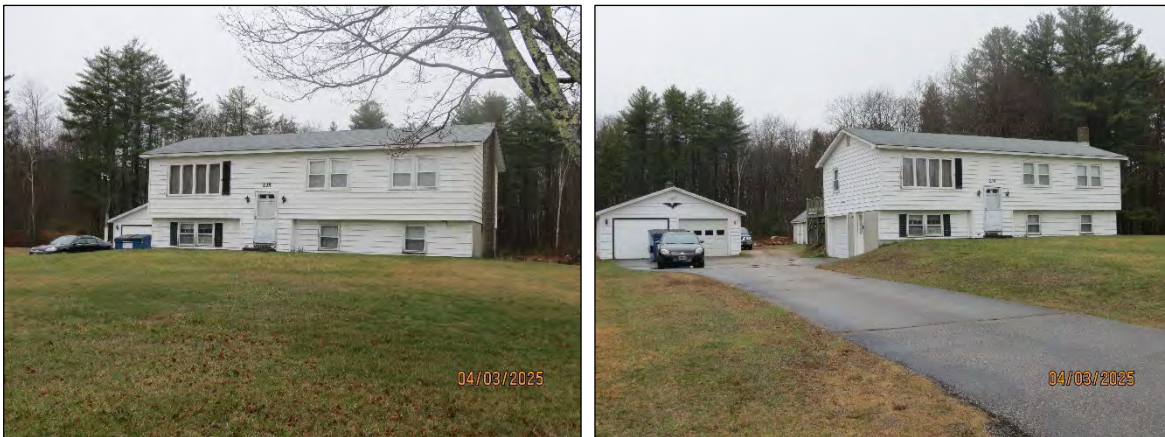
235 Bolt Hill Road is west of the project site. The building is a one-story Split Level dwelling built ca. 1971 (**Figure 19** and **Figure 20**). The building is set on a concrete foundation. The main entryway is on the southeastern facade. The exterior consists of vinyl siding. Fenestration includes double-hung sash windows and casement windows of varying size. The side-gabled roof is covered with asphalt shingles. A single-bay, under-house garage is on the northwestern elevation of the building. A raised deck extends off the northwestern elevation. A one-story, two-bay detached garage with a gabled roof and vinyl siding is adjacent to the building. The building and detached garage are in good condition.

**Figure 19. View of 235 Bolt Hill Road, facing northwest (left) and facing north (right).**

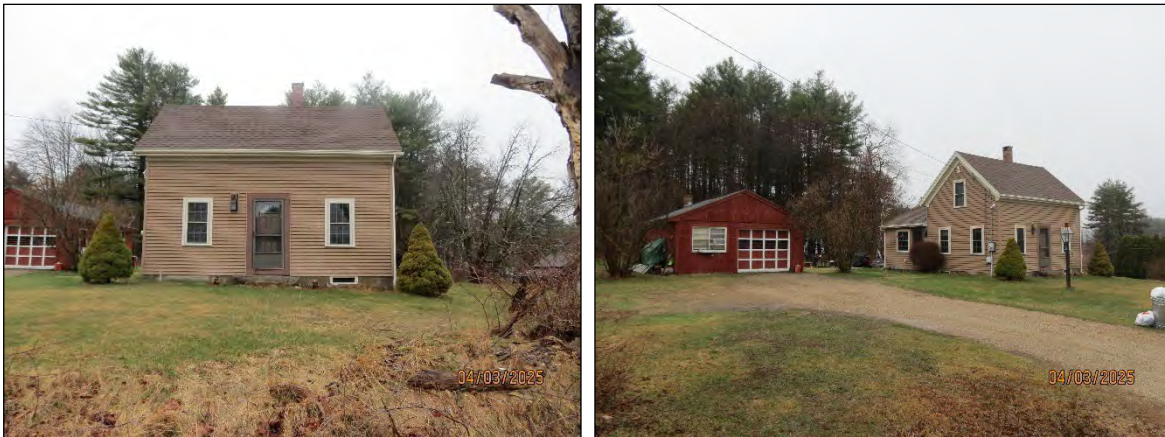
243 Bolt Hill Road is west of the project site. The building is a one-and-a-half-story Cape Cod dwelling built ca. 1905 (**Figure 21** and **Figure 22**). The building is set at-grade on a concrete-block foundation. The main entryway is on the southeastern facade; an enclosed secondary entryway is at the rear of the southwestern elevation. The exterior consists of vinyl siding. Fenestration includes double-hung sash windows. The side-gabled roof is covered with asphalt shingles. A single-bay garage with wooden paneling is northwest of the building. The garage has a front-gabled roof covered with asphalt shingles. The building and garage are in good condition.

Figure 21. View of 243 Bolt Hill Road, facing northwest (left) and facing north (right).

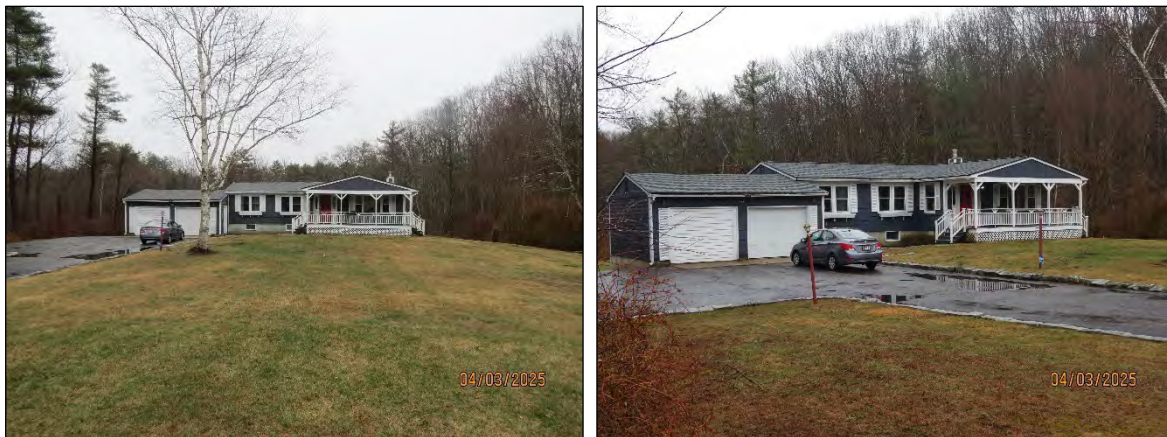
280 Bolt Hill Road is north of the project site. The building is a one-story Vernacular dwelling built ca. 1977 (**Figure 23** and **Figure 24**). The building is set on a concrete foundation. The main entryway is on the northwestern facade beneath a gabled porch with Y-bracketed support columns. The exterior consists of composite siding. Fenestration includes double-hung sash windows with decorative shutters. The cross-gabled roof is covered with asphalt shingles. A raised deck extends off the southeastern elevation. A two-bay attached garage is on the northeastern portion of the building. The building is in good condition.

**Figure 23. View of 280 Bolt Hill Road, facing southeast (left) and facing south (right).**

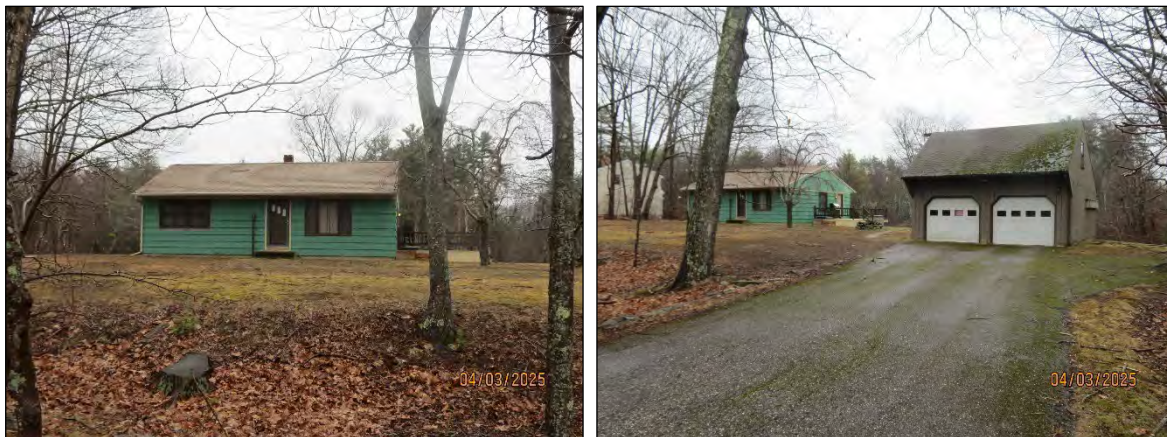
Figure 25. View of 294 Bolt Hill Road, facing southeast (left) and facing east (right).

294 Bolt Hill Road is north of the project site. The building is a one-story Ranch dwelling built ca. 1955 (**Figure 25** and **Figure 26**). The building is set at-grade on a concrete foundation. The main entryway is on the northwestern facade; a secondary entry is on the southwestern elevation, accessed by a wooden deck. The exterior consists of composite siding. Fenestration includes double-hung sash and casement windows. The side-gabled roof is covered with asphalt shingles. A two-bay, one-story detached garage with a loft is adjacent to the building. The building and garage are in good condition.

Background research did not determine whether the building is associated with events that have made a significant contribution to the broad patterns of our history. SEARCH recommends the building is not significant under Criterion A. Background research did not identify the building's architect or builder. SEARCH recommends the building is not significant under Criterion B because it lacks association with a person significant in history. The building is an example of a residential building and is not a notable representation of the Ranch style. SEARCH recommends the building is not significant under Criterion C because it lacks architectural distinction, is not the work of a master, and does not possess high artistic values. SEARCH recommends the building is not significant under Criterion D because it lacks the potential to yield further information of historical importance. Therefore, SEARCH recommends the building not eligible for NRHP listing.

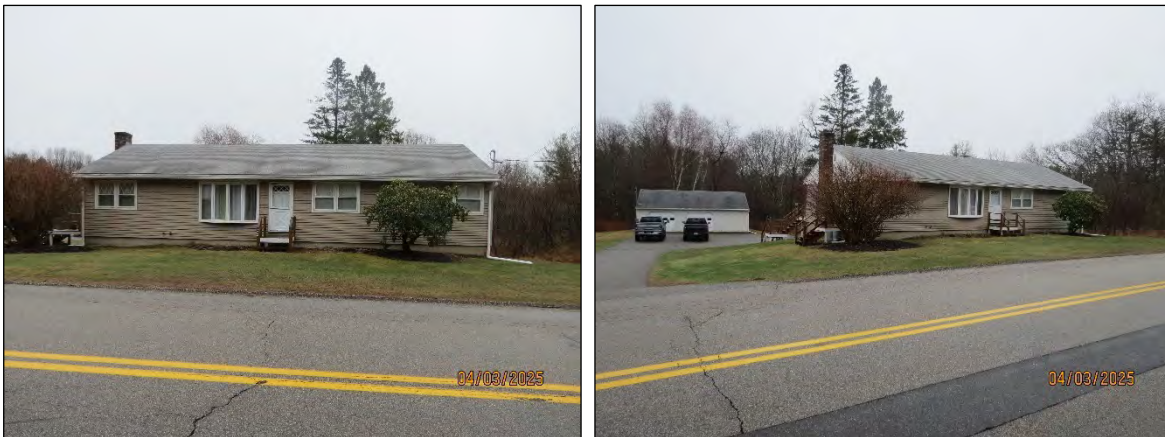
**Figure 27. View of 322 Bolt Hill Road, facing southeast (left) and facing south (right).**

322 Bolt Hill Road is north of the project site. The building is a one-story Ranch dwelling built ca. 1963 (**Figure 27** and **Figure 28**). The building is set on a concrete foundation. The main entryway is on the northwestern facade; a secondary entry is on the northeastern elevation, accessed by a raised wooden deck. The exterior consists of vinyl siding. Fenestration includes double-hung sash and bay windows. The side-gabled roof is covered with asphalt shingles. A single-bay, under-house garage is on the southeastern elevation beneath an elevated wooden deck. A two-bay, one-story detached garage adjacent to the building was constructed sometime after 1986. The building and garage are in good condition.

Background research did not determine whether the building is associated with events that have made a significant contribution to the broad patterns of our history. SEARCH recommends the building is not significant under Criterion A. Background research did not identify the building's architect or builder. SEARCH recommends the building is not significant under Criterion B because it lacks association with a person or people significant in history. The building is an example of a residential building and is not a notable representation of the Ranch style. SEARCH recommends the building is not significant under Criterion C because it lacks architectural distinction, is not the work of a master, and does not possess high artistic values. SEARCH recommends the building is not significant under Criterion D because it lacks the potential to yield further information of historical importance. Therefore, SEARCH recommends the building not eligible for NRHP listing.

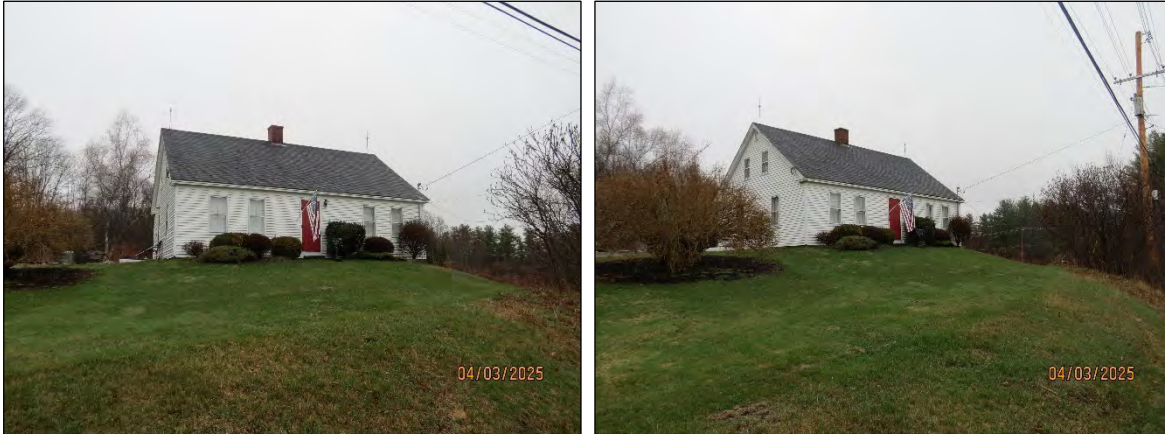
325 Bolt Hill Road is north of the project site. The building is a one-story Cape Cod dwelling built ca. 1840 (**Figure 29** and **Figure 30**). The building is set at-grade on a stone foundation. The main entryway is located centrally on the southeastern facade and consists of a vertical, wooden-slat door with gate-style hinges. A secondary entryway is on the southwestern elevation. The exterior consists of vinyl siding. Fenestration includes double-hung sash windows. The side-gabled roof is covered with asphalt shingles. The building is in good condition.

**Figure 29. View of 325 Bolt Hill Road, facing northwest (left) and facing north (right).**

Background research did not determine whether the building is associated with events that have made a significant contribution to the broad patterns of our history. SEARCH recommends the building is not significant under Criterion A. Background research did not identify the building's architect or builder. SEARCH recommends the building is not significant under Criterion B because it lacks association with a person or people significant in history. The building is an example of a residential building and is not a notable representation of the Cape Cod style. Modern renovations, such as the installation of vinyl siding, detract from its architectural distinction. SEARCH recommends the building is not significant under Criterion C because it lacks architectural distinction, is not the work of a master, and does not possess high artistic values. SEARCH recommends the building is not significant under Criterion D because it lacks the potential to yield further information of historical importance. Therefore, SEARCH recommends the building not eligible for NRHP listing.

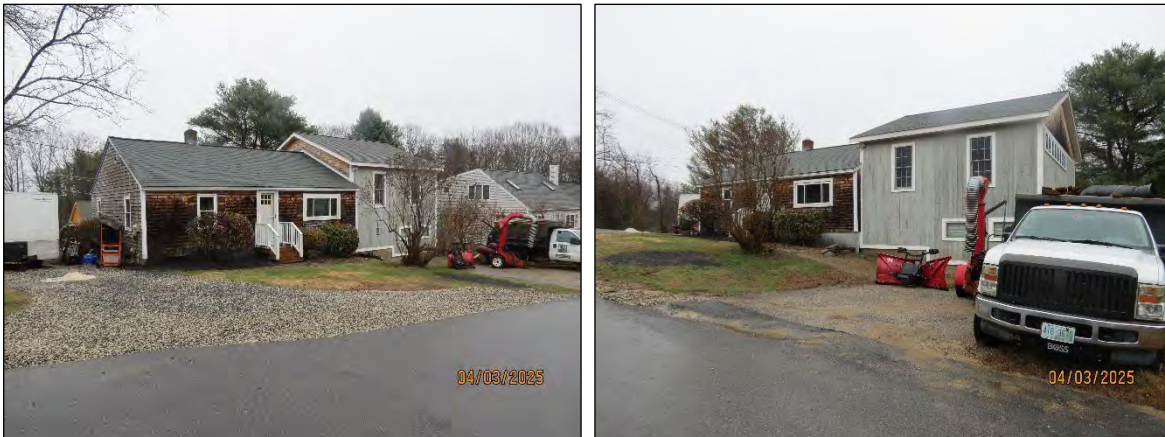
1 Willow Lane is northeast of the project site. The building is a one-story Minimal Traditional dwelling built ca. 1954 (**Figure 31** and **Figure 32**). The building is set on a concrete-block foundation. The main entryway is on the southwestern facade. The exterior consists of wooden shingles. Fenestration includes double-hung sash and set frame windows. The side-gabled roof is covered with asphalt shingles. A one-and-a-half story addition with a vertical, wooden panel exterior and gabled roof was added to the southeastern portion of the building sometime between 2011 and 2017. The building is in good condition.

**Figure 31. View of 1 Willow Lane, facing east (left) and facing north (right).**

Background research did not determine whether the building is associated with events that have made a significant contribution to the broad patterns of our history. SEARCH recommends the building is not significant under Criterion A. Background research did not identify the building's architect or builder. SEARCH recommends the building is not significant under Criterion B because it lacks association with a person or people significant in history. The building is an example of a residential building and is not a notable representation of the Ranch style. SEARCH recommends the building is not significant under Criterion C because it lacks architectural distinction, is not the work of a master, and does not possess high artistic values. SEARCH recommends the building is not significant under Criterion D because it lacks the potential to yield further information of historical importance. Therefore, SEARCH recommends the building not eligible for NRHP listing.
