# Maine Coastal Program Coastal Zone Management Act Federal Consistency Submission Form

| Project/Activity Name:<br>Bolt Hill Substation Project | | |
| Federal Agency:<br>U.S. Army Corps of Engineers | | |

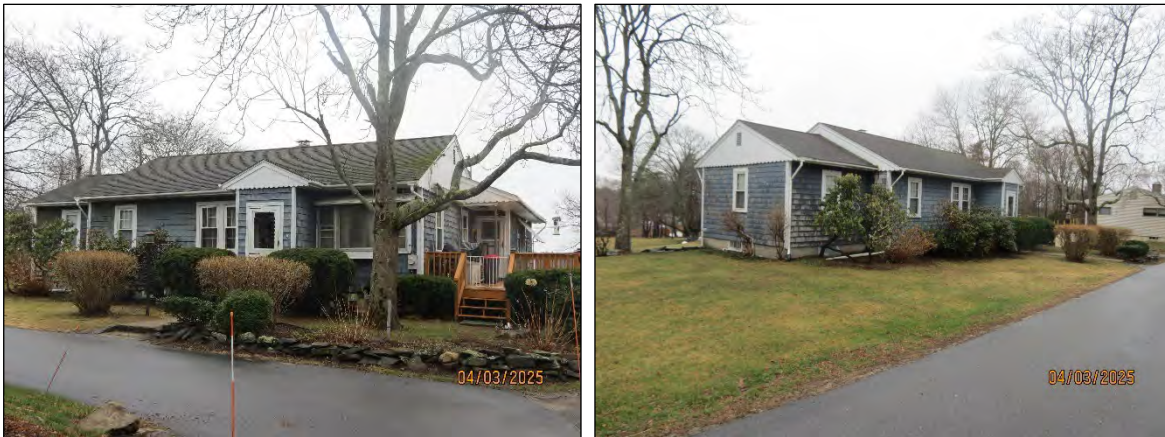
8 Hickory Lane is southwest of the project site. The building is a one-story Vernacular dwelling built ca. 1953 (**Figure 33** and **Figure 34**). The building is set on a concrete-block foundation. The main entryway is on the northeastern facade within an enclosed front porch. A secondary entrance is on the southwestern elevation and accessed by a raised wooden deck. The exterior consists of wooden shingles. Fenestration includes double-hung sash and set frame windows. The cross-gabled roof is covered with asphalt shingles. A one-bay, under-house garage is on the southeastern elevation. The building is in good condition.

**Figure 33. View of 8 Hickory Lane, facing southeast (left) and facing south (right).**

Background research did not determine whether the building is associated with events that have made a significant contribution to the broad patterns of our history. SEARCH recommends the building is not significant under Criterion A. Background research did not identify the building's architect or builder. SEARCH recommends the building is not significant under Criterion B because it lacks association with a person or people significant in history. The building is an example of a Vernacular residential building and is not a notable representation of an architectural style. SEARCH recommends the building is not significant under Criterion C because it lacks architectural distinction, is not the work of a master, and does not possess high artistic values. SEARCH recommends the building is not significant under Criterion D because it lacks the potential to yield further information of historical importance. Therefore, SEARCH recommends the building not eligible for NRHP listing.

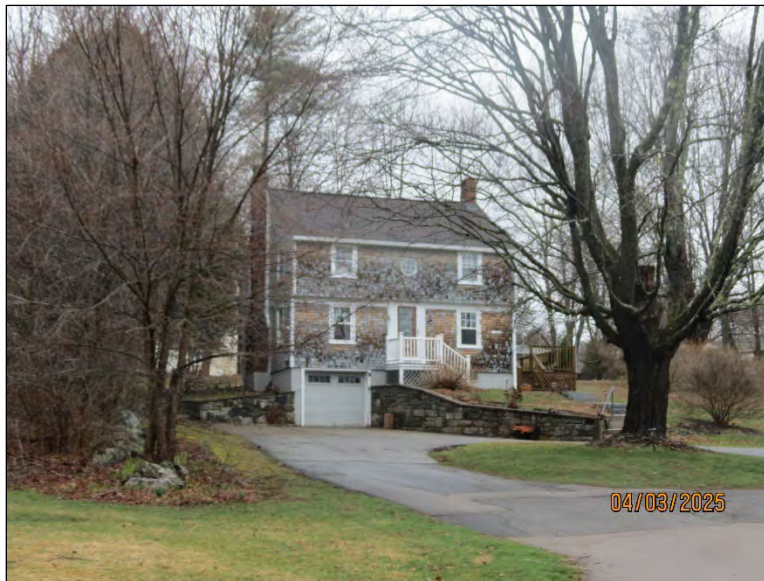
1048 State Road is southwest of the project site. The building is a two-story Neo-Colonial dwelling built ca. 1942 (**Figure 35** and **Figure 36**). The building is set on a concrete foundation with a single-bay, under-house garage. The main entryway is on the southeastern facade and accentuated with pilasters. A secondary entryway is on the northeastern elevation via an elevated wooden deck. The exterior consists of wooden shingles. Fenestration includes uniformly spaced, double-hung sash windows, and an octagonal vent window centrally located on the second story of the southeastern facade. The side-gabled roof is covered with asphalt shingles. Brick chimneys are on the northeastern and southwestern elevations. The building is in good condition.

**Figure 35. View of 1048 State Road, facing northwest.**

Background research did not determine whether the building is associated with events that have made a significant contribution to the broad patterns of our history. SEARCH recommends the building is not significant under Criterion A. Background research did not identify the building's architect or builder. SEARCH recommends the building is not significant under Criterion B because it lacks association with a person or people significant in history. The building is an example of a residential building and is not a notable representation of the Neo-Colonial style. SEARCH recommends the building is not significant under Criterion C because it lacks architectural distinction, is not the work of a master, and does not possess high artistic values. SEARCH recommends the building is not significant under Criterion D because it lacks the potential to yield further information of historical importance. Therefore, SEARCH recommends the building not eligible for NRHP listing.

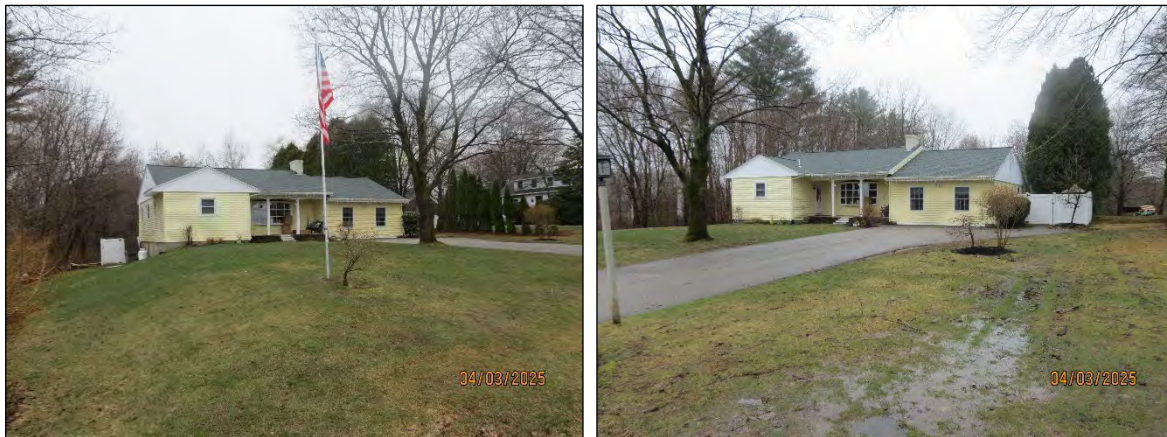
1039 State Road is southwest of the project site. The building is a one-story Vernacular dwelling built ca. 1967 (**Figure 37** and **Figure 38**). The building is set on a concrete foundation. The main entryway is on the northeastern facade within a covered front entryway. The exterior consists of vinyl siding. Fenestration includes double-hung sash windows and a glass-block bay window. The cross-gabled roof is covered with asphalt shingles. A two-bay garage is on the northern portion of the northeastern facade. It was enclosed sometime between 2017 and 2019 and incorporated into the residence. Its former door now consists of an exterior wall with double-hung sash windows. A raised porch is on the southwestern elevation. The building is in good condition.

**Figure 37. View of 1039 State Road, facing southwest (left) and facing south (right).**

Background research did not determine whether the building is associated with events that have made a significant contribution to the broad patterns of our history. SEARCH recommends the building is not significant under Criterion A. Background research did not identify the building's architect or builder. SEARCH recommends the building is not significant under Criterion B because it lacks association with a person or people significant in history. The building is an example of a Vernacular residential building and is not a notable representation of an architectural style. SEARCH recommends the building is not significant under Criterion C because it lacks architectural distinction, is not the work of a master, and does not possess high artistic values. SEARCH recommends the building is not significant under Criterion D because it lacks the potential to yield further information of historical importance. Therefore, SEARCH recommends the building not eligible for NRHP listing.

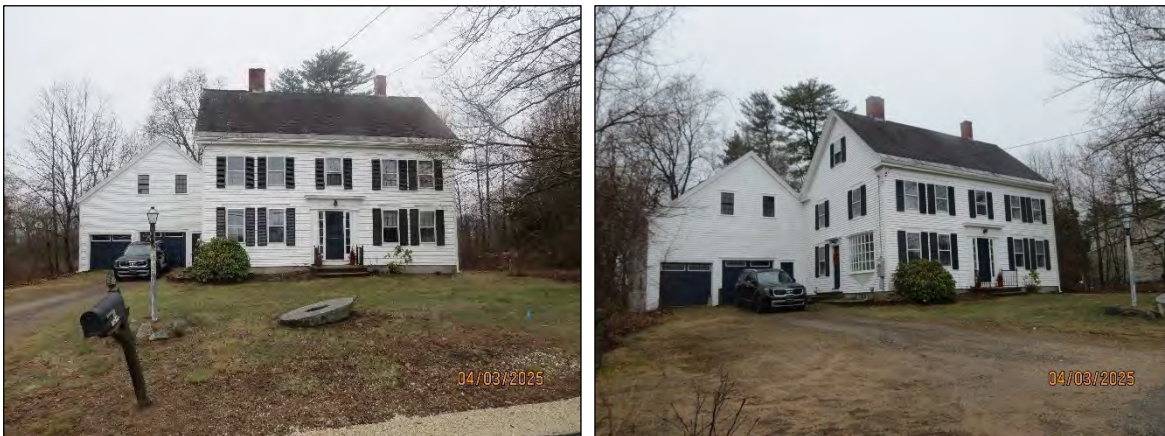
1019 State Road is southwest of the project site. The building is a two-story Colonial Revival dwelling built ca. 1858 (**Figure 39** and **Figure 40**). The building is set at-grade on a granite foundation. The main entryway is on the northeastern facade, accentuated with a decorative straight pediment with inset panel and vertical sidelights, and supported by pilasters. A secondary entryway is on the southeastern elevation with an extended pediment and pilasters. The exterior consists of vinyl siding. Fenestration includes uniformly spaced double-hung sash windows with decorative straight pediments, shutters, and a bay window on southeastern elevation of the first floor. The side-gabled roof is covered with asphalt shingles. Brick chimneys extend through the ridge of the roof; one is on the southeastern portion, and the other is on the northwestern portion. An enclosed porch is on the southwestern elevation. An attached one-story garage with a loft is on the southern corner of the building. The garage has two bays, a single-leaf entryway on the northeastern facade, and a front-gabled roof covered with asphalt shingles. Two double-hung windows are on the upper loft portion of the northeastern facade. The building and garage are in good condition.

**Figure 39. View of 1019 State Road, facing southwest (left) and facing west (right).**

Background research did not determine whether the building is associated with events that have made a significant contribution to the broad patterns of our history. SEARCH recommends the building is not significant under Criterion A. Background research did not identify the building's architect or builder. SEARCH recommends the building is not significant under Criterion B because it lacks association with a person or people significant in history. The building is an example of a residential building and is not a notable representation of the Colonial Revival style. Modern renovations, including the installation of vinyl siding, detract from its architectural distinction. SEARCH recommends the building is not significant under Criterion C because it lacks architectural distinction, is not the work of a master, and does not possess high artistic values. SEARCH recommends the building is not significant under Criterion D because it lacks the potential to yield further information of historical importance. Therefore, SEARCH recommends the building not eligible for NRHP listing.

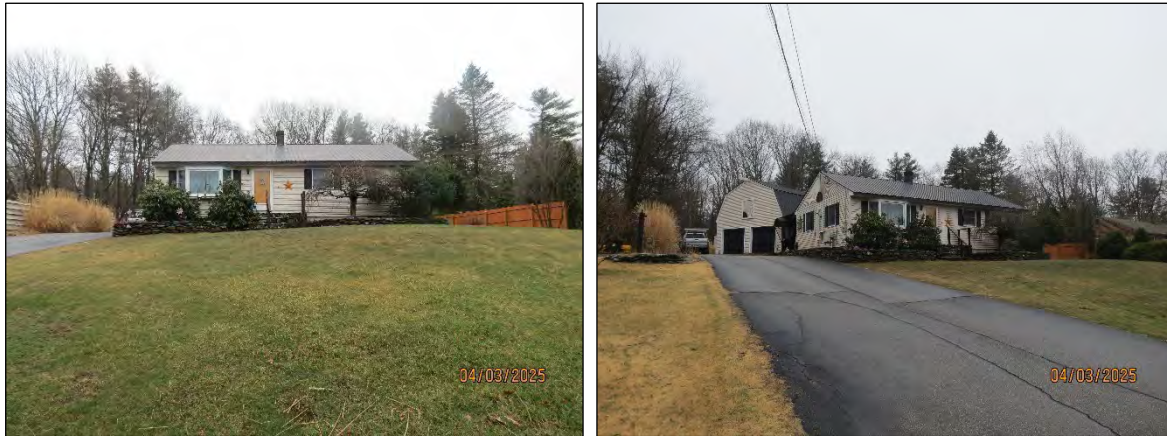
13 Leach Road is south of the project site. The building is a one-story Ranch Vernacular dwelling built ca. 1958 (**Figure 41** and **Figure 42**). The building is set on a concrete foundation. The main entryway is on the northern facade. The exterior consists of vinyl siding. Fenestration includes double-hung sash and bay windows. The seamed metal roof is cross-gabled. A one-story, two-bay, attached, barn-style garage with loft is on the southern elevation. The attached garage has vinyl siding and a gambrel seam metal roof. The building is in good condition.

**Figure 41. View of 13 Leach Road, facing southeast (left) and facing south (right).**

Background research did not determine whether the building is associated with events that have made a significant contribution to the broad patterns of our history. SEARCH recommends the building is not significant under Criterion A. Background research did not identify the building's architect or builder. SEARCH recommends the building is not significant under Criterion B because it lacks association with a person or people significant in history. The building is an example of a Vernacular Ranch residential building and is not a notable representation of the Ranch style. SEARCH recommends the building is not significant under Criterion C because it lacks architectural distinction, is not the work of a master, and does not possess high artistic values. SEARCH recommends the building is not significant under Criterion D because it lacks the potential to yield further information of historical importance. Therefore, SEARCH recommends the building not eligible for NRHP listing.

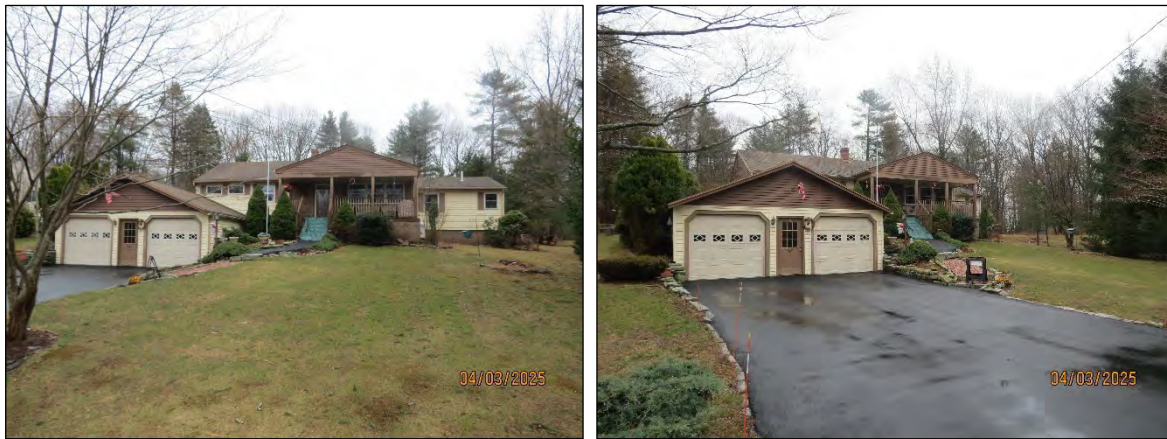
17 Leach Road is south of the project site. The building is a one-story Vernacular dwelling built ca. 1948 (**Figure 43** and **Figure 44**). The building is set on a concrete-block foundation. The main entryway is on the northern facade within a covered, raised, front-porch entryway. The exterior consists of vinyl siding and masonry elements. Fenestration includes double-hung sash windows with decorative shutters and fixed-frame windows. The cross-gabled roof is covered with asphalt shingles. A one-story, two-bay, attached garage is on the northern facade at a lower elevation. The attached garage has a single-leaf door entry between the bays, vinyl siding, and a front-gabled roof. The building appears to have undergone alterations and additions sometime between 1986 and 1992. The building is in good condition.

**Figure 43. View of 17 Leach Road, facing southeast (left) and facing south (right).**

Background research did not determine whether the building is associated with events that have made a significant contribution to the broad patterns of our history. SEARCH recommends the building is not significant under Criterion A. Background research did not identify the building's architect or builder. SEARCH recommends the building is not significant under Criterion B because it lacks association with a person or people significant in history. The building is an example of a Vernacular residential building and is not a notable representation of an architectural style. SEARCH recommends the building is not significant under Criterion C because it lacks architectural distinction, is not the work of a master, and does not possess high artistic values. SEARCH recommends the building is not significant under Criterion D because it lacks the potential to yield further information of historical importance. Therefore, SEARCH recommends the building not eligible for NRHP listing.
