National Transportation Safety Board

A Review of Significant Incidents

Sara Lyons, P.E.

Pipeline Accident Investigator

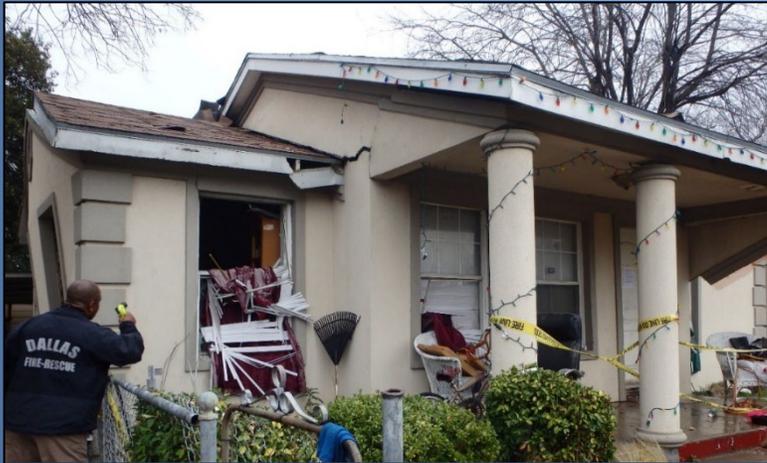
Event 1

February 21, 2018 – 5:49 a.m.
Explosion and fire reported

3527 Durango Drive
One injury - second-degree burns

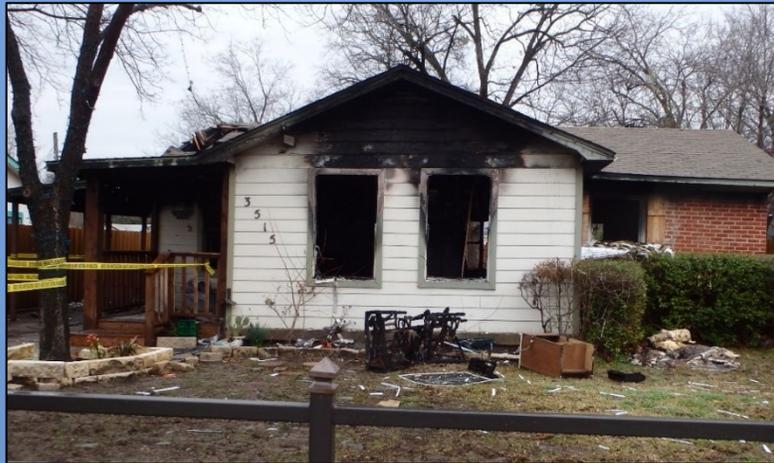
Event 2

February 22, 2018 – 10:21 a.m.
Fire reported

3515 Durango Drive
One injury - second-degree burns

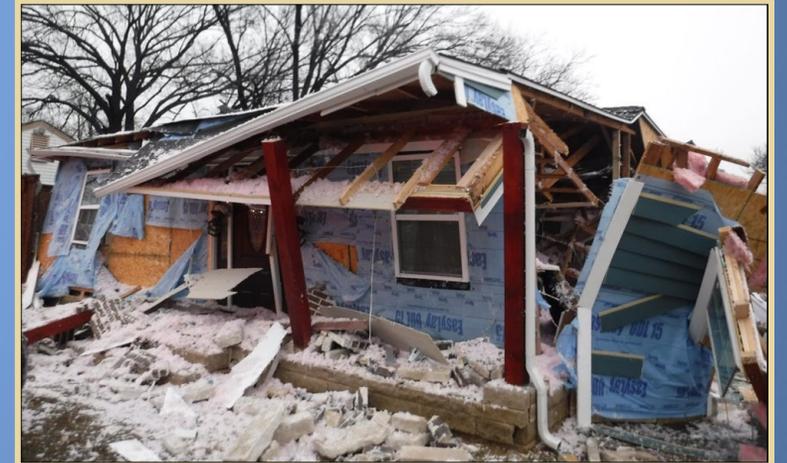
Event 3

February 23, 2018 – 6:38 a.m.
Explosion reported

3534 Espanola Drive
Five injuries - one fatal

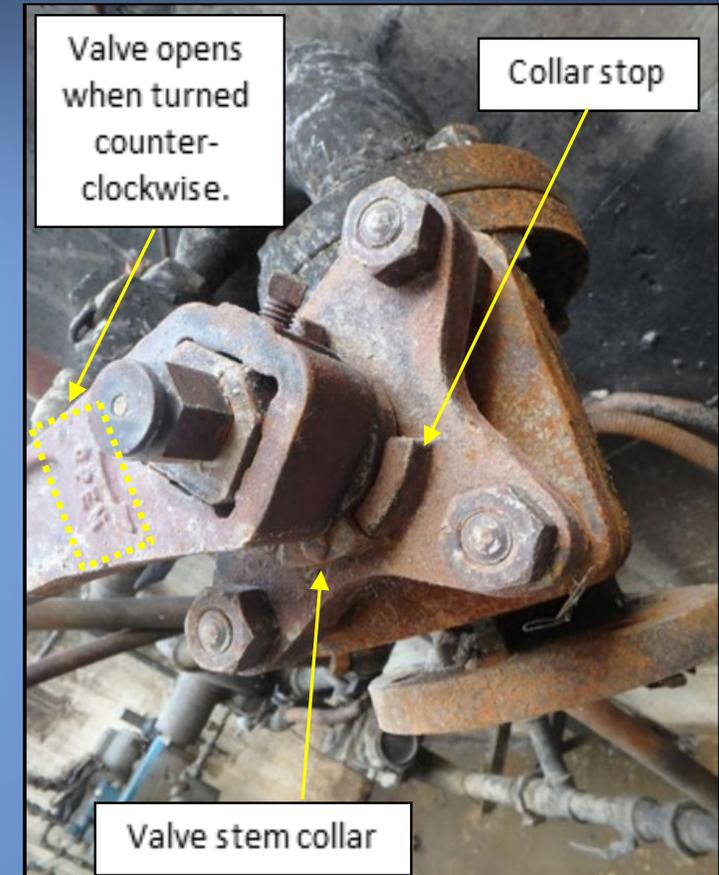
Minneapolis, Minnesota

Accident valve: Peak torque measured during opening and closing		
Action	Torque (lb-ft)	Tool used
1 st Closing attempt - no movement	430	Valve wrench
2 nd Closing attempt - no movement	409	Valve wrench
3 rd Closing attempt - no movement	721	Valve wrench with 4' extension
The valve was attached to the band saw table for better leverage and the torque transducer was not used to close and open the valve once using the 4' extension		
1 st Closing (after valve was opened and closed once)	243	Valve wrench with 4' extension
1 st Opening (after valve was opened and closed once)	185	Valve wrench with 4' extension

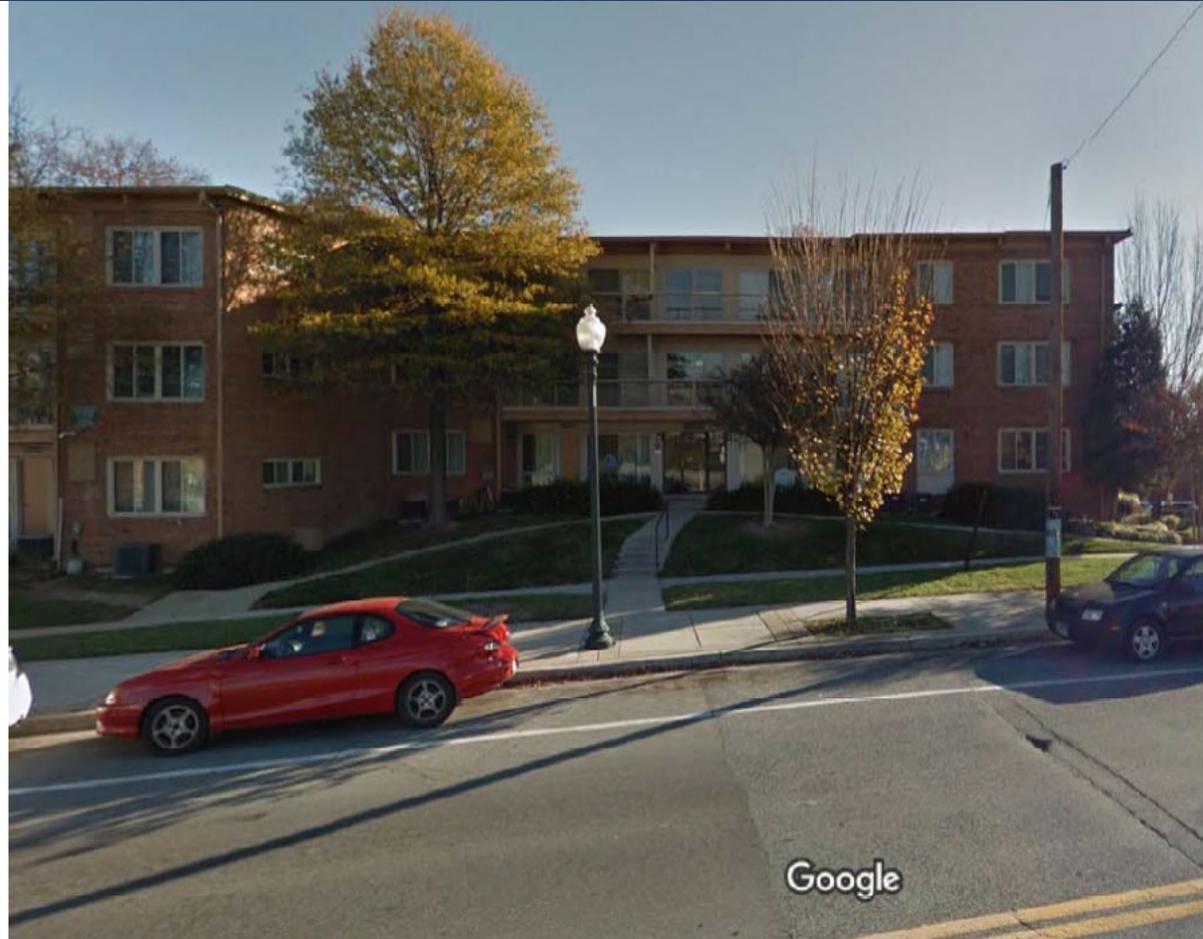
Flower Branch Apartment Complex in November 2015

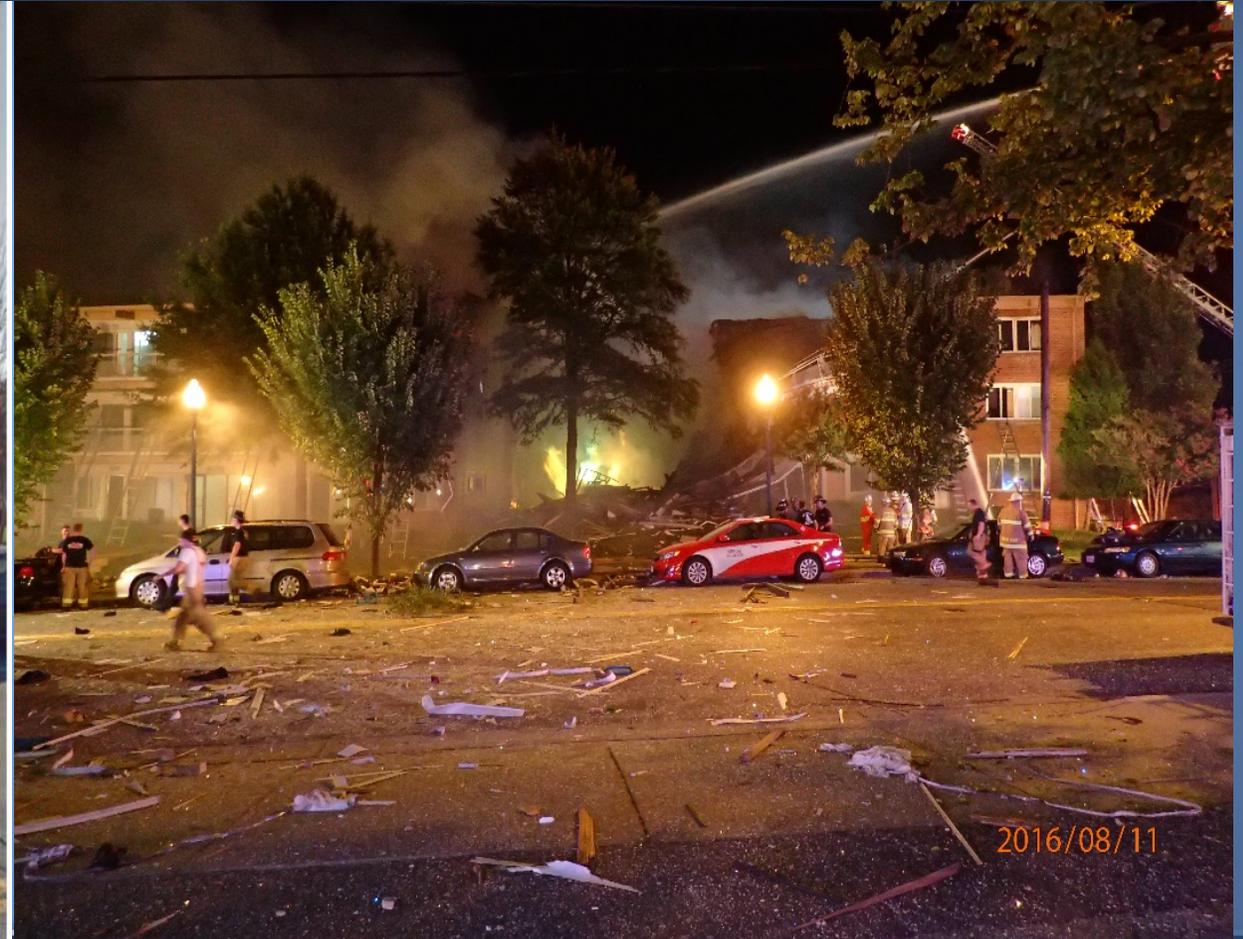
Flower Branch Apartment Complex on August 11, 2016
