Re: Hazardous Materials Assessment for the "Farmhouse" located on the Augusta Mental Health Institute Campus in Augusta, Maine

PROJECT TITLE
AUGUSTA MENTAL HEALTH INSTITUTE (AMHI)
AUGUSTA, MAINE

SHEET TITLE
FARMHOUSE BUILDING
ASBESTOS IDENTIFICATION SURVEY

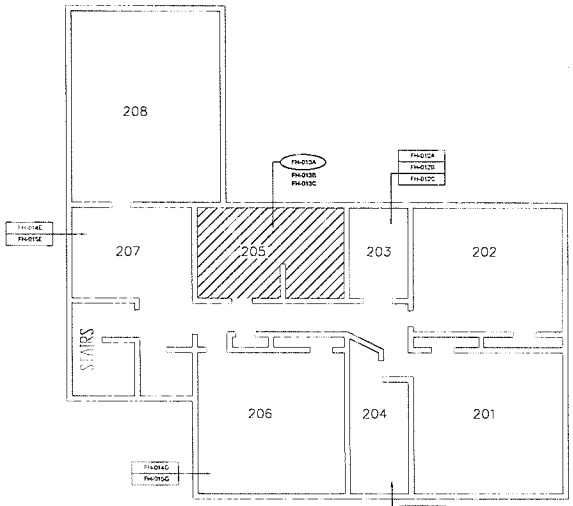
SECOND FLOOR PLAN
SCALE 3/16"=1'-0"

Walls, chair rails (where present), baseboards, doors, casings, jambs, attic hatch, fire escape access and all exterior window wells, stops and tracks. One original window unit

with lead-containing interior components (sill, casing, apron, inner stops) is present in Room #208. The paint on these components was observed to be in poor condition.

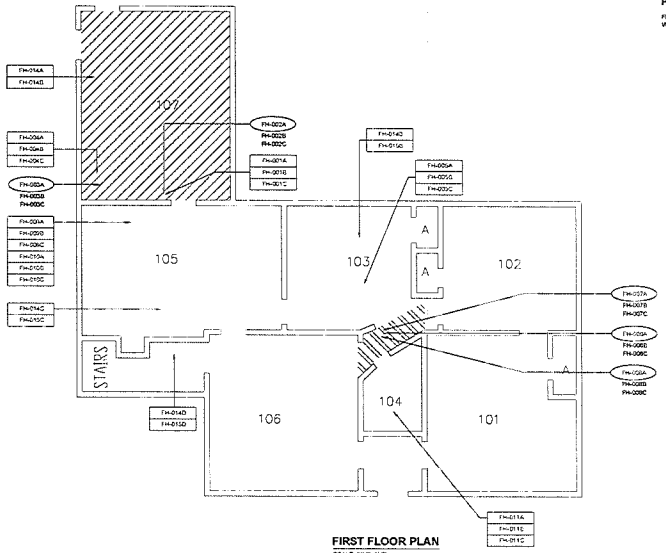
FIRST FLOOR PLAN
SCALE 3/16"=1'-0"

- Adhesive associated with non-ACM 12-inch by 12-inch (12x12) cream/gray mottled floor tile present over ACM 12x12 floor tile – Room 107;
- 9-inch by 9-inch (9x9) gray with black floor tile present over ACM green floor tile with associated ACM adhesive and felt paper underlayment – Hallway near Room 104; and
- 12-inch x 12-inch (12x12) brown mottled floor tile with associated ACM adhesive and felt paper underlayment – Room 205.

Baseboards, doors, casings, and jambs in all rooms; Kitchen walls (upper and lower) and chair rails; Entry door, casing, jamb, side-lites and transom window; and all exterior window wells, stops, tracks and storms. The paint on these components was observed to be in poor condition.

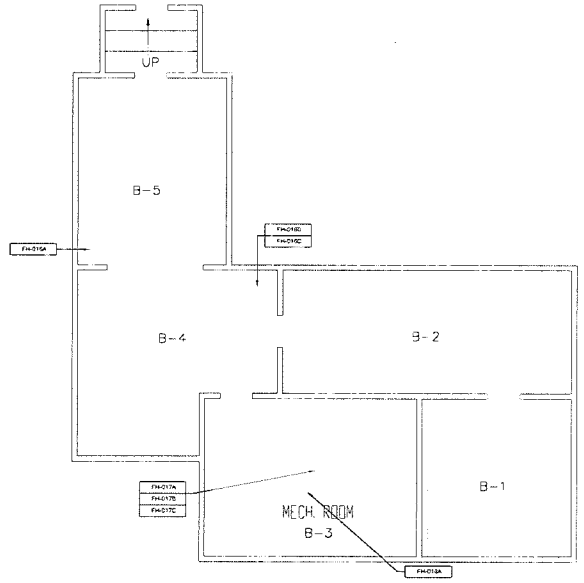
BASEMENT FLOOR PLAN
SCALE 3/16"=1'-0"

Cellar Windows with the paint observed to be in fair to poor condition.
