Maine Department of Transportation

Technical Report 02-3

The Use of Micro-Surfacing for Pavement Preservation

Interim Report - First Year, May 2004

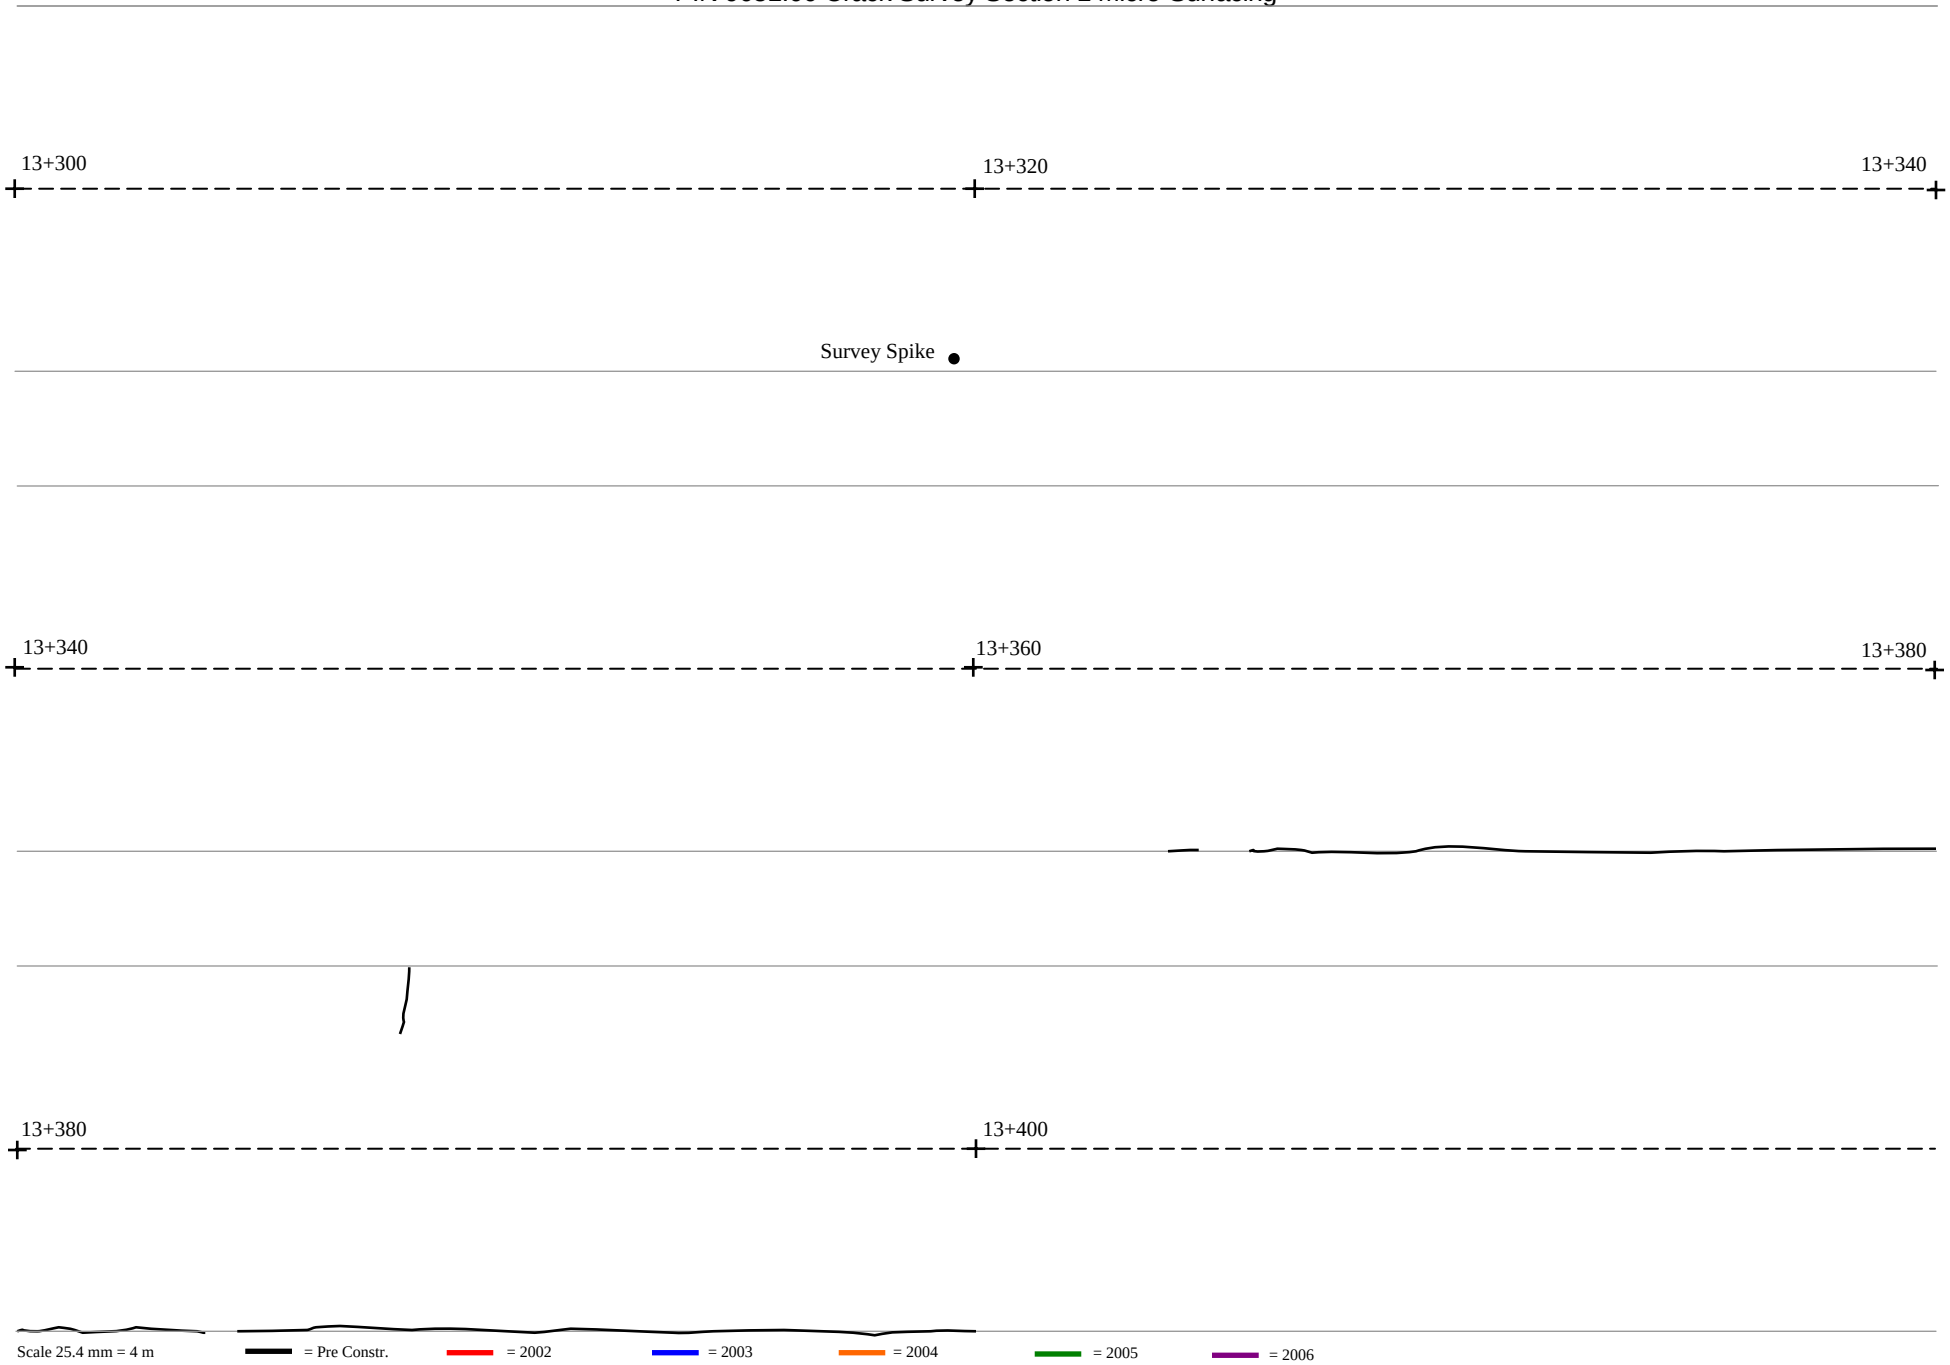
Figure 9
PIN 9051.00 Crack Survey Section 1 Micro-Surfacing

A crack survey of Section 1 with Micro-Surfacing is depicted in Figure 9. This section had the lowest amount of preconstruction longitudinal cracking and only one partial transverse crack. There were no visible cracks observed in 2002. Snow plow wear was observed at centerline and is displayed in Figure 15. It appears that the plow bounced on the surface, gouging the Micro-Surfaced treatment. Similar plow wear was mentioned in the Construction Report on the I-95 Oakfield project after one winter season.

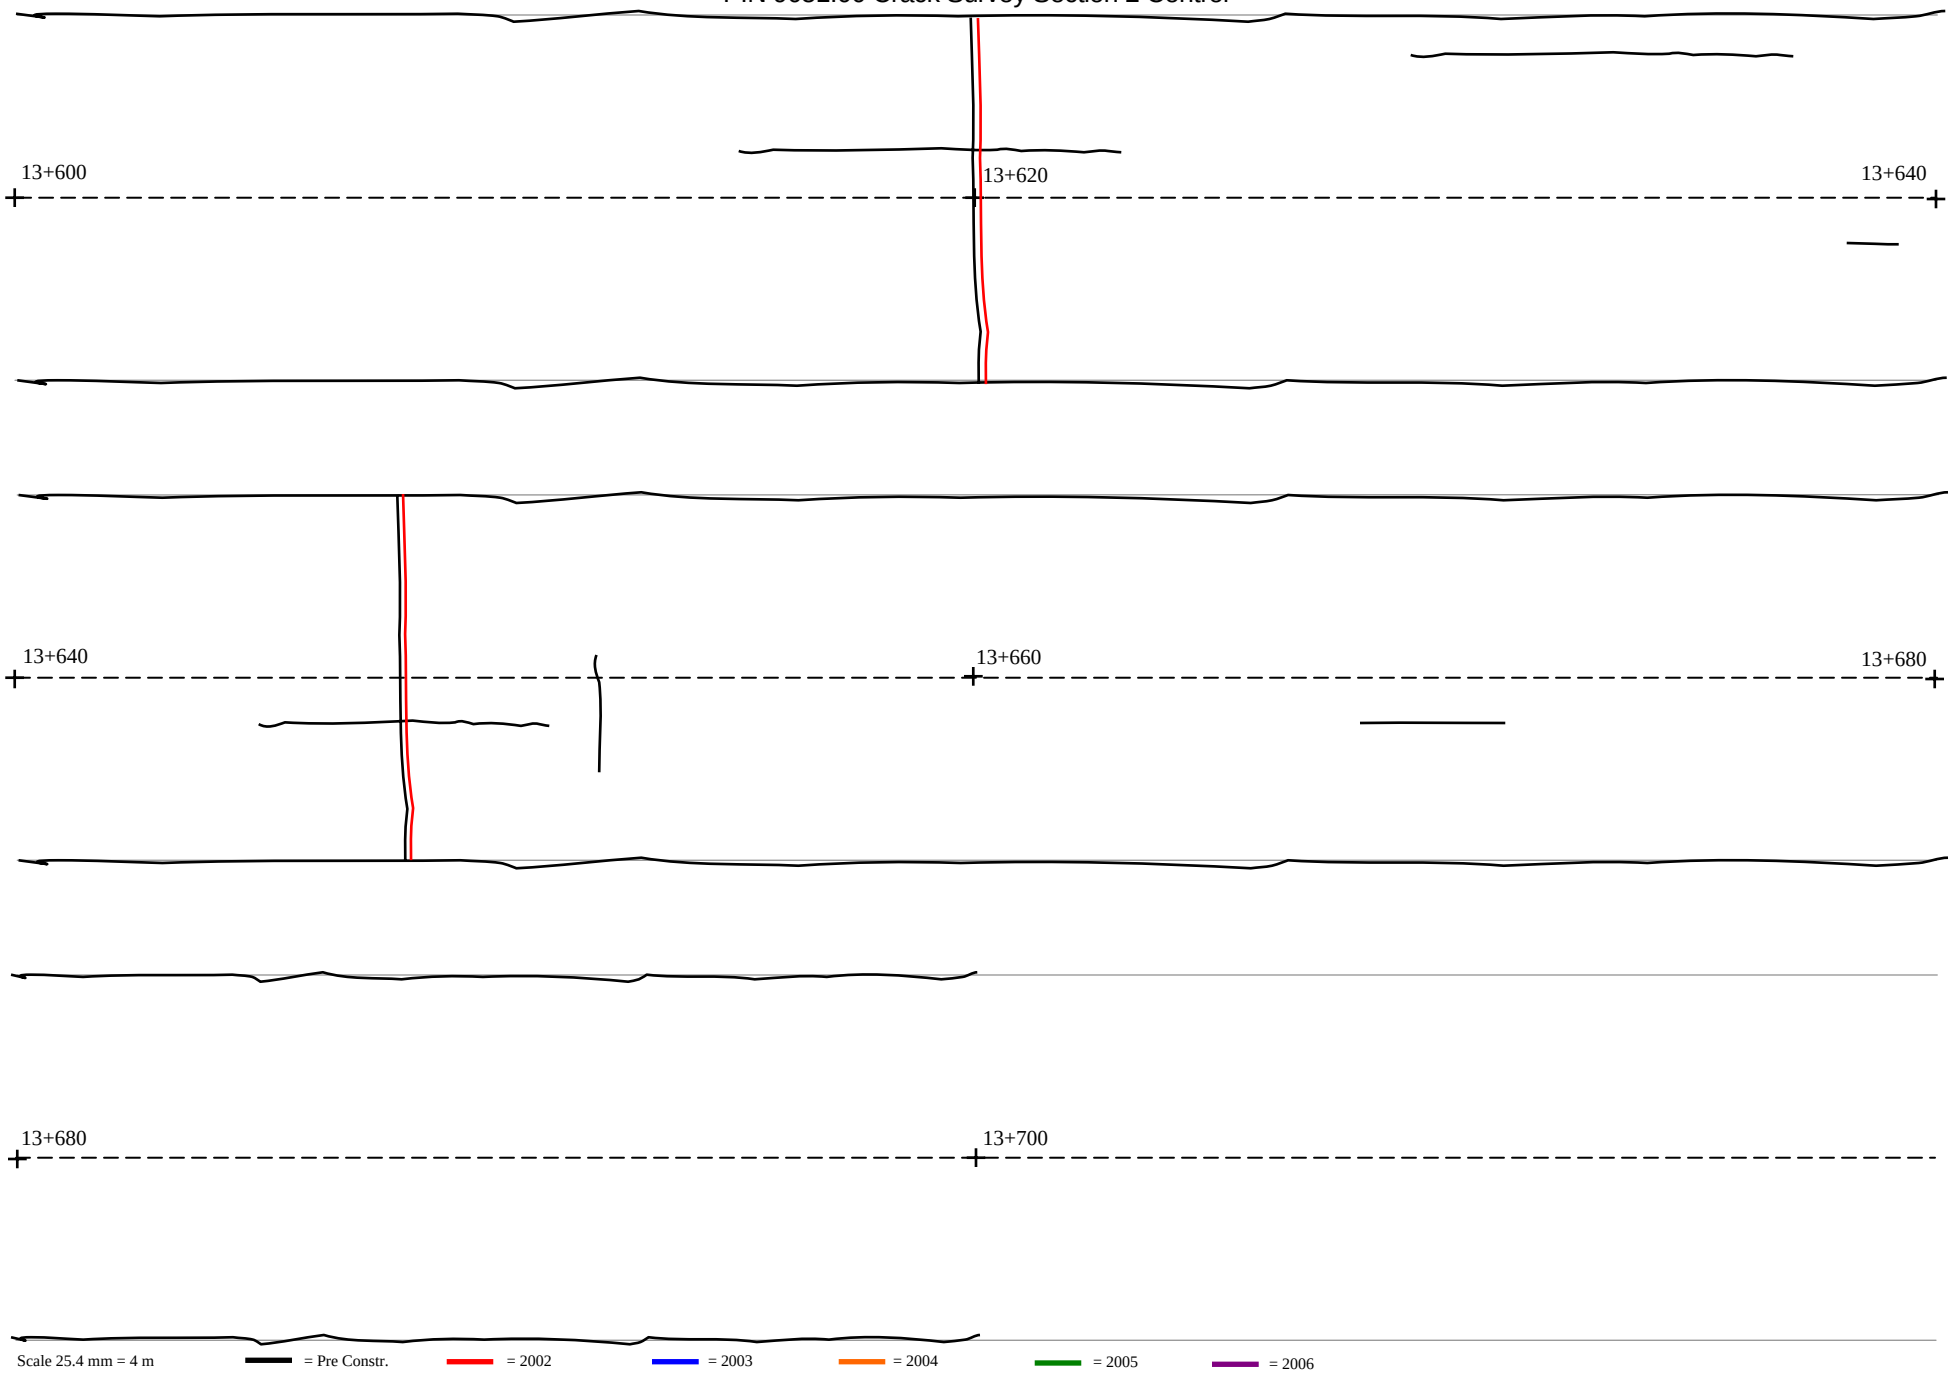
Figure 10
PIN 9051.00 Crack Survey Section 2 Control

Figure 10 contains a crack survey of Control Section 2. Two transverse cracks have reflected thru at stations 13+620 and 13+650. No longitudinal cracking was observed. Figure 16 contains a photo of the transverse crack at station 13+620.

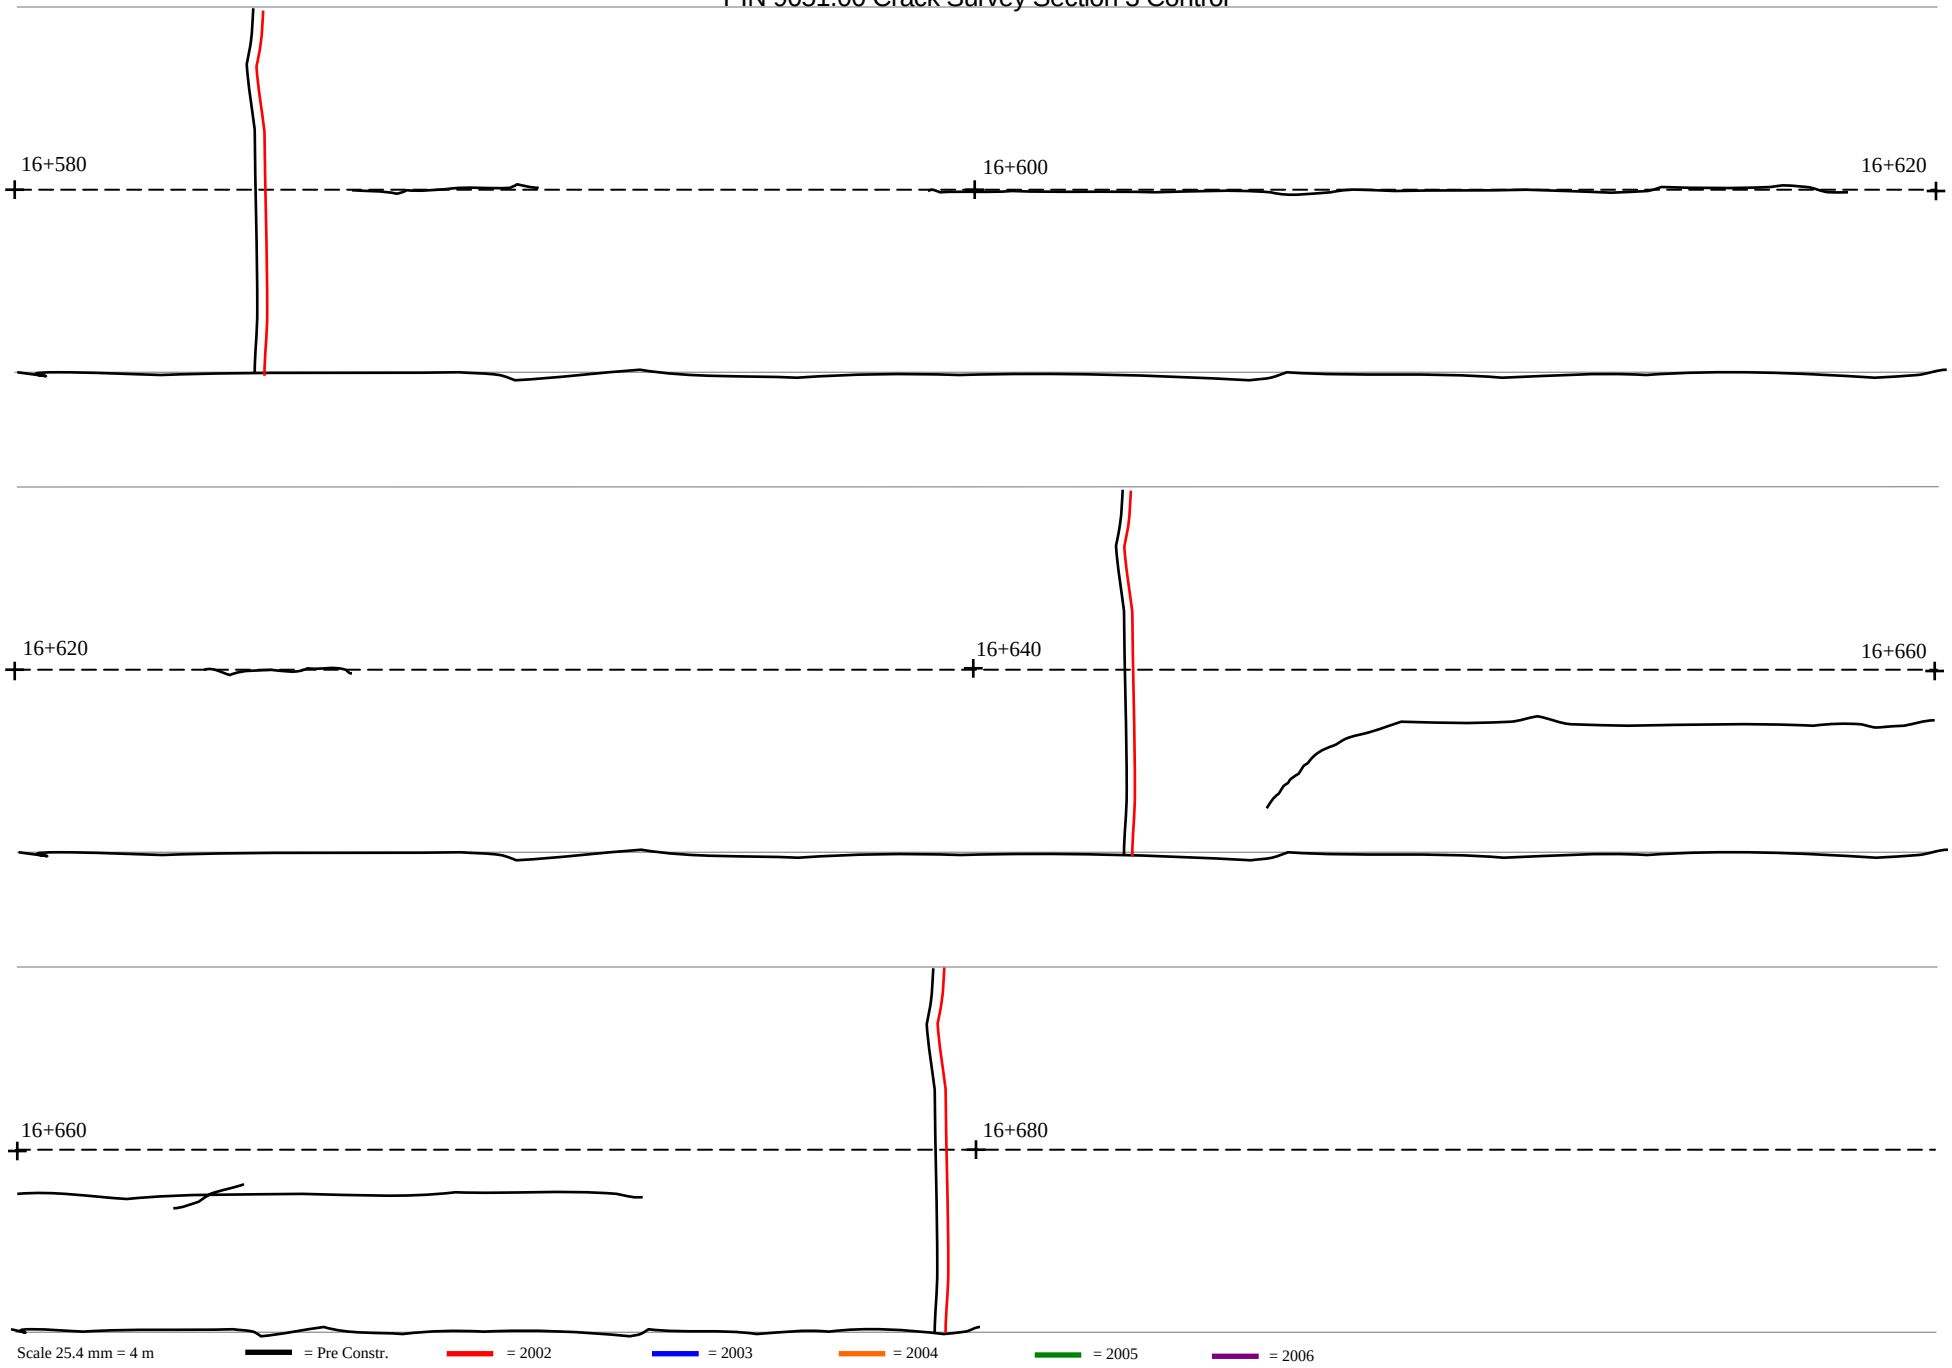
Figure 11
PIN 9051.00 Crack Survey Section 3 Control

Figure 11 displays the amount of cracking on Control Section 3. All three transverse cracks have reflected thru with no longitudinal cracking. A transverse crack is pictured in Figure 17.

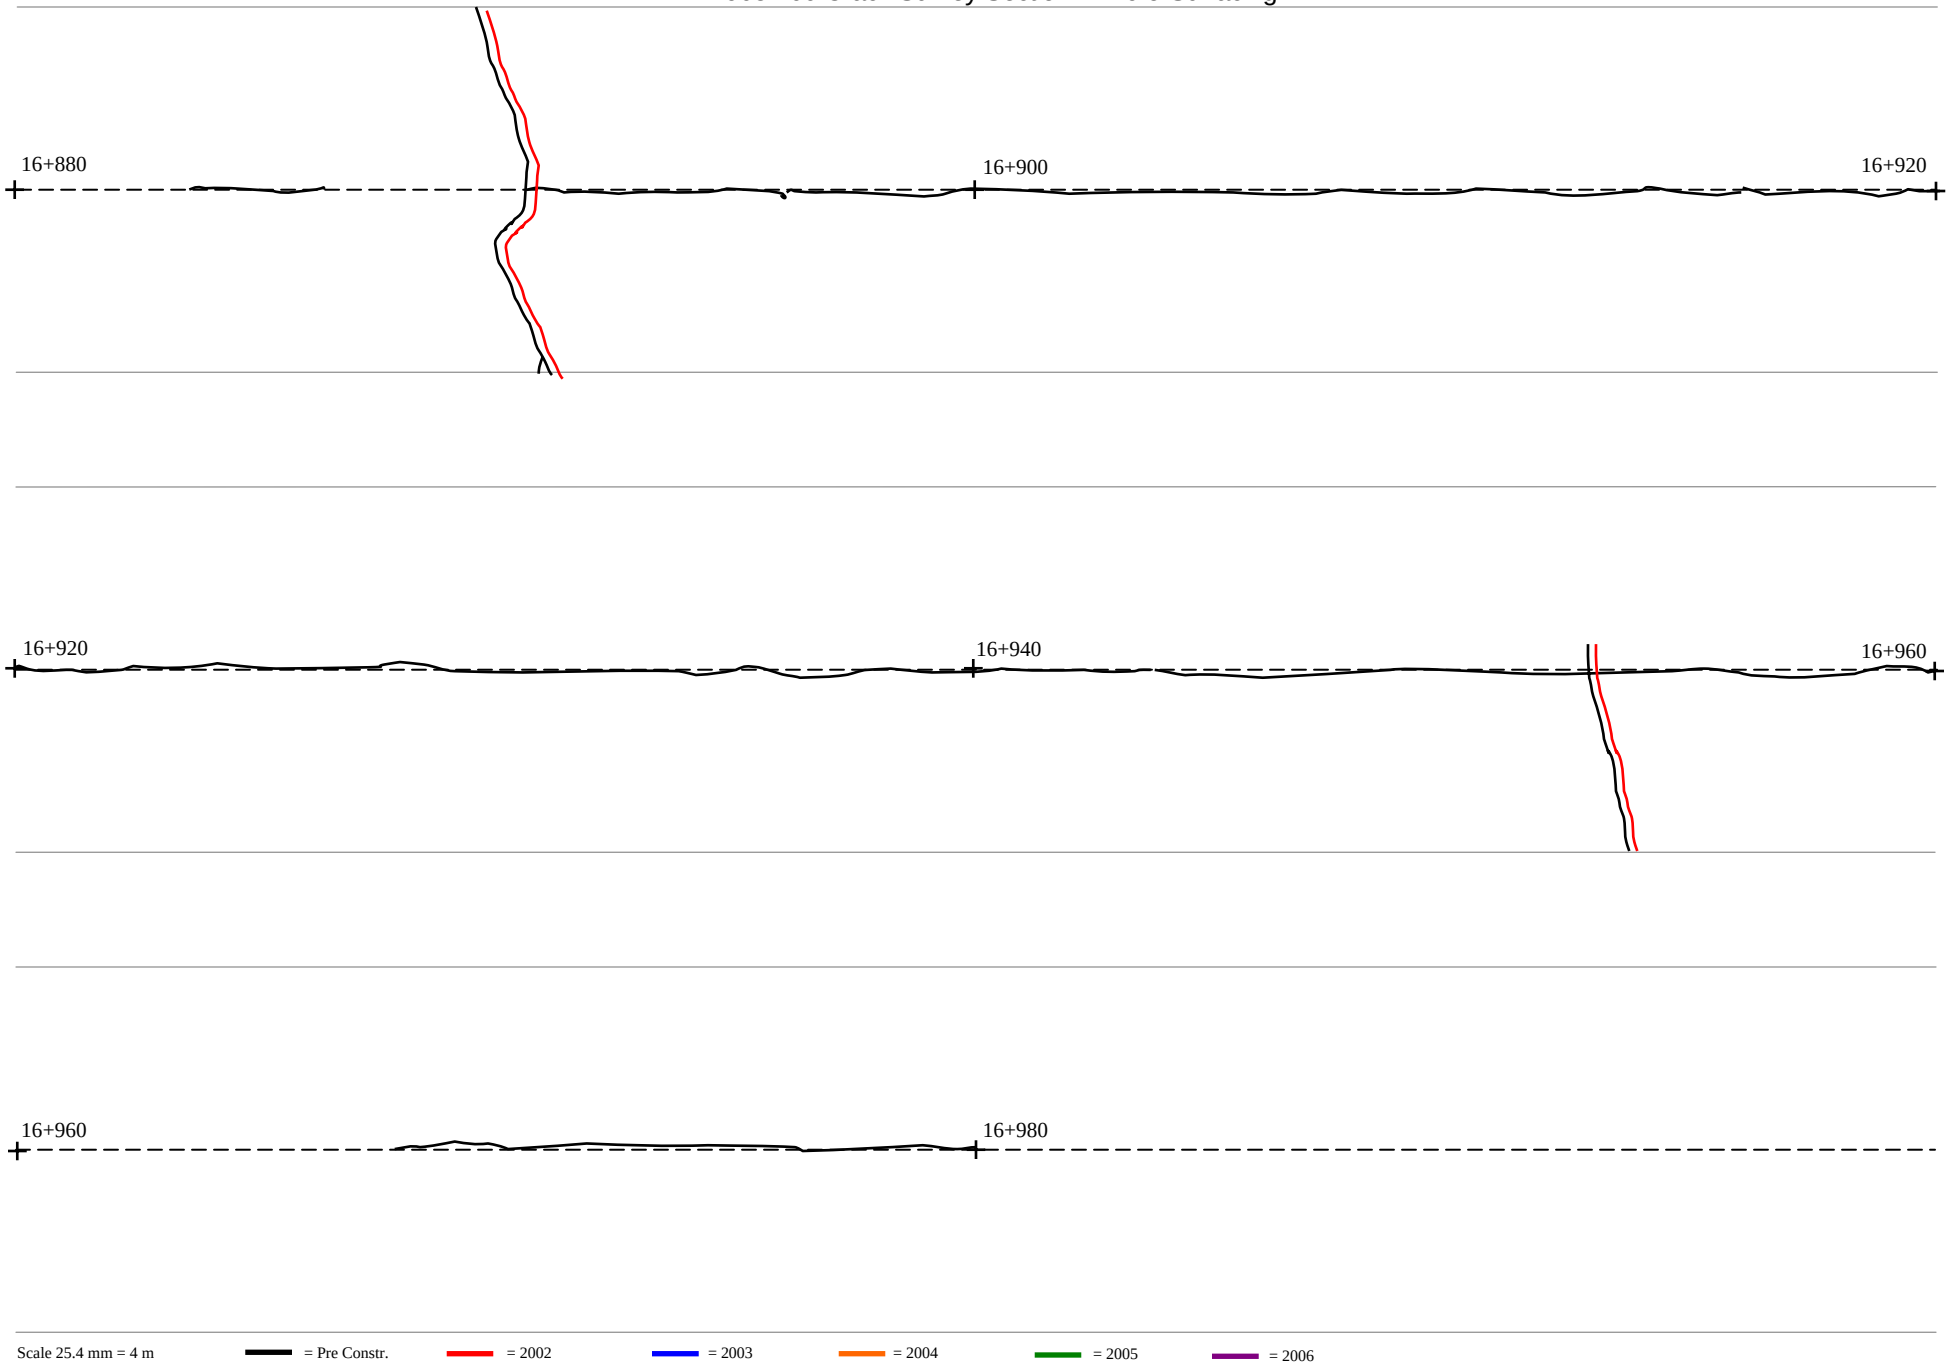
Figure 12
PIN 9051.00 Crack Survey Section 4 Micro-Surfacing

Micro-Surfaced Section 4 in Figure 12 had no longitudinal cracking but both transverse cracks have reflected thru. The centerline is experiencing snow plow wear as displayed in Figure 18.

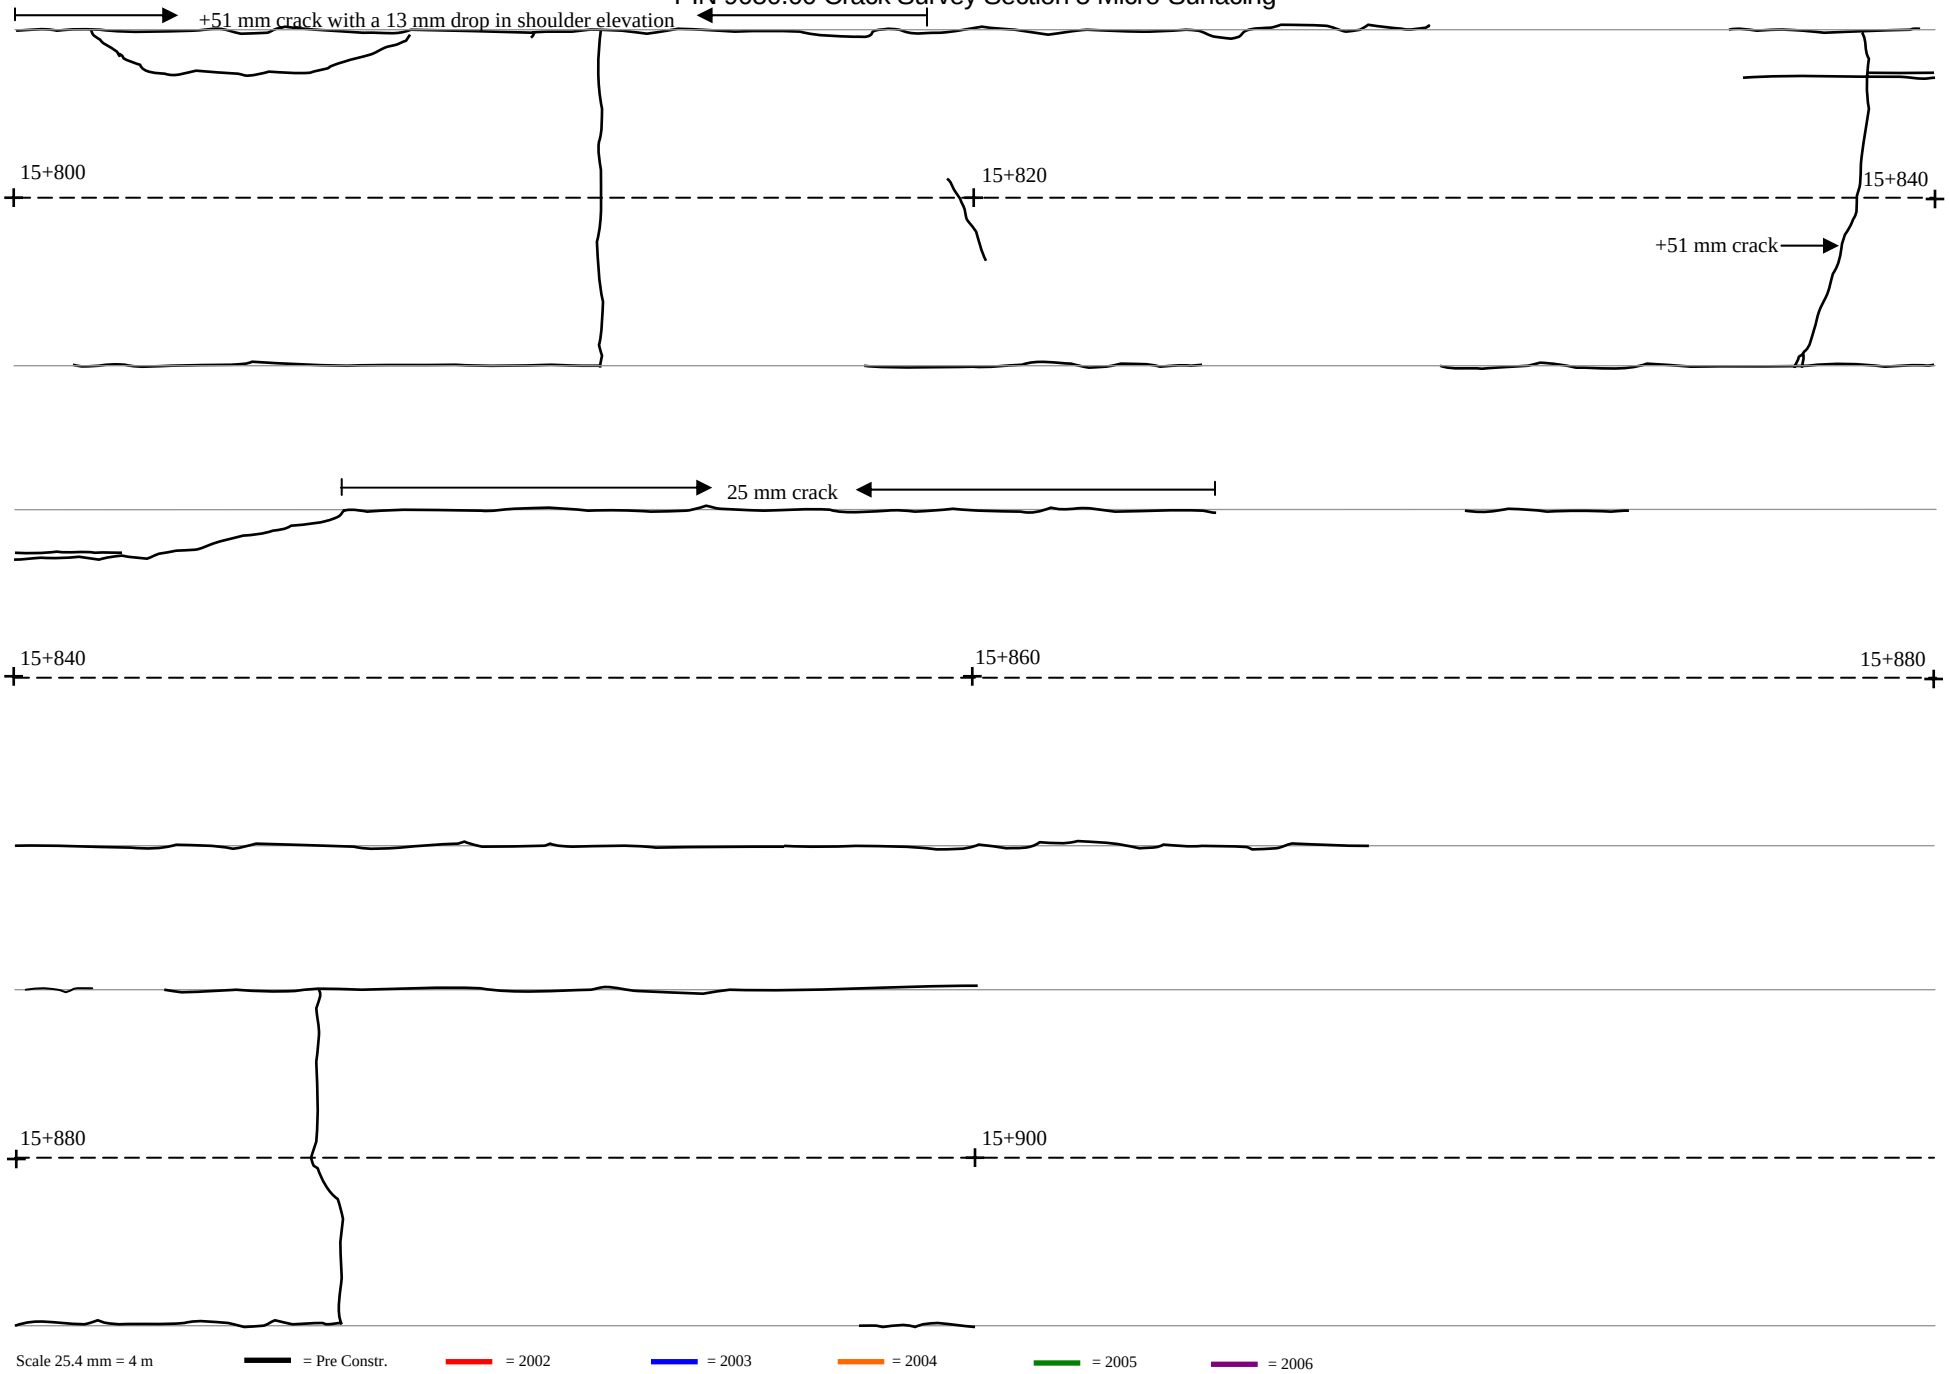
Figure 13
PIN 9050.00 Crack Survey Section 5 Micro-Surfacing

Micro-Surfaced Section 5 is displayed in Figure 13. There were no visible cracks after one year's exposure to traffic. As mentioned earlier, and displayed in Figure 2, plow wear was visible on most of the centerline and a few small areas between wheel paths.

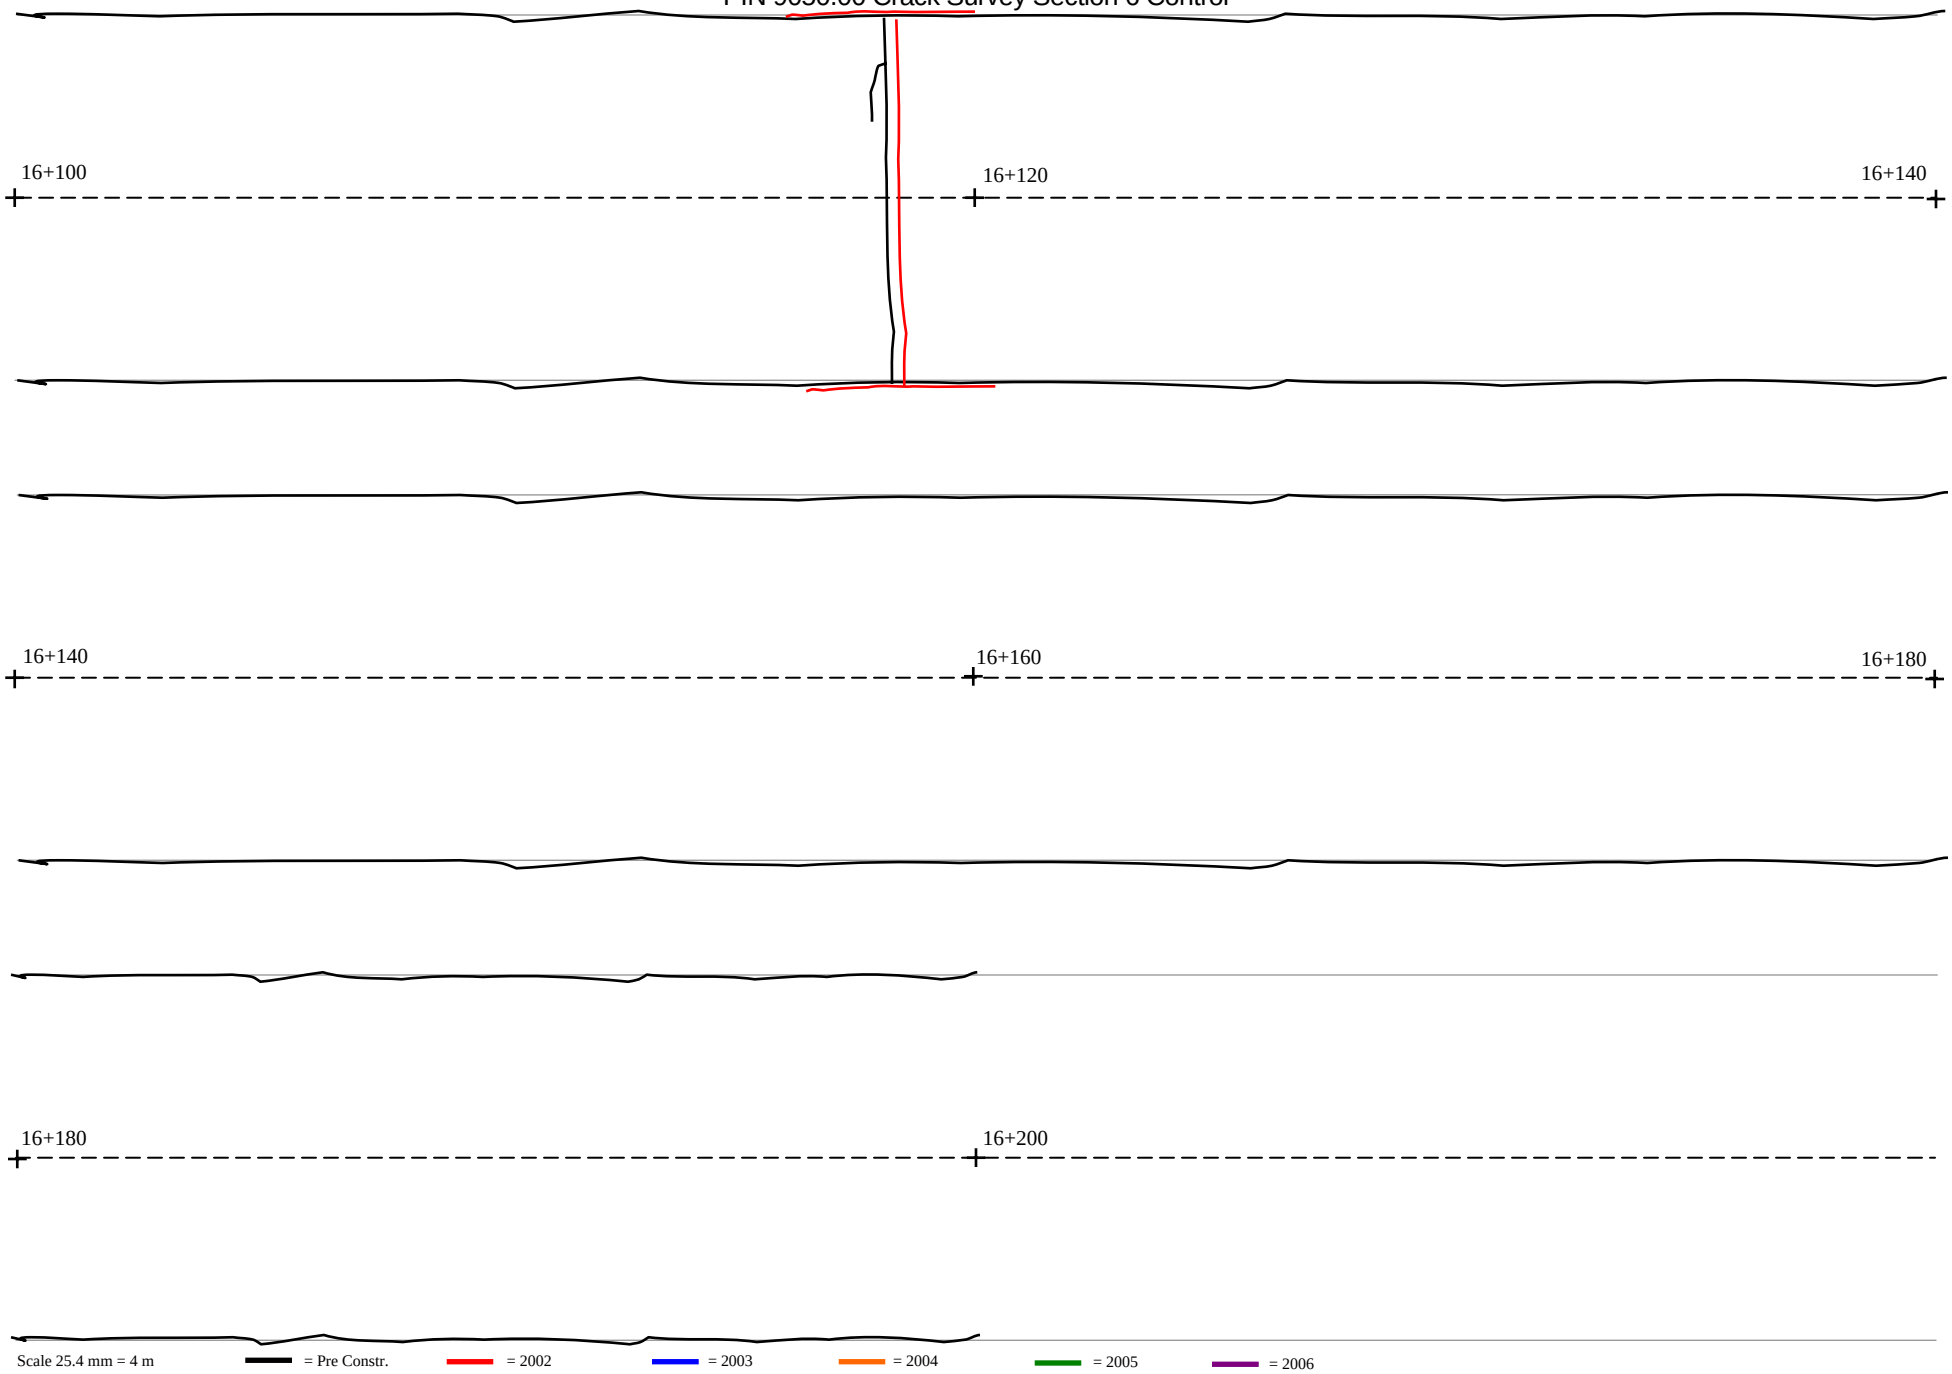
Figure 14
PIN 9050.00 Crack Survey Section 6 Control

A crack survey for Control Section 6 is exhibited in Figure 14. A transverse crack and a portion of edge cracking on either side has reflected thru. Figure 19 contains a photo of the transverse crack.

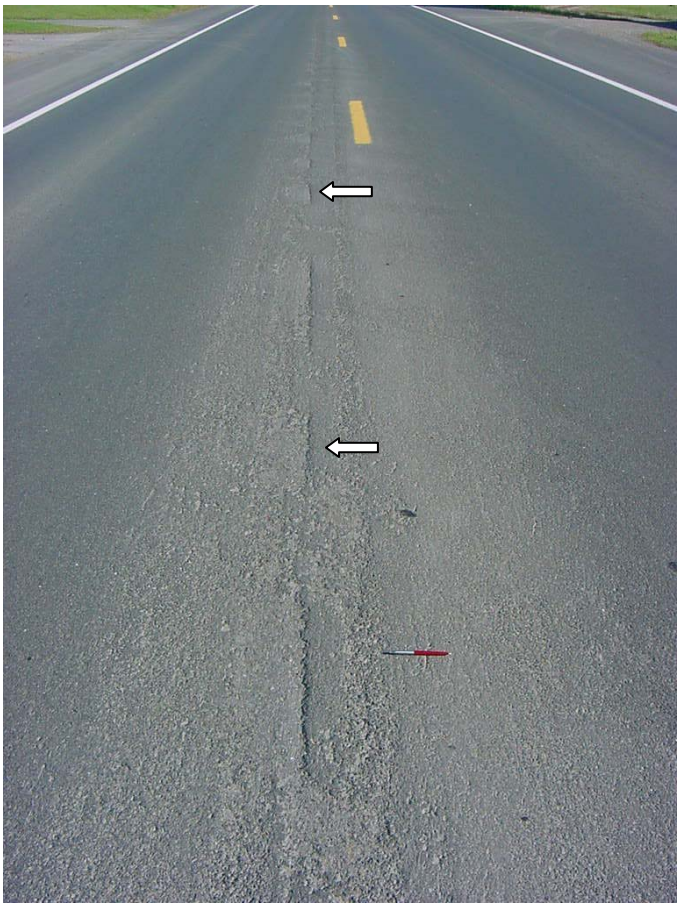
Figure 15: Micro-Surface Section 1 snow plow wear

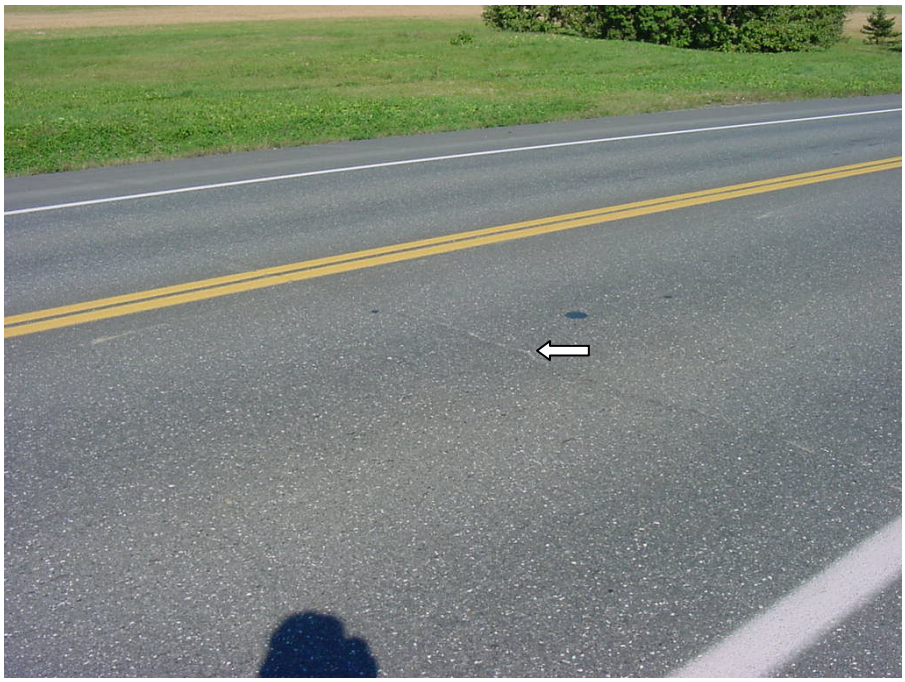
Figure 16: Control Section 2 transverse crack

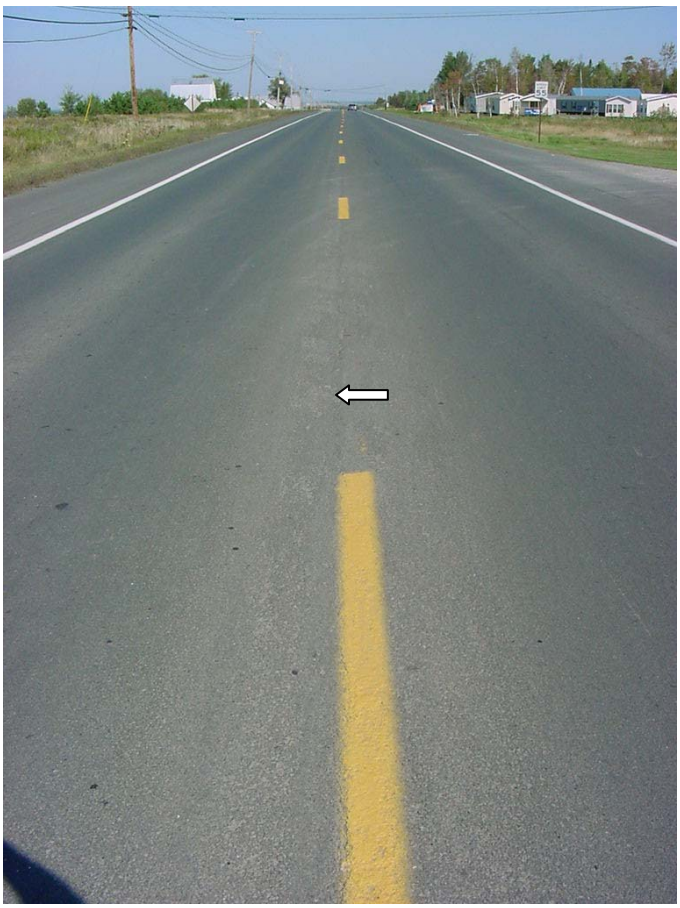
Figure 18: Micro-Surface Section 4 centerline plow wear
