WIN 26594.30
Boothbay Harbor, Rockport and Camden Ramp Report

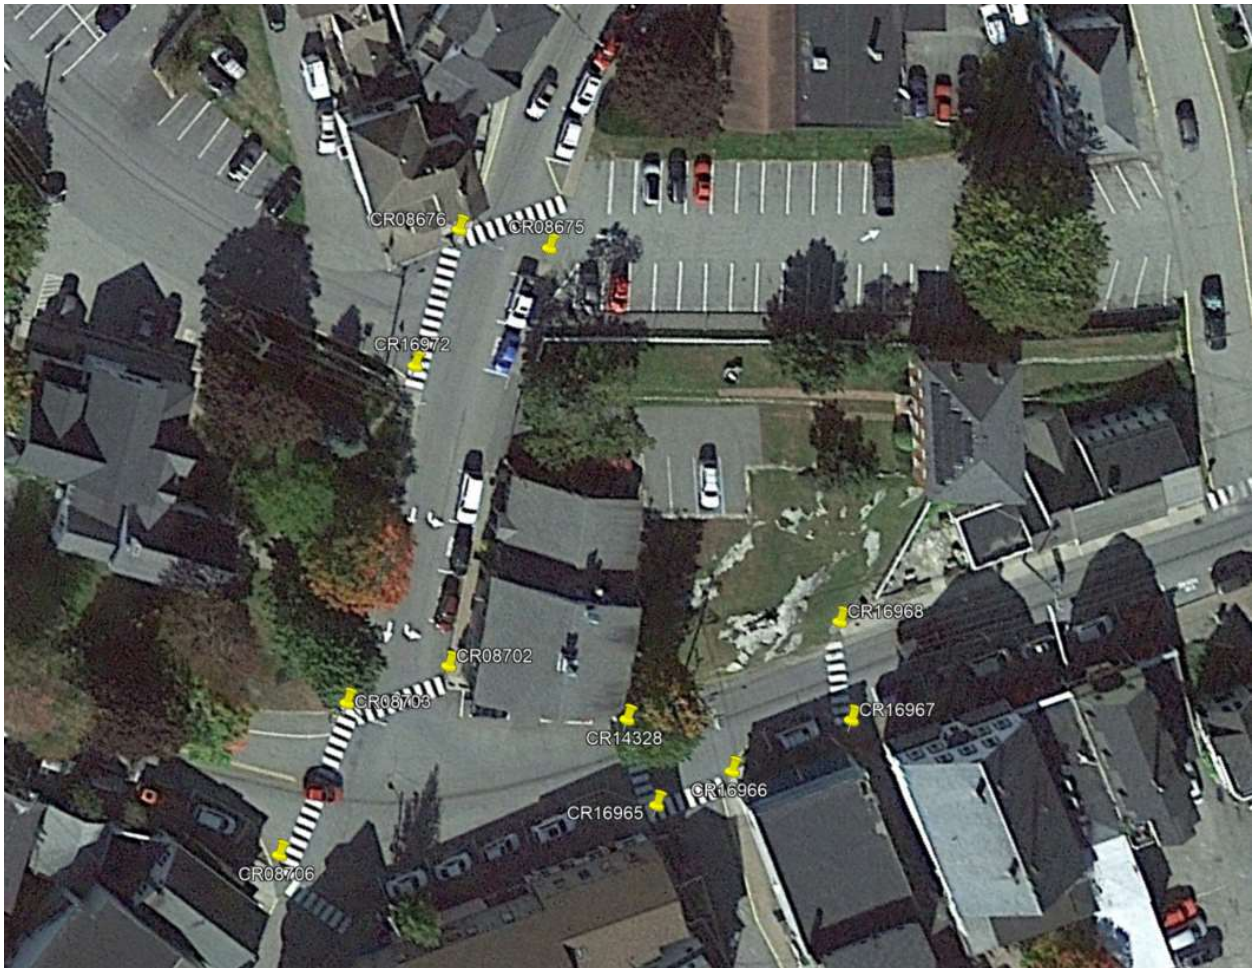
Boothbay ADA #2

Reconstruct Pedestrian Ramp on Southeast side of Oak St & McClintock St

- Cut and remove 2' in front of curb 15' up oak street and 8' down on McClintock,
- Remove curb on both sides and replace with 15' tip down on oak, opening for DWF, 4' tip up, 4' tip down, DWF opening then 8' tip up. Radius around corner.
- Place 2x4 DWF on oak, and 2x4 DWF on McClintock.
- Grade, loam, seed disturbed area behind sidewalk.
