Pavement Condition Report

STEPHEN A. BEAN MUNICIPAL AIRPORT (8B0)

STEPHEN A. BEAN
MUNICIPAL AIRFIELD

Submitted To:
Maine Department of Transportation
16 State House Station
Augusta, ME 04333

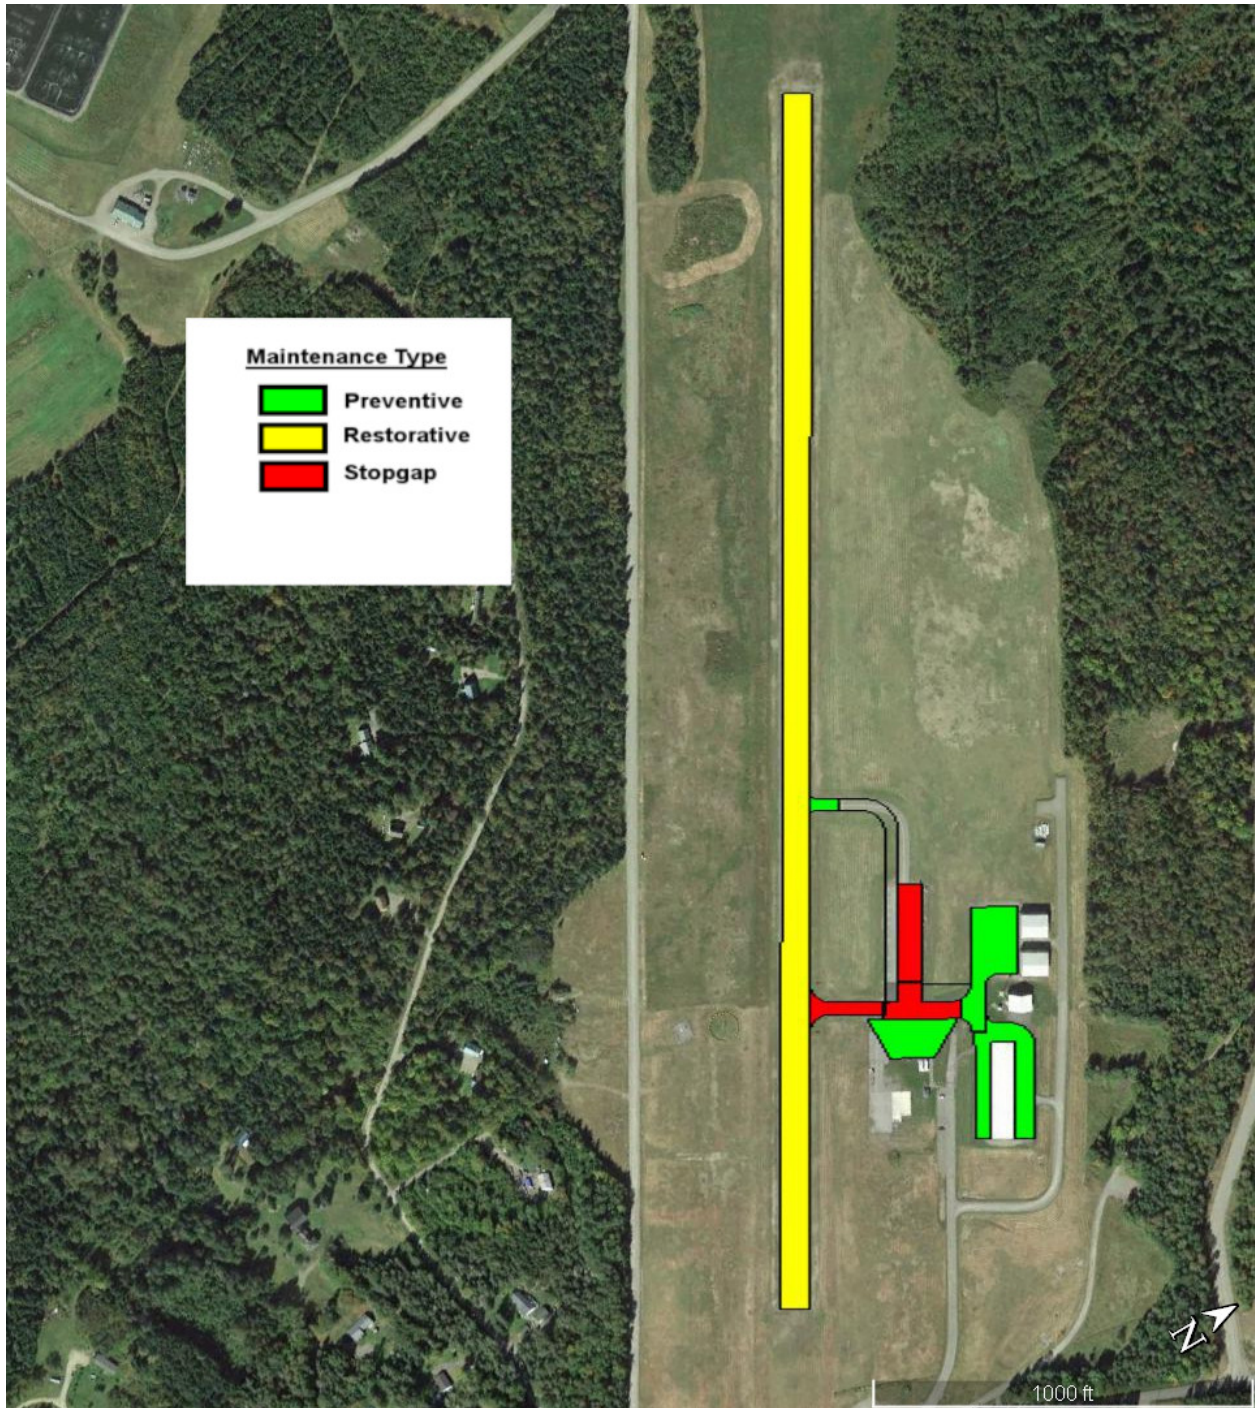
Figure 8. Maintenance type

Branch	Section	Work Type	Quantity	Unit	Cost
APA	001	Crack Sealing - AC	4,968	Ft	\$6,856
APA	002	Crack Sealing - AC	11,003	Ft	\$15,185
APA	003	Crack Sealing - AC	233	Ft	\$322
APA	004	Crack Sealing - AC	152	Ft	\$209
APA	005	Crack Sealing - AC	595	Ft	\$821
CTB	001	Crack Sealing - AC	339	Ft	\$468
CTC	001	Crack Sealing - AC	62	Ft	\$86
RY1432	001	Crack Sealing - AC	1,881	Ft	\$2,596

It is important to understand that the maintenance plan is based on the distress types, severities, and quantities found during the 2018 PCI survey. As field conditions change, the maintenance plan will become less accurate. Therefore, the maintenance plan will be most useful if implemented as soon as is practical. Applying maintenance treatments should be an annual event at the airport, and this maintenance plan can serve as a baseline for that work. The recommended maintenance type for each section is shown in Figure 9 and summarized in Table 8. Recommended maintenance actions by section are provided in Table 9. Guidelines for performing crack sealing and patching techniques are provided in appendix F.

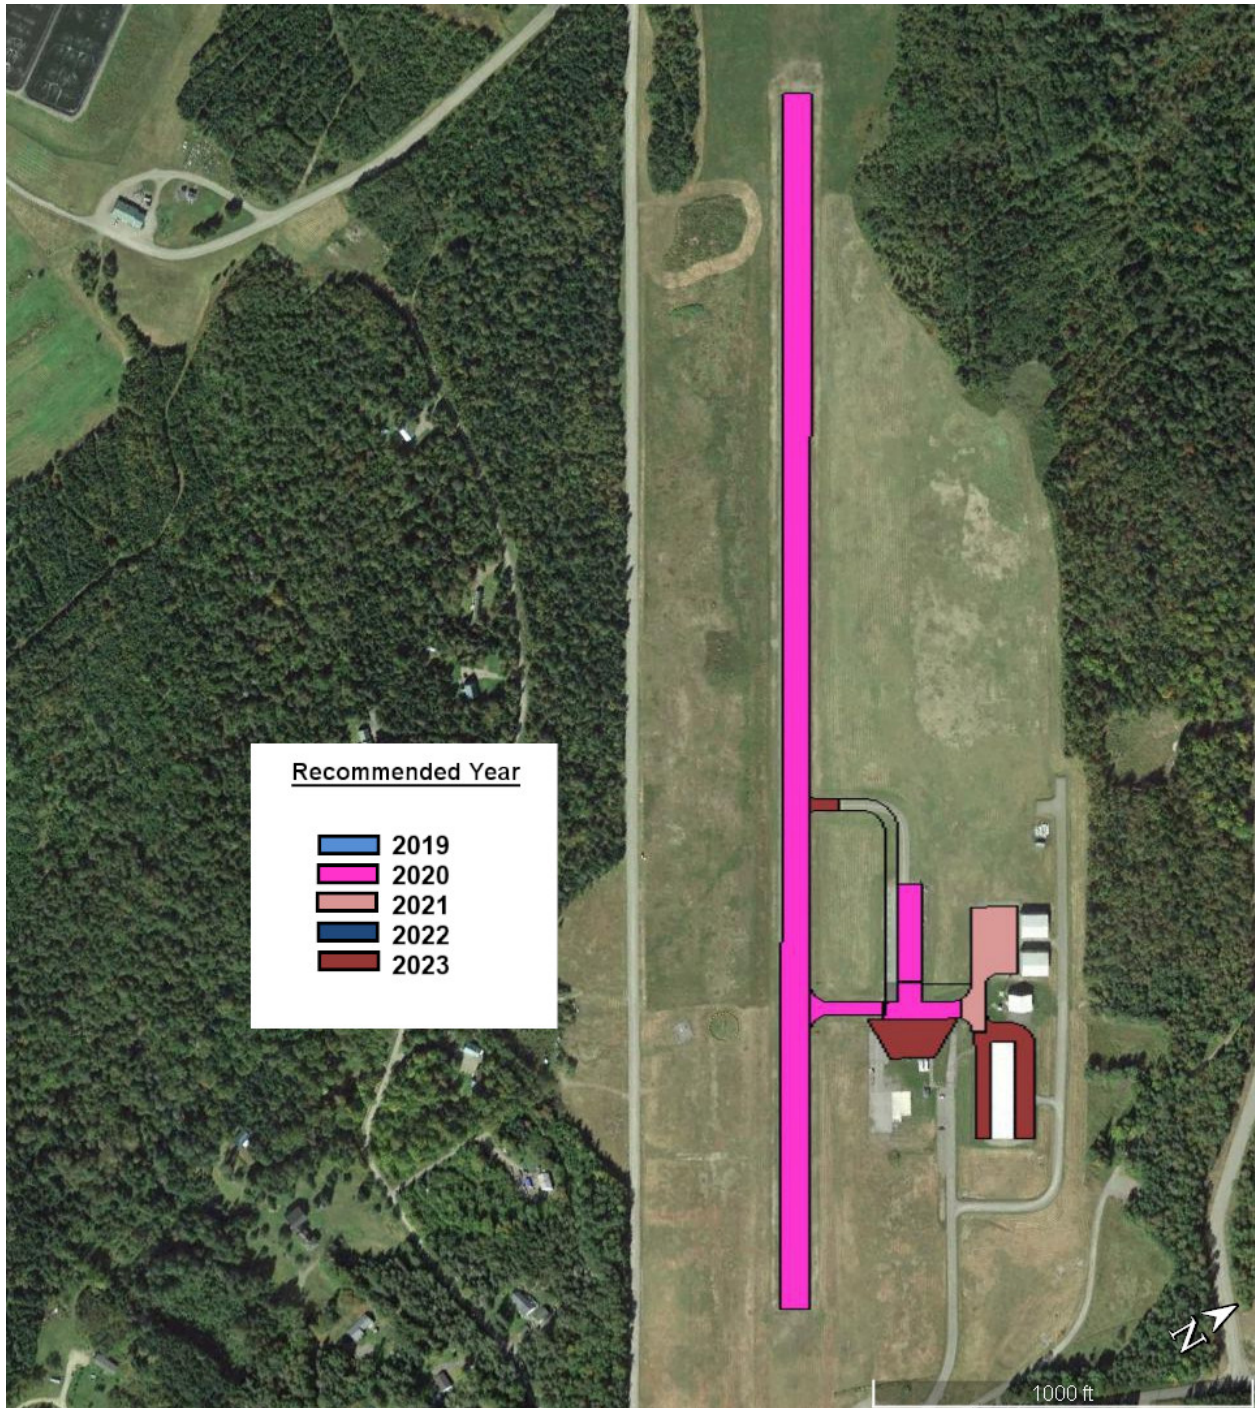
Figure 9. Major M&R

The pavement sections identified for major rehabilitation in Table 10 and shown in Figure 9 are at or are predicted to reach a condition level where major M&R should be considered. While the predicted rehabilitation timeline identifies specific sections and the general timing for the repair, more in-depth project-level studies will be needed to determine exactly how to fix each pavement (i.e. asphalt overlay, reconstruction, or some other repair alternative). Additionally, the airport may find it desirable to adjust the timing of projects to meet fiscal and operational constraints. For example, if the runway and several connector taxiways were forecast to reach the MSL in various years ranging from 2019-2023, it may be preferable to group these pavement sections into a single project.

Branch ID	Section ID	Year	Predicted PCI Before Rehab	Estimated Cost
APA	001	2020	20	\$332,514
APA	002	2020	33	\$261,320
CTB	001	2020	50	\$170,337
RY1432	001	2020	63	\$660,396
APA	003	2021	69	\$81,865
APA	004	2023	69	\$49,966
APA	005	2023	68	\$84,340
CTC	001	2023	68	\$10,780
5-year Airport Total				\$1,651,518

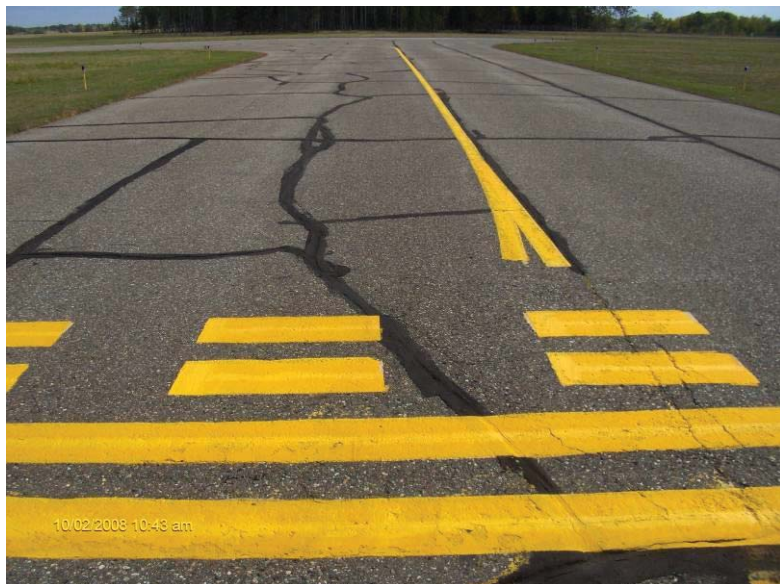
Example of Longitudinal and Transverse Cracking (L&T cracking)

Longitudinal and transverse cracks are caused by pavement aging, by construction, and by subsurface movement. Aging occurs as pavement loses some of its components to the atmosphere and becomes more brittle. Consistent application of pavement sealcoats can help to prevent the occurrence of age related cracks. Cracks will also develop along poorly constructed paving lane joints. Ensuring that joints are made when both sides are still hot, and near the same temperature, is one of the best ways to mitigate this potential problem. Seasonal movement caused by changes in moisture content or temperature differences can also cause pavement cracks. Asphalt pavement placed over a PCC pavement or cement stabilized base course may evidence reflective cracking from the underlying material. Longitudinal and transverse cracks are not caused by wheel loads, although traffic may worsen their condition.

Low severity longitudinal and transverse cracks are less than ¼ inch wide, or if sealed with suitable filler material in satisfactory condition can be any width, less than 3 inches, if they are not spalled. Maintenance usually is not indicated for low-severity cracking. Moderately spalled cracks and cracks wider than ¼ inch which are not satisfactorily sealed are at medium severity. Medium-severity cracks should be sealed with a high-quality crack filling material. Severely spalled cracks and cracks wider than 3 inches are at high severity. High-severity L&T cracks normally require patching.

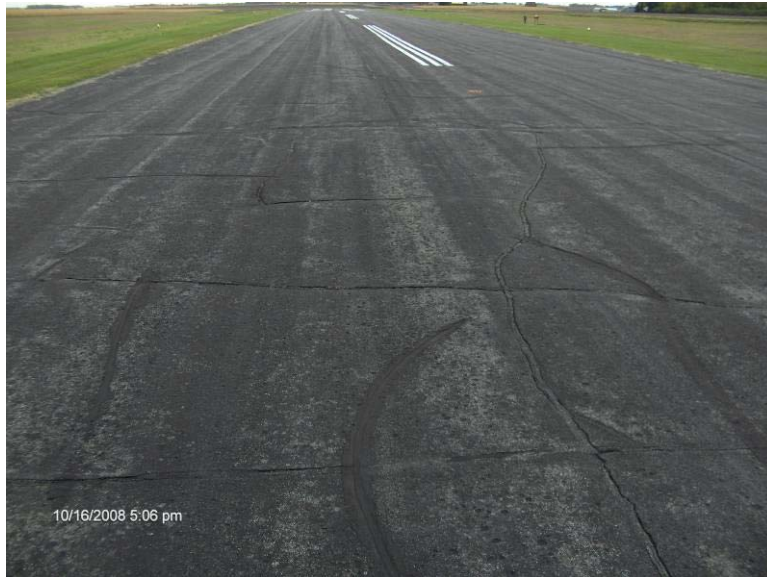
Example of Block Cracking

Block cracking is longitudinal and transverse cracking that has established a pattern of blocks ranging in size from 1ft x 1ft to 10ft x 10ft. This distress typically happens in older asphalt pavements and is an indication that the bituminous binder has lost most of its flexibility. The severity determination is basically determined by the crack width criteria defined for longitudinal and transverse cracking. Crack sealing typically is used to repair block cracking; however, the amount of required sealant can be extensive due to the high density of cracks.

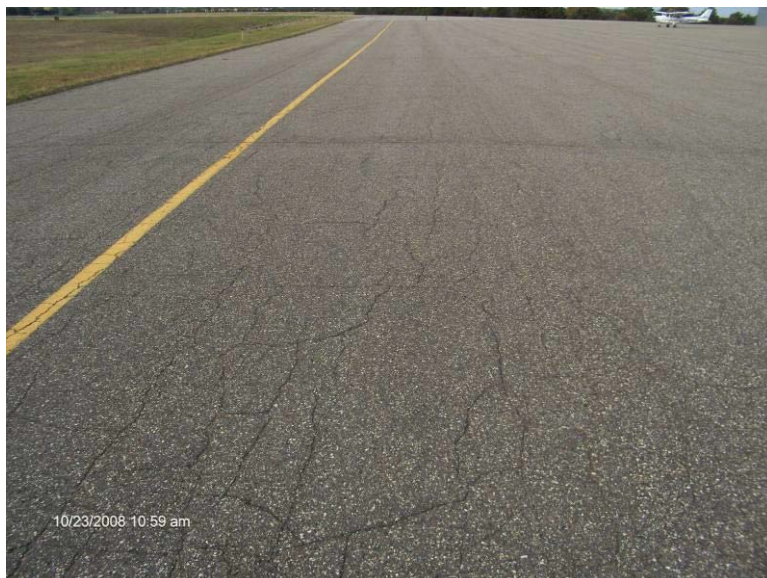
Example of Alligator Cracking

Alligator (or fatigue) cracks are a series of interconnected load-related cracks caused by fatigue of the asphalt surface. Alligator cracking is a significant structural distress and develops only in places subject to traffic loads. These cracks typically initiate at the bottom of the asphalt layer (where tensile strains

are highest) and propagate upward - so once a fatigue crack is visible, significant damage has already occurred.

At low severity, alligator cracks are evidenced by a series of parallel hairline cracks (usually in a wheel path). Further traffic and deterioration leads to the interconnection of these cracks. Medium severity alligator cracking is a well-defined pattern of interconnected cracks, some spalling may be present. High severity alligator cracks have lost aggregate interlock between adjacent pieces, the cracks may be severely spalled with FOD potential, and most likely the pieces will move freely under traffic. Alligator cracking is a structural failure and cannot be repaired with sealant, the proper repair is full-depth patching.

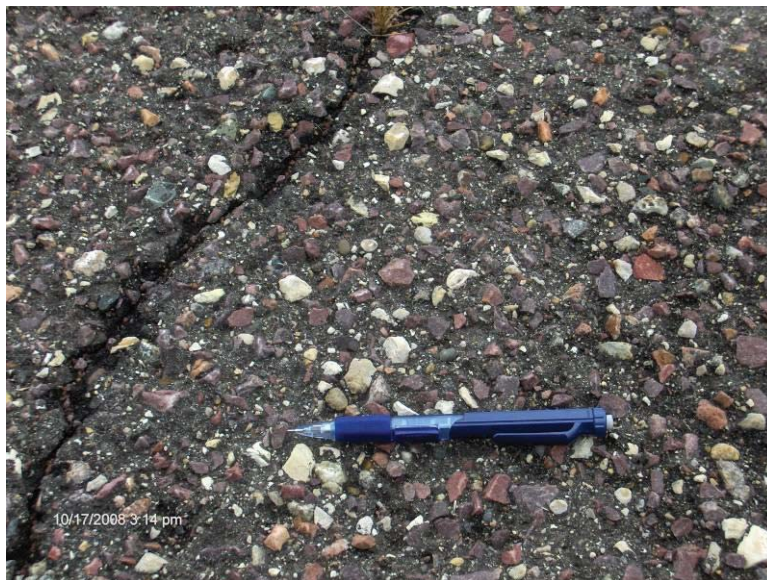
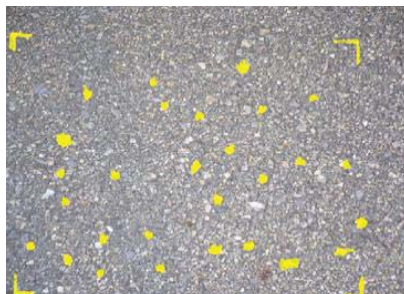
Example of Raveling/Weathering

Raveling and weathering are the wearing away of the pavement surface. Raveling is the condition where the mid- to large size aggregates are becoming dislodged; weathering is when the fine aggregate wears away exposing the edges of the larger aggregate. These distresses are usually evident over large areas and may occur together (pictured above) or separately. Raveling and weathering may indicate that the asphalt binder has hardened significantly.

Raveling – At low severity, the number of missing coarse aggregates (> 3/8 inch) is between 5-20 missing/yd², medium severity (pictured below where the missing coarse aggregates have been dotted with yellow paint) is 21-40 missing/yd², and high severity is > 40 missing/yd².

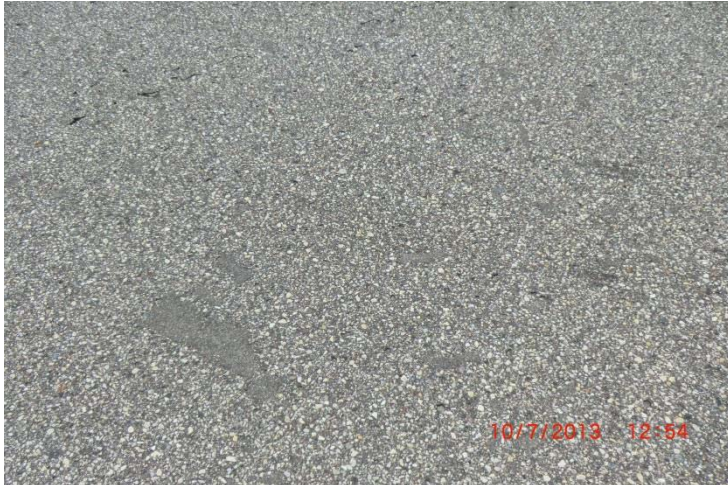
Low severity

Weathering – At low severity, the coarse aggregate is slightly exposed due to the wearing away of the fine aggregate. At medium severity, the coarse aggregate is exposed up to $\frac{1}{4}$ the width of the longest side. At high severity, the coarse is exposed greater than $\frac{1}{4}$ the width of the longest side.

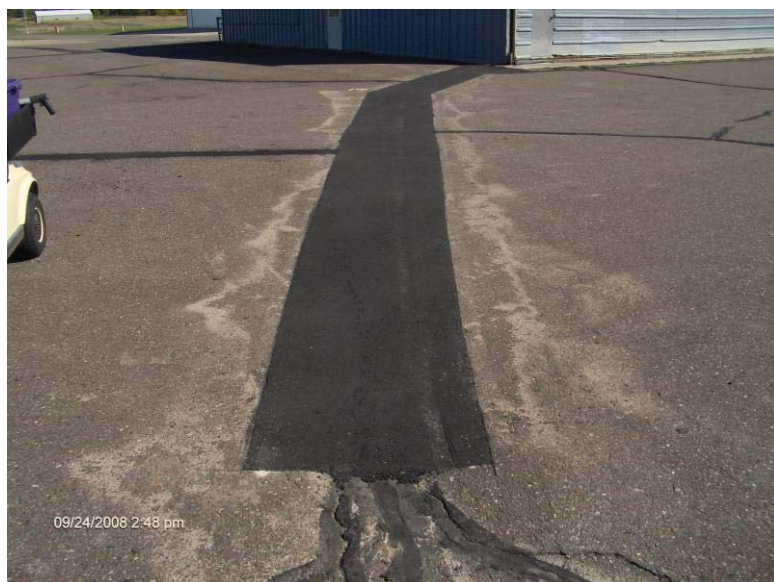
Example of Patching

Patched areas are defined when a portion of the original pavement is replaced with a material intended as a semi-permanent repair. A patch is documented as a defect because it is considered a break in the integrity of the pavement structure. Patches are constructed for a variety of reasons including utility repairs, correcting grade issues, and addressing a defect in the original pavement. The severity level of patches is determined by the amount of distress (i.e. cracking, depression, weathering/raveling, etc.) occurring within the limits of the patched area.

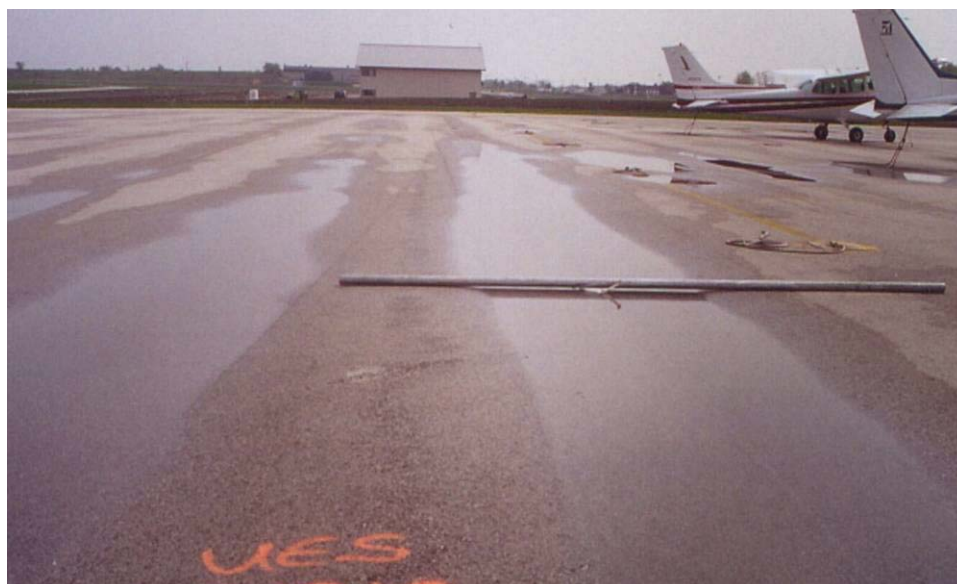
Example of Rutting

Ruts are localized, load related, areas of pavement having elevations lower than the surrounding sections. Rutting is due to base and subgrade consolidation, caused by excessive wheel loads or poor compaction. Ruts indicate structural failure, and can cause hydroplaning. At low severity, ruts have an

average depth of ¼ to ½ inches. At medium severity, ruts have an average depth of ½ to 1 inch. High severity, ruts have an average depth greater than 1 inch. Full-depth patching is the appropriate repair for ruts.

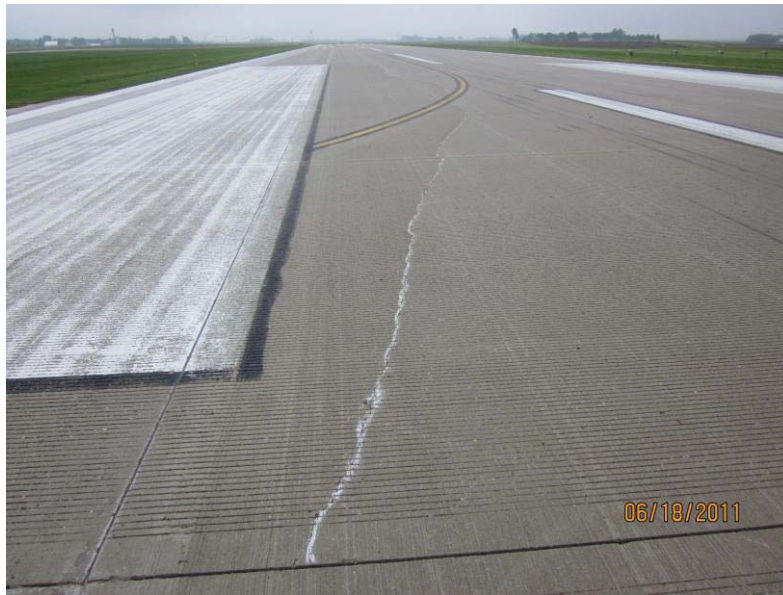
Example of Longitudinal, Transverse, and Diagonal Cracking

LTD cracking is most often a result of externally applied loads and/or constrained temperature deformations. External loads cause LTD cracking through flexure. Temperature changes on restrained slabs will result in stresses due to friction or curling. When any of these stresses exceed the strength of the slab, cracking will occur. LTD cracking is recorded at low, medium, or high severity, depending on the width of crack opening and degree of deterioration. At low severity, the crack is less than 1/8th inch wide with little spalling and no corrective action is indicated. At medium severity, LTD cracks can be up to 1 inch wide with moderate spalling, and should be repaired and sealed using procedures similar to joint sealing. At high severity, cracks exceed 1 inch in width and may be severely spalled. High-severity LTD cracking is evidence of serious load failure of the slab, and correction may require patching or slab replacement. If the distress occurs in several adjacent slabs at medium or high severity, major rehabilitation of that pavement area is indicated.

When a slab is divided by LTD cracks into four or more pieces, the slab is said to be "divided" or "shattered." Shattered slab is a separate distress category and is indicative of significant structural failure as the slab loses its ability to distribute loads to subgrade and further slab deterioration can be expected. Shattered slabs are rated in three severities, with slab replacement recommended for medium and high severities.

Longitudinal/transverse/diagonal (LTD) cracks at low and medium severity should be considered for sealing as part of the joint sealing project. High-severity LTD cracks require sealing, patching, or slab replacement, depending on the extent of deterioration.

High-severity LTD cracks and shattered slabs are candidates for patching and slab replacement. Low-severity shattered slabs can be left in place pending further deterioration.

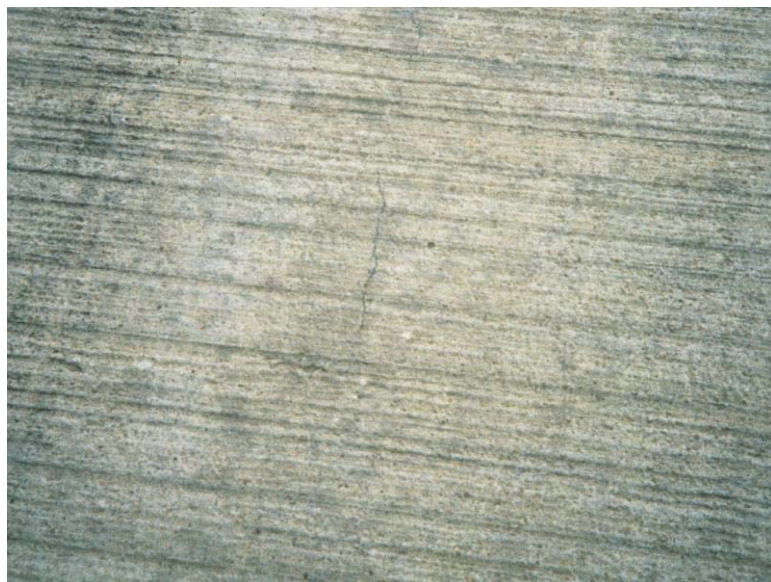
Example of Shrinkage Cracking

Shrinkage cracks are small, nonworking (no spalling along edge) cracks that are visible at the surface but do not penetrate through the full depth of concrete. Shrinkage cracks most commonly occur shortly after construction due to concrete shrinkage during the curing process. Shrinkage cracks are usually so small that they are not visible until staining or material loss at crack edges begins to take place. Shrinkage cracks do not represent a structural weakness, and no corrective action is prescribed.

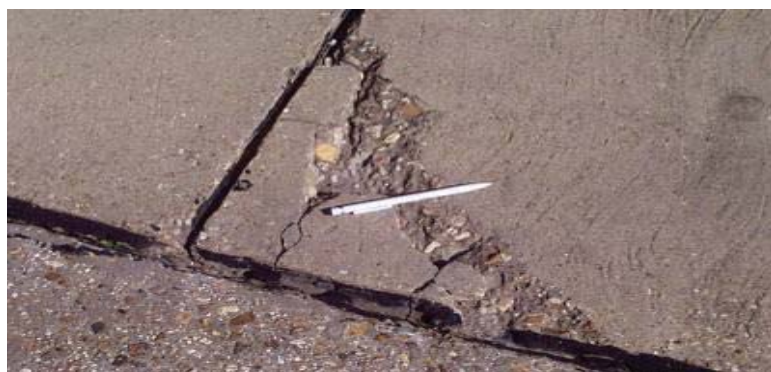
Example of Joint and Corner Spalling

Spalls at slab joints and corners are caused by excessive internal stress in the pavement. Spalls occur when these stresses exceed the shear strength of the concrete. Spalling usually results from thermal expansion during warm or hot weather. As slabs expand, they push against one another at joints. If the joints are filled with incompressibles, such as sand, or if adjacent slabs offset slightly, stresses can become severe, causing spalls. Spalling can be reduced significantly by conscientious maintenance of joint sealant.

Spall repair requires patching. The extent and severity of spalling on a pavement surface suggests appropriate action. For example, at low severity, spalled concrete remains securely in place in the slab. A low-severity spall should be monitored closely for further deterioration and should be patched when

spalled particles become loose in place, or at the next scheduled patching activity in the section. Medium- and high-severity spalls should be repaired immediately to prevent the incidence of FOD. If the pavement can be restored to serviceable condition, spalls should be carefully patched for long-term service. If the pavement is beyond repair, temporary patching should be considered to control FOD.

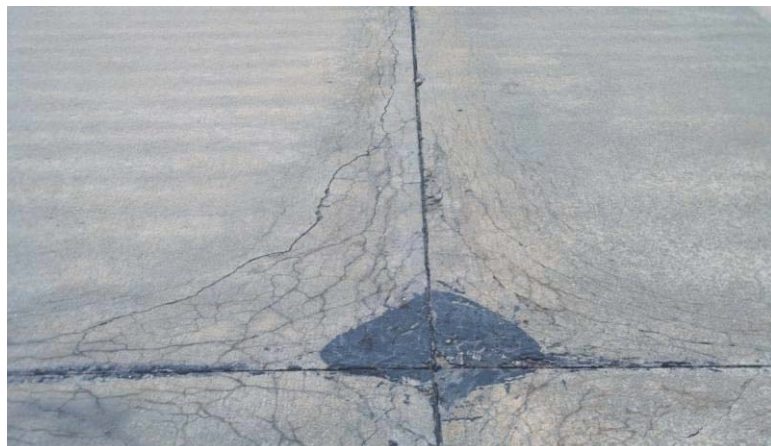
Example of Durability Cracking

Durability cracking (D-cracking) is caused by environmental factors, the most common of which is freezing/thawing. It usually appears as a pattern of hairline cracks running parallel to a joint or crack, or in a corner, where water tends to collect. This type of cracking eventually leads to disintegration of the pavement, creating FOD potential. At low severity, D-cracking is evident, but no disintegration has occurred. As the distress advances to medium severity, the distress pattern is evident over a significant area of the slab, and some disintegration and FOD potential exists. High severity durability cracking is evidenced by extensive cracking with loose and missing pieces and significant FOD potential.

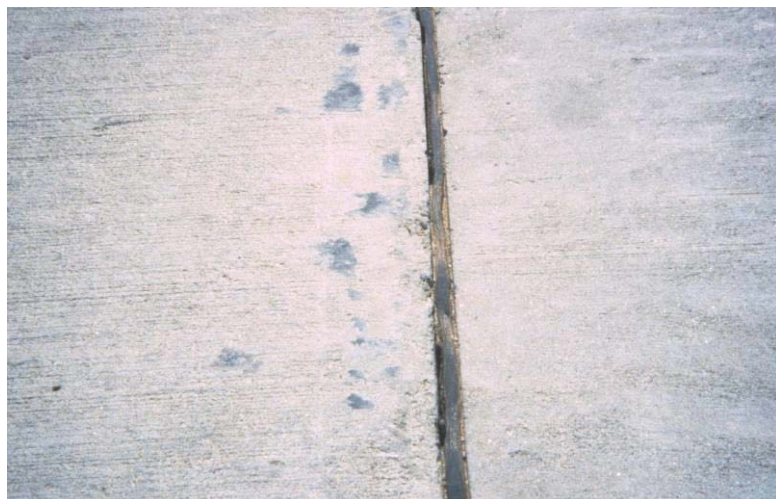
Example of Joint Seal Damage

Joint seal damage is recorded at three severities: low, medium, and high. When joint sealant is in perfect condition (no damage), it is not a distress. At low severity, at least 10 percent of the sealant is debonded but still in contact with the joint edges (i.e., joint sealant is in serviceable condition but should

be monitored for evidence of more serious failure). Medium-severity joint seal damage is recorded when at least 10 percent of the sealant has visible gaps smaller than 1/8th inch and is an indicator that replacement should be programmed as soon as is practicable. In the meantime, aggressive inspection and sustaining maintenance is recommended to minimize subsurface damage from moisture penetration. At high severity, visible gaps exceed 1/8th inch and the amount and degree of joint seal damage is such that repair is no longer feasible. The only appropriate corrective action is sealant replacement.

On serviceable pavement, deteriorated joint sealant should be repaired or replaced to preserve pavement and subgrade integrity and prolong service life. The issue is not so clear-cut with unserviceable pavement. Pavement that can be restored to serviceable condition by maintenance activities such as patching and joint seal repair, or by slab replacement, should be so maintained as long as the process is cost-effective. However, when age and condition preclude economical return to serviceable condition by such means, joint seal repair would no longer be cost-effective and should be suspended except for an interim maintenance program to control FOD potential.

Joint seal damage at medium and high severity should be repaired. If medium- and high-severity damage is limited to less than about 25 percent of total joint length, sustaining maintenance is recommended. If medium and high-severity damage exceeds about 25 percent of the total joint length, joint sealant should be removed and replaced under a restorative repair project.
