# Maine Department of Transportation

## Pavement Condition Report

## NORTHERN AROOSTOOK REGIONAL AIRPORT (KFVE)

Submitted By:  
**DuBois & King & ARA**  
355 Husson Avenue - Suite 1  
Bangor, Maine 04401

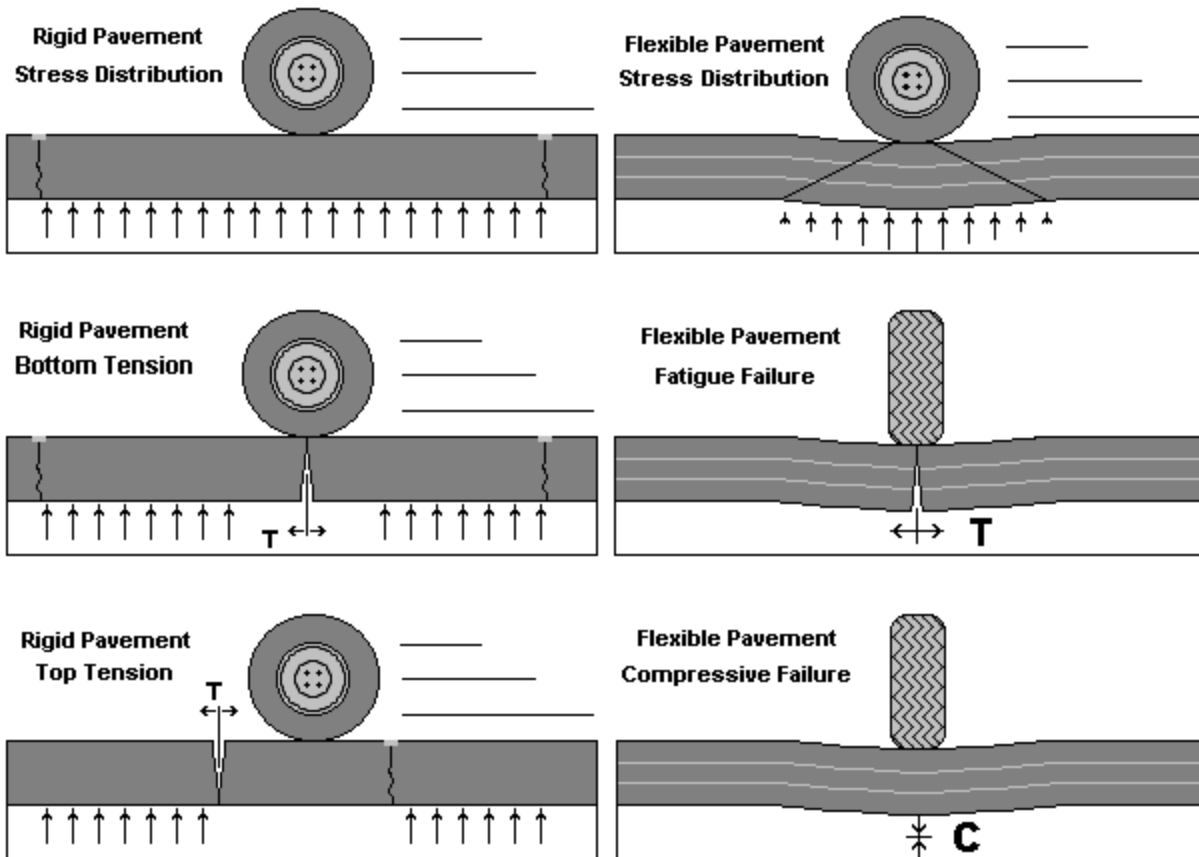
Figure 10. Pavement failure.

Load-related cracks can start at the top or bottom of a pavement section. In asphalt sections, load-related (fatigue) cracks start at the bottom. If a load-related crack reaches the surface, it usually indicates significant structural deficiency. In PCC pavement, corner breaks are caused by top tension, and the crack propagates downward. Mid-slab LTD cracks are examples of bottom tension.

Spalls can be caused by either wheel loads or environmental factors, anytime there is movement between adjacent slabs. If a small rock is allowed into a joint, a differential movement between adjacent slabs can cause a spall. Spalling can be minimized by keeping joint and crack sealant intact.
