# Sandy River Restoration Project

FISHERY INTERIM SUMMARY REPORT SERIES NO. 09-01  
SANDY RIVER RESTORATION PROJECT

January 2009

JOB NO. F-027  
SANDY RIVER RESTORATION  
INTERIM SUMMARY REPORT (2006-2008)

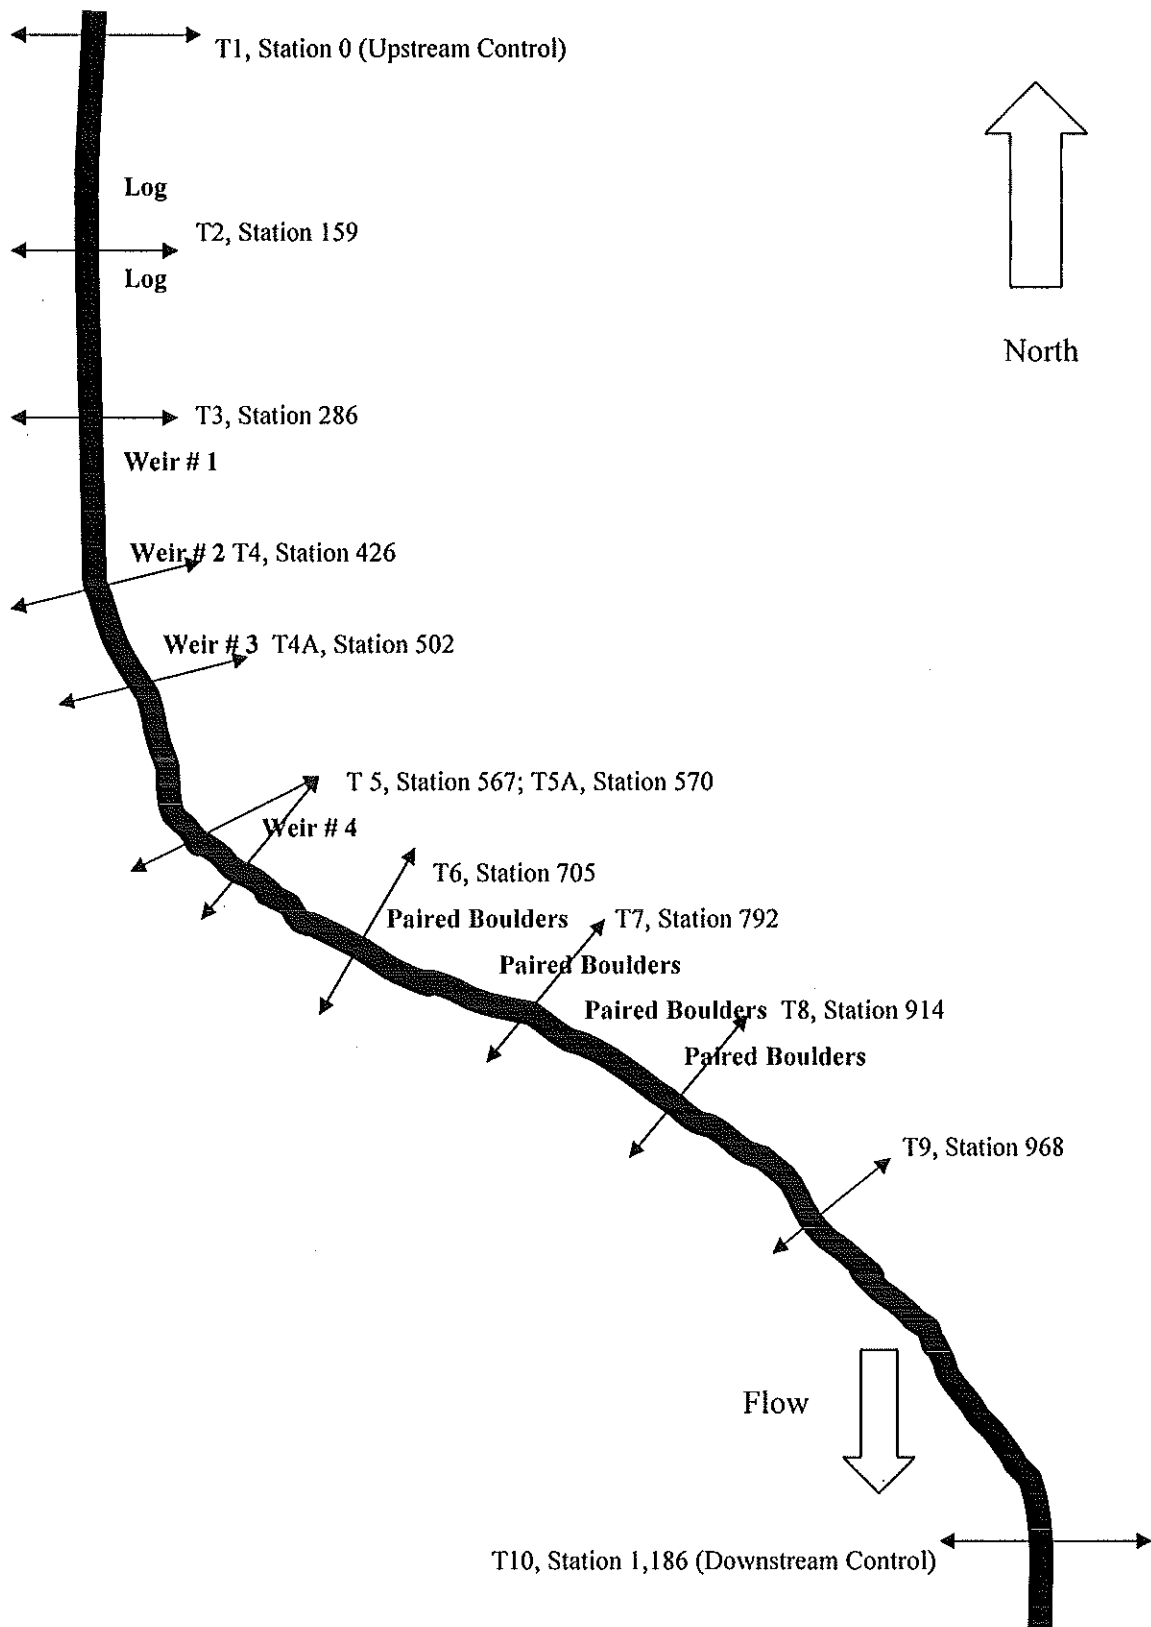
Figure 2. Schematic of Sandy River restoration reach, transects, and treatments.

Several structures failed or were displaced during high flows that occurred in October 2006:

- Of the two logs cabled and weighted mid-channel in an effort to narrow the channel, the upper log attachment failed and the log was washed downstream next to the lower log, where both continued to trap sediment and woody material but are not diverting flow as intended. The situation could likely be remedied by the placement of additional logs secured by larger boulders.

- Rock Weir No. 1 (furthest upstream) had some top boulders moved out of place with the footer rocks below still concentrating flow in the center of the channel. The top boulders moved into the pool downstream and are providing additional habitat complexity. Consequently, no effort was made to repair this weir.

- Rock Weir No. 3 withstood high flows and needed no repair through the fall of 2008.
- Rock Weir No. 4 (furthest downstream) collapsed when its rocks were carried out of position by high flows in October 2006 and was rebuilt in October 2007 with larger boulders and remained stable through the fall of 2008.
