Pavement Condition Report

## **NEWTON FIELD AIRPORT (59B)**

## Executive Summary

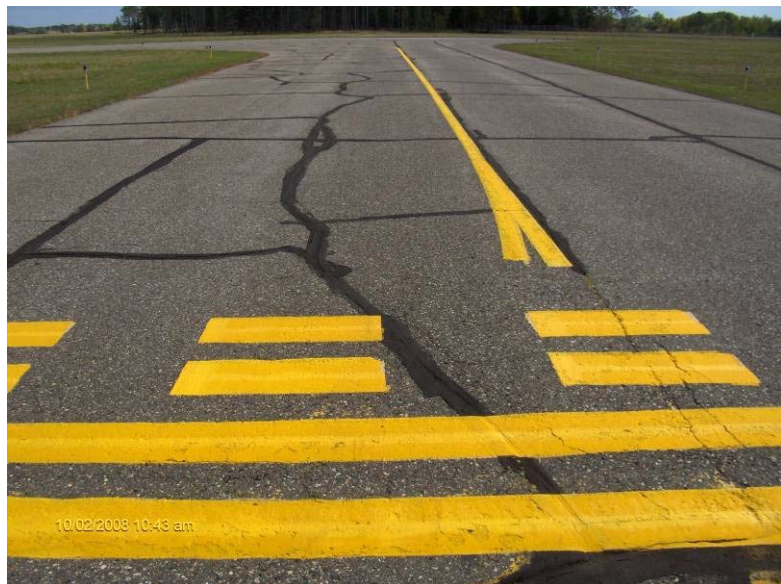
### *Example of Longitudinal and Transverse Cracking (L&T cracking)*

Longitudinal and transverse cracks are caused by pavement aging, by construction, and by subsurface movement. Aging occurs as pavement loses some of its components to the atmosphere and becomes more brittle. Consistent application of pavement sealcoats can help to prevent the occurrence of age related cracks. Cracks will also develop along poorly constructed paving lane joints. Ensuring that joints are made when both sides are still hot, and near the same temperature, is one of the best ways to mitigate this potential problem. Seasonal movement caused by changes in moisture content or temperature differences can also cause pavement cracks. Asphalt pavement placed over a PCC pavement or cement stabilized base course may evidence reflective cracking from the underlying material. Longitudinal and transverse cracks are not caused by wheel loads, although traffic may worsen their condition.

Low severity longitudinal and transverse cracks are less than  $\frac{1}{4}$  inch wide, or if sealed with suitable filler material in satisfactory condition can be any width, less than 3 inches, if they are not spalled. Maintenance usually is not indicated for low-severity cracking. Moderately spalled cracks and cracks wider than  $\frac{1}{4}$  inch which are not satisfactorily sealed are at medium severity. Medium-severity cracks should be sealed with a high-quality crack filling material. Severely spalled cracks and cracks wider than 3 inches are at high severity. High-severity L&T cracks normally require patching.

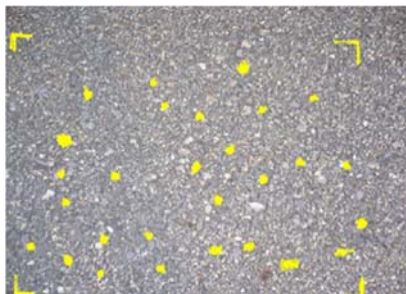
Raveling – At low severity, the number of missing coarse aggregates (> 3/8 inch) is between 5-20 missing/yd<sup>2</sup>, medium severity (pictured below where the missing coarse aggregates have been dotted with yellow paint) is 21-40 missing/yd<sup>2</sup>, and high severity is > 40 missing/yd<sup>2</sup>.
