Maine Department of Transportation

Pavement Condition Report

AUGUSTA STATE AIRPORT (KAUG)

Executive Summary

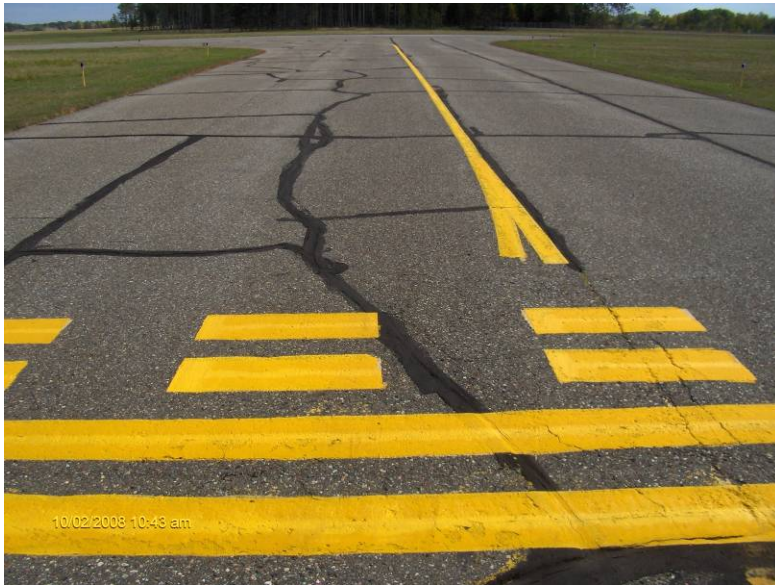
Example of Longitudinal and Transverse Cracking (L&T cracking)

Longitudinal and transverse cracks are caused by pavement aging, by construction, and by subsurface movement. Aging occurs as pavement loses some of its components to the atmosphere and becomes more brittle. Consistent application of pavement sealcoats can help to prevent the occurrence of age related cracks. Cracks will also develop along poorly constructed paving lane joints. Ensuring that joints are made when both sides are still hot, and near the same temperature, is one of the best ways to mitigate this potential problem. Seasonal movement caused by changes in moisture content or temperature differences can also cause pavement cracks. Asphalt pavement placed over a PCC pavement or cement stabilized base course may evidence reflective cracking from the underlying material. Longitudinal and transverse cracks are not caused by wheel loads, although traffic may worsen their condition.

Low severity longitudinal and transverse cracks are less than ¼ inch wide, or if sealed with suitable filler material in satisfactory condition can be any width, less than 3 inches, if they are not spalled. Maintenance usually is not indicated for low-severity cracking. Moderately spalled cracks and cracks wider than ¼ inch which are not satisfactorily sealed are at medium severity. Medium-severity cracks should be sealed with a high-quality crack filling material. Severely spalled cracks and cracks wider than 3 inches are at high severity. High-severity L&T cracks normally require patching.

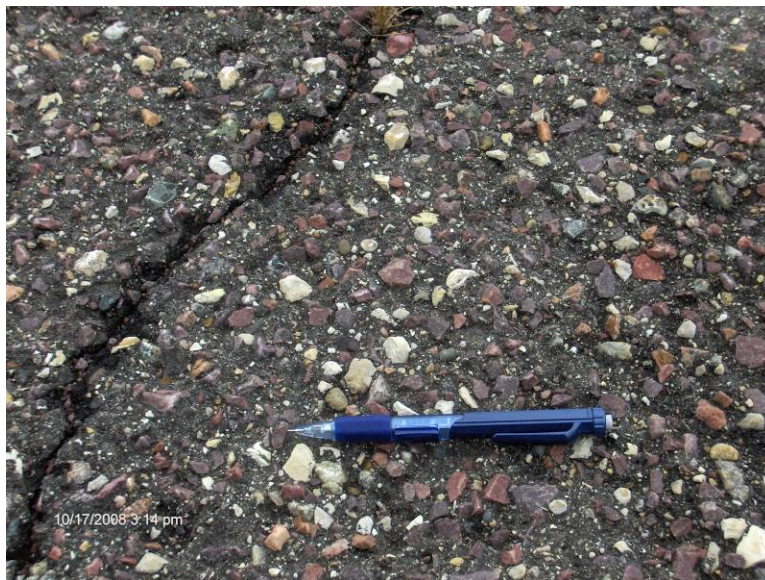
Example of Raveling/Weathering

Raveling and weathering are the wearing away of the pavement surface. Raveling is the condition where the mid- to large size aggregates are becoming dislodged; weathering is when the fine aggregate wears away exposing the edges of the larger aggregate. These distresses are usually evident over large areas and may occur together (pictured above) or separately. Raveling and weathering may indicate that the asphalt binder has hardened significantly.

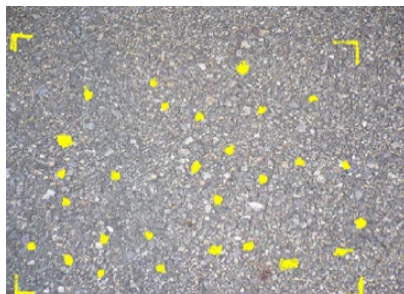
Raveling – At low severity, the number of missing coarse aggregates (> 3/8 inch) is between 5-20 missing/yd², medium severity (pictured below where the missing coarse aggregates have been dotted with yellow paint) is 21-40 missing/yd², and high severity is > 40 missing/yd².

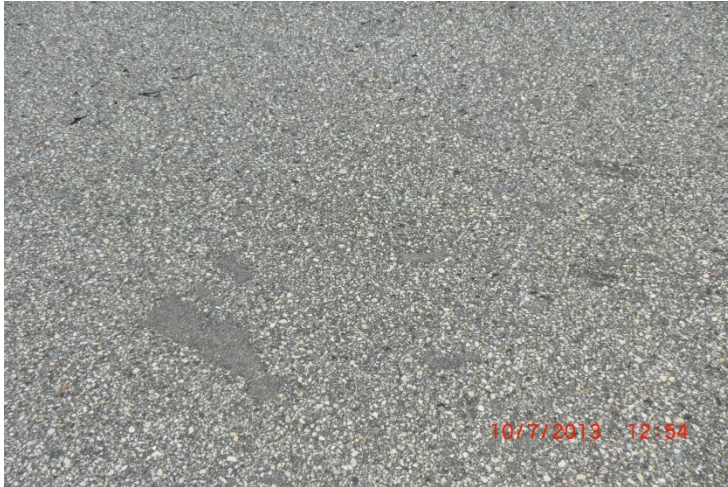
Low severity

Weathering – At low severity, the coarse aggregate is slightly exposed due to the wearing away of the fine aggregate. At medium severity, the coarse aggregate is exposed up to $\frac{1}{4}$ the width of the longest side. At high severity, the coarse is exposed greater than $\frac{1}{4}$ the width of the longest side.

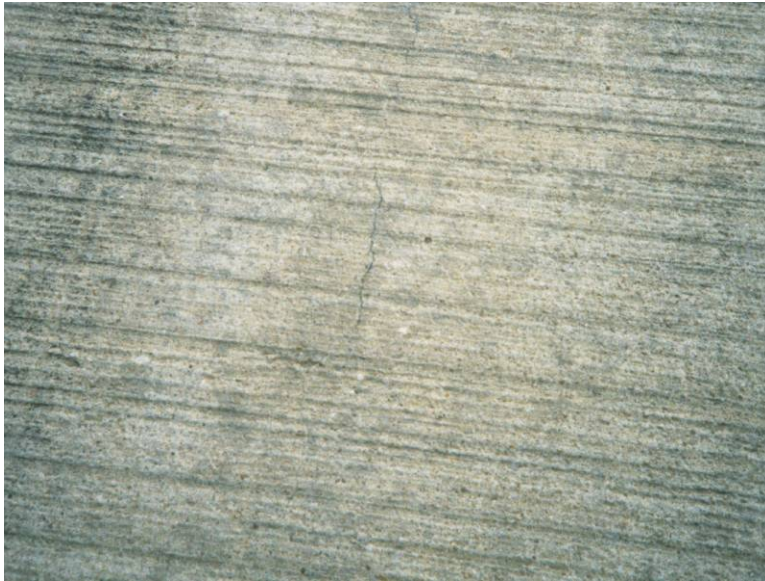
Example of Shrinkage Cracking

Shrinkage cracks are small, nonworking (no spalling along edge) cracks that are visible at the surface but do not penetrate through the full depth of concrete. Shrinkage cracks most commonly occur shortly after construction due to concrete shrinkage during the curing process. Shrinkage cracks are usually so small that they are not visible until staining or material loss at crack edges begins to take place. Shrinkage cracks do not represent a structural weakness, and no corrective action is prescribed.

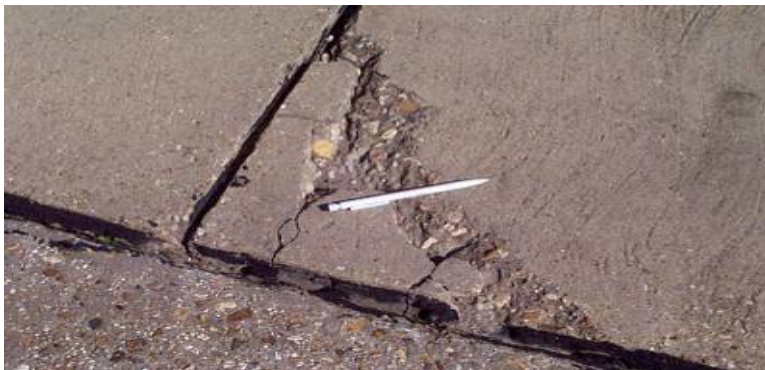
Example of Joint and Corner Spalling

Spalls at slab joints and corners are caused by excessive internal stress in the pavement. Spalls occur when these stresses exceed the shear strength of the concrete. Spalling usually results from thermal expansion during warm or hot weather. As slabs expand, they push against one another at joints. If the joints are filled with incompressibles, such as sand, or if adjacent slabs offset slightly, stresses can become severe, causing spalls. Spalling can be reduced significantly by conscientious maintenance of joint sealant.

Spall repair requires patching. The extent and severity of spalling on a pavement surface suggests appropriate action. For example, at low severity, spalled concrete remains securely in place in the slab. A low-severity spall should be monitored closely for further deterioration and should be patched when

spalled particles become loose in place, or at the next scheduled patching activity in the section. Medium- and high-severity spalls should be repaired immediately to prevent the incidence of FOD. If the pavement can be restored to serviceable condition, spalls should be carefully patched for long-term service. If the pavement is beyond repair, temporary patching should be considered to control FOD.

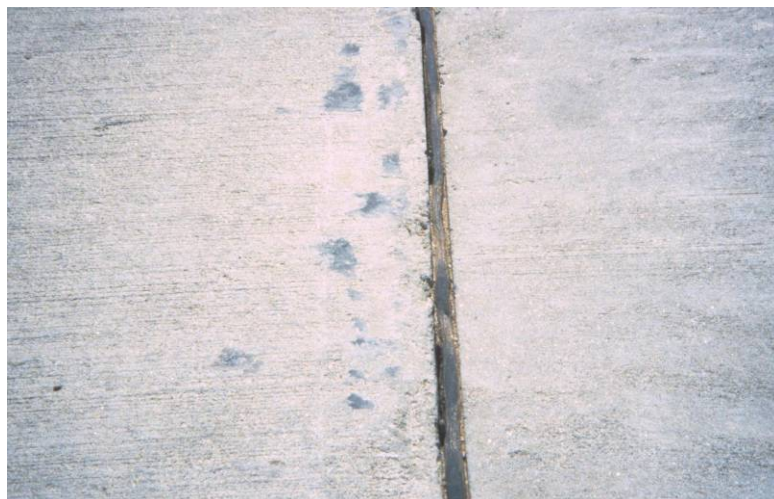
Example of Joint Seal Damage

Joint seal damage is recorded at three severities: low, medium, and high. When joint sealant is in perfect condition (no damage), it is not a distress. At low severity, at least 10 percent of the sealant is debonded but still in contact with the joint edges (i.e., joint sealant is in serviceable condition but should

be monitored for evidence of more serious failure). Medium-severity joint seal damage is recorded when at least 10 percent of the sealant has visible gaps smaller than 1/8th inch and is an indicator that replacement should be programmed as soon as is practicable. In the meantime, aggressive inspection and sustaining maintenance is recommended to minimize subsurface damage from moisture penetration. At high severity, visible gaps exceed 1/8th inch and the amount and degree of joint seal damage is such that repair is no longer feasible. The only appropriate corrective action is sealant replacement.

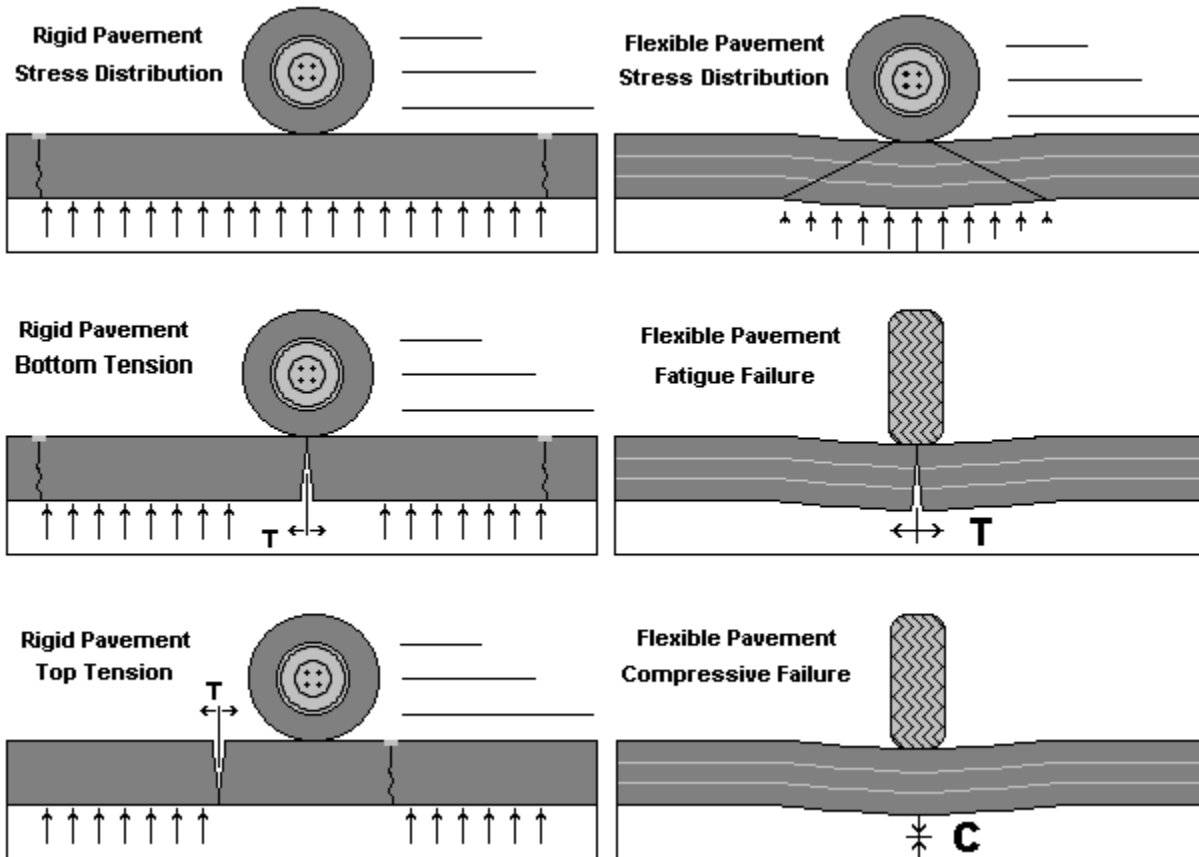
Figure 10. Pavement failure.

Load-related cracks can start at the top or bottom of a pavement section. In asphalt sections, load-related (fatigue) cracks start at the bottom. If a load-related crack reaches the surface, it usually indicates significant structural deficiency. In PCC pavement, corner breaks are caused by top tension, and the crack propagates downward. Mid-slab LTD cracks are examples of bottom tension.

Spalls can be caused by either wheel loads or environmental factors, anytime there is movement between adjacent slabs. If a small rock is allowed into a joint, a differential movement between adjacent slabs can cause a spall. Spalling can be minimized by keeping joint and crack sealant intact.
