Pavement Condition Report

BELFAST MUNICIPAL AIRPORT (KBST)

Submitted To:
Maine Department of Transportation
16 State House Station
Augusta, ME 04333

Submitted By:
DuBois & King & ARA
355 Husson Avenue - Suite 1
Bangor, Maine 04401

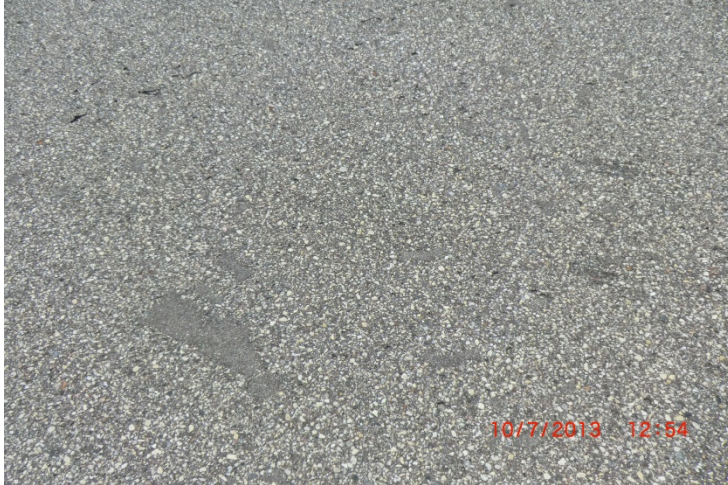
Low severity

Weathering – At low severity, the coarse aggregate is slightly exposed due to the wearing away of the fine aggregate. At medium severity, the coarse aggregate is exposed up to $\frac{1}{4}$ the width of the longest side. At high severity, the coarse is exposed greater than $\frac{1}{4}$ the width of the longest side.

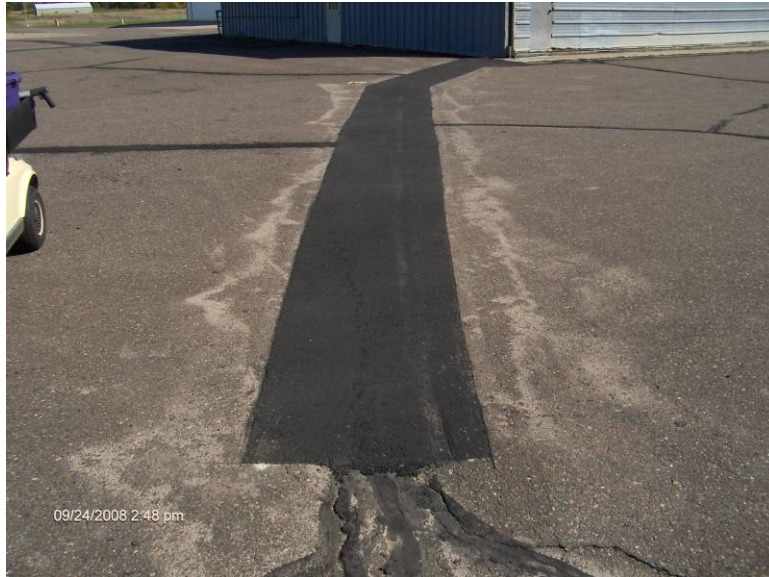
Example of Patching

Patched areas are defined when a portion of the original pavement is replaced with a material intended as a semi-permanent repair. A patch is documented as a defect because it is considered a break in the integrity of the pavement structure. Patches are constructed for a variety of reasons including utility repairs, correcting grade issues, and addressing a defect in the original pavement. The severity level of patches is determined by the amount of distress (i.e. cracking, depression, weathering/raveling, etc.) occurring within the limits of the patched area.

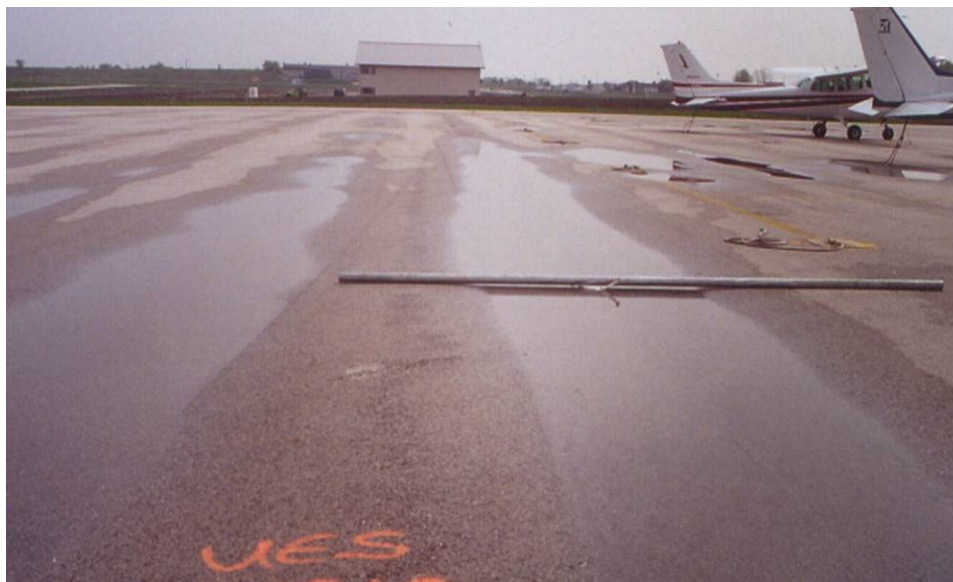
Example of Rutting

Ruts are localized, load related, areas of pavement having elevations lower than the surrounding sections. Rutting is due to base and subgrade consolidation, caused by excessive wheel loads or poor compaction. Ruts indicate structural failure, and can cause hydroplaning. At low severity, ruts have an

average depth of ¼ to ½ inches. At medium severity, ruts have an average depth of ½ to 1 inch. High severity, ruts have an average depth greater than 1 inch. Full-depth patching is the appropriate repair for ruts.
