Maine Department of Transportation

Pavement Condition Report

AUBURN/LEWISTON MUNICIPAL AIRPORT (KLEW)

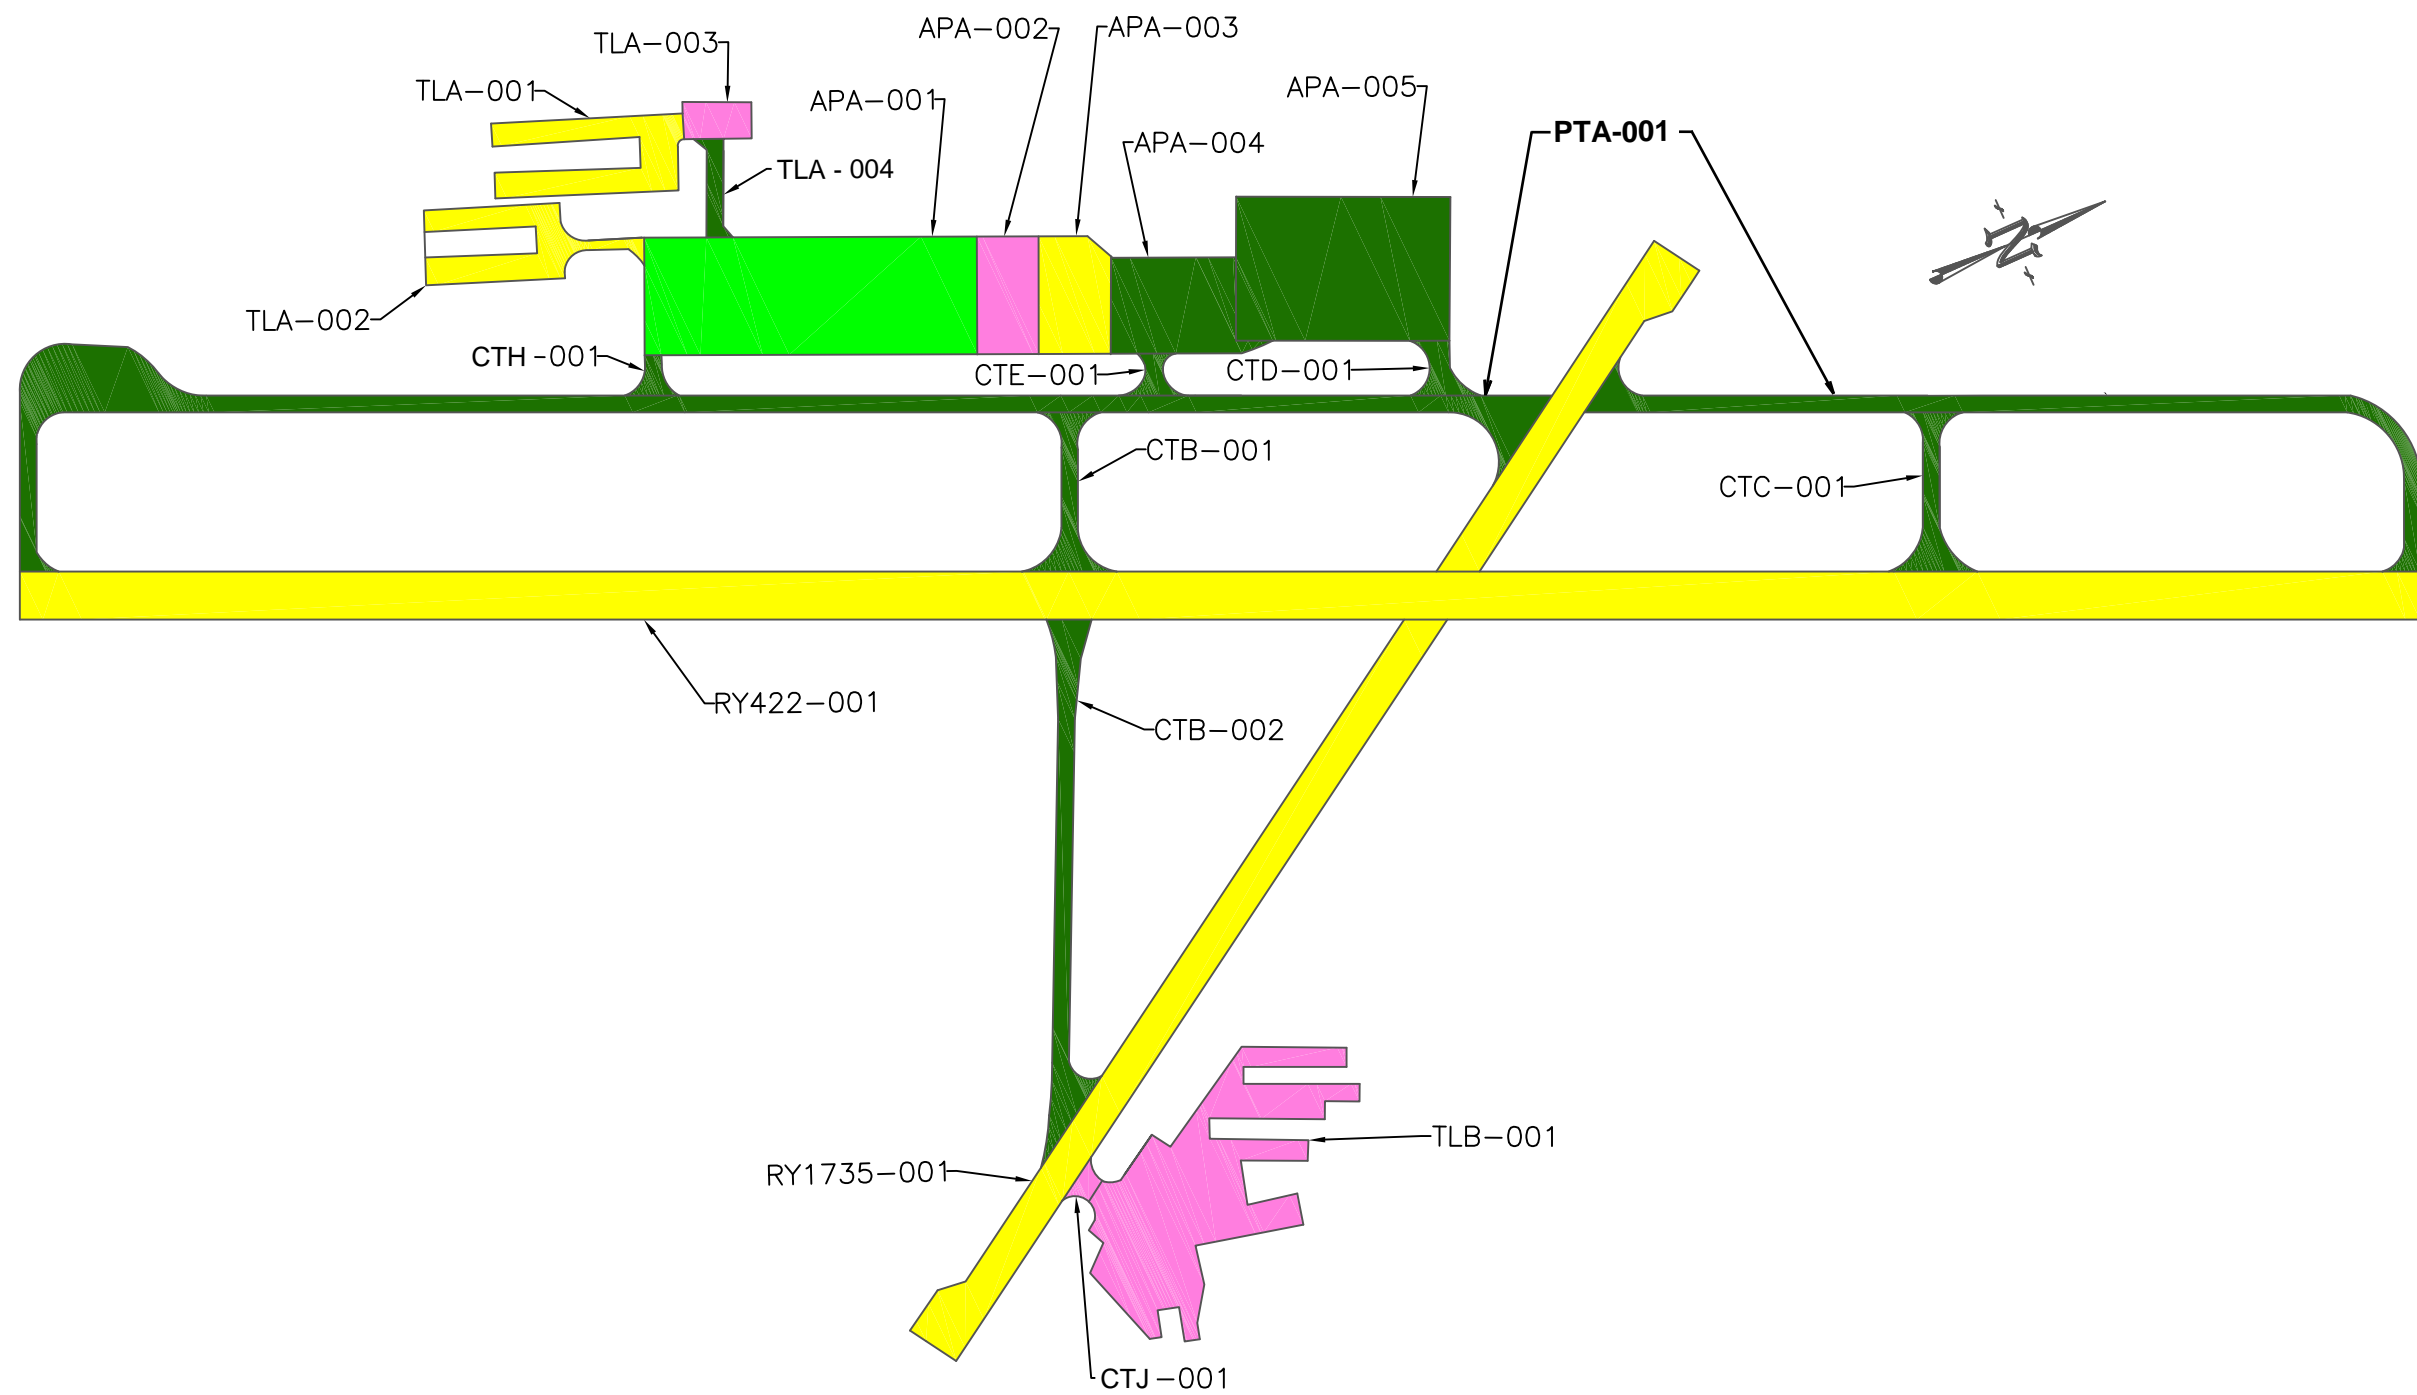
2018 Pavement Condition Map
Auburn/Lewiston Municipal Airport (LEW)

The average inspected Pavement Condition Index (PCI) for all the airfield pavements at LEW was 75. Runways had an average inspected PCI of 68, which is below the MSL of 70. Taxiways had an average inspected PCI of 97, taxilanes had an average inspected PCI of 53, and aprons had an average inspected PCI of 83. A comparison of the average PCI values at LEW to the statewide average PCI values, by branch use, is shown in the figure below.

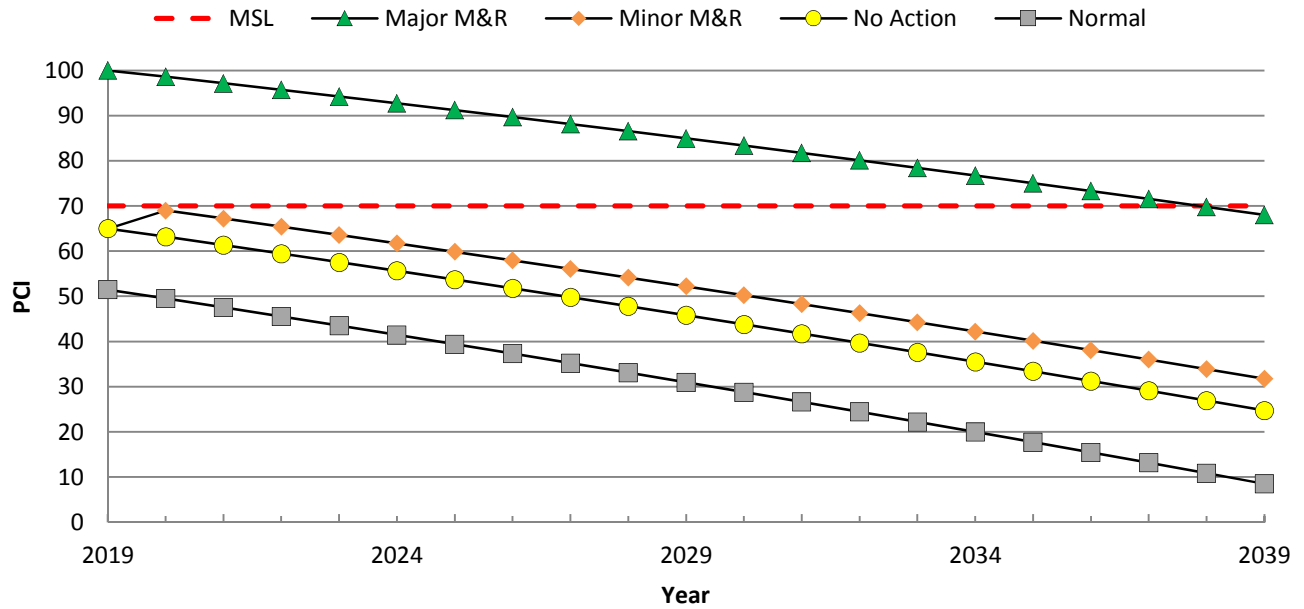
Runway 17-35

| Extrapolated Distress: | Type | Quantity | Severity | Units |
|---|---|---|---|---|
| 1 | l & t crack | 24,714 | low | Ft |
| 2 | l & t crack | 1,850 | medium | Ft |

| M&R | Action | Year / Quantity | Cost (\$) | Ending PCI |
|---|---|---|---|---|
| Major | Major M&R | 2019 | 576,935 | 100 |
| 1 | Crack Sealing - AC | 1850 Ft | 2,554 | - |

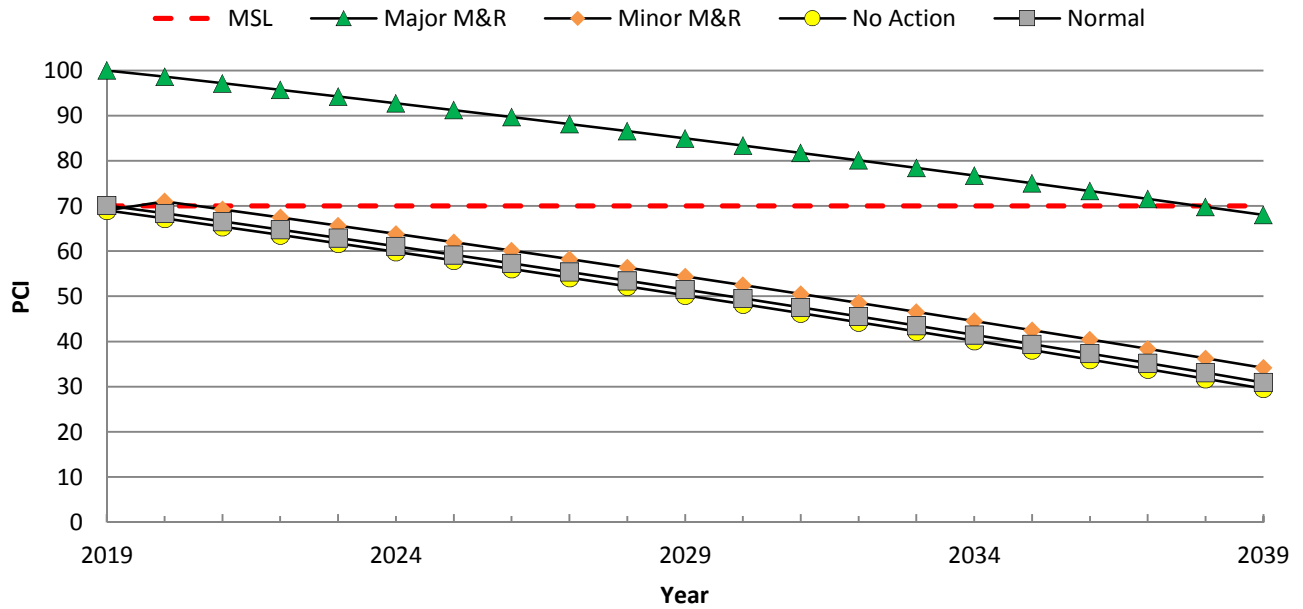
Runway 4-22

| Extrapolated Distress: | Type | Quantity | Severity | Units |
|---|---|---|---|---|
| 1 | l & t crack | 45,144 | low | Ft |
| 2 | l & t crack | 3,085 | medium | Ft |
| 3 | l & t crack | 95 | high | Ft |

| M&R | Action | Year / Quantity | Cost (\$) | Ending PCI |
|---|---|---|---|---|
| Major | Major M&R | 2019 | 1,374,415 | 100 |
| 2 | Crack Sealing - AC | 3179 Ft | 4,388 | - |

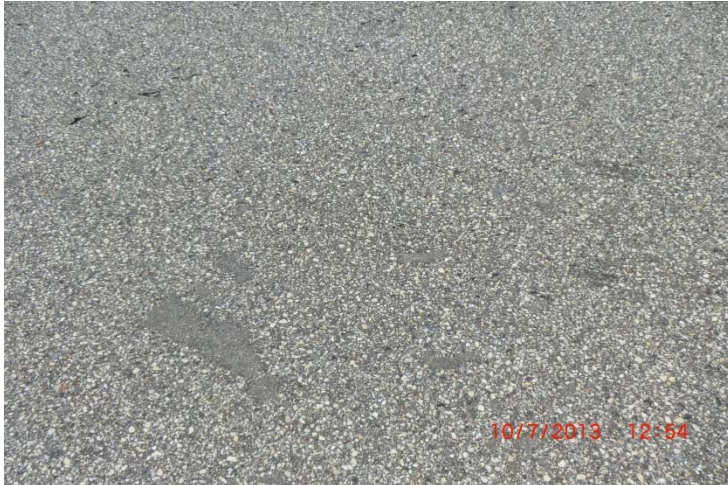
Weathering – At low severity, the coarse aggregate is slightly exposed due to the wearing away of the fine aggregate. At medium severity, the coarse aggregate is exposed up to $\frac{1}{4}$ the width of the longest side. At high severity, the coarse is exposed greater than $\frac{1}{4}$ the width of the longest side.

Low severity

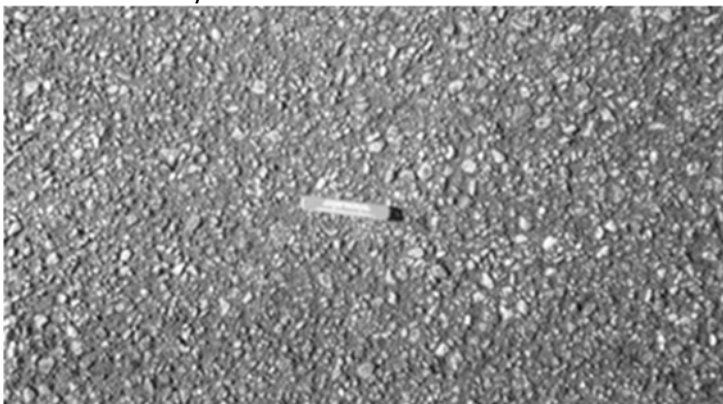
Medium severity

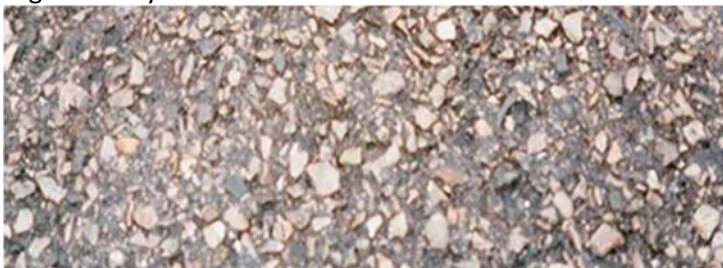
High severity
