Maine Department of Transportation

Pavement Condition Report

MACHIAS VALLEY AIRPORT (KMVM)

To assist individual airports to effectively maintain their pavement infrastructure and help improve airport pavement conditions statewide, the Maine Department of Transportation (MaineDOT) contracted with DuBois & King, Inc. (D&K) to provide pavement evaluation surveys at local airports. Assisting D&K on this effort was Applied Research Associates, Inc. (ARA). This report documents the pavement condition at Machias Valley Airport (MVM) in October 2018.

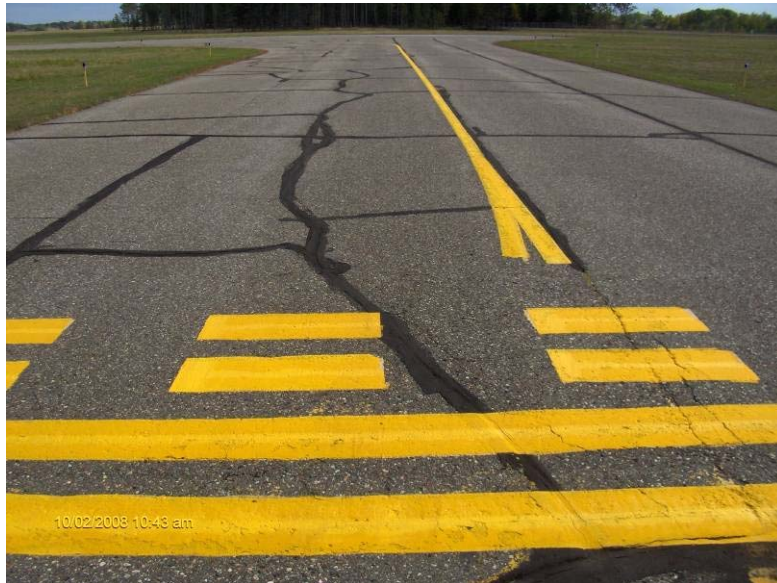
Example of Longitudinal and Transverse Cracking (L&T cracking)

Longitudinal and transverse cracks are caused by pavement aging, by construction, and by subsurface movement. Aging occurs as pavement loses some of its components to the atmosphere and becomes more brittle. Consistent application of pavement sealcoats can help to prevent the occurrence of age related cracks. Cracks will also develop along poorly constructed paving lane joints. Ensuring that joints are made when both sides are still hot, and near the same temperature, is one of the best ways to mitigate this potential problem. Seasonal movement caused by changes in moisture content or temperature differences can also cause pavement cracks. Asphalt pavement placed over a PCC pavement or cement stabilized base course may evidence reflective cracking from the underlying material. Longitudinal and transverse cracks are not caused by wheel loads, although traffic may worsen their condition.

Low severity longitudinal and transverse cracks are less than $\frac{1}{4}$ inch wide, or if sealed with suitable filler material in satisfactory condition can be any width, less than 3 inches, if they are not spalled. Maintenance usually is not indicated for low-severity cracking. Moderately spalled cracks and cracks wider than $\frac{1}{4}$ inch which are not satisfactorily sealed are at medium severity. Medium-severity cracks should be sealed with a high-quality crack filling material. Severely spalled cracks and cracks wider than 3 inches are at high severity. High-severity L&T cracks normally require patching.

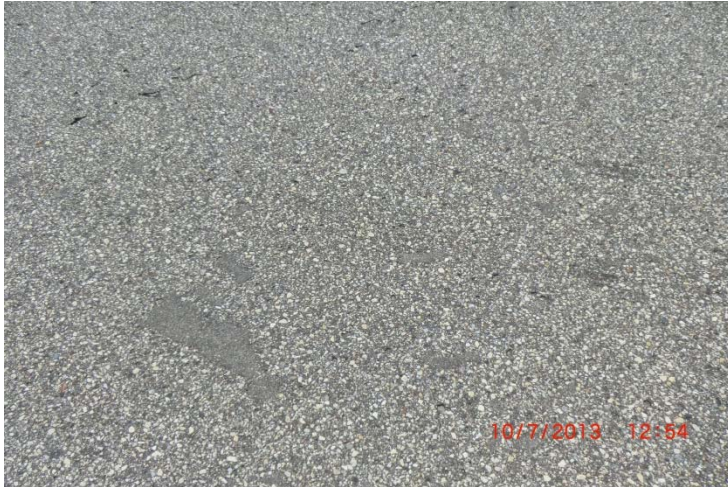
Low severity

Weathering – At low severity, the coarse aggregate is slightly exposed due to the wearing away of the fine aggregate. At medium severity, the coarse aggregate is exposed up to $\frac{1}{4}$ the width of the longest side. At high severity, the coarse is exposed greater than $\frac{1}{4}$ the width of the longest side.

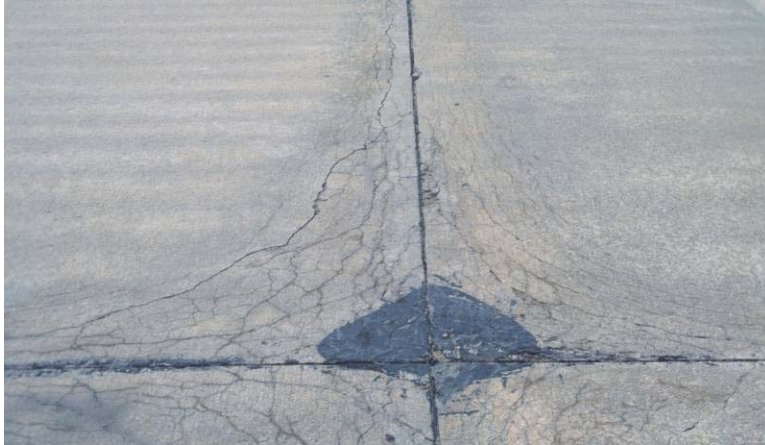
Example of Durability Cracking

Durability cracking (D-cracking) is caused by environmental factors, the most common of which is freezing/thawing. It usually appears as a pattern of hairline cracks running parallel to a joint or crack, or in a corner, where water tends to collect. This type of cracking eventually leads to disintegration of the pavement, creating FOD potential. At low severity, D-cracking is evident, but no disintegration has occurred. As the distress advances to medium severity, the distress pattern is evident over a significant area of the slab, and some disintegration and FOD potential exists. High severity durability cracking is evidenced by extensive cracking with loose and missing pieces and significant FOD potential.
