20 December 2019

Project Number: 3611191238

**Subject: Vulnerability Assessment and Resilience Planning, Public Landing and Harbor Park, Camden, Maine  
Penobscot Bay Working Waterfront Resiliency Analysis  
State of Maine, Department of Marine Resources**

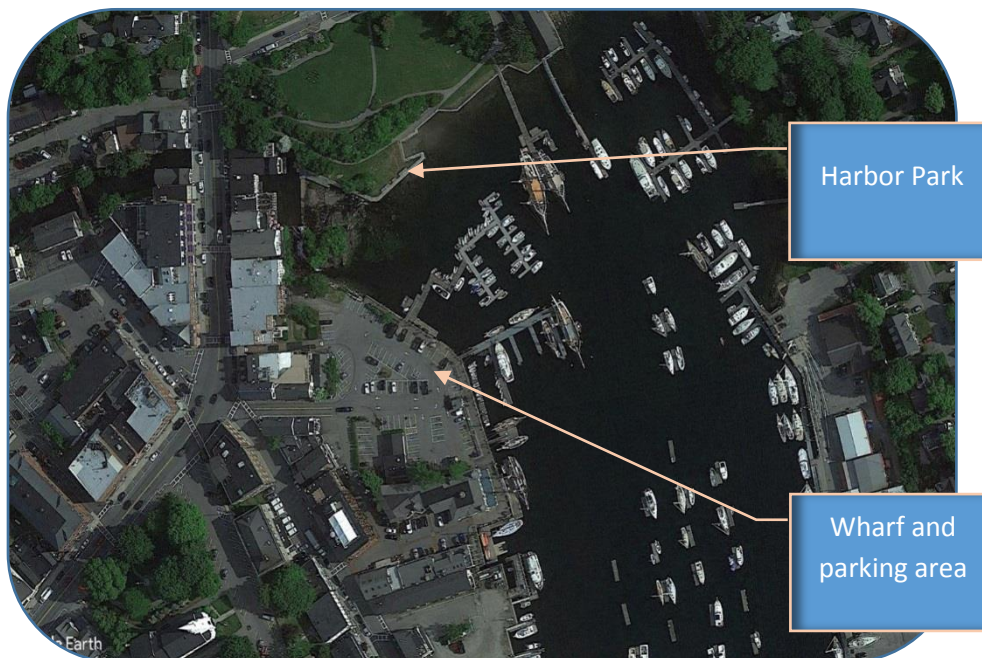
**Figure 1: Site Overview**

- The site consists of the wharf, parking area, and a public park/greenspace (See **Figure 1** below).
- Structures located on site include an office (Harbor Master) and public restrooms.
- The wharf is constructed of quarried granite blocks, timber piles and timber framing.
- Four wooden floating dock systems are located on the east side of the wharf (see Photograph No. 16).
- There was some previous renovation work of the Harbor Park sea wall.
- There is no formal ongoing maintenance plan in place; maintenance is addressed, as needed, when a deficiency is identified.

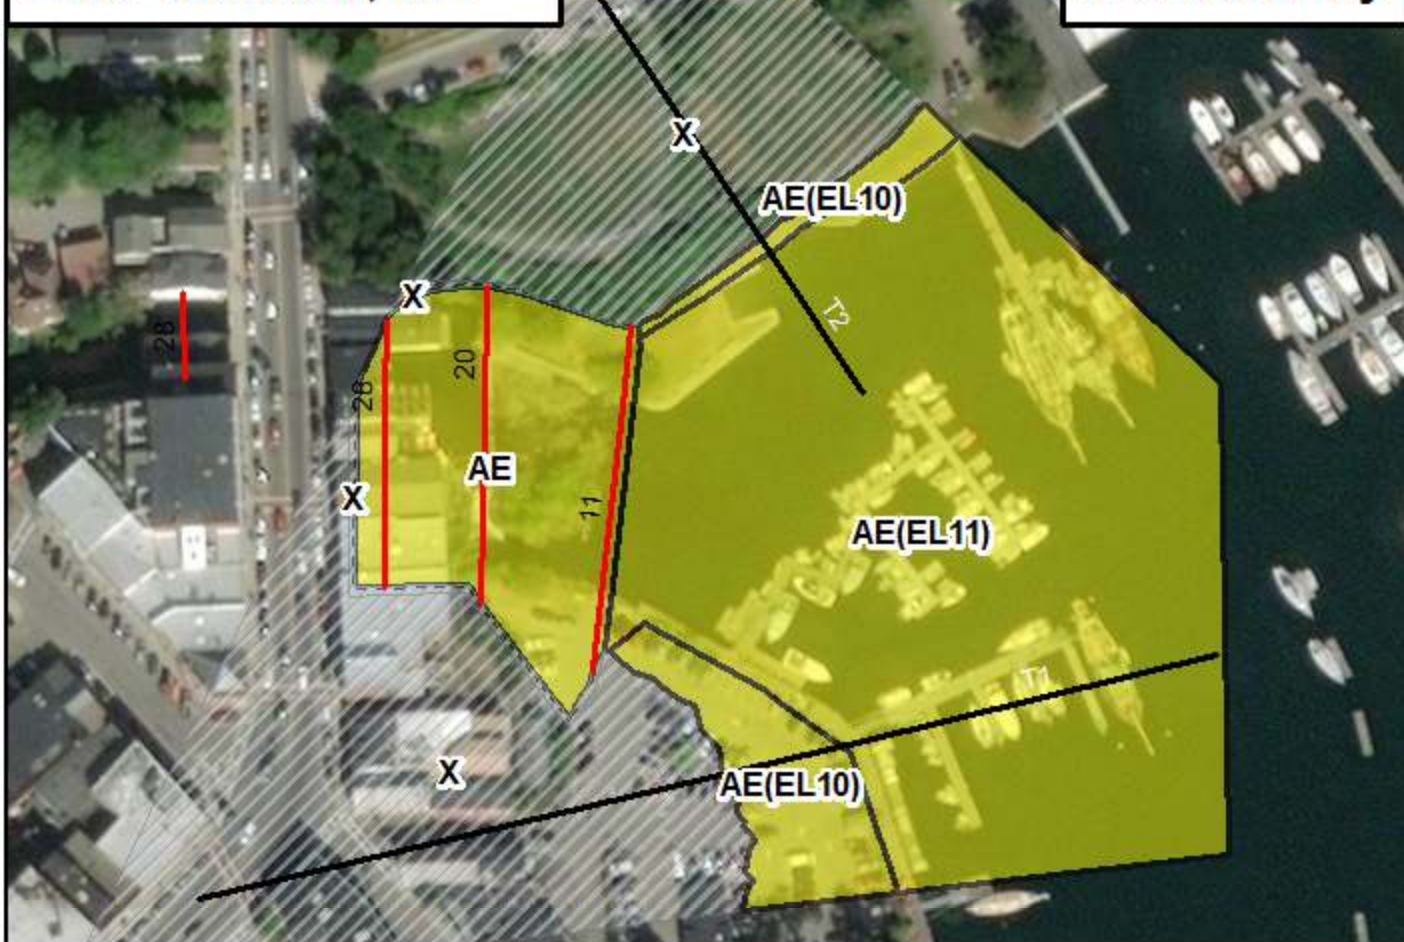
Present Day

Based on the present-day model for BFE of 10 to 11 feet, which includes a wave height of 1 to 2 feet, the wharf and boardwalk decking could be potentially impacted by nearly high velocity wave action. In the case that any elements such as the stringers, decking, etc., are not positively attached to associated load carrying members, dislodgement or delamination of material at the top of deck can be expected. Otherwise, we would not expect significant impact to the wharf. We were unable to view and assess locations behind the face of the wharf or subsurface conditions beyond observations noted beneath the boardwalk. The wharf can be expected to experience some loss of the smaller diameter crushed rock at the sub-base and gravels between the top of the granite blocks and bottom of the boardwalk from washout. Similar behaviour of the wharf can be expected for future flood scenarios and the possibility of impact is more likely as the return period for conditions representing the present day BFE decreases.
