Mackworth Island

Conceptual Utilization
Master Plan

Final Report

January 27, 2023

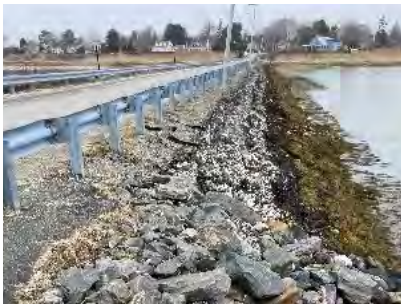
CAUSEWAY

The causeway, a stone armored filled construction, has immediate, short-term and long-term improvement needs. It is low and overtopped by wave action during significant storm events. It is reported that the low portions of the causeway are overtopped by seawater more than once per year. Each overtopping event undermines the integrity of the causeway by pulling fine material from the composition and leaving gaps which accelerates settling. Immediate concerns include utility pole damage, and transverse steel beam play at one of the bridge support locations. Short-term needs include repair and stabilization of the two locations where the marine mattresses have failed, and settlement of the causeway has occurred. Long-term needs include reducing vulnerability from sea level rise and storm surge. This may be achieved by rebuilding the causeway at a higher elevation, partial replacement of the causeway, or complete replacement with a bridge. Recommended modifications include raising the causeway between 6 feet and 10 feet above its current road height to meet the Maine Climate Council's (MCC) 'Commit to Manage' (C2M) and/or the more conservative 'Prepare to Manage' (P2M) design criteria. Depending on the forecast, the causeway and bridge will be underwater throughout the year within 27 or 47 years.

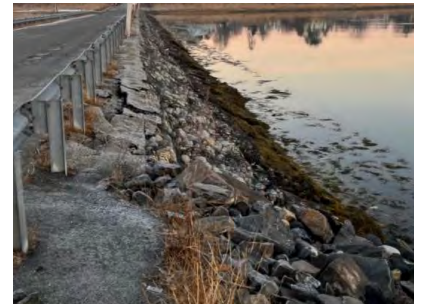
EMBANKMENT DETAIL

A review of the coastal embankments identified a history of embankment armoring at several areas of active erosion that should be monitored. Imported rip rap armoring supplements areas of natural armoring such as ledge. The most cost-effective long-term resiliency response will be to introduce a program of regrading, replanting and relocating trails and overlooks to increase the setback to the top of bank.

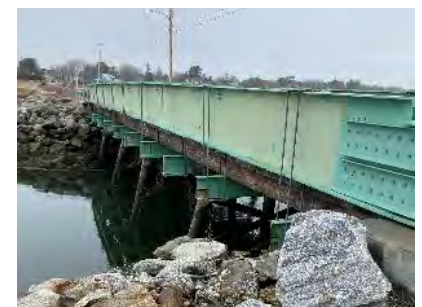
BRIDGE

The bridge, overseen by Maine Department of Transportation (MDOT), was rehabilitated in 2011 by adding structural steel above and below the existing timber structure. It is posted with a weight limit of 22 tons. Aside from creating limitations of island access by large, heavy vehicles, the bridge is in good working condition. GEI recommends an investigation to determine whether it is cost-effective in the short-term to increase the load capacity of the bridge to fully accommodate construction traffic associated with campus improvements. In the long term, a new raised bridge will be needed to accommodate sea level rise (see MCC projections above).

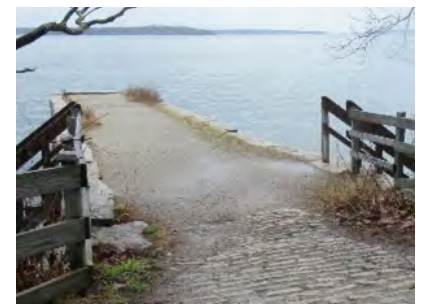
STONE PIER

The Stone Pier, a historic component of the original Baxter property, is in relatively good condition but lacks deep-water access. An extension to deep-water is needed to provide an effective boat landing and might be accommodated with the addition of a ramp and float for seasonal

access and/or a fixed pier for year-round access. Such alterations are not recommended since no specific need was identified to support it. No use beyond pedestrian recreation has been presented as a viable use for the pier in its current condition during the Master Planning process.

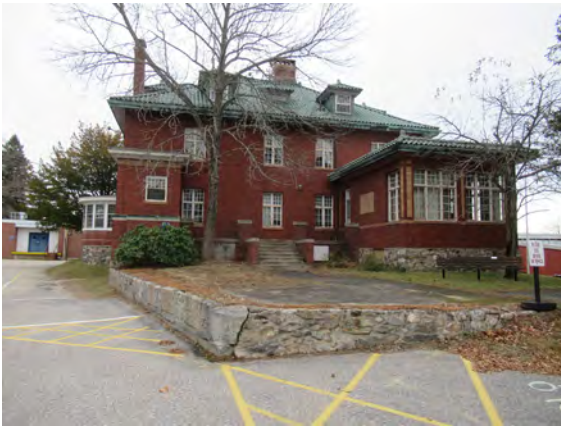
MANSION: BUILDING A

Year Constructed **1917**
 Use **Office**
 Building GSF **7,988 GSF**
 Number of Floors **2 + Attic & Basement**
 Construction type **Masonry & Wood (Porch floor is Concrete & Steel)**
 Average rating (scale of 0-5) **3.5**
 Overall Condition Rating **Good**

Building Exterior																			19 Total Review Categories	
Exposed Foundation	Brick / Masonry	Siding / Cladding	Windows	Doors	Canopies / Overhangs	Roof / Flashing	Fire Alarm / Strobes	CO / Smoke Detector	Life Safety: Exit Signs	Life Safety: Emergency Lighting	Condition of Walls	Base	Flooring	Ceiling	Stairs	Handrails	Doors	Glazing	Total Score	Building Average Rating
3	2	2	1	2	2	3	5	5	0	0	3	4	3	3	4	4	4	3	53.0	2.79
Electrical			Lighting		Mechanical				Plumbing					Structure				38 Total Review Categories		
Service Entrance	Panel / Distribution	Emergency Power	Lighting	Lighting Controls	Boiler	Fuel	HVAC	Specialty Areas	Toilet Rooms	Kitchen	Domestic Water	Sprinkler Riser	Sprinkler Distribution	Showers	Wood Trusses	Observable Masonry	Headers / Lintels	Misc Metals / Stairs	Total Score	Building Average Rating
3	4	n/a	1	1	n/a	n/a	3	n/a	2	2	2	n/a	n/a	1	3	3	n/a	n/a	78.0	3.00

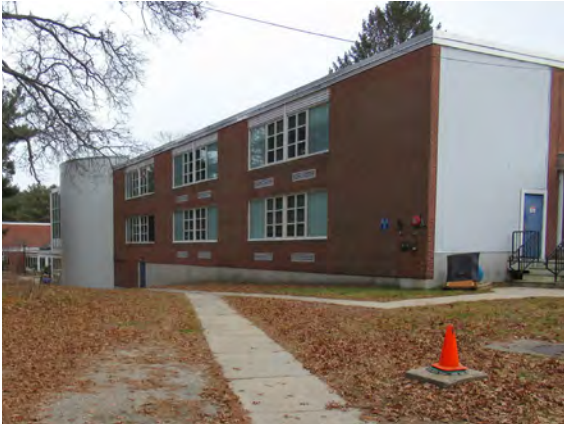
GREENLAW: BUILDING D

Year Constructed **1959/ Renovated 1996**
 Use **Classroom & Office**
 Building GSF **21,504 GSF**
 Number of Floors **3**
 Construction type **Masonry & Steel**
 Average rating (scale of 0-5) **3.4**
 Overall Condition Rating **Good**

Building Exterior																			Life Safety		Interior								19 Total Review Categories	
Exposed Foundation	Brick / Masonry	Siding / Cladding	Windows	Doors	Canopies / Overhangs	Roof / Flashing	Fire Alarm / Strobes	CO / Smoke Detector	Life Safety: Exit Signs	Life Safety: Emergency Lighting	Condition of Walls	Base	Flooring	Ceiling	Stairs	Handrails	Doors	Glazing	Total Score	Building Average Rating										
4	4	3	4	4	3	5	4	3	4	4	3.5	3	2.5	3	3	1	2	3	63.0	3.32

Electrical				Lighting		Mechanical				Plumbing					Structure				38 Total Review Categories	
Service Entrance	Panel / Distribution	Emergency Power	Lighting	Lighting Controls	Boiler	Fuel	HVAC	Specialty Areas	Toilet Rooms	Kitchen	Domestic Water	Sprinkler Riser	Sprinkler Distribution	Showers	Observable Steel	Observable Masonry	Headers / Lintels	Misc Metals / Stairs	Total Score	Building Average Rating
4	4	4	4	n/a	n/a	n/a	4	n/a	3	n/a	2	3	3	n/a	4	3	3	4	108.0	3.38

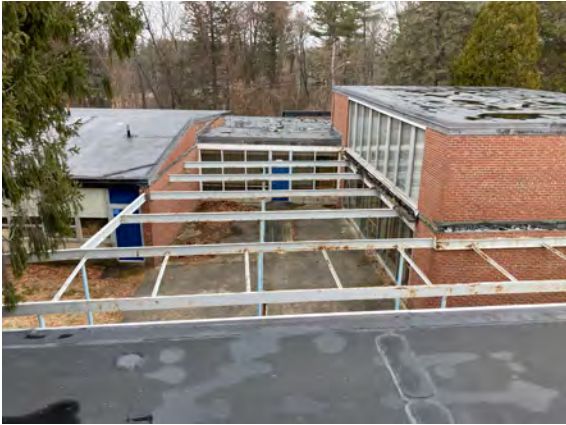
CARTER: BUILDING G

Year Constructed **1957**
 Use **Classroom, office, and Gym**
 Building GSF **17,600 GSF**
 Number of Floors **1**
 Construction type **Masonry & Steel**
 Average rating (scale of 0-5) **1.84**
 Overall Condition Rating **Poor**

Building Exterior																		19 Total Review Categories		
Exposed Foundation	Brick / Masonry	Siding / Cladding	Windows	Doors	Canopies / Overhangs	Roof / Flashing	Fire Alarm / Strobes	CO / Smoke Detector	Life Safety: Exit Signs	Life Safety: Emergency Lighting	Condition of Walls	Base	Flooring	Ceiling	Stairs	Handrails	Doors	Glazing	Total Score	Building Average Rating
3	3	1	1	2	1	2	4	n/a	2	2	2	2	2	2	2	1	2	2	33.0	1.83

Electrical			Lighting		Mechanical				Plumbing					Structure				38 Total Review Categories		
Service Entrance	Panel / Distribution	Emergency Power	Lighting	Lighting Controls	Boiler	Fuel	HVAC	Specialty Areas	Toilet Rooms	Kitchen	Domestic Water	Sprinkler Riser	Sprinkler Distribution	Showers	Observable Steel	Observable Masonry	Headers / Lintels	Misc Metals / Stairs	Total Score	Building Average Rating
3	2	1	1	n/a	n/a	n/a	3	n/a	1	n/a	2	3	3	1	2	2	2	n/a	57.0	1.84

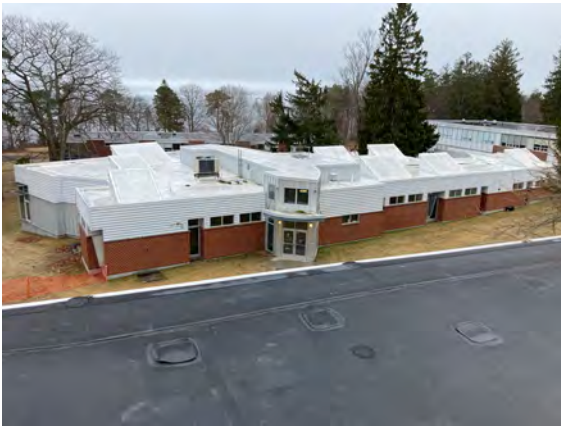
BREWSTER: BUILDING H

Year Constructed **2004**
 Use **Classroom, Library, Office**
 Building GSF **9,000 GSF**
 Number of Floors **1**
 Construction type **Steel Frame**
 Average rating (scale of 0-5) **3.9**
 Overall Condition Rating **Very Good**

Building Exterior																			Life Safety		Interior										19 Total Review Categories	
Exposed Foundation	Brick / Masonry	Siding / Cladding	Windows	Doors	Canopies / Overhangs	Roof / Flashing	Fire Alarm / Strobes	CO / Smoke Detector	Life Safety: Exit Signs	Life Safety: Emergency Lighting	Condition of Walls	Base	Flooring	Ceiling	Stairs	Handrails	Doors	Glazing	Total Score	Building Average Rating												
4	4	3	4	4	4	3	4	4	4	4	4.5	4.5	4.5	4.5	4.5	4.5	4	4.5	73.5	3.87

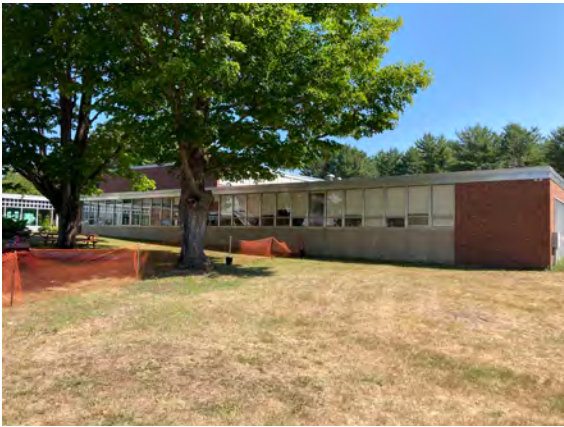
PATRICK HALL: BUILDING I

Year Constructed **1958**
 Use **Classroom & Office**
 Building GSF **1,900 GSF**
 Number of Floors **1**
 Construction type **Masonry & Wood**
 Average rating (scale of 0-5) **2.69**
 Overall Condition Rating **Fair**

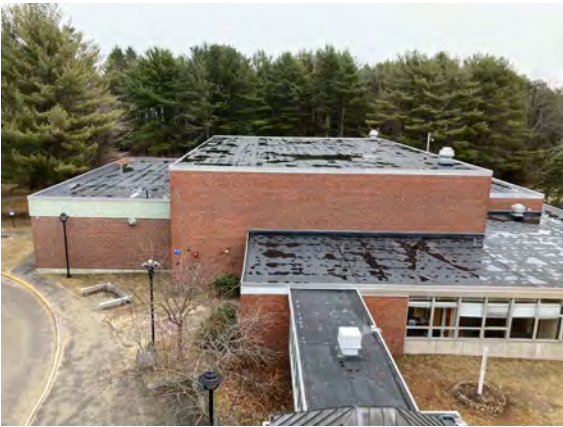
DRAPER HALL: BUILDING J

Year Constructed **1958**
 Use **Office & Gym/Assembly**
 Building GSF **12.370 GSF**
 Number of Floors **1**
 Construction type **Masonry & Wood**
 Average rating (scale of 0-5) **2.4**
 Overall Condition Rating **Fair**

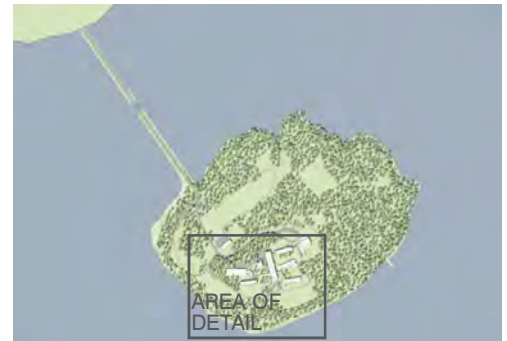
PHASE 2 KEY PLAN

- Remove Building C (currently underutilized and in need of extensive exterior envelope repair)
- Remove Associated Connectors

- Renovate Building J gymnasium and associated support spaces to improve utilization of existing large function space
- Consolidate Building H
- Consolidate Building C lease space into Building K
- Additional plantings and site improvements along campus and trail edges

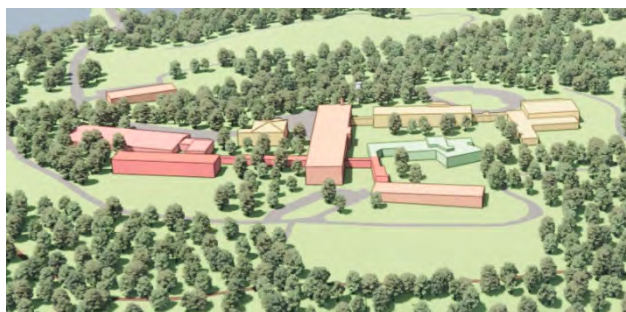
Facility condition varies greatly from building to building. Some buildings are in a state of extensive decline and should be considered for removal and others are in very good working order. Images below reflect overall condition: green is very good, yellow is good, orange is fair, red is poor, and dark red is very poor.

Campus buildings colored by overall condition

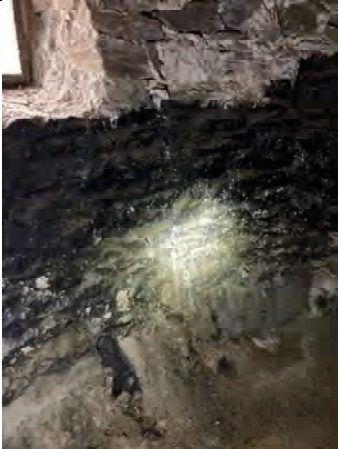
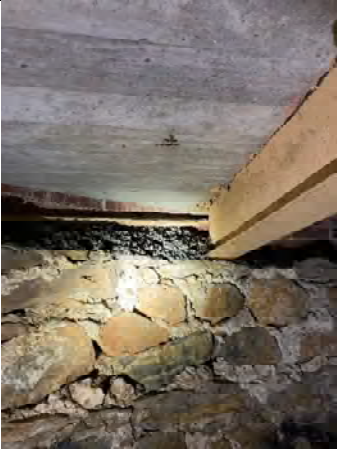
<i>Existing foundation wall.</i>	<i>Existing slab and floor structure.</i>

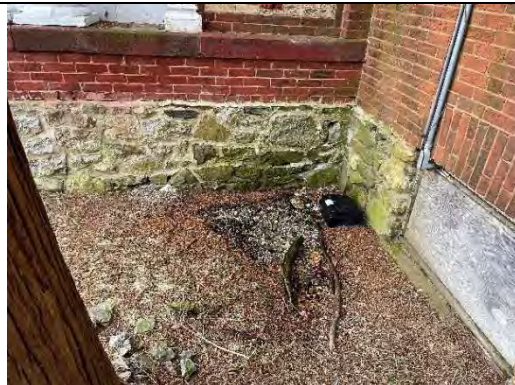
The existing façade is comprised of load bearing masonry walls with mortared fieldstone foundation and brick walls. Window openings are supported by painted steel lintels and sills are made of shaped stone. Moderate pointing is needed throughout the building. Higher levels of mortar deterioration were observed around the side entrance (near door A2). Recent pointing does not appear to be in keeping with the original masonry construction and should be redone, if possible, to match the original building elements.

Root infiltration at masonry

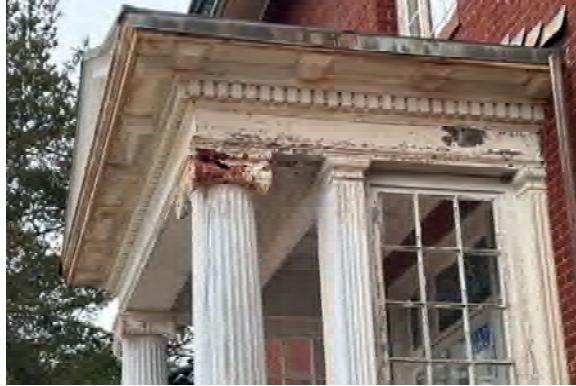
Exterior trim and detail elements are painted wood with copper flashing at roof edges. Significant signs of rot were observed. Due to the historic significance of the building replication of rotted elements is recommended. All exterior wood trim and detail surfaces need painting. Existing paint should be tested for lead prior to scraping and prep.

Wood deterioration near door A2

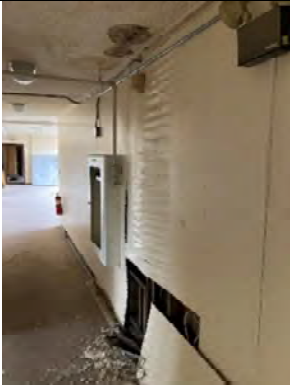
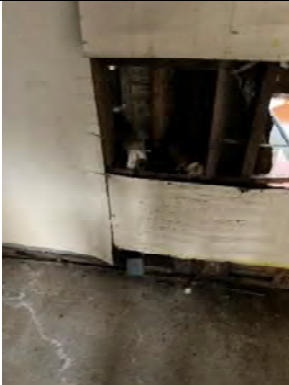
Interior Systems	
<p>Overall interior is in poor condition. Roof has caused major water damage throughout building. Many areas of interior finish have been stripped and most remaining interior finishes are beyond repair. The building has a posted sign declaring the interior spaces will expose occupants to asbestos containing building materials (ACBM).</p>

<p>Water damage.</p>	<p>Water damage.</p>

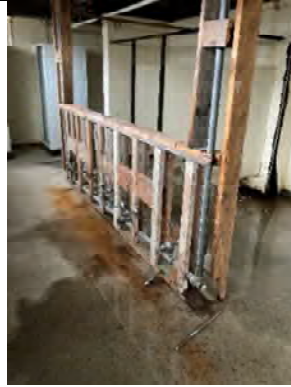
Standing water.

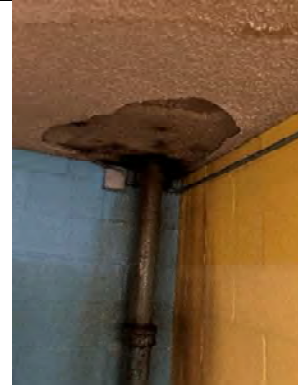
Roof leak.

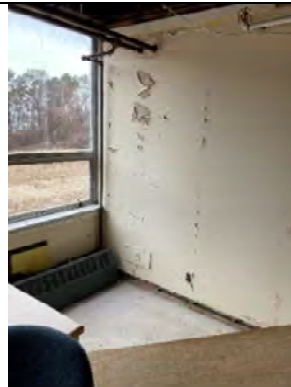
Deterioration at existing partition wall.

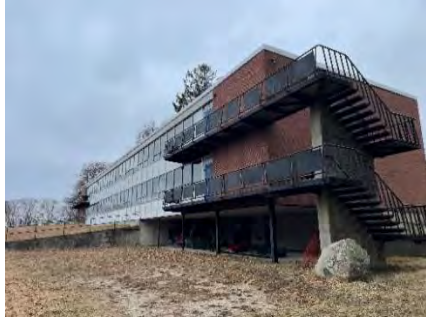
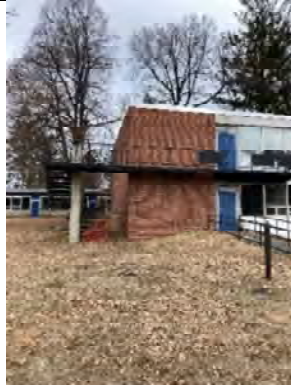
Steel egress stairs and balconies are in in dangerous condition.

Canopy/overhang and exterior stair west side

Exterior stair detail

Canopy/overhang and exterior stair east side

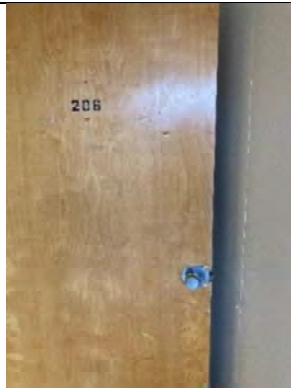
Non-compliant door hardware.

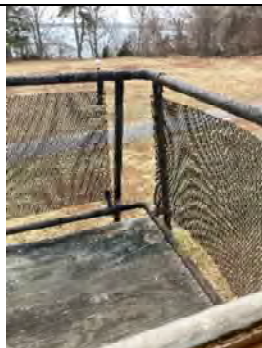
Steel egress and balconies are in dangerous condition.

Steel and Plywood Balcony.

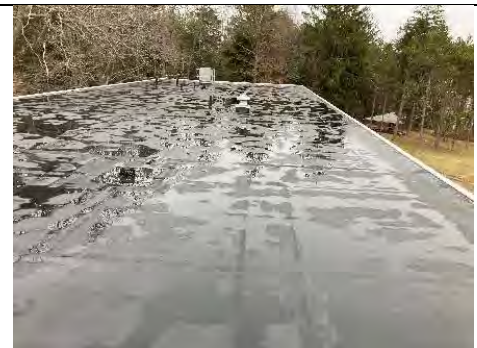
EPDM roofing and aluminum roof edge flashing are in good condition.

EPDM Roofing.

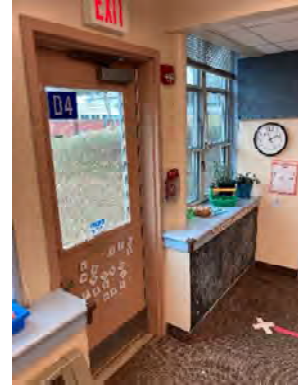
Grade-level exterior door.

<p style="text-align: center;"><i>Overhang.</i></p>	
<i>Recommendations Summary</i>	
<ul style="list-style-type: none"> • Address water infiltration at ground floor at exterior doors. • At the main stair window a more permanent metal protective element, ideally somewhat transparent, should replace the plywood in lieu of replacing the window with tempered glass. • Prep and repaint exterior steel elements. • Repair damaged metal siding and brick veneer. 	
Building E: Garage Inman	
<i>Introduction</i>	
<p>The original building was constructed in 1961 by Stevens and Saunders Architects of Portland, Maine. It is 1 story with a total area of 4,000 GSF. The building is part of the original school campus planning and construction initiative and is designed in the modern style. The architectural condition ranges from poor to good depending on the assessment category with the overall building condition identified as fair: see accompanying Building Condition Summary Table for additional information.</p>

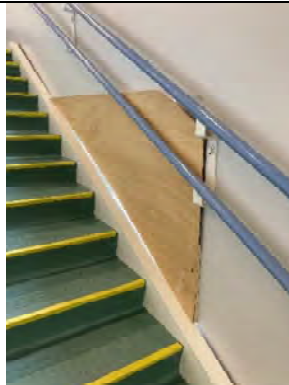
Main stair window protection.

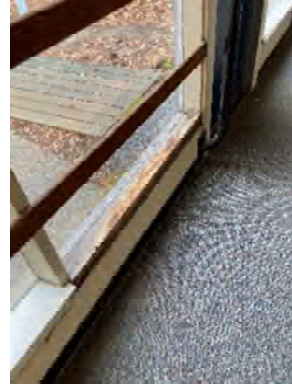
Water damage at sill.

- Repair water damage at sills.
- Upgrade all door hardware to lever type.
- Install Handrails in restroom.
- Address non-ADA compliant approach to doors.
- Replace curtain walls and windows.
- Repair overhangs.

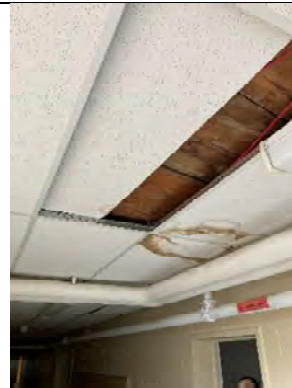
Damaged ACT

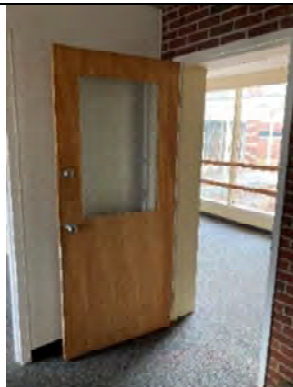
Non-compliant door hardware.

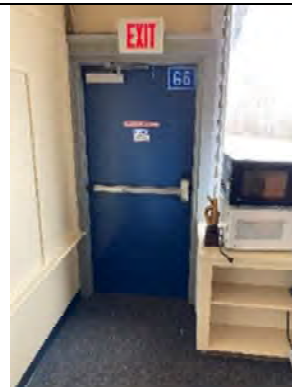
Non-ADA compliant approach at exterior door.

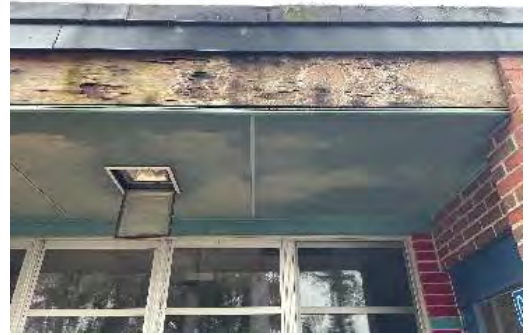
Aluminum composite panels failed and missing at overhangs.

Overhang.

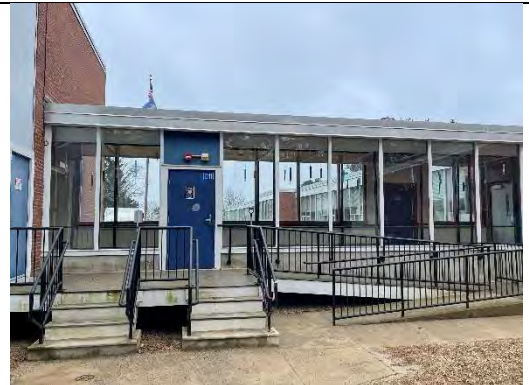
Grade: Site drains underneath through 3 pipes.
Foundations: Cast in place concrete.
Walls: T-1-11.
Windows: Site built wood frames with glass infill.
Doors: Hollow metal in metal frames.
Canopies/Overhangs: Remove roof, retained steel frame.
Roof/Flashing: Aluminum roof edge flashing.
Exterior stairs are in poor-fair condition and should be repaired.

Exterior stairs and ramp.

- Repair exterior stairs and railings.

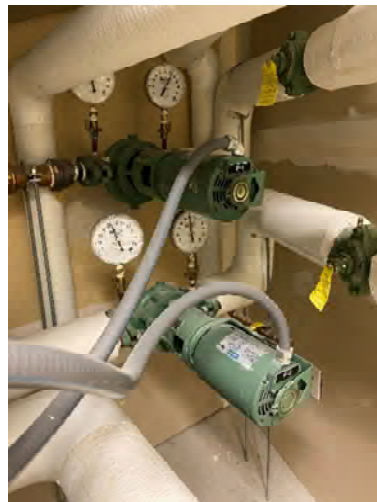
Figure 4 - Radiant Floor Pumps

Heating is achieved mostly through radiant floors which is served by a separate hydronic loop providing low temperature water from a dedicated set of pumps is in the mechanical mezzanine. Heat is also achieved with some perimeter fin tube and cabinet unit heaters which is connected to main, high temperature water loop. The scope of the control system was reduced when the building was constructed so there are spaces that are not maintaining a comfortable temperature.

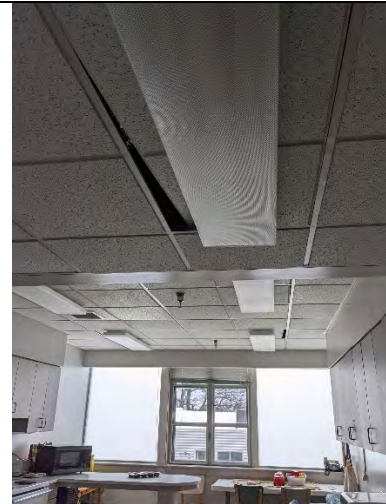
Ex. Space – Needs Daylight/Vacancy Controls

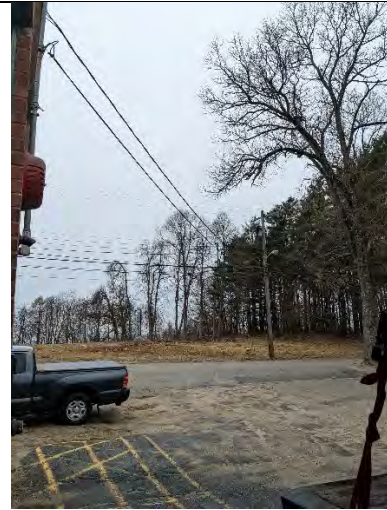
Incoming Overhead Power

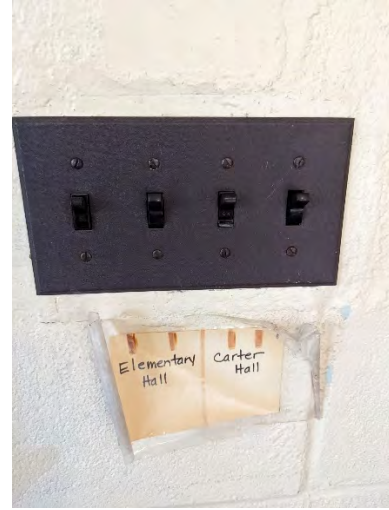
Existing Lighting Controls

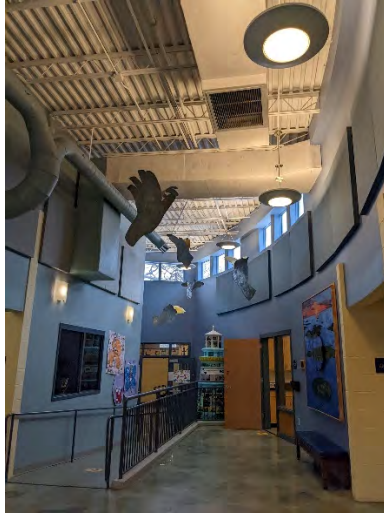
Lighting is comprised of various styles of surface and pendant mounted fluorescent fixtures of which demolition will require the lamps to be recycled and properly disposed of. The majority of fixtures are beyond their recommended life, and many are dirty. Dimming and occupancy sensor capability was witnessed in specific areas (“the lab”) of the building. A Sapling time and control system was noted on the wall in the Electrical room. Reuse of these fixtures is not expected with LED technology replacing fluorescent lamp technology and the age of the light fixtures.

Interior Lighting

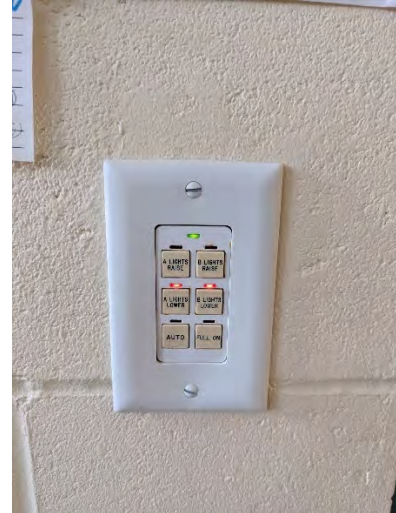
Lighting Controls

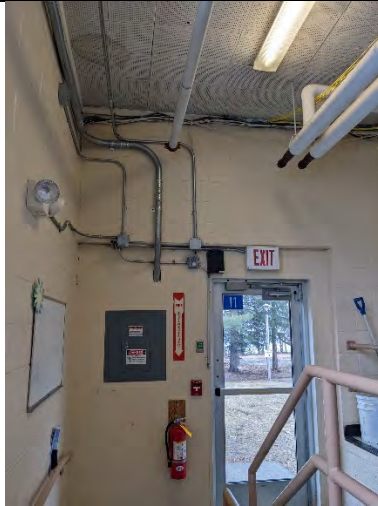
Lighting is comprised of various styles of surface mounted fluorescent fixtures of which demolition will require the lamps to be recycled and properly disposed of. The majority of fixtures are older, and beyond their recommended life. No visible dimming or occupancy controls were witnessed. Reuse of these fixtures is not expected with LED technology replacing fluorescent lamp technology and the age of the light fixtures.

Lights, Elec Pnl, Exit Lights

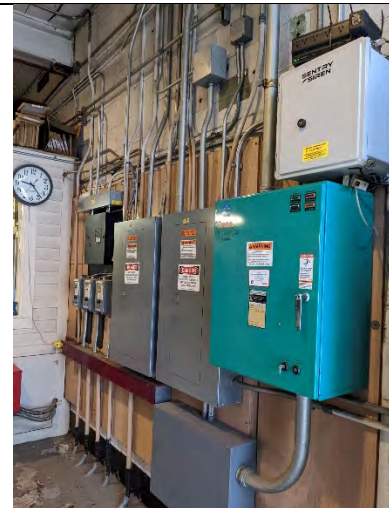
This section addresses the facilities area only of Building K. This building houses the campus boilers, emergency generator, as well as other main campus equipment. The normal power for this building is provided from the campus power poles, via an overhead connection. Three square D type panels are provided within the building area, as well as an Onan transfer switch. All three panels appear to be on emergency power via the transfer switch, and all equipment is in fair condition.

Electrical Panels and Transfer Switch.

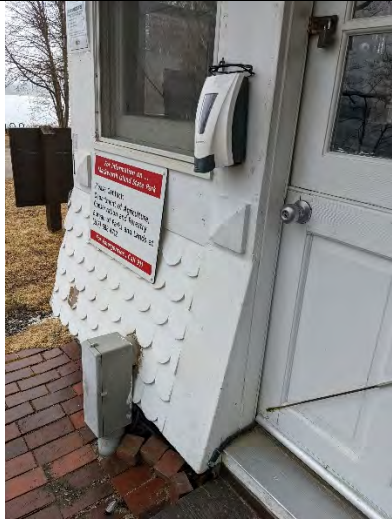
Power Entry to Gatehouse

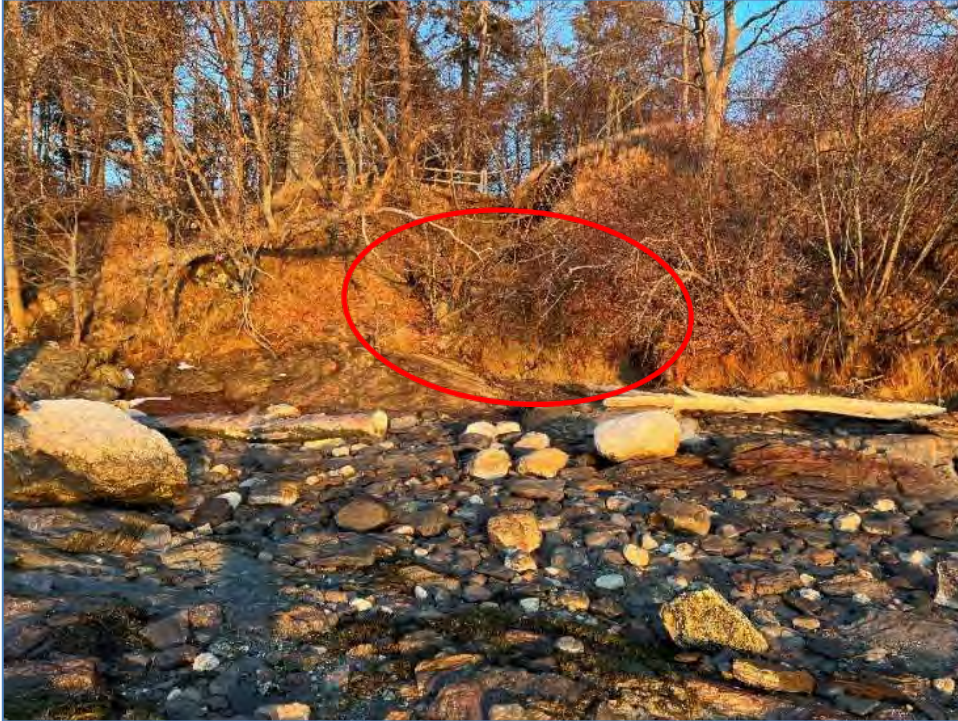
migrate up the slope over time. In areas where the root system of a tree is undercut, the erosion occurs quickly when the tree fails. Refer to Fig. 16.

Fig. 16. Pocket Erosion in the Area where the Embankment Toe is Exposed

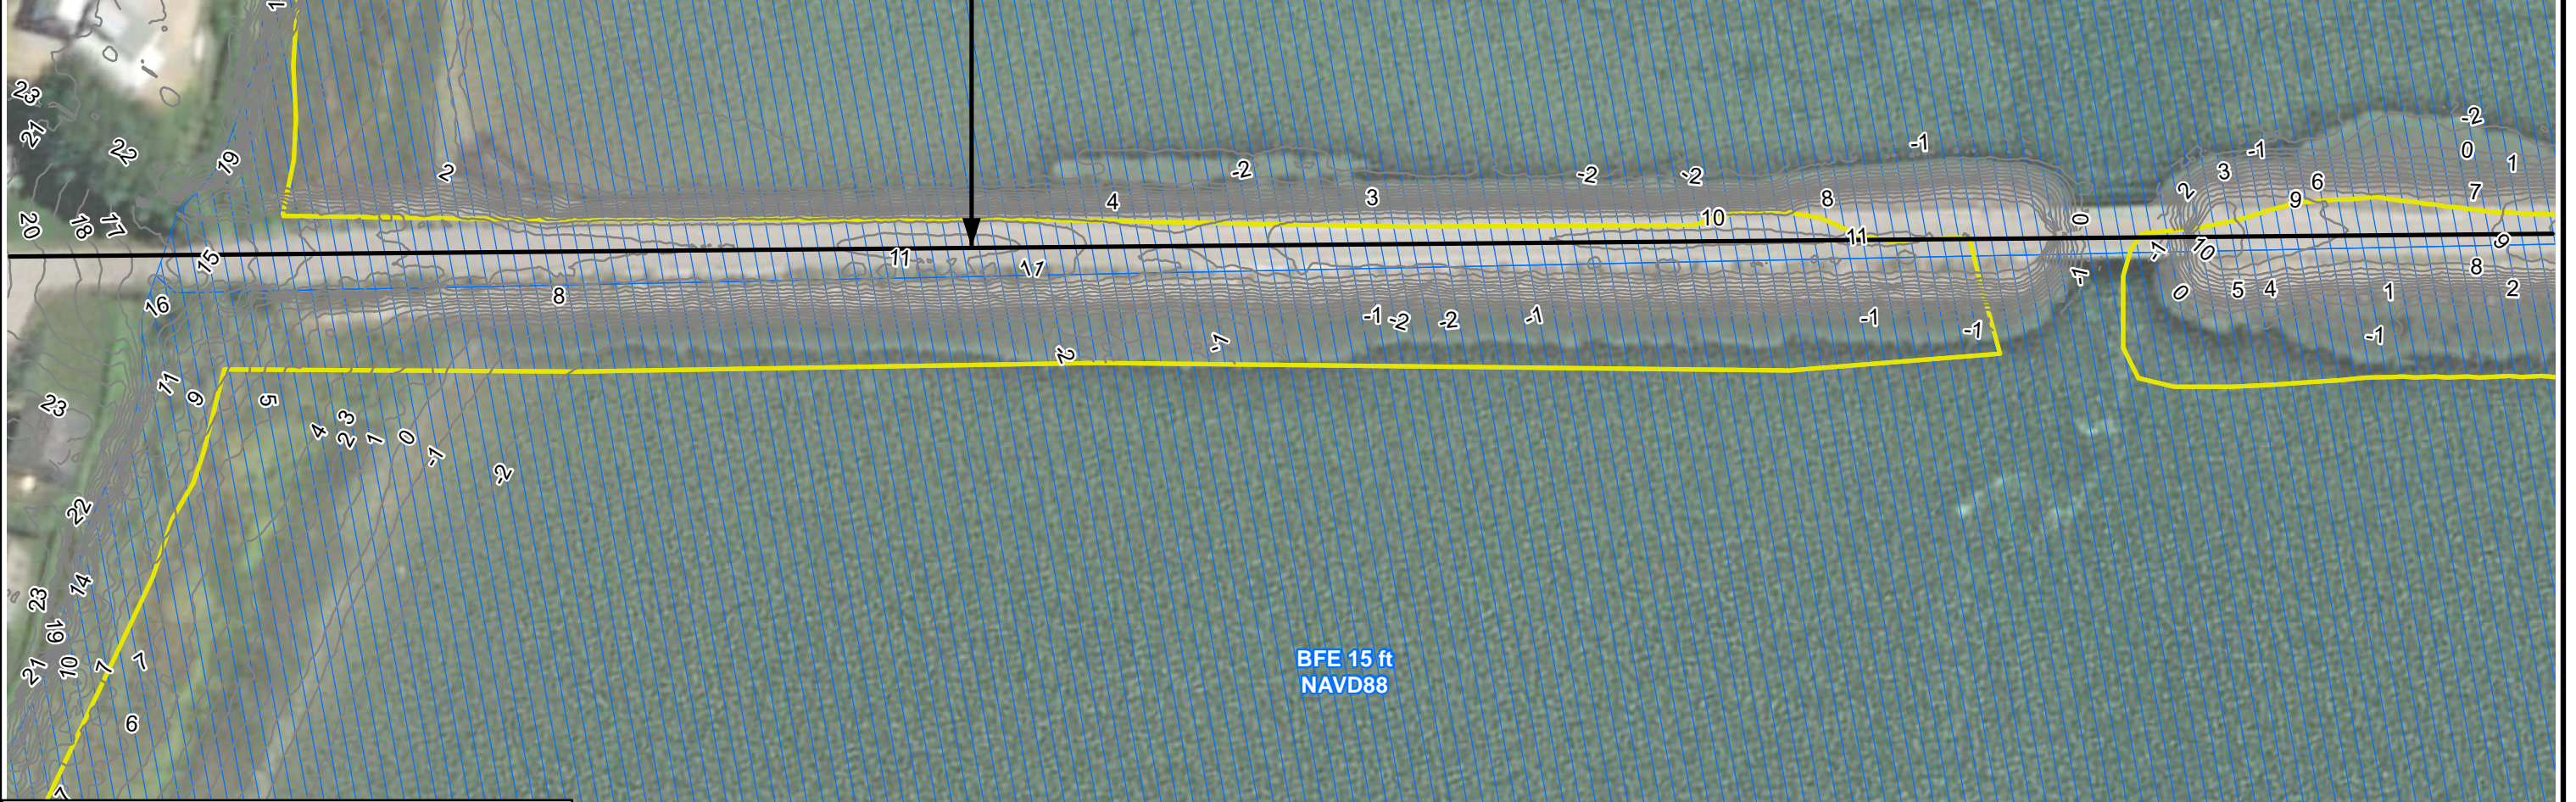
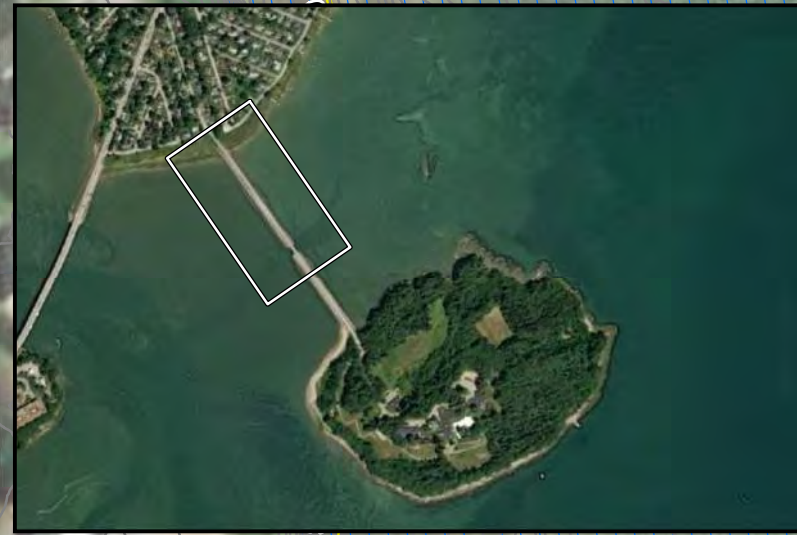
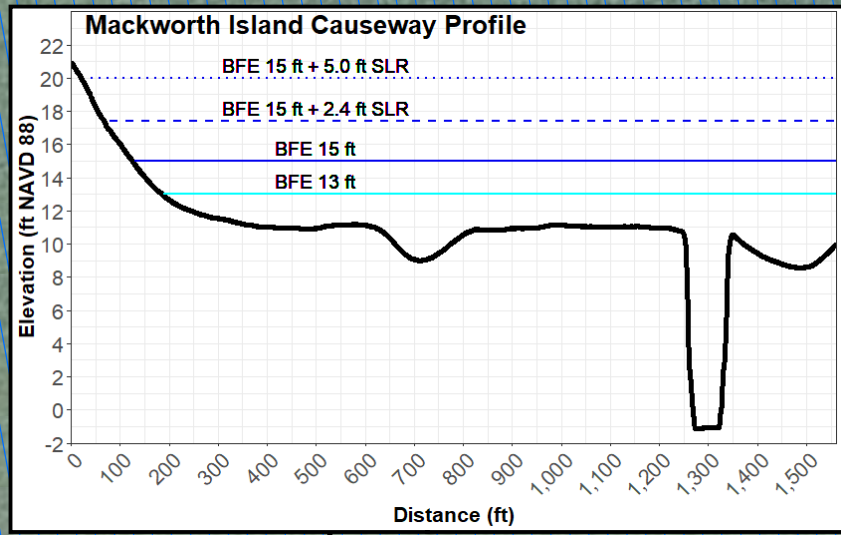
1-1

MACKWORTH ISLAND
VULNERABILITY MAP -
WEST CAUSEWAY

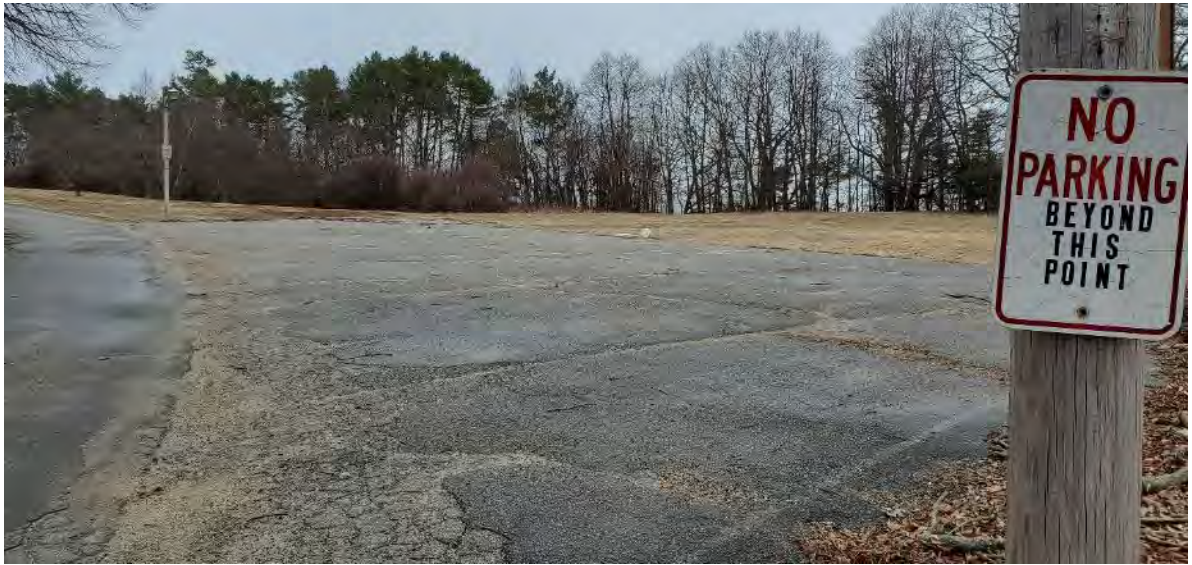
Photo 7: Athletic Field area parking lot

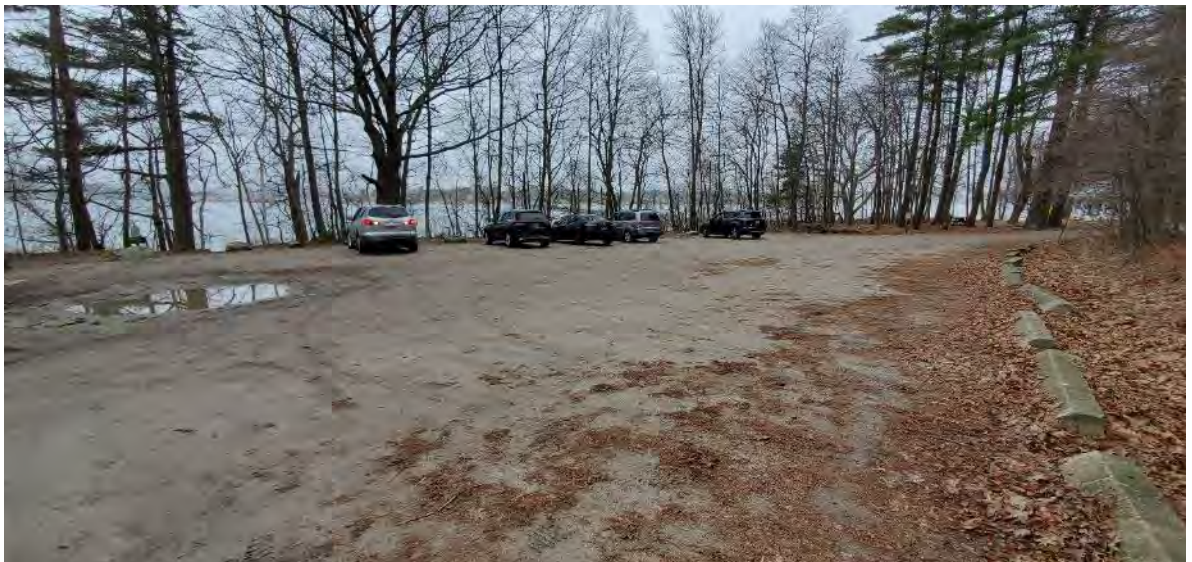
Photo 8: Mackworth Island State Park parking lot

As the data collected for the public State Park parking lot was during a non-peak season, the data is only representative for the time of year in which it was taken. Interviews with staff from Mackworth Island indicate that the public parking is consistently at capacity.

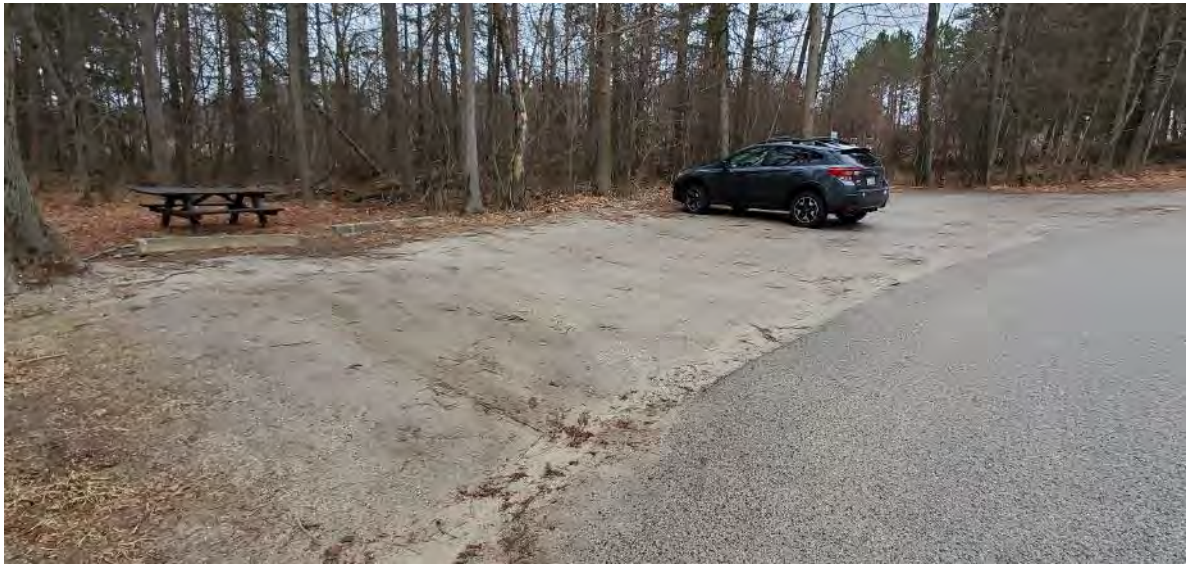
Photo 9: Mackworth Island State Park gate parking lot

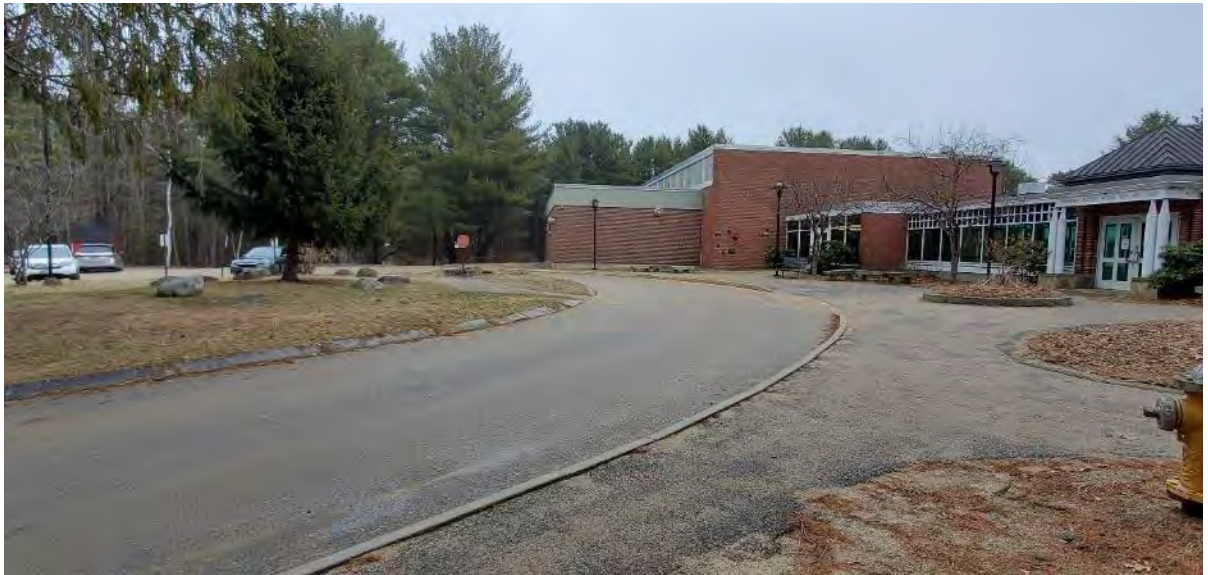
Photo 10: MECDHH Main Entrance

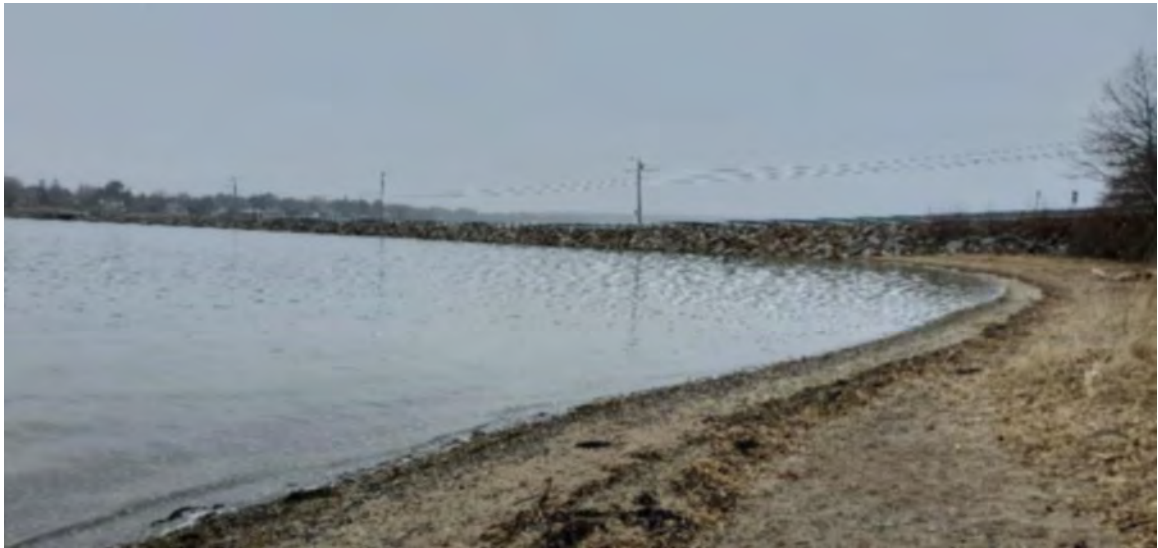
Photo 11: The causeway to Mackworth Island

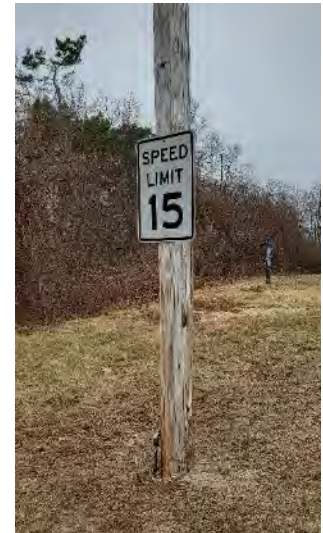
Site observations on the campus show a number of signs for traffic control, parking restrictions, and speed limits. A cursory analysis of the signs reveal that they are generally in poor and deteriorating condition. The signs should be replaced and adhere to the Manual on Uniform Traffic Control Devices (MUTCD) and provide a retroreflective surface to be more visible to drivers.
