## Scour Critical Bridge Plan of Action (POA) Report

Town: Augusta

Bridge Number: 3077

Bridge Name: Bond Brook No 1

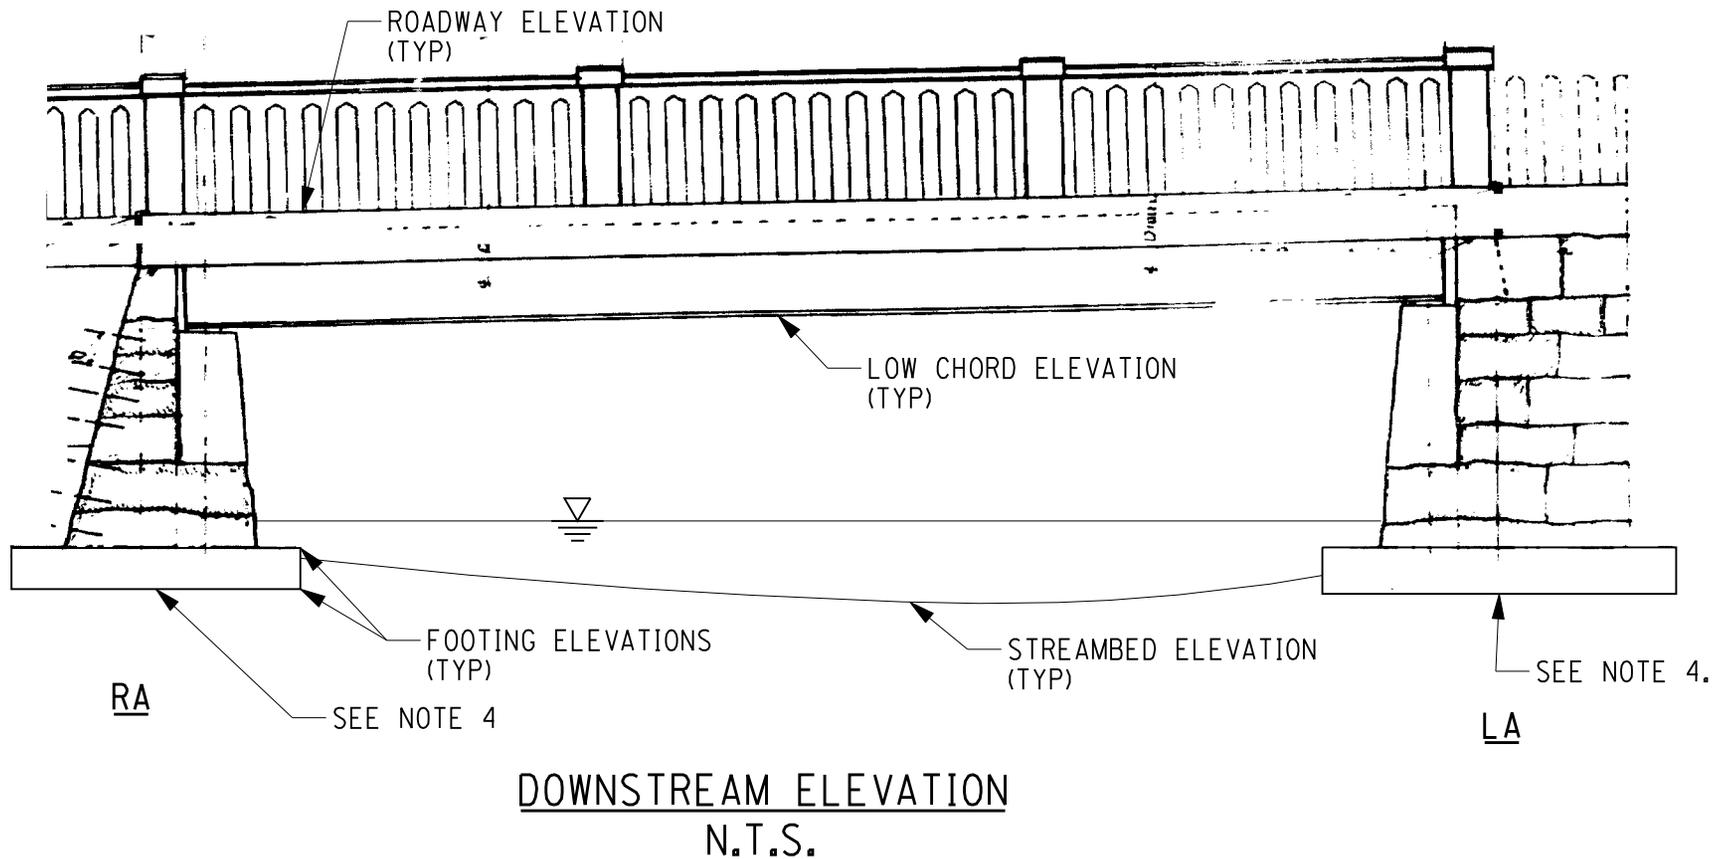
SUBSTR. UNIT	ROADWAY ELEVATION (FT)	LOW CHORD ELEVATION (FT)	FOOTING ELEVATION (FT)		STREAMBED ELEVATION (FT)			
			TOP	BOTTOM	ORIGINAL DESIGN PLANS (1933)	TY LIN (1995)	FIELD (2009)	CHA 100-YEAR SCOUR ELEVATION
LEFT ABUT.	33.5±	29.9±	5.5±	3.2±	7.0	3.1±	4.5± (DS)	N/A
RIGHT ABUT.	33.2±	29.3±	3.1±	1.7±	7.0	5.1±	2.6± (US)	N/A

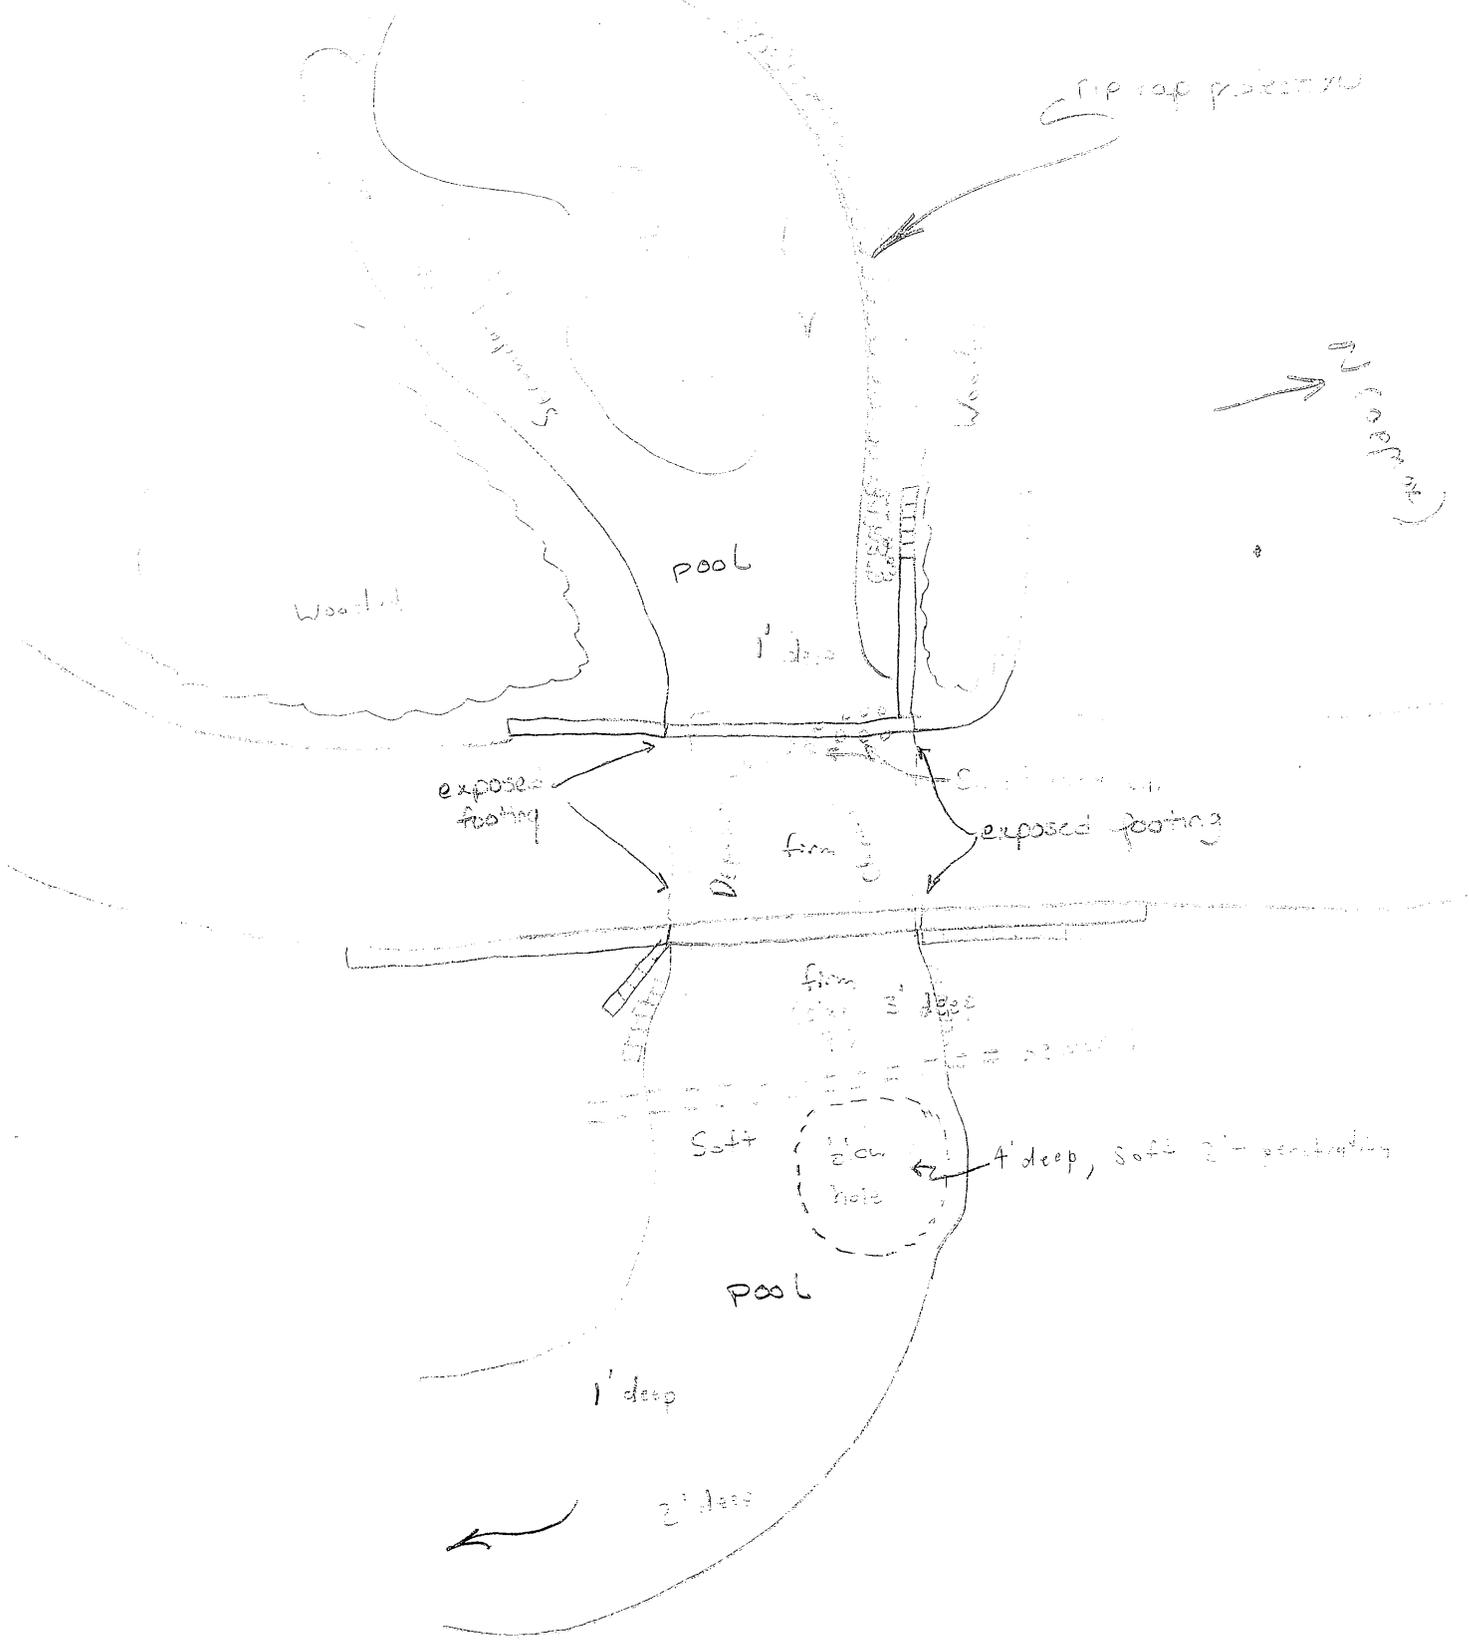
Sketch (Plan view)

No structural evidences of scour damage to the bridge were observed. However, the scour hole at the left downstream abutment may be below the base of the timber grillage which supports the granite footing. Probes penetrated 5.5' between the timbers and the granite block footing and several feet between the granite blocks, indicating a loss of fines behind the blocks.
