Building Resiliency Along Maine's Bluff Coastline

Technical Manual for use of the Shoreline Management Assessment Decision Tree

Finalized October 2017
Revised November 27, 2017

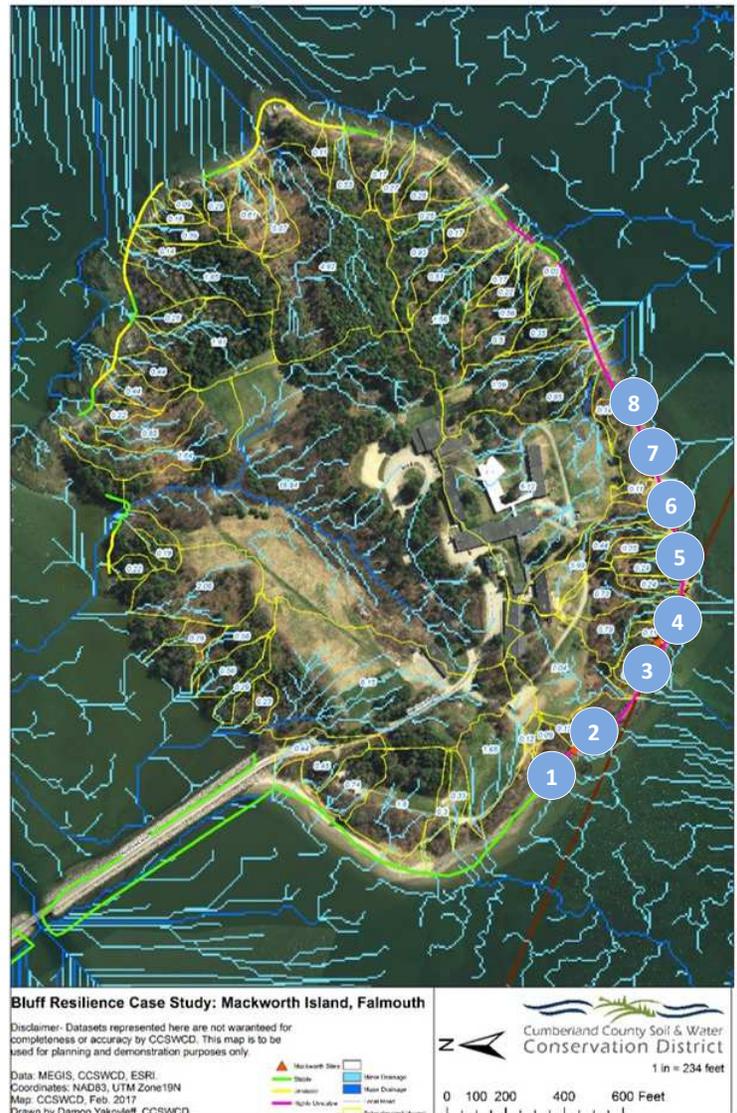
Figure 1. Eight Study Sites at Mackworth Island, Falmouth, ME

Evaluation date:	November 10, 2016
Evaluators:	Damon Yakovleff (CCSWCD), Troy Barry
Study sites:	8

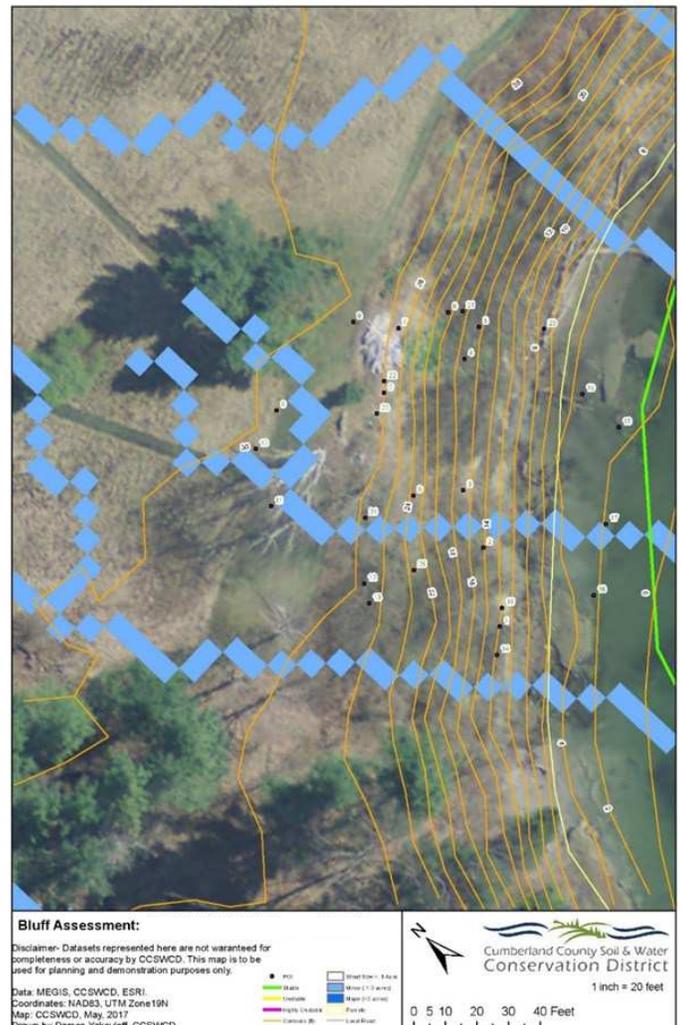
Figure 1. Mere Point Case Study Location, Brunswick, ME

Top Perimeter: 200 feet
Toe Length at high tide: 185 feet
Vertical height from high tide: 15 feet
Conditions observed: The location has a large mass wasting failure.

Three large trees visible at the top of the bluff in the 2007 aerial imagery (Figure 1) and through spring 2016 have slid downslope and maintained upright growth by holding the failure block together during movement. These trees are birch and scotch pine, all of which are growing and appear to be healthy. Reduced vegetation in the upland area has reduced any potential for root structure to assist in binding soil near the bluff-upland interface. Smaller herbaceous bushes have also moved with the failure. Some have continued to grow upright, while others are currently growing at an angle. This is likely due to the shallower root structure of these plantings.

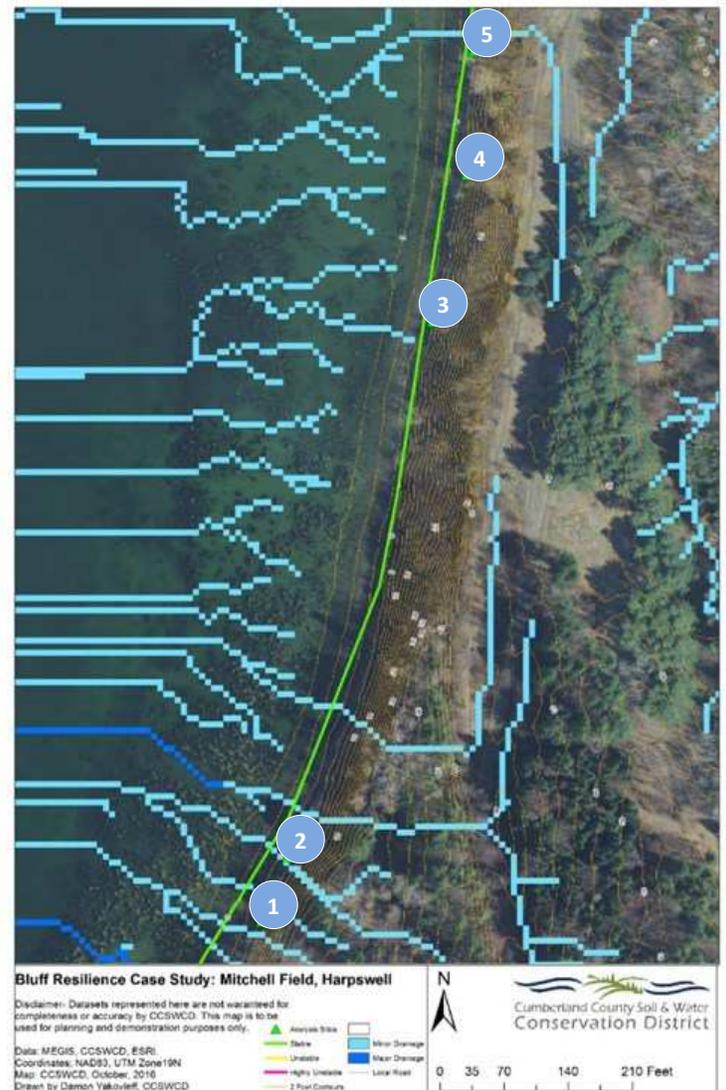
Figure 1. Five Study Sites at Mitchell Field, Harpswell, ME

The site has various shoreline failures ranging in size from upper bank shallow failures to toe erosion due to wave scour. Five of these failures were analyzed, as shown on Figure 1. The largest shallow failure is located at study site 3 and is approximately 50 feet long by 20 feet wide.

Upland top length:	1,485 feet
Toe length at low tide:	1,060 feet
Vertical height from high tide:	49 feet (15 meters)
Conditions observed:	Multiple top of bank shallow failures and multiple toe erosion sites.

Site	Treatment Concept
1	Stabilize toe and lower bank. Mitigate surf runup.
2	Stabilize toe and lower bank. Mitigate surf runup.
3	Stabilize upper slope with vegetation. Investigate hydrology runoff pattern in upland.
4	Stabilize toe and lower bank. Mitigate surf runup.
5	Stabilize toe and lower bank. Establish vegetation in lower bank.
