Colburn House

33 Arnold Road
Pittston, Maine

Historic Structure Assessment

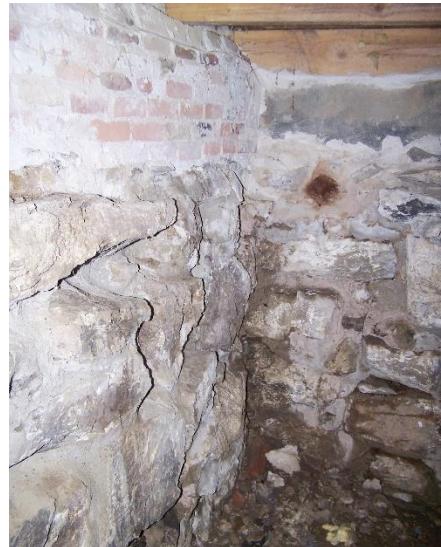
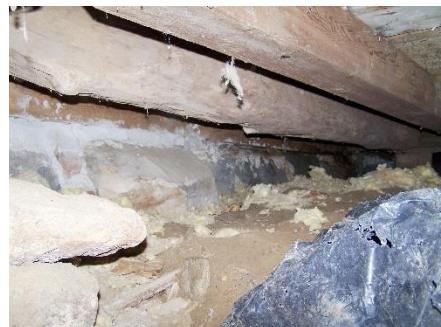
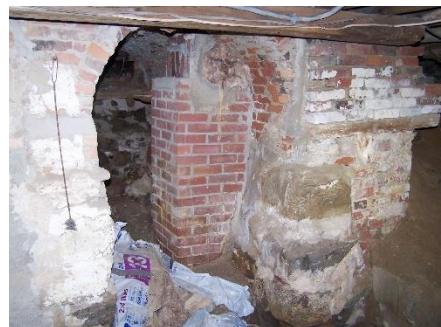
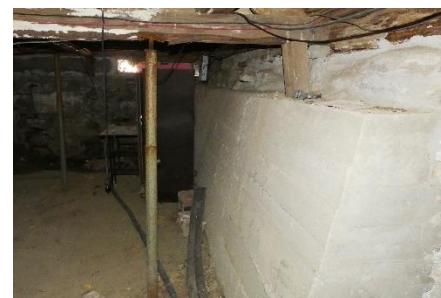
Extending south from the southeast corner of the chimney block to intersect with the south exterior wall is a retaining wall that maintains the high grade level of the west crawlspace. This was originally constructed of rubblestone masonry, but it has been augmented by the addition of a board-formed concrete wall cast against the east face of the wall and chimney block. A similar retaining wall was probably located to run from the northwest corner of the chimney block northward to intersect with the original north foundation wall, but after the ell addition resulted in removal of the old foundations at the junction, the retaining wall likely fell into disrepair and collapse and so was removed.

Over the life of building there have been many modifications to the original foundations. Along the north wall, the ell addition resulted in removal of about 17 feet of the foundations. To provide for support of the timber-framing in that area, at least one dry-laid pier/footing of fieldstone was placed as foundation support under the former sill beam, located at about its mid-length. Later, failure of the remaining original rubble-stone north wall at the ell intersection and along the balance of the 1765 building north wall resulted in re-construction of the bulkhead stair foundations and the north basement wall using a mix of concrete unit-masonry and panel-formed cast-in-place concrete.

At the chimney base block, there are two arched vaults which run north-south through the block. The south end of these two vault openings were walled to retain the soil fill of the crawlspace beyond. The infill walls do not reach to close the brick arches of the vaults. The west vault is open to view, and a chimney was added at the basement level in this vault to connect a basement furnace to the main chimney above. Use of this chimney extension has been discontinued.

The east vault, on the other hand, has been fully closed by added concrete and masonry on the north end of the vault opening. It appears that this was done in response to failing masonry of the east vault arch.

There appears to be a history of degradation of the masonry of the base block, largely due to water infiltration both from ground water into the basement and crawlspaces and from the brick chimney and fireplace flues above. The stone masonry of the base block has been repeatedly and coarsely re-pointed with cement mortar. In the west vault, the brick of the arched ceiling is heavily re-pointed and there are some displacements of the brick units visible in both of the vaults.

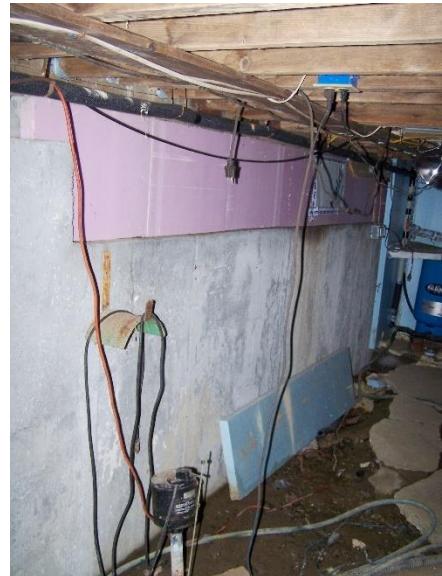
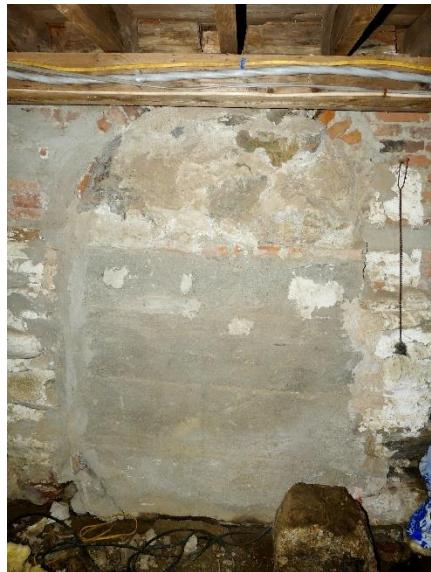
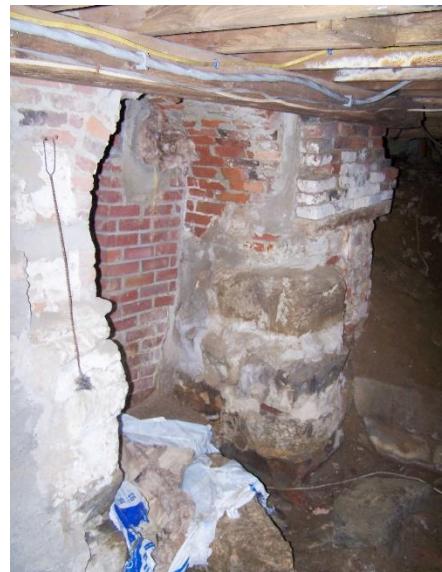
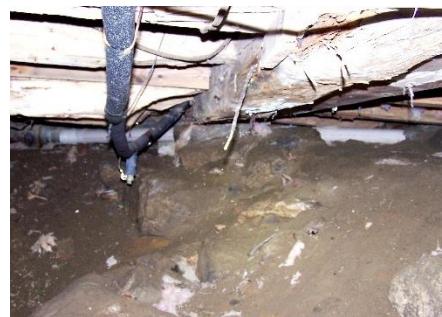
The added interior footing for the old sill at the ell junction is set on the natural grade, and so is not frost-protected, except to the extent that the basement retains warmth when the building is heated. Since the building has not been

heated, the footing is and has been susceptible to movements due to the presence of frost and water. Erosion of the footing subgrade over time has rendered this support unstable.

The granite blocks used for the upper foundations of the south and east walls are cut, single slabs set on edge as a both a finish veneer and a supporting element of the timber framing to the rubblestone walls. There are some significant displacements of the granite blocks noted relative to the sills, in excess of several inches in some locations. In an attempt to improve the situation, a single wythe of brick was added along the top of the east wall, possibly with the intent to provide additional support under the timber sill there. This brick obscures the upper portion of the foundation wall from view, and it allows a conduit for intruding moisture through the masonry. There is a bow in the brick, which may be due to the displacements of the granite curb blocks of the outer wythe of the wall.

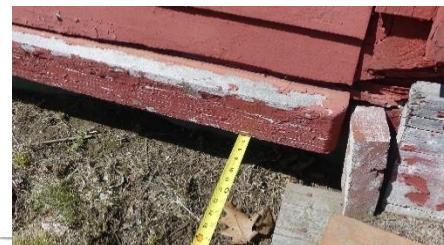
The displacements are due to frost and frozen soils in the exterior ground pressing on the dry-laid foundation masonry, working the joints along the basement walls, particularly where the granite block top curb meets with the stone masonry. This, combined with a lack of fixity between the granite and the timber framing, has allowed some significant movement of the wood-framed wall sills, some bowing of the stone masonry foundation walls, and separations of the granite block joints, some of which have been mortared-over or filled with caulking. The movements in the foundations over time has opened joints between

the stones of the masonry, to allow further infiltration of water and subsequent damage to the structure as a whole. The addition of cement mortar into the joints of the basement has had little benefit against this on-going problem. Issues of freeze/thaw resulting from a lack of heat in the building during winter months are extended into the general basement area, increasing the potential for heave damage to the foundations.

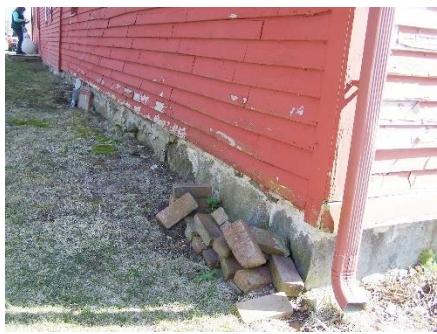
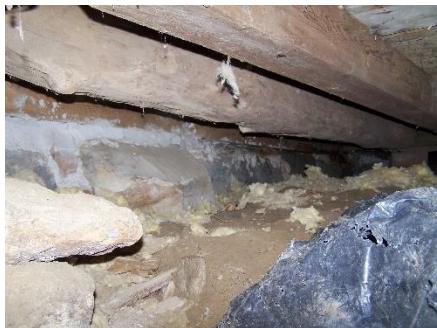
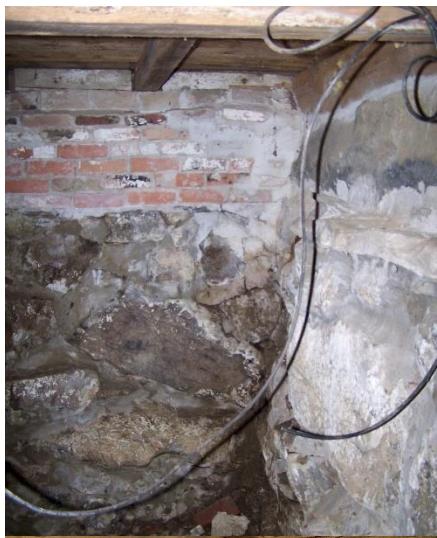
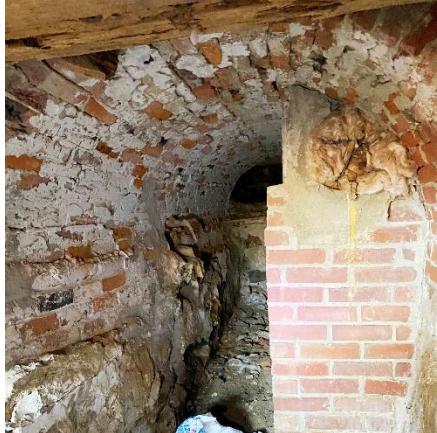
The masonry walls of the exterior east, south and west walls generally appear to be in poor to fair condition, due to rotations of the granite curb blocks on the east and south walls, and spalls and mortar loss along the west wall. Viewed from the interior the stone masonry has open joints and cracked mortar. The walls of the crawlspace area could not be viewed due to the high grade of the fill soils. Visible joints of the stone have been mortared, but it is not known when this mortar was added. The added brick masonry infills at the east wall prevent evaluation of the original masonry at the top of the wall; The brick appears to be bowed, and it may need reconstruction due to the effects of water infiltration.

The east and south stone walls in the basement area appear to be bowed inward, from top to bottom. This displacement has developed over the life of the building, due to push from frost or water in the retained soil outside it. This appears to be a persistent problem which might be best addressed from the outside by improving site drainage at the building perimeter. Further investigation of this condition is recommended, and this will likely require excavation along the building.

The brick masonry vault arches of the chimney block show signs of extensive water infiltrations, look to be weathered, and have been subject to repair in the past, with mixed result. The stone masonry supporting the brick vaulting has been mortared, repeatedly, and the joints of the west arch are heavily re-pointed.

The original stone masonry along the east side of the chimney base and the southeast crawlspace fill retaining wall was reinforced by the placement of a cast-in-place concrete wall to about four feet above the level of the basement floor. The concrete was cast directly against the old stone masonry walls, with a significant degree of batter on the outer face. This suggests that there may have been some significant displacements or deterioration of the retaining wall, and possibly the chimney base, which were intended to be addressed by the addition of the new concrete wall.

The north wall shows concrete on both interior and exterior faces. This section of the foundations, from the ell to the junction corner of the east wall, is probably solid concrete, replacing the original stone wall. Exposed areas of the north foundation wall appear to be in fair- to good condition, generally. Much of the upper portion of the concrete wall could not be seen from the interior side, due to the presence of insulation board. While the base of the wall was largely viewable, it could not be determined at the time of the site visit whether there is a strip footing supporting the concrete wall.

Due to the poor condition of the upper portion of the masonry walls, it is recommended that, at a minimum, the top 3 feet or more of the masonry should be removed and reconstructed to provide a more stable base for the support of the building superstructure above. The existing walls do not appear to extend to below the minimum recommended bearing depth of 5 feet below finished exterior grade, so frost and water intrusion through the masonry and basement floor will continue to be a problem, where the existing foundations remain. The concrete north wall appears to be serviceable, but also may not reach bearing levels that are below frost-depth, and the exterior concrete curb that is exposed to exterior view is not authentic to the building's historic fabric.

- 3.2.B.1 *Removal and reconstruction of the top 3 feet of the remaining stone masonry walls is recommended, at a minimum. This includes historic restoration of the granite exterior curbing to support the timber framing for the east and south walls.*

- 3.2.B.2 *Removal and reconstruction of the foundation walls to provide frost-protection to the foundations is recommended to restore the integrity of the building foundations and stabilize the building structure and envelope.*
- 3.2.B.3 *Investigation of the subsurface conditions along the exterior foundation walls is recommended to ascertain condition of the foundations and site drainage. If results indicate, a scheme for improvements to site drainage and waterproofing around the building perimeter to maintain the integrity of the foundations should be developed and implemented.*

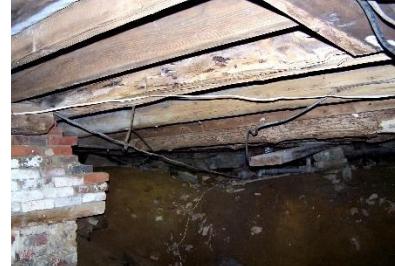
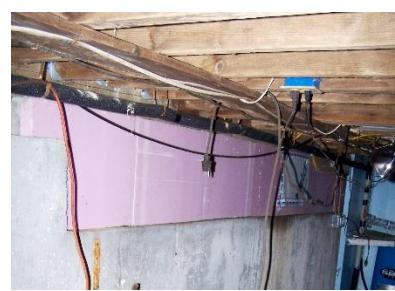
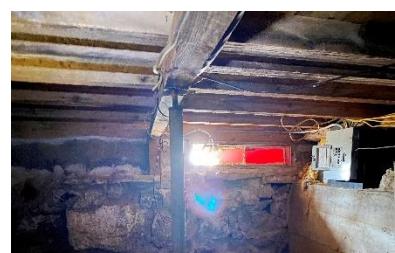
South of the mid-line beams, the floor joisting changes span direction to run east-west. The southeast bay of joists is rough-sawn 4"x 6" joists spanning from the east wall timber sill to the transverse timber beam which runs above the southeast crawlspace retaining wall and onto the chimney foundation block. The joists are not original construction. At about the mid-span of these joists, a newer 4"x 4" beam has been added to provide them with extra support. The new 4"x 4" is supported by a light-gage metal screw-jack post at its mid span, and by a piece of 4"x 4" inserted as a post from its

Joists in the crawlspace were typically of whole logs, some with bark still on, with tops flattened to receive the floor planking. The log joist were about 8-inches in diameter, set at about 2 feet on centers.

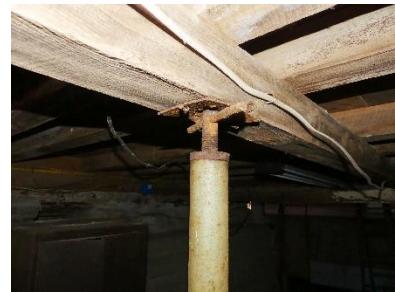
south end to the top of the original stone masonry wall. Screw-jack posts are not suitable supports for long-term use, especially in damp areas, such as basements, due to their light construction, propensity for corrosion and wasting, and their relatively low load capacity. The jack posts in this case have deformed bearing plates which indicate overload and have resulted in compression of the wood fibers of the beams which they are supporting. Oxidation present on the metal surfaces may progress, to irreversible damage and a loss of functionality for the posts.

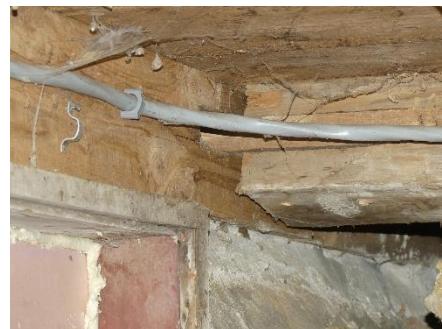
The timber framing sills along each side of the chimney base were set upon a continuous base sill which acted as a buffer between the framing sill and the surface of the base masonry. The eastern base sill shows extensive rot and this rot is extending into the sill timber above it. The condition of the west sill was not noted due to difficulty of access at the time of the site visit

- 3.2.C.1 *The mitigation of rot and fungi growth on the timbers of the structure is recommended.*
- 3.2.C.2 *No modifications of the first floor framing are anticipated at this time, so long as the current occupancy use remains the same. Replacement of screw-jack posts and ad-hoc timber posting with proper columns, foundations and positive framing connections is recommended.*
- 3.2.C.3 *Because of a lack of access to the timber sills at the masonry foundations, and poor condition noted at some spot-locations, further investigation of the perimeter and interior timber sills is recommended to verify the condition of the sills with regard to deterioration due to rot, etc., and that a scheme for remediation of any damaged or unsound conditions found be developed and implemented as needed.*

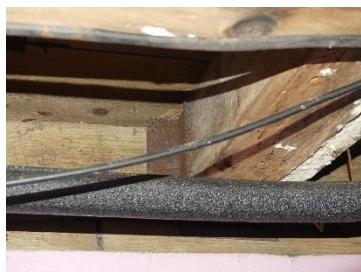
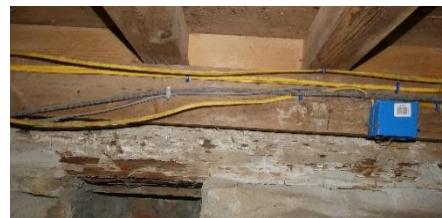
Along the north, concrete foundation, the original sills were probably replaced when the concrete foundation wall was constructed, and steel strap hangers can be seen carrying the replacement floor joists.

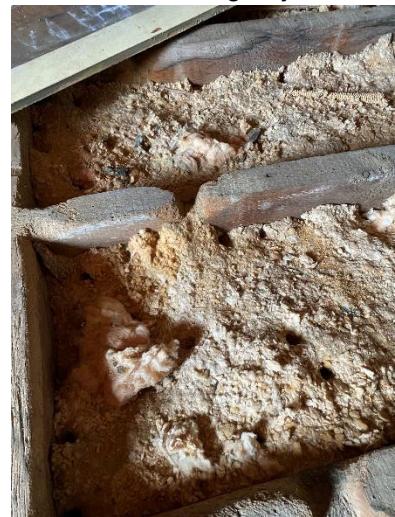
The attic floor rafters seem to be in fair condition, but the presence of insulation in the joist cavities hides most of the floor the framing from view. Throughout the attic framing there is evidence of damage by mice or other rodents, including pathways which have been chewed in the wood members. This presents a loss of strength for the joists affected, but due to the limited use of the attic space, this does not appear to have resulted in problems for the ceilings below, yet. There is evidence of cracking in the plaster finishes below, which may be the result of deflections in the framing. It may be that the wood lathing that supports the plaster has separated from the attic floor joisting.

- 3.2.E.1 *Generally, the condition of the roof and timber joist-purlins appears to be fair- to good.*
- 3.2.E.2 *The condition of the four timber roof trusses appears to be generally good, but joints between the column posts and the truss principal rafter and bottom chord members were obscured by the presence of other framing and finishes.*
- 3.2.E.3 *The condition and serviceability of the attic insulation is poor, and the habitation of pests in the insulation is undesirable. It is recommended that all the existing attic insulation be removed, the space cleared of debris and other living things, and, if desired, a new system of insulation selected and installed*
- 3.2.E.4 *Many of the attic floor joists have been damaged by pests. It is recommended that plan for removal and replacement of damaged joists with new, or some other remediation, be developed and implemented.*

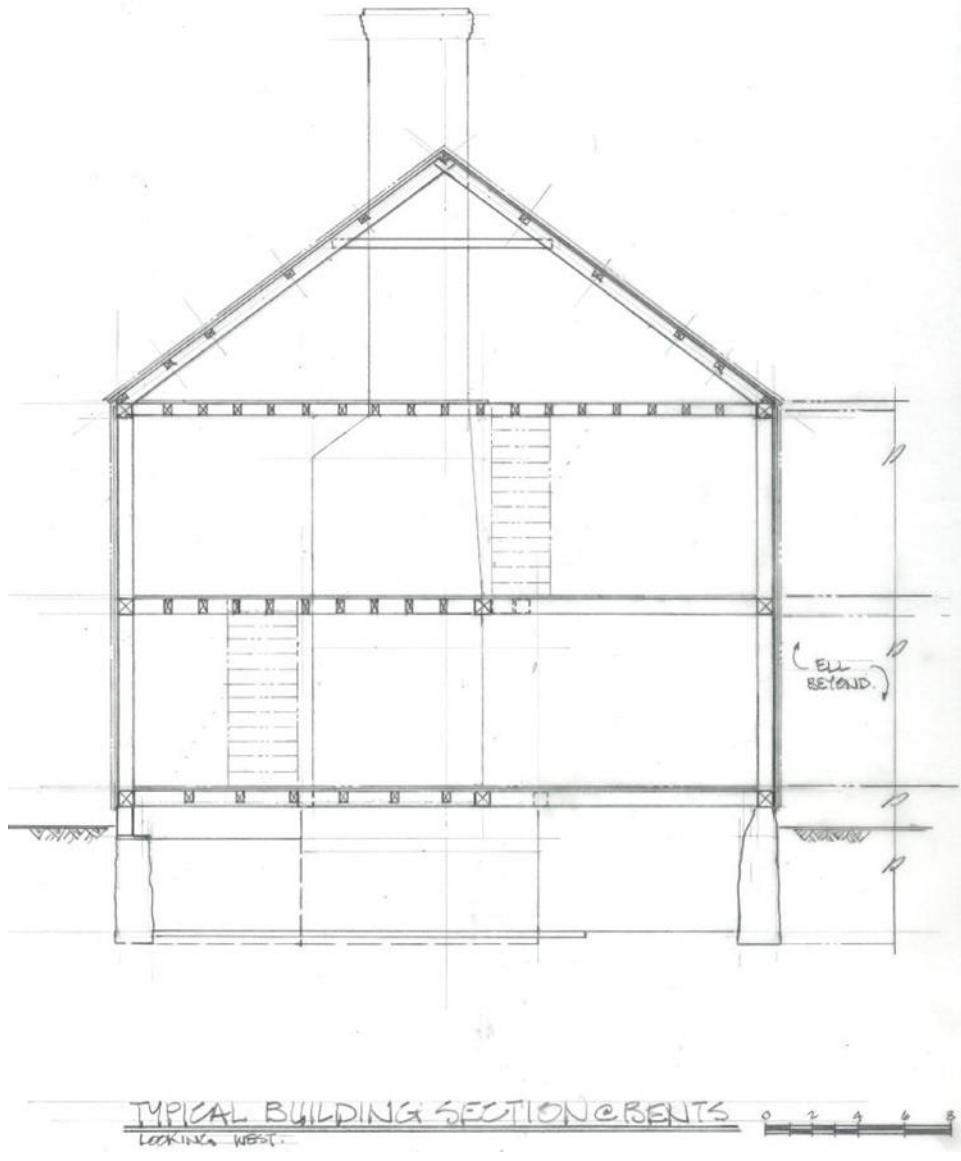
The displacements of the exterior wall framing due to settlement and degradation of the base sills were significant, particularly on the east and south walls. This has been accompanied by the dislocation of the granite block curbing and failure of other parts of the foundation masonry. This has resulted in deterioration of the exterior clapboard siding the opening of joints in the exterior trim and siding, and water intrusion into the interstitial spaces of the walls and foundations.

Timber sills forming the sole of the walls were not able to be viewed extensively, but based on the degree of movement and dislocation noted, it is likely that a program of widespread replacement or repair is needed, generally. Rot was noted in the corners of exterior of the building suggesting that the condition of the framing bents at the foundations and first floor is poor. Weathered areas along the exterior wall base should be reviewed specifically for indications and extent of deterioration.

- 3.2.F.3 Because the weather envelope of the building has been compromised for a long period of time, a review of weathered areas along the exterior walls, especially at the base and foundations, should be made to determine the presence and extent of any damage to the existing timber sills due to rot and weathering. Where found, a plan for remediation and repair of the damaged sills and timber frame columns should be developed and implemented.(See also Section #3.2.C.)

- 3.2.F.4 It is recommended that a plan for remediation of the building foundations that support the sills and timber frame columns should be developed and implemented.(See also Section #3.2.B.)

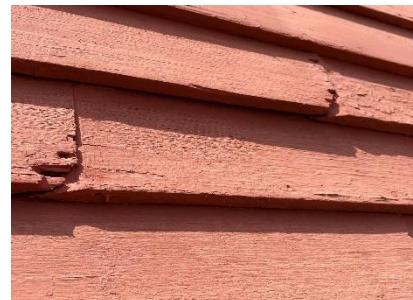
Clapboards with skived joints are fastened with cut-nails on most of the exterior. Clapboards at the south wall, particularly at the first floor and in the areas adjacent to the entry, have failed and are falling from the building. This failure is likely due to the tilt of the south façade causing water to wash down the building. As this area of siding has been redone in recent years and has already failed, it demonstrates the presence of a recurring issue that should be addressed.

Skived joints at clapboards

- 1. We recommend that the failed siding at the south façade be repaired as soon as possible to avoid further damage to the building sheathing and structure. We also recommend that a low-profile drainable housewrap be installed generally between the siding and sheathing (extents shown on drawing 1/A200). This would aid in allowing the siding to dry while also protecting the sheathing and structure of the building from penetrating moisture.
- 2. We recommend that the exterior be prepared and painted as paint has peeled in several locations about the building.

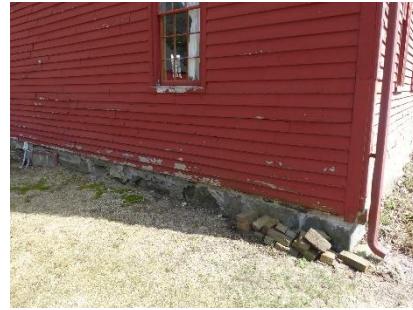
Two sides of the house, the south and east sides, are set on a granite foundation with rubblestone underpinning below grade. The west wall is parged rubblestone masonry. New concrete has replaced the original masonry at the north wall.

Fieldstone foundation at west wall

- 1. The Colburn House foundation has settled significantly, resulting in the tilting of the structure. We recommend a new foundation be installed under the entire building, resetting the existing granite caps. (See section 3.2.B for recommendations regarding foundation)

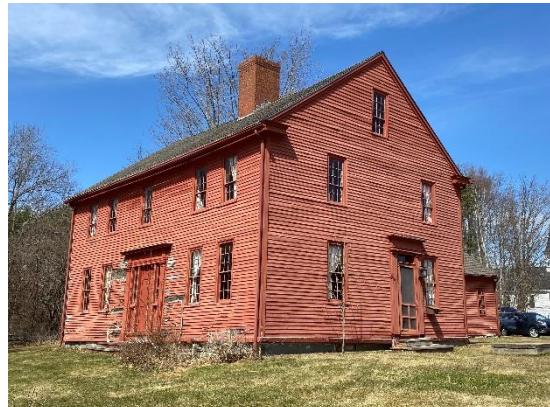
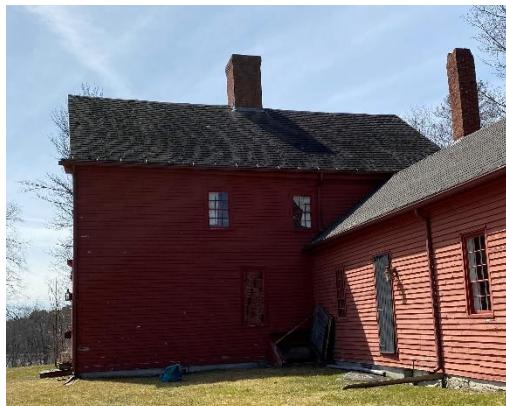
The existing roofs of the main house are textured architectural asphalt shingles, which simulate cedar shingles. Shingles on the south (front) side of the house appear to be in good condition. Shingles on the north side are in poor condition.

- 1. *We recommend replacement of the shingles on the main house over a continuous coverage waterproof membrane.*

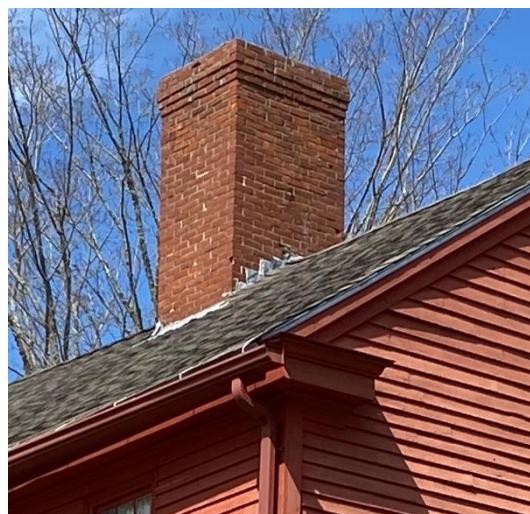
Lead-coated copper step flashings exist where the roof closes around the brick chimney. These are showing signs of wear and have outlived their service life.

- 1. *We recommend that the LCC step flashings be replaced in-kind extending a minimum of 8" above the roof surface.*

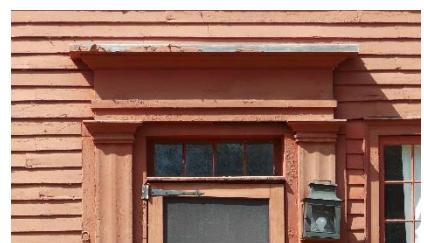
Metal flashing was not observed at the east portico entry. The entablature should be properly roofed and flashed.

- 3. We recommend that the entablature at the east entrance should be roofed and flashed.

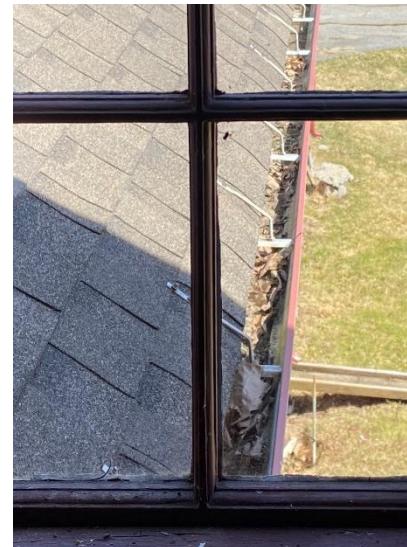
Gutters and downspouts exist on the eave sides of the house. Hangers for the gutters are fastened through the asphalt shingles creating opportunities for water infiltration to occur.

- *1. We recommend at the time the roofs are replaced that strap-type hidden hangers be installed under the roofing as recommended by the manufacturer.*
Also, gutters and downspouts need to be maintained on an annual basis to remove organics and monitor performance.

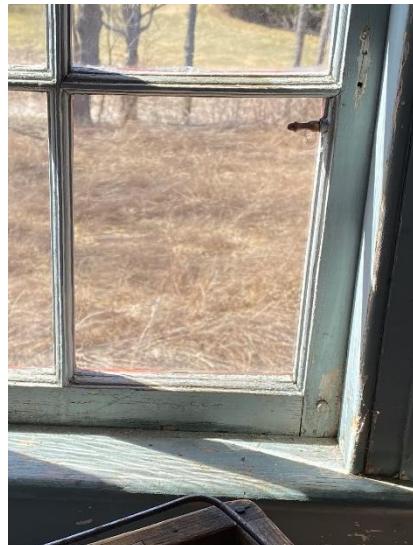
No sash locks or sash cord, weights, or pulleys were observed. Sliding bolts within the frame of the window sash were observed in some of the windows. These would have been used to hold the window sash in particular locations (i.e., open or closed).

- 3. *Due to the general absence of locking hardware, for security purposes operable sashes should incorporate discrete wooden stops in the jambs to limit total vertical movement.*

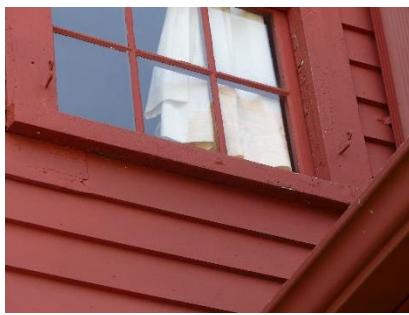
Photographs, mounting hardware, and numbering tacks provide evidence that the house once had wood frame storm window sash mounted at the exterior. Some storm sashes were observed at the ell, but none on the main house.

2nd story window w/ hardware & # tack

- *5. We recommend existing storm windows be restored, and missing storm windows be recreated. These are to be reinstalled on the building to help preserve historic windows and assist with overall thermal performance.*

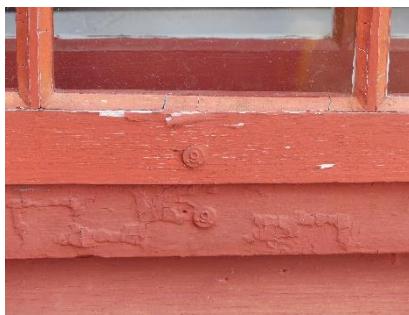
Window at ell showing use of # tacks

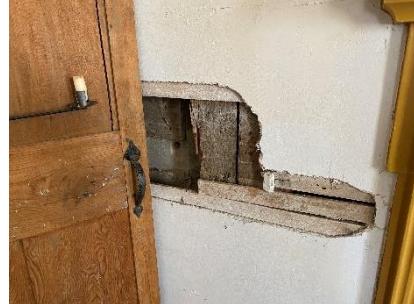
Wall finishes vary throughout the building. Horizontal and vertical wood paneling is used in the Keeping and Borning rooms. Wood paneling is also used between chambers 201 & 202 and to close off the attic stair in chamber 203. Remainder of the house is finished in plaster. Small holes (approximately 1 foot square in size) appear in several places throughout the house.

- 1. *We recommend that areas of missing plaster finish be filled and refinished to match surrounding wall finish. And cracked plaster be repaired.*
- 2. *Based on prior Lead paint analysis, we recommend remediation of painted surfaces*

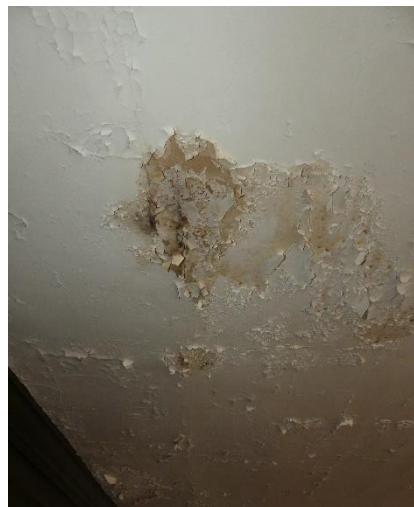
Plaster is used throughout the remainder of the house for the ceiling finish. A large section of plaster has fallen from the ceiling in the southeast corner of chamber 202.

Painted ceiling finishes in much of the house have peeled extensively. It is purported that deceased animals within the ceiling structure are causing areas of discoloration at the plaster ceiling finish.

- 1. *We recommend that areas of missing plaster to be refinished to match surrounding ceiling finish.*

- 2. *We recommend that ceiling stains be remediated and that ceilings be prepared and painted as needed.*

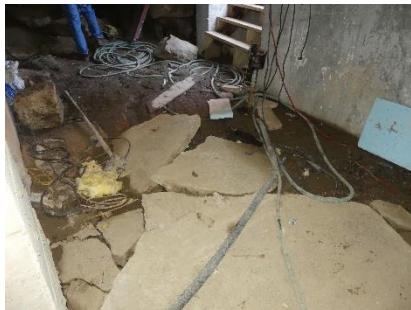
Floor surface is largely dirt with sections of concrete on the east side of the house. Basement is not excavated under most of the house. A

historic report compiled by Crosby Milliman in 1992 mentions that an eight-foot-deep foundation of dry-laid fieldstone masonry was used under the Colburn House. If that is the case, then the cellar has refilled by the way of dirt washing into the cellar between the open joints of the fieldstone masonry. The presence of large rocks in the unexcavated portion of the basement would suggest that the cellar has not simply refilled via the washing in of silt and mud; although, the rocks could have been left there from now missing sections of wall. It is most likely, however, that the basement was never fully excavated.

- 1. *Basement is full of debris and dirt. We recommend that basement be cleaned of loose insulation, wiring, tools, loose concrete, and other debris. Floor finish in new basement to be concrete slab-on-grade with epoxy seal coating.*

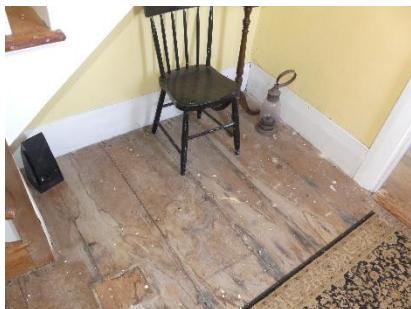
All floors at this level are wide plank floors. Floors in the hall and parlor were observed to have staining due to water entering the building along the south wall.

- 2. *We recommend, that following efforts made to weatherproofing the south façade (see section 3.3 – Envelope-Exterior Walls for recommendations), water-stained floors be refinished to match historic appearance.*

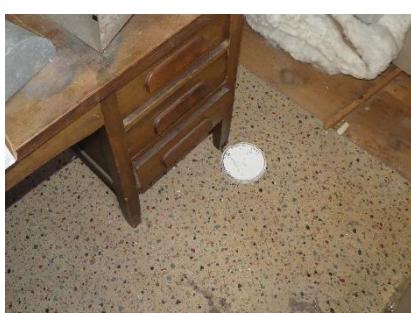
Floors are wide plank throughout. One room (chamber 206) in the northwest corner of the house was converted or use as a bathroom and has linoleum installed over the wood floor.

- 3. *We recommend the linoleum floor be removed and the wood floor beneath be restored to its original appearance.*

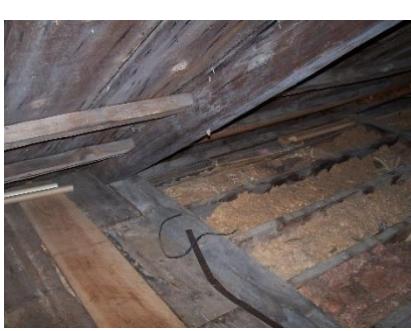
Approximately half of the attic space is floored but was likely fully floored originally as flooring was removed when the attic was insulated in the 1950s. It is believed that a stair once accessed the attic in a location that is no longer floored. The remainder of the attic is exposed floor framing.

- *It is recommended that loose insulation be removed and replaced..*

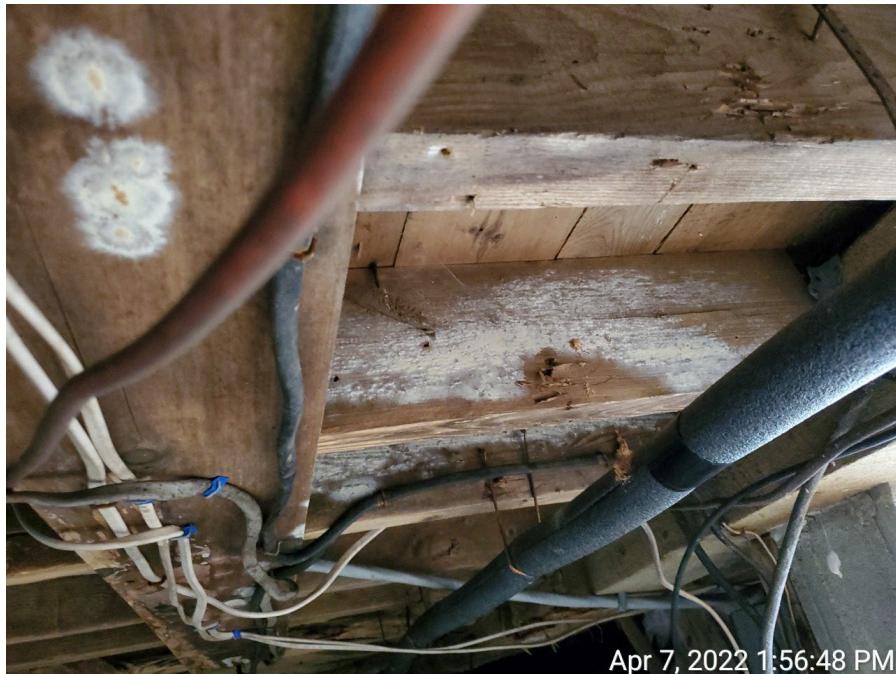
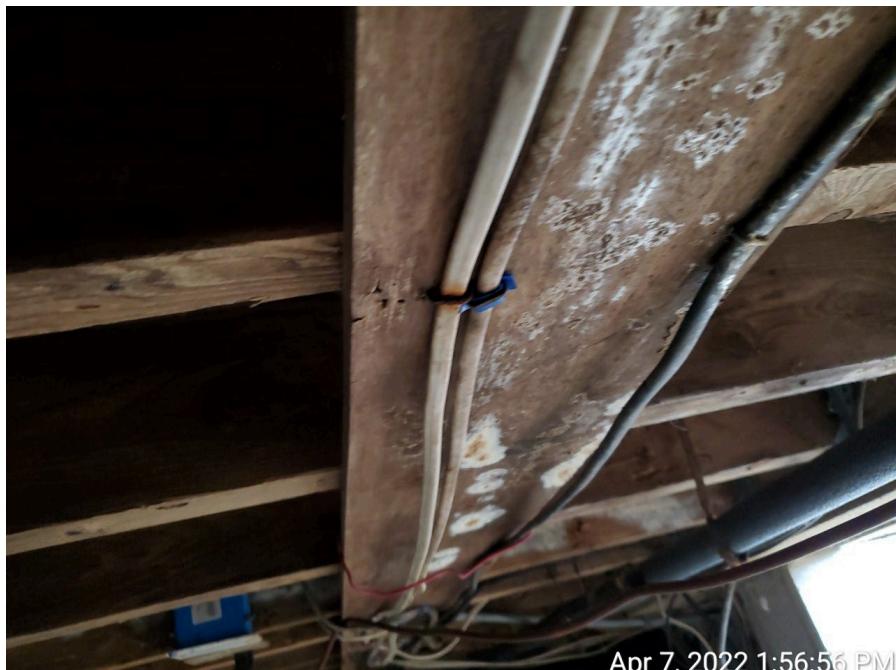
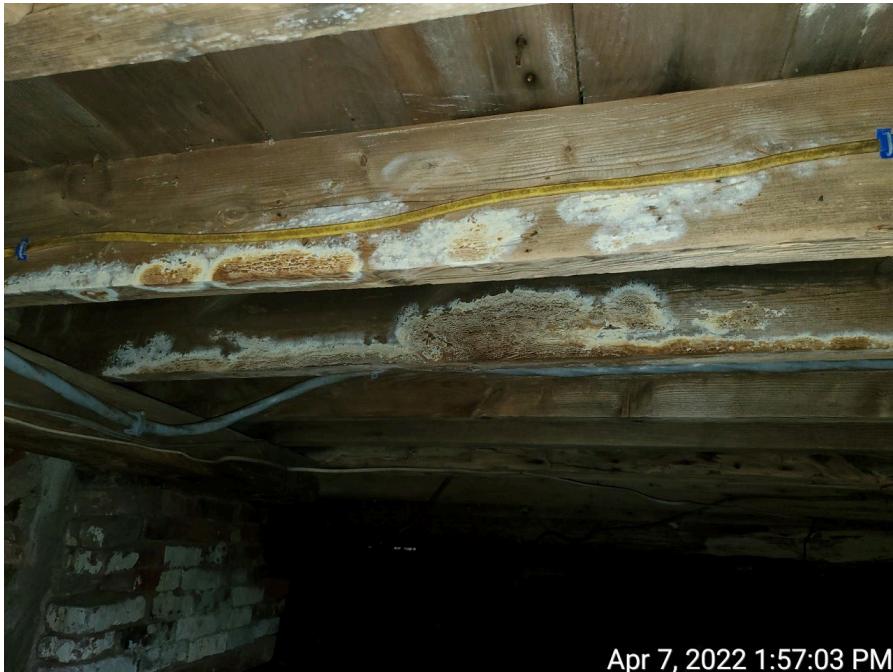
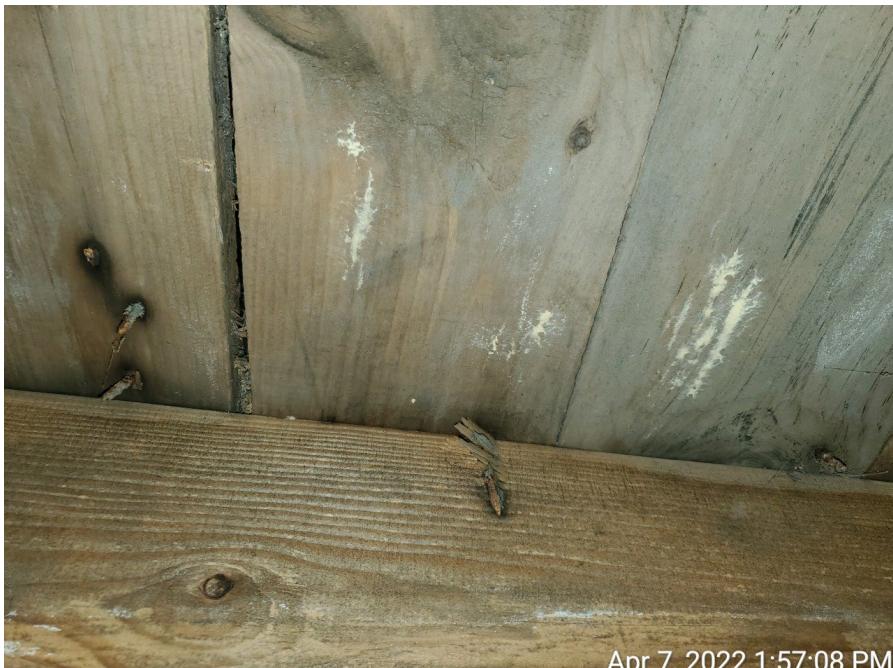
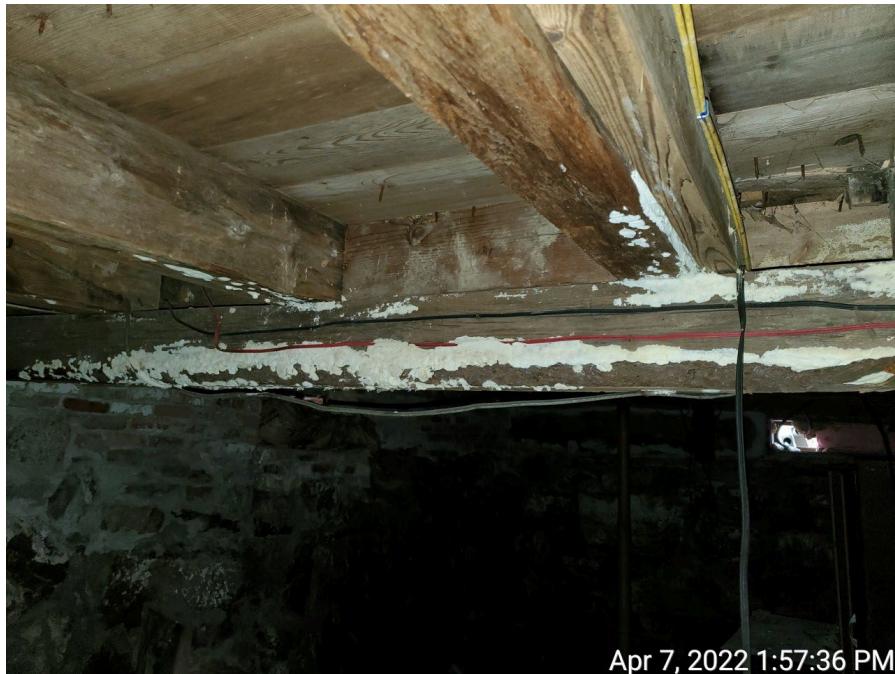
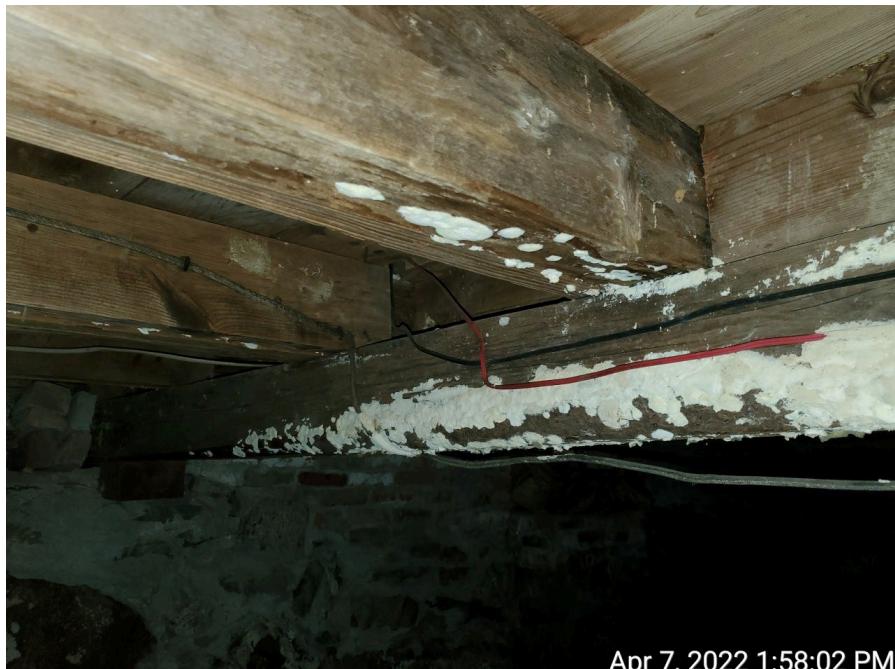
The “wet rot” fungus tends to grow on porous surfaces, so after removal and treatment of remaining wood areas, all wood materials exposed in the basement space should be treated with a penetrating sealant.

View of "wet rot" fungi for wood framing in basement area.

- 1. The earthen floor areas in the basement need to be covered either by use of seam-sealed poly sheeting or have a cement floor cover poured [complimentary to recommendation for new basement foundation – see section 3.2.B]. In addition, installation of an air-to-air exchanger and/or dehumidification system may also be required to control moisture in this space.
- 2. The “wet rot” areas for wood framing and floor joists in the basement area need to be cut-out and replaced. Adjacent non-removed wood material areas need to be treated with a wood hardener and preservative.

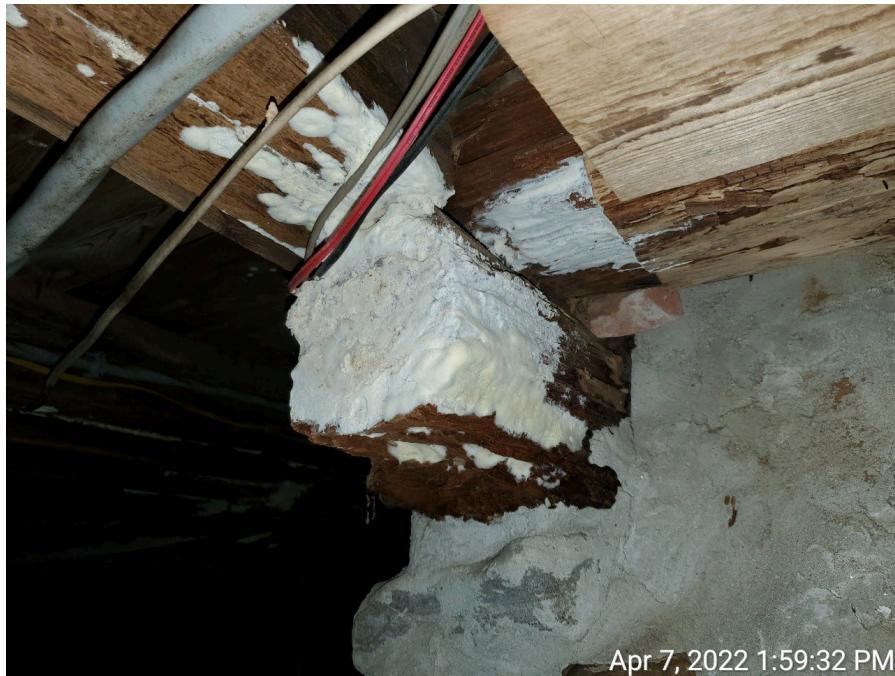
View of "wet rot" fungi for wood framing in basement area.
