# **Maine Emergency Management Agency**

## **Dam Safety After Action Review Form**

1.1 The purpose of this report is to provide an engineering assessment of the general condition of the Bucksport Mill's Water System. The following maps show an overview of the entire water intake system. This report will evaluate from Silver Lake to the Bucksport Mill. The report also includes: Design capacity, life expectancy, spare parts, and operational / maintenance budgets.

## 2.0 Silver Lake Dam

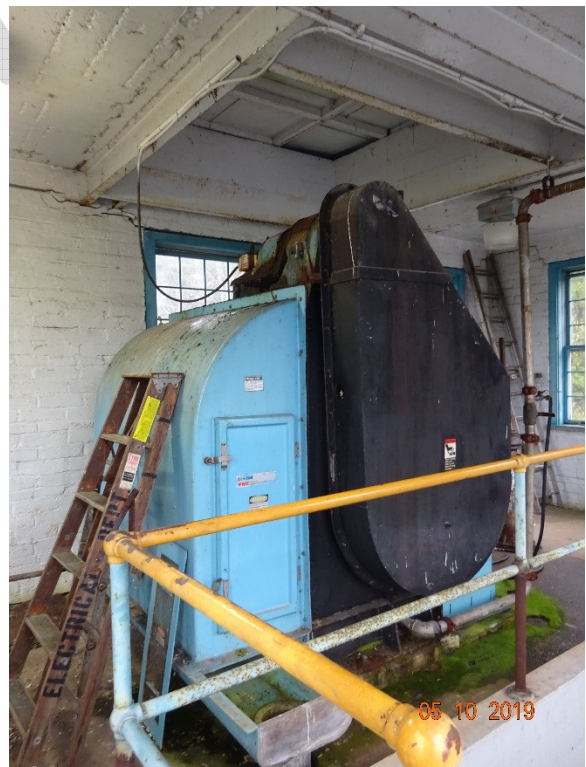
4.2 The 36" piping inlets to the Filter House traveling screen. This equipment is an automatic screen cleaner shown in the following pictures. If this screen is plugged, the water just outlets thru the surge tank.

4.3 The red valve shown above in the flow diagram is a 36" valve that is presently closed. This valve allows by pass of the remainder of the filter plant. The issue with by passing is at 5 MGD flow rate the velocity is only 1.14 ft/sec. Therefore, the sand and heavy material will settle in the bottom of the gravity piping to the Mill.

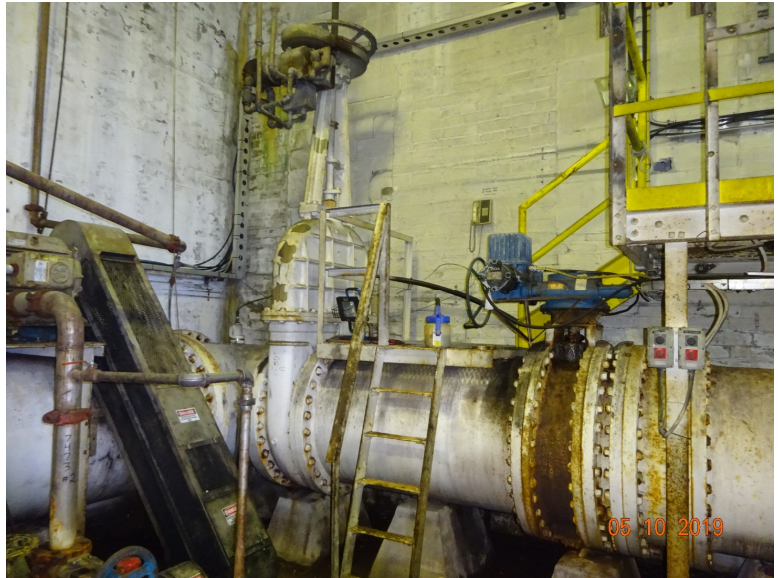
4.4 The water to the filters has two valves in series on the main line.

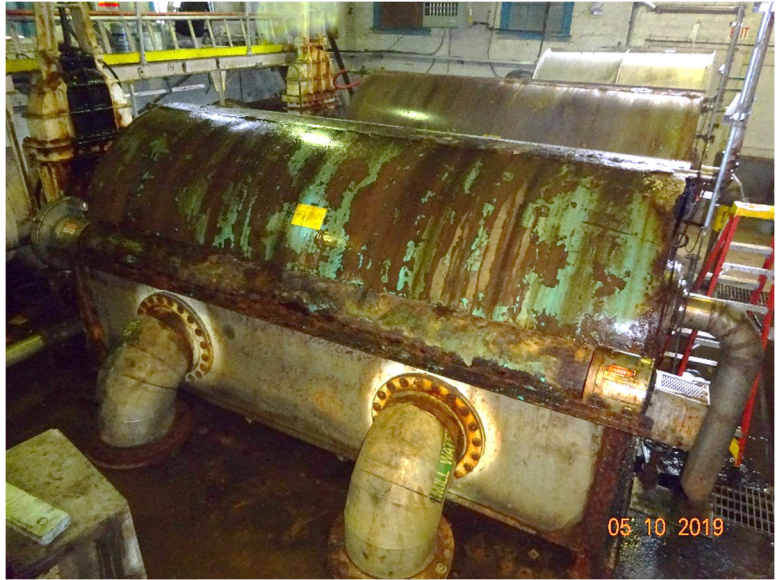
4.6 Each filter is design for 10 MGD. This picture is of the #2 filter. The inlet is on the left side. The clean water flows thru the screens on the front side. The spray water is on the top back side which pushes the debris to an internal outlet gutter. The debris and spray water drains on the right side.

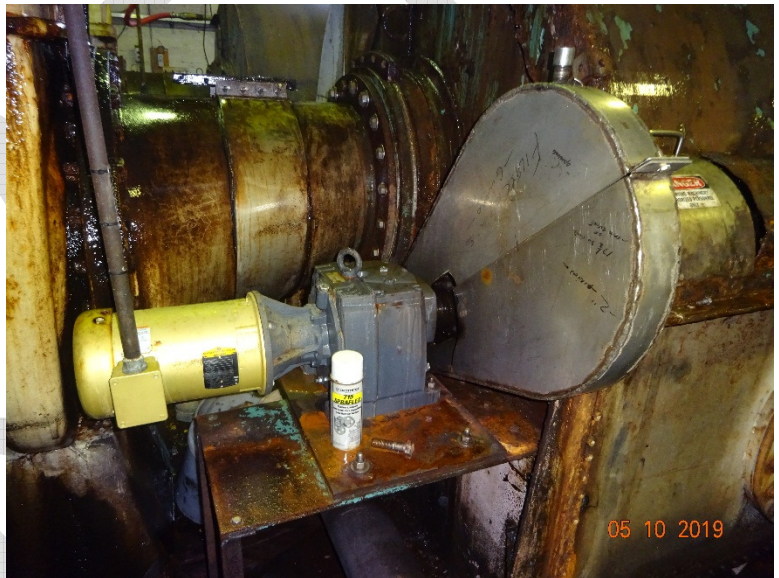
4.7 The screen slowly rotates and is powered by a 3 HP motor. The drive rotates a gearbox and a chain which drives the shaft.

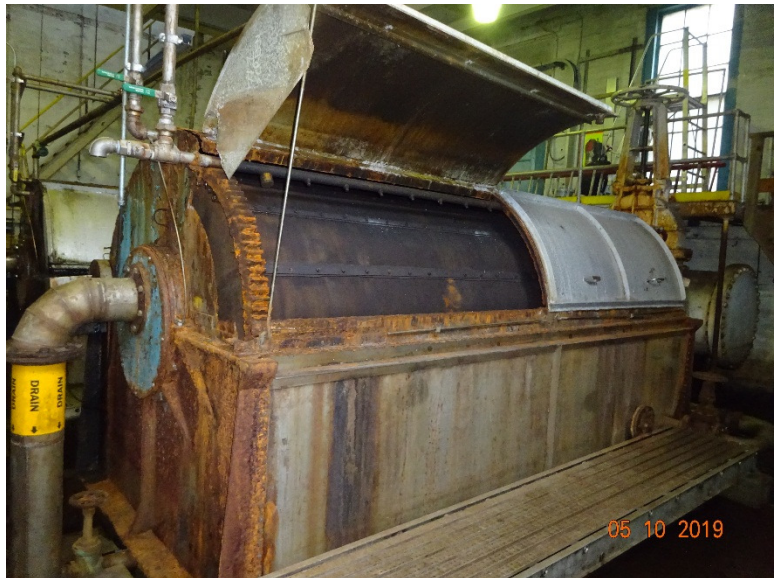
4.9 This is the #1 filter which has not run for several years.

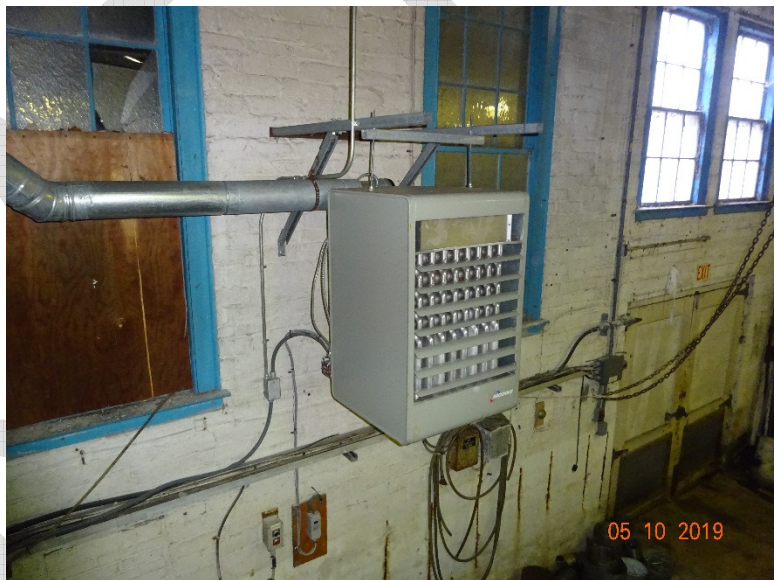
4.13 The building is heated by a propane heater. It was not running during our evaluation.

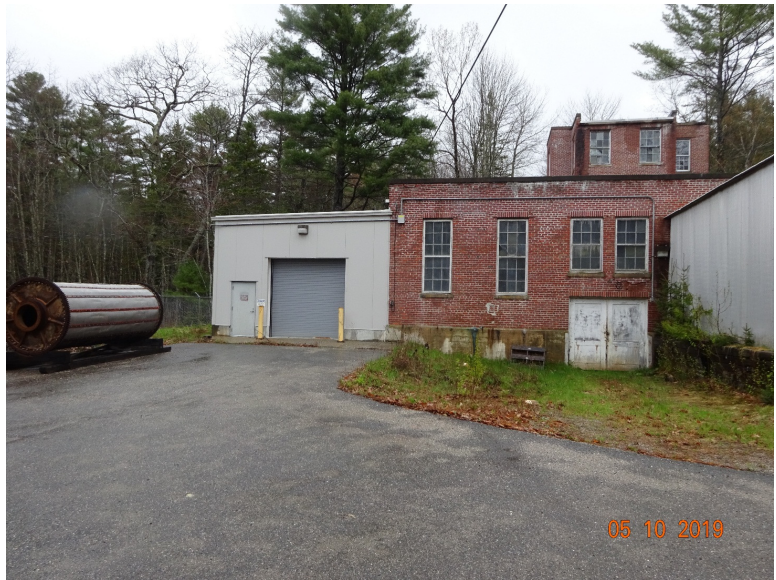
4.15 The addition on the left was built in 2006 for the chemical treatment of the water. This build is in good condition.

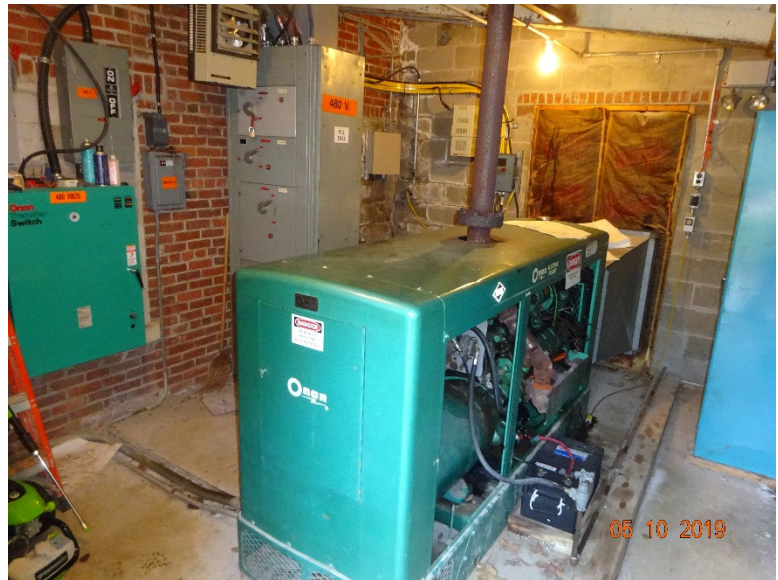
4.18 The filter house has a backup generator. It is propane powered. We did not see this equipment running.

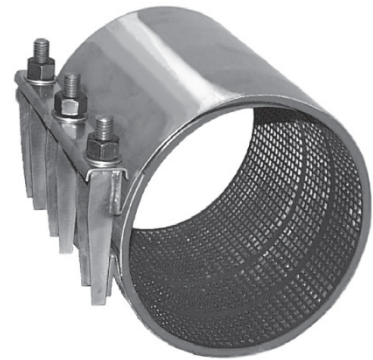
5.3 As for the 2,000 feet of carbon steel 36" diameter piping from Silver Lake and the 3,400 feet of carbon steel 36" diameter pipe to the Mill, you should expect a leak about every other year. These repairs are typical done with a stainless steel pipe repair clamp (see photo). If the leak is a small hole, this type of repair allows you to do the repair on the run. This type of underground water system are very common for Mills in the State of Maine.

I personally know of raw water intake systems still in use that are over 100 years old. The Bucksport piping system is 89 years old. The expected life is that least 10 years.

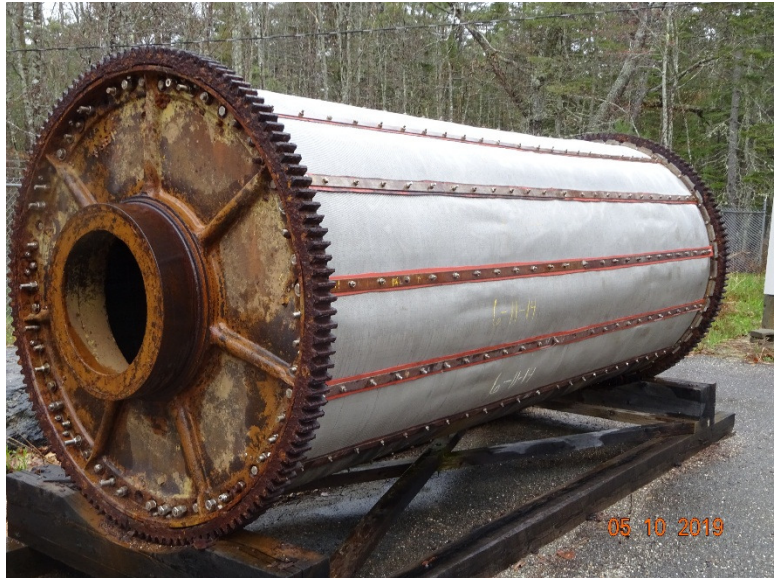
6.1 The filter has one spare screen drum that is stored outside. The screens are new on this filter.

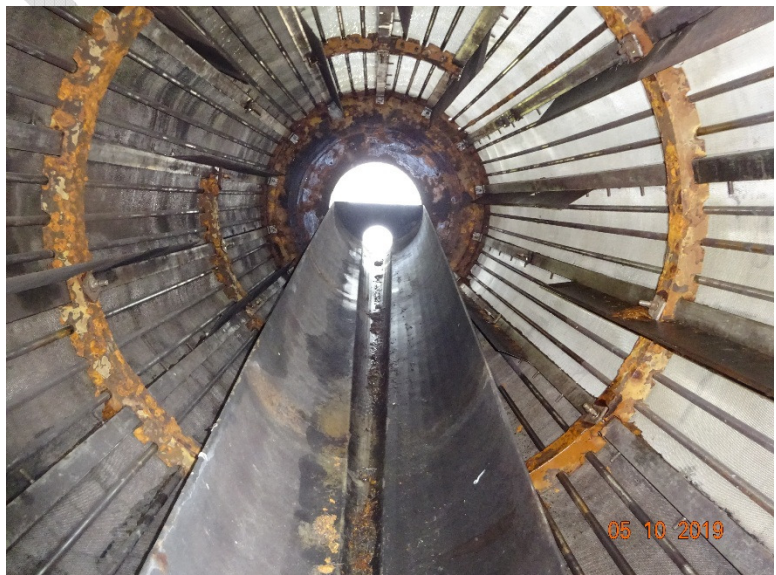
6.4 Since the pipeline can have routine leaks, I would recommend that least one 36" SS repair clamp be on site. Presently none are on site.

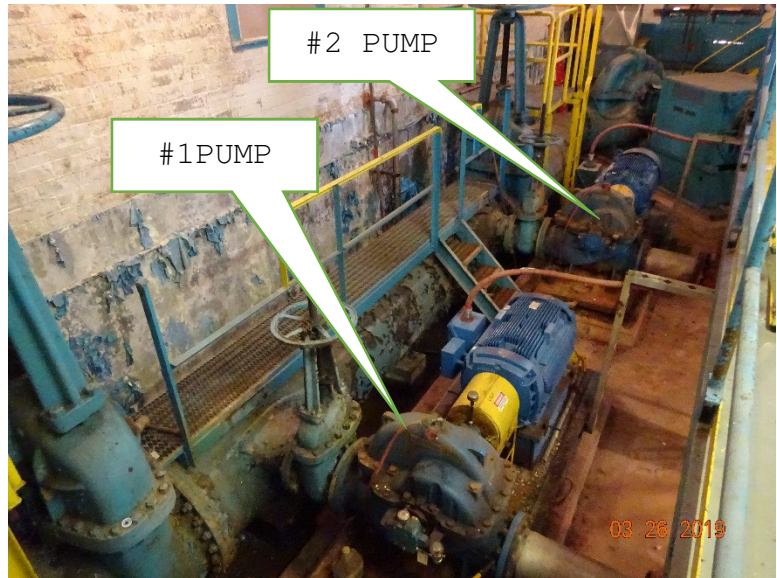
2.1 The following picture shows the 3 pumps in the pump house. The #3 pump is not usable. The #1 & #2 pumps are operational.

2.3 The equipment file shows that pumps #1 & #2 are Goulds 3410 Size 10x12x17L with a 14.5" bronze impellor. The pumps are a premium brand which was installed in mid-2001.

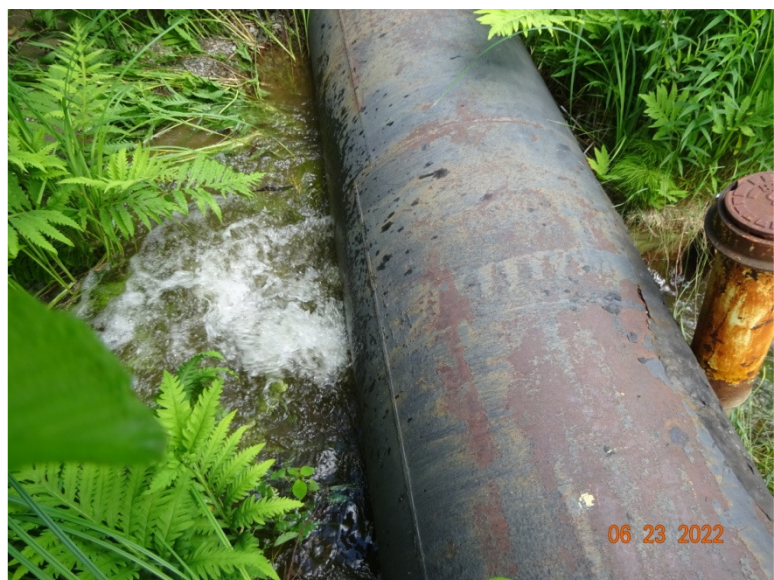
3.2 During the pump tests, a leak was found in the pipe that go worse as time went on. The pipe was repaired and we reinspected the piping.

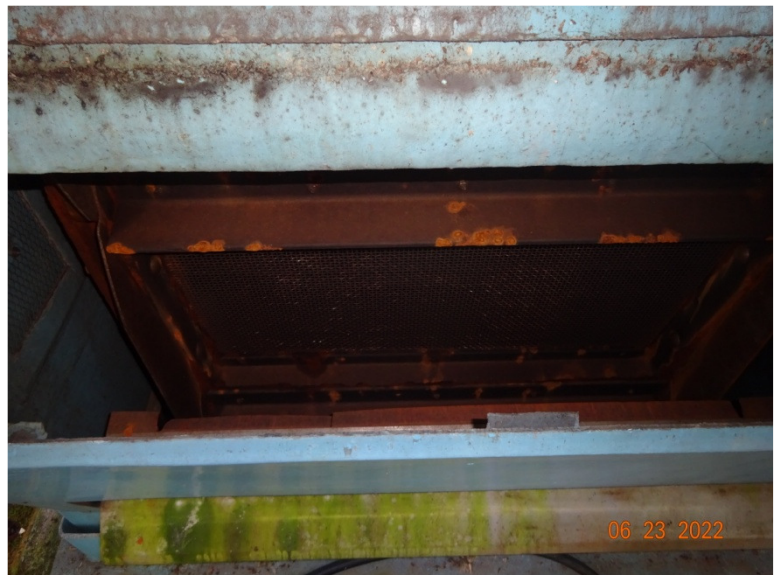
4.2 The 36" piping inlets to the Filter House traveling screen. This equipment is an automatic screen cleaner shown in the following pictures. If this screen is plugged, the water just outlets thru the surge tank.

4.3 The red valve shown above in the flow diagram is a 36" valve that is presently closed. This valve allows by pass of the remainder of the filter plant. The issue with by passing is at 5 MGD flow rate the velocity is only 1.14 ft/sec. Therefore, the sand and heavy material will settle in the bottom of the gravity piping to the Mill.

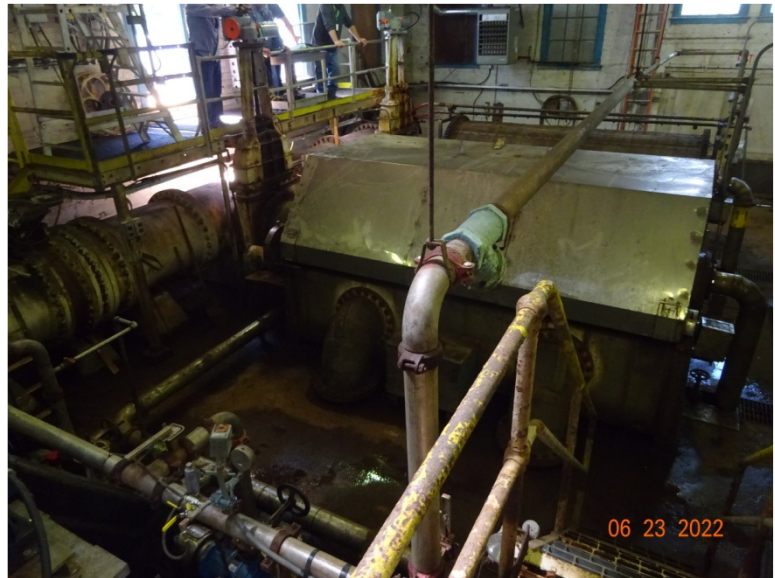
4.4 Each filter is design for 10 MGD. This picture is of the #2 filter. The inlet is on the left side. The clean water flows thru the screens on the front side. The spray water is on the top back side which pushes the debris to an internal outlet gutter. The debris and spray water drains on the right side.

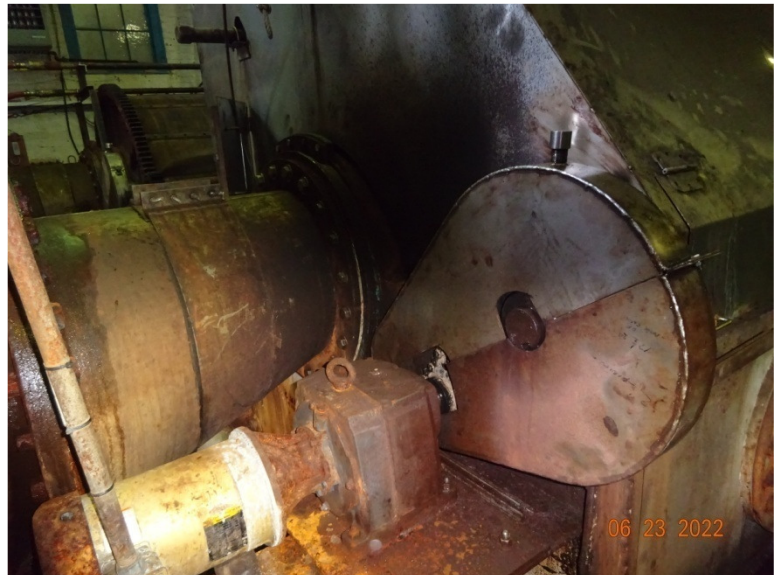
4.5 The screen slowly rotates and is powered by a 3 HP motor. The drive rotates a gearbox and a chain which drives the shaft.

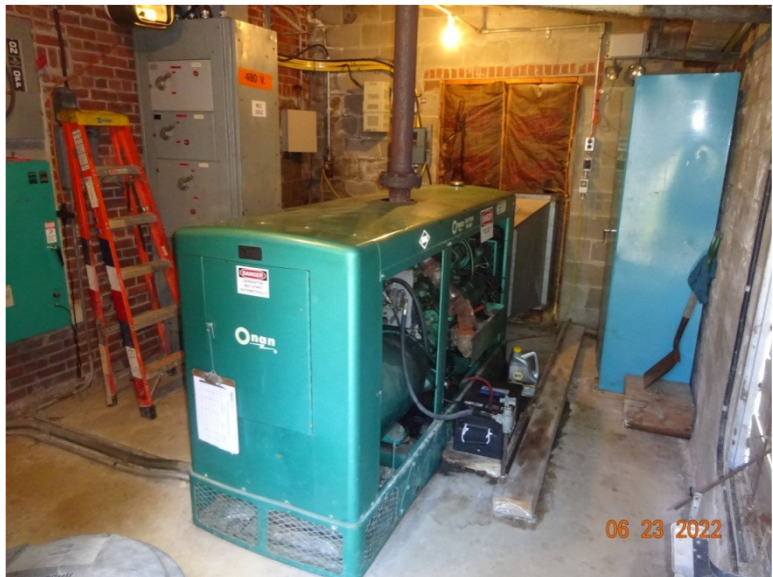
4.13 The filter house has a backup generator. It is propane powered. We did not see this equipment running.

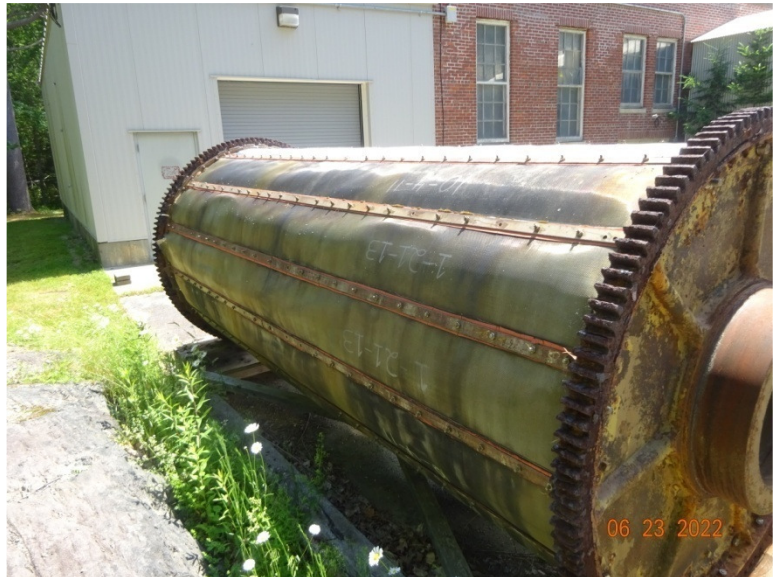
6.1 The filter has one spare screen drum that is stored outside. The screens are new on this filter.
