SUBJECT: Dam Inspection Report for MEMA #110 – Alamoosook Lake Dam

#110 Alamoosook Lake Dam
Town of Orland, Hancock County, ME

Hazard & Condition Report
Date of Inspection – 10/12/2021

RE: Condition Assessment of #110 Alamoosook Lake Dam, Town of Orland, Hancock County, ME

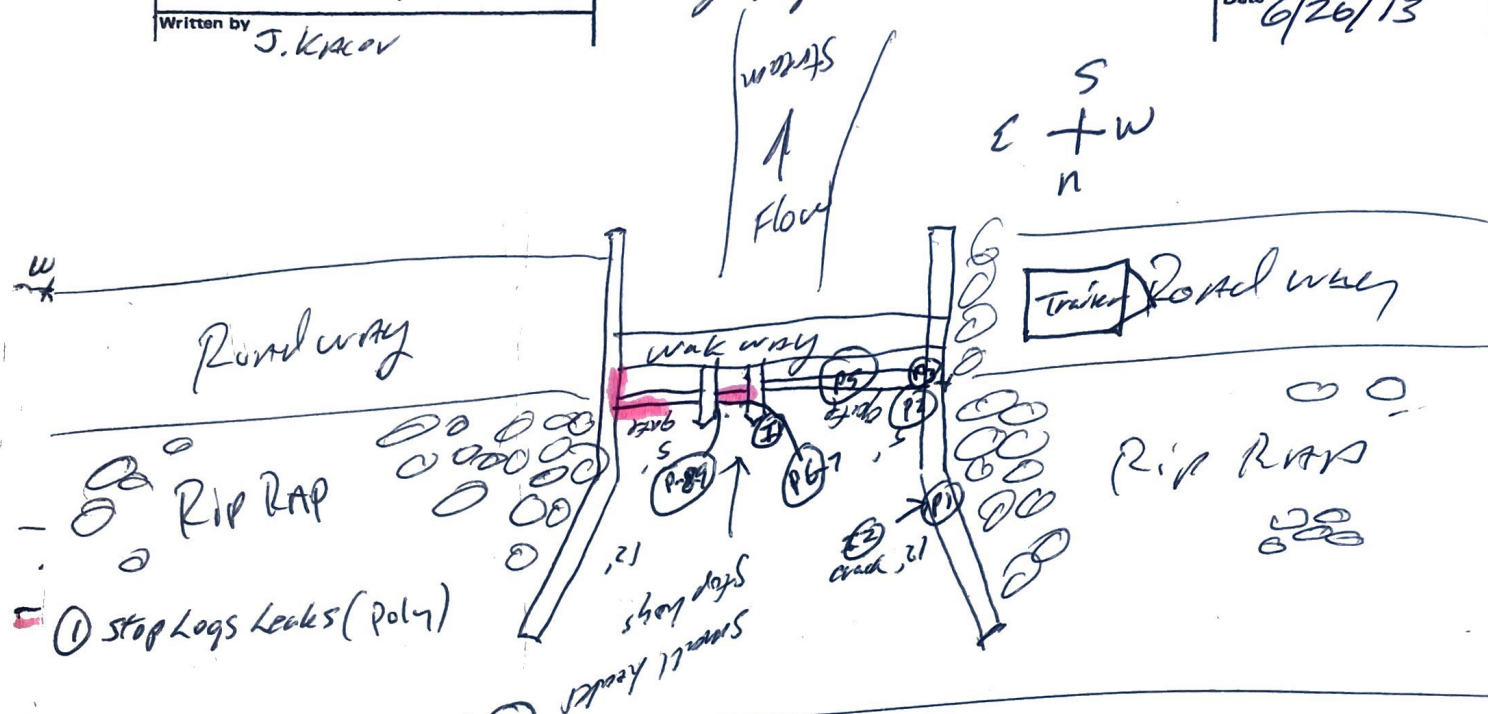
- Camera #1
- Picture 1 Crack west side (I2)
- 2 SO. wall corner
- 3 Corner west concrete
- 4 corner west concrete
- 5 Gate weld west
- P- 6 stop logs / Rust west
- 7 stop logs west
- P- 8 stop logs east
- P- 9 stop logs west
- P- 10 East Gate welds

Notes: Bottom of gate worn
Crack @ water (spill way)

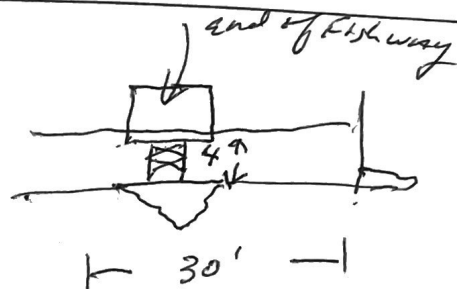
* *Alamoosoc Dam To Do:*

- ① Fishway Rip-Rap + Grout Bags
Cavity under screen Building Undermine

- ② cracks upstream Holes in concrete

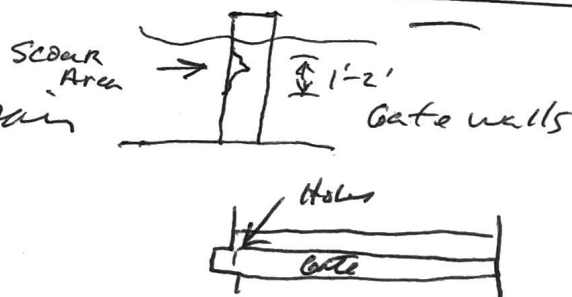
* *Silver Lake Dam: To Do*

- ① Gate walls need concrete Repair
- ② Split in Pier of concrete
- ③ Holes in corner large gate
