SUBJECT: Dam Inspection Report for MEMA #105 Silver Lake Dam

#105 Silver Lake Dam
Town of Buckport, Hancock County, ME

Hazard & Condition Report
Date of Inspection – 10/12/2021

#105 Silver Lake Dam – Hazard & Condition Inspection Report

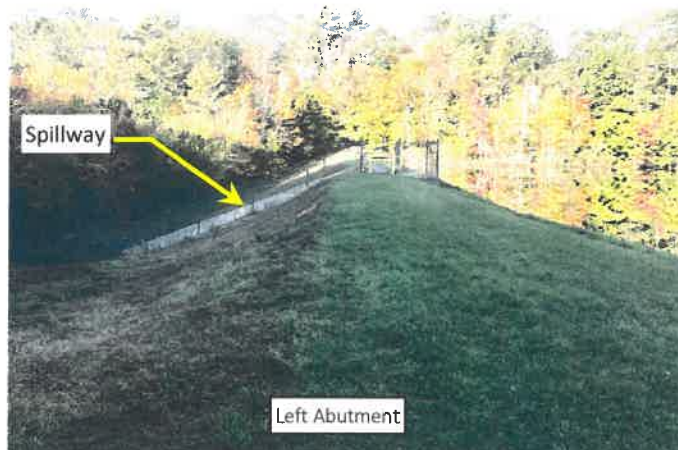
1. Left abutment from top of dam (TOD). Brush recently cut, bank well grassed. Some settlement along TOD. Downstream slope has significant settlement in place.

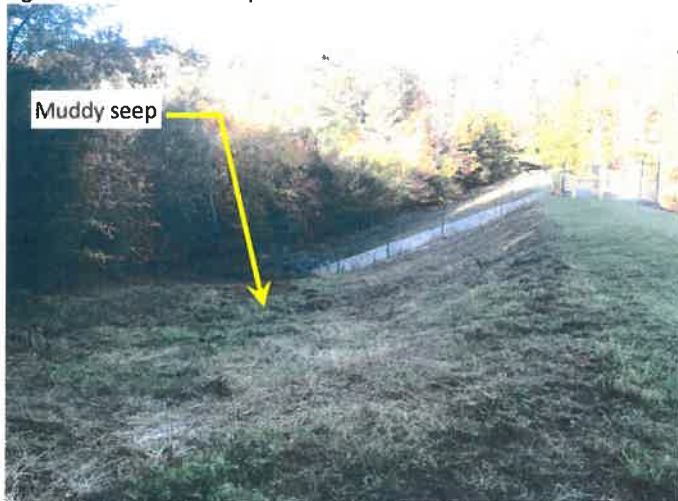
3. Left embankment downstream recently cleared of brush. Both the inclined & level surfaces show unevenness indicating embankment or local slippage.

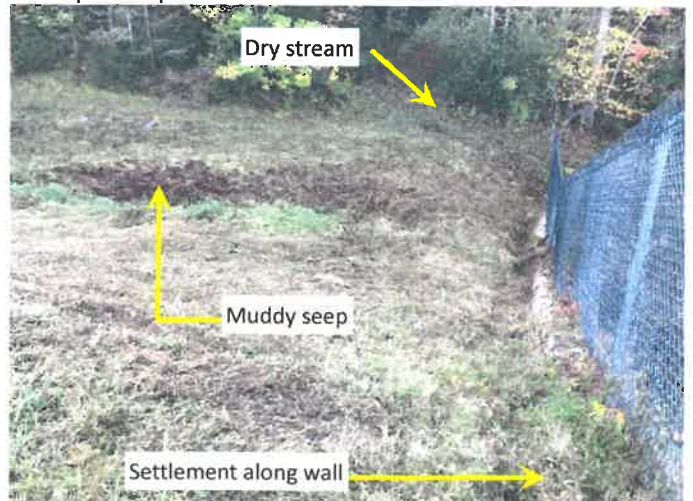
4. Left embankment looking downstream. The brown area is a muddy seep which must be inspected after spring runoff & around labor day & monitored for flow & reservoir stage.

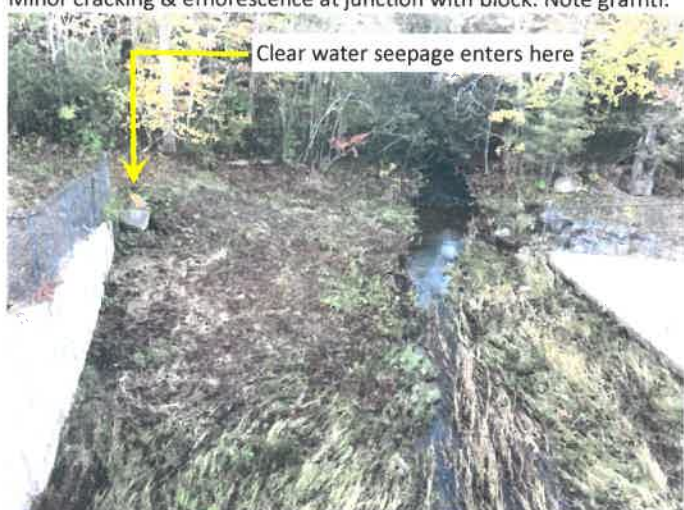
A11, A12, shows the results of a recent storm which caused the dam's spillway to flow. Significantly the channel has silted, see D6 supporting thick vegetation. D6 also shows the components of the channel bed covered by silt. On the day of the inspection, Silver Lake was at NP elevation.

11. Spillway downstream channel between left & right wingwalls silted. Note flattened grass from recent storm.

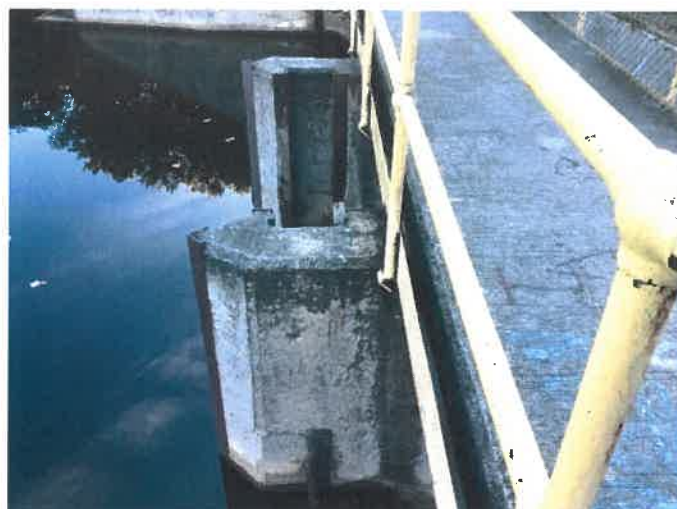
14. Stoplog gate guides.

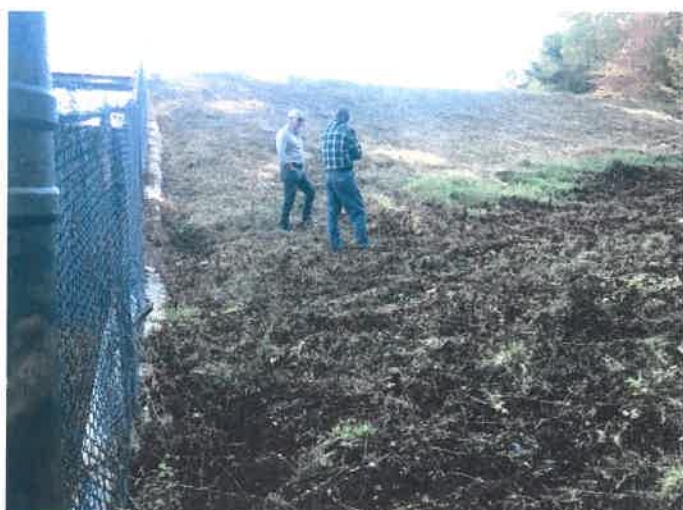
17. Left embankment/wing-wall abutment. Swamp from seepage in the area where the brush has been cut.

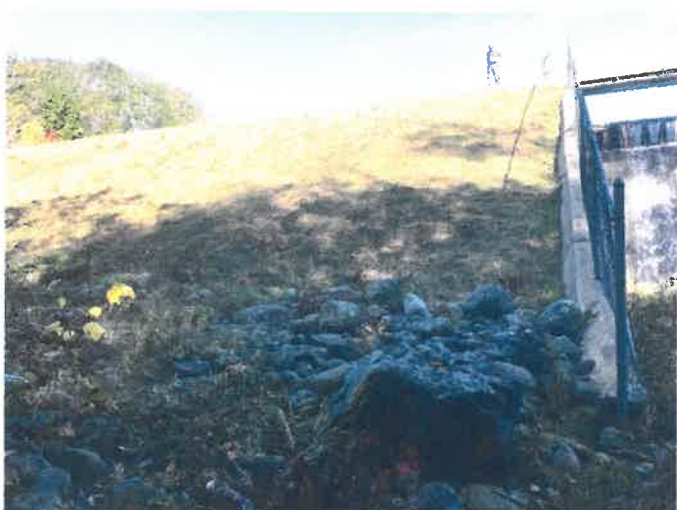
18. Right embankment/wing-wall abutment. Note either settlement or erosion along wall

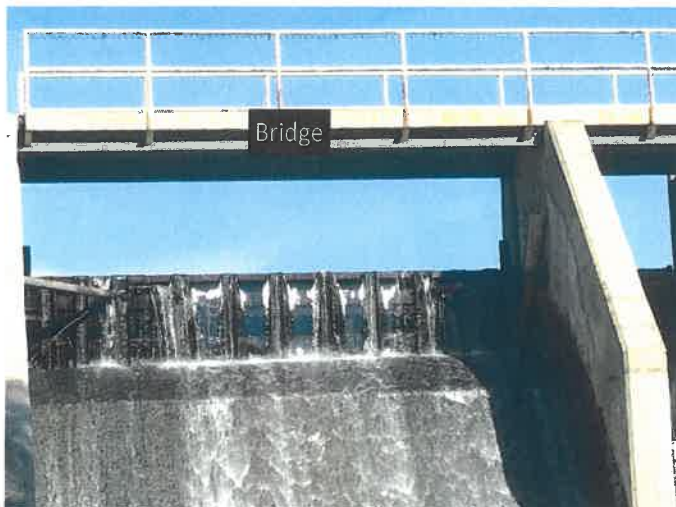
19. Right Spillway. The reason for overflow is that the top of the bulkhead is lower than the left bulkhead.

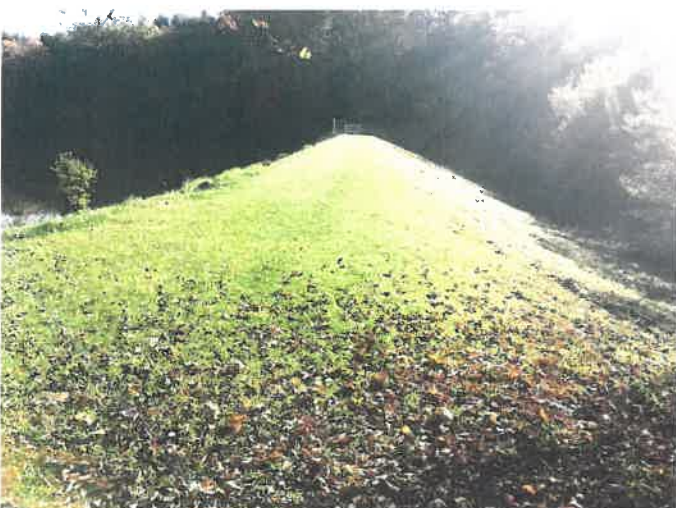
23. Top of Right embankment & downstream face — mostly covered by grass. Downstream face of dam uneven due to local settlement and/or small slips.

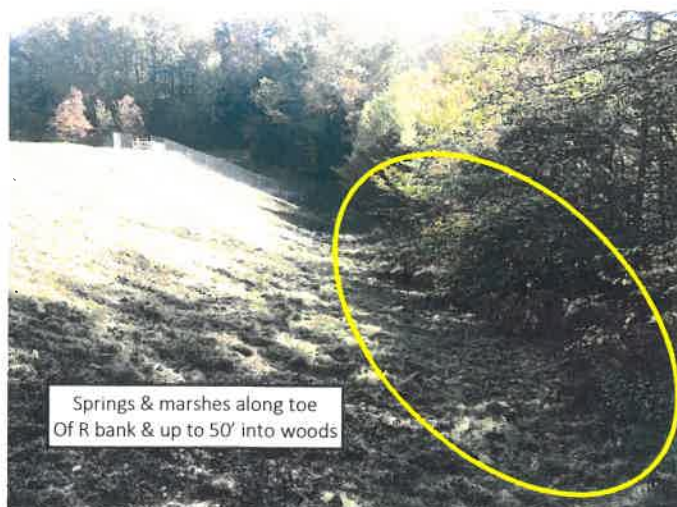
26. View down right embankment toe. Yellow ellipse is area where at least 6 separate marshes have formed. No seepage carried silt or was discoloured.

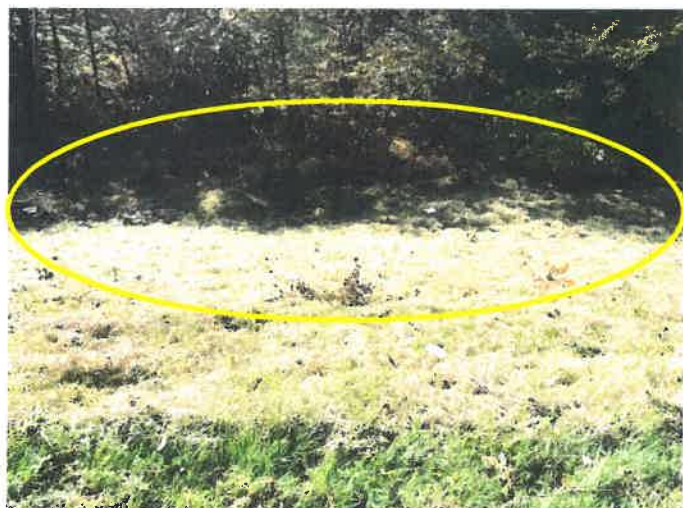
27. View down embankment toward seepage. A28 is in the middle of the photo.

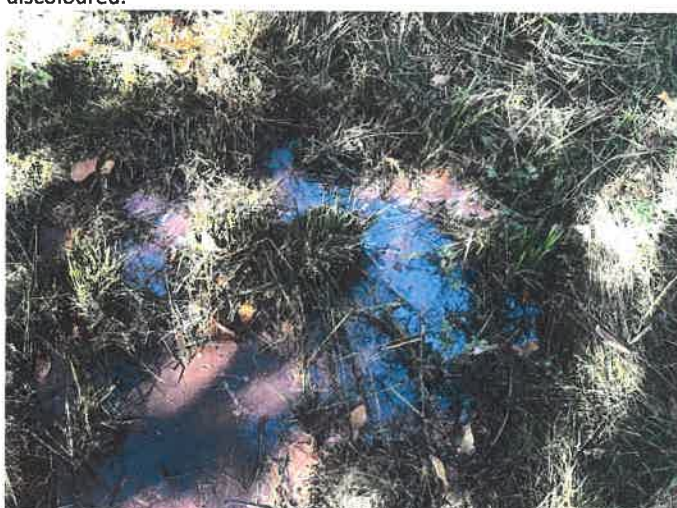
28. Typical low flow marsh showing seepage. This spot is located about 150 feet from the left spillway wall.

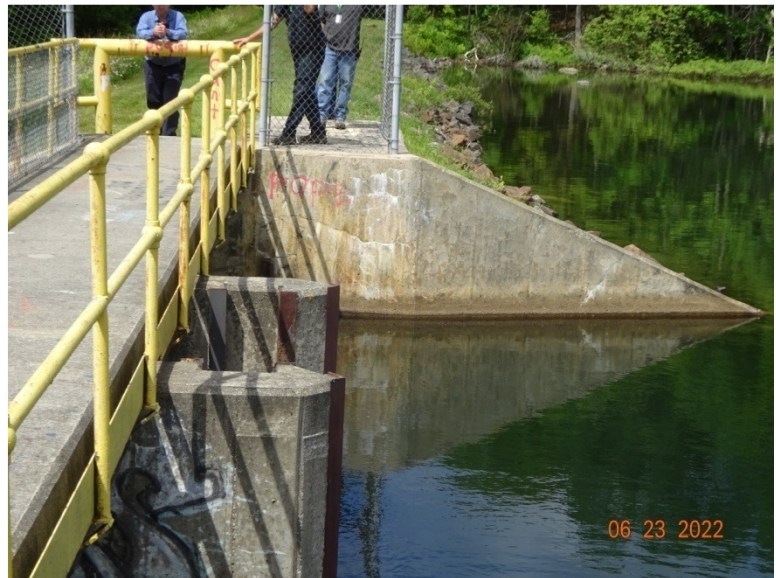
2.3 The concrete wing walls show water leaks thru the concrete cracks. To protect the rebar in the concrete, these cracks should be pressure injected if water leakage occurs.

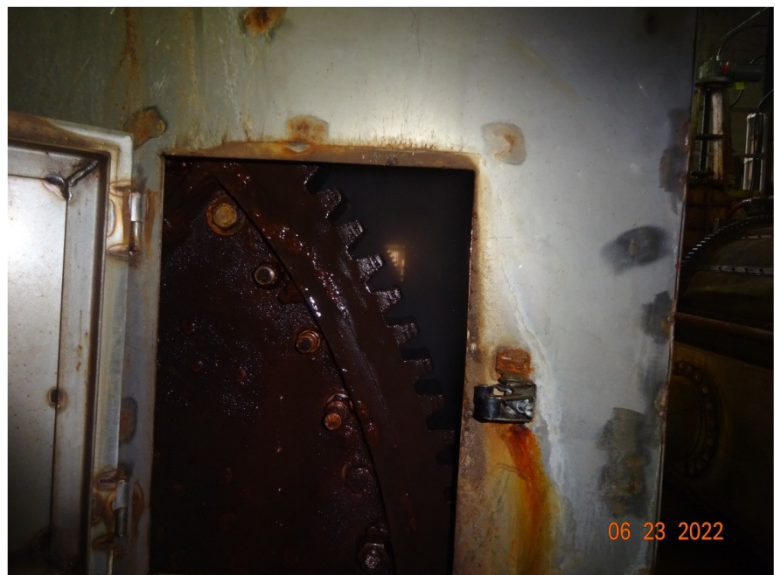
4.9 This is the #1 filter which has not run for several years.

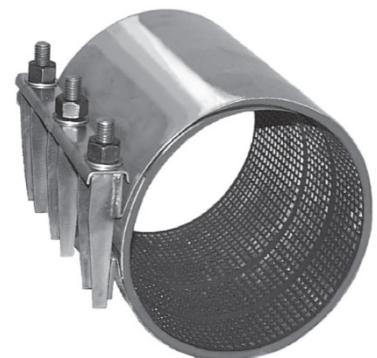
5.3 As for the 2,000 feet of carbon steel 36" diameter piping from Silver Lake and the 3,400 feet of carbon steel

36" diameter pipe to the Mill, you should expect a leak about every other year. These repairs are typical done with a stainless steel pipe repair clamp (see photo). If the leak is a small hole, this type of repair allows you to do the repair on the run. This type of underground water system are very common for Mills in the State of Maine. I personally know of raw water intake systems still in use that are over 100 years old that are still in service. The Bucksport piping system is 92 years old and no immediate issues are present.

6.4 Since the pipeline can have routine leaks, I would recommend that at least one 36" SS repair clamp be on site. Presently none are on site.

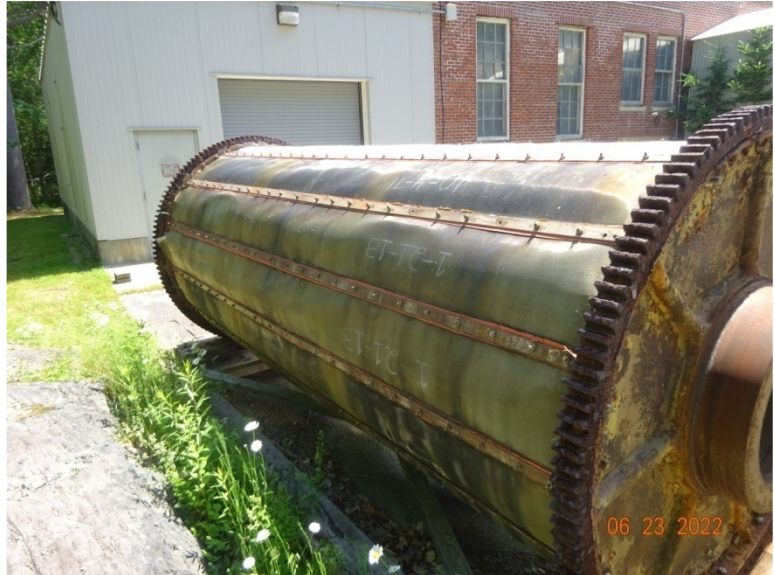
6.1 The filter has one spare screen drum that is stored outside. The screens are new on this filter.

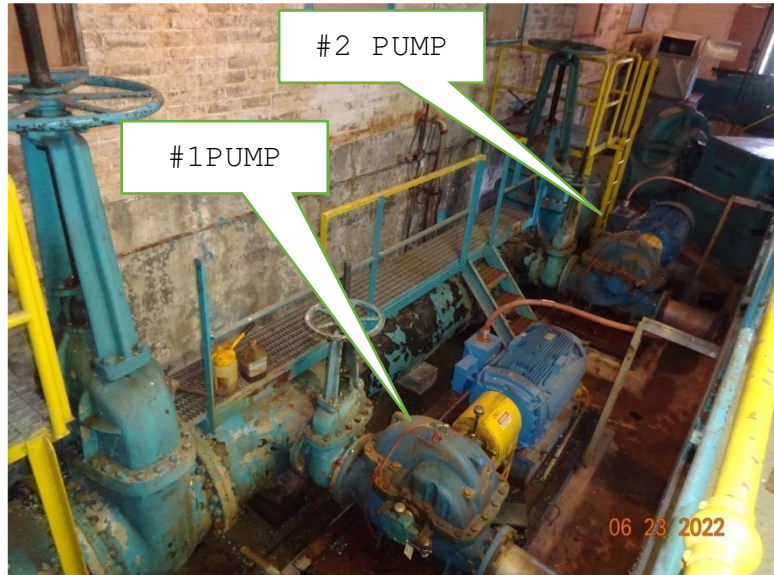
2.4 Per the original pump curve (see atch 2), one pump could pump 4,200 gpm. Using the amp meters on the MCC, we back calculated that one existing pump is pumping around 4,300 gpm or 6.2 MGD. By using both pump #1 & #2, the flow rate will be around 8,400 gpm or 12.1 MGD. The flow rate is nearly double due to most of the head is caused by the static head component.

2.5 We did witness both pumps running. They ran with no excessive vibration and typical packing leakage.

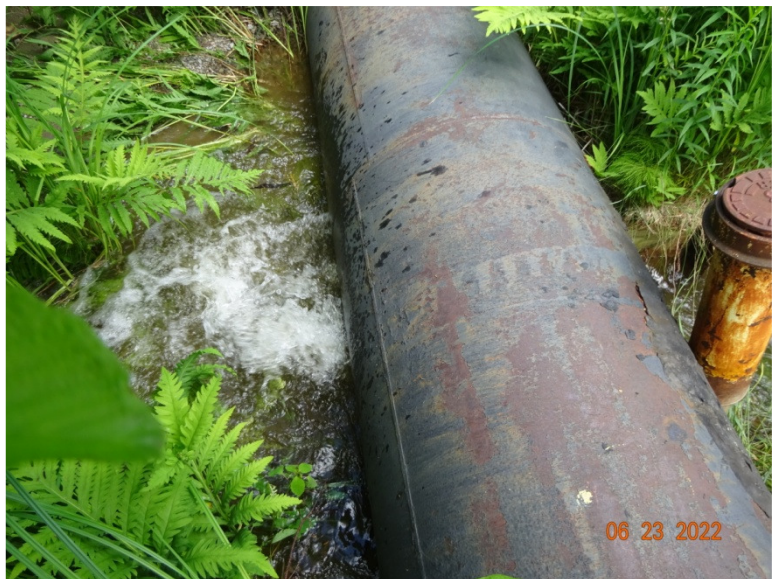
3.3 This next picture shows outlet which flows to Silver Lake after the leak was fixed. We measured the wall thickness of this pipe to be:

- At 12:00 0.480 Inches
- At 3:00 0.448 Inches
- At 6:00 0.269 Inches
- At 9:00 0.469 Inches

3.4 The original pipe thickness is 0.5". Therefore the pipe has lost 47 % due to corrosion. Most of the leaks are occurring that the welds which is typical and will continue. The pipe is pitted on the bottom half.

3.5 The concrete under the end of the pipe is undermining and will eventually need a repair.

8.3 Another capital job will be repair the concrete outfall of the piping system. The budget price for this project is \$45,000. This is expected within 5 years.

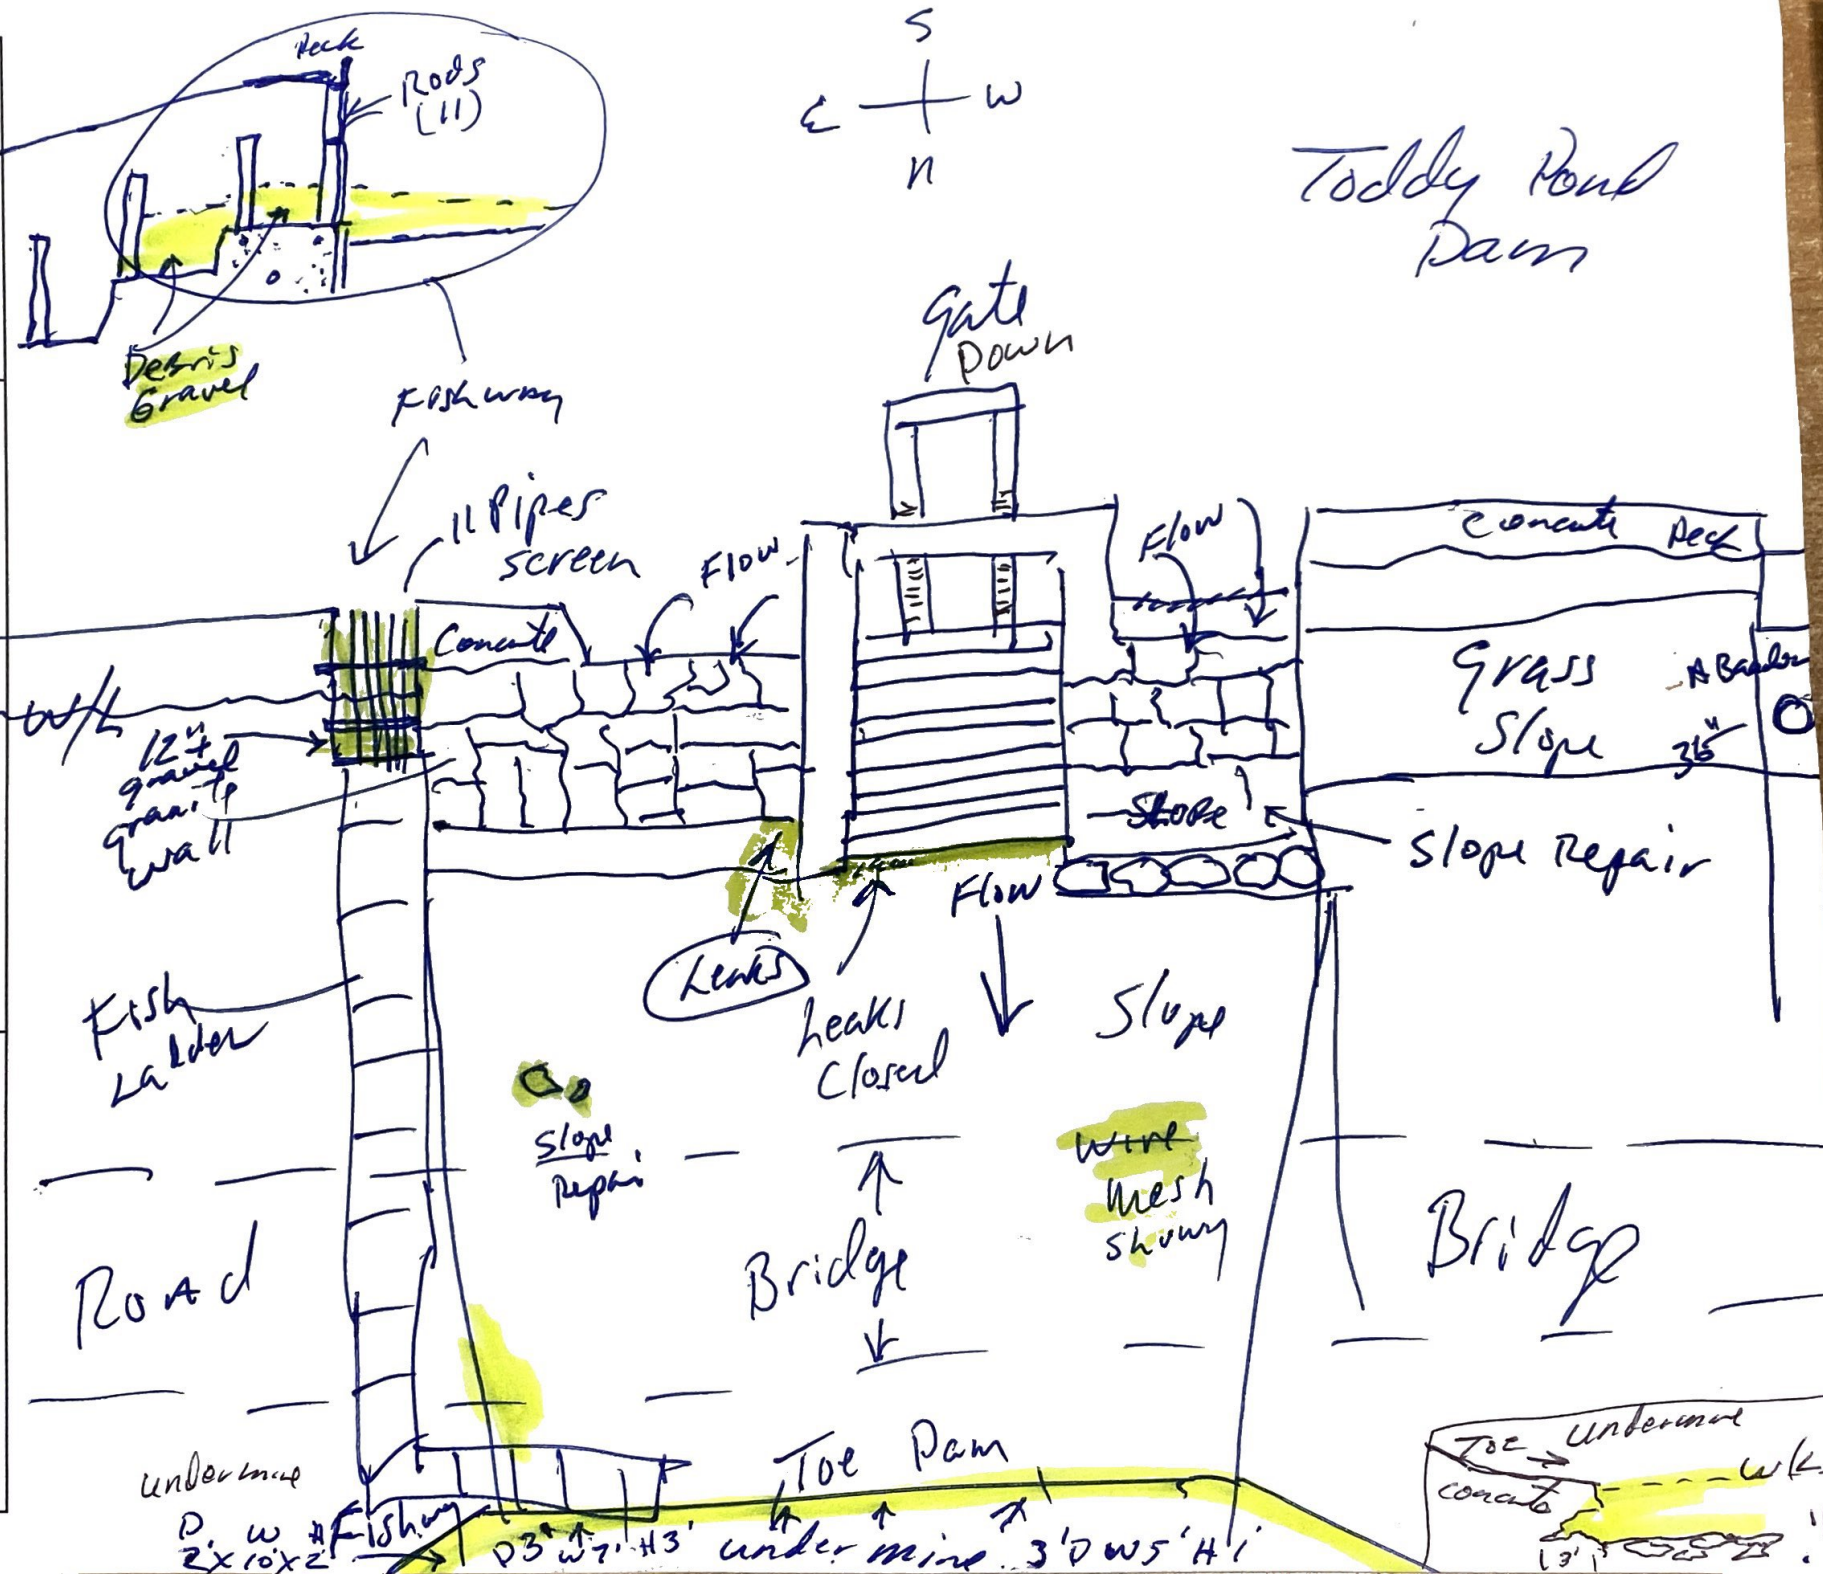
View looking DS

8 ft of water
