RE: RFP#202008127 Grant Application for Thomaston, Maine Stream Crossing Replacement

Beechwood Street Culvert Replacement Project

Attachment 1
Town of Thomaston
Application for 2020 Stream Crossing Public Infrastructure Grant

TOWN OF THOMASTON, MAINE
 BEECHWOOD STREET
 CULVERT REPLACEMENT PROJECT

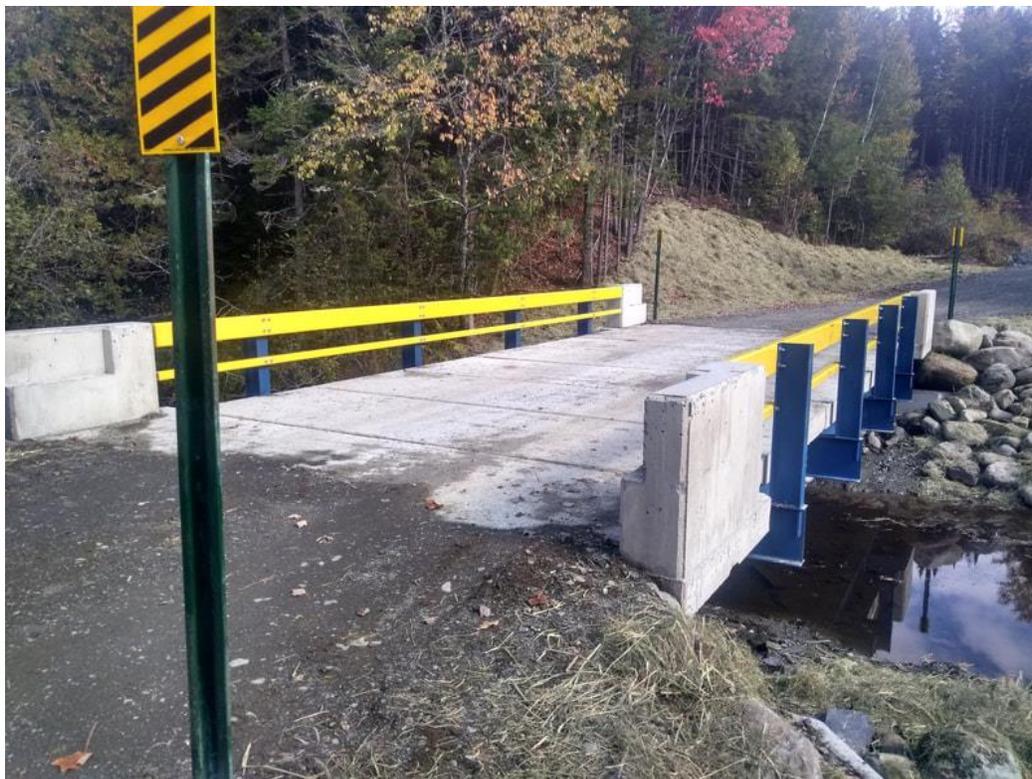
Figure 5 The proposed bridge would be similar to this

The structure recommended for this location is a clear span modular steel bridge as shown in Figure 5.

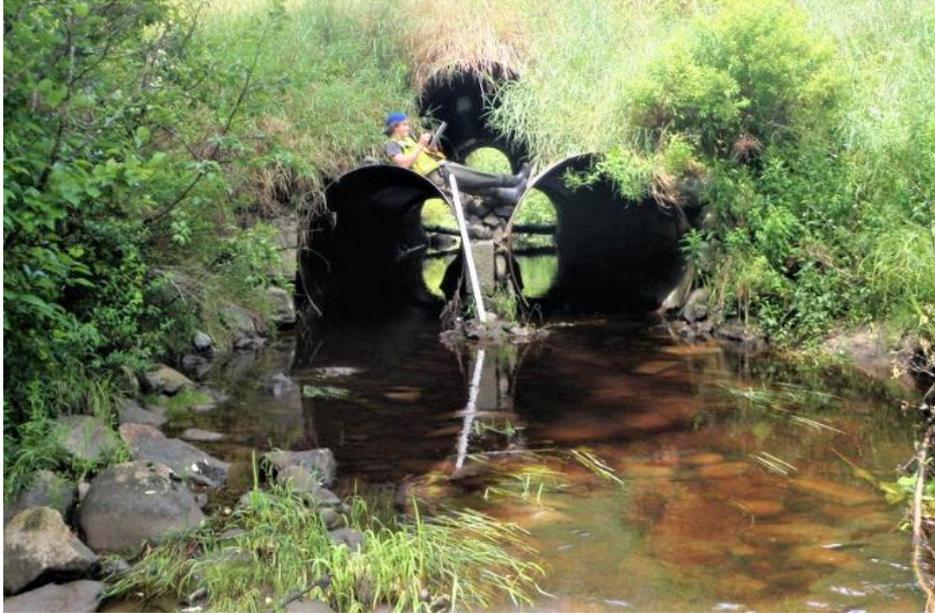
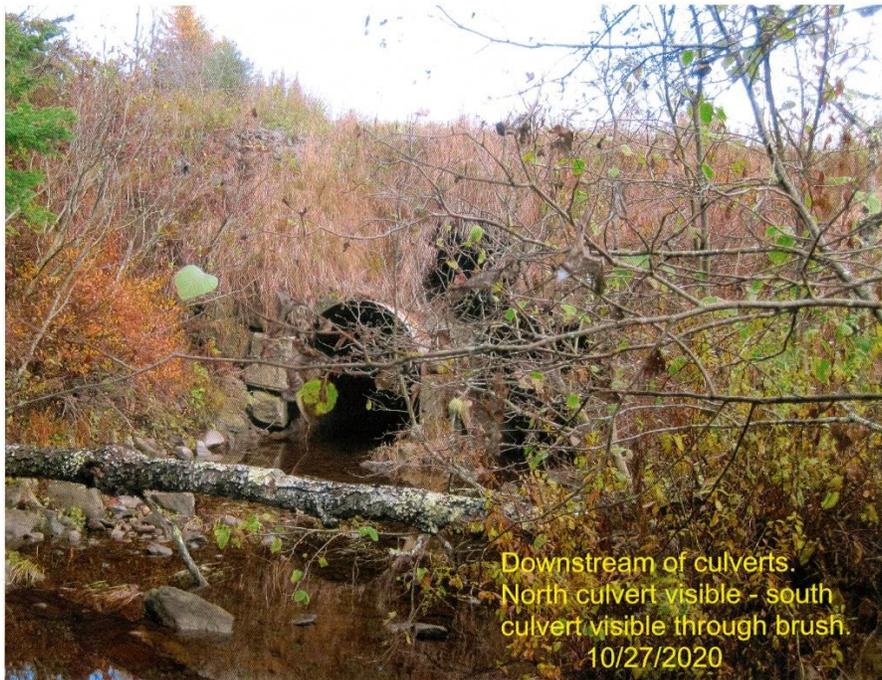
DOWNSTREAM CULVERT VIEW

8. Describe any issues with the current condition of the crossing						Much of the bottom and some of the sides of the culverts have corroded away, allowing material to wash into the culverts and creating voids around the culverts. This has created sinkholes and will ultimately result in collapse of the roadway.

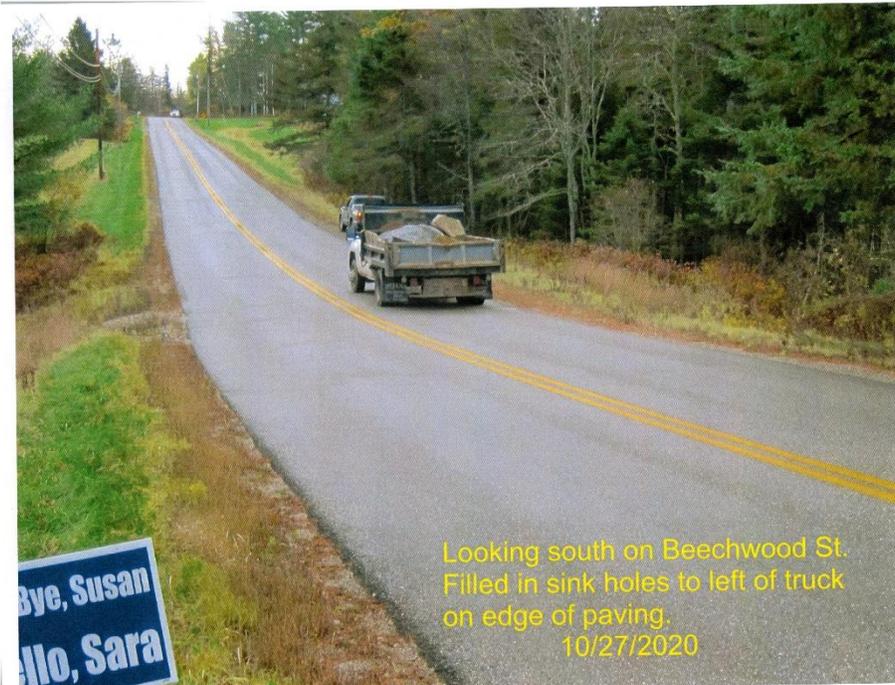
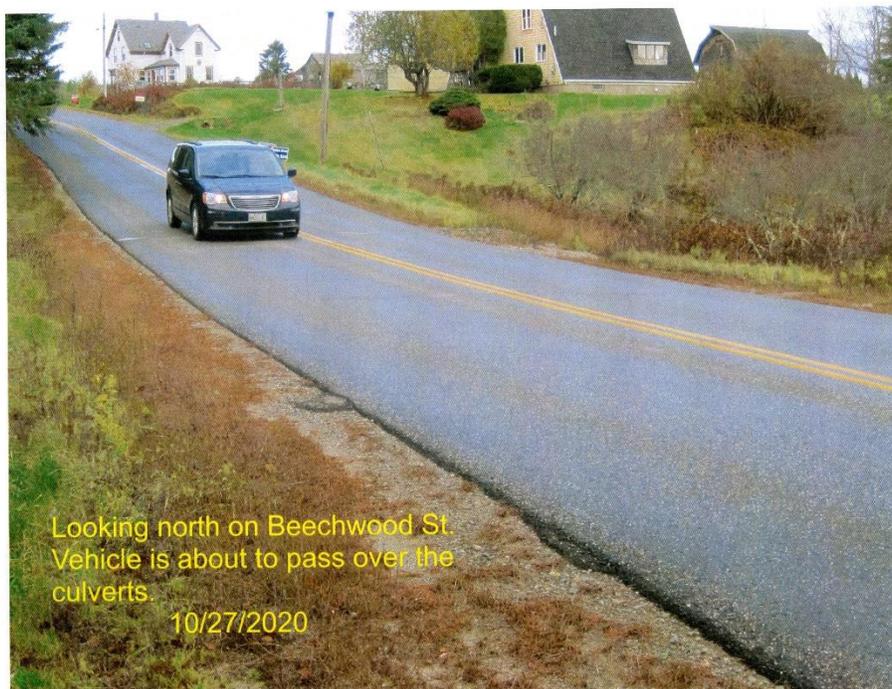
ROAD OVER CULVERTS

15. Using the space below, discuss any other safety concerns about the existing culvert/crossing.						The existing culverts are decayed nearly to the point of failure, which could lead to road washout and a hazard to traffic. Side slopes warrant guard rails.
