## UNDERWATER INSPECTION REPORT

TOWN(S) ABBOTBR. NAME PAGE - CARR193 5 7 2 5

VISIBILITY 10' FT686   8 Repair scourCURRENT moderateINSP. SIGN Carl EdwardsSTREAMBED DESC. Sandy gravel, head sized stones - boulders  
COMMENTS/PROBLEMS/HAZARDS Heavy riprap @ piers.INSPECTION REPORT 3 span continuous steel bridge on conc. spread footings. Large scour basin (22' DEEP) remains downstream in center of channel. No change in footing exposure on Pier #1 compared to previous reports. Large sand bar off downstream end of Pier #2NO MAJOR CHANGES OTHER THAN DEBRIS PILE FOUND @ HEAD OF SCOUR BASIN. 24.0 H2O SURFACE TO BRIDGE CURB.

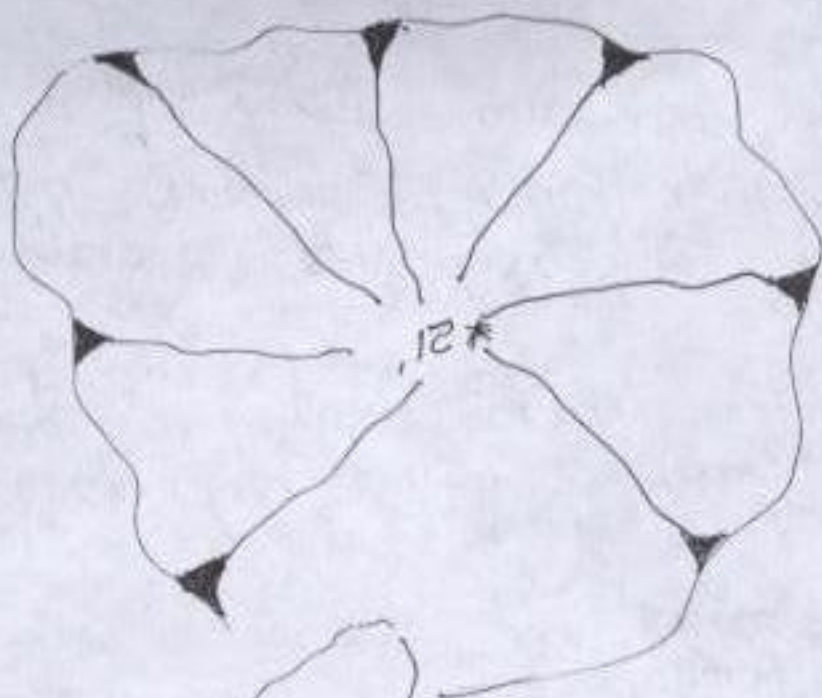
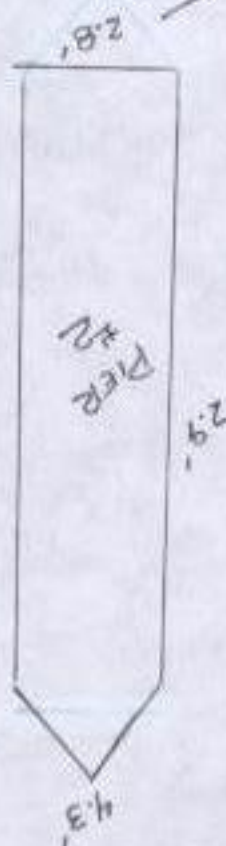
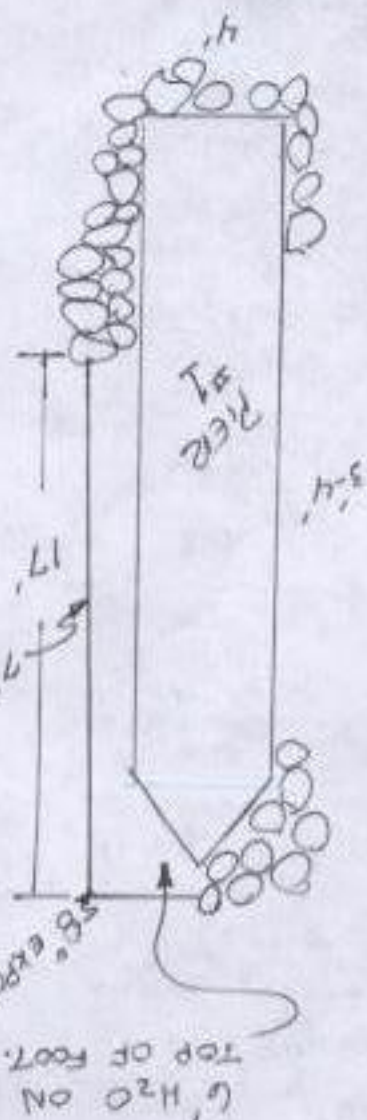
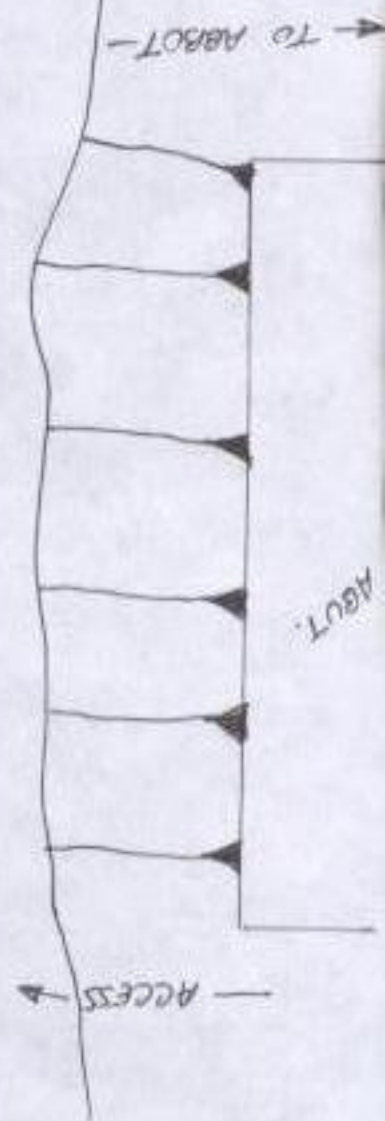
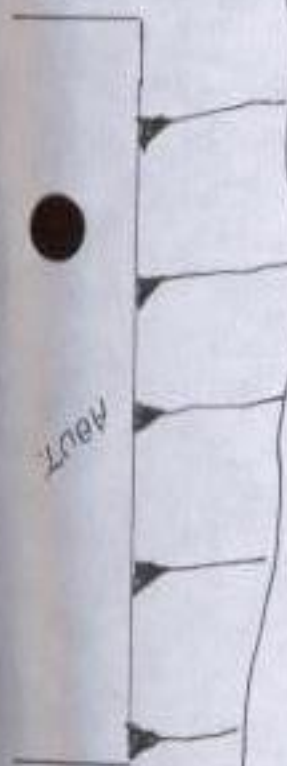
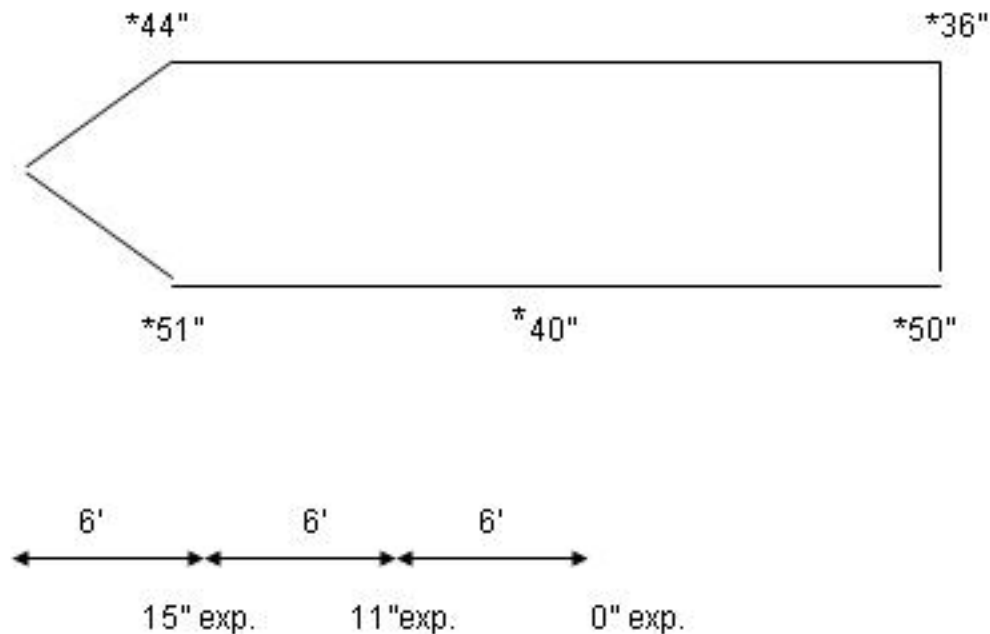
2 conc. piers on spread footings. Large scour basin  
downstream still remains. Partial footing still remains  
exposed on Pier #1. Large sand bar still remains off  
Pier #2.

18" exposed
