town 11-16
 bridge 3244
 State Highway Commission
 Bridge Division
PLEASANT RIVER BRIDGE
 OVER
PLEASANT RIVER
 in the town of
MILO PISCATAQUIS COUNTY
 Bridge Details
 Sheet of Augusta Sept. 4, 1935

Surveyed by MacDannell
 Plotted and Traced by Lyon

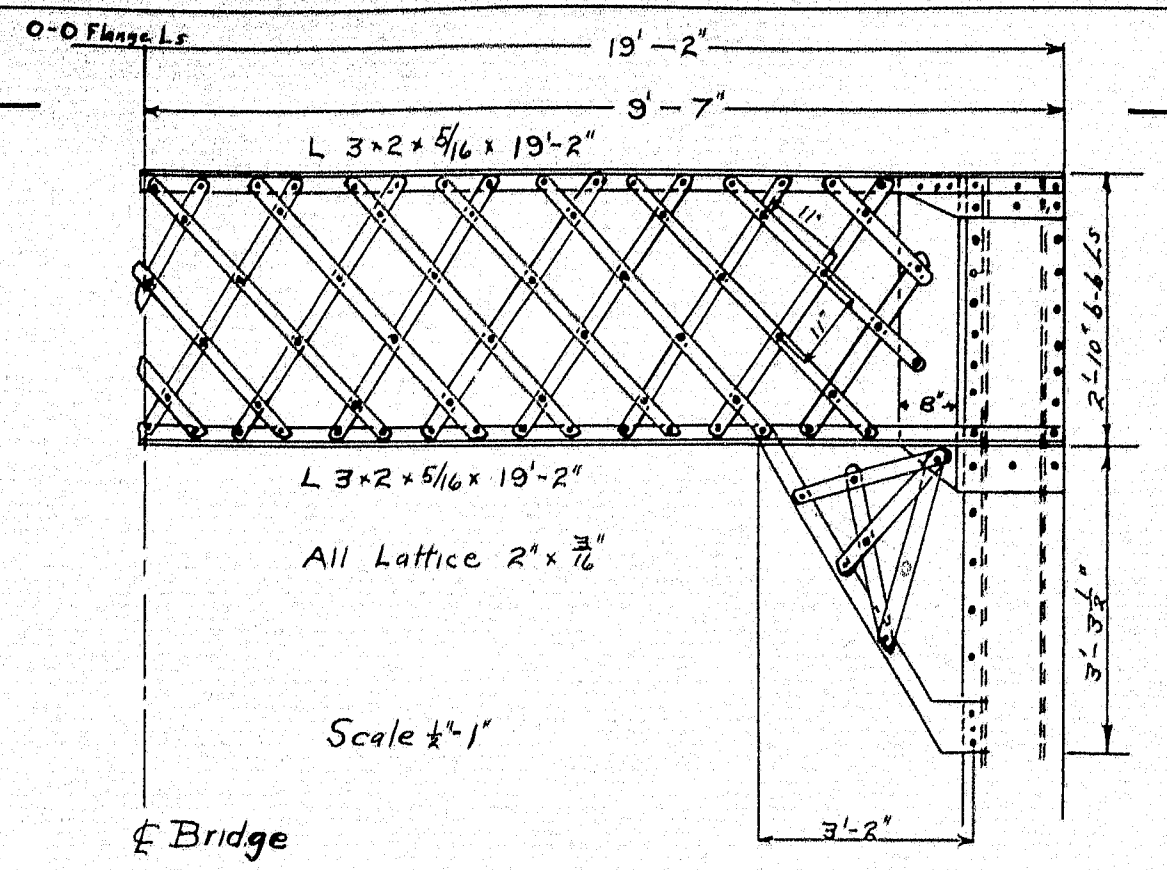
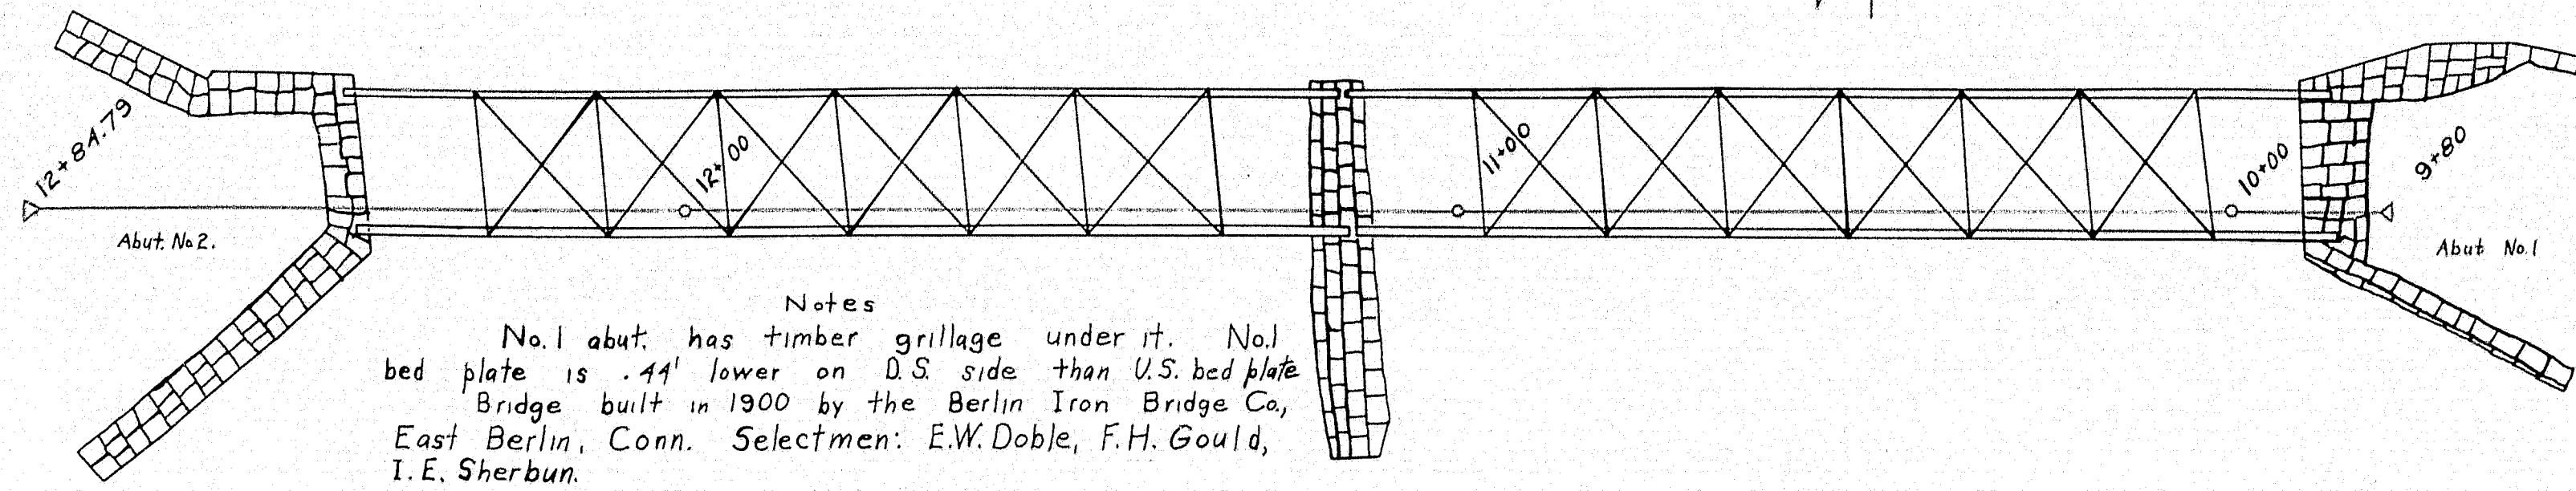
Notes
 No. 1 abut. has timber grillage under it. No. 1 bed plate is .44' lower on D.S. side than U.S. bed plate. Bridge built in 1900 by the Berlin Iron Bridge Co., East Berlin, Conn. Selectmen: E.W. Doble, F.H. Gould, I.E. Sherburn.
 Rollers under bridge are 2' diam. are in bad shape, of no use and badly out of line.
 The top of timber grillage under pier is at elev. 74.0.
 No. 1 abut grillage is undermined 2'-3' on U.S. corner. Small stones are around grillage. Water is 3'-6" deep at U.S. corner and about 6" deep at D.S. corner. Grillage probably large logs slotted parallel to E. road. Three inch planks are on grillage. Plank in center of two trusses at middle of stream is in very poor shape. Several large holes are in top planking. Under planks in two or three places are nearly rotted thru.
 No. 2. abut. timber grillage parallel to E. road, top grillage elev. 73.0. Grillage covered with flagstone on top of which is a row of split stone headers.
