Project: MAINE LOAD Rating
 Location: Berwick, Maine
 Calculated by: KRW
 Checked by:
 Title BRIDGE Number 1238

Project # 52106.00
 Sheet 1 of 6
 Date: 10-18-11
 Date:
 Field Inspection

Title Bridge # 1238 Field Inspection Notes

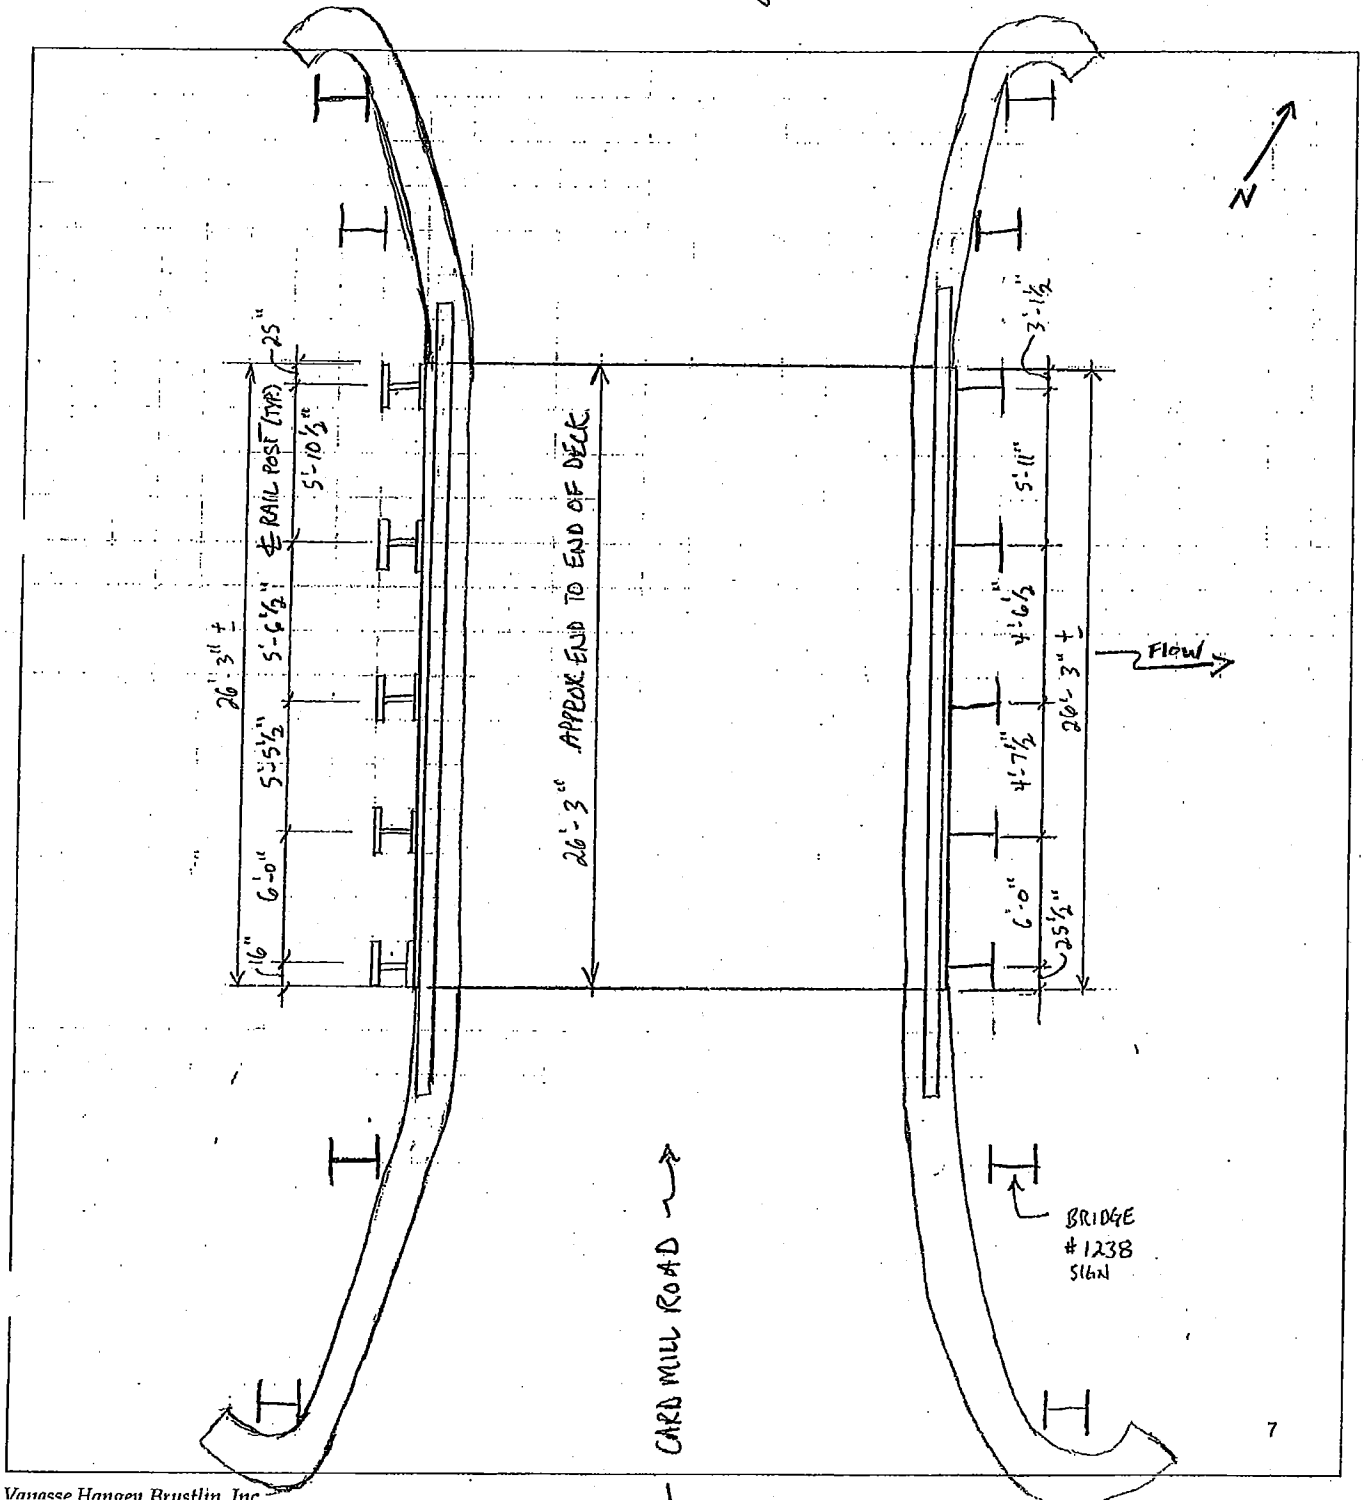
- 10 stringers
- 5 Rail Posts supported on transverse W-beams or 1/2 Long timbers
- Transverse Timbers
- Pavement
- Timber deck planks appear to be eastern hemlock (can't tell whether it was treated - does not appear to be creosote treated)

- Railings posts appear to be W6 x 25 standard steel beam guard rail posts. Continuous W section dimensions as shown on separate sketch.
- Pipe rail marked as 3" inside dia. x 0.266" wall thickness.

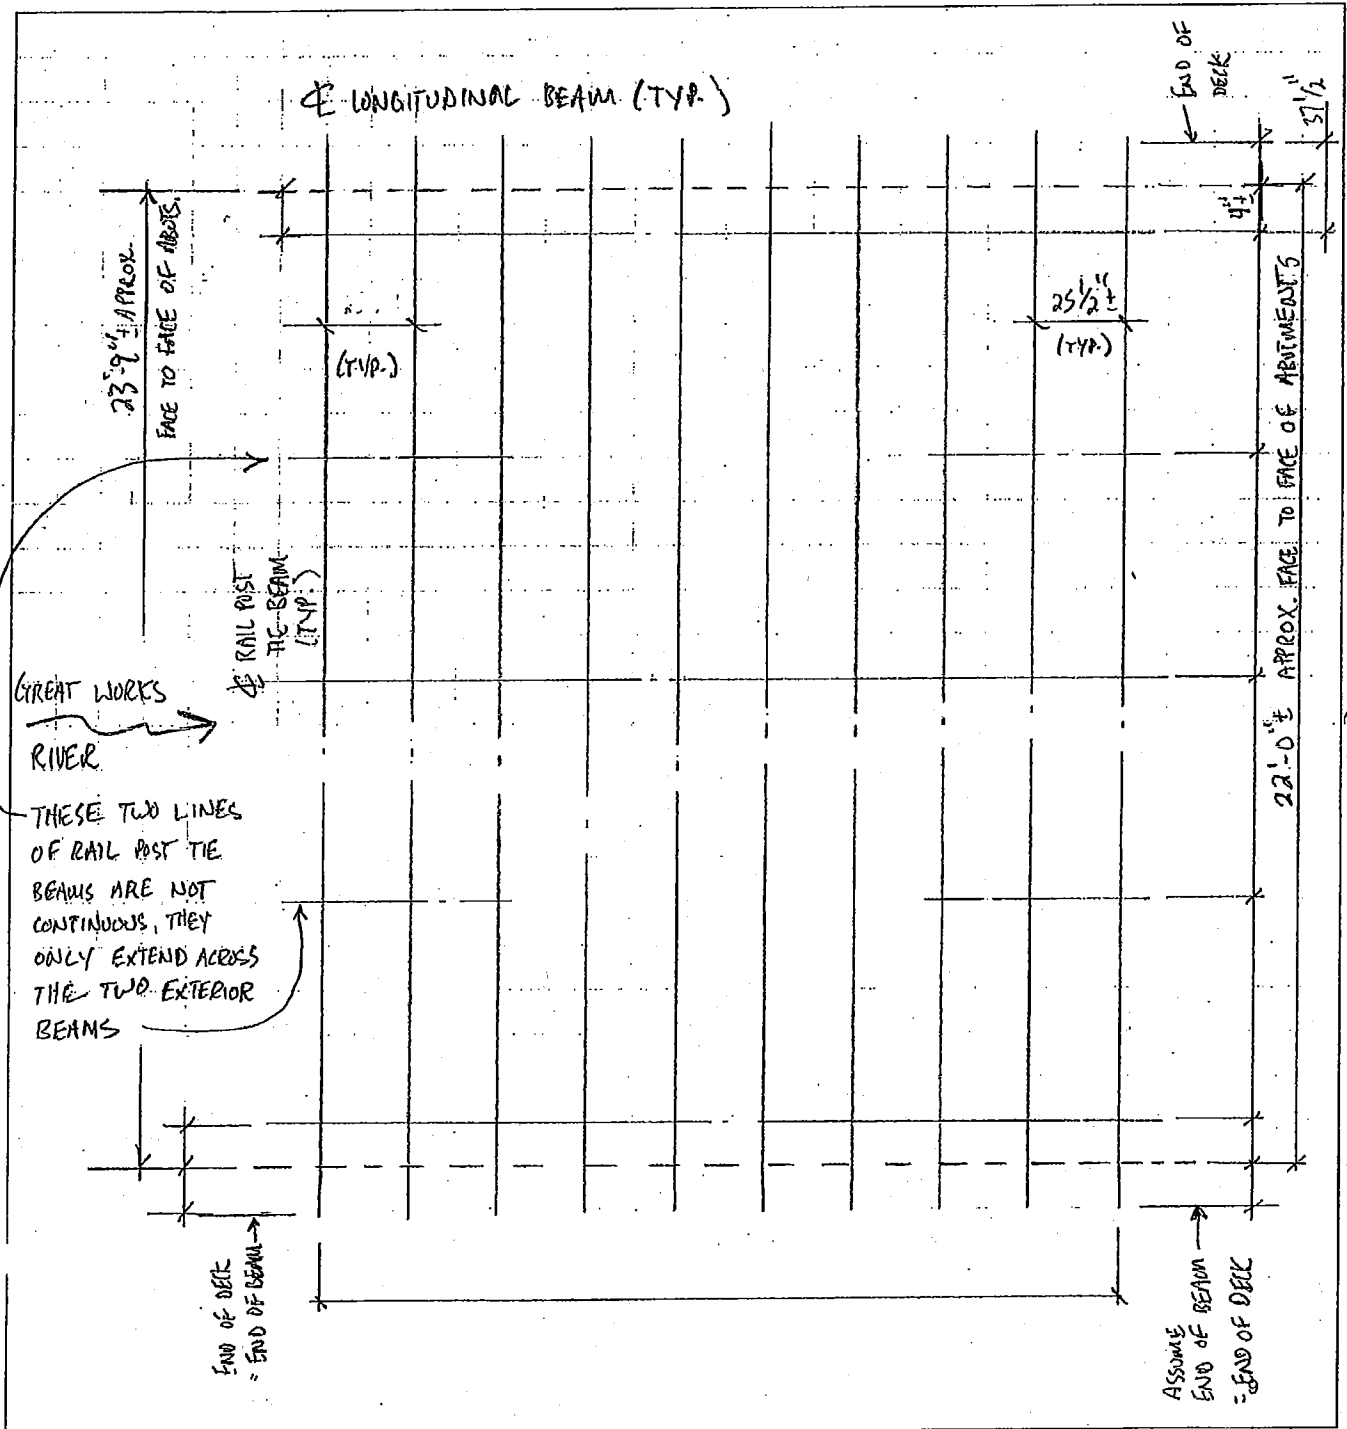
NOTE: SEVERE CORROSION ON ALL BEAMS, HEAVY LAMINAR RUST. IN RATING USE
 1/16" SECTION LOSS FROM WEB AND BOTH FLANGE THICKNESSES.
 (TOTAL)

DIMENSIONS SHOWN ARE NOMINAL
 DIMENSIONS, SUBTRACT SECTION LOSS
 FROM THESE TO GET ACTUAL
 DIMS. TO USE IN LOAD RATING.
