## TECHNICAL MEMORANDUM

**Project No.** 31404817.004

**RE: GEOTECHNICAL SOIL CORROSIVITY FINDINGS – REV01  
HOGAN ROAD BRIDGE REPLACEMENT, BANGOR, MAINE  
WIN 018595.10**

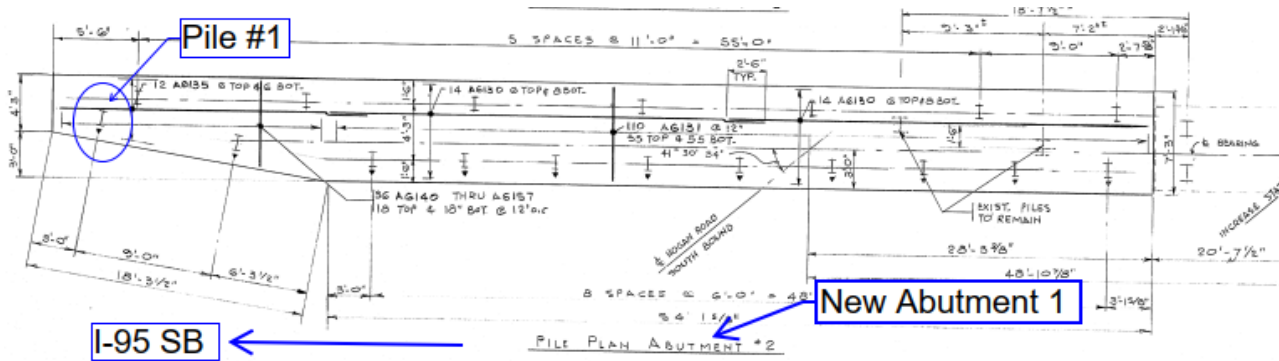
Figure 1

Small spots of rust were observed on the pile, otherwise the pile was in good condition. Pile cap installed in the fill layer. No Groundwater observed during excavation of the piles.

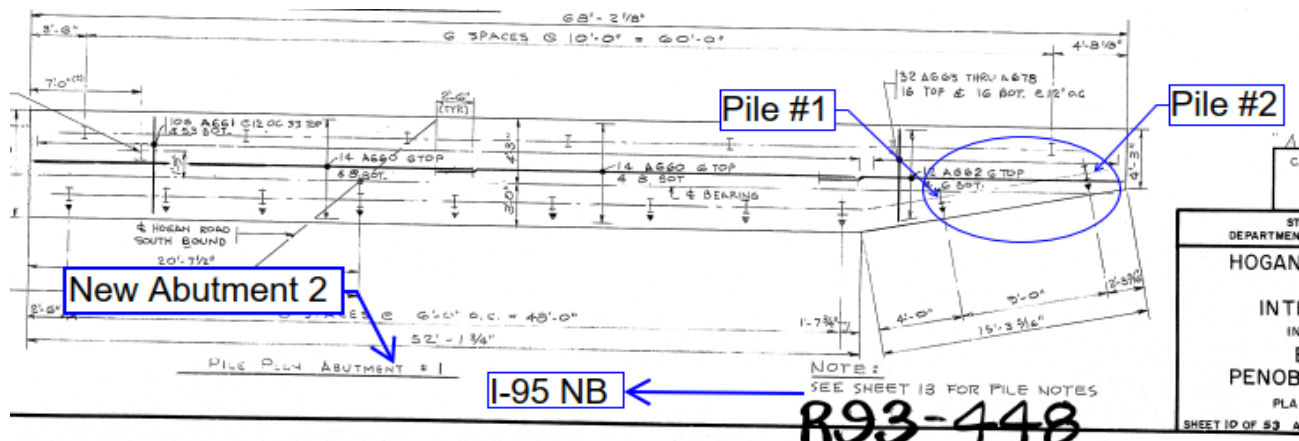
Figure 1

Small spots of rust were observed on the pile, otherwise the pile was in good condition. Pile cap installed in the fill layer. No Groundwater observed during excavation of the piles.

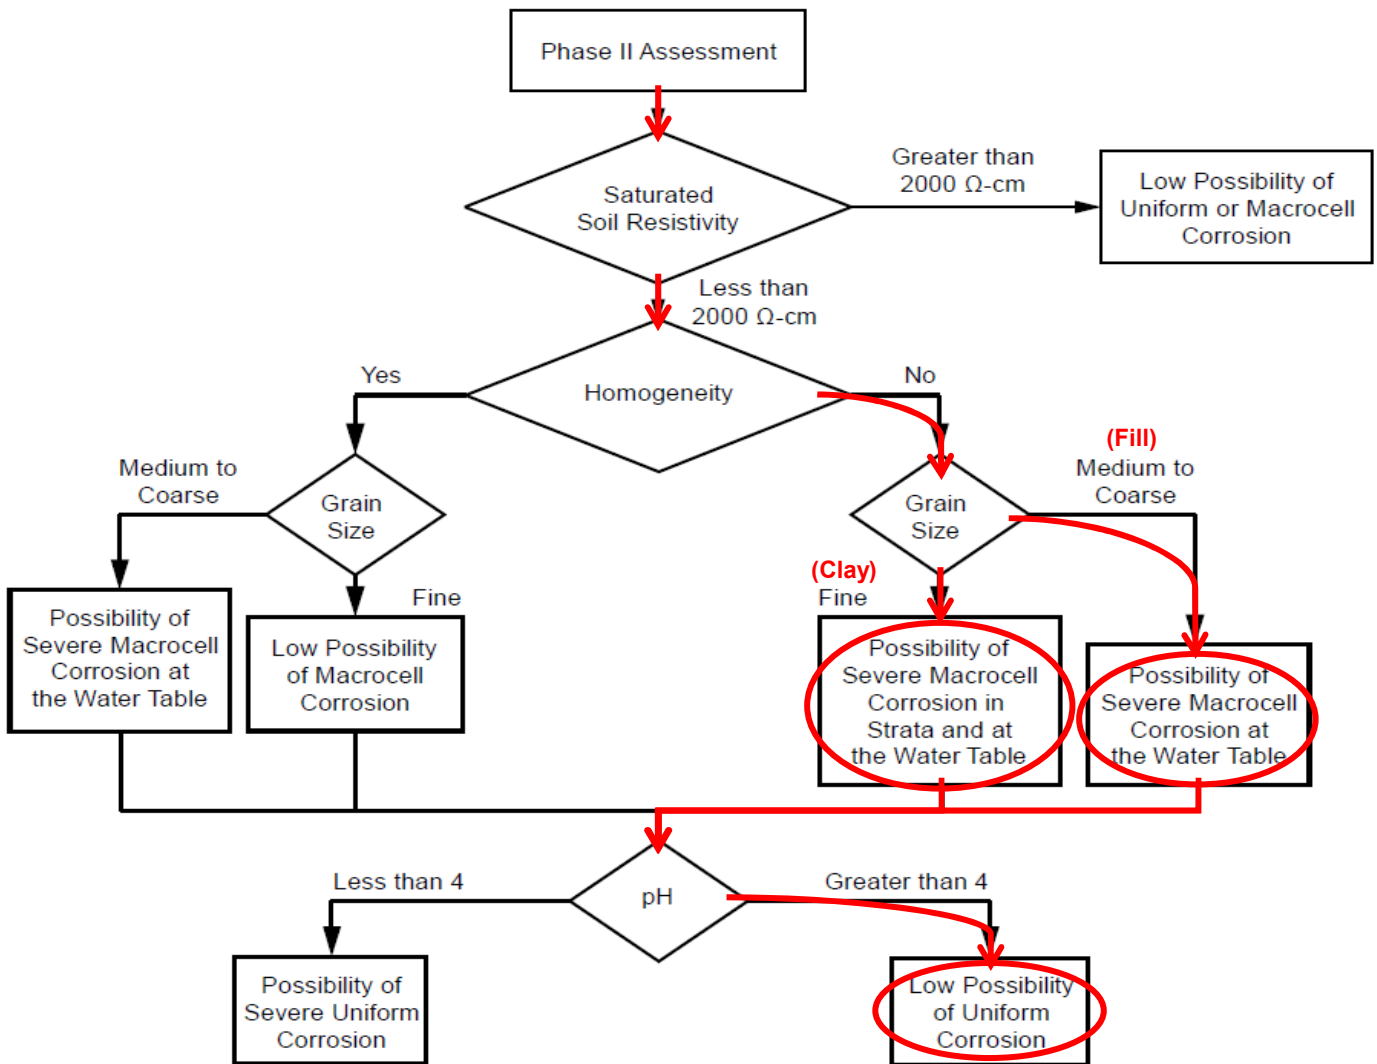
**Figure 3**—Determination of the Possibility for General and/or Macrocell Corrosion Based on Soil Analysis

*Step 1:* use AASHTO flowchart Figure 3 (Ref. 3) and the corrosivity laboratory test results for the soil at site (Ref. 1) to determine the possibility of macrocell and uniform corrosion of the existing piles.

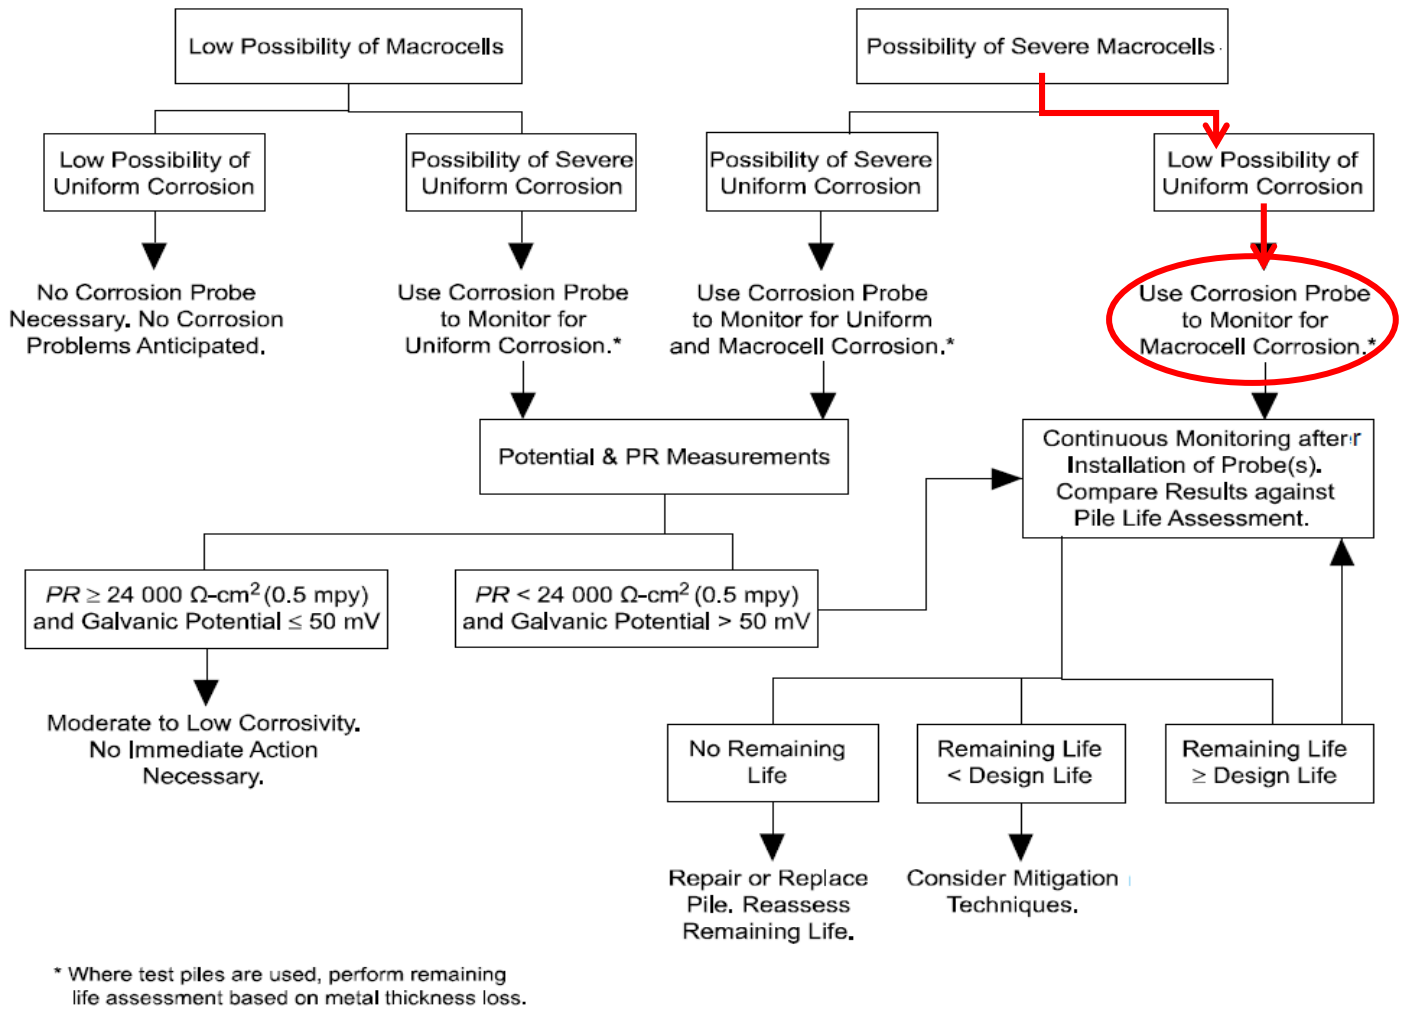
**Figure 4**—Determination of the Necessity for Electrochemical Testing, Corrosion Monitoring, and Mitigation

Step 2: use AASHTO flowchart Figure 4 (Ref. 3) to determine the recommended corrosion assessment procedure for the existing piles.

Based on the corrosivity lab test results, the AASHTO Standard Practice recommends using a corrosion probe to monitor for macrocell corrosion.
