Routine & Special Member Inspection Report

Bridge No. 2399
BRIDGE AVENUE (INTERNATIONAL BRIDGE)
OVER
ST. JOHN RIVER & CNRR
MADAWASKA, MAINE (U.S.A.) / EDMUNDSTON, NEW BRUNSWICK (CANADA)

June 19, 2020

WIN #: 22035.20

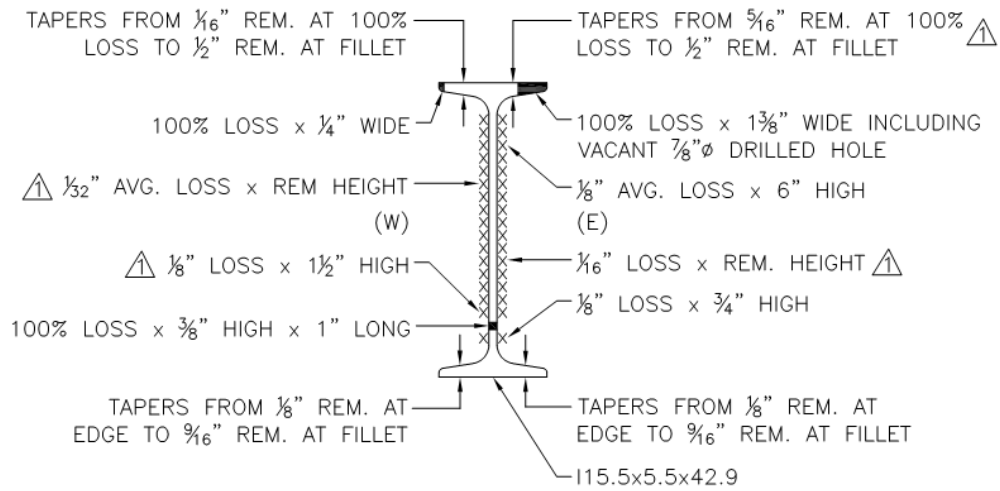
1. SIMILAR CONDITION FOR FULL LENGTH OF STRINGER.
2. SPAN 1, STRINGER S9 BETWEEN FB0N & FB1N: SIMILAR LESS SEVERE CONDITION FOR FULL LENGTH.

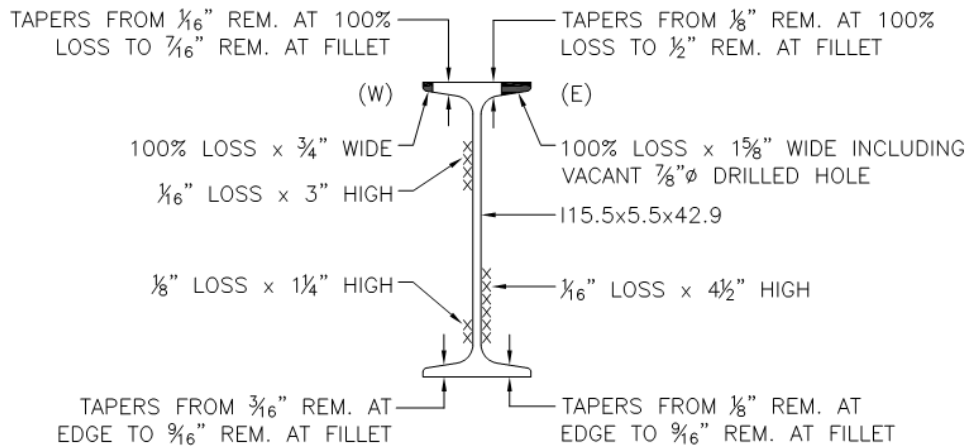
1. SIMILAR CONDITION FOR FULL LENGTH OF STRINGER.
2. SPAN 1, STRINGERS S7 THROUGH S9 BETWEEN FB1N & FB2N: SIMILAR LESS SEVERE CONDITION FOR FULL LENGTH.

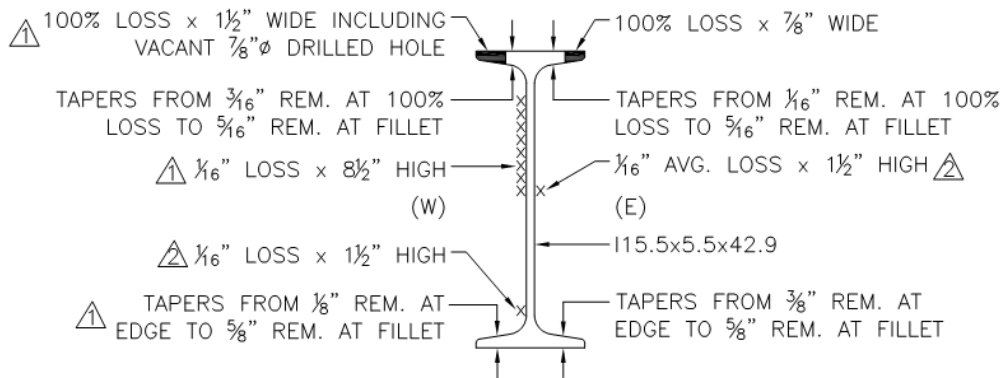
1. SIMILAR CONDITION FOR FULL LENGTH OF STRINGER.
- △ 2. EAST HALF OF TOP FLANGE AT 8 1/2" NORTH OF SECTION WITH 1 1/2" WIDE CORROSION CRACK.
3. SPAN 1, STRINGERS S6 & S8 BETWEEN FB2N & FB3N: SIMILAR CONDITION FOR FULL LENGTH.

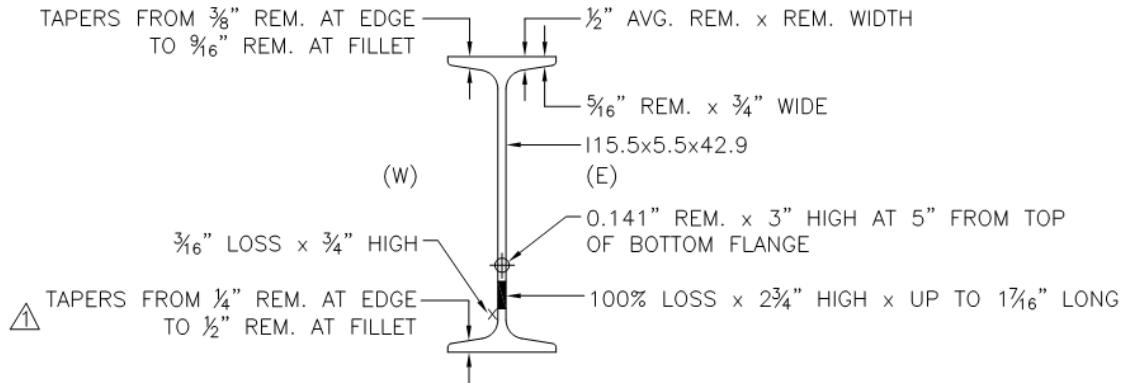
SPAN 1, STRINGER S5 AT MIDSPAN BTWN FLOORBEAMS FB4N & FB5N

Stringer S5 at midspan of most floorbeam bays in spans 1 and 2 exhibits up to 5/16" section loss by 7" high of the web along the vertical bent plate of the lower lateral bracing connection (**see photo 26**). Stringer S5 at midspan between floorbeams FB4N and FB5N in span 1 exhibits the most severe web section loss along the vertical bent plate of the lower lateral bracing connection including an area of 100% section loss by 2 3/4" high by up to 1 7/16" long (**see sketch 6 and photo 27**).

NOTE:
SECTION TAKEN ADJACENT TO LOWER LATERAL BRACING BENT CONNECTION PLATE.

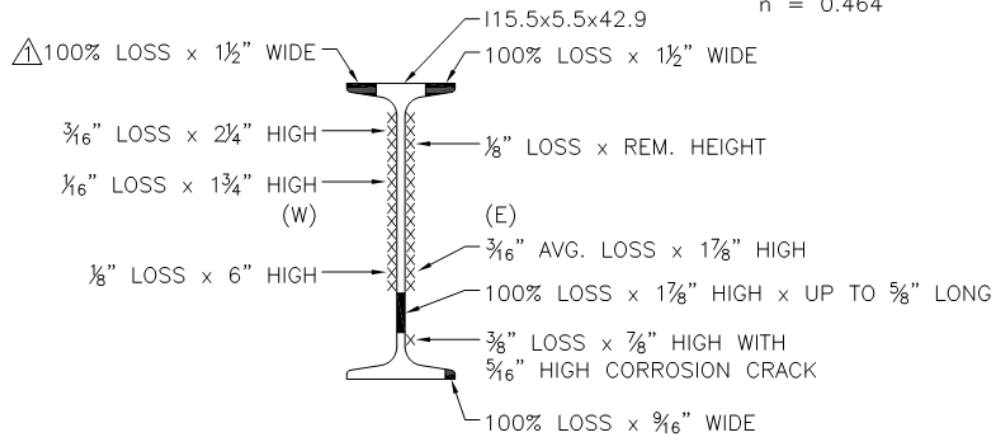
SPAN 1, STRINGER S6 AT SOUTH SIDE OF FLOORBEAM FB5S

NOTE:
LOWER WEB BEYOND THIS SECTION WITH 100% LOSS x $\frac{1}{2}$ " HIGH x $1\frac{3}{4}$ " LONG BELOW STRINGER CONNECTION ANGLES TO FLOORBEAM.

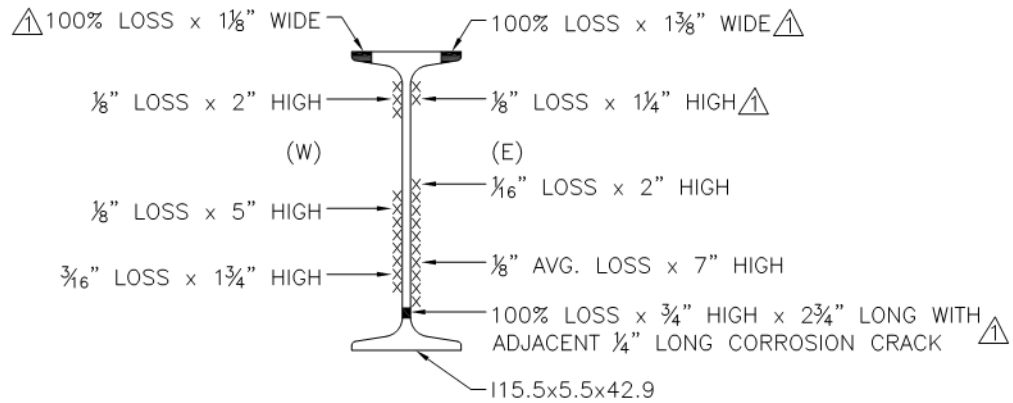
1. SPAN 1, STRINGERS S4, S6 & S8 AT SOUTH SIDE OF FB2N: SIMILAR LESS SEVERE CONDITION.
2. SPAN 1, STRINGERS S5 & S8 AT SOUTH SIDE OF FB3N: SIMILAR LESS SEVERE CONDITION.
3. SPAN 1, STRINGERS S6 & S7 AT SOUTH SIDE OF FB3S: SIMILAR LESS SEVERE CONDITION.

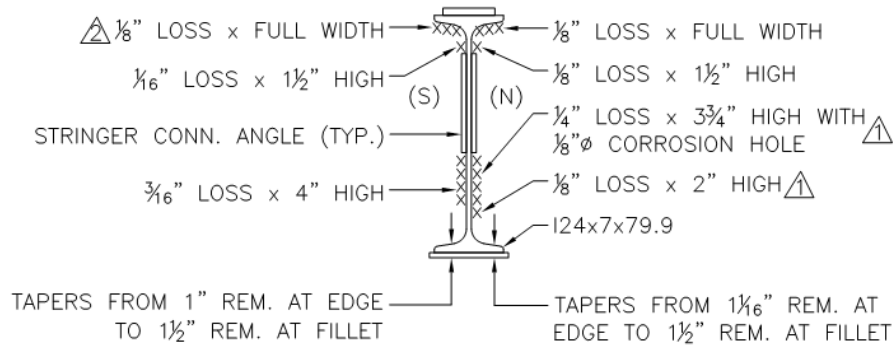
SPAN 3, FLOORBEAM FB5S AT STRINGER S6

NOTE:
SIMILAR LESS SEVERE CONDITION ON THIS FLOORBEAM AT STRINGERS S7 & S8 (NO CORROSION HOLE).

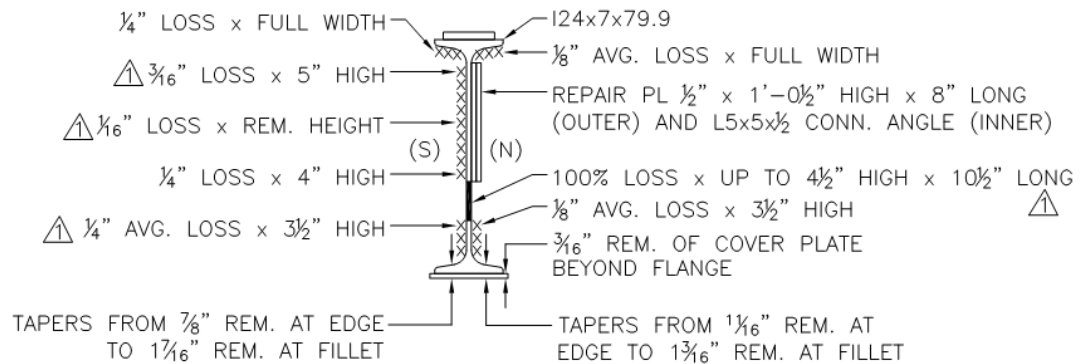
1. SIMILAR CONDITION ON THIS FLOORBEAM AT STRINGERS S3 & S4.
2. SIMILAR LESS SEVERE CONDITION ON THIS FLOORBEAM AT STRINGERS S5 THROUGH S8.
3. WEB WITH 100% LOSS x 2"φ AT REPAIR 5" EAST OF THIS SECTION.

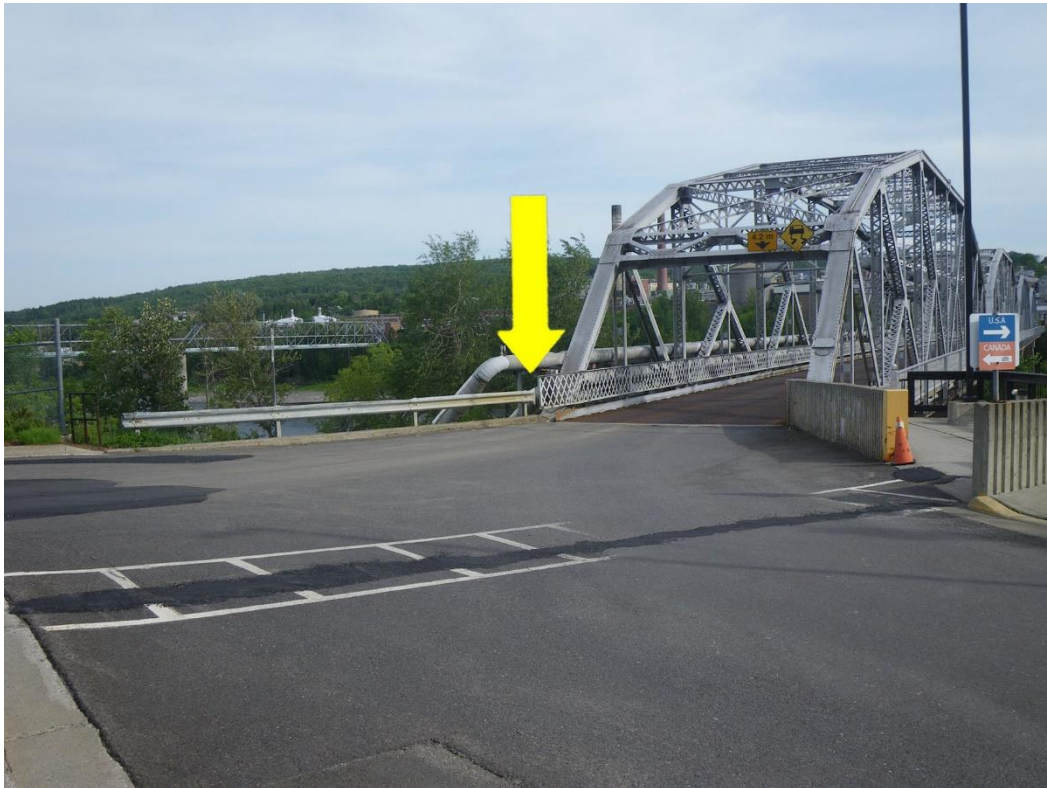
There is no connection between the east bridge railing and the W-beam guardrail on the north approach (**see photo 3**). The northwest concrete traffic barrier terminates with an encased steel end section at the north abutment deck joint. This approach barrier aligns with the curb on the bridge.

There is a transverse corrugated concrete pedestrian barrier at the north end of the northwest sidewalk, which directs pedestrian traffic exiting the bridge toward the Canada Border Service Agency building (**see photo 3**).

Photo 3: North Approach, Looking Southeast. Note "At-Bridge" vertical clearance sign, no "At Bridge" bridge load posting sign and no connection of east bridge railing to approach guardrail.

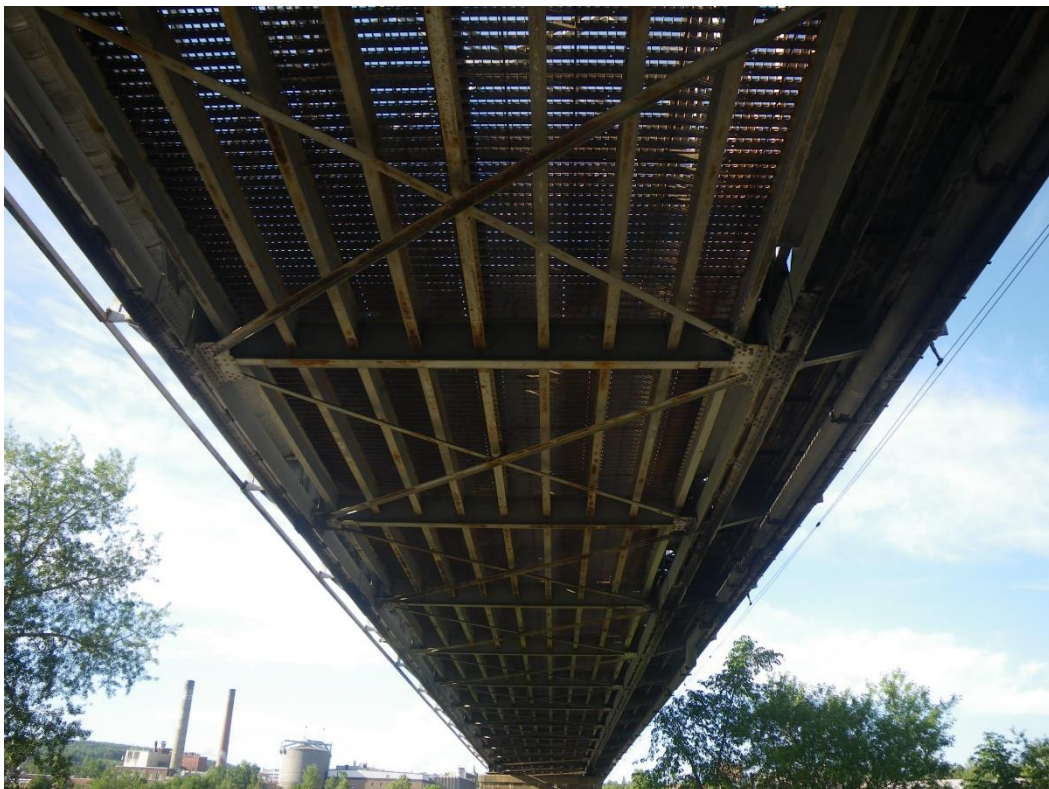
Photo 6: Underside of Span 1 near North Abutment, Looking South. Note conduits/abandoned pipe along west truss and areas of a failed paint system on the stringers and floorbeams.

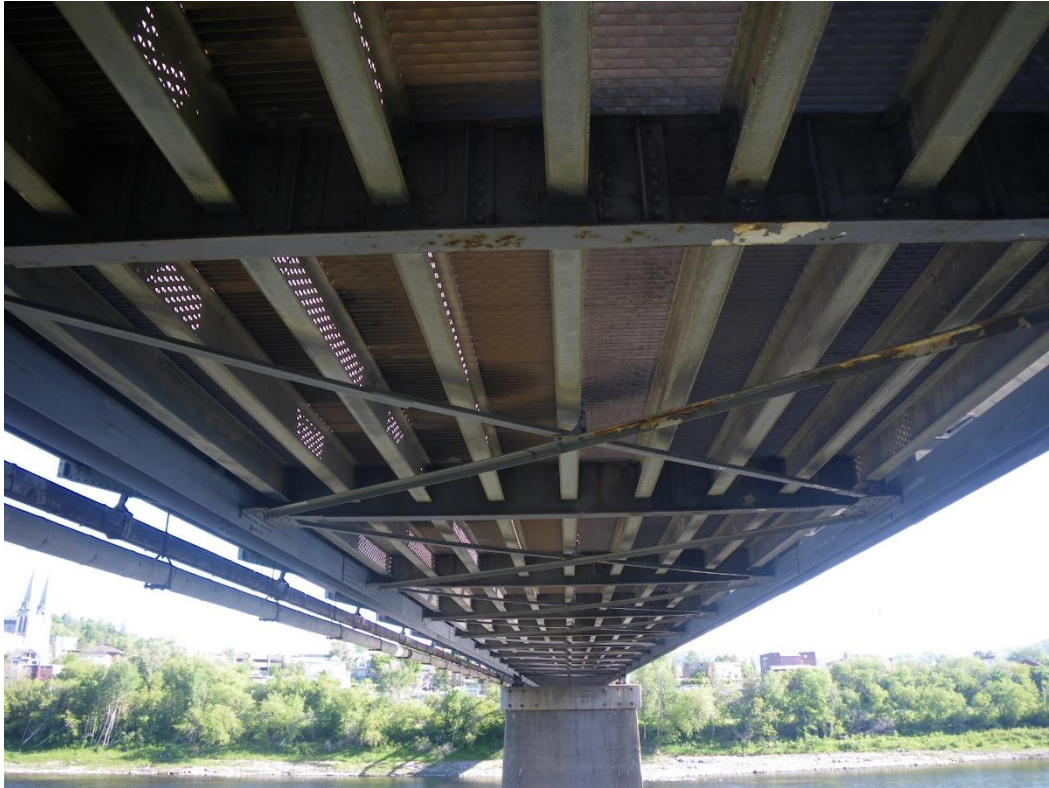
Photo 7: Underside of Span 4 near South Abutment, Looking North. Note areas of a failed paint system on the floorbeams.

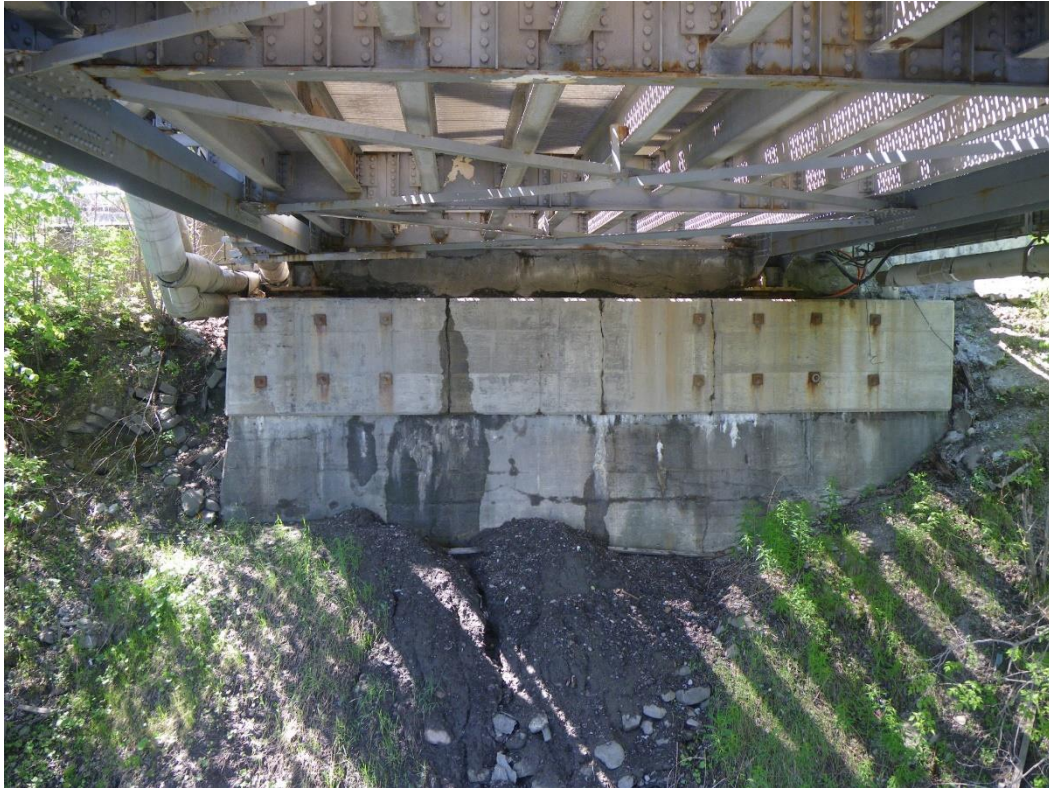
Photo 9: South Abutment, Looking South. Note bridge seat with steel post-tensioning rods.

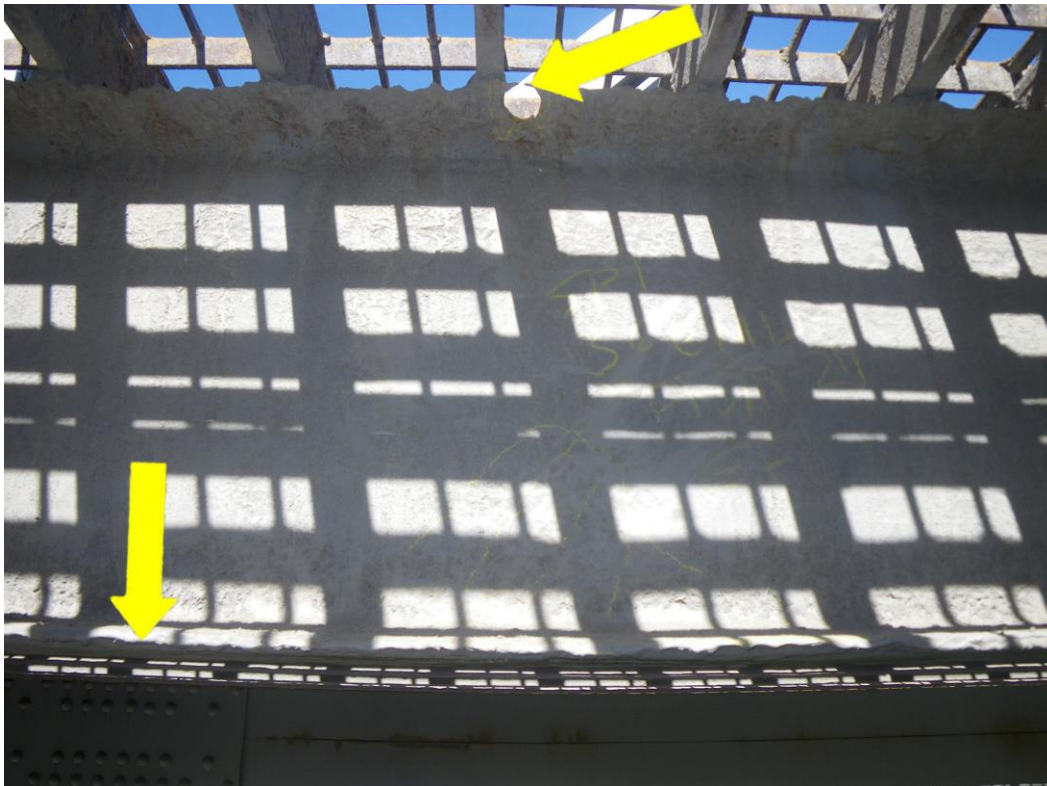
The roadway stringers (stringers S1 to S9) in spans 1 and 2 are in poor condition and govern the condition rating of Item 59.1, particularly in span 1. The roadway stringers in spans 1 and 2 exhibit advanced section loss of the top flange throughout including areas of 100% section loss by up to 1 5/8" wide of one/both edges within the midspan region (**see sketches 4 through 8 and photos 21 through 25**). Many of these areas of 100% section loss in the top flanges encompass a vacant 7/8" diameter drilled hole, which is most likely from the anchors for the removed timber deck (**see sketches 4, 5 & 8, and photos 21 & 22**). Numerous roadway stringers have 100% section loss by up to full width of one/both halves of the top flange at the floorbeams (**see sketches 5 through 7 and photos 23 through 25**).

The bottom flanges of the roadway stringers in spans 1 and 2 exhibits moderate to advanced section loss throughout (**see sketches 4 through 8 and photos 21 through 25**). Scattered roadway stringers have 100% section loss by up to 1 5/16" wide of one/both edges of the bottom flange at the floorbeams (**see sketches 6 & 7 and photos 23 through 25**).

The web of the roadway stringers in spans 1 and 2 exhibits moderate to advanced section loss at/near the floorbeams and minor to moderate section loss elsewhere (**see sketches 4 through 8 and photos 21 through 25**). Scattered roadway stringers have an area of 100% section loss by up to 3/4" high by up to 2 3/4" long in the lower web below the connection angles to the floorbeams (**see sketches 5 through 7 and 23 through 25**). Isolated roadway stringers have areas of 100% section loss by up to 1 7/8" high by up to 5/8" long or an up to 15/16" long/high corrosion crack in the web adjacent to the connection angles to the floorbeams (**see sketch 5 through 7 and photo 23 through 25**).

Photo 22: Stringer S6 at Midspan, between Floorbeams FB1N and FB2N, East Face, Span 1 - Section loss of flanges and web. Note top flange with 100% section loss of the outer edge including a vacant drilled hole.

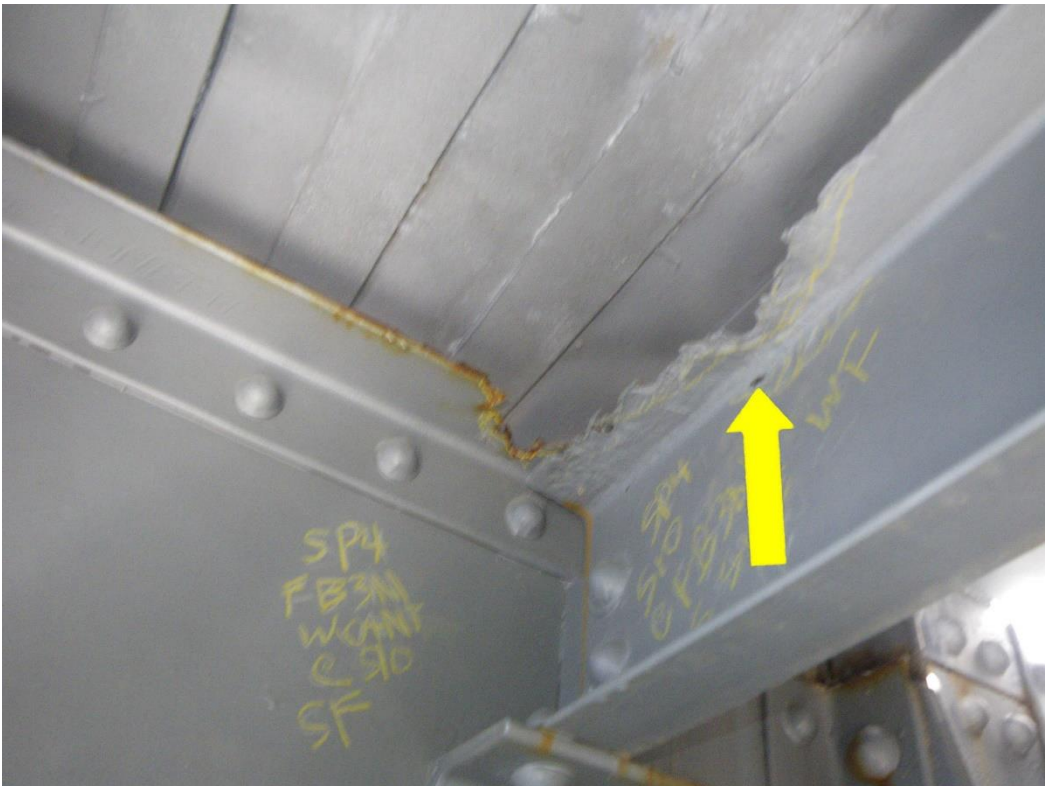
The sidewalk stringers (stringers S10 to S12) in all spans are in fair condition. Isolated sidewalk stringers exhibit advanced section loss of the top flange including areas of 100% section loss by up to 1 1/2" wide of one/both edges. Stringer S10 at the south side of the floorbeam FB3N cantilever in span 4 has 100% section loss by up to 1 1/4" wide of the top flange including a vacant drilled hole and 100% section loss by 3/16" high by 7/16" long in the upper web (**see photo 28**).

Photo 28: Stringer S10 at South Side of Floorbeam FB3N, West Face, Span 4, Looking Northeast - Areas of 100% section loss in top flange and web. Note area of 100% section loss in floorbeam cantilever top flange.

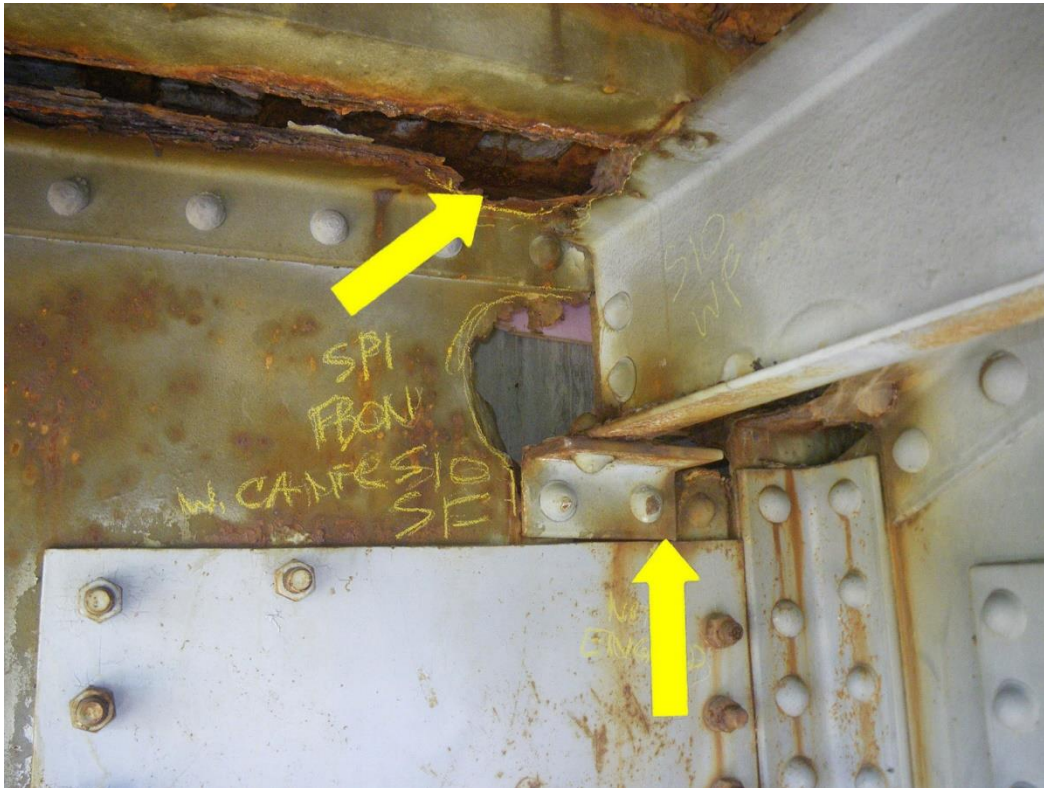
Stringer S10 at the floorbeam FB0N cantilever in span 1 and the floorbeam FB0S cantilever in span 4 is not connected to the floorbeam cantilever web due to 100% section loss of the floorbeam cantilever (**see photos 29 and 30**). These stringers only have a bottom flange seat angle with two rivets connecting to the floorbeam cantilever as a result of this 100% section loss. Stringer S10 at the floorbeam FB0N cantilever in span 1 only has one rivet engaged at the seat angle and the seat angle appears to have rotated down and is in contact with the web repair plate (**see photo 29**). Refer to Item 59.2 for additional comments.

Photo 29: Stringer S10 at Floorbeam FB0N Cantilever, South Face, Span 1 - Not connected to floorbeam web due to 100% section loss of floorbeam web. Note rotated stringer seat angle and 100% section loss of the floorbeam cantilever top flange.

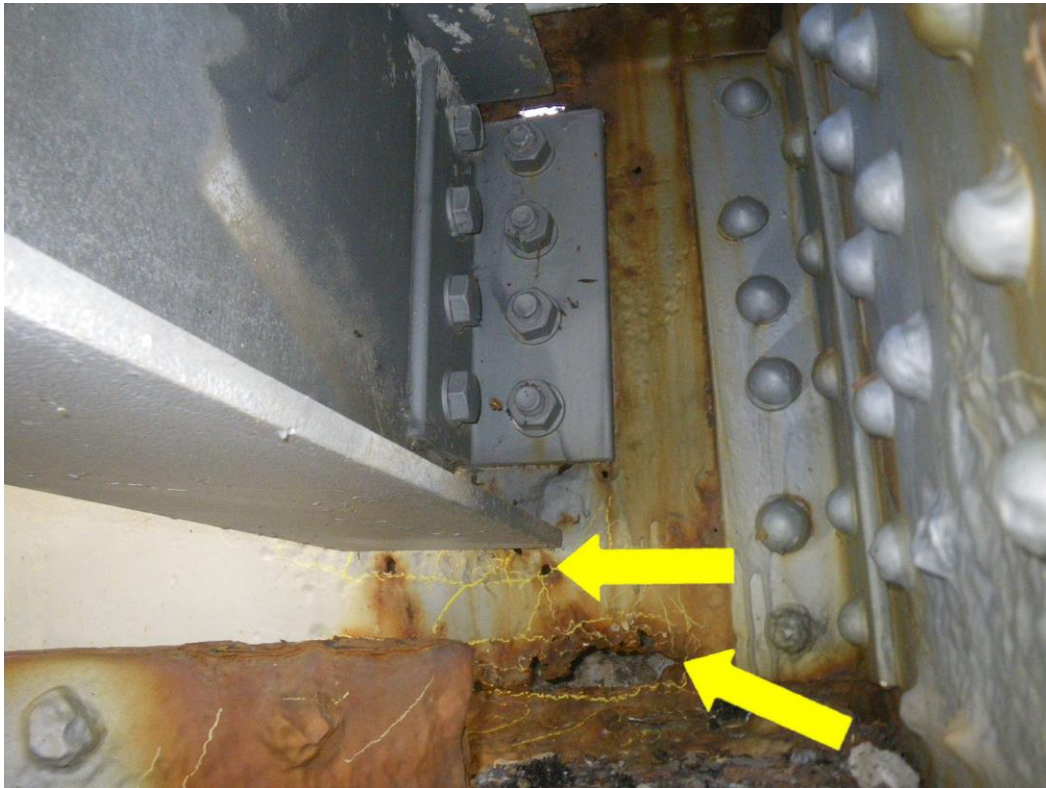
Scattered rivets of the stringer to floorbeam connections in spans 1 and 2 exhibit heavy blooming with up to 25% head loss, particularly along floorbeams FB2S and FB1S in span 2. Rivets have been replaced by high strength bolts for the stringer to floorbeam connections in spans 3 and 4. One bolt of the stringer S5 connection to the south side of floorbeam FB5S in span 3 has a backed off nut on the east face of the stringer web. There is up to 90% head loss of the rivets within the lower 6" of the floorbeam to lower chord connections (**see photo 37**).

The top surface of the lower chords exhibits 50% rivet head loss throughout including the batten and splice plates. Isolated batten and splice plates have up to 90% rivet head loss. Isolated rivets of the panel points L0N and L0S interior gusset plate exhibit up to 95% head loss, particularly within gusset plate section loss regions along the lower lateral bracing connection angles (**see photo 37**).

The rivets of the lower lateral bracing within the panel point and midspan connection plates exhibit up to 95% head loss (**see photo 37**).

Photo 37: Floorbeam FB0S at Stringer S9, North Face, Span 4 - Web section loss below stringer connection including areas of 100% section loss. Note floorbeam connection, lower lateral bracing and lower chord gusset plate with rivet head loss.

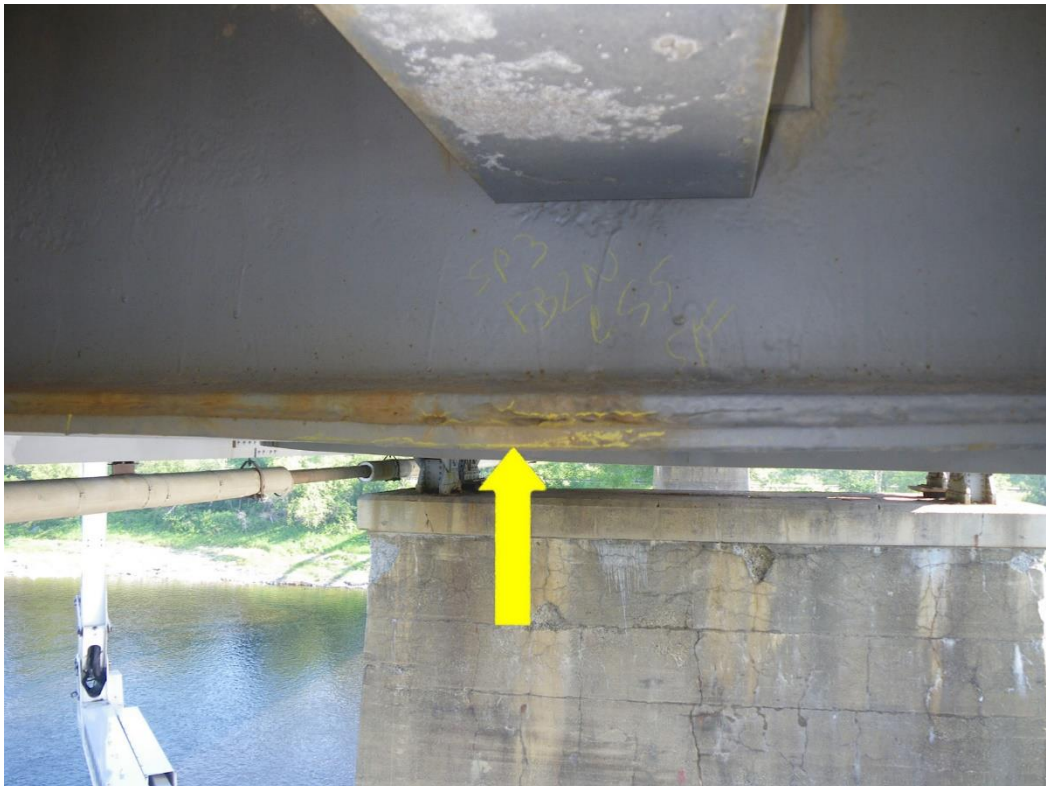
Photo 40: Floorbeam FB1N at Stringer S5, South Face, Span 3 - Bottom flange cover plate with bend. Note gap in weld between bottom flange and cover plate.

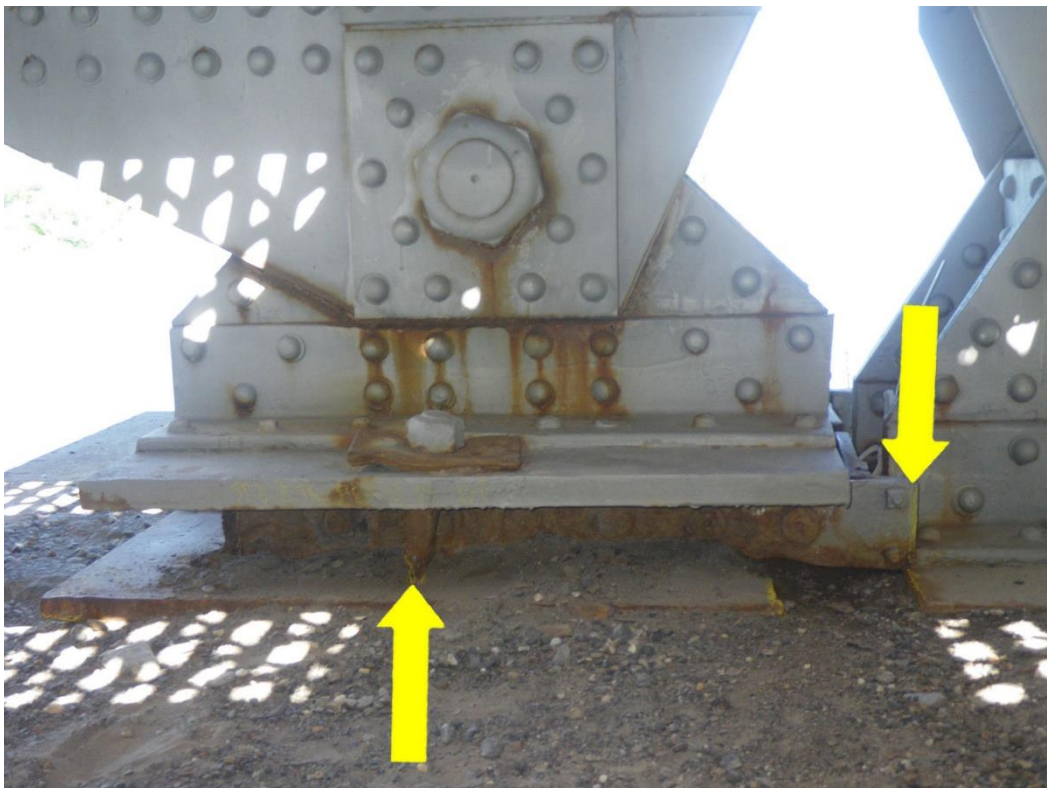
Photo 52: East Truss Bearing at Pier 3, West Face, Span 3 - Nested roller assembly expanded beyond the masonry plate edge and in contact with adjacent fixed bearing. Note anchor bolt severely bent with section loss.

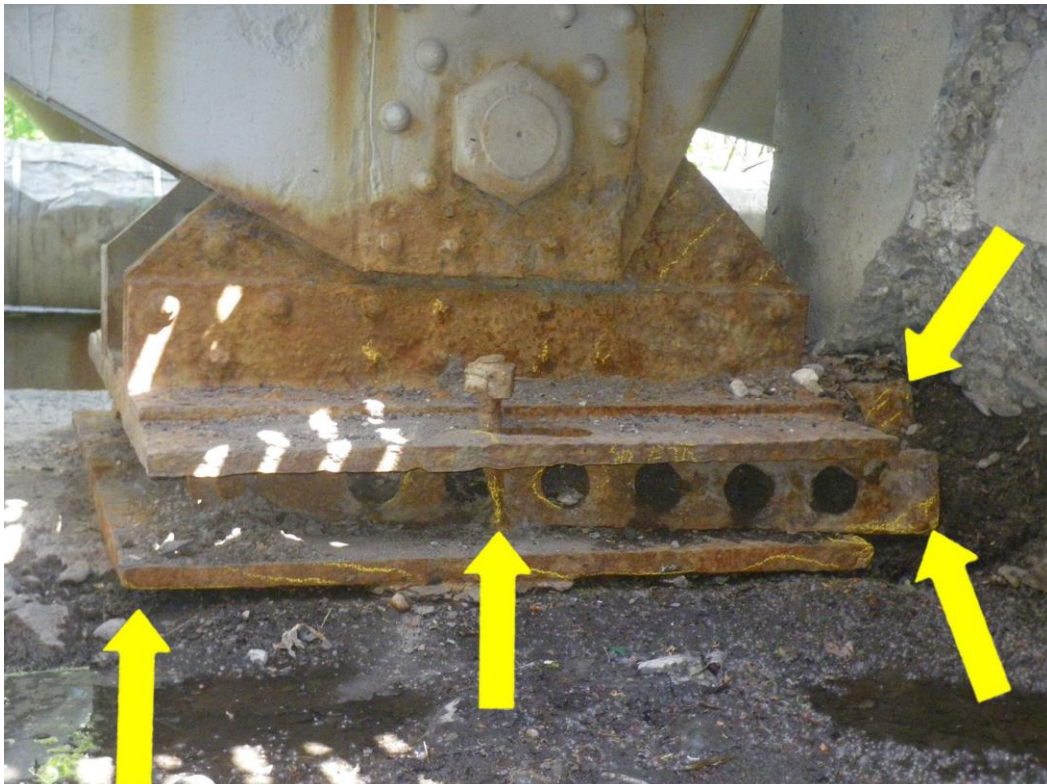
Photo 54: East Truss Bearing at South Abut., West Face, Span 4 - Nested roller assembly twisted, expanded beyond masonry plate edge, in contact w/ backwall & detached vertical plate. Note anchor bolt severely bent w/ section loss and in contact w/ sole plate slotted hole edge, & angle section loss w/ rivet head loss.

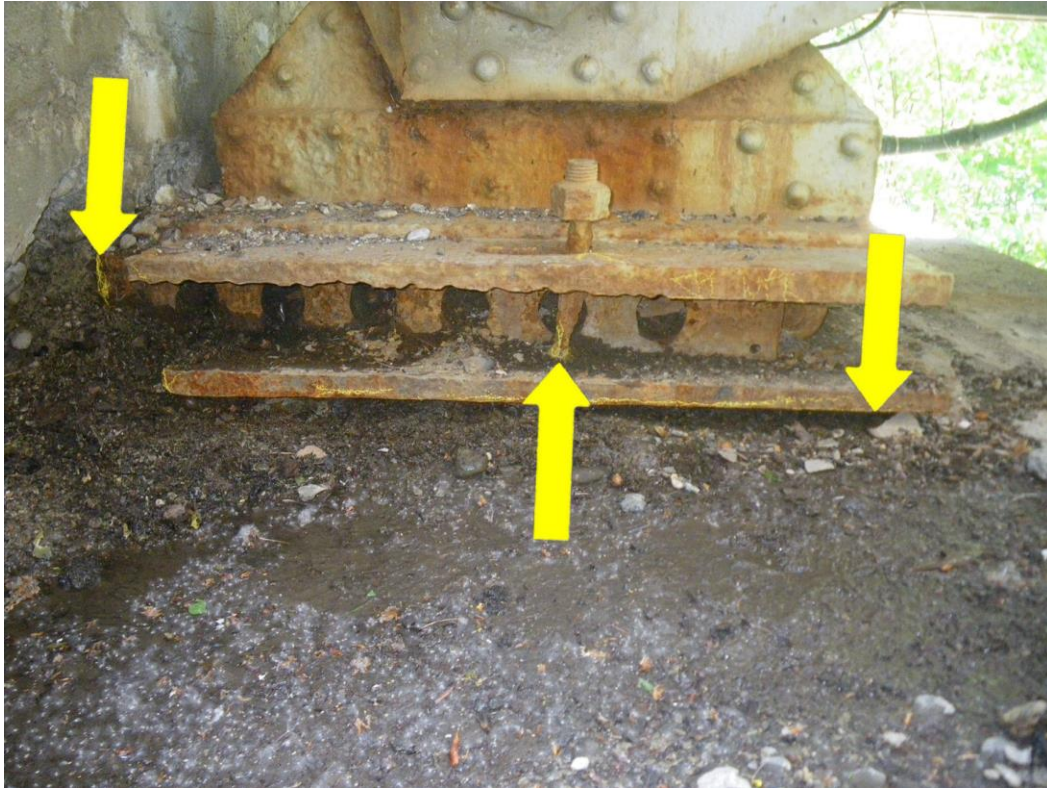
Photo 55: West Truss Bearing at South Abut., East Face, Span 4 - Nested roller assembly expanded beyond masonry plate, in contact w/ backwall & detached vertical plate. Note anchor bolt severely bent w/ section loss & in contact w/ sole plate slotted hole edge, angle section loss w/ rivet head loss & undermining of masonry plate.
