Soils Report 78-17  
Brooklin/Sedgwick - Hancock County  
Benjamin River Bridge  
No. 3216  
March, 1978

SURFACE AND SUBSURFACE INVESTIGATION  
FOR THE PROPOSED RECONSTRUCTION OF THE  
BENJAMIN RIVER BRIDGE BETWEEN THE  
TOWNS OF BROOKLIN AND SEDGWICK

Bridge No. 3216

Soils Report 78-17

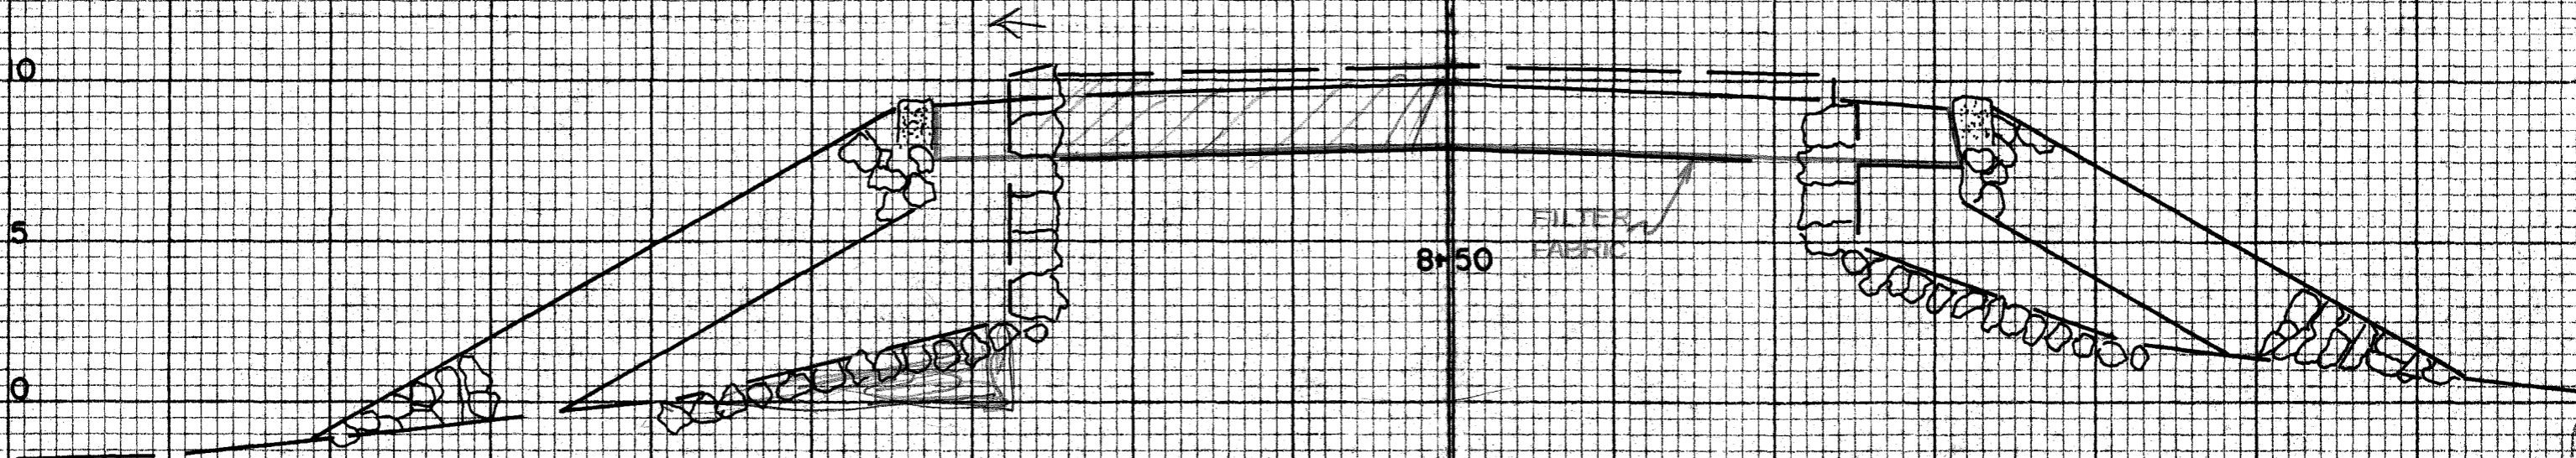
Excavated to subgrade from Bucklin end  
to Abut.

Excavated from Abut to Sedgewick wall  
kicked out in vicinity 8+50-8+75 during  
excavations. Wall tipped in at 9+50 I

On opposite side in vicinity 8+50 wall  
bowed out and crack opened in

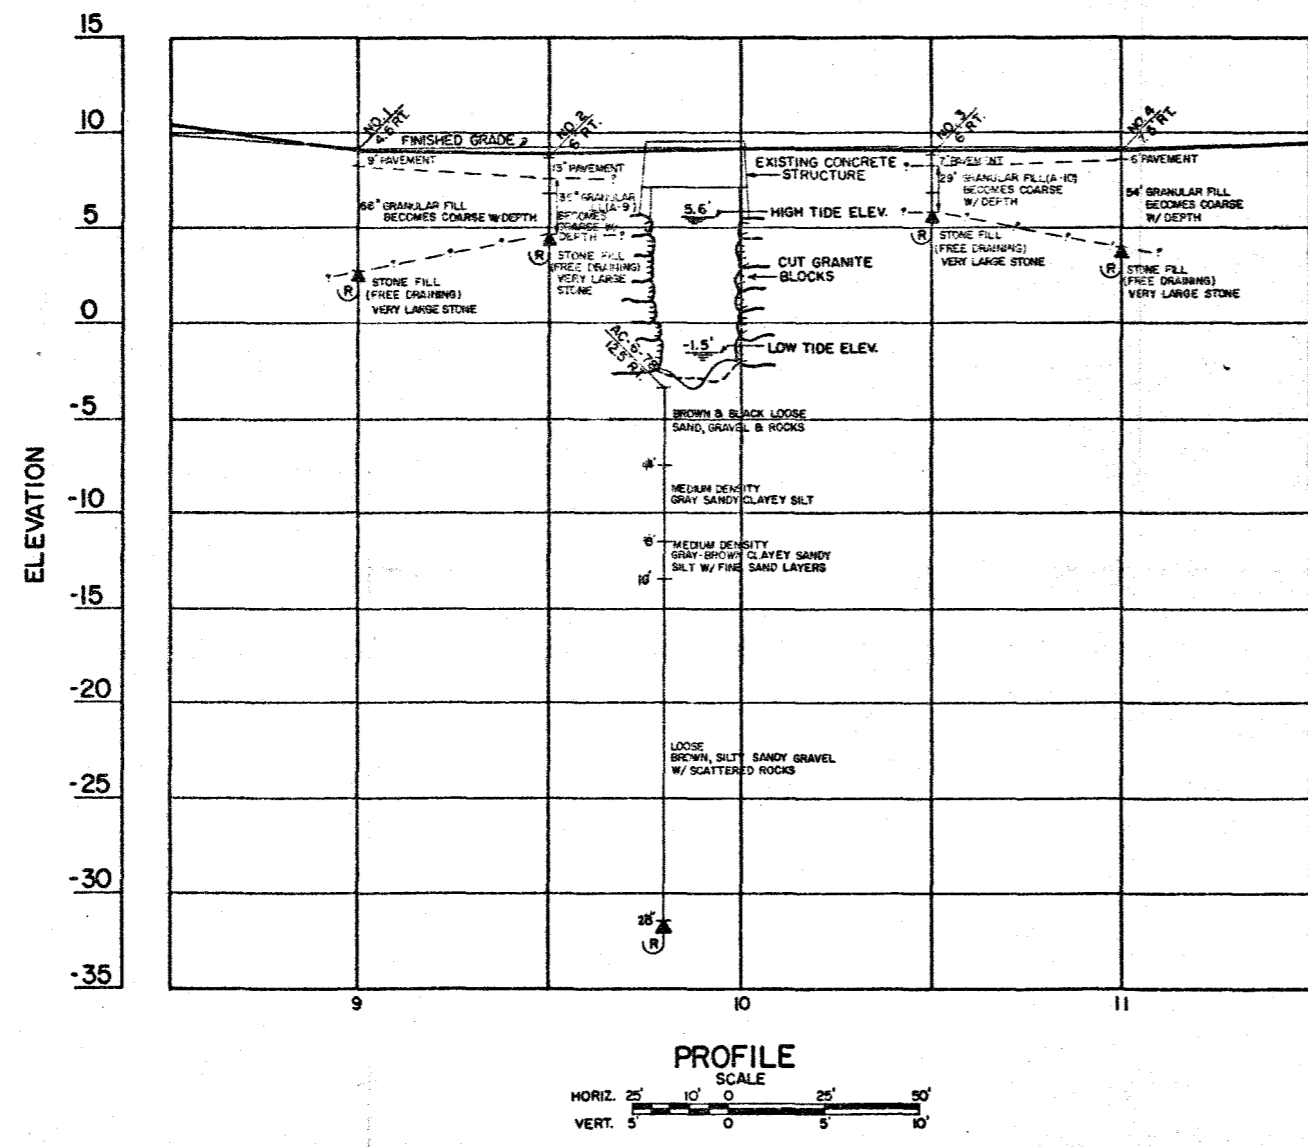
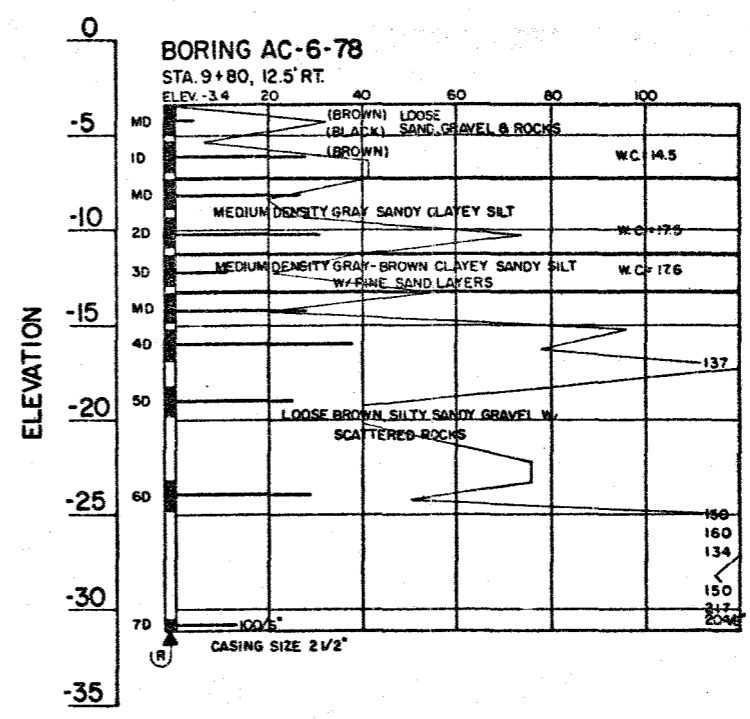
**QUARRY BIT EXPLORATIONS**

1	2	3	4
9+00, 4.5' RT.	9+50, 6' RT.	10+50, 6' RT.	11+00, 7.5' RT.
EL. 9.0'	EL. 8.7'	EL. 8.8'	EL. 9.0'
BIT PAVEMENT 5' LAYERS VISIBLE	BIT PAVEMENT 7 DIFFERENT LAYERS SAND BASE - BECOMES SANDY	BIT PAVEMENT 4 LAYERS VISIBLE SANDY BASE - BECOMES SANDY	BIT PAVEMENT 5' LAYERS VISIBLE
GRANULAR FILL BECOMES VERY COARSE BELOW 5'. LOST WATER.	GRANULAR FILL BECOMES COARSE W/ DEPTH	GRANULAR FILL BECOMES COARSE W/ DEPTH	GRANULAR FILL BECOMES COARSE W/ DEPTH
STONE FILL (FREE DRAINING) VERY LARGE STONE	STONE FILL (FREE DRAINING) VERY LARGE STONE	STONE FILL (FREE DRAINING) VERY LARGE STONE	STONE FILL (FREE DRAINING) VERY LARGE STONE
REFUSAL	REFUSAL ON LARGE STONE. LOST WATER. DRAINED THRU CAUSWAY TO LEFT AT 6'-10" BELOW ROADWAY	REFUSAL ON COARSE STONE. LOST WATER. DRAINED FROM CAUSWAY AT TIDAL FLAT LEVEL, LEFT	REFUSAL ON COARSE STONE. LOST WATER IN FREE DRAINING STONE FILL
