# Highway Bridge Inspection Report

BR# 1427

I-95 SOUTHBOUND  
Over  
STILLWATER AVENUE

Town:  
Bangor

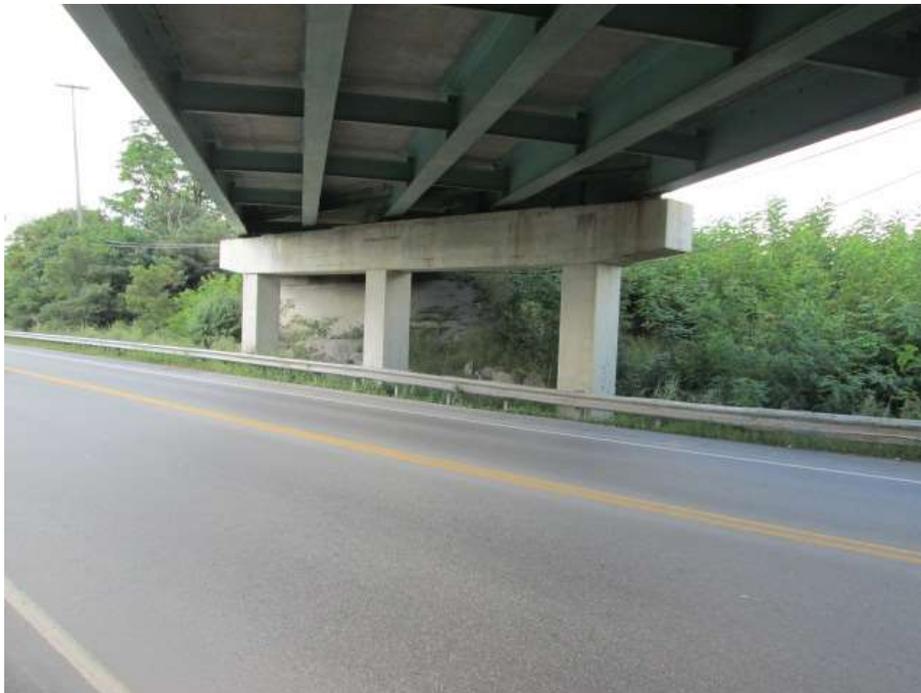
PHOTO 13

Deck underside has scattered minor cracking, patches and minor spalls with exposed rebar. large areas of wet staining interior bays. Bridge rail has scattered areas of plow scrapes and minor damage.

Description Spall bottom of deck center span
