SOILS REPORT

DRUMMOND ROAD STRUCTURE

**SUBSURFACE INVESTIGATION FOR  
DRUMMOND ROAD STRUCTURE  
INTERSTATE HIGHWAY PROJECT IN  
SIDNEY, MAINE**

**March 1958**

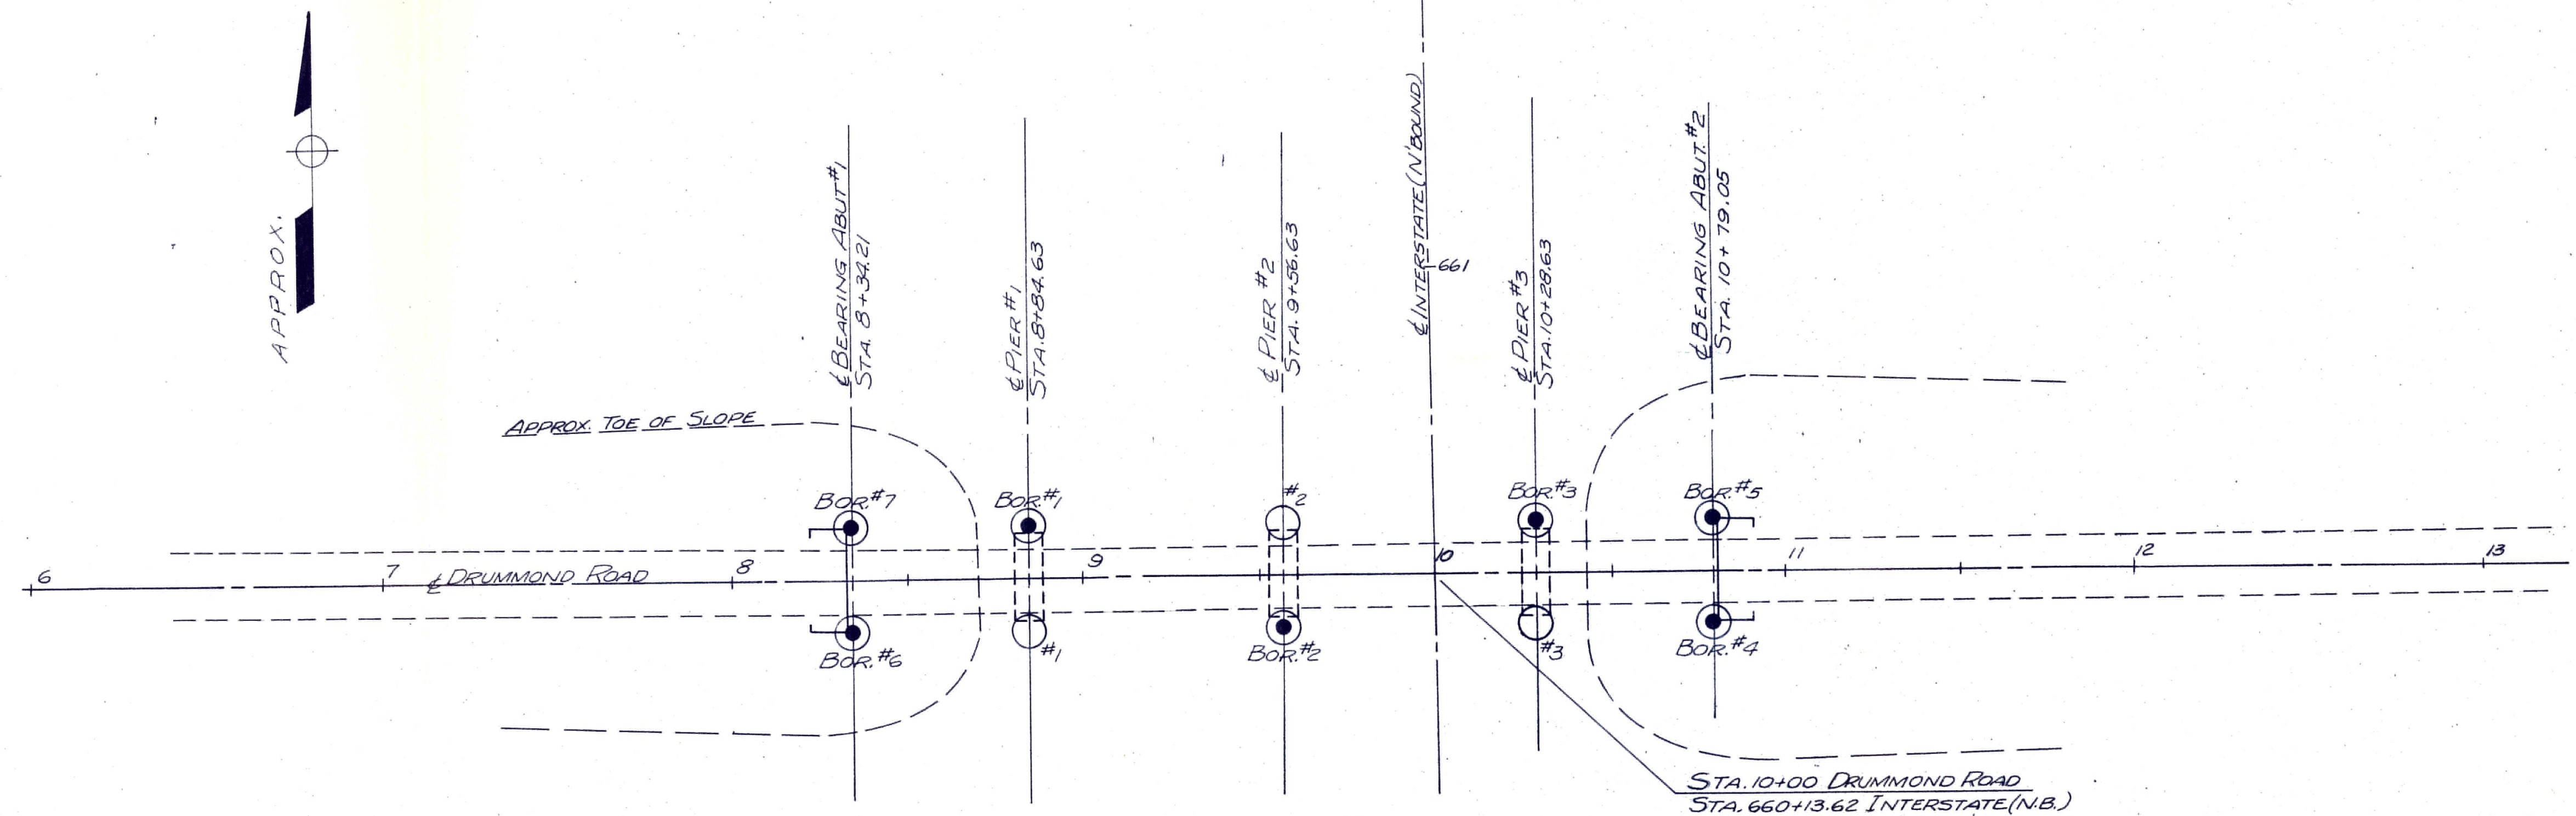
MAINE STATE HIGHWAY COMMISSION  
PLAN & PROFILE  
SIDNEY INTERSTATE  
DRUMMOND ROAD STRUCTURE  
SCALE: PLAN: 1"=30' VERT: 1"=5' DATE: 1958  
SOUTH ENGINEERING CO. 11 of 11

The ledge surface was found within five (5) feet at the surface of Abutment No. 1, and dips gradually to twenty-five (25) feet below the surface under Abutment No. 2. The overburden is divided into three (3) soils. The top and thickest layer is a weathered silty clay. Due to weathering (or drying out) the material is stiff and appears brownish gray in color. A layer of brown silty sand and gray stony silty sand complete the soils with the brown silty sand layer becoming thicker in the same direction as the ledge dips.

Borings 6 and 7 (Detailed Sheet No. 8) and the transverse profile sheet No. 2 show the underlying soil conditions at Abutment No. 1. Since ledge is shallow at this point, it is believed the abutment can be supported directly on the ledge surface. If the structure is not placed directly on ledge surface, it is believed steel piles can be driven through the compacted fill to the ledge surface. Since frictional resistance will be high in driving piles through the fill, any reduction in height of the approach fill before the piles are placed would insure the ability to drive piles to the ledge surface. Jetting may be an assistance in driving the piles through the fill.

Borings 1 and 2 (Detailed Sheets 5 and 6) were made at alternate ends of Piers 1 and 2. Since the ledge surface was found seven and one half ( $7\frac{1}{2}$ ) and nine (9) feet below the surface, rod soundings were made at the remaining alternate ends to show the transverse profile of the ledge surface, as shown on Sheet 2. Since a footing should be placed five (5) feet below the existing ground surface in order to avoid frost action, and also since the footings are usually three (3) feet thick, this would place the bottom of the footing at, or near the ledge surface. It is recommended that these two piers be supported directly on bedrock. Excavation in these sections should encounter a weathered silt with the bottom two (2) feet granular. Since the ground water table follows the ledge surface in this section, and the silt is fairly impermeable, water seepage will cause minor difficulties, easily overcome by a standard water pump.

Since the ledge surface was found between five (5) and nine (9) feet below the surface at Abutment No. 1, and Piers 1 and 2, it is recommended that these three (3) structures be supported directly on the firm durable ledge. At Pier No. 3 and Abutment No. 4, the ledge dips more than fifteen (15) feet below the surface. The overburden is a weathered clay which would
