SOILS REPORT

SUBSURFACE INVESTIGATION FOR
DENSMORE ROAD STRUCTURE
INTERSTATE HIGHWAY PROJECT
SIDNEY, MAINE

State Highway Commission
Soils Division

May 1958

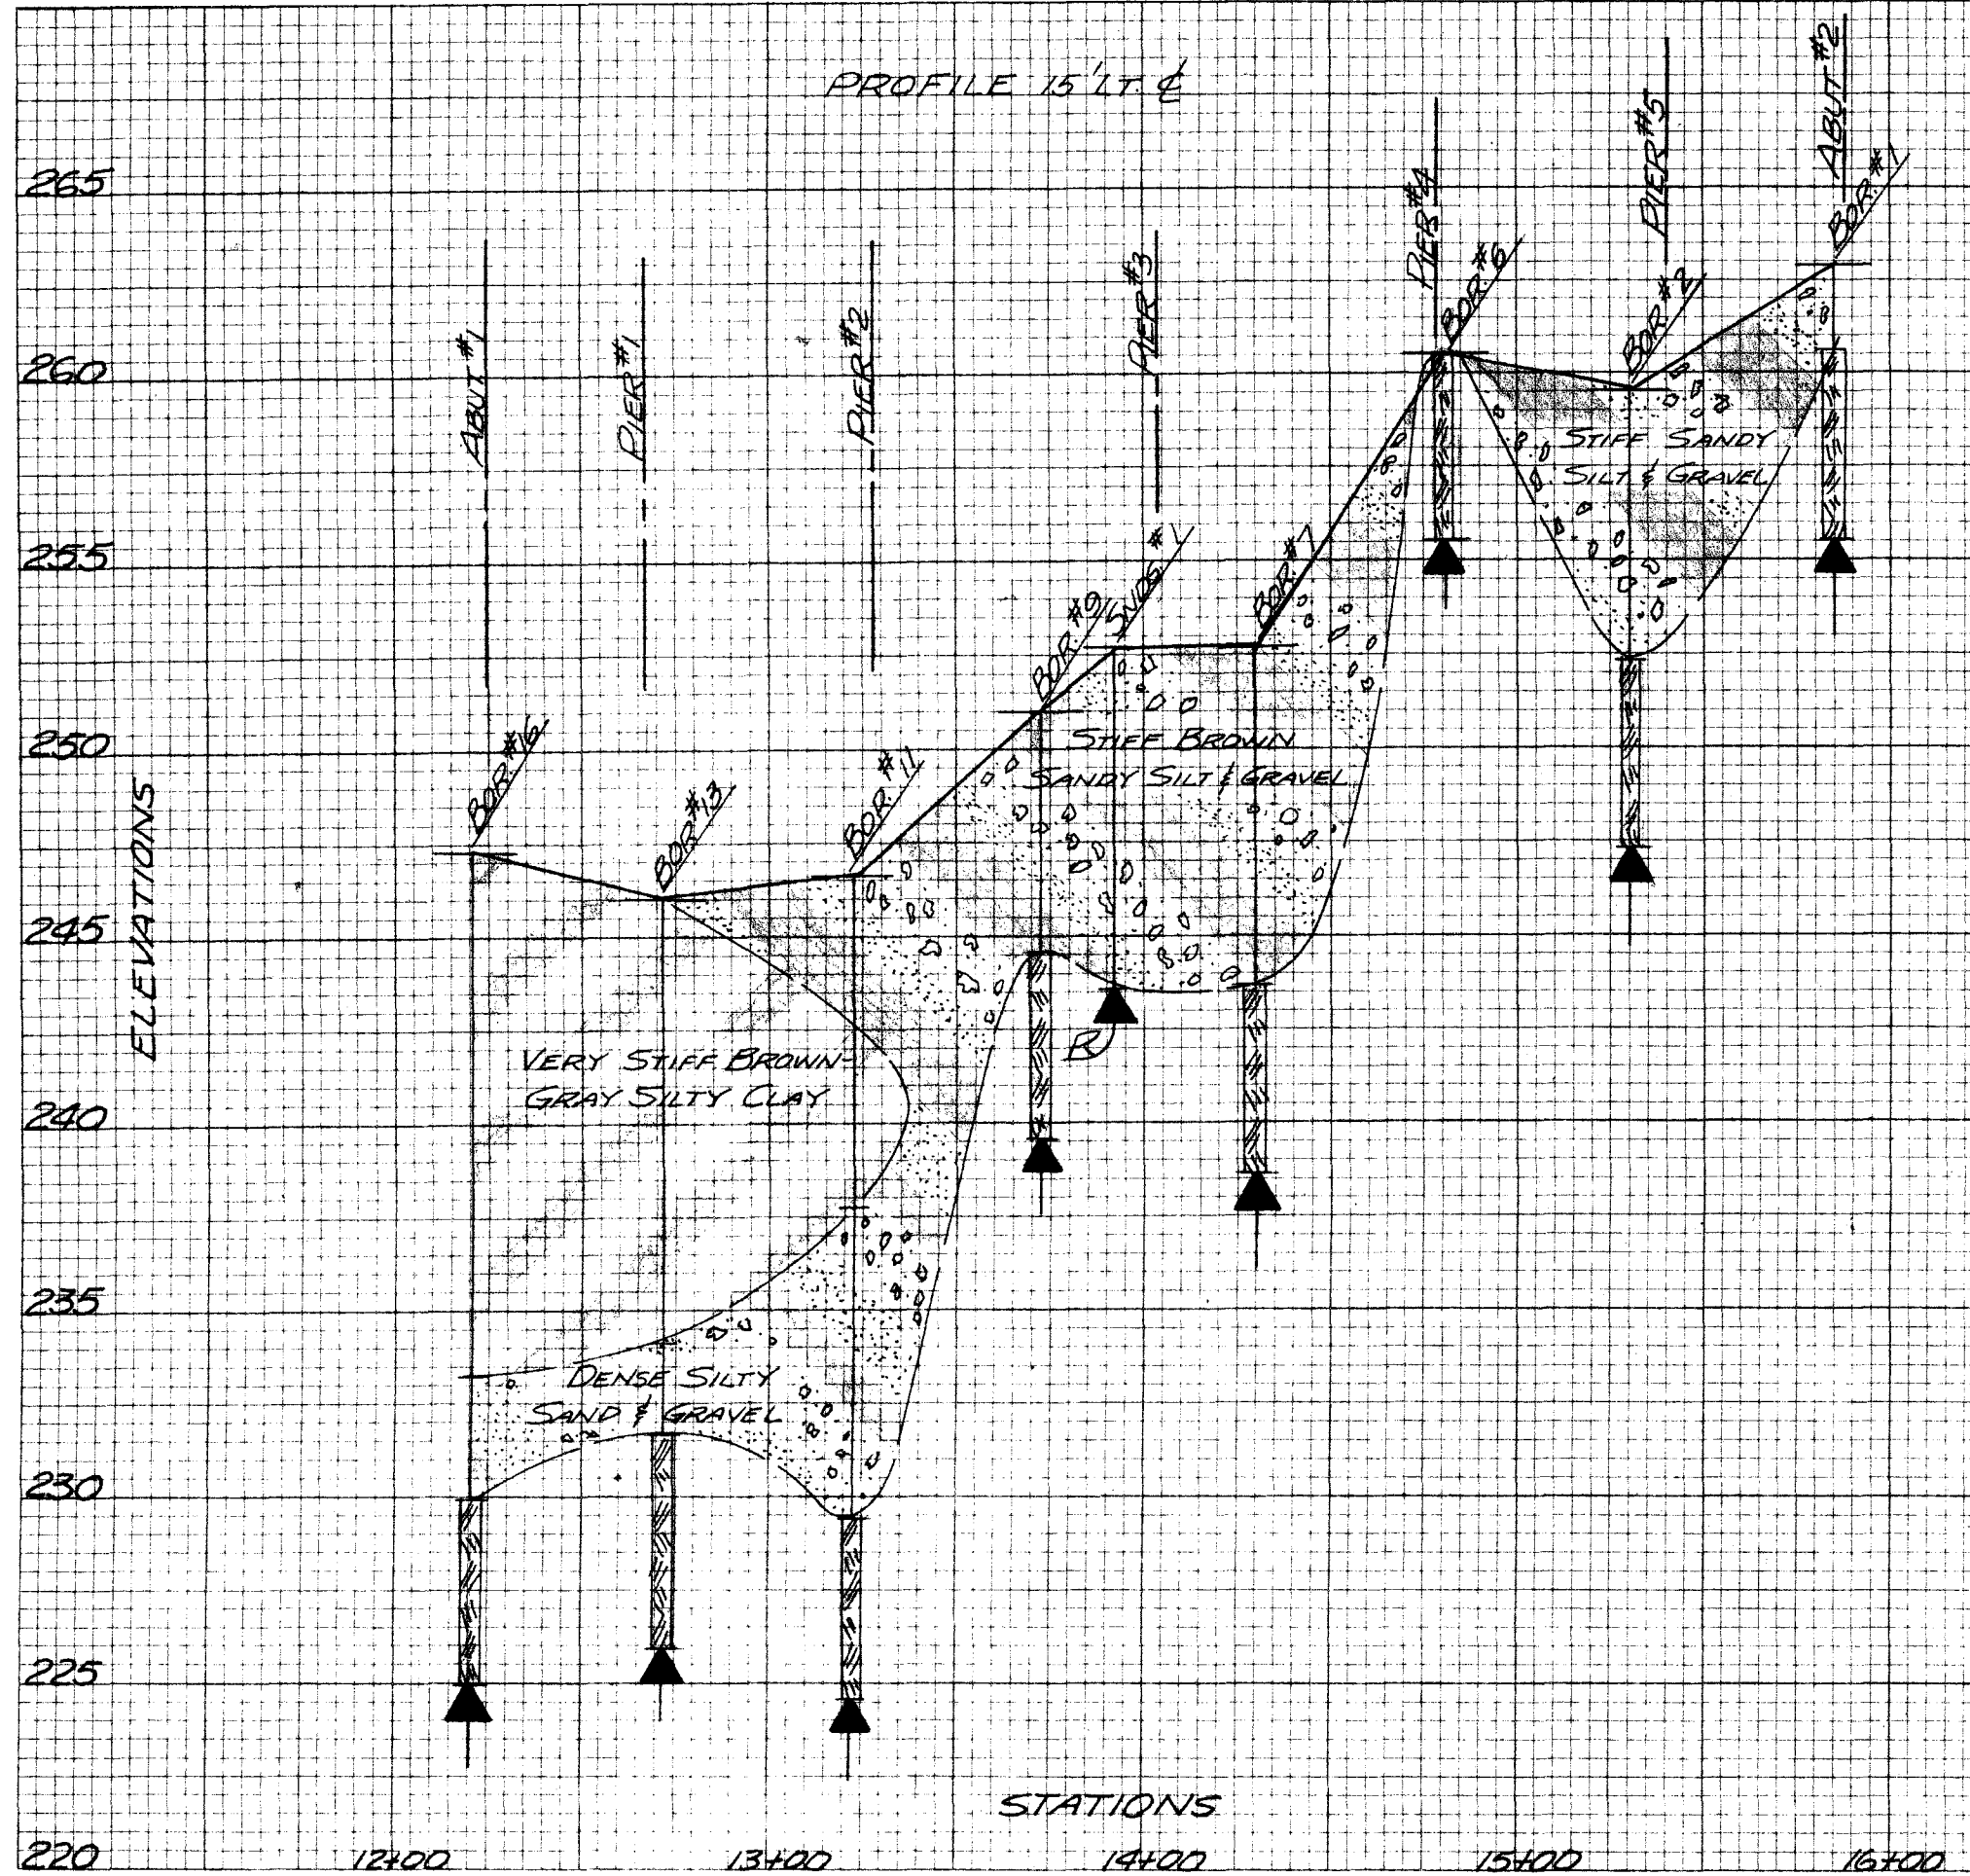
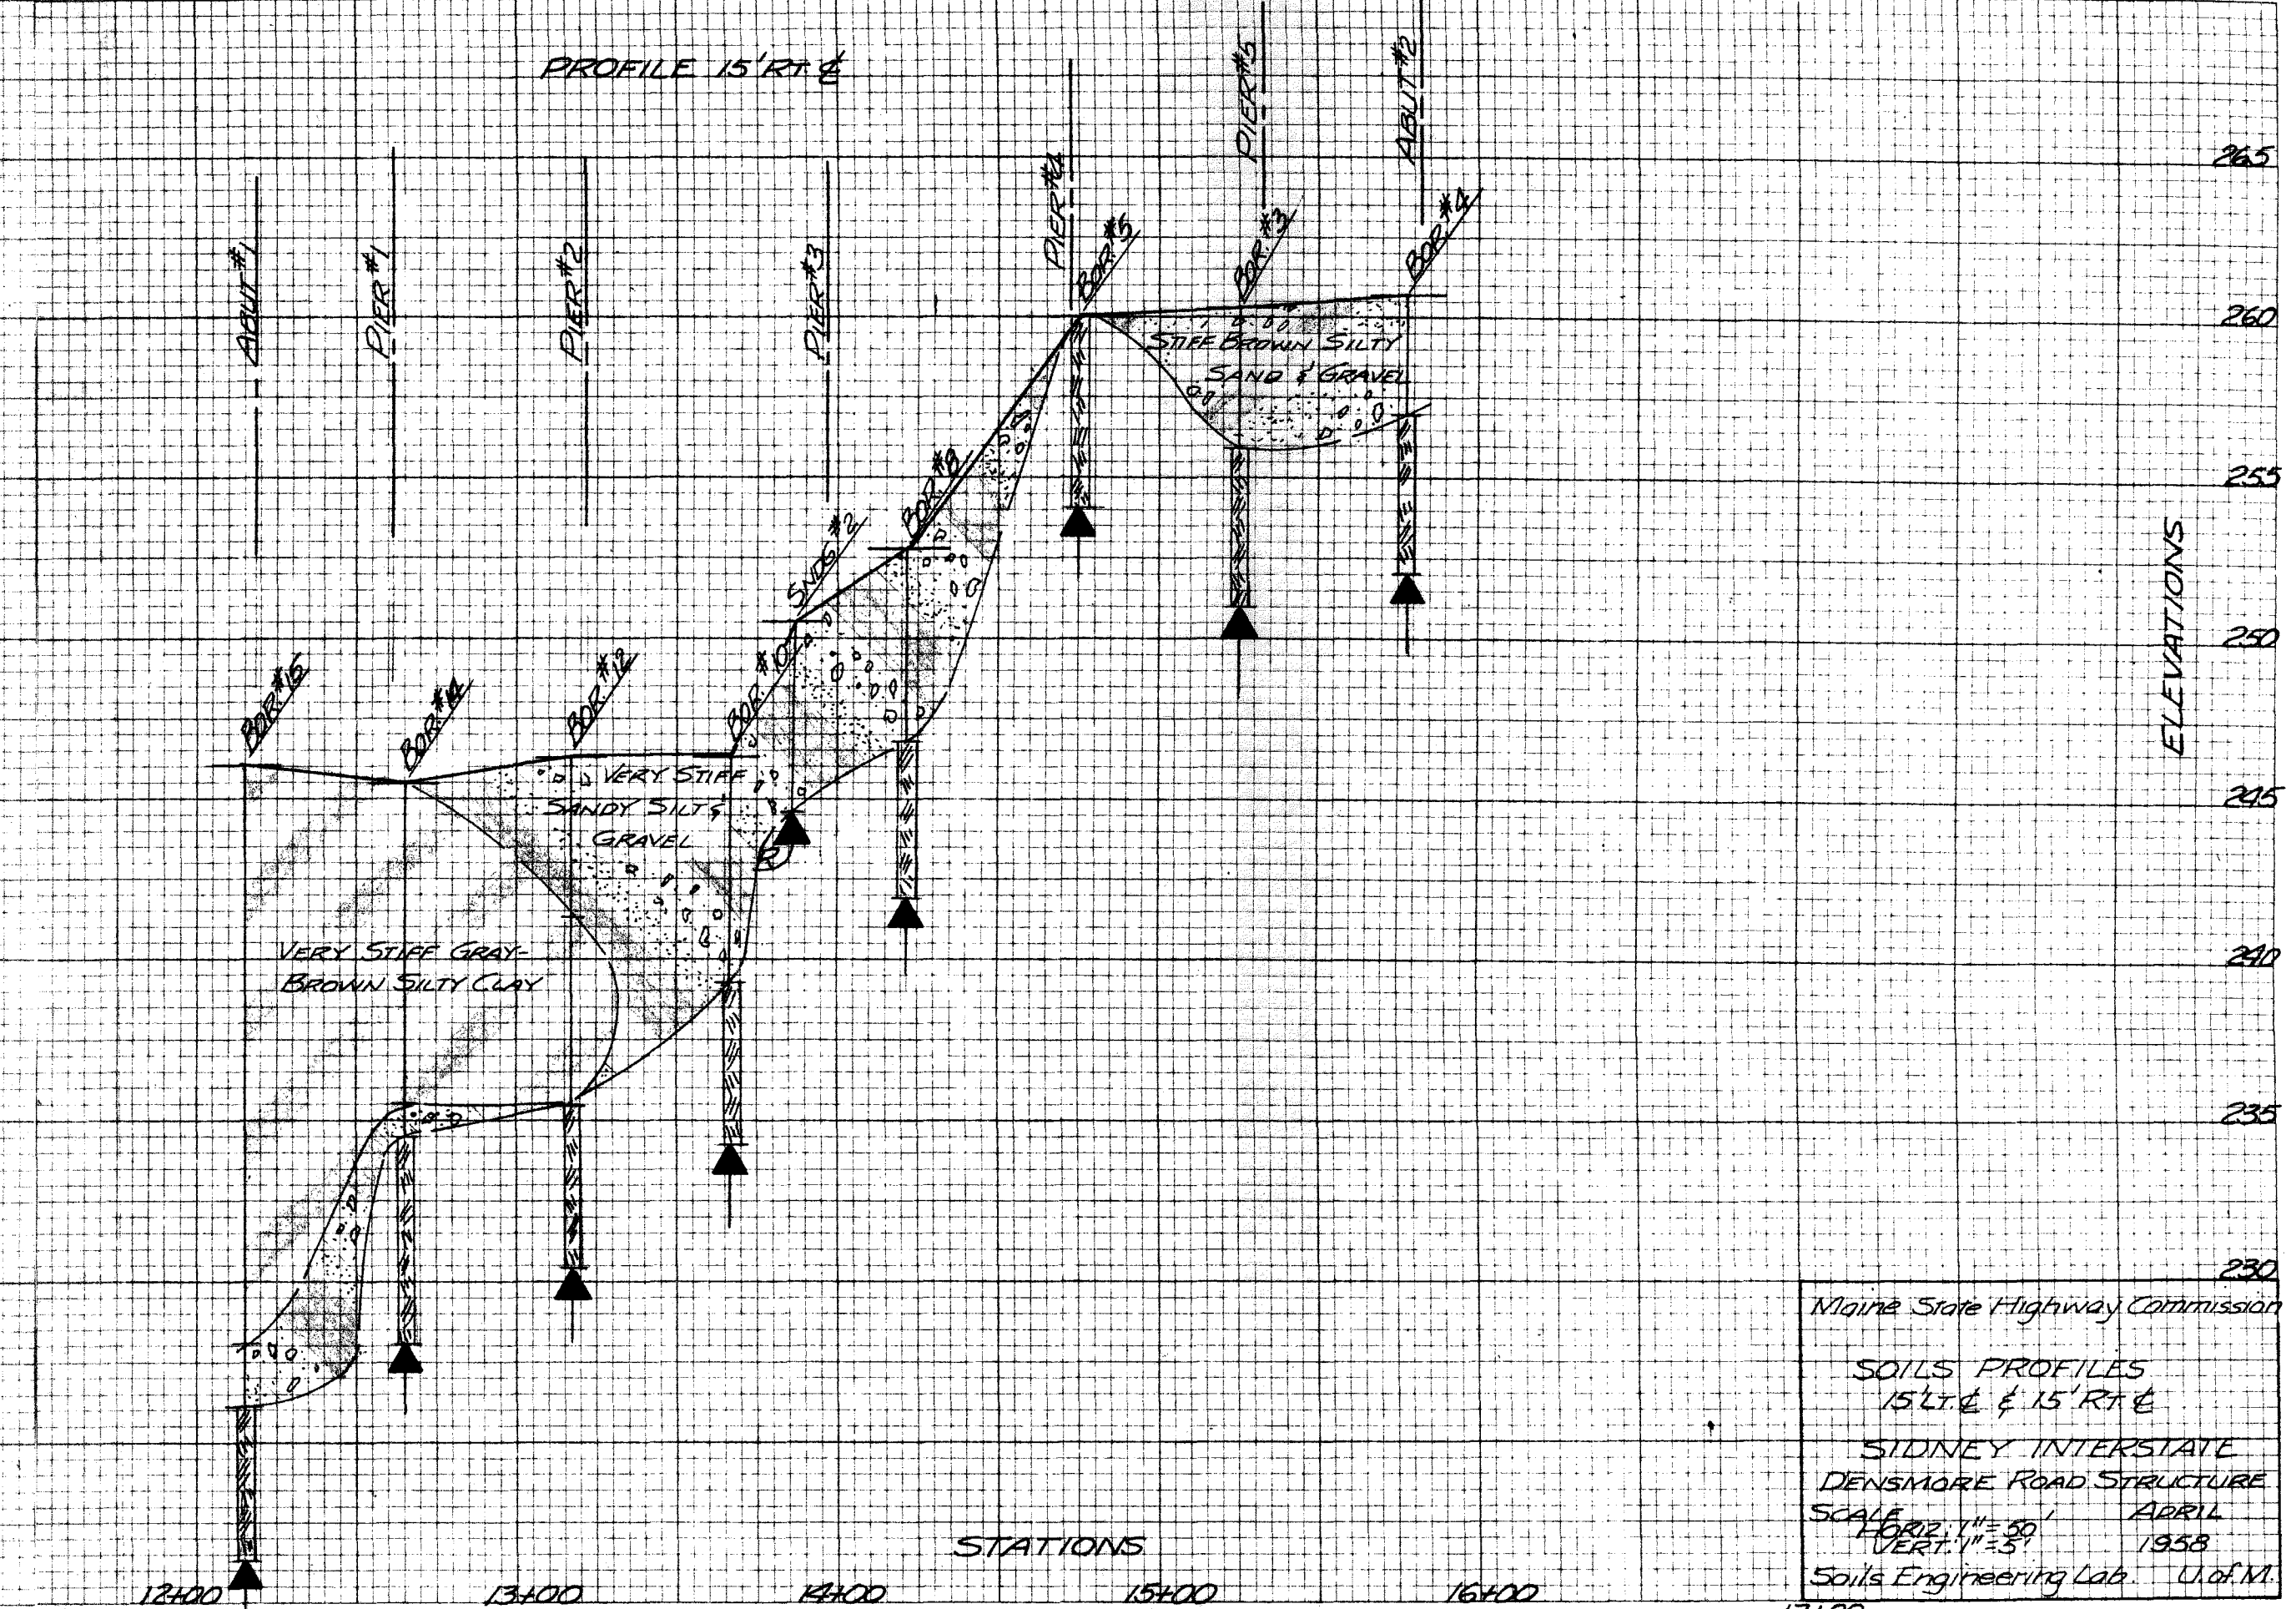
SOILS PROFILES
15' LT. E & 15' RT. E

Borings 13 and 14 (Sheets 12 and 13) and the transverse section (Sheet 4) show the underlying conditions at the proposed location of Pier No. 1. Since the overburden is stiff clay and will undergo consolidation, and the ledge surface is fourteen (14) feet below the surface, piles are recommended. It is believed that piles can be driven to ledge on the north end to elevation 231.5 and possibly to ledge on the south end with jetting at elevation 232.5.

Borings 11 and 12 (Sheets 11 and 12) and the transverse section (Sheet 4) show the underlying soils at Pier No. 2. Since the overburden is the stiff weathered silty clay and will consolidate, and the ledge surface is sixteen (16) feet below the surface, piles are recommended. It is believed piles can be driven to elevation 237.

rod soundings (Soundings 1 and 2), but the location of this pier has since been changed; approximately five (5) feet to the east. The data obtained has been interpolated to show the soils profile at Pier 3 as shown on Sheet 4. Since the ledge surface is but eight (8) feet below the surface, it is recommended that the pier be supported directly on the bedrock. If piles are used, it is believed they can be driven to the ledge surface.

Borings 5 and 6 (Sheet 8) were made three (3) feet east of the proposed location of Pier No. 4. A rod sounding crew found ledge outcrops at the proposed location and the boring data has been used to draw up the transverse profile (Sheet 4). It is recommended that the pier be supported directly on the ledge. As can be seen on the profile fifteen (15) feet either side of centerline (Sheet 3) the ledge sticks up in a pinnacle at this location. It is recommended that five (5) feet of the ledge be removed before the pier is placed to minimize any shearing in the ledge.

Borings 2 and 3 (Sheet 7) and the transverse section (Sheet 4) show the underlying soils at the proposed site of Pier No. 5. Since the ledge surface was from five to seven (5-7) feet below the ground, it is recommended that Pier 5 be supported directly on the ledge surface.
