Maine Department of Transportation

Pavement Condition Report

BRUNSWICK EXECUTIVE AIRPORT (KBXM)

To assist individual airports to effectively maintain their pavement infrastructure and help improve airport pavement conditions statewide, the Maine Department of Transportation (MaineDOT) contracted with DuBois & King, Inc. (D&K) to provide pavement evaluation surveys at local airports. Assisting D&K on this effort was Applied Research Associates, Inc. (ARA). This report documents the pavement condition at Brunswick Executive Airport (BXM) in October 2018.

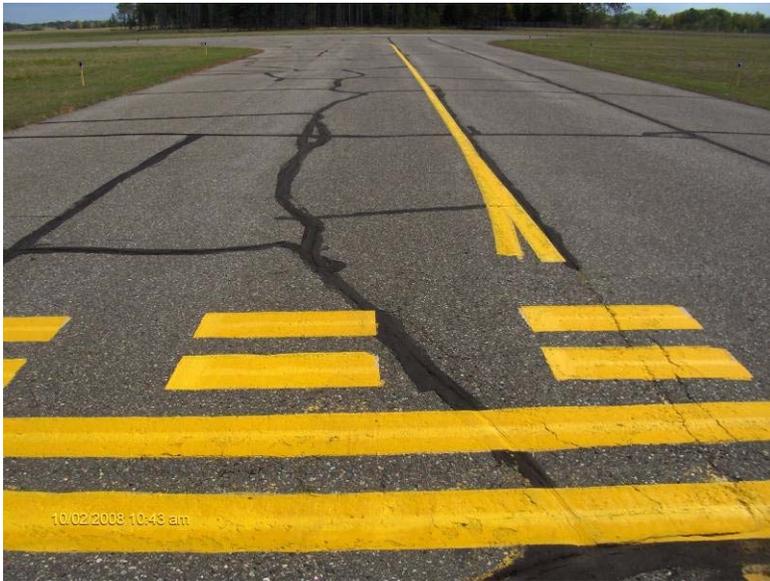
Example of Longitudinal and Transverse Cracking (L&T cracking)

Longitudinal and transverse cracks are caused by pavement aging, by construction, and by subsurface movement. Aging occurs as pavement loses some of its components to the atmosphere and becomes more brittle. Consistent application of pavement sealcoats can help to prevent the occurrence of age related cracks. Cracks will also develop along poorly constructed paving lane joints. Ensuring that joints are made when both sides are still hot, and near the same temperature, is one of the best ways to mitigate this potential problem. Seasonal movement caused by changes in moisture content or temperature differences can also cause pavement cracks. Asphalt pavement placed over a PCC pavement or cement stabilized base course may evidence reflective cracking from the underlying material. Longitudinal and transverse cracks are not caused by wheel loads, although traffic may worsen their condition.

Low severity longitudinal and transverse cracks are less than $\frac{1}{4}$ inch wide, or if sealed with suitable filler material in satisfactory condition can be any width, less than 3 inches, if they are not spalled. Maintenance usually is not indicated for low-severity cracking. Moderately spalled cracks and cracks wider than $\frac{1}{4}$ inch which are not satisfactorily sealed are at medium severity. Medium-severity cracks should be sealed with a high-quality crack filling material. Severely spalled cracks and cracks wider than 3 inches are at high severity. High-severity L&T cracks normally require patching.

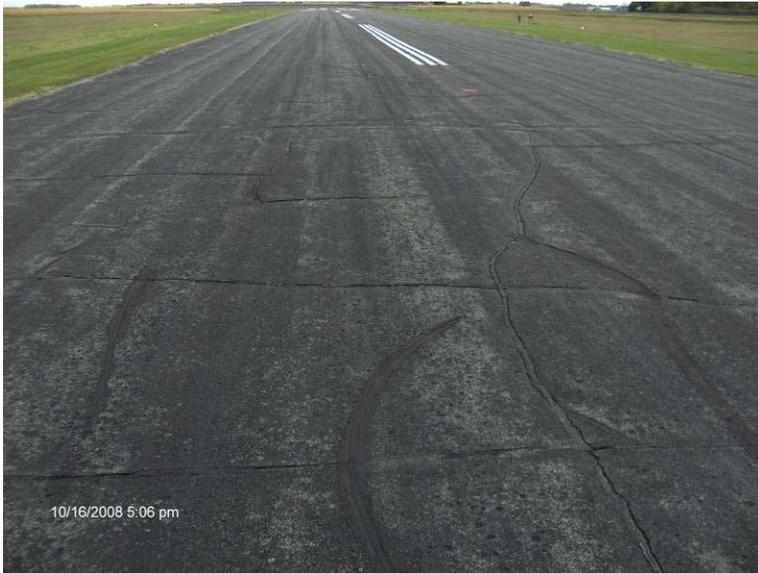
Example of Block Cracking

Block cracking is longitudinal and transverse cracking that has established a pattern of blocks ranging in size from 1ft x 1ft to 10ft x 10ft. This distress typically happens in older asphalt pavements and is an indication that the bituminous binder has lost most of its flexibility. The severity determination is basically determined by the crack width criteria defined for longitudinal and transverse cracking. Crack sealing typically is used to repair block cracking; however, the amount of required sealant can be extensive due to the high density of cracks.

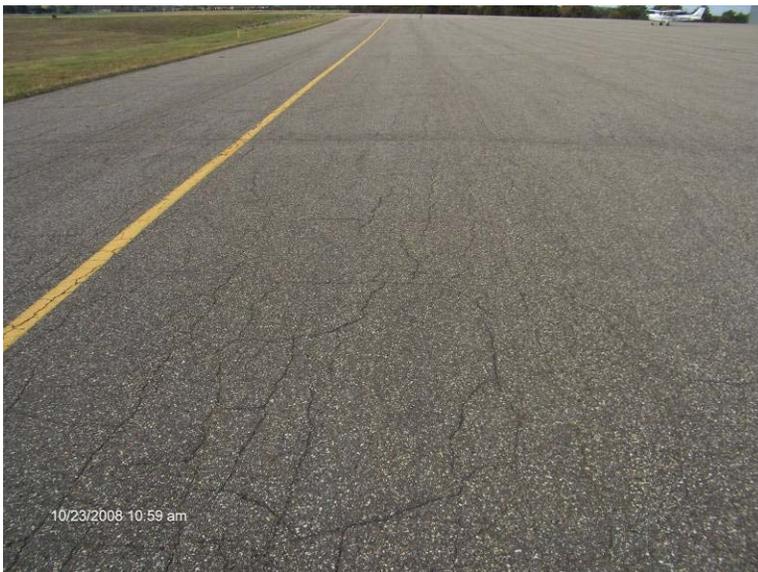
Example of Alligator Cracking

Alligator (or fatigue) cracks are a series of interconnected load-related cracks caused by fatigue of the asphalt surface. Alligator cracking is a significant structural distress and develops only in places subject to traffic loads. These cracks typically initiate at the bottom of the asphalt layer (where tensile strains

are highest) and propagate upward - so once a fatigue crack is visible, significant damage has already occurred.

At low severity, alligator cracks are evidenced by a series of parallel hairline cracks (usually in a wheel path). Further traffic and deterioration leads to the interconnection of these cracks. Medium severity alligator cracking is a well-defined pattern of interconnected cracks, some spalling may be present. High severity alligator cracks have lost aggregate interlock between adjacent pieces, the cracks may be severely spalled with FOD potential, and most likely the pieces will move freely under traffic. Alligator cracking is a structural failure and cannot be repaired with sealant, the proper repair is full-depth patching.

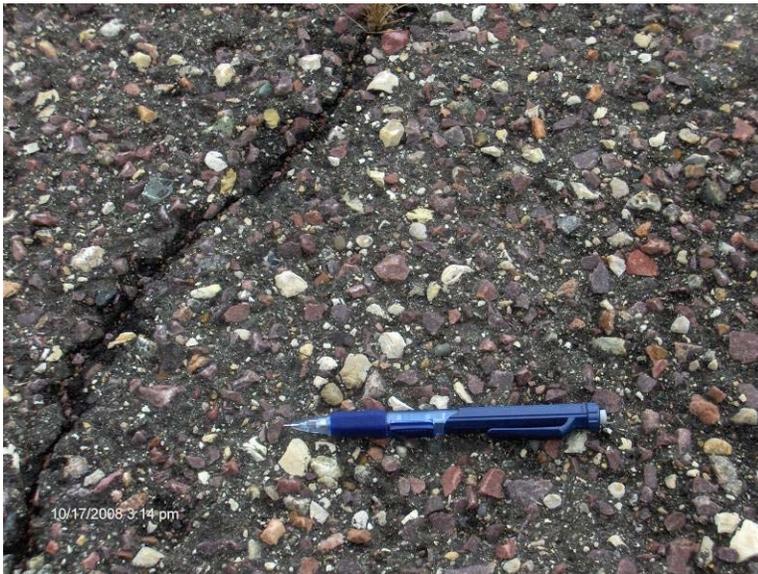
Example of Raveling/Weathering

Raveling and weathering are the wearing away of the pavement surface. Raveling is the condition where the mid- to large size aggregates are becoming dislodged; weathering is when the fine aggregate wears away exposing the edges of the larger aggregate. These distresses are usually evident over large areas and may occur together (pictured above) or separately. Raveling and weathering may indicate that the asphalt binder has hardened significantly.

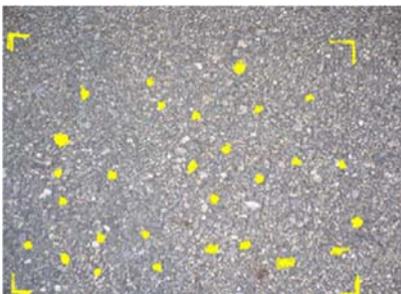
Raveling – At low severity, the number of missing coarse aggregates (> 3/8 inch) is between 5-20 missing/yd², medium severity (pictured below where the missing coarse aggregates have been dotted with yellow paint) is 21-40 missing/yd², and high severity is > 40 missing/yd².

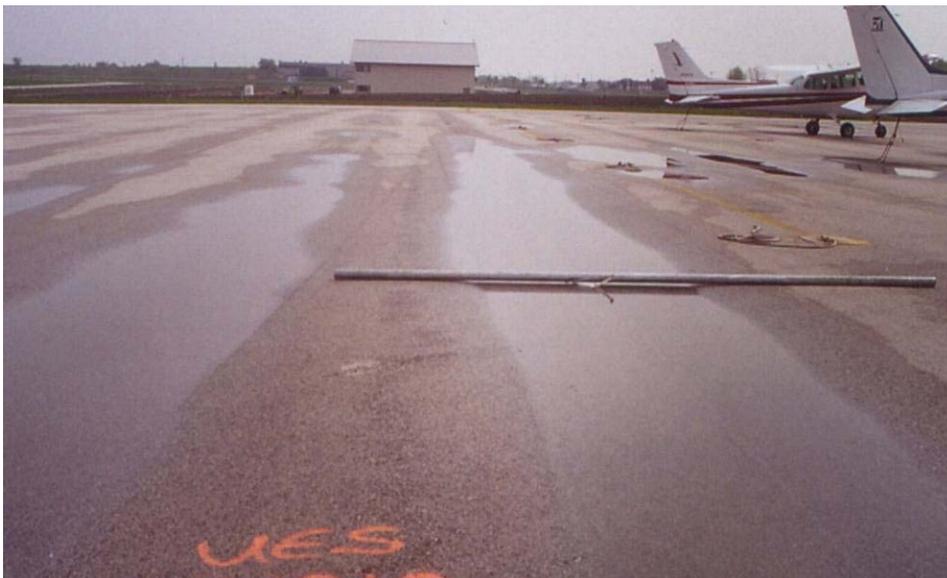
Example of Rutting

Ruts are localized, load related, areas of pavement having elevations lower than the surrounding sections. Rutting is due to base and subgrade consolidation, caused by excessive wheel loads or poor compaction. Ruts indicate structural failure, and can cause hydroplaning. At low severity, ruts have an

average depth of ¼ to ½ inches. At medium severity, ruts have an average depth of ½ to 1 inch. High severity, ruts have an average depth greater than 1 inch. Full-depth patching is the appropriate repair for ruts.

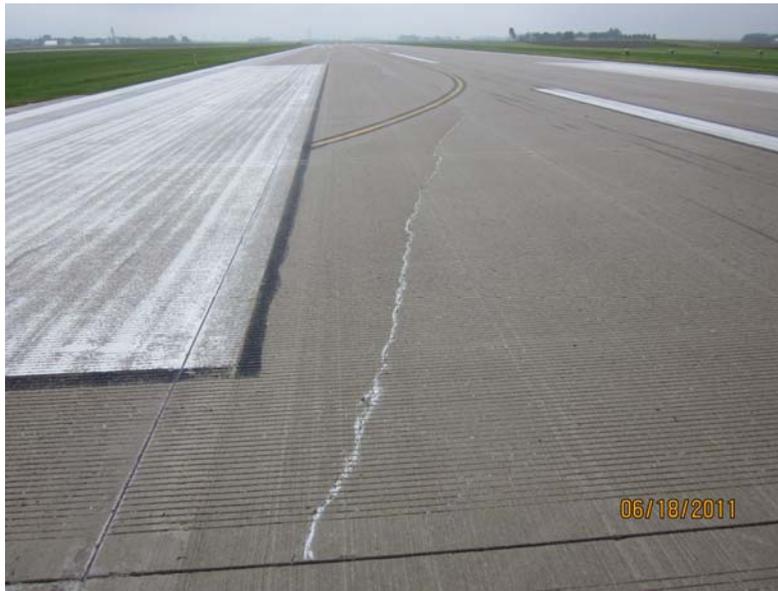
Example of Longitudinal, Transverse, and Diagonal Cracking

LTD cracking is most often a result of externally applied loads and/or constrained temperature deformations. External loads cause LTD cracking through flexure. Temperature changes on restrained slabs will result in stresses due to friction or curling. When any of these stresses exceed the strength of the slab, cracking will occur. LTD cracking is recorded at low, medium, or high severity, depending on the width of crack opening and degree of deterioration. At low severity, the crack is less than 1/8th inch wide with little spalling and no corrective action is indicated. At medium severity, LTD cracks can be up to 1 inch wide with moderate spalling, and should be repaired and sealed using procedures similar to joint sealing. At high severity, cracks exceed 1 inch in width and may be severely spalled. High-severity LTD cracking is evidence of serious load failure of the slab, and correction may require patching or slab replacement. If the distress occurs in several adjacent slabs at medium or high severity, major rehabilitation of that pavement area is indicated.

When a slab is divided by LTD cracks into four or more pieces, the slab is said to be "divided" or "shattered." Shattered slab is a separate distress category and is indicative of significant structural failure as the slab loses its ability to distribute loads to subgrade and further slab deterioration can be expected. Shattered slabs are rated in three severities, with slab replacement recommended for medium and high severities.

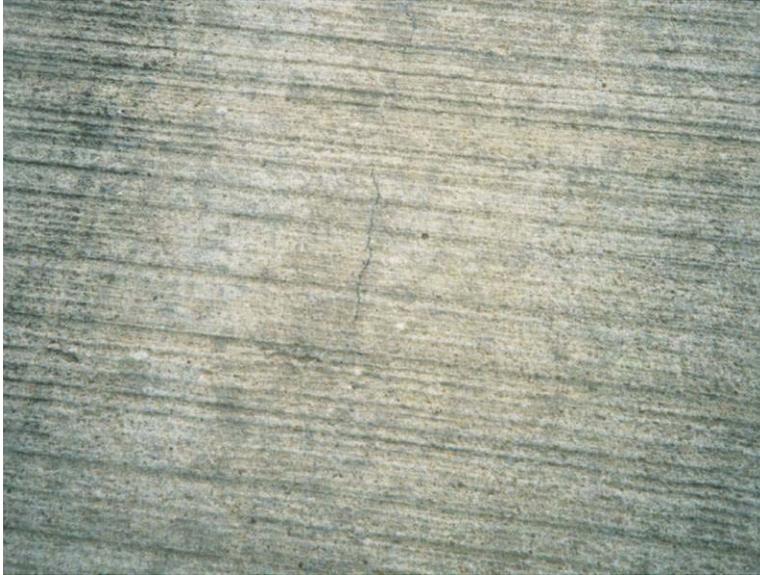
Example of Shrinkage Cracking

Shrinkage cracks are small, nonworking (no spalling along edge) cracks that are visible at the surface but do not penetrate through the full depth of concrete. Shrinkage cracks most commonly occur shortly after construction due to concrete shrinkage during the curing process. Shrinkage cracks are usually so small that they are not visible until staining or material loss at crack edges begins to take place. Shrinkage cracks do not represent a structural weakness, and no corrective action is prescribed.

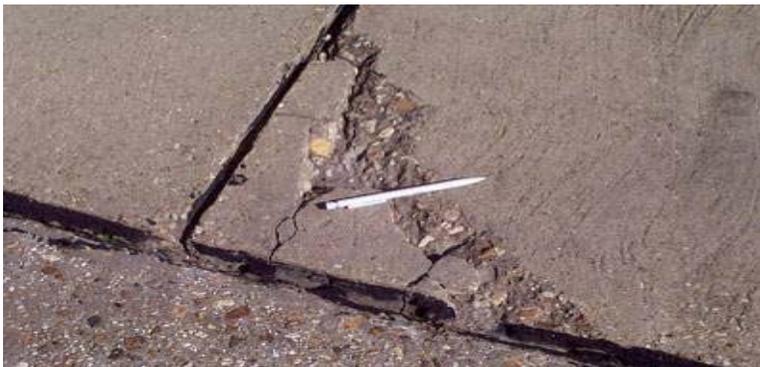
Example of Joint and Corner Spalling

Spalls at slab joints and corners are caused by excessive internal stress in the pavement. Spalls occur when these stresses exceed the shear strength of the concrete. Spalling usually results from thermal expansion during warm or hot weather. As slabs expand, they push against one another at joints. If the joints are filled with incompressibles, such as sand, or if adjacent slabs offset slightly, stresses can become severe, causing spalls. Spalling can be reduced significantly by conscientious maintenance of joint sealant.

Spall repair requires patching. The extent and severity of spalling on a pavement surface suggests appropriate action. For example, at low severity, spalled concrete remains securely in place in the slab. A low-severity spall should be monitored closely for further deterioration and should be patched when

spalled particles become loose in place, or at the next scheduled patching activity in the section. Medium- and high-severity spalls should be repaired immediately to prevent the incidence of FOD. If the pavement can be restored to serviceable condition, spalls should be carefully patched for long-term service. If the pavement is beyond repair, temporary patching should be considered to control FOD.

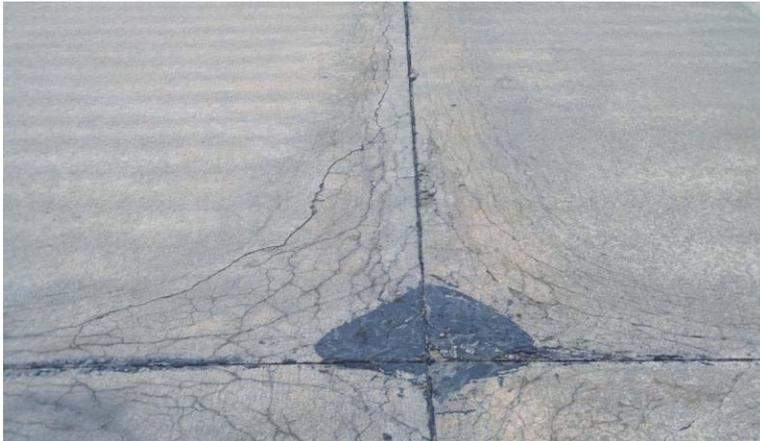
Example of Durability Cracking

Durability cracking (D-cracking) is caused by environmental factors, the most common of which is freezing/thawing. It usually appears as a pattern of hairline cracks running parallel to a joint or crack, or in a corner, where water tends to collect. This type of cracking eventually leads to disintegration of the pavement, creating FOD potential. At low severity, D-cracking is evident, but no disintegration has occurred. As the distress advances to medium severity, the distress pattern is evident over a significant area of the slab, and some disintegration and FOD potential exists. High severity durability cracking is evidenced by extensive cracking with loose and missing pieces and significant FOD potential.

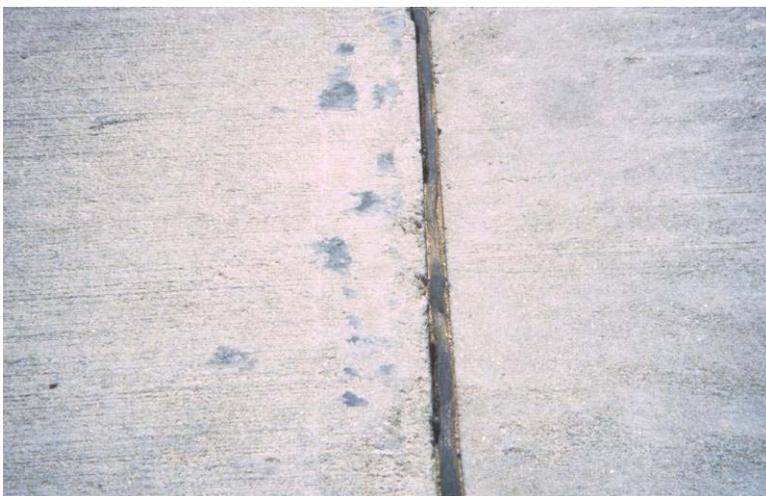
Example of Joint Seal Damage

Joint seal damage is recorded at three severities: low, medium, and high. When joint sealant is in perfect condition (no damage), it is not a distress. At low severity, at least 10 percent of the sealant is debonded but still in contact with the joint edges (i.e., joint sealant is in serviceable condition but should

be monitored for evidence of more serious failure). Medium-severity joint seal damage is recorded when at least 10 percent of the sealant has visible gaps smaller than 1/8th inch and is an indicator that replacement should be programmed as soon as is practicable. In the meantime, aggressive inspection and sustaining maintenance is recommended to minimize subsurface damage from moisture penetration. At high severity, visible gaps exceed 1/8th inch and the amount and degree of joint seal damage is such that repair is no longer feasible. The only appropriate corrective action is sealant replacement.

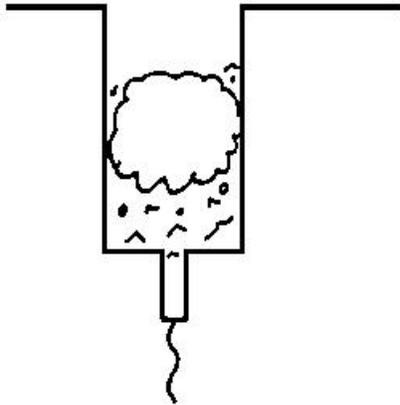
Typical joint with deficient sealant and a collection of debris & incompressibles.
