Pavement Condition Report

LORING INTERNATIONAL AIRPORT (ME 16)

LORING COMMERCE CENTRE

Submitted To:
Maine Department of Transportation
16 State House Station
Augusta, ME 04333

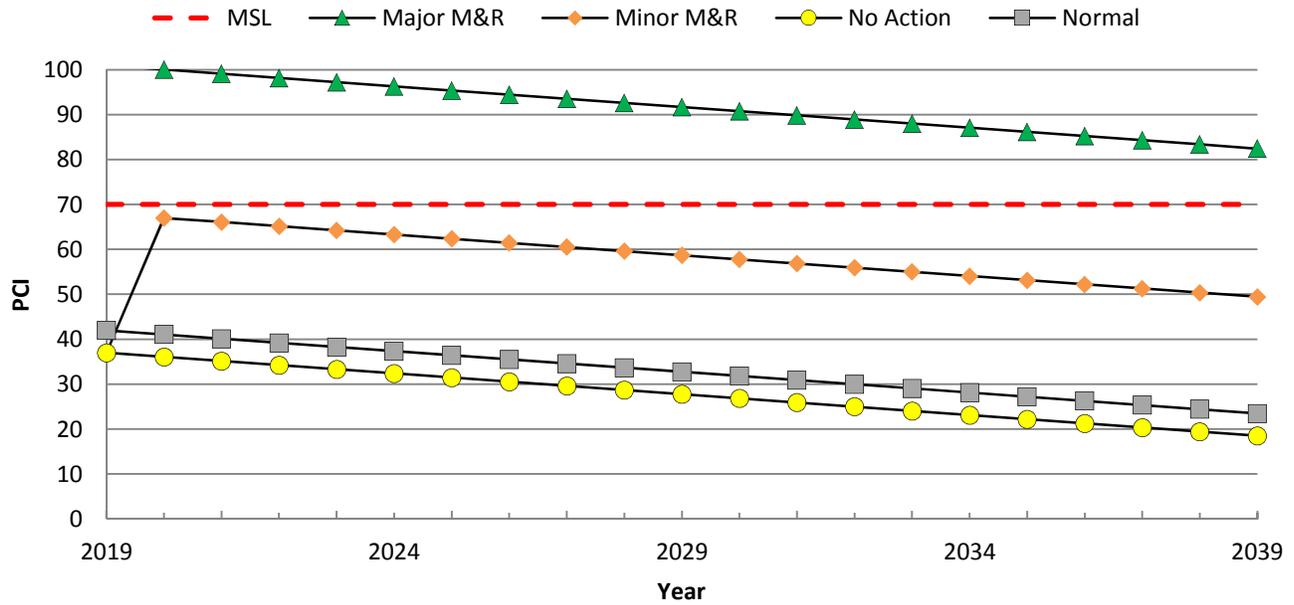
Runway 1-19

Extrapolated Distress:	Type	Quantity	Severity	Units
1	corner break	6	low	Slabs
2	corner spall	6	high	Slabs
3	d-crack	2	medium	Slabs
4	joint spall	6	high	Slabs
5	jt seal dmg	160	medium	Slabs
6	large patch	2	medium	Slabs
7	ltd crack	60	low	Slabs
8	ltd crack	38	medium	Slabs
9	ltd crack	2	high	Slabs
10	scaling	24	low	Slabs
11	scaling	2	medium	Slabs
12	shattered slab	4	low	Slabs
13	shattered slab	8	medium	Slabs
14	shrinkage	4	n/a	Slabs
15	small patch	2	low	Slabs
16	small patch	2	medium	Slabs
17	-	-	-	-
18	-	-	-	-
19	-	-	-	-
20	-	-	-	-

M&R	Action	Year / Quantity	Cost (\$)	Ending PCI
Major	Major M&R	2020	3,101,011	100
Minor	All Minor	2020	255,880	67
1	Slab Replacement - PCC	6250 SqFt	197,188	-
2	Joint Seal (Localized)	6900 Ft	26,565	-
3	Patching - PCC Full Depth	205 SqFt	24,401	-
4	Patching - PCC Partial Depth	65 SqFt	3,993	-
5	Crack Sealing - PCC	950 Ft	3,734	-
6	-	-	-	-
7	-	-	-	-

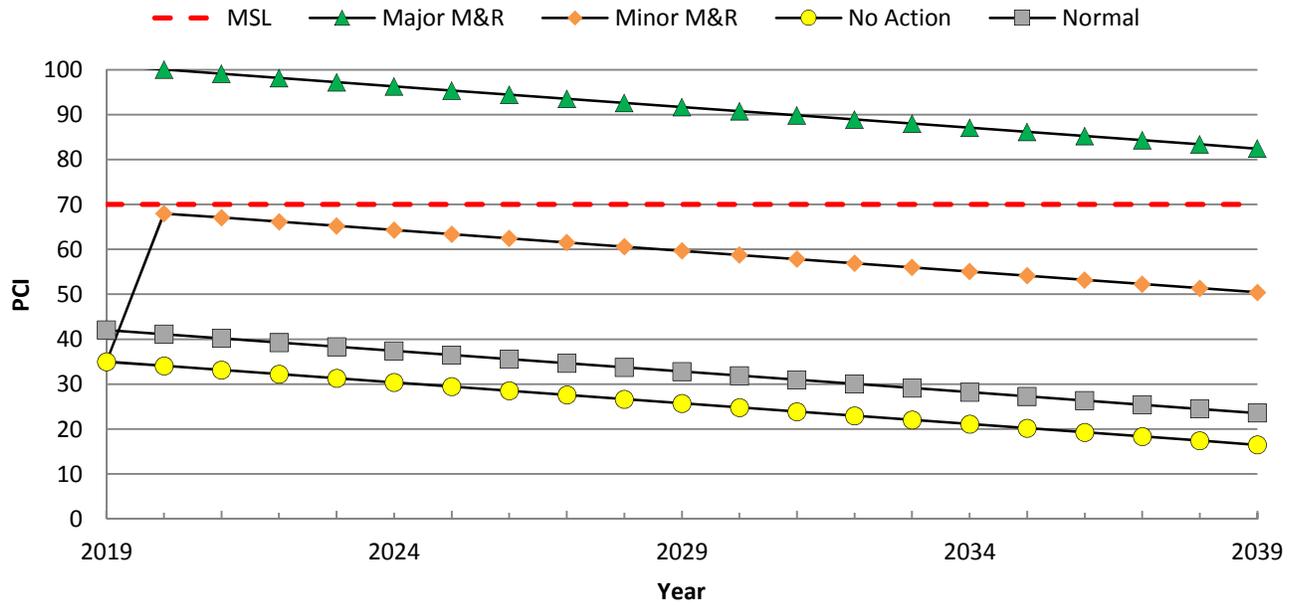
Runway 1-19

Extrapolated Distress:	Type	Quantity	Severity	Units
1	corner break	3	medium	Slabs
2	corner spall	3	medium	Slabs
3	jt seal dmg	274	medium	Slabs
4	jt seal dmg	46	high	Slabs
5	ltd crack	174	low	Slabs
6	ltd crack	71	medium	Slabs
7	scaling	3	medium	Slabs
8	shattered slab	31	low	Slabs
9	shattered slab	17	medium	Slabs
10	shattered slab	3	high	Slabs
11	shrinkage	3	n/a	Slabs
12	-	-	-	-
13	-	-	-	-
14	-	-	-	-
15	-	-	-	-
16	-	-	-	-
17	-	-	-	-
18	-	-	-	-
19	-	-	-	-
20	-	-	-	-

M&R	Action	Year / Quantity	Cost (\$)	Ending PCI
Major	Major M&R	2020	6,202,021	100
Minor	All Minor	2020	469,827	68
1	Slab Replacement - PCC	12500 SqFt	394,375	-
2	Joint Seal (Localized)	14800 Ft	56,980	-
3	Patching - PCC Full Depth	93 SqFt	10,979	-
4	Crack Sealing - PCC	1786 Ft	7,018	-
5	Patching - PCC Partial Depth	8 SqFt	475	-
6	-	-	-	-
7	-	-	-	-

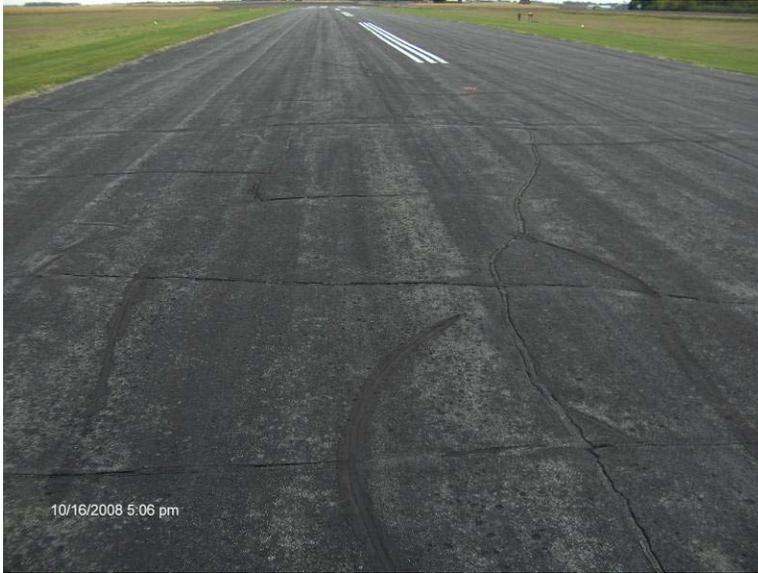
Example of Block Cracking

Block cracking is longitudinal and transverse cracking that has established a pattern of blocks ranging in size from 1ft x 1ft to 10ft x 10ft. This distress typically happens in older asphalt pavements and is an indication that the bituminous binder has lost most of its flexibility. The severity determination is basically determined by the crack width criteria defined for longitudinal and transverse cracking. Crack sealing typically is used to repair block cracking; however, the amount of required sealant can be extensive due to the high density of cracks.

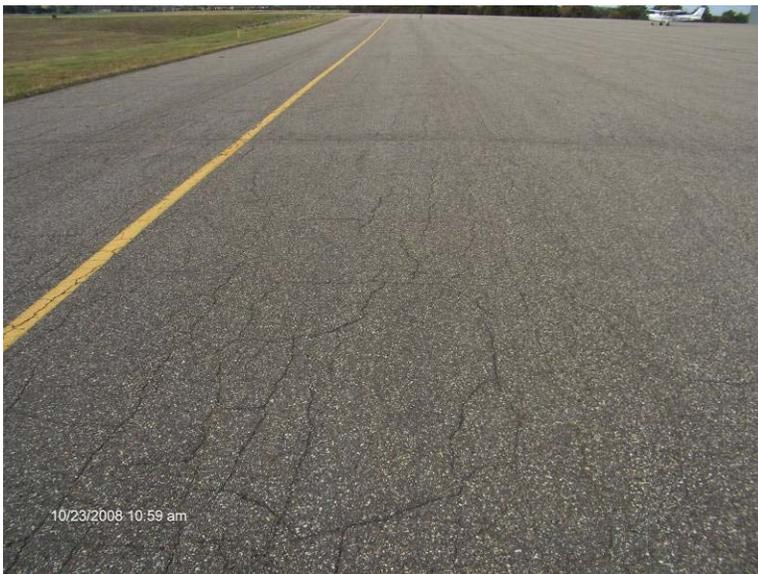
Example of Alligator Cracking

Alligator (or fatigue) cracks are a series of interconnected load-related cracks caused by fatigue of the asphalt surface. Alligator cracking is a significant structural distress and develops only in places subject to traffic loads. These cracks typically initiate at the bottom of the asphalt layer (where tensile strains

are highest) and propagate upward - so once a fatigue crack is visible, significant damage has already occurred.

At low severity, alligator cracks are evidenced by a series of parallel hairline cracks (usually in a wheel path). Further traffic and deterioration leads to the interconnection of these cracks. Medium severity alligator cracking is a well-defined pattern of interconnected cracks, some spalling may be present. High severity alligator cracks have lost aggregate interlock between adjacent pieces, the cracks may be severely spalled with FOD potential, and most likely the pieces will move freely under traffic. Alligator cracking is a structural failure and cannot be repaired with sealant, the proper repair is full-depth patching.

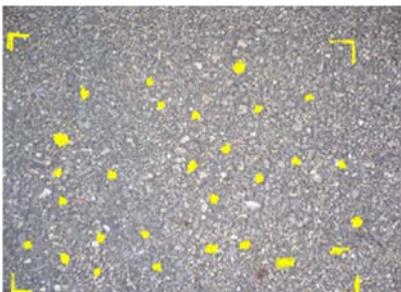
Raveling – At low severity, the number of missing coarse aggregates (> 3/8 inch) is between 5-20 missing/yd², medium severity (pictured below where the missing coarse aggregates have been dotted with yellow paint) is 21-40 missing/yd², and high severity is > 40 missing/yd².

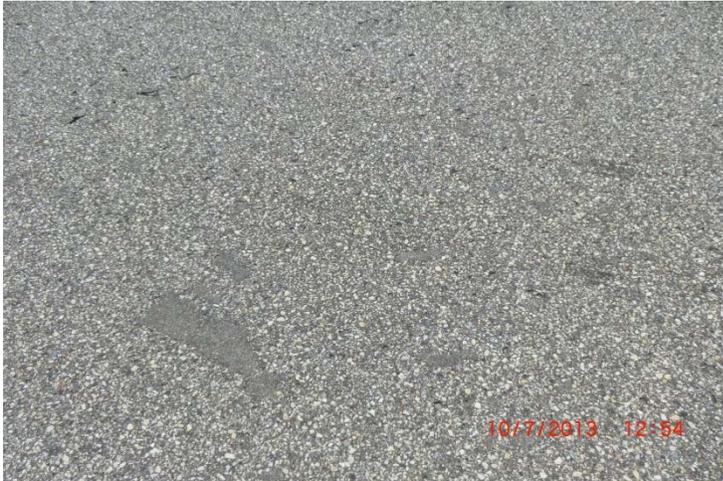
Low severity

Weathering – At low severity, the coarse aggregate is slightly exposed due to the wearing away of the fine aggregate. At medium severity, the coarse aggregate is exposed up to $\frac{1}{4}$ the width of the longest side. At high severity, the coarse is exposed greater than $\frac{1}{4}$ the width of the longest side.

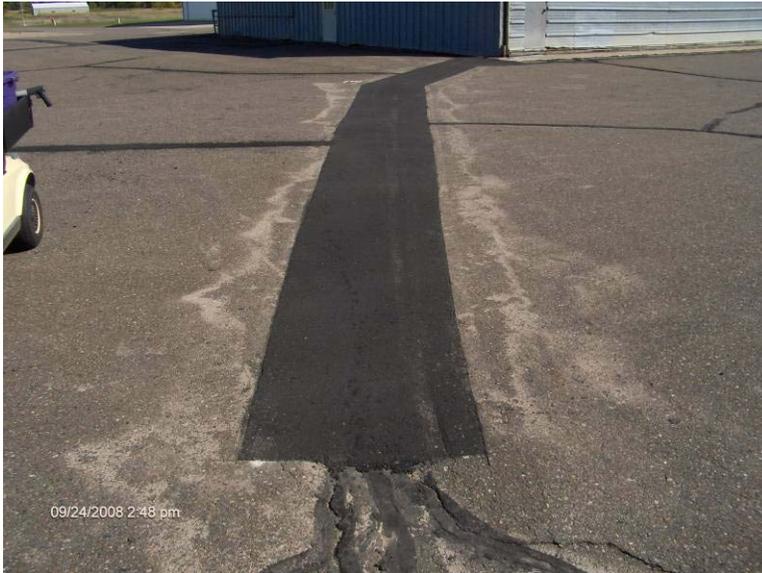
Example of Patching

Patched areas are defined when a portion of the original pavement is replaced with a material intended as a semi-permanent repair. A patch is documented as a defect because it is considered a break in the integrity of the pavement structure. Patches are constructed for a variety of reasons including utility repairs, correcting grade issues, and addressing a defect in the original pavement. The severity level of patches is determined by the amount of distress (i.e. cracking, depression, weathering/raveling, etc.) occurring within the limits of the patched area.

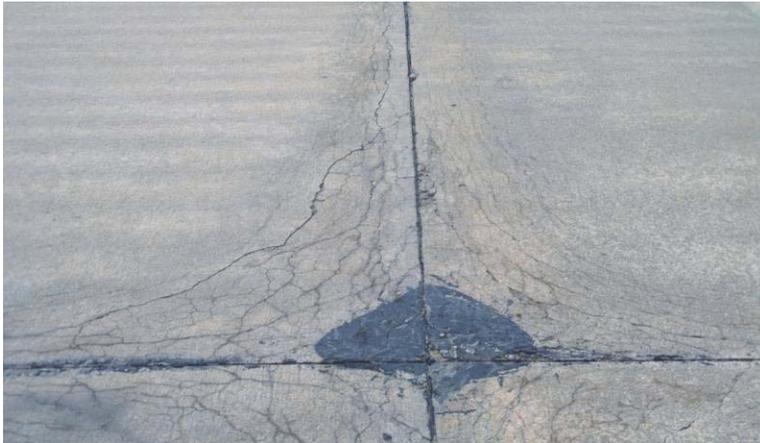
Example of Durability Cracking

Durability cracking (D-cracking) is caused by environmental factors, the most common of which is freezing/thawing. It usually appears as a pattern of hairline cracks running parallel to a joint or crack, or in a corner, where water tends to collect. This type of cracking eventually leads to disintegration of the pavement, creating FOD potential. At low severity, D-cracking is evident, but no disintegration has occurred. As the distress advances to medium severity, the distress pattern is evident over a significant area of the slab, and some disintegration and FOD potential exists. High severity durability cracking is evidenced by extensive cracking with loose and missing pieces and significant FOD potential.

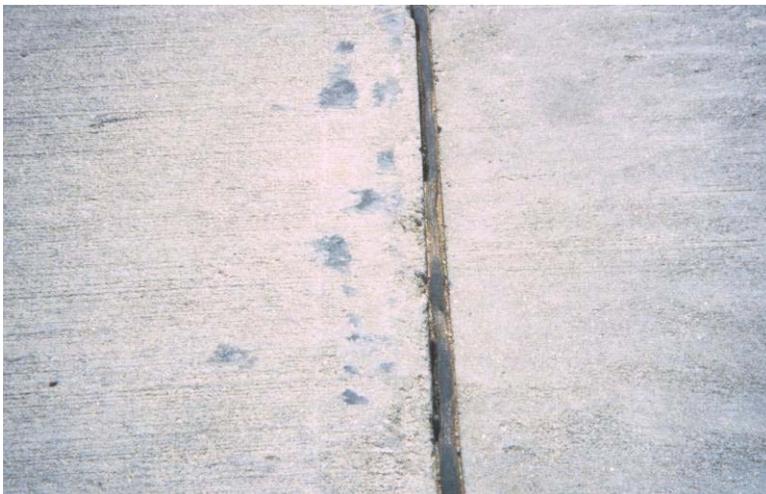
Example of Joint Seal Damage

Joint seal damage is recorded at three severities: low, medium, and high. When joint sealant is in perfect condition (no damage), it is not a distress. At low severity, at least 10 percent of the sealant is debonded but still in contact with the joint edges (i.e., joint sealant is in serviceable condition but should

be monitored for evidence of more serious failure). Medium-severity joint seal damage is recorded when at least 10 percent of the sealant has visible gaps smaller than 1/8th inch and is an indicator that replacement should be programmed as soon as is practicable. In the meantime, aggressive inspection and sustaining maintenance is recommended to minimize subsurface damage from moisture penetration. At high severity, visible gaps exceed 1/8th inch and the amount and degree of joint seal damage is such that repair is no longer feasible. The only appropriate corrective action is sealant replacement.

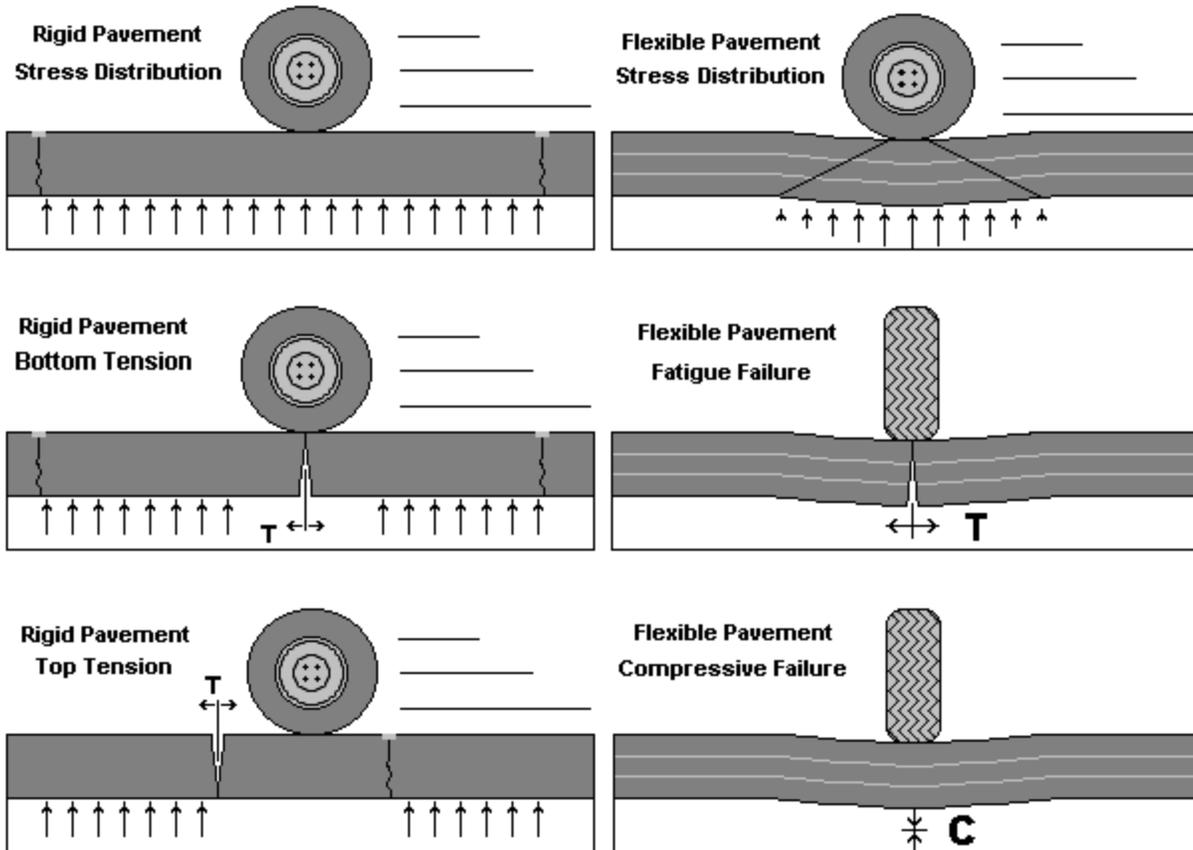
Figure 10. Pavement failure.

Load-related cracks can start at the top or bottom of a pavement section. In asphalt sections, load-related (fatigue) cracks start at the bottom. If a load-related crack reaches the surface, it usually indicates significant structural deficiency. In PCC pavement, corner breaks are caused by top tension, and the crack propagates downward. Mid-slab LTD cracks are examples of bottom tension.

Spalls can be caused by either wheel loads or environmental factors, anytime there is movement between adjacent slabs. If a small rock is allowed into a joint, a differential movement between adjacent slabs can cause a spall. Spalling can be minimized by keeping joint and crack sealant intact.

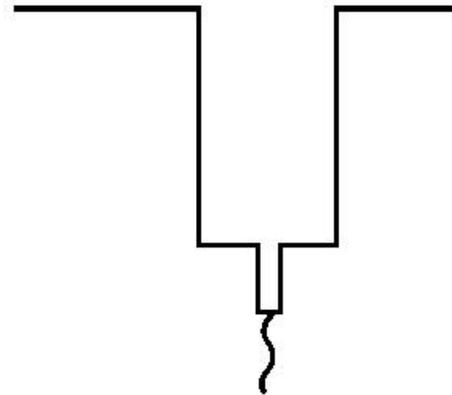
Typical joint with deficient sealant and a collection of debris & incompressibles.

Rout out old sealant, debris and incompressibles. Clean joint sides to expose fresh, clean concrete and stone. Retain existing reservoir shape.

Fill to 1/8" below surface.
Do not overfill.
