Maine Department of Transportation

Pavement Condition Report

LINCOLN REGIONAL AIRPORT (KLRG)

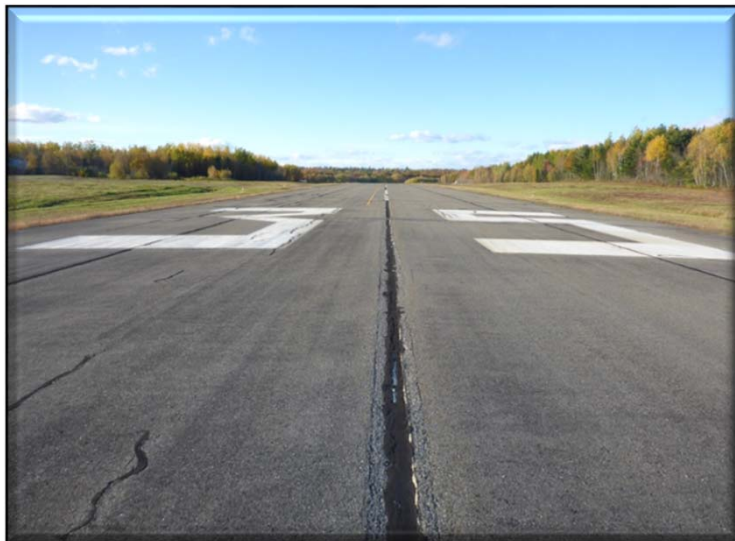
ARA Pavement Analysis

⁴ The higher than expected deterioration rate of 5.0 PCI/Yr for TLA-001 is primarily due to medium-and high-severity alligator cracking.

M&R	Action	Year / Quantity	Cost (\$)	Ending PCI
Major	Major M&R	2020	581,335	100
Minor	All Minor	2020	11,575	69
1	Surface Seal	10066 SqFt	6,141	-
2	Crack Sealing - AC	3938 Ft	5,435	-
3	-	-	-	-
4	-	-	-	-
5	-	-	-	-
6	-	-	-	-
7	-	-	-	-

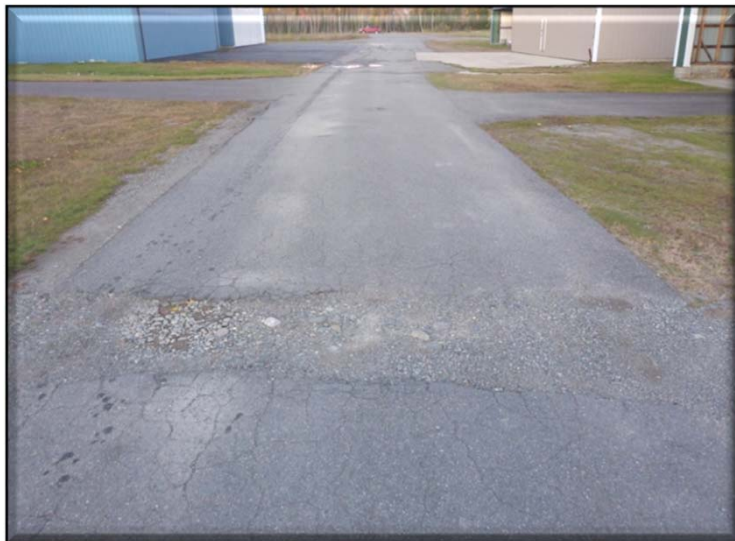
ARA Pavement Analysis

⁵ The higher than expected deterioration rate of 4.8 PCI/Yr for TLB-001 is primarily due to low-, medium-and high-severity alligator cracking.

M&R	Action	Year / Quantity	Cost (\$)	Ending PCI
Major	Major M&R	2020	124,438	100
Minor	All Minor	2020	16,742	75
1	Patching - AC Deep	762 SqFt	14,146	-
2	Patching - AC Shallow	155 SqFt	2,596	-
3	-	-	-	-
4	-	-	-	-
5	-	-	-	-
6	-	-	-	-
7	-	-	-	-

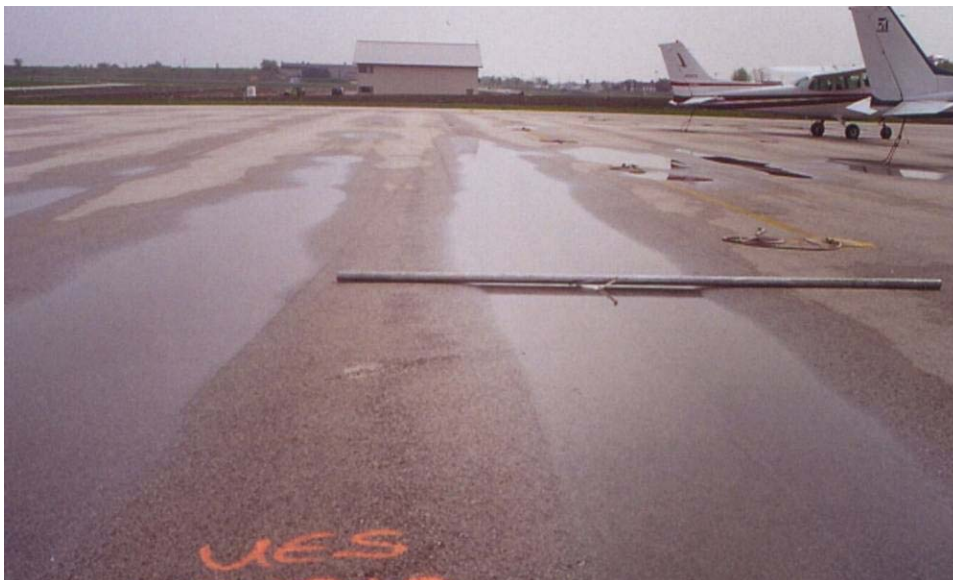
Example of Rutting

Ruts are localized, load related, areas of pavement having elevations lower than the surrounding sections. Rutting is due to base and subgrade consolidation, caused by excessive wheel loads or poor compaction. Ruts indicate structural failure, and can cause hydroplaning. At low severity, ruts have an

average depth of ¼ to ½ inches. At medium severity, ruts have an average depth of ½ to 1 inch. High severity, ruts have an average depth greater than 1 inch. Full-depth patching is the appropriate repair for ruts.
