Maine Department of Transportation

Pavement Condition Report

SANFORD SEACOAST REGIONAL AIRPORT (KSFM)

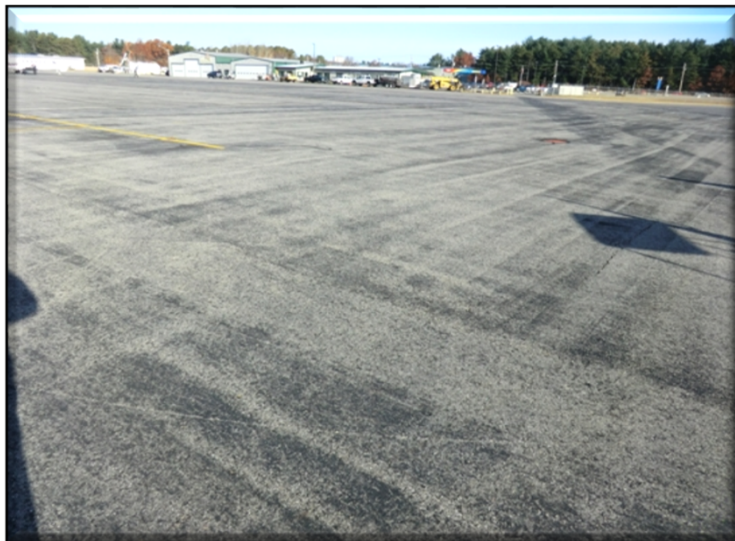
Section:	SFM::APB::001
Description:	Apron B
PaveType:	AC
Area:	70,450
Built:	1/15/2010
Age:	9yr

M&R	Action	Year / Quantity	Cost (\$)	Ending PCI
Major	-	-	-	-
Minor	-	-	-	-
1	-	-	-	-
2	-	-	-	-
3	-	-	-	-
4	-	-	-	-
5	-	-	-	-
6	-	-	-	-
7	-	-	-	-

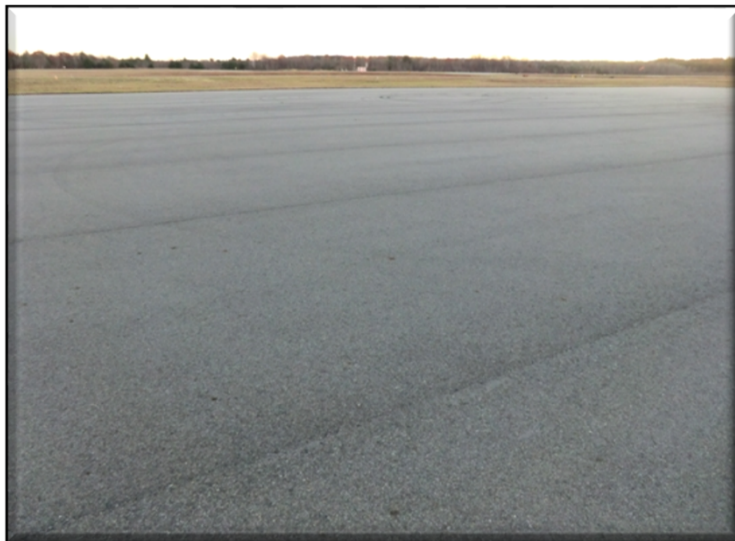
Section:	SFM::APC::001
Description:	Apron C
PaveType:	AC
Area:	124,750
Built:	2/15/1995
Age:	24yr

M&R	Action	Year / Quantity	Cost (\$)	Ending PCI
Major	Major M&R	2020	2,544,856	100
Minor	All Minor	2020	54,711	54
1	Patching - AC Deep	1663 SqFt	30,893	-
2	Crack Sealing - AC	17259 Ft	23,818	-
3	-	-	-	-
4	-	-	-	-
5	-	-	-	-
6	-	-	-	-
7	-	-	-	-

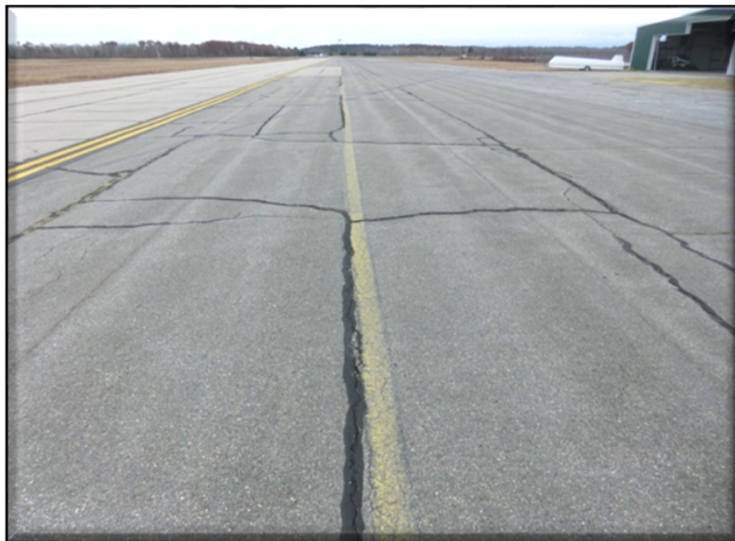
Section:	SFM::APC::002
Description:	Apron C
PaveType:	AC
Area:	30,000
Built:	2/15/1995
Age:	24yr

M&R	Action	Year / Quantity	Cost (\$)	Ending PCI
Major	Major M&R	2020	611,990	100
Minor	All Minor	2020	76,005	49
1	Patching - AC Deep	3546 SqFt	65,884	-
2	Crack Sealing - AC	7335 Ft	10,122	-
3	-	-	-	-
4	-	-	-	-
5	-	-	-	-
6	-	-	-	-
7	-	-	-	-

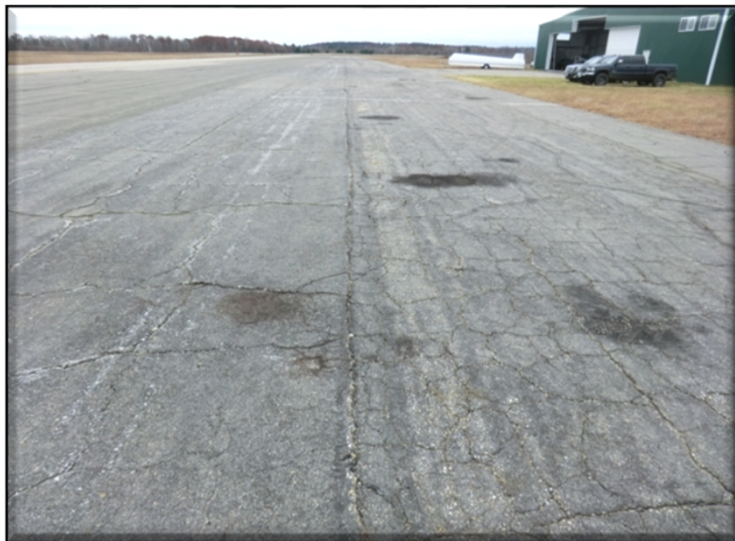
Section:	SFM::APC::003
Description:	Apron C
PaveType:	AC
Area:	64,650
Built:	2/15/1995
Age:	24yr

M&R	Action	Year / Quantity	Cost (\$)	Ending PCI
Major	Major M&R	2020	1,318,837	100
Minor	All Minor	2020	51,044	56
1	Surface Seal	51720 SqFt	31,549	-
2	Crack Sealing - AC	14126 Ft	19,494	-
3	-	-	-	-
4	-	-	-	-
5	-	-	-	-
6	-	-	-	-
7	-	-	-	-

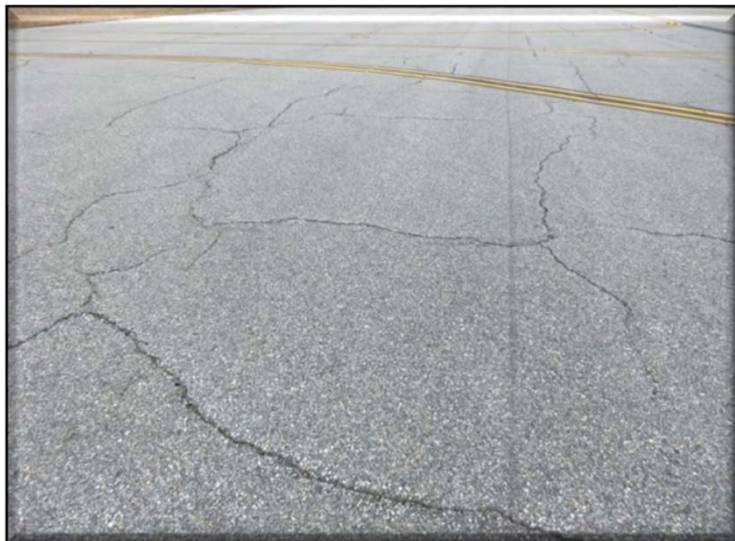
Section:	SFM::CTA::001
Description:	Connecting Taxiway A
PaveType:	AC
Area:	8,900
Built:	1/15/1997
Age:	22yr

M&R	Action	Year / Quantity	Cost (\$)	Ending PCI
Major	Major M&R	2020	24,474	100
Minor	All Minor	2020	14	74
1	Crack Sealing - AC	11 Ft	14	-
2	-	-	-	-
3	-	-	-	-
4	-	-	-	-
5	-	-	-	-
6	-	-	-	-
7	-	-	-	-

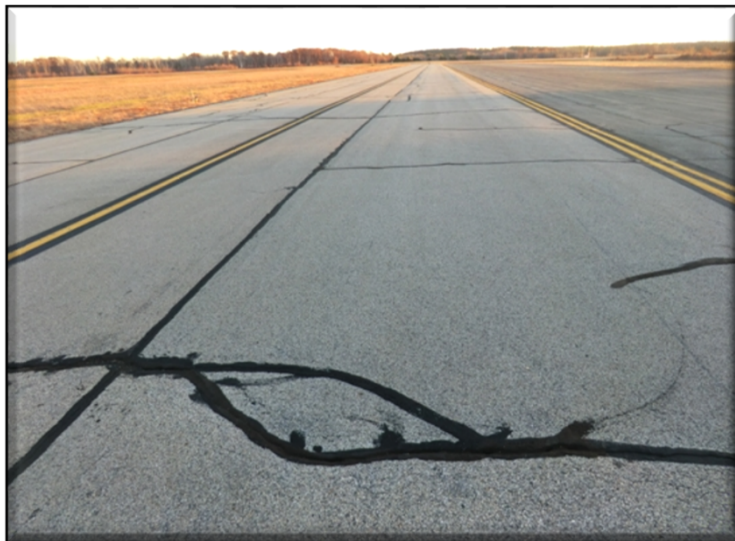
Section:	SFM::CTC::002
Description:	Connecting Taxiway C
PaveType:	AC
Area:	146,900
Built:	2/15/1995
Age:	24yr

M&R	Action	Year / Quantity	Cost (\$)	Ending PCI
Major	Major M&R	2020	2,996,709	100
Minor	All Minor	2020	90,541	61
1	Surface Seal	142073 SqFt	86,665	-
2	Crack Sealing - AC	2300 Ft	3,174	-
3	Patching - AC Deep	38 SqFt	702	-
4	-	-	-	-
5	-	-	-	-
6	-	-	-	-
7	-	-	-	-

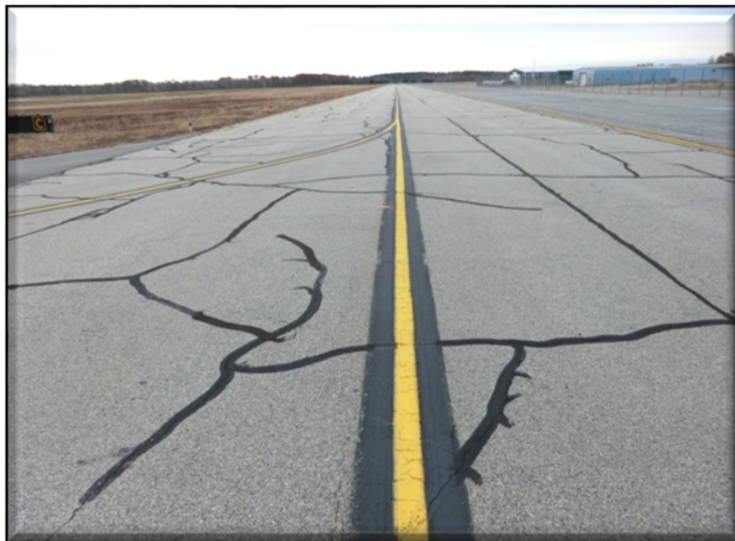
Section:	SFM::CTD::001
Description:	Connecting Taxiway D
PaveType:	AC
Area:	58,500
Built:	1/15/2000
Age:	19yr

M&R	Action	Year / Quantity	Cost (\$)	Ending PCI
Major	Major M&R	2020	1,193,400	100
Minor	All Minor	2020	16	65
1	Crack Sealing - AC	12 Ft	16	-
2	-	-	-	-
3	-	-	-	-
4	-	-	-	-
5	-	-	-	-
6	-	-	-	-
7	-	-	-	-

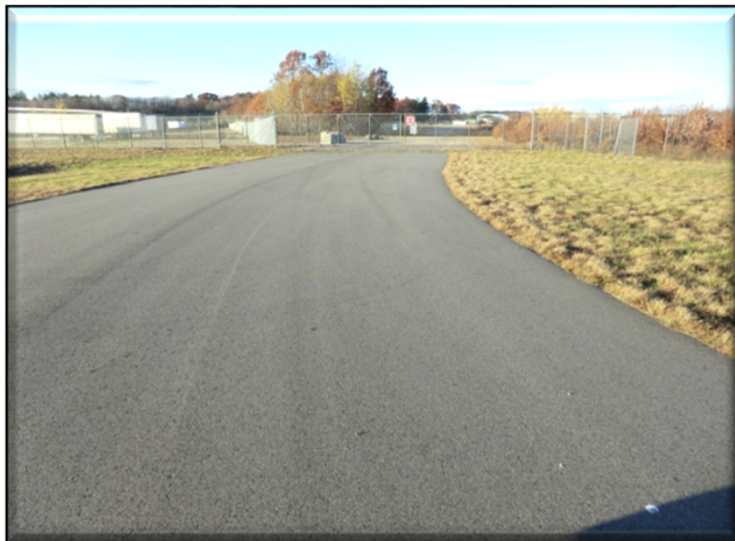
Section:	SFM::PTE::001
Description:	Parallel Taxiway E
PaveType:	AC
Area:	160,200
Built:	1/15/1997
Age:	22yr

M&R	Action	Year / Quantity	Cost (\$)	Ending PCI
Major	Major M&R	2022	440,539	100
Minor	All Minor	2020	7,568	78
1	Surface Seal	12324 SqFt	7,517	-
2	Crack Sealing - AC	37 Ft	51	-
3	-	-	-	-
4	-	-	-	-
5	-	-	-	-
6	-	-	-	-
7	-	-	-	-

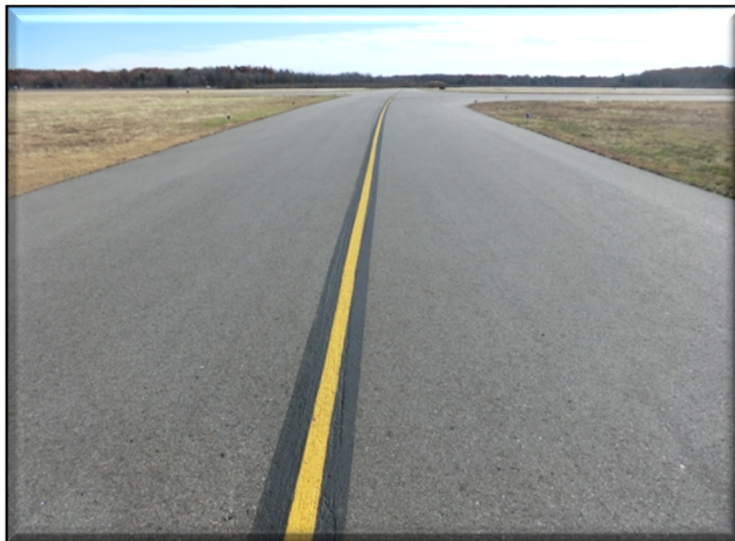
Section:	SFM::PTE::003
Description:	Parallel Taxiway E
PaveType:	AC
Area:	30,550
Built:	1/15/2006
Age:	13yr

M&R	Action	Year / Quantity	Cost (\$)	Ending PCI
Major	-	-	-	-
Minor	All Minor	2020	9	92
1	Crack Sealing - AC	6 Ft	9	-
2	-	-	-	-
3	-	-	-	-
4	-	-	-	-
5	-	-	-	-
6	-	-	-	-
7	-	-	-	-

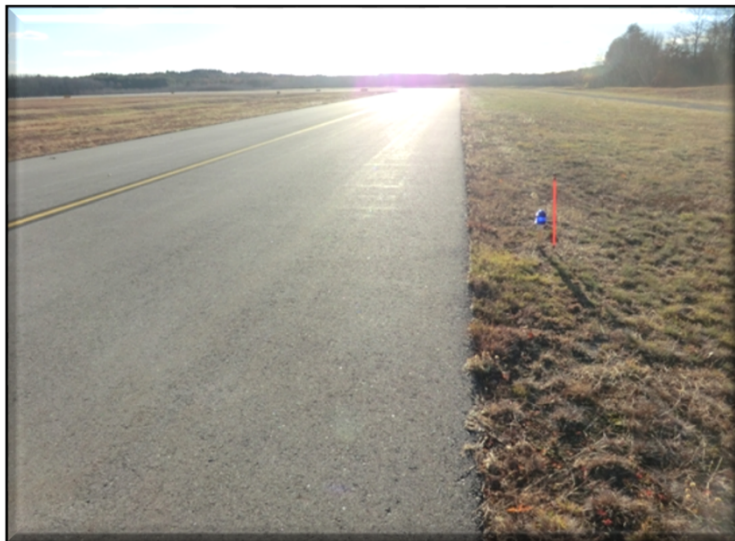
Section:	SFM::RY725::001
Description:	Runway 7-25
PaveType:	AC
Area:	638,950
Built:	1/15/2010
Age:	9yr

M&R	Action	Year / Quantity	Cost (\$)	Ending PCI
Major	-	-	-	-
Minor	All Minor	2020	298	97
1	Crack Sealing - AC	216 Ft	298	-
2	-	-	-	-
3	-	-	-	-
4	-	-	-	-
5	-	-	-	-
6	-	-	-	-
7	-	-	-	-

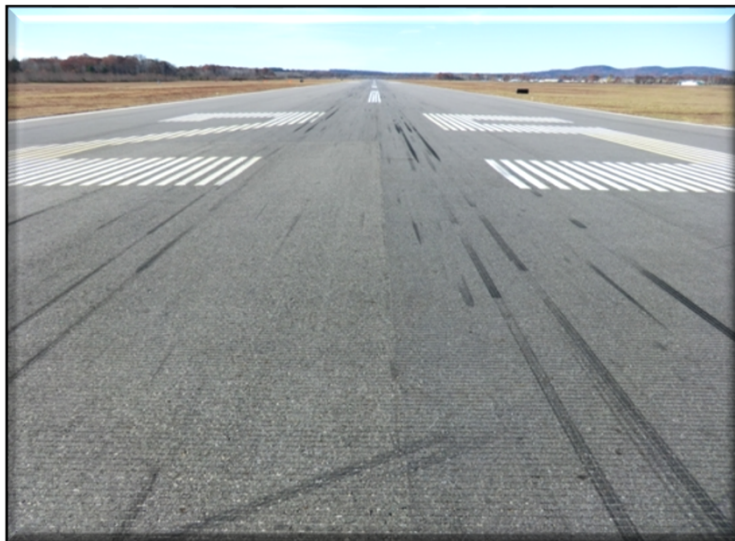
Section:	SFM::RY1432::001
Description:	Runway 14-32
PaveType:	AC
Area:	439,600
Built:	1/15/1994
Age:	25yr

M&R	Action	Year / Quantity	Cost (\$)	Ending PCI
Major	Major M&R	2020	1,208,869	100
Minor	All Minor	2020	7,671	74
1	Crack Sealing - AC	5558 Ft	7,671	-
2	-	-	-	-
3	-	-	-	-
4	-	-	-	-
5	-	-	-	-
6	-	-	-	-
7	-	-	-	-

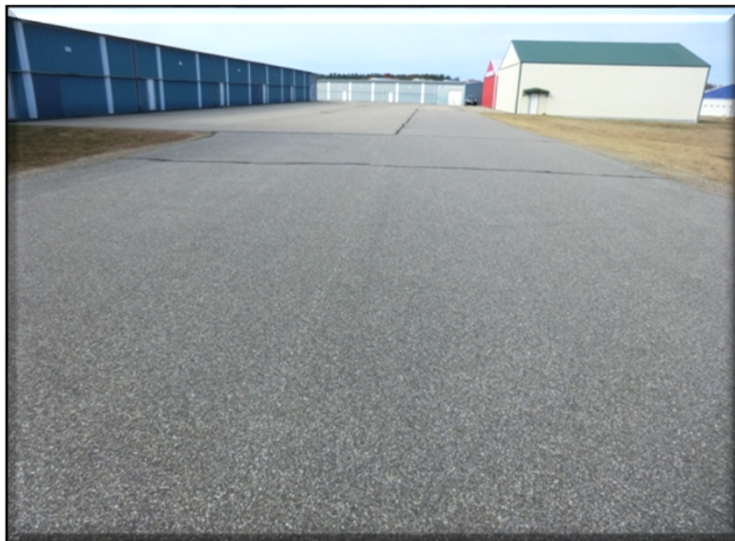
Section:	SFM::TLA::003
Description:	Taxilane A
PaveType:	AC
Area:	23,250
Built:	1/15/2007
Age:	12yr

Extrapolated Distress:	Type	Quantity	Severity	Units
1	l & t crack	1,187	low	Ft
2	-	-	-	-
3	-	-	-	-
4	-	-	-	-
5	-	-	-	-
6	-	-	-	-
7	-	-	-	-
8	-	-	-	-
9	-	-	-	-
10	-	-	-	-
11	-	-	-	-
12	-	-	-	-
13	-	-	-	-
14	-	-	-	-
15	-	-	-	-
16	-	-	-	-
17	-	-	-	-
18	-	-	-	-
19	-	-	-	-
20	-	-	-	-

M&R	Action	Year / Quantity	Cost (\$)	Ending PCI
Major	-	-	-	-
Minor	All Minor	2020	52	90
1	Crack Sealing - AC	33 Ft	45	-
2	Surface Seal	11 SqFt	7	-
3	-	-	-	-
4	-	-	-	-
5	-	-	-	-
6	-	-	-	-
7	-	-	-	-

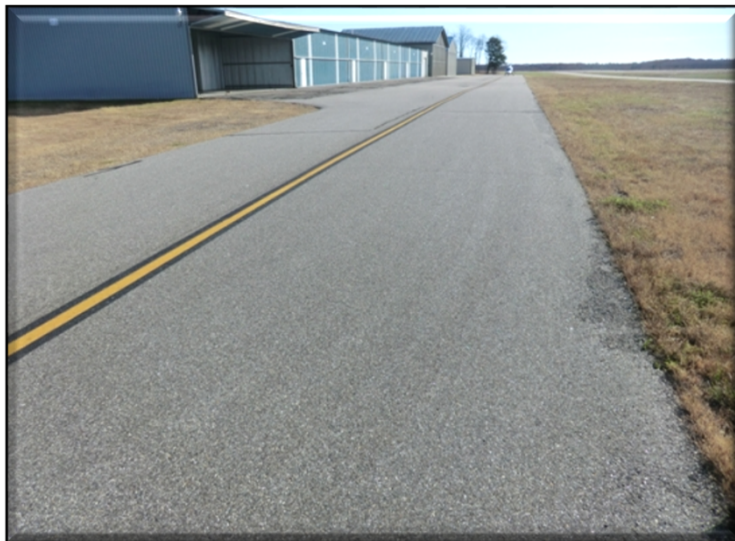
Section:	SFM::TLB::001
Description:	Taxilane B
PaveType:	AC
Area:	97,400
Built:	1/15/2006
Age:	13yr

Extrapolated Distress:	Type	Quantity	Severity	Units
1	l & t crack	707	low	Ft
2	-	-	-	-
3	-	-	-	-
4	-	-	-	-
5	-	-	-	-
6	-	-	-	-
7	-	-	-	-
8	-	-	-	-
9	-	-	-	-
10	-	-	-	-
11	-	-	-	-
12	-	-	-	-
13	-	-	-	-
14	-	-	-	-
15	-	-	-	-
16	-	-	-	-
17	-	-	-	-
18	-	-	-	-
19	-	-	-	-
20	-	-	-	-

M&R	Action	Year / Quantity	Cost (\$)	Ending PCI
Major	Major M&R	2026	63,936	100
Minor	-	-	-	-
1	-	-	-	-
2	-	-	-	-
3	-	-	-	-
4	-	-	-	-
5	-	-	-	-
6	-	-	-	-
7	-	-	-	-

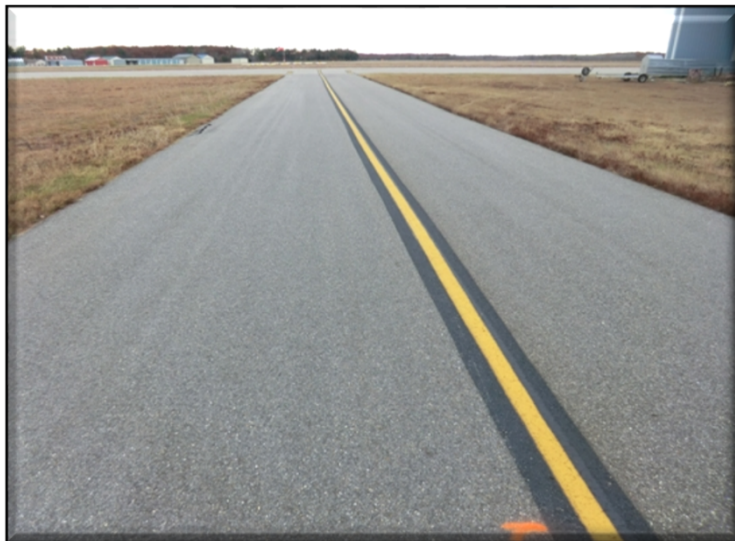
Section:	SFM::TLC::001
Description:	Taxilane C
PaveType:	AC
Area:	20,950
Built:	2/15/1995
Age:	24yr

Extrapolated Distress:	Type	Quantity	Severity	Units
1	l & t crack	6,051	low	Ft
2	l & t crack	17	medium	Ft
3	weathering	4,190	low	SqFt
4	weathering	16,760	medium	SqFt
5	-	-	-	-
6	-	-	-	-
7	-	-	-	-
8	-	-	-	-
9	-	-	-	-
10	-	-	-	-
11	-	-	-	-
12	-	-	-	-
13	-	-	-	-
14	-	-	-	-
15	-	-	-	-
16	-	-	-	-
17	-	-	-	-
18	-	-	-	-
19	-	-	-	-
20	-	-	-	-

M&R	Action	Year / Quantity	Cost (\$)	Ending PCI
Major	Major M&R	2020	427,373	100
Minor	All Minor	2020	10,248	57
1	Surface Seal	16760 SqFt	10,224	-
2	Crack Sealing - AC	17 Ft	24	-
3	-	-	-	-
4	-	-	-	-
5	-	-	-	-
6	-	-	-	-
7	-	-	-	-
