Maine Department of Transportation

Pavement Condition Report

Waterville Le Robert LaFleur Airport (WVL)

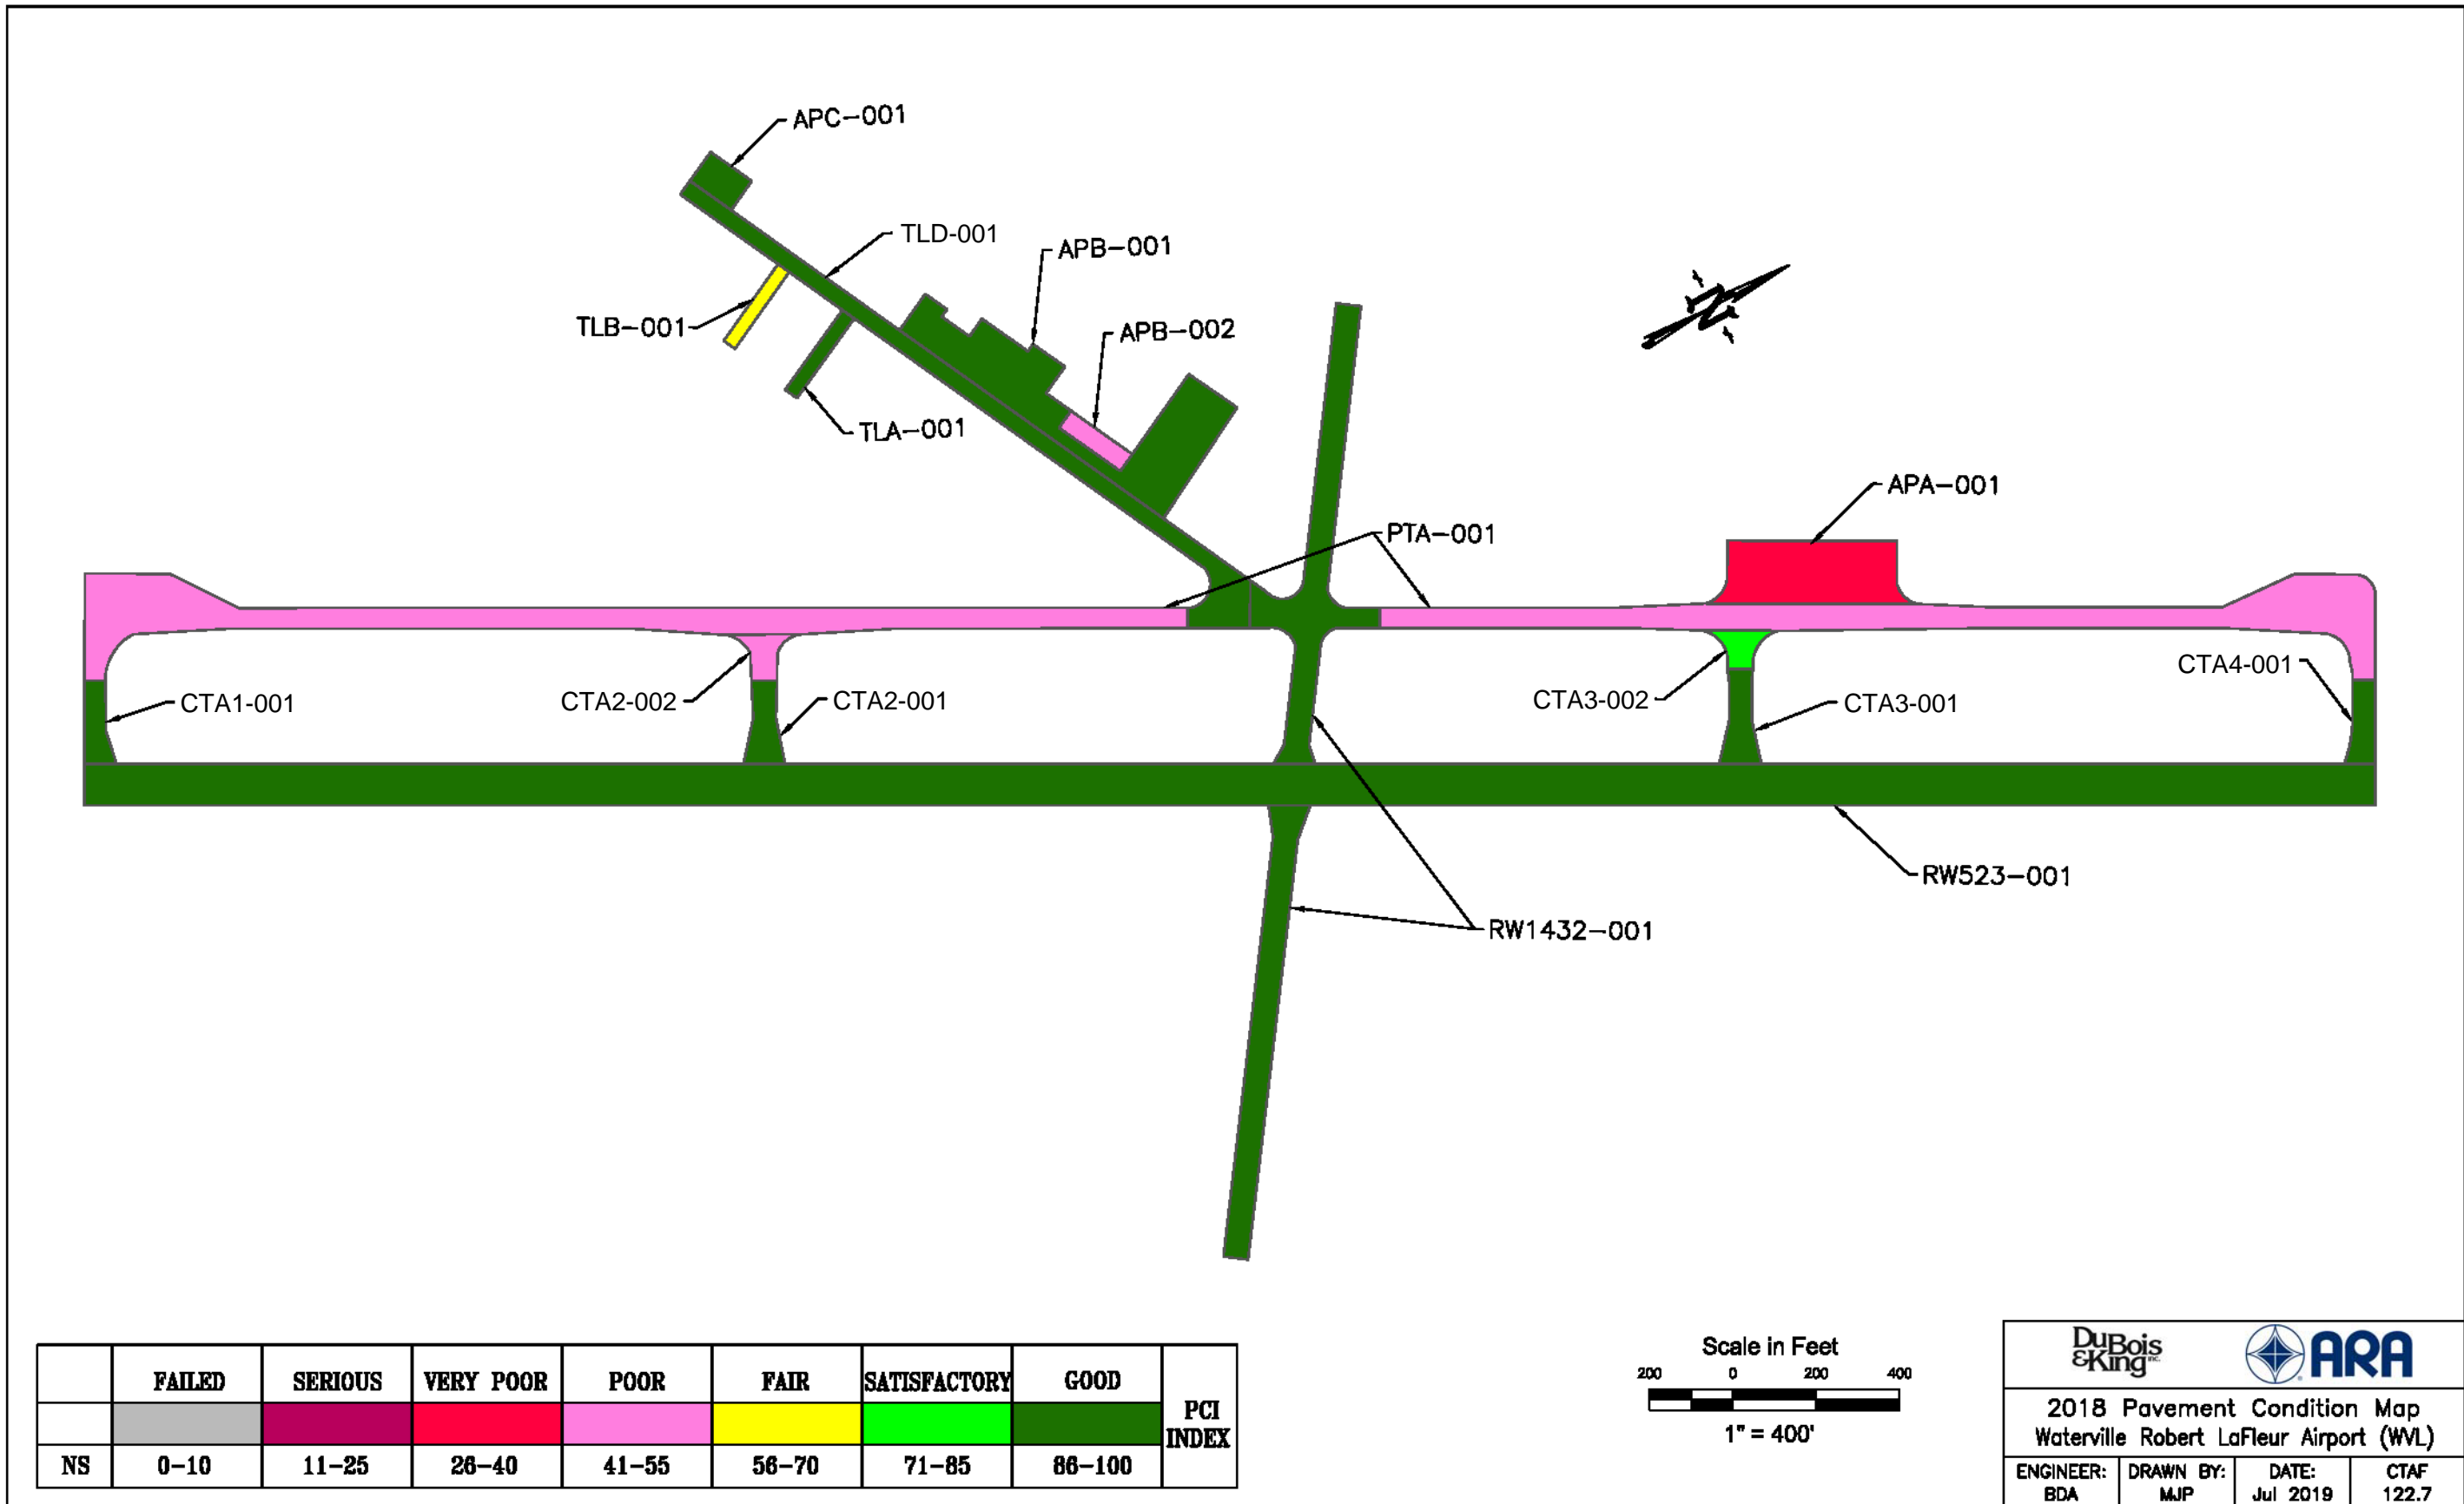
Figure 7. 2018 PCI Map at Waterville Robert LaFleur Airport (WVL)

The results of the 2018 PCI inspection are presented in Table 3 and Figure 7. The overall area-weighted PCI for WVJ is 79. When summarizing PCI values, an area-weighted calculation is used instead of a straight mathematical average because the area-weighted calculations eliminate the skewing of the PCI due to disparities between section sizes.

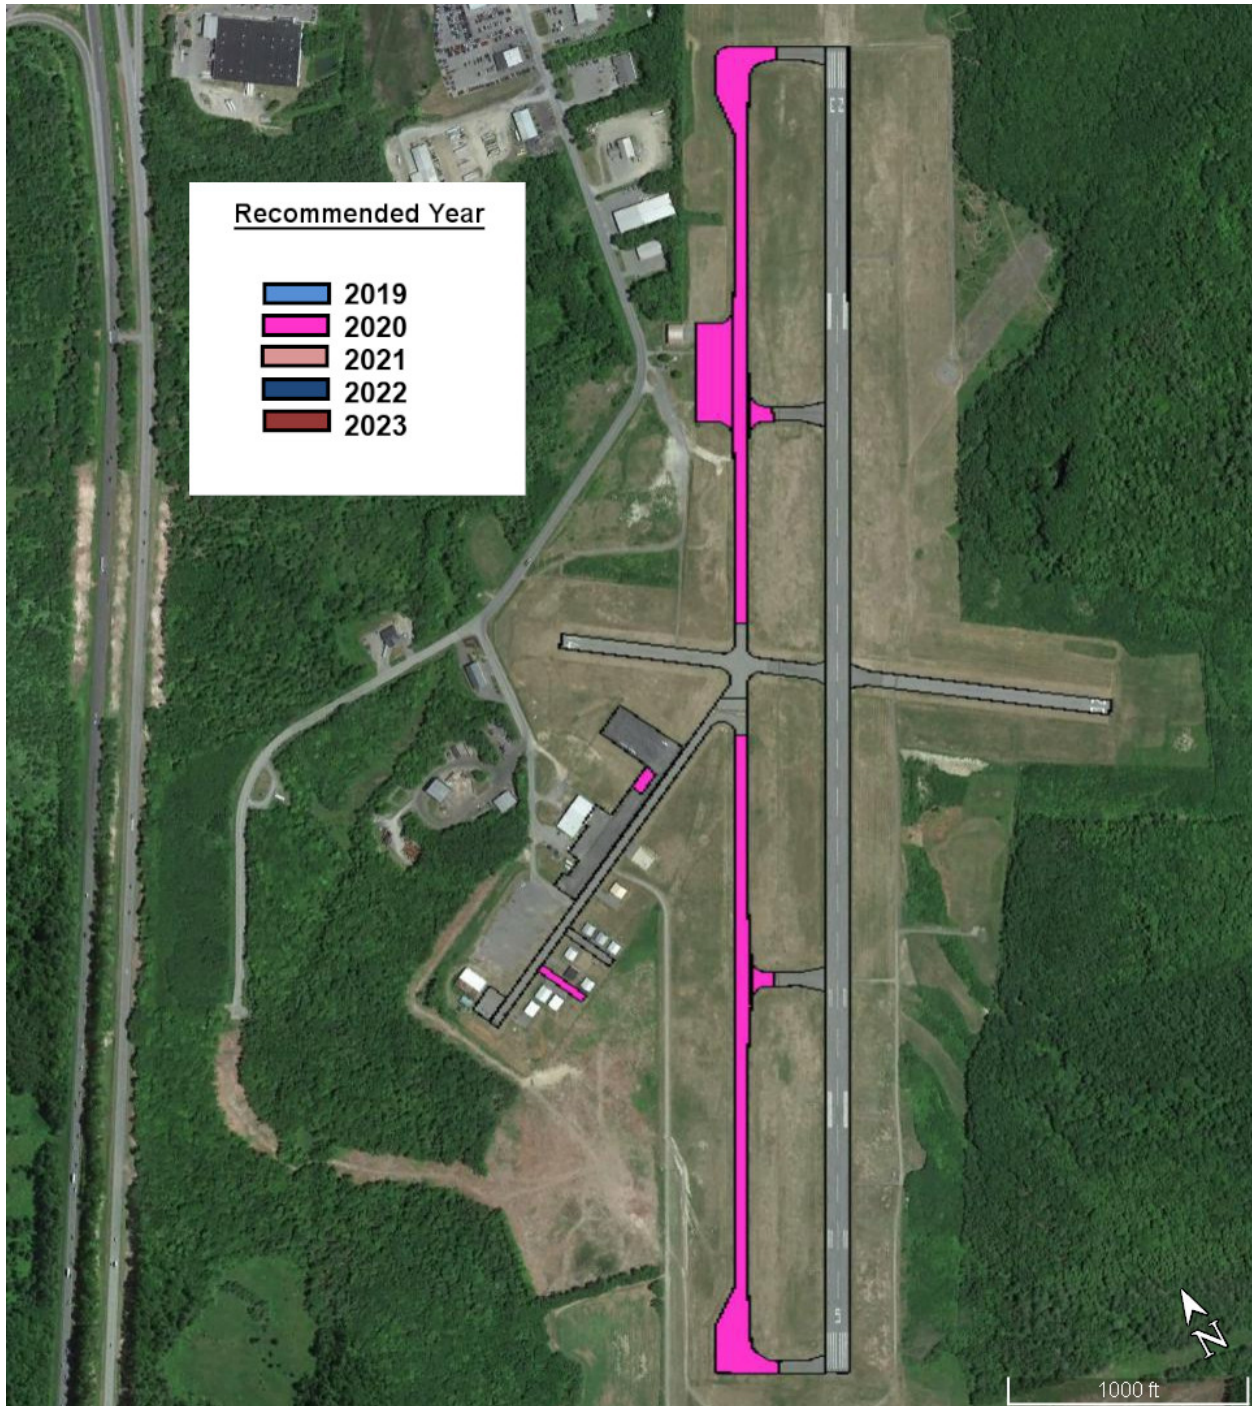
Figure 9. Major M&R

The pavement sections identified for major rehabilitation in Table 10 and shown in Figure 9 are at or are predicted to reach a condition level where major M&R should be considered. While the predicted rehabilitation timeline identifies specific sections and the general timing for the repair, more in-depth project-level studies will be needed to determine exactly how to fix each pavement (i.e. asphalt overlay, reconstruction, or some other repair alternative). Additionally, the airport may find it desirable to adjust the timing of projects to meet fiscal and operational constraints. For example, if the runway and several connector taxiways were forecast to reach the MSL in various years ranging from 2019-2023, it may be preferable to group these pavement sections into a single project.

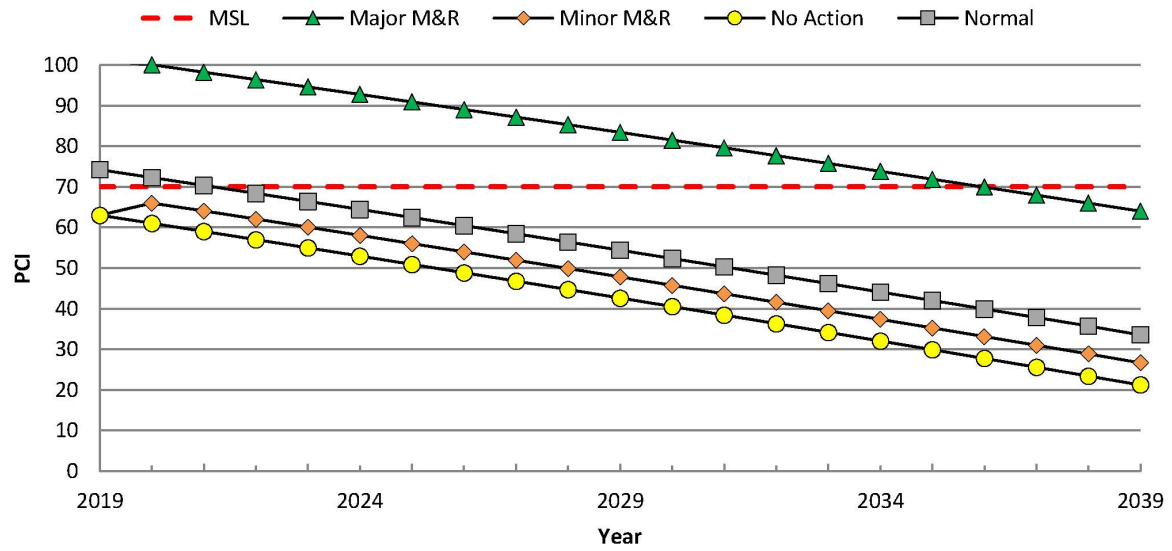
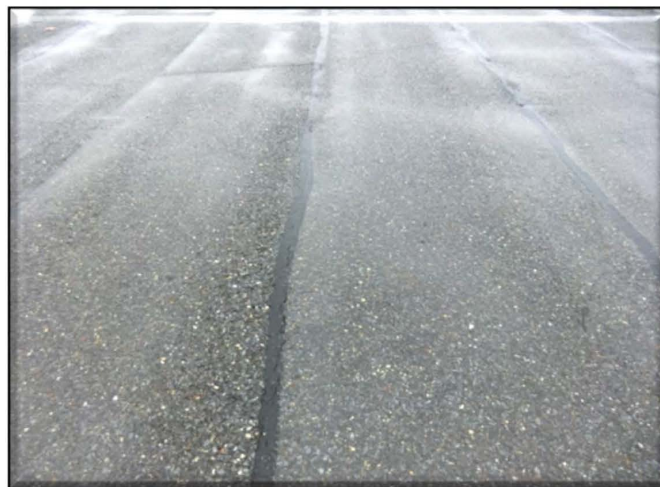
Section: **WVL::TLB::001**

Extrapolated Distress:	Type	Quantity	Severity	Units
1	depression	57	low	SqFt
2	l & t crack	833	low	Ft
3	l & t crack	22	medium	Ft
4	weathering	6,544	medium	SqFt
5	-	-	-	-
6	-	-	-	-
7	-	-	-	-
8	-	-	-	-
9	-	-	-	-
10	-	-	-	-
11	-	-	-	-
12	-	-	-	-
13	-	-	-	-
14	-	-	-	-
15	-	-	-	-
16	-	-	-	-
17	-	-	-	-
18	-	-	-	-
19	-	-	-	-
20	-	-	-	-

M&R	Action	Year / Quantity	Cost (\$)	Ending PCI
Major	Major M&R	2020	151,977	100
Minor	All Minor	2020	4,022	66
1	Surface Seal	6544 SqFt	3,992	-
2	Crack Sealing - AC	22 Ft	30	-
3	-	-	-	-
4	-	-	-	-
5	-	-	-	-
6	-	-	-	-
7	-	-	-	-
