Preliminary Design Report

Frank J. Wood #2016

Brunswick-Topsham, Maine

August 4, 2017

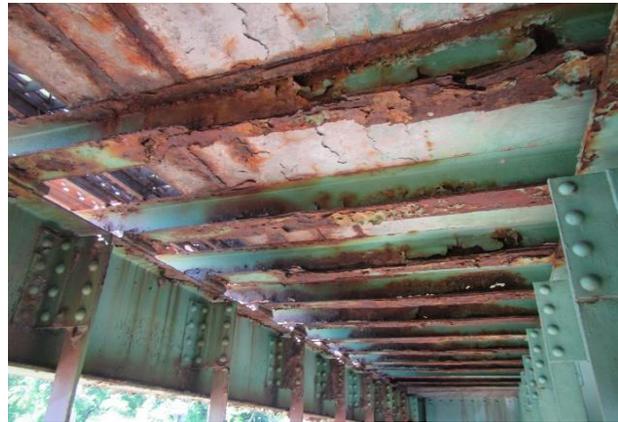
1. Replace the existing bridge deck (including crossbeams) with a new reinforced concrete bridge deck. The existing concrete-filled steel grid deck is in poor condition and the supporting transverse crossbeams are badly deteriorated (See Figure 8).

Figure 8: Deteriorated crossbeams & deck

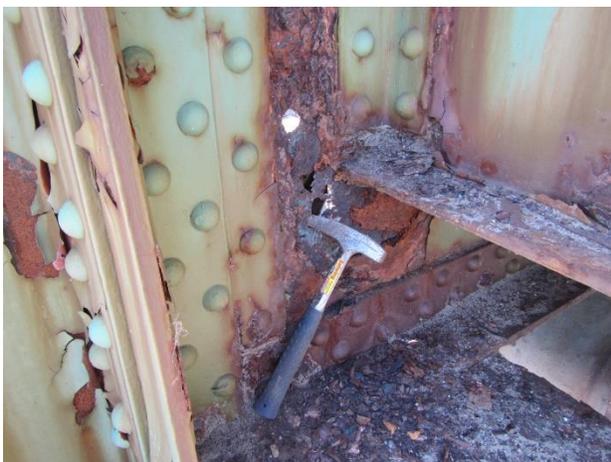
4. Replace the entire steel floor system, including the longitudinal stringer beams and transverse floor beams. The new floor system would be composite with the new deck. The floor system is heavily deteriorated and is below load carrying standards (see Figures 9 and 10).

Figure 9: Hole in floor beam

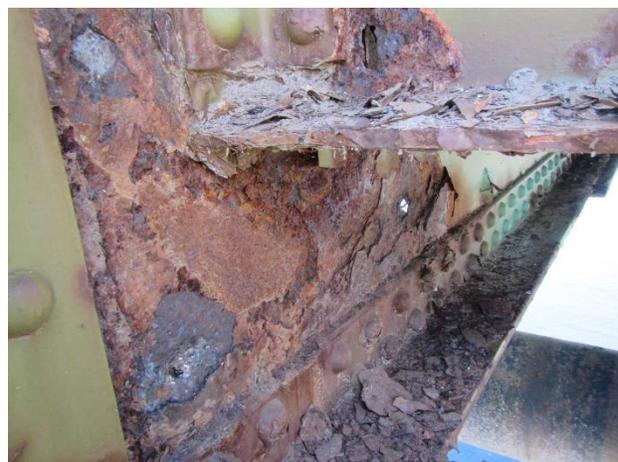
Figure 10: Deteriorated floor beam

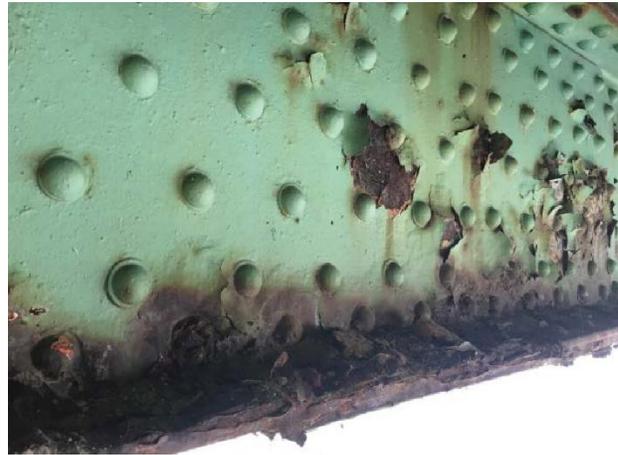
5. Replace the bottom flange angles of the bottom chord of the main trusses due to corrosion and distortion from pack rust, as seen in Figure 11. It is anticipated this work could be done one angle at a time without shoring while the deck is off the bridge.

Figure 11: Bottom chord bottom flange corrosion

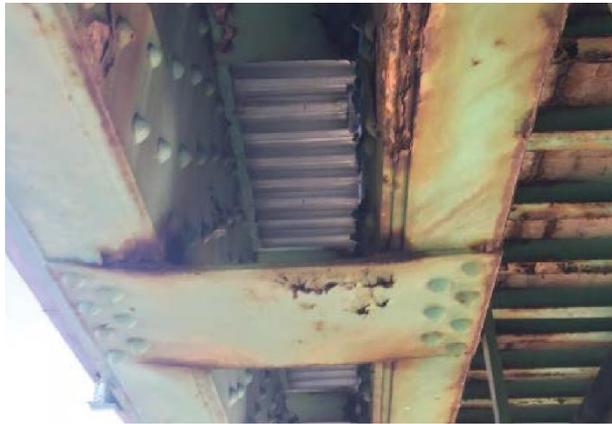
6. Replace the lattice plates of the bottom chord, which are severely bowed due to pack rust. See Figure 12.

Figure 13: Bottom chord lattice plate bowing

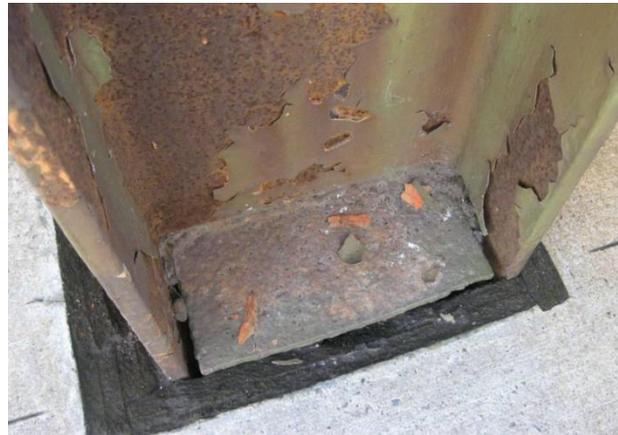
7. Remove the welded steel plates attached to truss vertical members. These are fatigue sensitive details on fracture critical members. Remediate these locations using cover plates. See Figure 13.

Figure 13: Plate welded to truss vertical

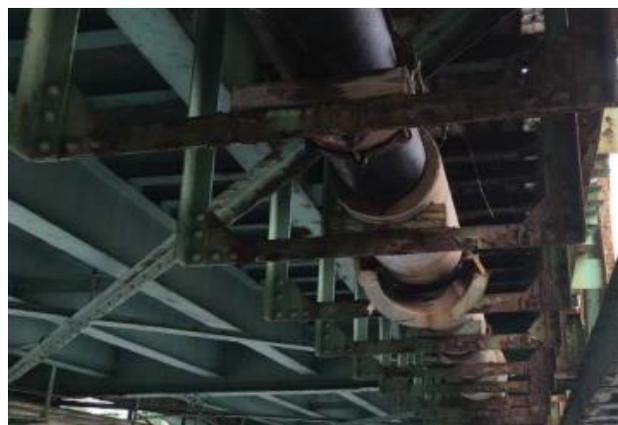
9. Replace all existing utility brackets that support the conduit and water lines on the bridge. See Figure 14.

Figure 14: Utility brackets

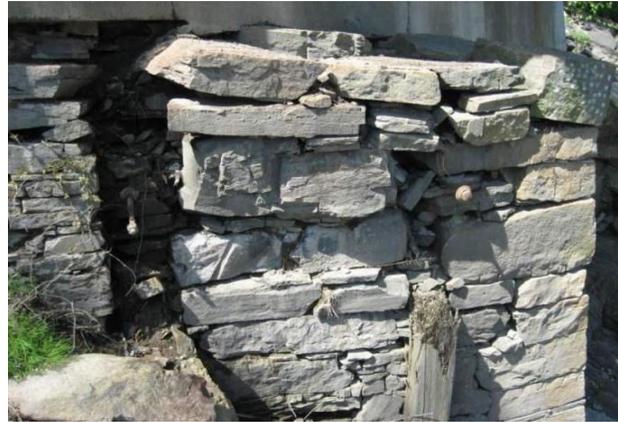
12. Repair areas of stone masonry with missing and loose stones at the south abutment by encasing the masonry in concrete. See Figure 15.

Figure 15: Abutment masonry

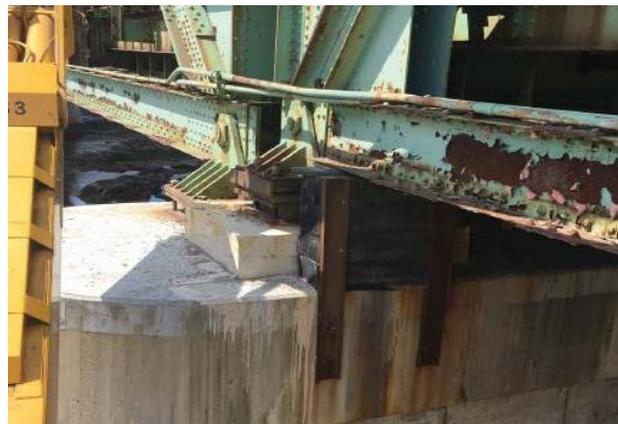
13. Replace cracked concrete bearing pedestals at Pier 2 supporting the east side truss of Span 3 near the Topsham end of the bridge. This work will also include removal, refurbishing, and resetting of the truss bearing at this support. See Figure 16.

Figure 16: Damaged concrete pedestals

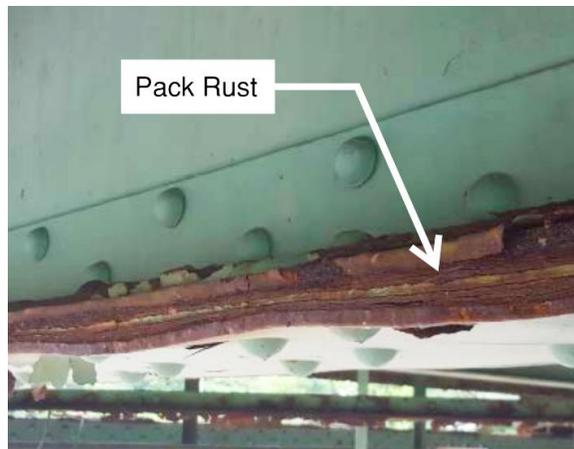
Built-up members (where multiple pieces of steel are riveted together to make a larger member) present a special challenge for paint systems. Over time, pack rust develops in the crevices between pieces of steel and gradually expands, pushing the plates apart (See Figure 17). It is impossible to remove this corrosion using the normal cleaning processes used when painting the steel. The best way to remove pack rust is to disassemble the member, clean the pieces, and then reassemble. That approach is time-consuming and expensive.

Figure 17: Pack rust is corrosion in the crevice between two plates of steel that are bolted or riveted together. As the rust progresses, it gradually pushes the pieces of steel apart, bending them and sometimes breaking bolts or rivets. To truly fix pack rust, the members need to be taken apart and thoroughly cleaned, which is a complex and expensive effort.

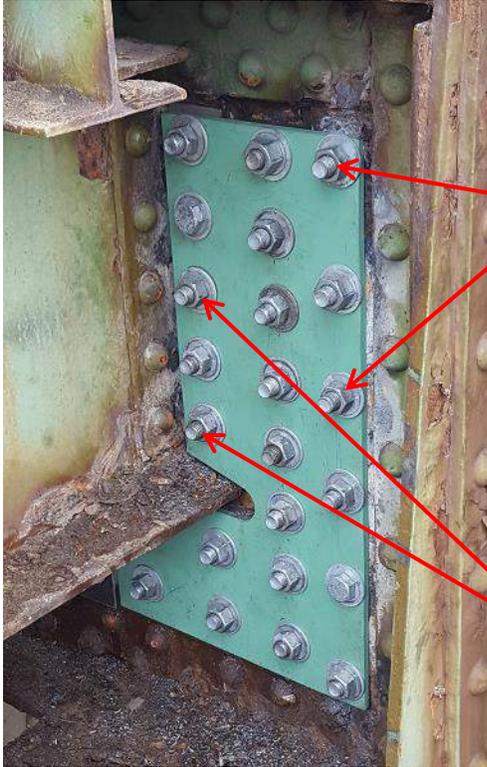
Floorbeam 2 (5 & 7 identical repair).

This column of 6 high strength fasteners has 5 plies of steel engaged: 2 cover plates, 2 filler plates and the web of the floorbeam.

This column of 5 high strength fasteners joins the cover plates to the 5/16" thick angles that fasten the Stringer webs to the Floorbeam webs. This forms a bridge over the thinning area of the Floorbeams.

Technical Work Performed: Floorbeams 2, 5 and 7 were repaired identically. The existing specified rivets were removed and replaced with temporary high strength bolts after the Traffic Control Plan was in place. The “J” shaped cover plates needed to be modified as they would not fit on to the web around the stringer connection as detailed. Bill Doukas, Designer, indicated the coverplate could be cut and then tied back in with a small 8 fastener splice plate. BMB cut the plate where suggested and MaineDOT Fleet produced the additional splice plates and supplied longer high strength bolts.

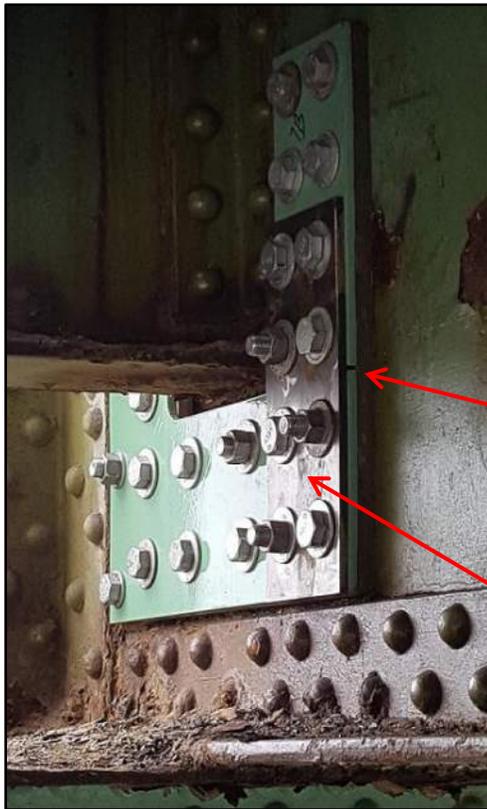
The backside of the cover plate needed to be cut and then spliced back together in order to fit around the Stringer.

Neat cut by contractor.

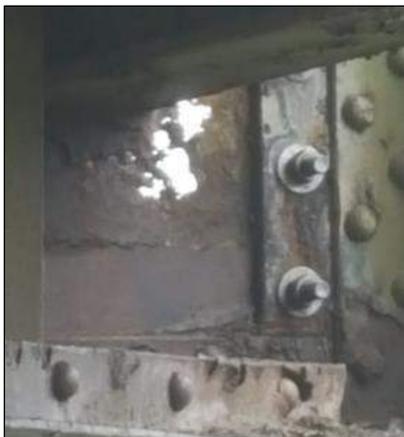
Floorbeam 7 was in the worst condition.

Holes and thinning obviously apparent in this area of the Floorbeam.

Another view of Floorbeam 7 deterioration prior to repair.

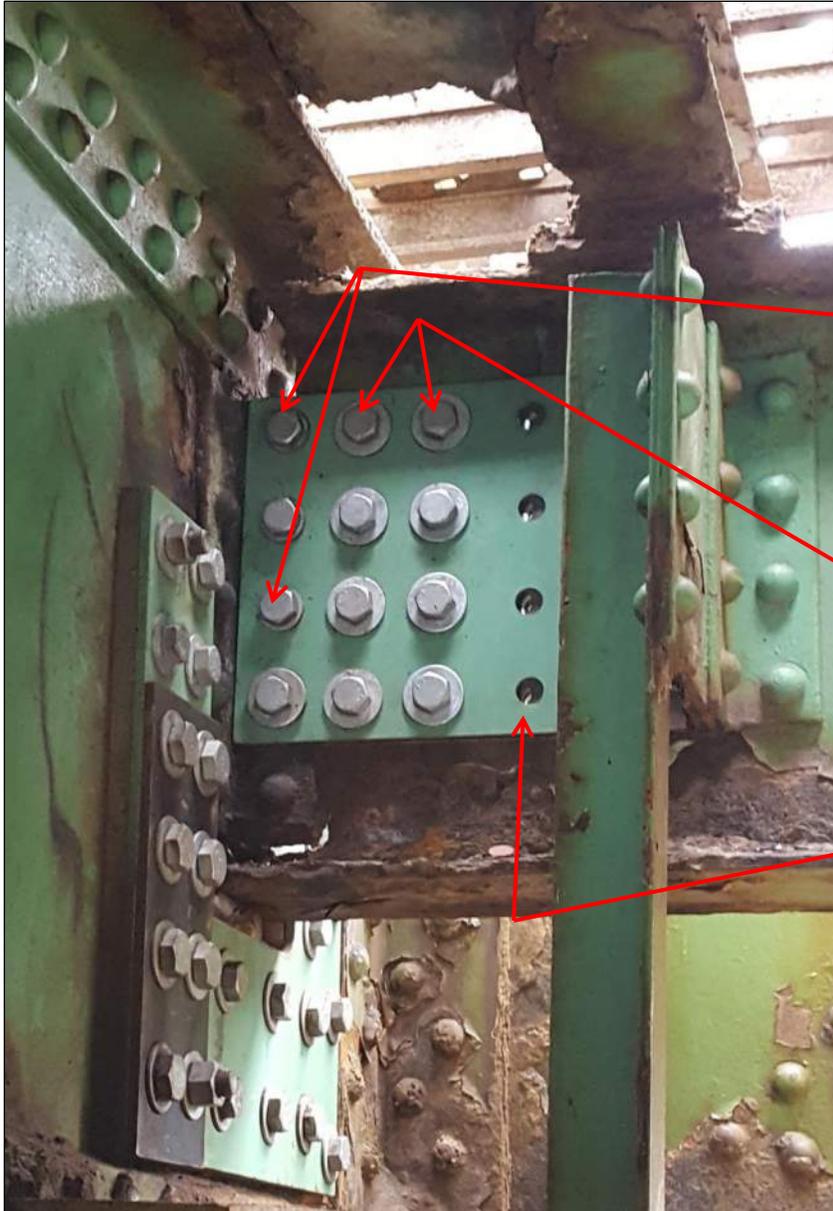
**Repair of Stringer 8 to Floorbeam 2
(Brunswick side).**

This column of 4 high strength fasteners joins the cover plates to the 5/16" thick angle fastened to the Floorbeam web. 5 plies of steel involved.

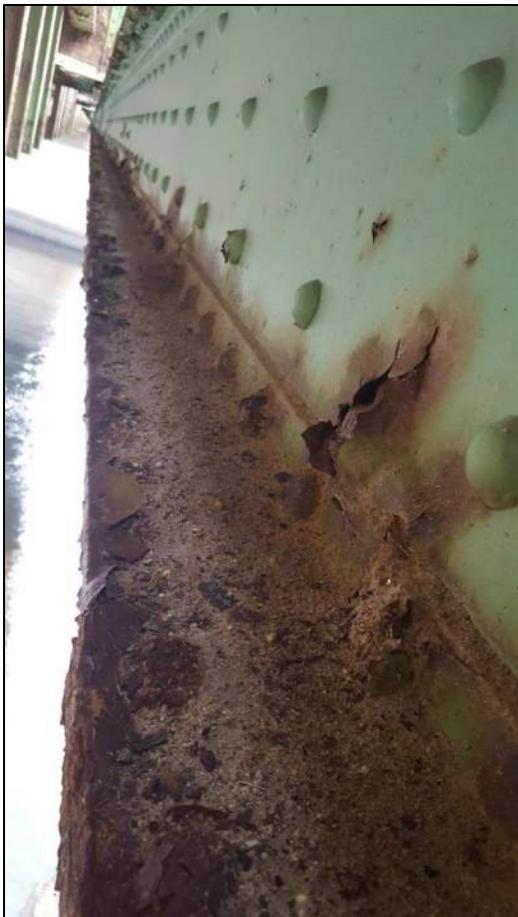
During August of 2016 Special Inspection it was noted a significant buildup of sand/dirt made visual clues more difficult.

BMB, the Subcontractor, utilized an Underbridge Truck to blow off sand and dirt from level surfaces on components under the bridge deck. This occupied 2 workers for at least 6-7 working days. One operated the truck while the other 2 hoses: 1 for fluid film (with air) application and the 2nd for high pressure air for cleaning.

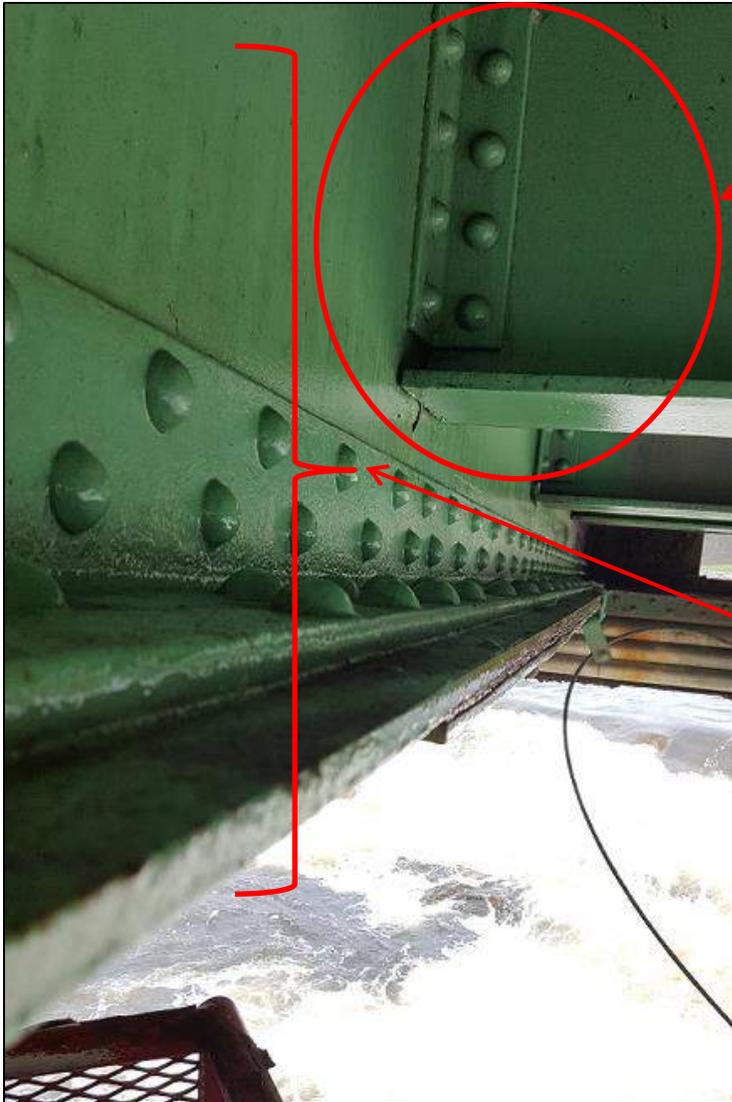
Although the contract indicated to apply fluid film to the connection of Stringers 3 & 8 (exterior stringers), the contract was modified to include the interior stringers as well. Blown and fluid film applied 3 foot min along their lengths.

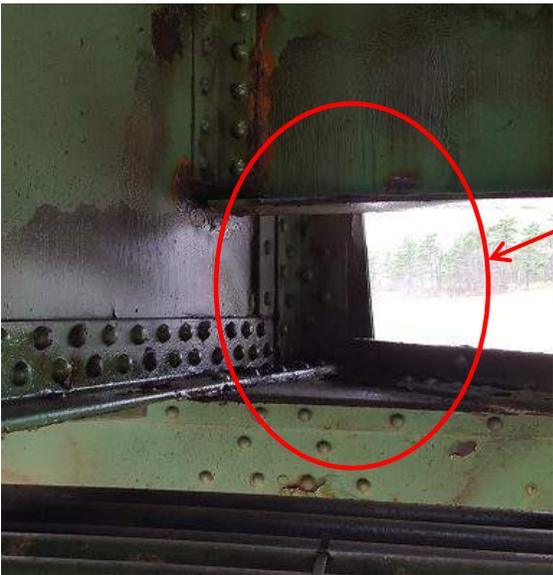
The apparent most susceptible area of the Floorbeam to deterioration were blown clean and coated with fluid film where reasonably accessible with a UBIT.

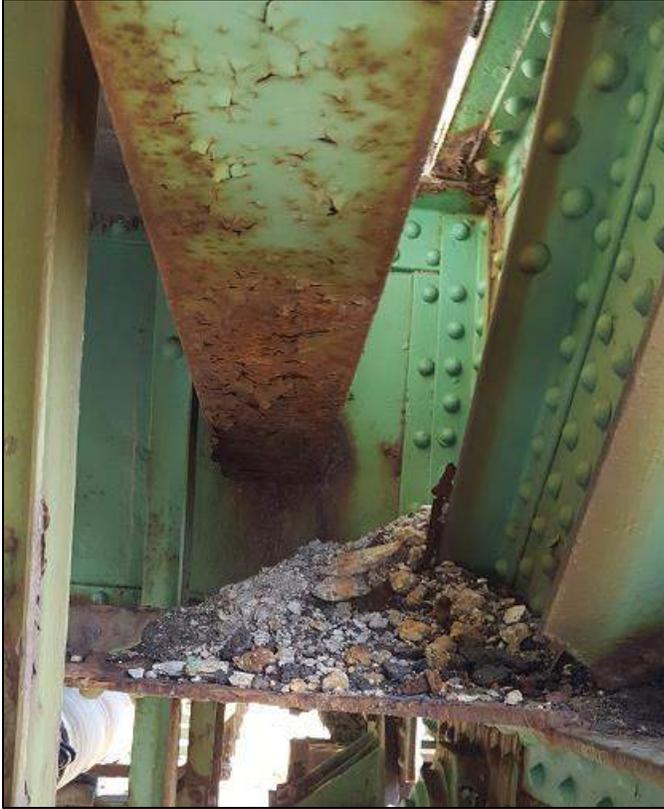
Noted last August was significant build-up of sand, dirt & debris on horizontal members including gusset plates.

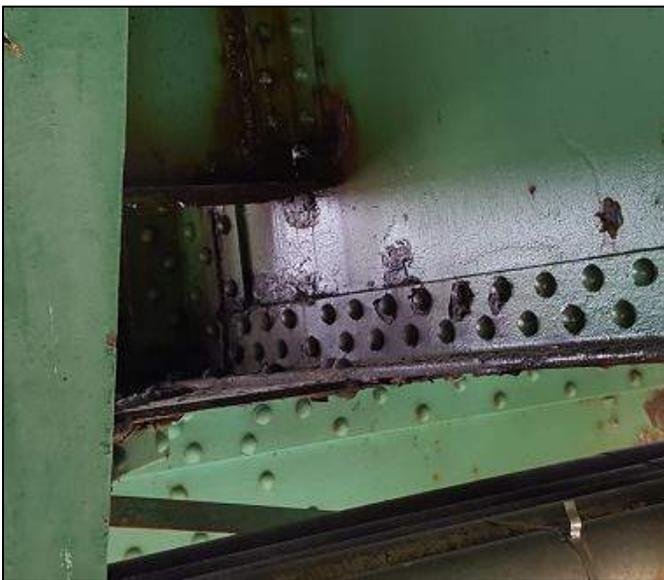
The modification of this contract resulted in most of these areas successfully blown clean with 145 psi of air.

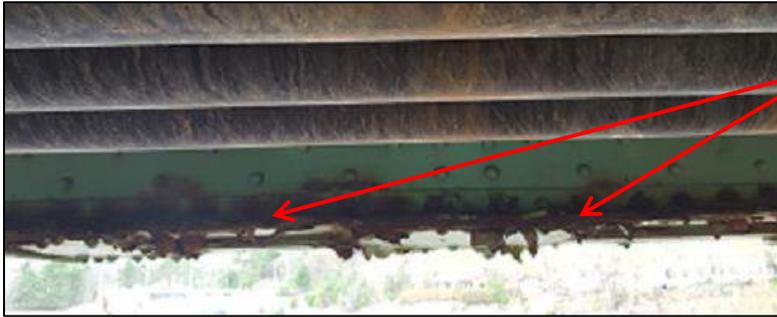
These rivets should be more exposed after blowing sand and dirt off.

- 1. Conduct a close inspection of the sidewalk chord rivet condition along the bottom angles, particularly span 3. (Contractor UBIT could not extend far enough for analysis.)**

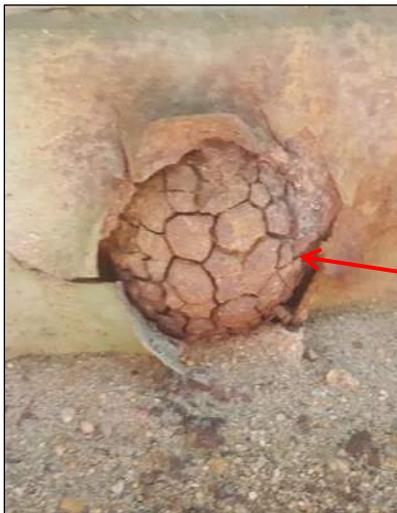
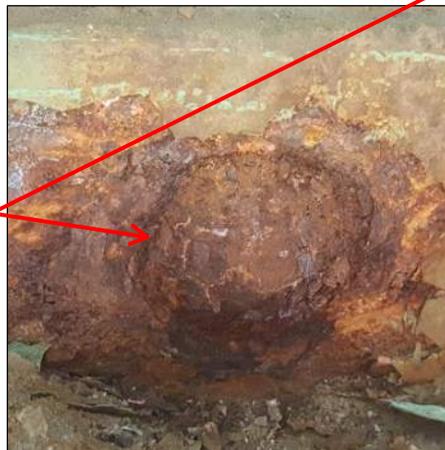
In August of 2016 a typical rivet was located in the sand/debris was struck until rusted portion was removed. A smaller head resulted.

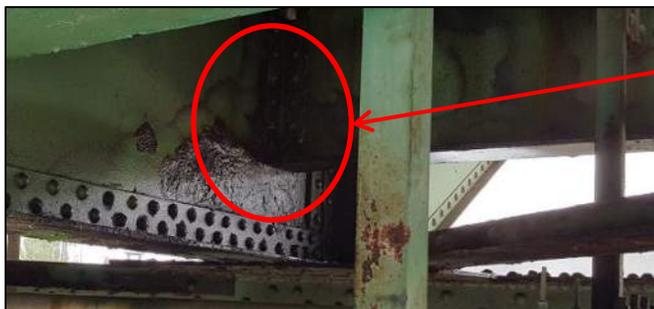
This area in particular.

- 2. Check closely the web thickness of Floorbeams 5 and 7 in Span 1 on the Sidewalk Truss side. (Repairs have been completed on the Roadside Truss side.) It looked as though the deterioration was more significant in these 2 Floorbeams.**

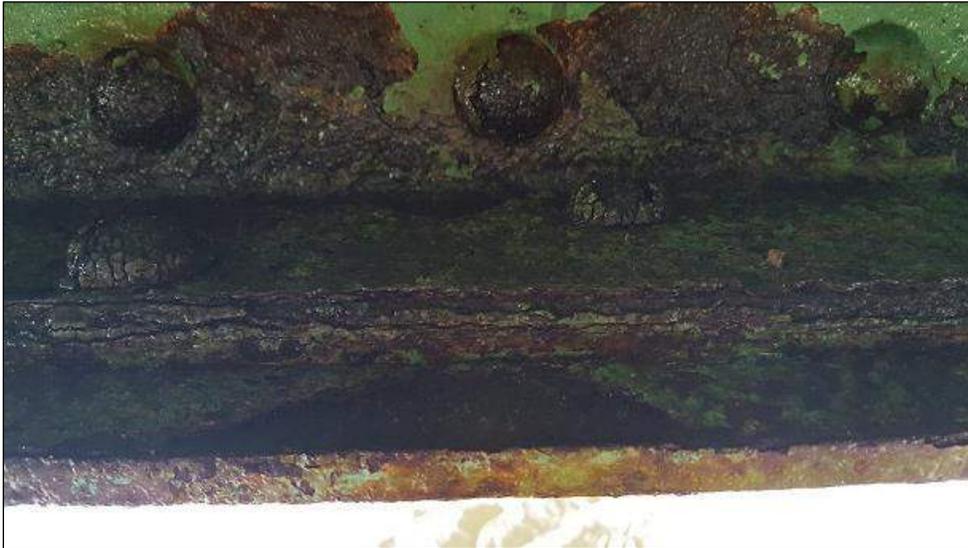
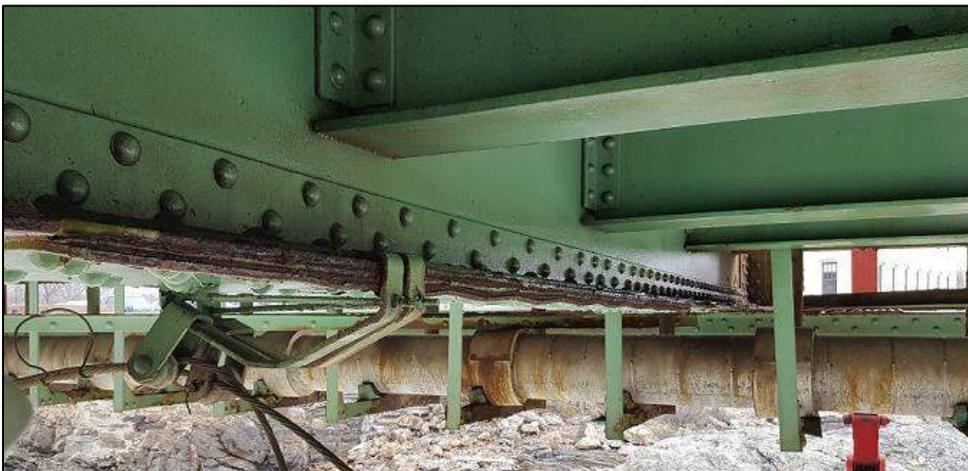
3. **Inspect the condition of the rivets and cover plates that appear rusty or excessive wave shape:** These components appear to contain significant pack rust but I have not observed any missing or popped off rivets. (Most of these in Span 2 but could also be located in Span 1. None in Span 3.)

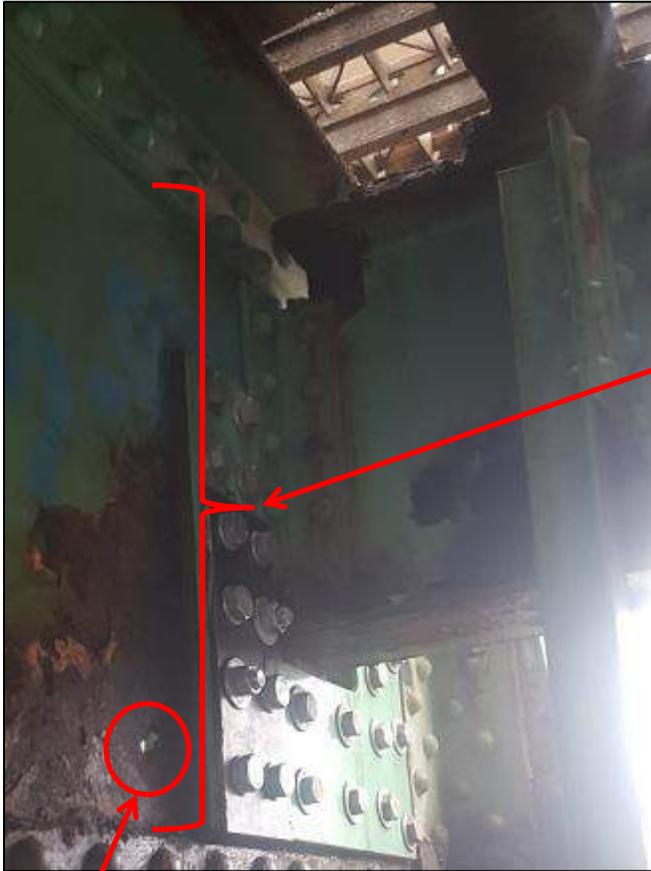
Repair Location at Floorbeam 5, Roadside Truss – Stringer 8, note hole through web to the left of cover plate.

Location of web hole.

4. **Inspect the web area above and below pin hole in the Floorbeam web shown below.**
This would be a good spot check for a series of D-meter readings. This spot check will serve as good general information for the Department.

Suggest collecting D-meter readings along this vertical length for thickness of web. (Original thickness = 0.5".)

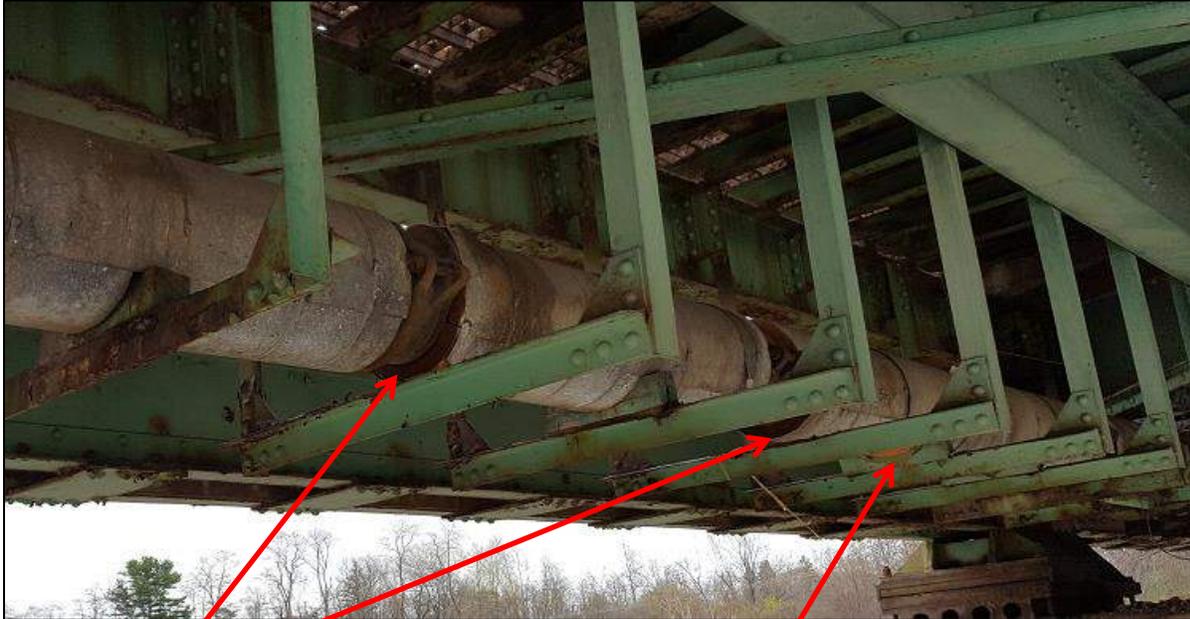
Custom blocks of wood missing.

This block appears to be “rolling over”.

5. **Review full length of water pipe hangers for significant loss of continuous support.** A determination should be made on how many compromised water pipe hangers is acceptable. It currently appears that the system is at a stage where more than one in a row may become ineffective. Some steel hangers have deteriorated steel components.

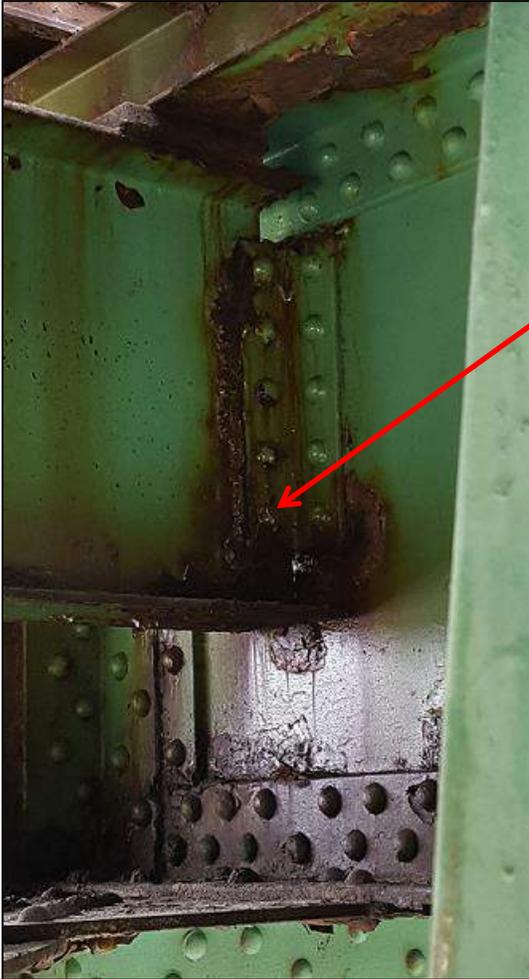
7. Continue to review/inspect Stringer ends. Significant numbers in Spans 1 and 3 are deteriorating. If any rivets become suspect, identify which one(s).

The Department has a standard uniform fix for stringer end connection. The bottom rivet remains to keep the stringer in place while plating is added.

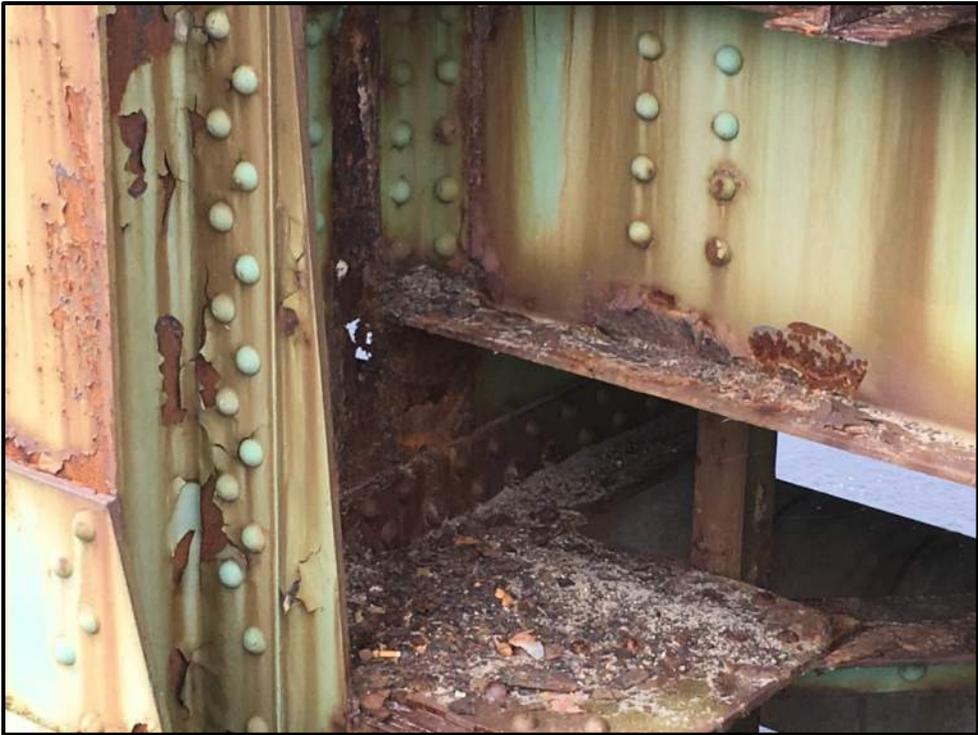
Floorbeams 7, 5 and 2 (in order of most deterioration) had holes representing significant section loss to the web. See table and photos below.

Photo A1 – Floorbeam 7, Roadway Truss @ Stringer 8 (Exterior)

A conceptual design repair was developed for Floorbeam 7 & 5 (and eventually could be applied to Floorbeam 2 and possibly others). Essentially the section loss in the web would be restored by bolting steel plates (shim and cover) on both sides by high strength bolts.

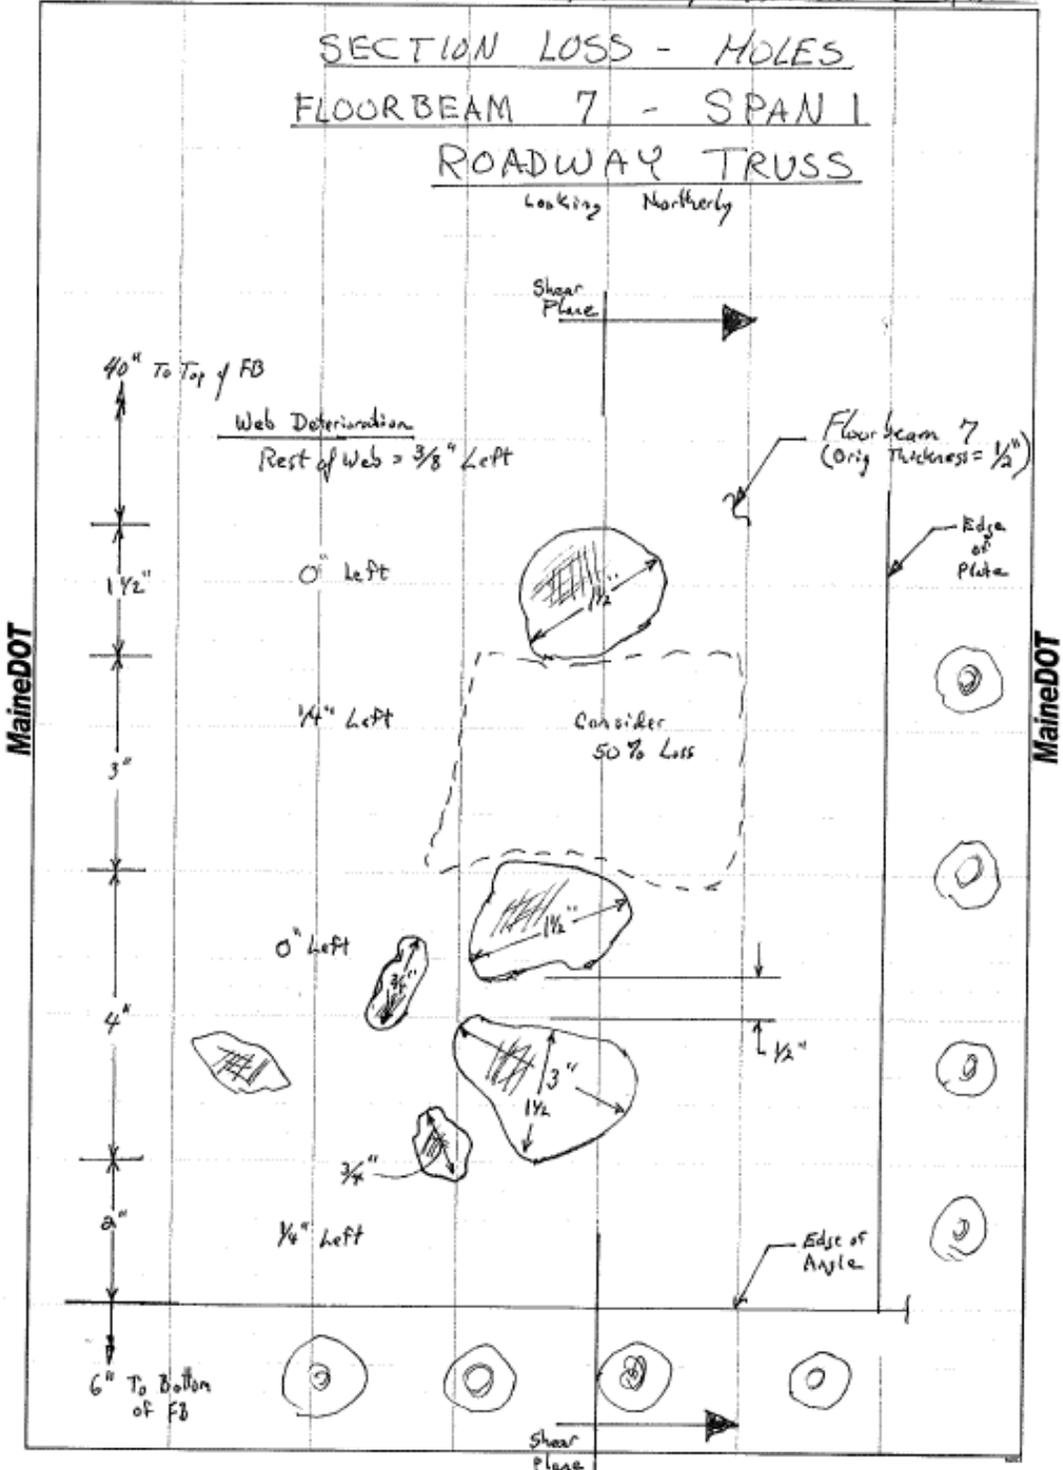
Sketch 1 – Section Loss in Floorbeam 7 Shear Plane. See Photo A1.

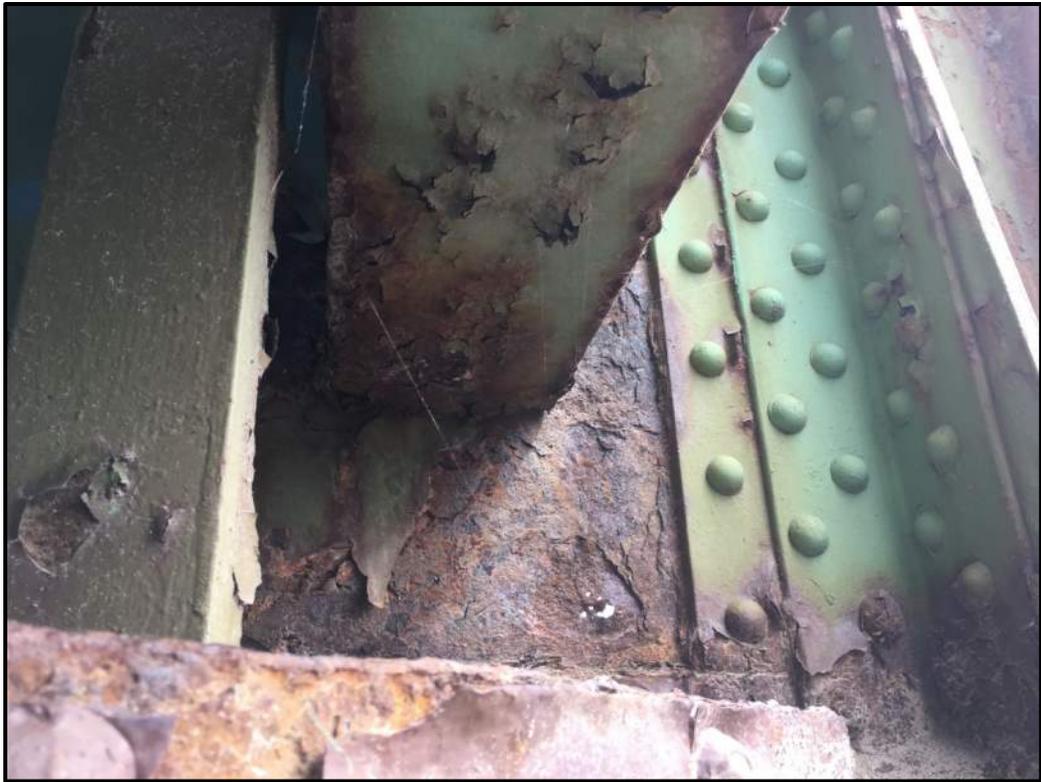
Photo A2 – Floorbeam 5, Roadway Truss @ Stringer 8 (Exterior)

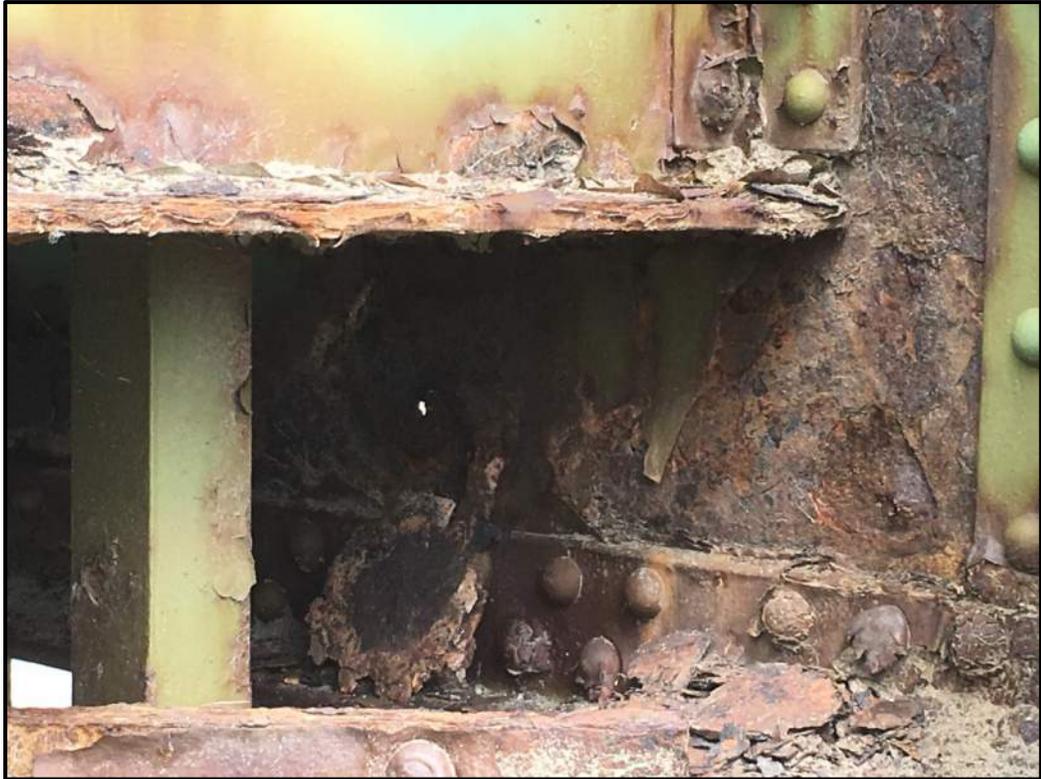
Photo A3 – Floorbeam 2, Roadway Truss @ Stringer 8 (Exterior)

Floorbeam 2, bottom flange cover plate is exhibiting advanced corrosion, pack rust, significant loss of rivet head section loss reaching enough concern to warrant a repair in the next 5 years.

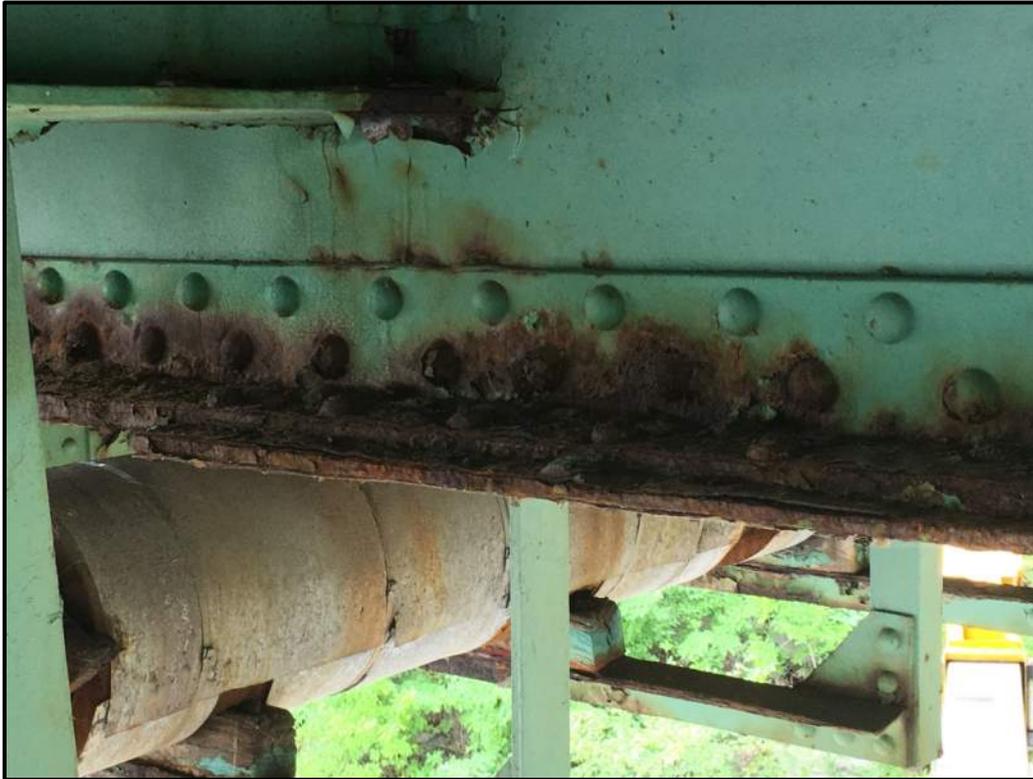
Photo A4 – Floorbeam 2 coverplate particularly between Stringer 7 & 6 is an area of concern which will be closely monitored.

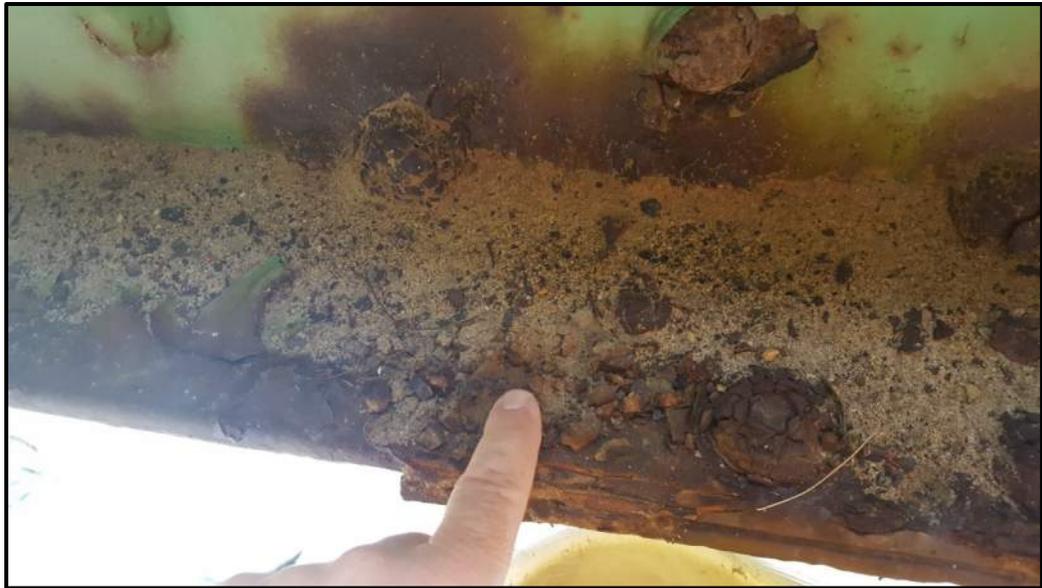
Span 2 of the bridge is exhibiting more concerns with the riveted bottom flange cover plates at Floorbeams 5, 6 and 8. The other Floorbeams have noted corrosion problems as well, but likely may remain adequate over the next 5 years.

Photo A5 – Floorbeam 5 coverplate has enough deterioration issues to expect a repair within 5 years.

Midspan of a distressed Floorbeam caused by pack rust could be temporarily repaired by replacing the rivets with bolts and adding a new steel coverplate. This could possibly be accomplished using a “split coverplate” to accommodate a 2 phase installation rather than removing all of the rivets at one time.

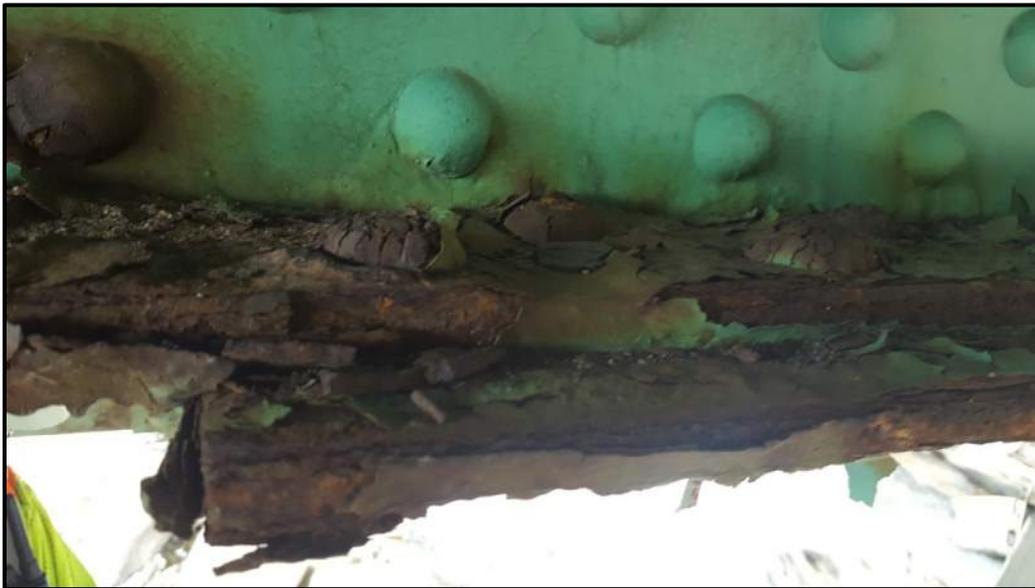
Photo A6 – Floorbeam 6 exhibiting excessive pack rust and rivet deterioration.

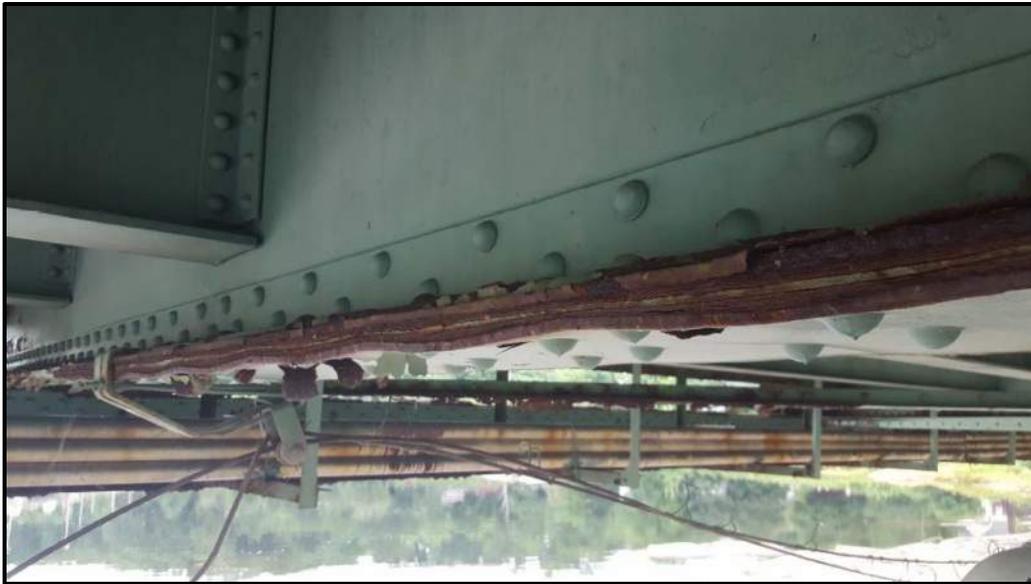
Photo A7 – Floorbeam 8 bottom flange midspan plies showing pack rust and deformation which may lead to repair activity within the next 5 years.

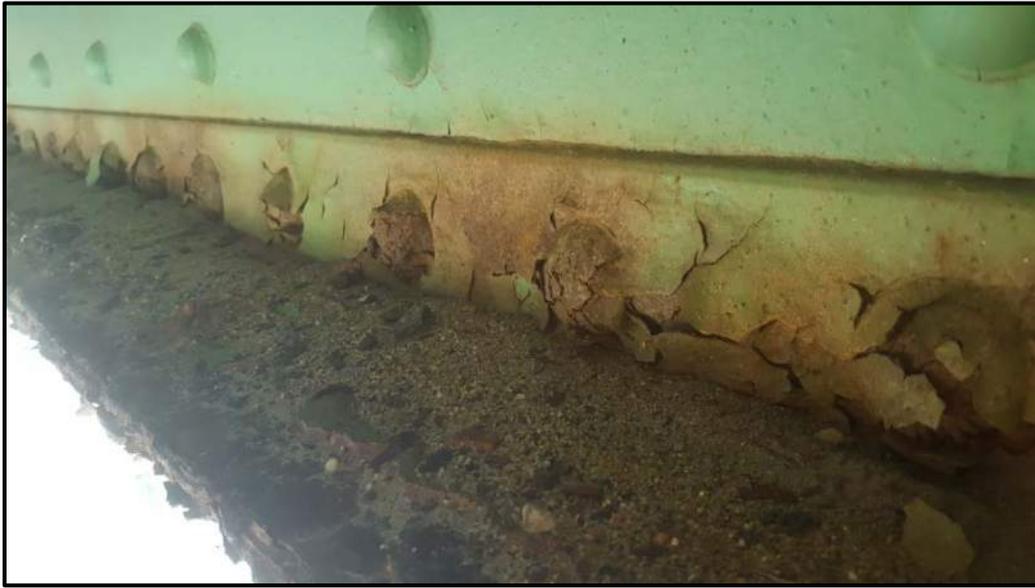
Span 3 exhibited a rivet deterioration issue which could reach a necessary repair status within the next 5 years. Due to the open grid at the gutter lines of this bridge, a good amount of sand, salts and debris are left covering portions of primary members. The difference of Span 3 and the others is the Sidewalk Truss has continuous rivet head deterioration in the lower tension chord. The panels of Span 3 are 22' in length. Along the lower chord, from Floorbeam 5 to 8 (3 panels @ 22' = 66'), the rivets fastening the lower angle to the plate will need to be monitored. Additionally, at least another portion of this same chord had this same condition from Floorbeam 1 to 2. See table and photos below.

Photo A8 - View of the inside of Sidewalk Truss's lower angle depicts continuous corroding rivet heads and sand, salts and debris occupying the angle flange.

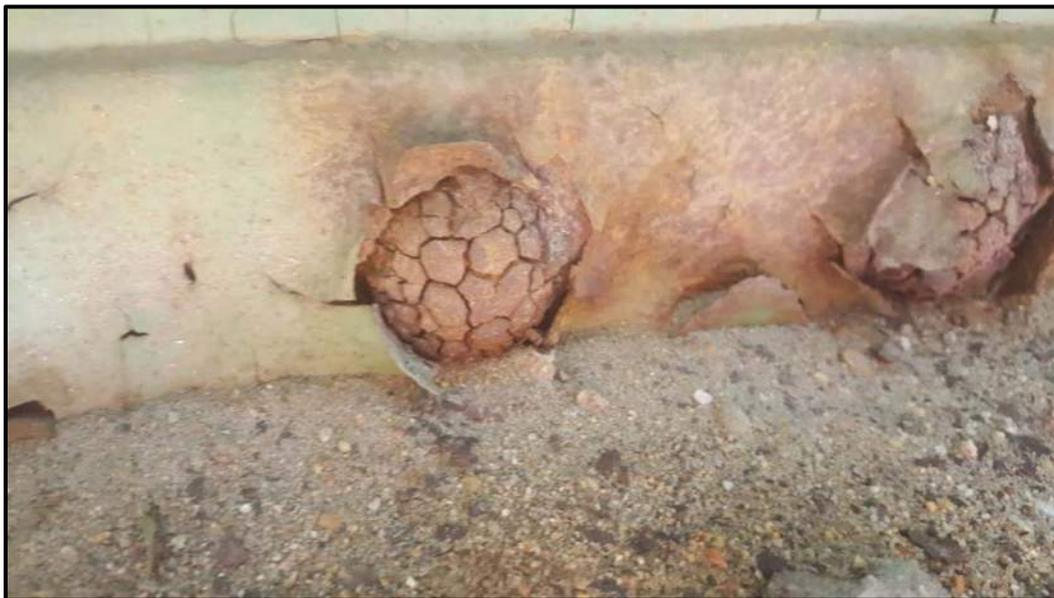
Using a claw hammer the loose corrosion was pounded away from a typical rivet head just described to reveal what remained. The result was a significantly smaller head size. See Photos A9 and A10. Further investigation and computations may be necessary before determining precise remedial action.

Photo A9 - Typical rivet head condition along Sidewalk Truss Lower Chord of Span 3 for at least 100 ' length of angle to plate connection.

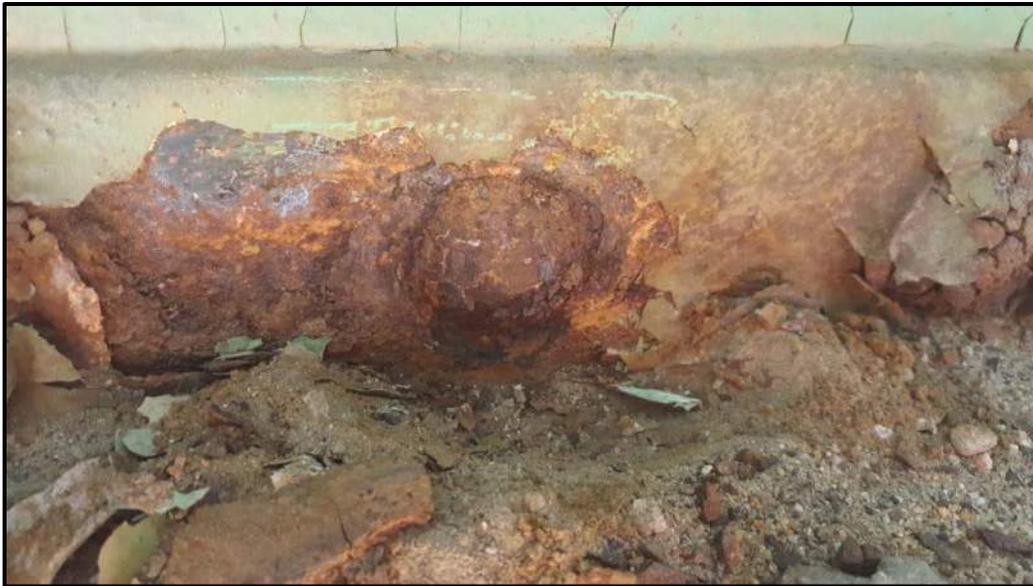
Photo A10 – This is the same rivet as above after briefly pounding loose corrosion away. The rivet head size is significantly smaller than the diameter and height of a new rivet head.

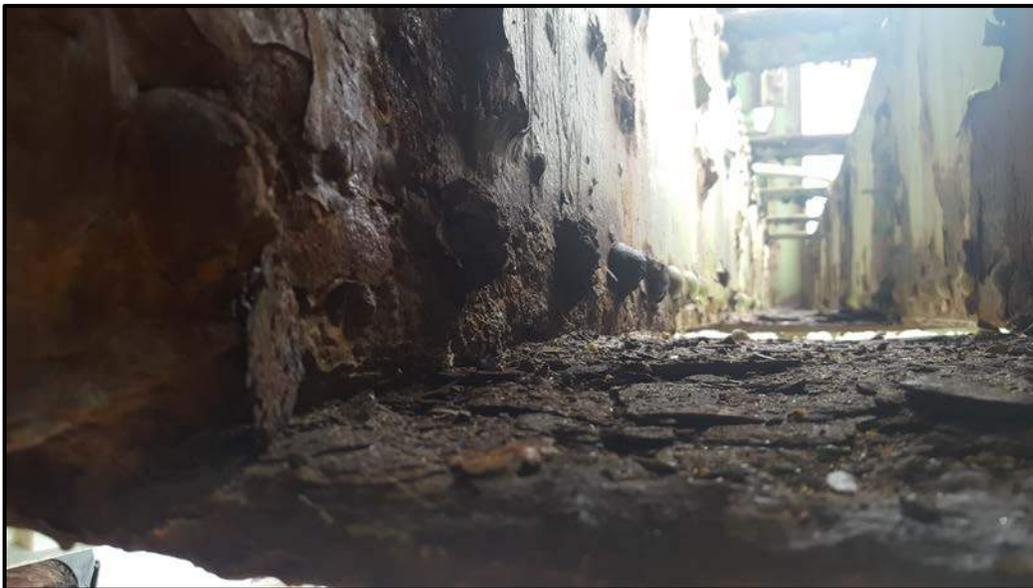
Although Spans 1 & 2 had noted corrosion and accumulated debris, the trusses did not appear to require an immediate repair or one within 5 years at this time.

Photo A11 – This is the general condition view of the inside lower chord truss member collecting rust and debris on the lacing bars.
