Preliminary Design Report

Frank J. Wood #2016

Brunswick-Topsham, Maine

August 4, 2017

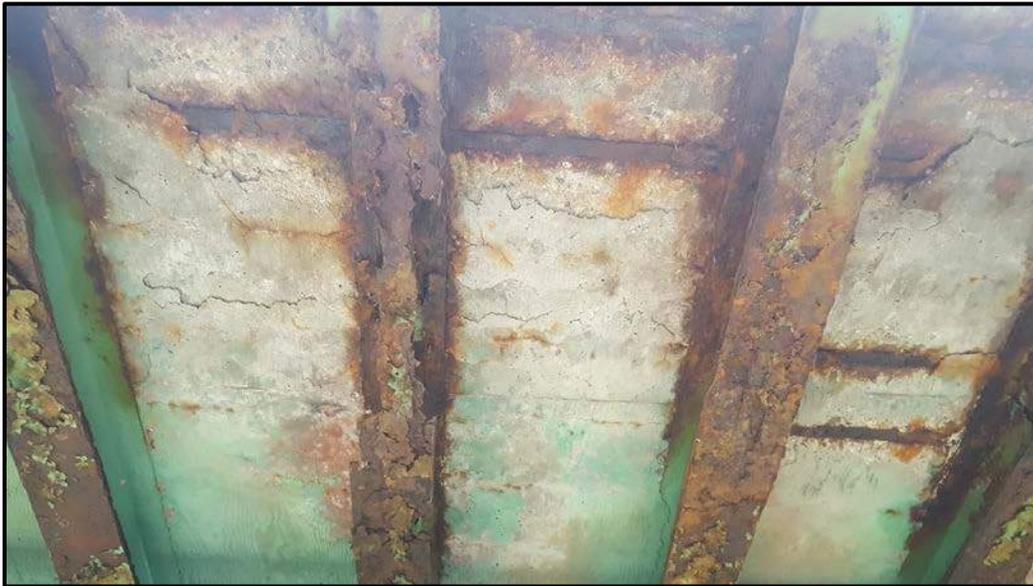
In particularly poor condition are areas in Span 1, Floorbeam 0 to 1 on the Roadway side of the truss and Floorbeams 3 to 4 on the Sidewalk side of the truss. Additionally, areas near Floorbeam 2 at Stringers S7 and S8 are in similar condition. Area between Floorbeams 3 and 4 on the Sidewalk Truss side have multiple Needle Beams with major section loss.

Photo A20 – Deteriorated Needle Beams shown here in Span1, Floorbeam 0 to 1, are evident throughout all 3 spans. These beams are 2'-0" on center supporting a grid deck mostly filled with concrete supporting an 1 ½ " to 2" asphalt wearing surface.

The grid is supported by these needle beams at every 2', distributing the loads effectively. The grid is adequate condition filled with concrete with the exception of 1 foot gutter area (open). The deterioration of the Needle Beams is widespread to the point where the Department will carefully monitor the deck for distress over the next 5 years. Should there be a compromise of the deck, one repair method would be to cut out area topside, lay in similar grid with a steel plate and then fill with asphalt as a temporary repair until a full deck is replaced or a new bridge is built.

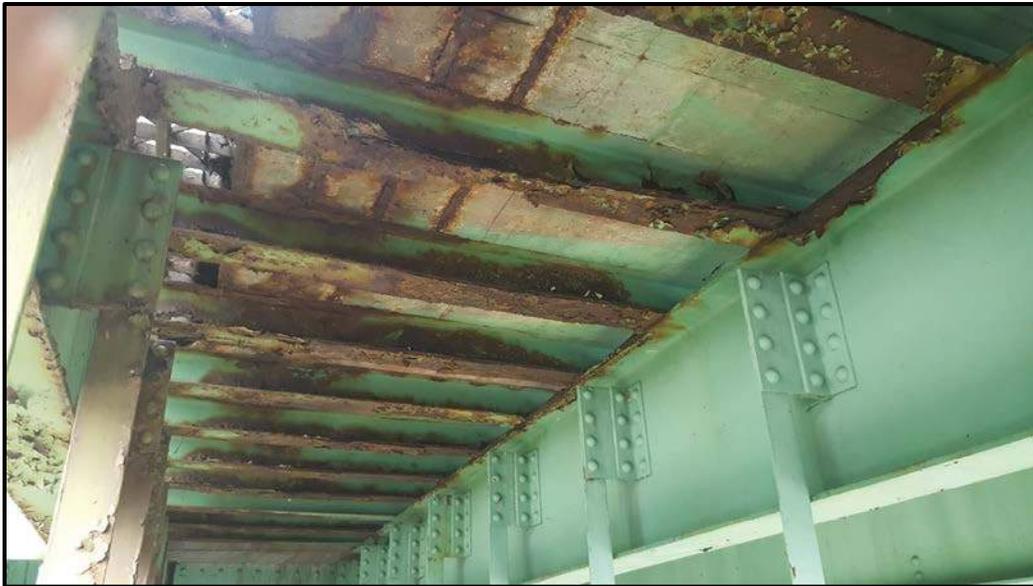
Photo A21 – View showing Needle Beams between Stringers 7 and 8. Area between stringers 3 and 4 are similar.

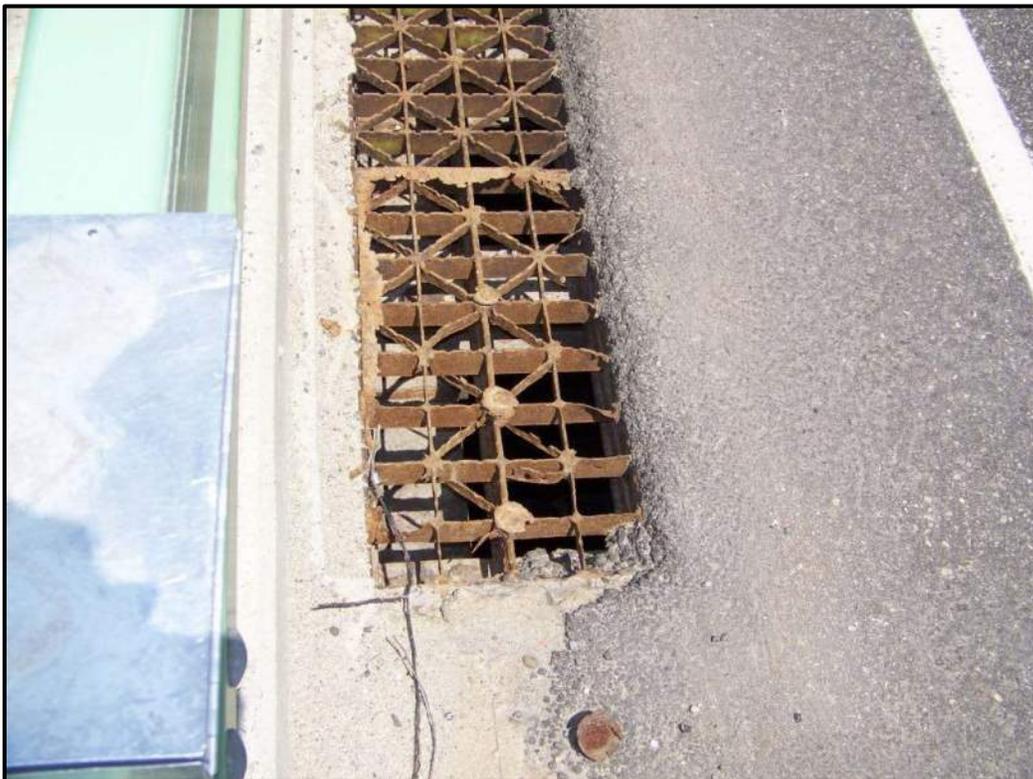
Photo A22 – An open grid approximately 1 foot wide runs parallel to Stringers.

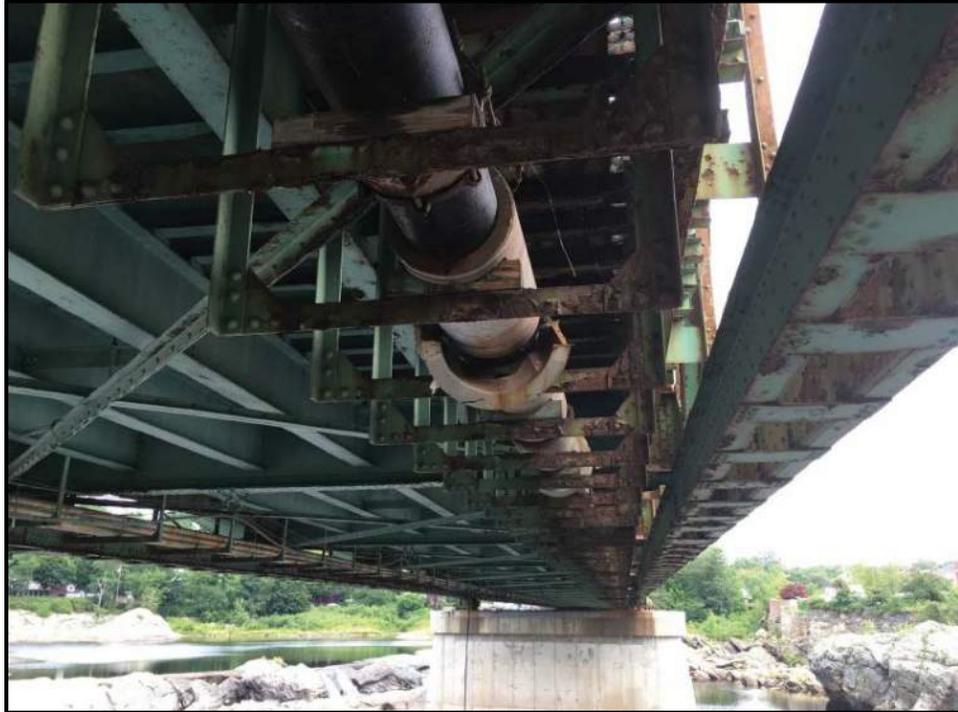
The utility brackets supporting an insulated steel pipe are in generally poor condition. There is a possibility of strengthening a percentage of them within the next 5 years - and will be monitored.

Photo A23 – View of steel insulated utility pipe extending across the bridge on the Roadside Truss side.

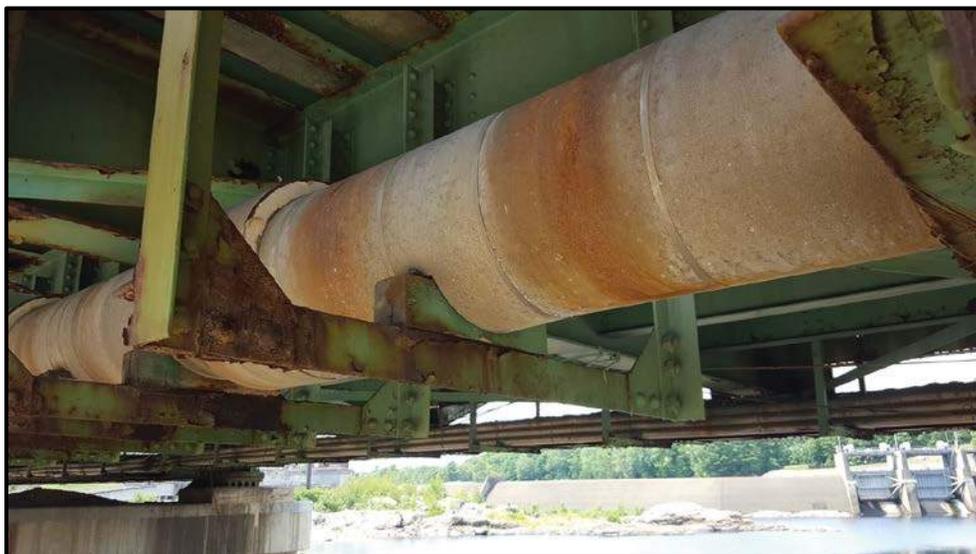
Photo A24 – The Utility Brackets are in poor condition with extensive active corrosion.

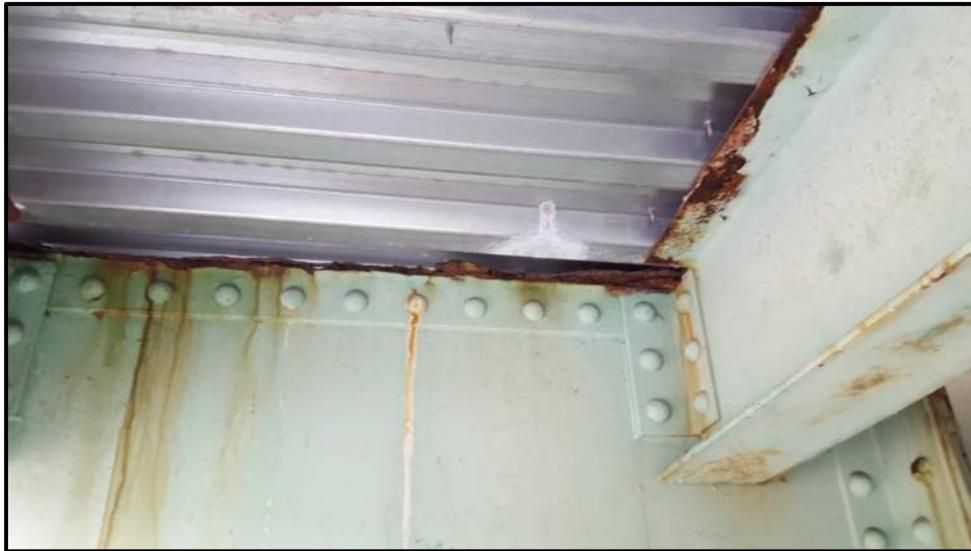
The Routine And Fracture Critical Bridge Inspection Report, 8/2012, from Parsons Brinckerhoff considered the top flange of these cantilevered sections to be severely corroded in all 3 spans. It is likely the top flange of the angle was likely removed roughly with a torch when the sidewalk was upgraded/installed. This component can be monitored rather than repaired immediately.

Photo A25 – View of the top half of cantilevered brackets that support the sidewalk.

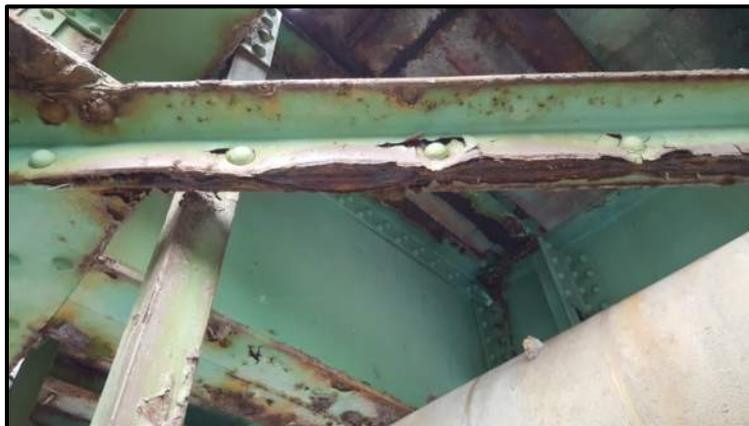
Lateral bracing has pack rust issues throughout the structure. Considered essentially for construction forces and loads, these components will be monitored rather than be targeted for repair.

Photo A26 – In general, a good amount of deterioration exists in the lateral bracing system.

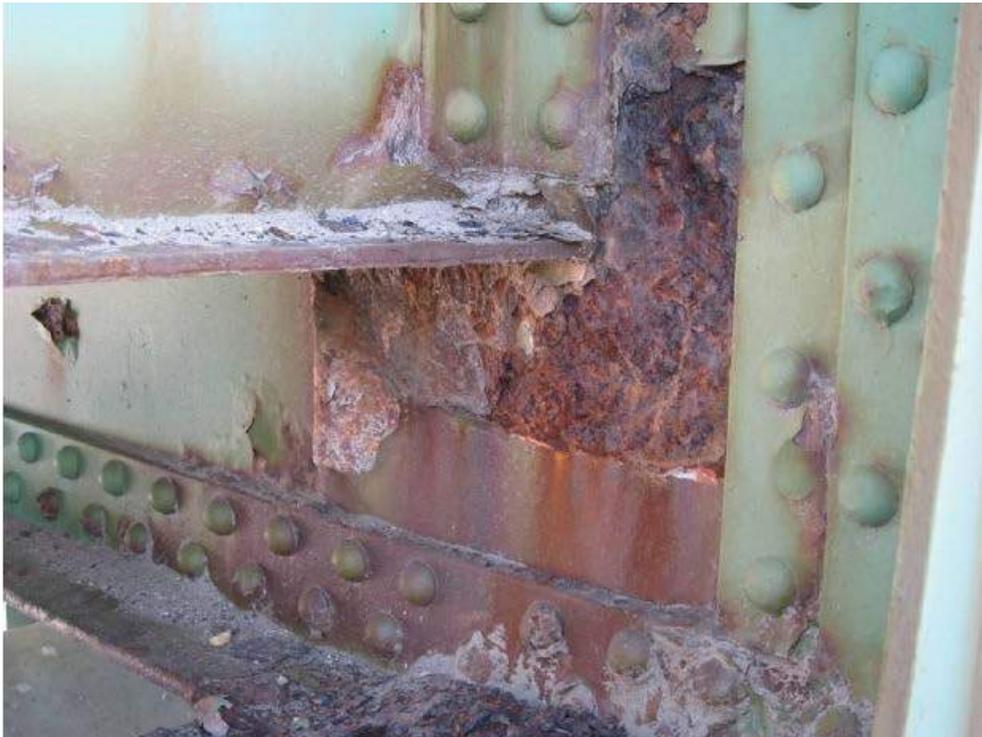
At Span 1 FB7 below S8 both faces of the web exhibit active corrosion with section loss of 1/8 inch depth over a height of 8 inches and length of 12 inches (Photo 44).

Photo 44 – At Span 1 FB7 below S8 both faces of the web exhibit active corrosion with section loss of 1/8 inch depth over a height of 8 inches and length of 12 inches.

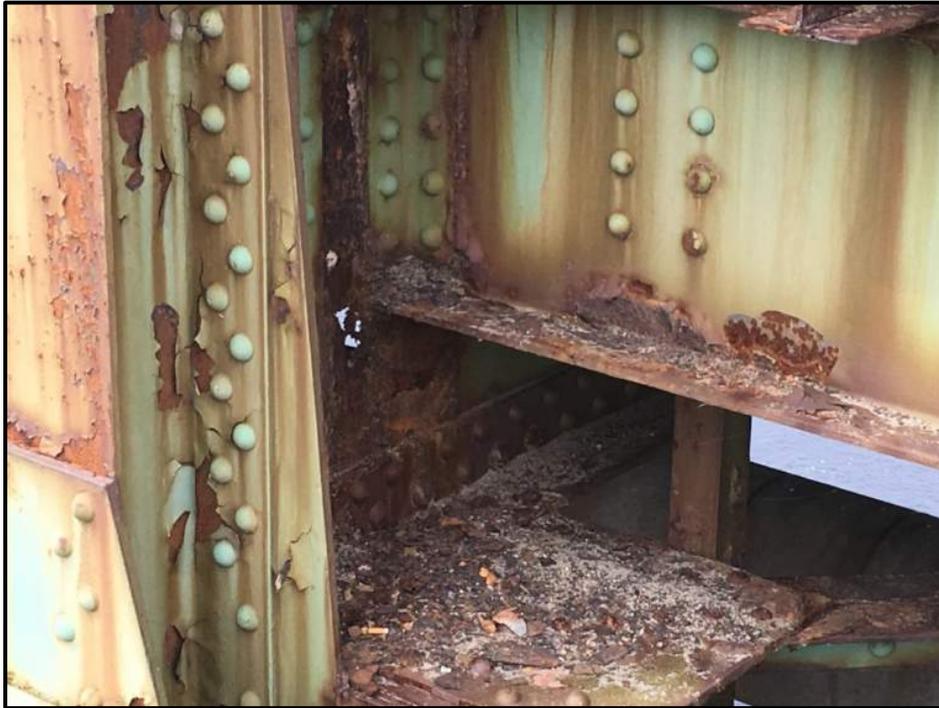
Photo A1 – Floorbeam 7, Roadway Truss @ Stringer 8 (Exterior)

12 inches at the bottom of this 42" Floorbeam has nearly 100% section loss.

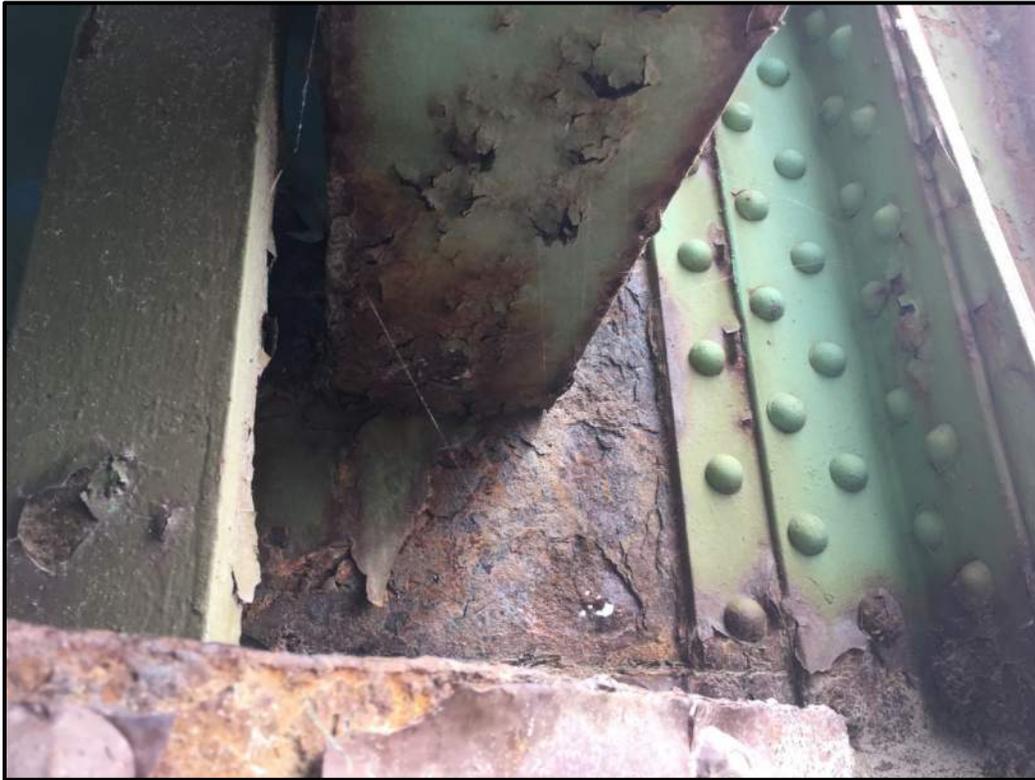
Photo A2 – Floorbeam 5, Roadway Truss @ Stringer 8 (Exterior)

Span 1 FB5 has a zone of significant active corrosion to the top of the bottom flange on the north side of the web between S6 and S7 with up to 1/8 inch section loss to rivet heads in this zone (Photo 43). The ends of the floorbeams below S1 and S8 exhibit paint loss and active

This area of 100% section loss was not targeted as a corrosion problem 4 years ago.

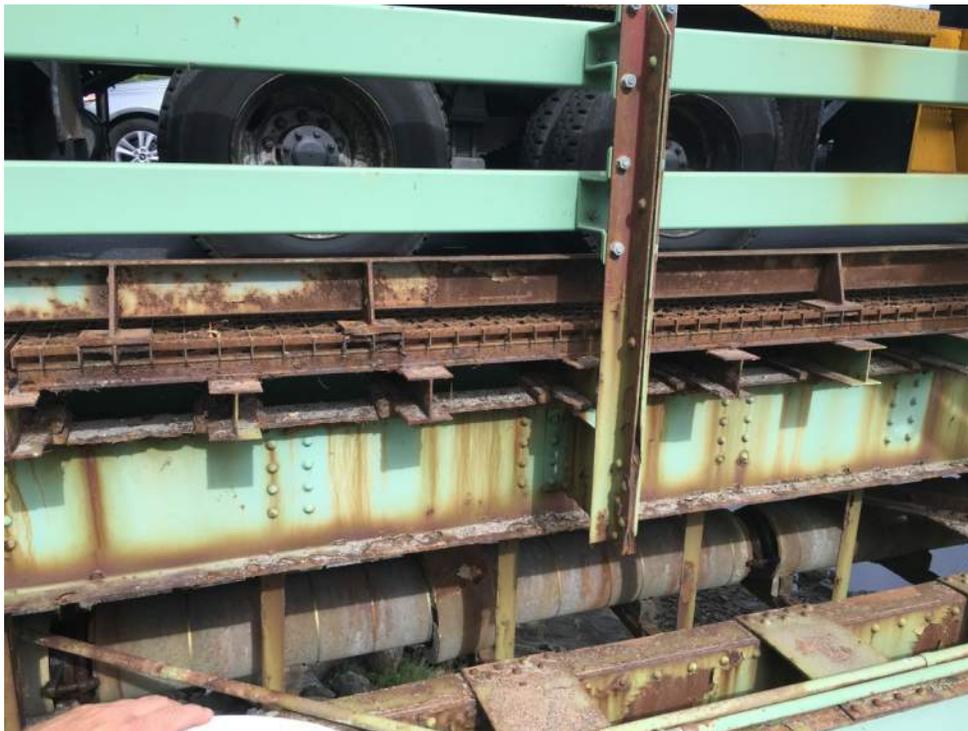
Photo #4: General view of the superstructure section (8/1/16)

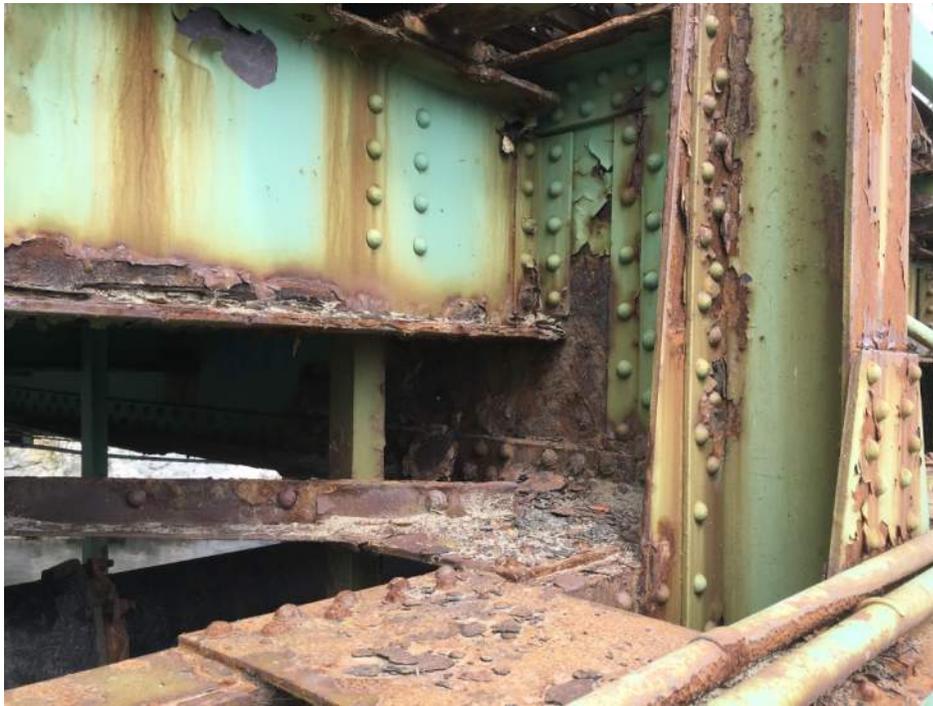
Photo #5: General view of the Floor Beam, Stringer & Vertical Truss member connection (8/1/16)

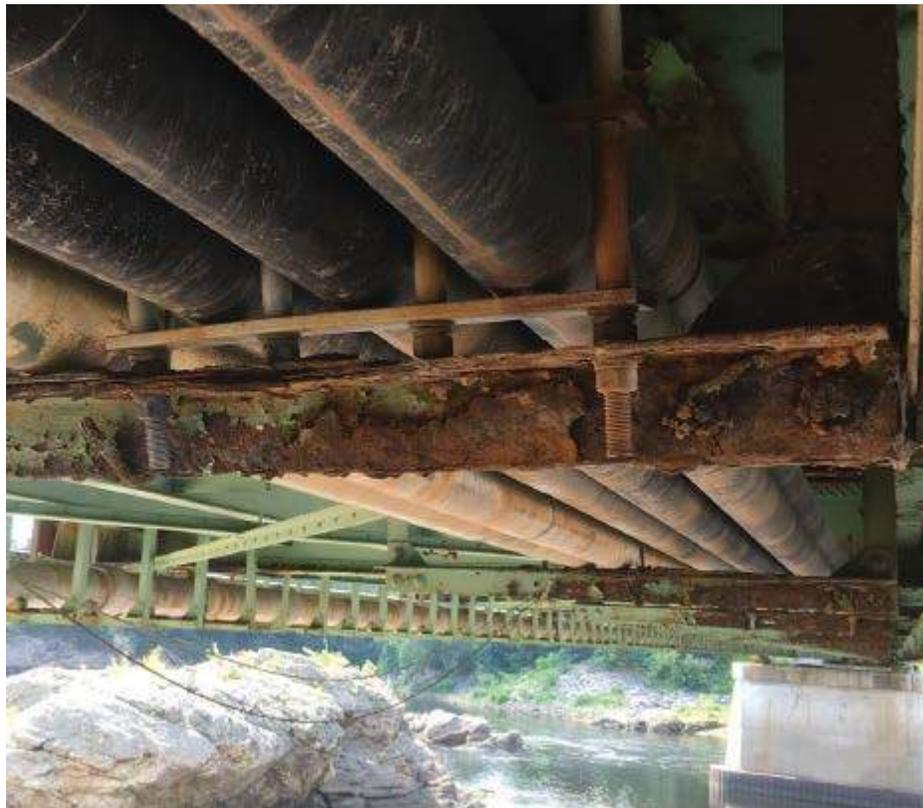
The utility hangers that support the conduit on the western side, and the water pipe on the eastern side of the structure are in overall poor condition. These hangers are extremely redundant, as they appear to be spaced every 3-4' along the structure, however their condition will not last 30-75 years. These hangers are currently supported by the first two (2) roadway stringers on each side of the structure (S3-S4 & 37-S8), and since the recommendation is to replace all of the stringers, the utilities will need to be temporarily supported during the rehabilitation work. This may not be at a direct cost to MaineDOT, but it should still be noted that it will affect the constructability of any rehabilitation project.

Photo #6: General view utility conduit supported by a hanger system attached to the stringers (western side of structure looking south) (8/1/16)

Recommendation: Replace all utility hangers

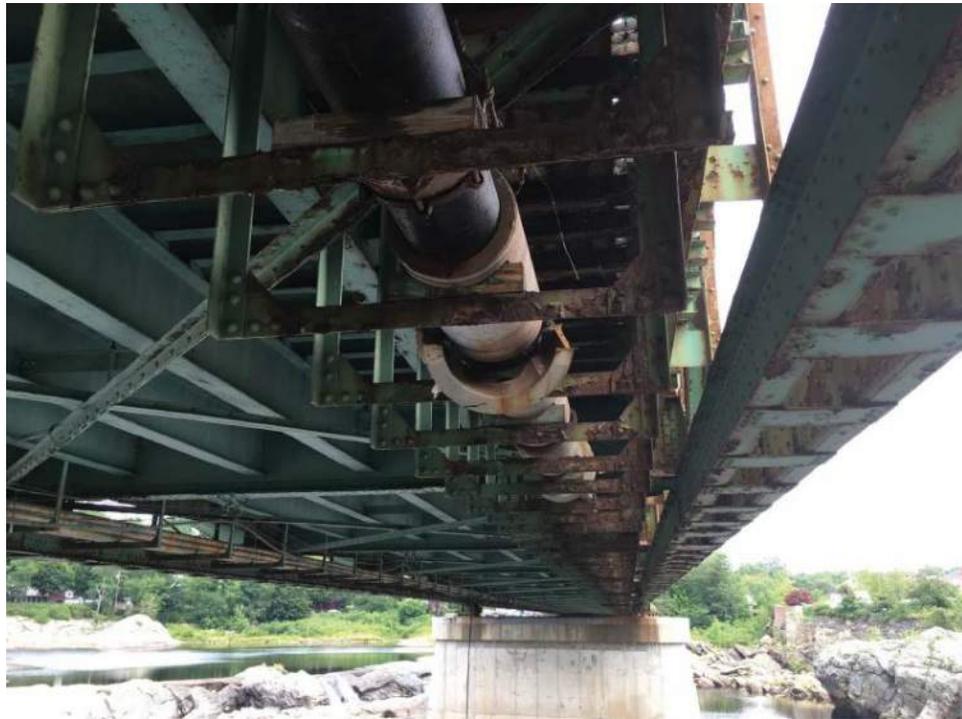
Photo #7: General view of utility pipe supported by a hanger system attached to the stringers (eastern side of structure looking north) (8/1/16)

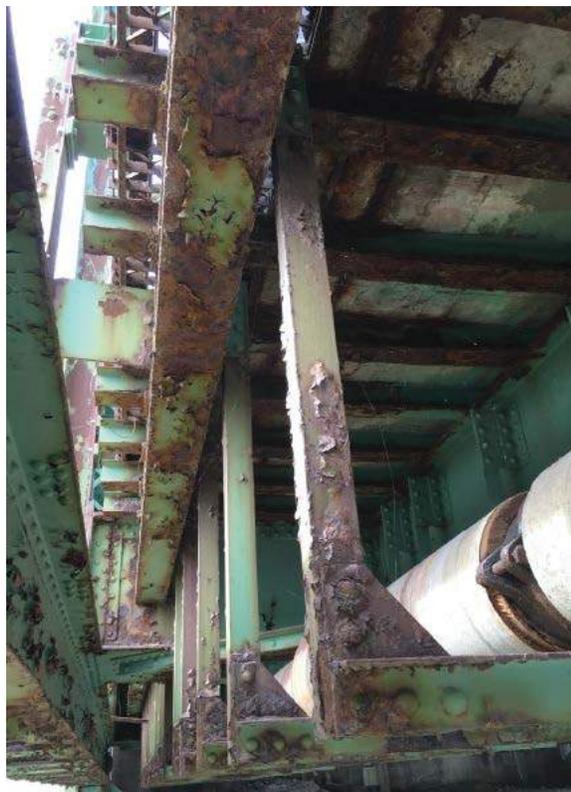
Photo # 8: General view of paint loss and corrosion to bays below the open grid decking in the travel way shoulders on the non-sidewalk side (eastern) of the bridge (8/1/16)

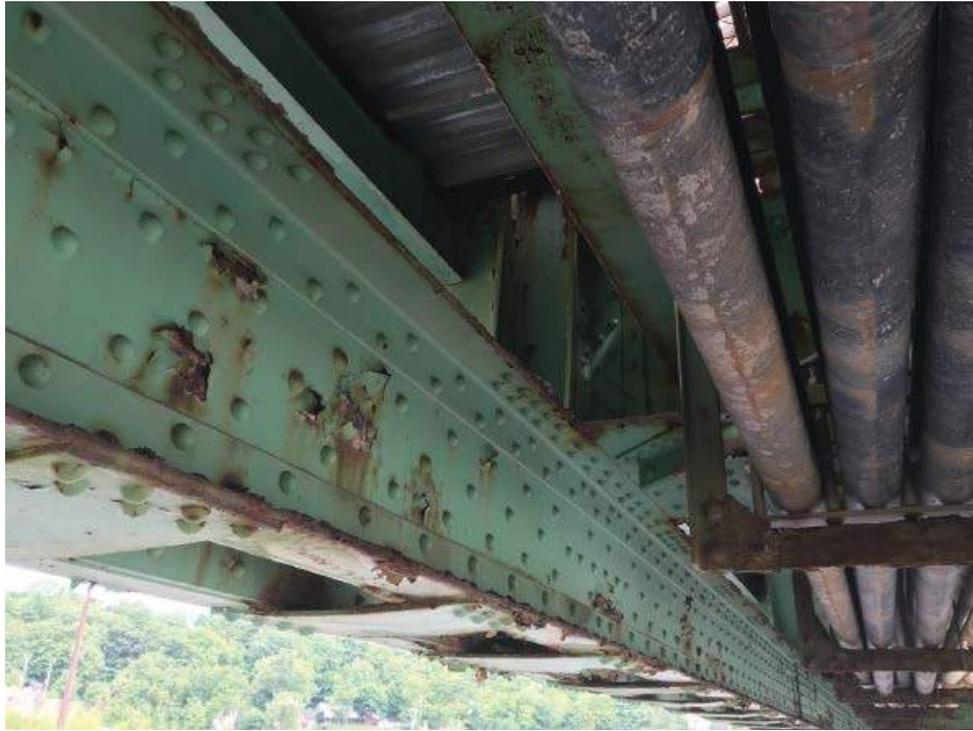
Photo # 9: General view of paint loss and corrosion to bays below the open grid decking in the travel way shoulders on the sidewalk side (western) of the bridge (8/1/16)

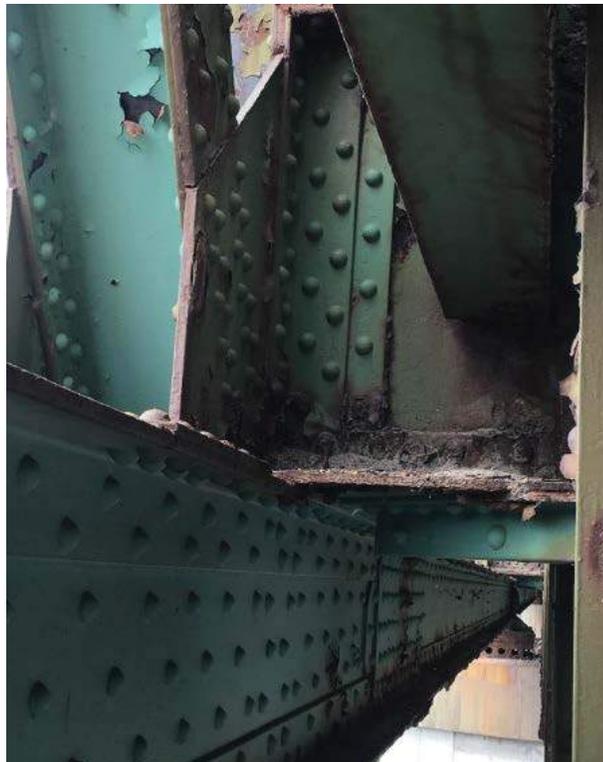
Photo # 10: General view of floor beam to truss gusset plate connection (8/1/16)

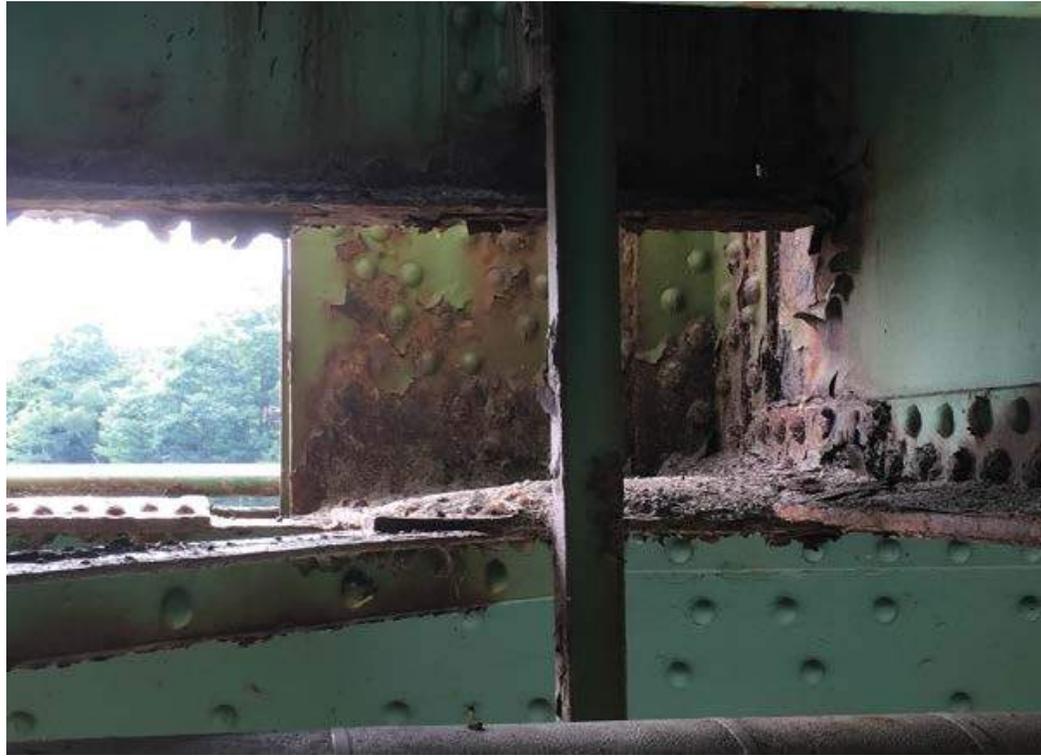
Photo # 11: General view of typical paint loss & debris collection at floor beam ends (8/1/16)

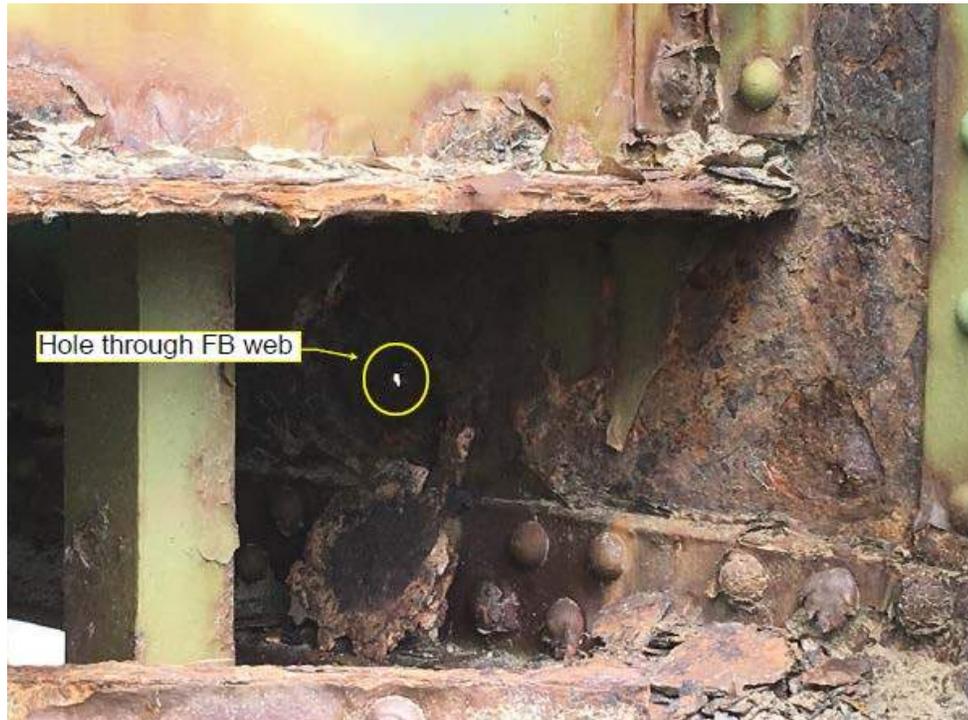
Span 1 had the highest level of floorbeam deterioration as several floorbeams have areas of complete section loss. Holes through the web were present in FB2, FB5 & FB7, with the condition of the web on FB7 being significantly worse than the other two. During the 2016 routine inspection mentioned above, the inspector was able to punch holes through the web of FB7 when struck with a hammer on the non-sidewalk truss end of beam. Holes in the web were naturally formed in FB2 & FB5, however the steel near the holes appeared sound when struck during the 8/1/16-8/2/16 inspection. These three floorbeams were the only beams in the structure that had holes through the webs, although the condition of the all of the remaining floorbeams could result in similar section loss in the near future. See Appendix A, photos 12 through 17 for images of the holes through the floor beam webs.

Photo # 12: General view of corrosion & hole through the web on the non-sidewalk (eastern) end of FB2 in span 1 (8/1/16)

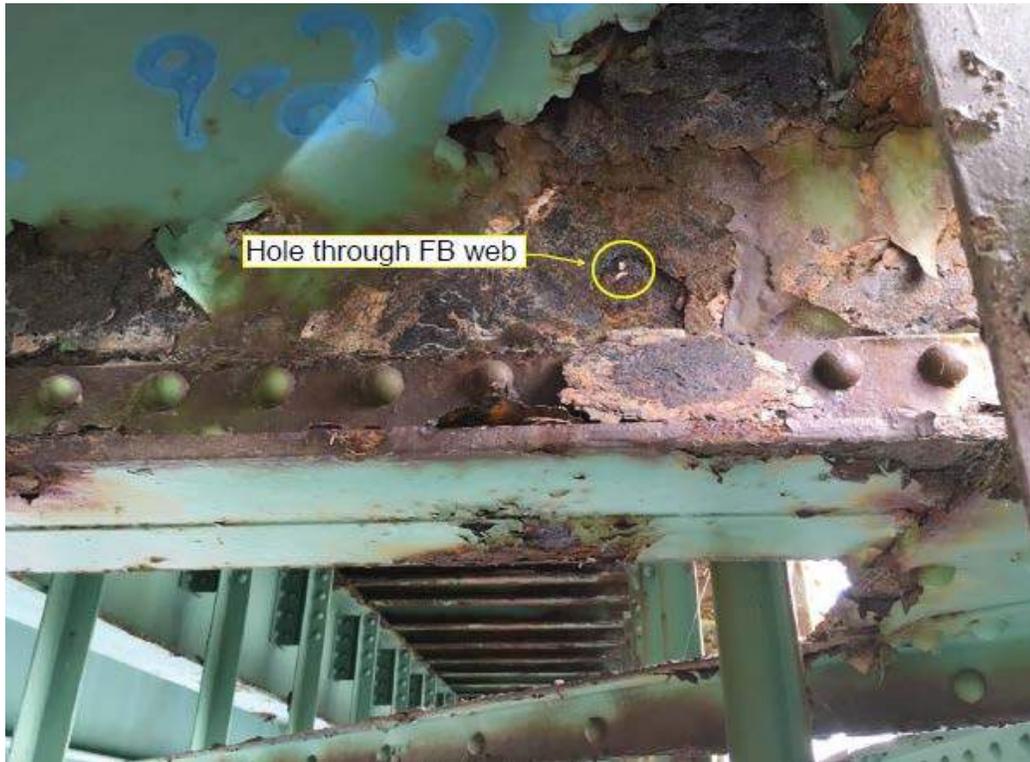
Photo # 13: Closer image of hole through the web of FB2 in span 1 (8/1/16)

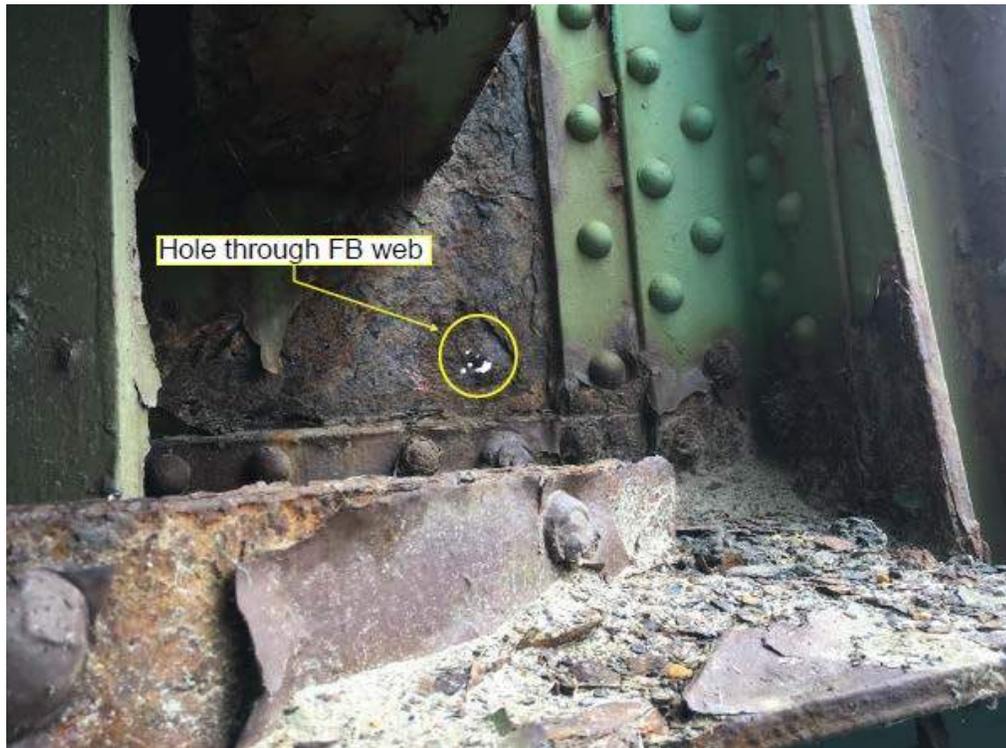
Photo # 14: General view of corrosion and hole through the web of the non-sidewalk (eastern) end of FB5 in span 1 (8/1/16)

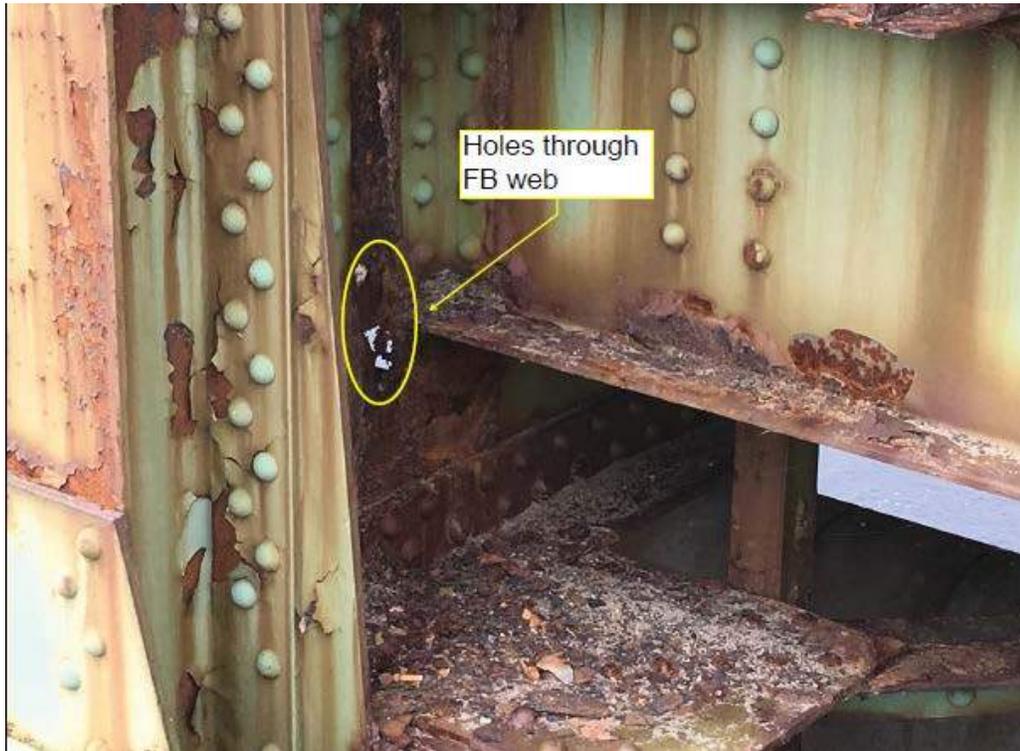
Photo # 15: General view of corrosion and holes through the web of non-sidewalk (eastern) end of FB7 in span 1 (8/1/16)

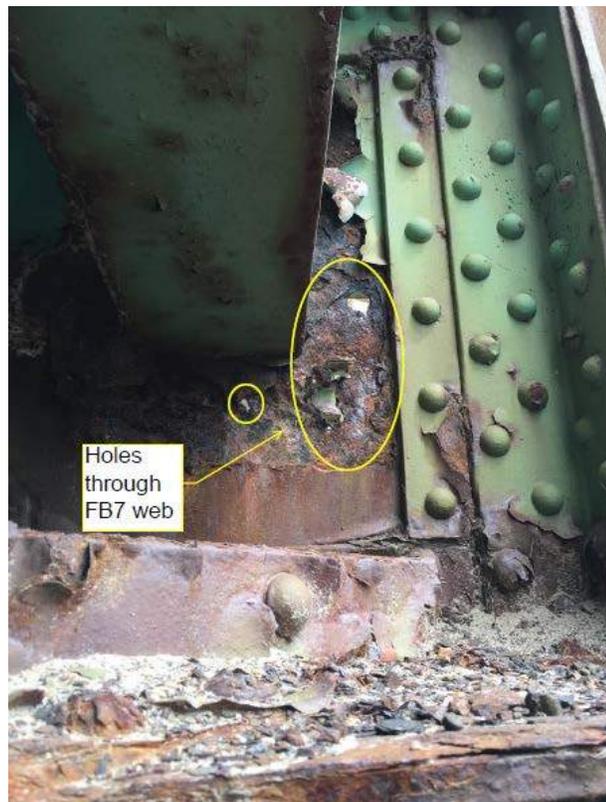
Photo # 16: Closer view of holes through the web of FB7 (8/1/16)

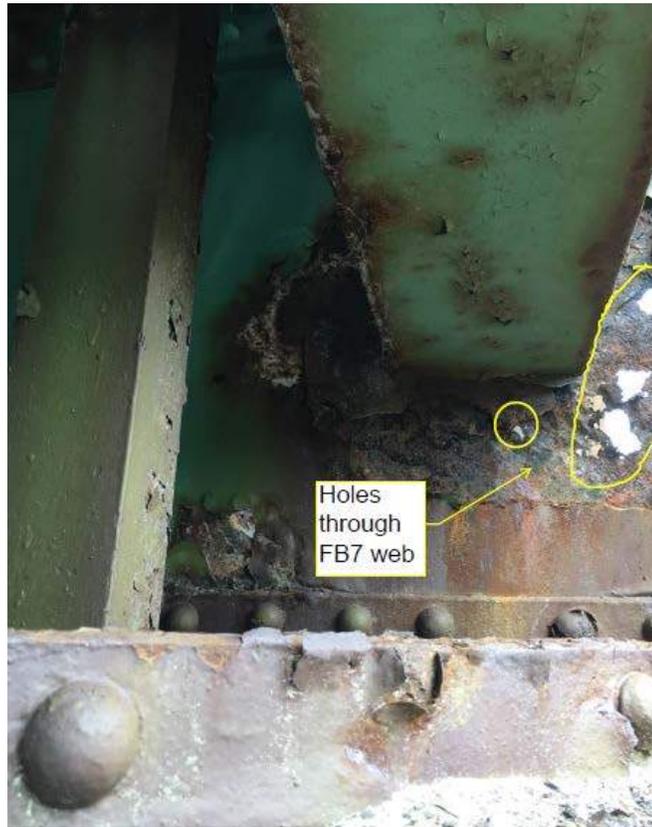
Photo # 17: Closer view of holes through the web of FB7 (8/1/16)

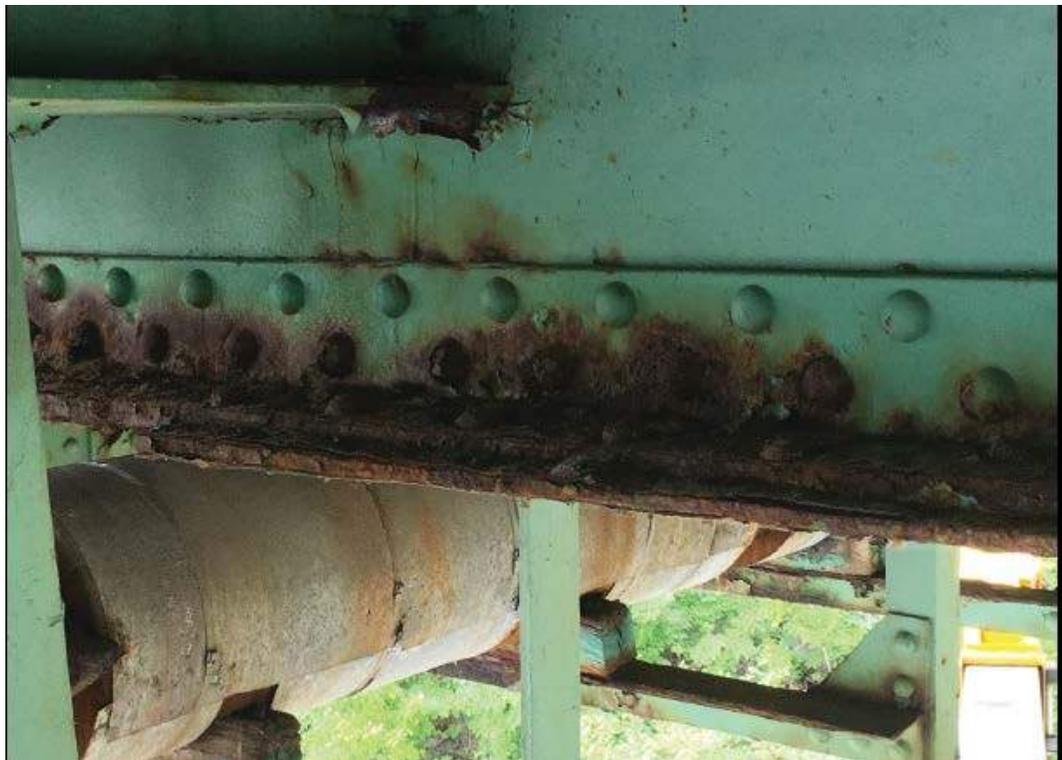
Paint failure and varying degrees of corrosion, pack rust and section loss was present near midspan of all of the floorbeams in all three spans of the bridge. Several floorbeams in span 2 have the worst deterioration, as there is severe corrosion and section loss to the bottom flange and rivets, as well as pack rust between the cover plate and the angles making up the bottom flange of the floorbeams at FB5, FB6 and FB8, (see Appendix A, photos 18 through 20 for images of the midspan corrosion). These floorbeams had the worst deterioration in the cover plated area of the beams near midspan, however most, if not all of the floorbeams showed corrosion at this location.

Photo # 18: Severe corrosion & pack rust between the bottom flange of the floor beam and the cover plate near midspan of FB5 in span 2, (span 2 FB4, FB6 & FB7 similar) (8/2/16)

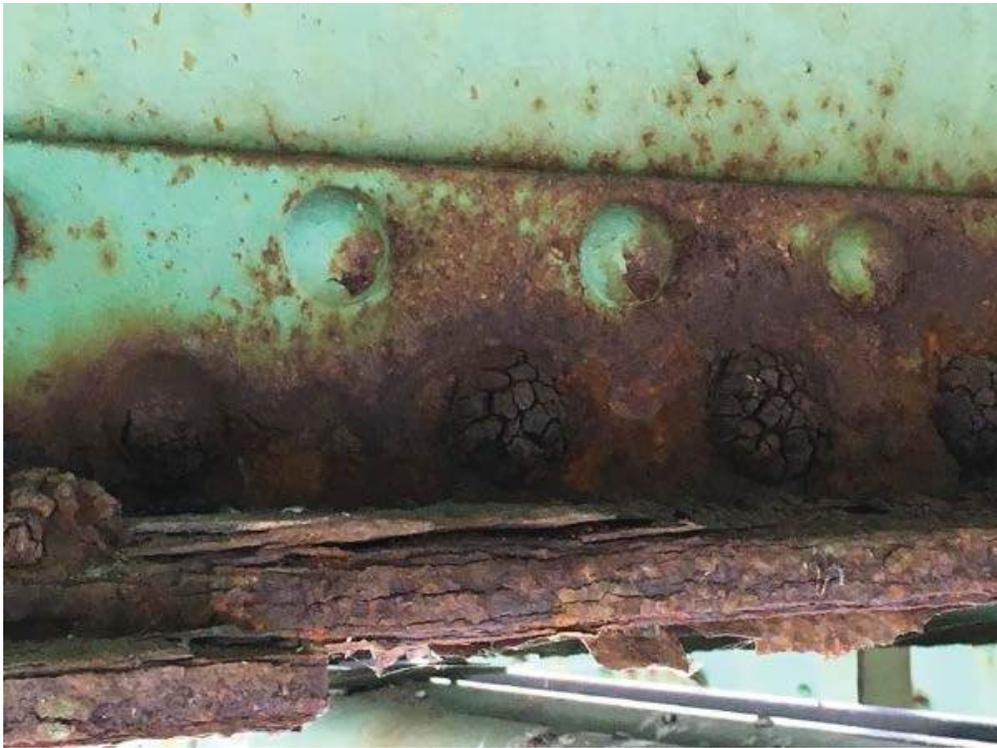
Photo # 19: Severe corrosion to the rivets as well as corrosion & pack rust between the bottom flange of the floor beam and the cover plate near midspan of FB5 in span 2 (span 2 FB4, FB6 & FB7 similar) (8/2/16)

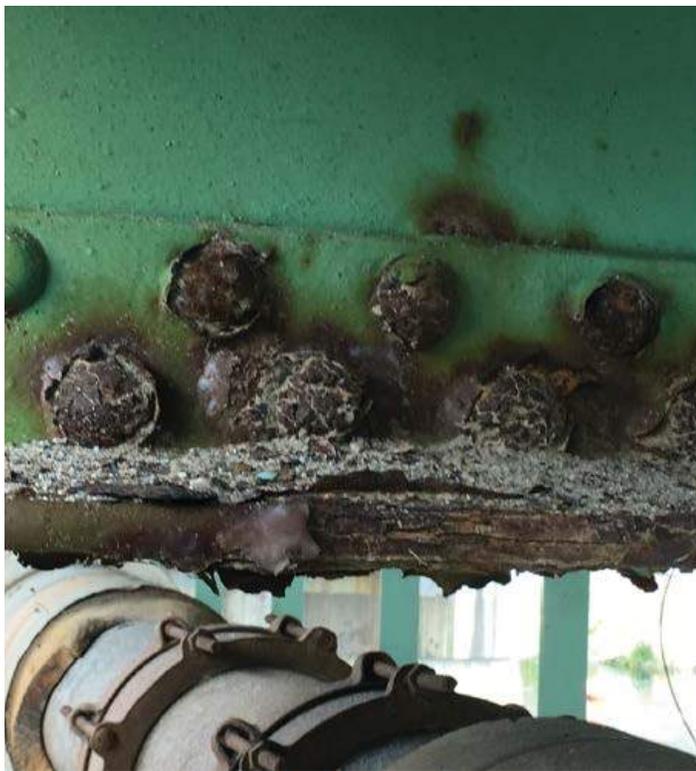
Photo # 20: Advanced deterioration of rivets near midspan of FB7 in span 2 (8/2/16)

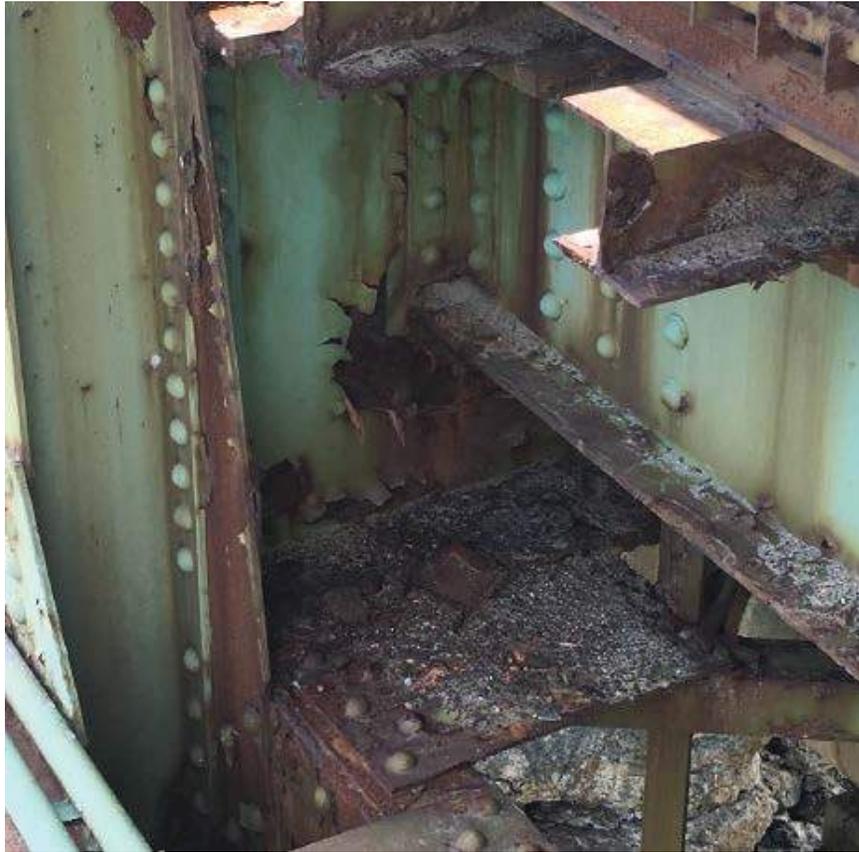
Photo # 21: General view of floor beam end in span 3 (8/2/16)

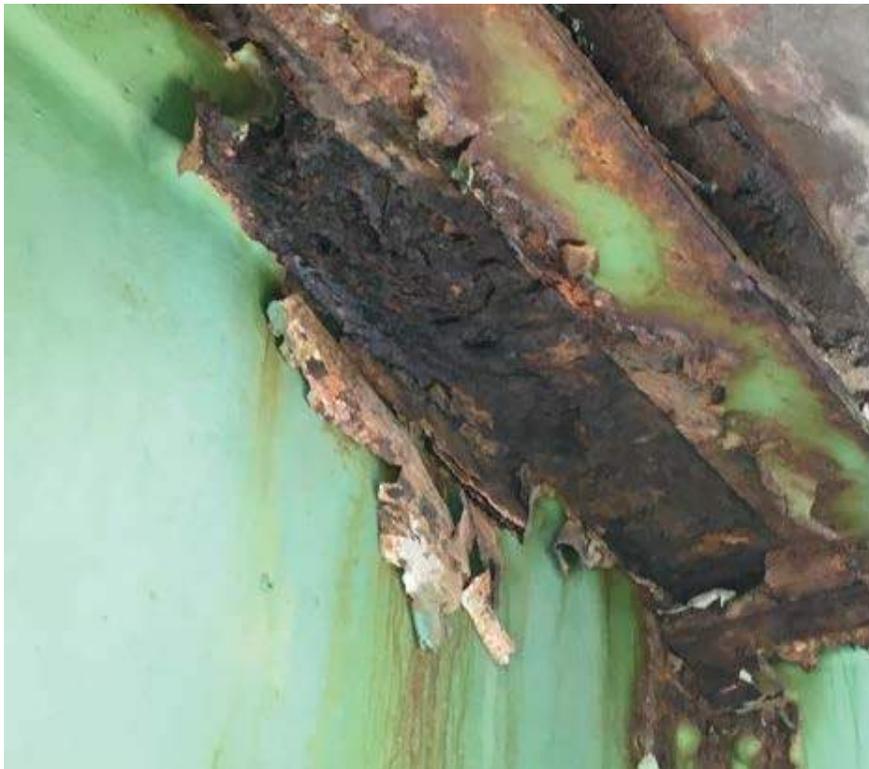
Photo # 22: Top flange corrosion & section loss of FB 5 in span 3 (8/2/16)

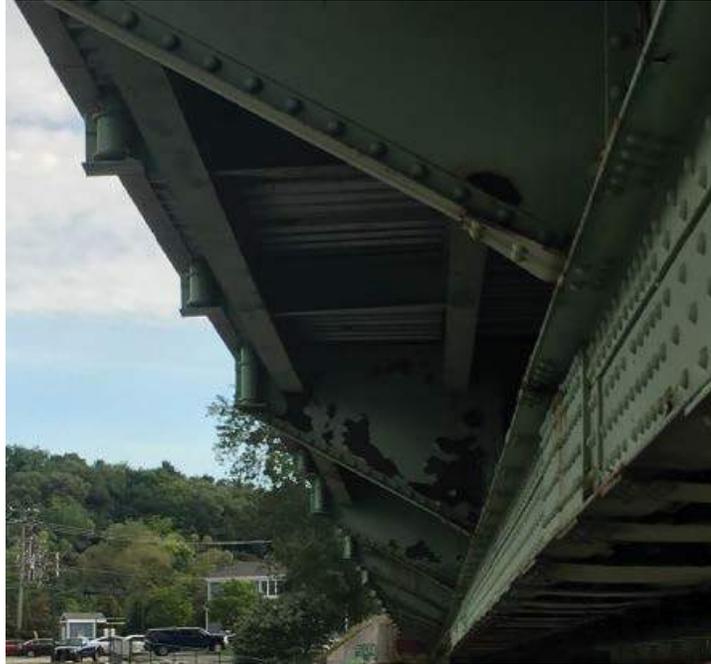
Photo #23: Typical view of the sidewalk stringers (S1 & S2) on the upstream side of the bridge (western side, looking north) (8/1/16)

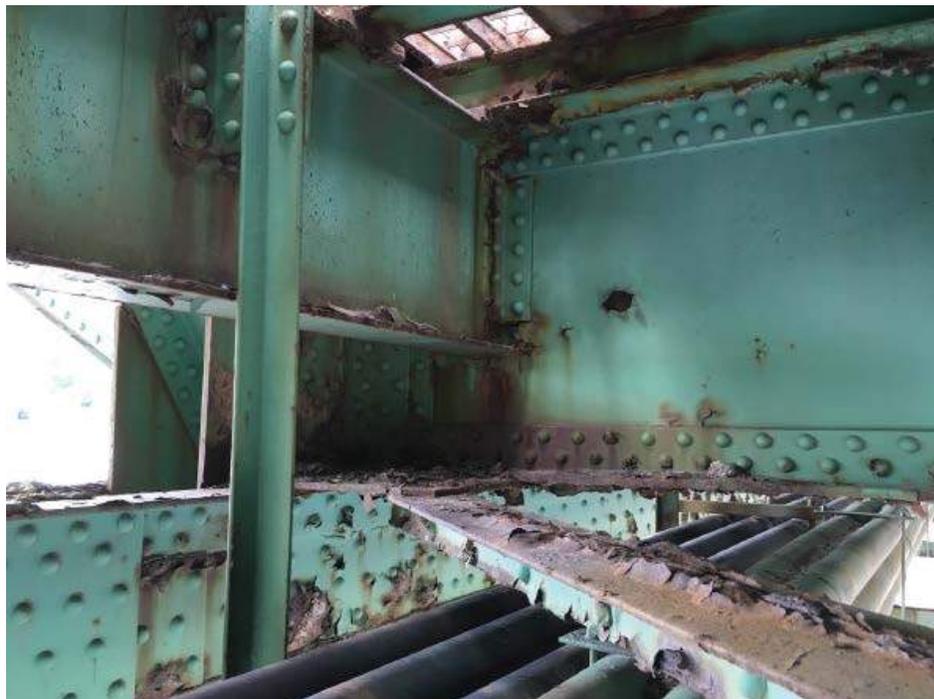
The exterior roadway stringers in all three spans were consistently in the worst condition due to their location below the open grid decking in the roadway shoulders which allows roadway salts and debris to drop directly onto S3 & S8. As a result, there is varying degrees of corrosion, pack rust and section loss along the length of these stringers and at the stringer to floorbeam connections areas. The worst deterioration was a hole through the web of S8 near its connection to FB2 (see Appendix A, photo 26). Pack rust between the connection angle and the stringer/floorbeam webs has begun to twist the connection angles at several locations. The top and bottom flanges have varying degrees of deterioration, section loss and pack rust.

Photo #24: Typical exterior stringer (S3 & S8) to floor beam connection (Typ. all spans) (8/1/16)
