Preliminary Design Report

Frank J. Wood #2016

Brunswick-Topsham, Maine

August 4, 2017

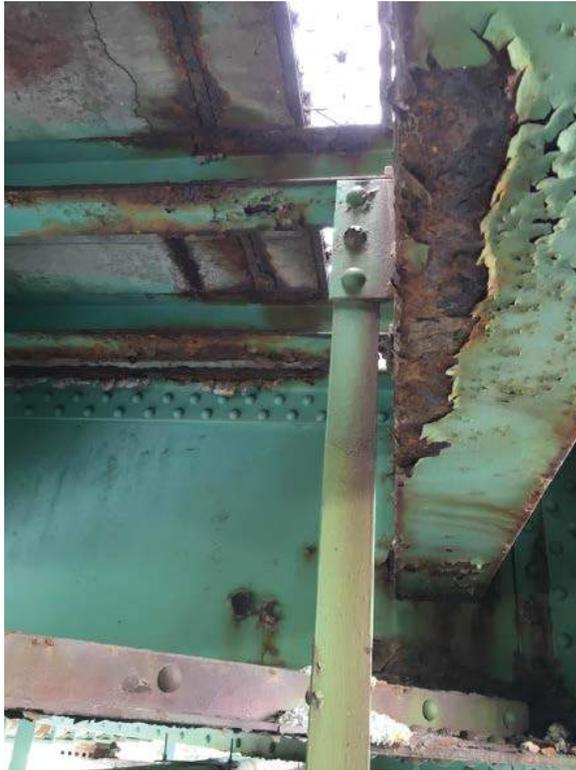
The exterior roadway stringers in all three spans were consistently in the worst condition due to their location below the open grid decking in the roadway shoulders which allows roadway salts and debris to drop directly onto S3 & S8. As a result, there is varying degrees of corrosion, pack rust and section loss along the length of these stringers and at the stringer to floorbeam connections areas. The worst deterioration was a hole through the web of S8 near its connection to FB2 (see Appendix A, photo 26). Pack rust between the connection angle and the stringer/floorbeam webs has begun to twist the connection angles at several locations. The top and bottom flanges have varying degrees of deterioration, section loss and pack rust.

Photo #25: Typical view of bottom flange of S3 & S8 in spans 1 & 2 (8/1/16)

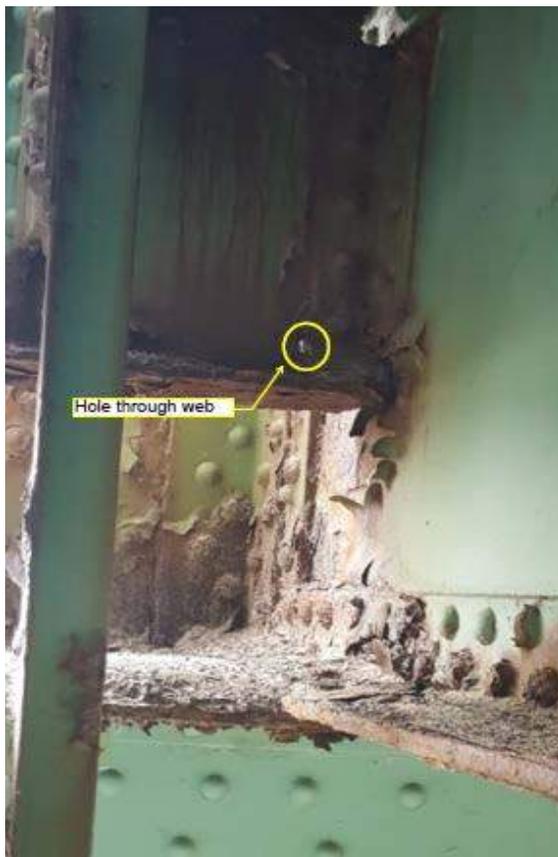
Photo #26: Hole through the web of S8 at FB2 in span 1 (8/1/16)

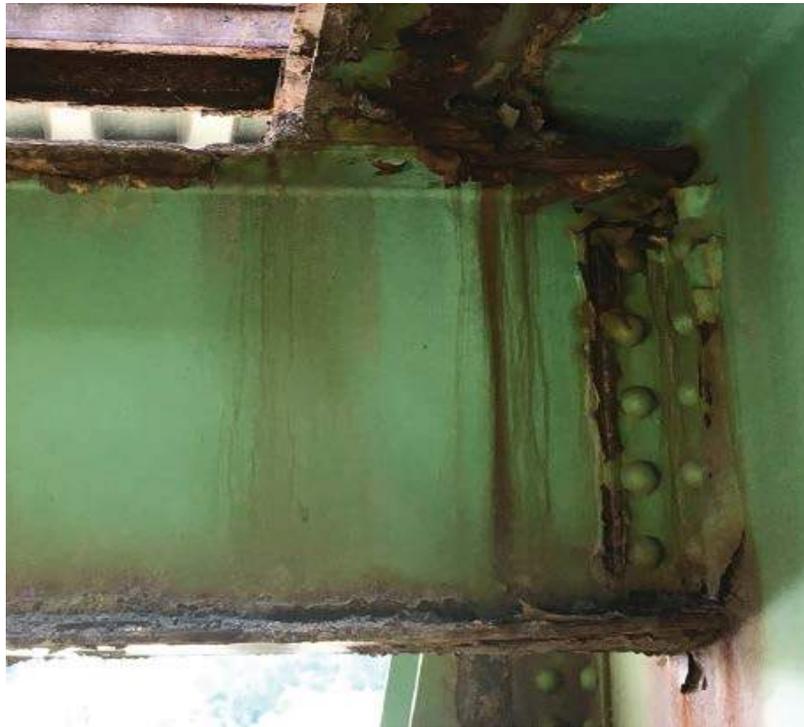
Photo #27: Moderate corrosion to S3 in span 3 near FB4 (8/2/16)

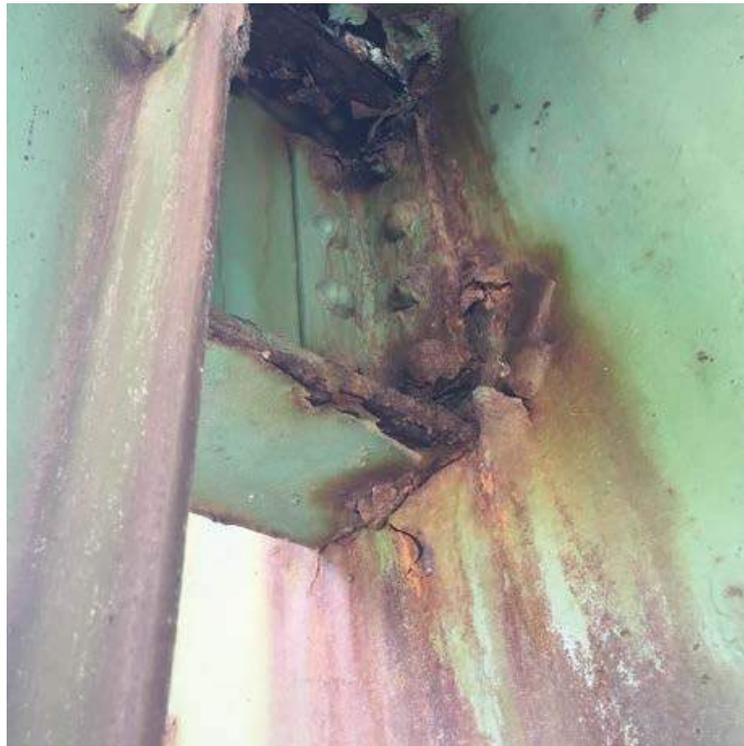
Photo #28: Moderate corrosion with pack rust between the connection angles and floor beam, at S8 in span 3 near FB5 (8/2/16)

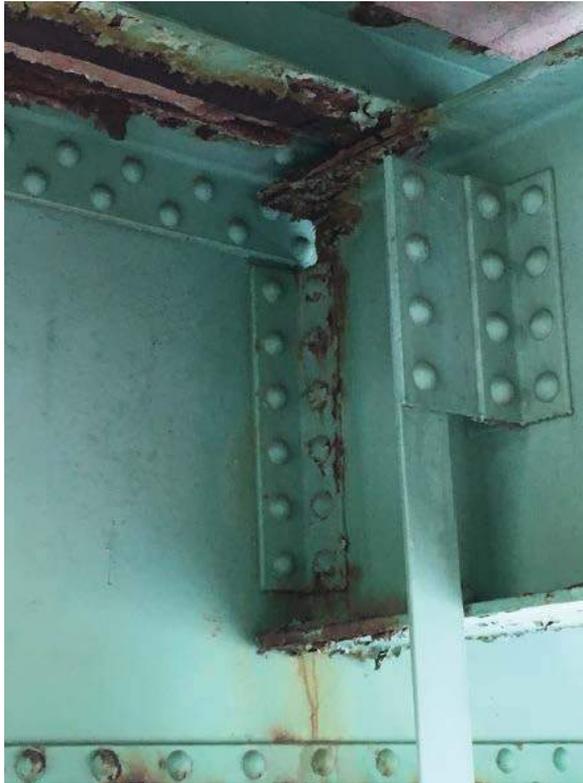
Photo #29: Typical interior stringer (S4 through S7) to floor beam connection (Typ. all spans) (8/1/16)

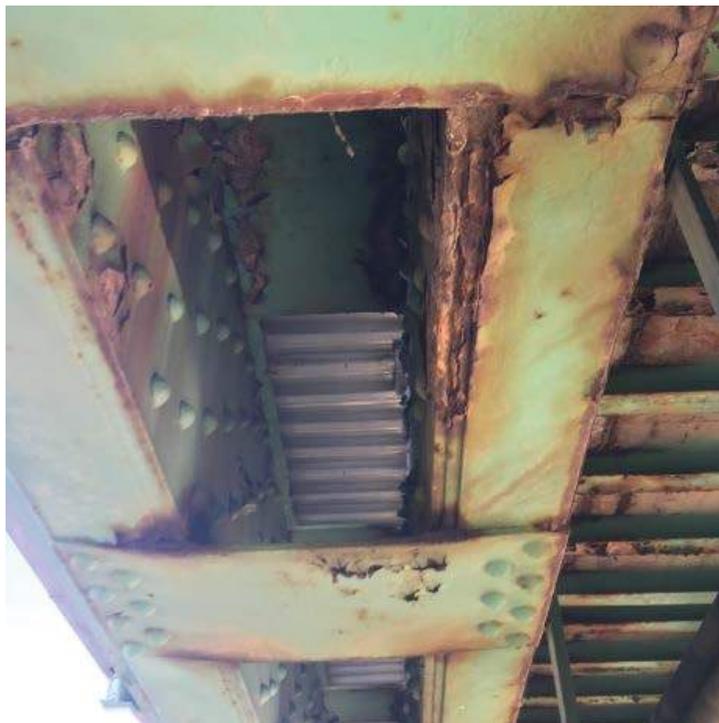
The lattice plates connecting the two vertical components of the truss bottom chord are in poor condition as all of the bottom lattice plates have “bowed” due to general corrosion to the plates and pack rust between the connection of the plates and the vertical components. There are multiple top lattice plates that have a lesser degree of “bow” to them, due to general corrosion of the plates and pack rust at the plate to vertical component connection. (See Appendix A, (photos 30 through 34) for images of the “bowed” lattice plates).

Photo #30: Typical corrosion of the bottom chord of the truss members, showing “bowing” of the Lattice plates due to pack rust (8/2/12)

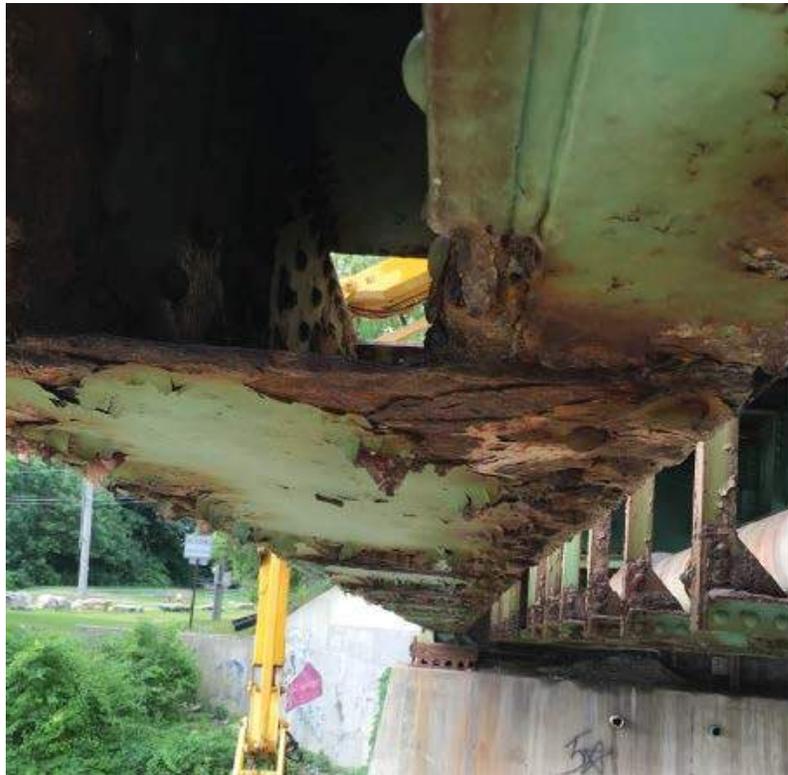
Photo #31: Corrosion of lattice plate on bottom chord of non-sidewalk truss in span 1 (8/1/16)

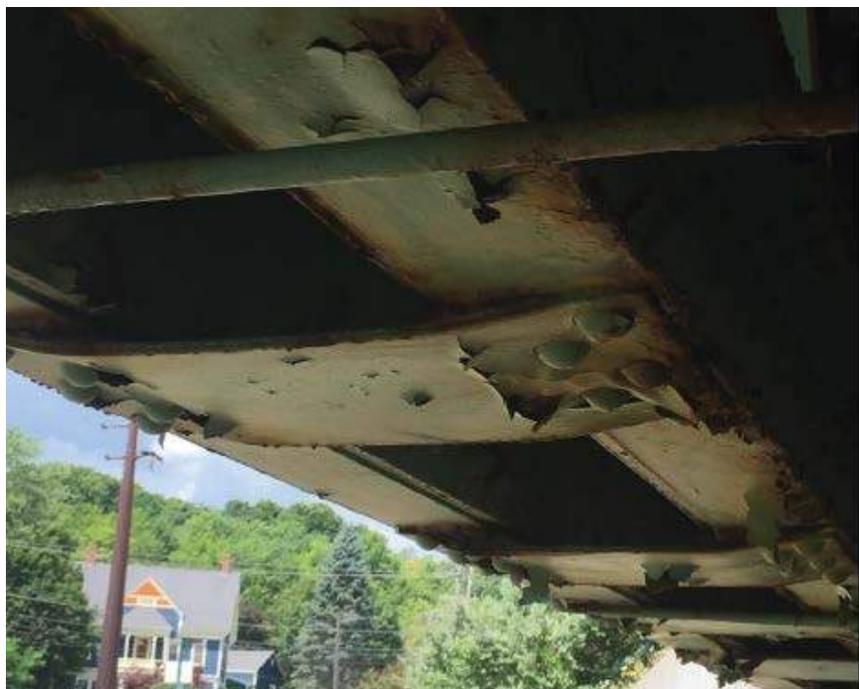
Photo #32: "Bowing" of lattice plates on the bottom chord of the sidewalk truss in span 3 (8/2/16)

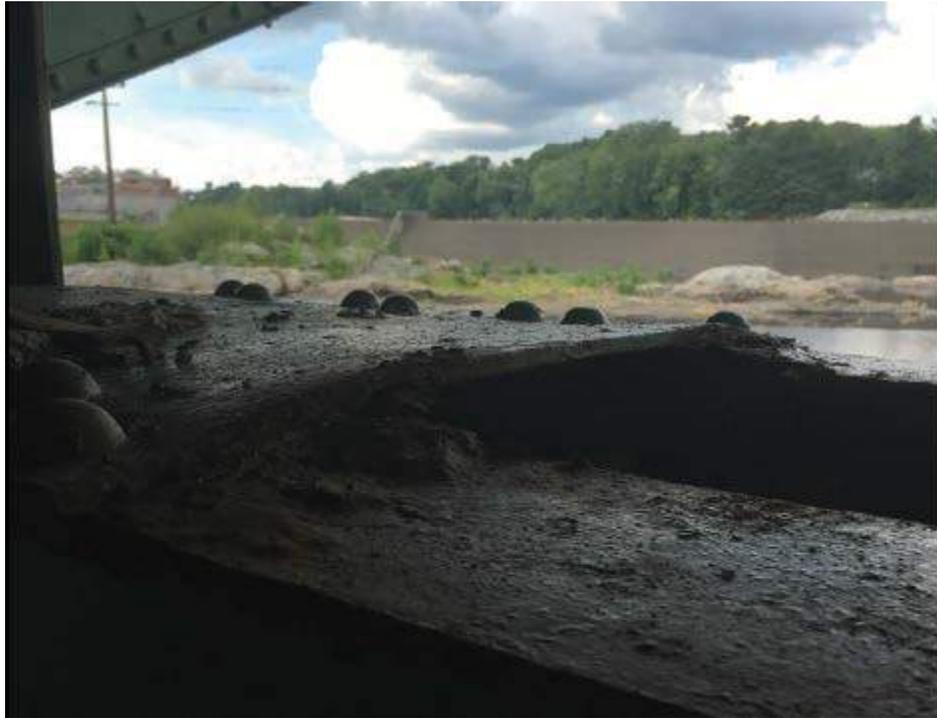
Photo #33: "Bowing" of lattice plates on the top of the bottom chords of the sidewalk truss in span 3 (8//16)

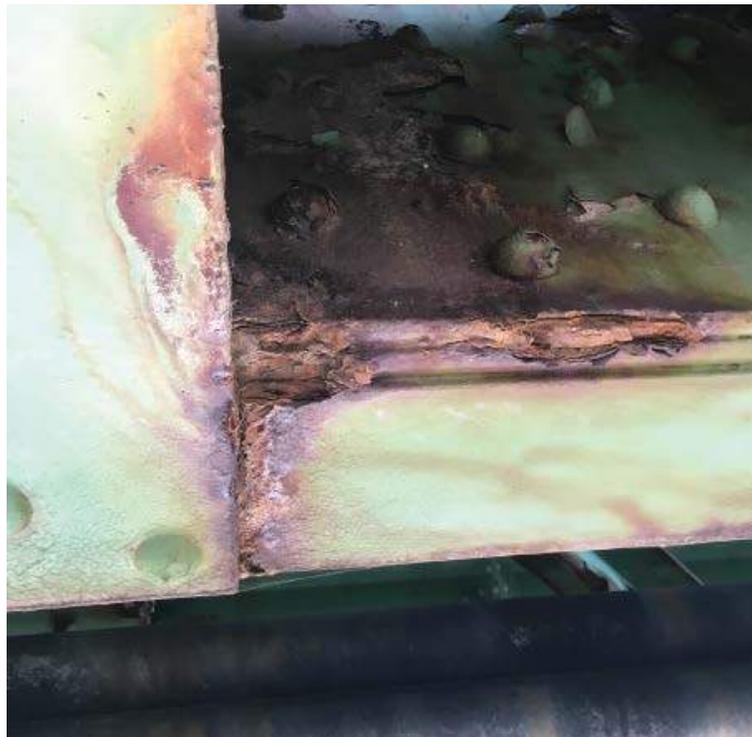
Photo #34: Pack rust between lattice plate and bottom angle on the the bottom chord of the sidewalk truss in span 3 (8//16)

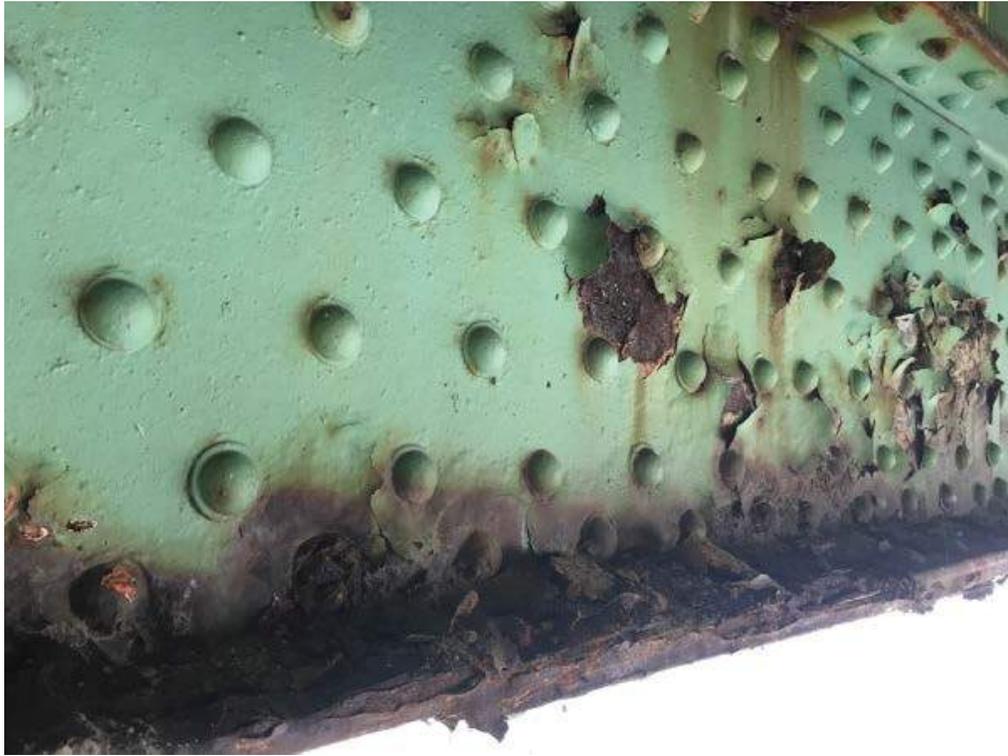
The bottom angle of the vertical component of the bottom chord is overall in poor condition. Paint failure has resulted in varying degrees of corrosion, section loss and pack rust to the bottom flange as roadway salts and debris has collected on top of the bottom flange and on the lattice plates. Span 3 has the worst deterioration as a large portion of the bottom chord on the sidewalk truss has severe deterioration, section loss and pack rust to the angles, cover plates and rivets. (See Appendix A, photos 35 through 39 for images of the corroded bottom chord).

Photo #35: Bottom chord of non-sidewalk (eastern) truss, in span 1 near FB 2 (8/1/16)

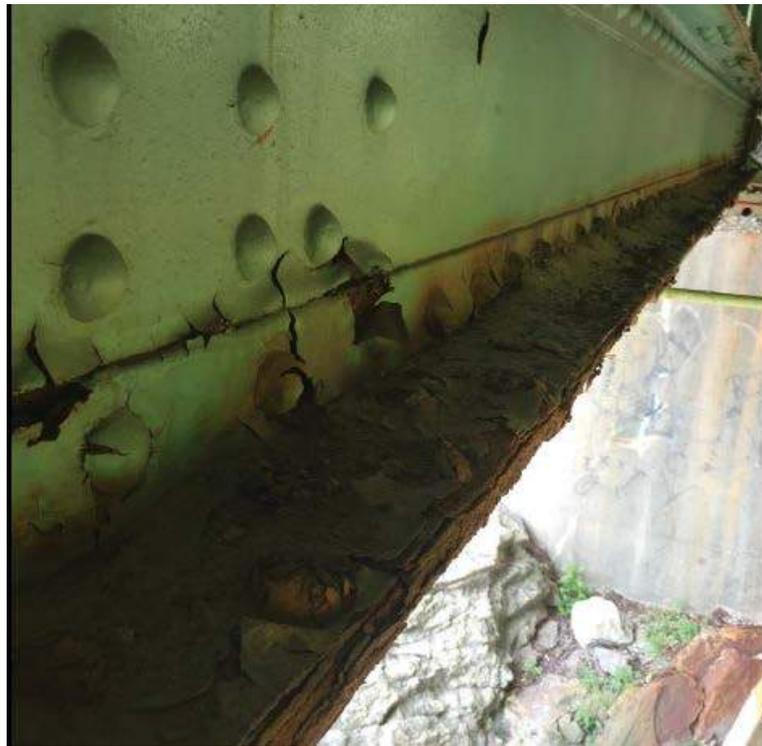
Photo #36: Corrosion to the bottom flange of the bottom chord of the sidewalk side truss in span 3 (western side of the bridge looking north) (8/2/16)

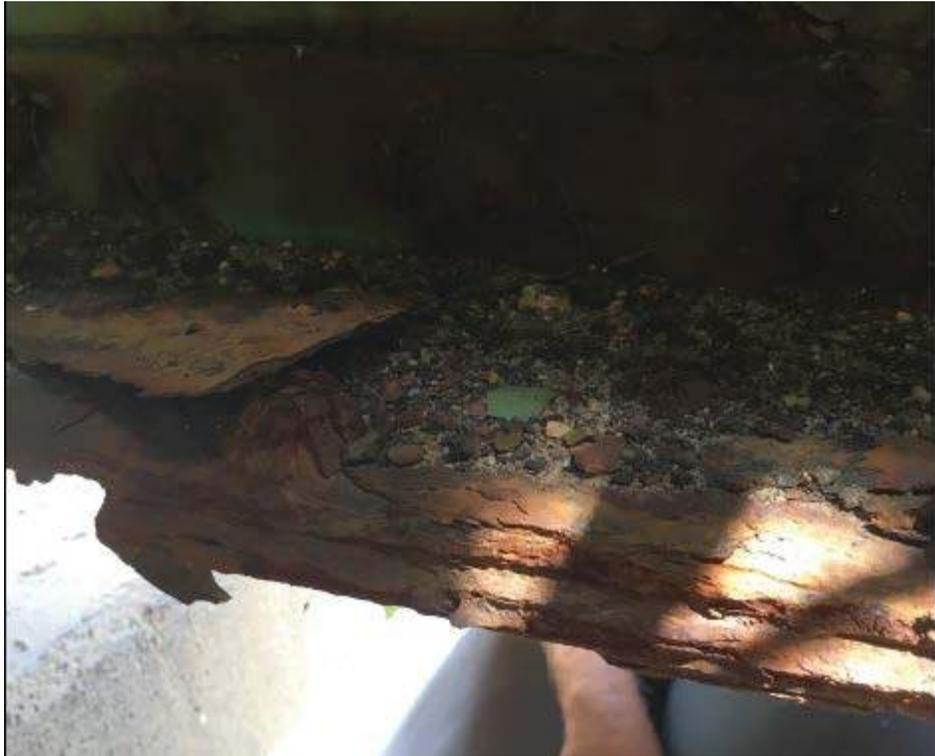
Photo #37: Pack rust between plates on the bottom chord of the non-sidewalk truss in span 3 (eastern side of the bridge) (8/2/16)

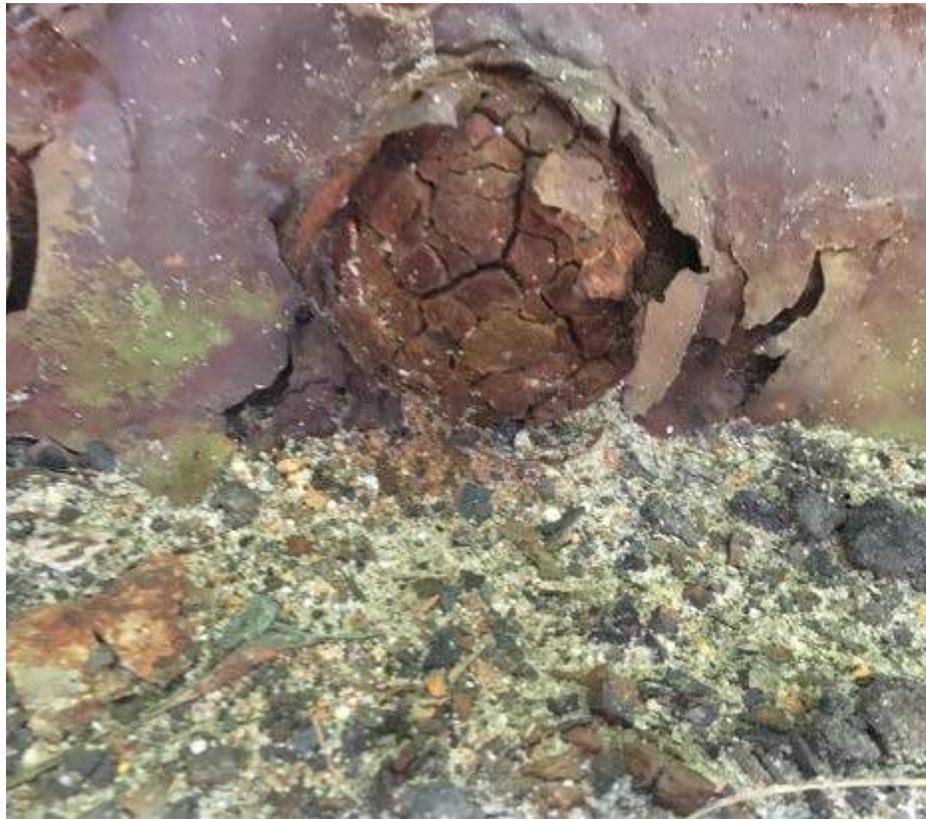
Photo #38: Severely deteriorated rivet heads on the bottom chord of the sidewalk side truss, span 3 (8/2/16)

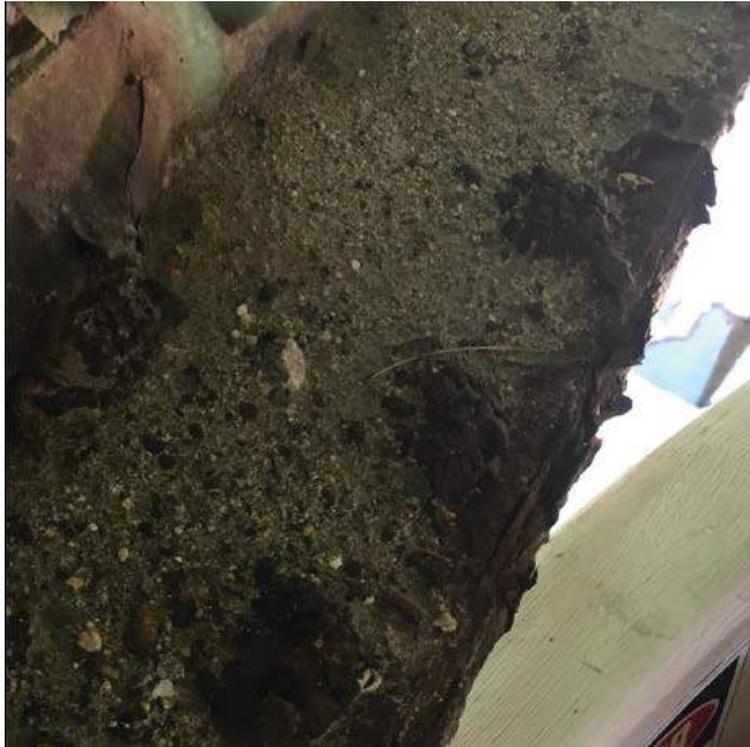
Photo #39: Remnants of rivet heads along the top of the bottom flange of the bottom chord of the sidewalk truss (western) in span 3 (8/2/16)

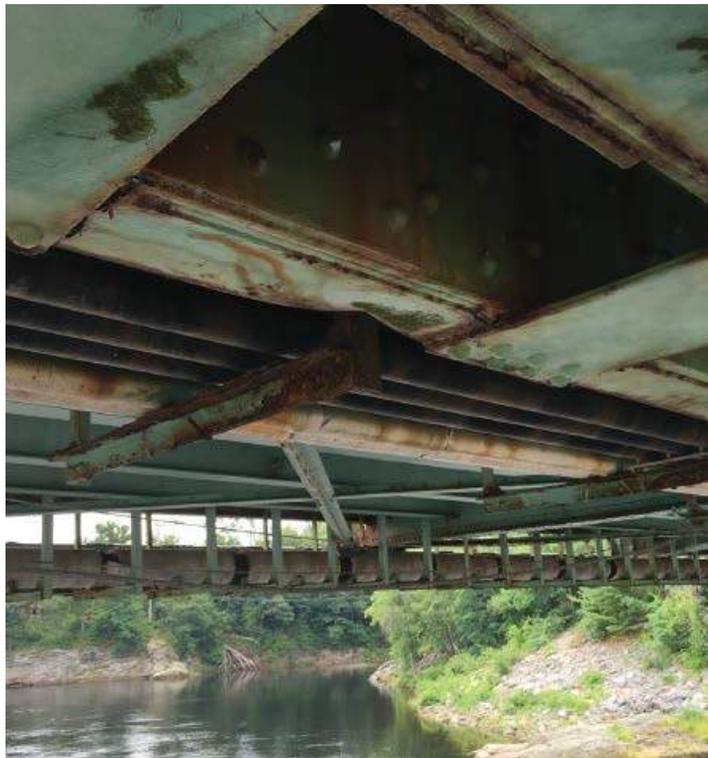
Photo #40: "Dent" to the interior member making up the bottom chord on the sidewalk (western) truss, located near midspan of span 1, likely due to impact of debris during extreme high flood waters (8/1/16)

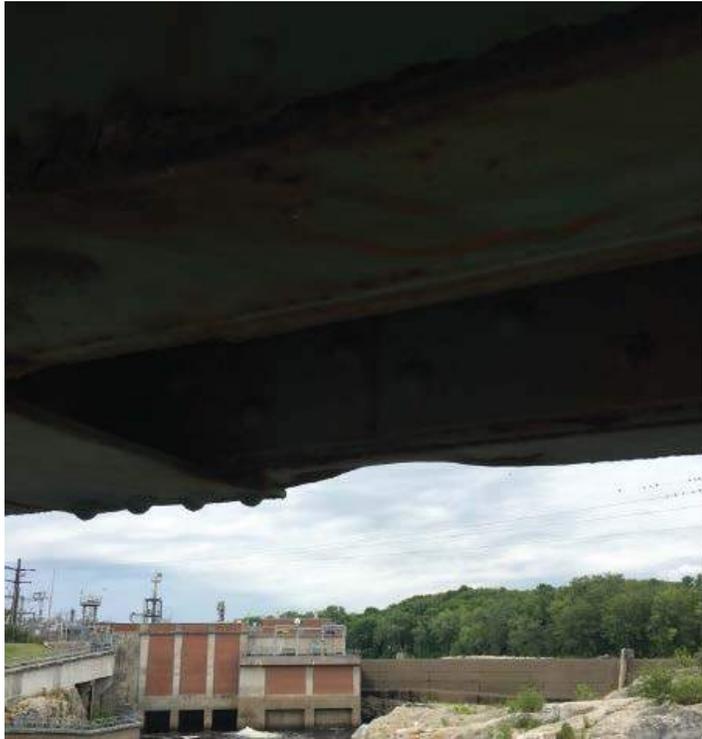
Photo #41: “Dent” to the exterior member making up the bottom chord on the sidewalk (western) truss at the same location of the previous photo (8/1/16)

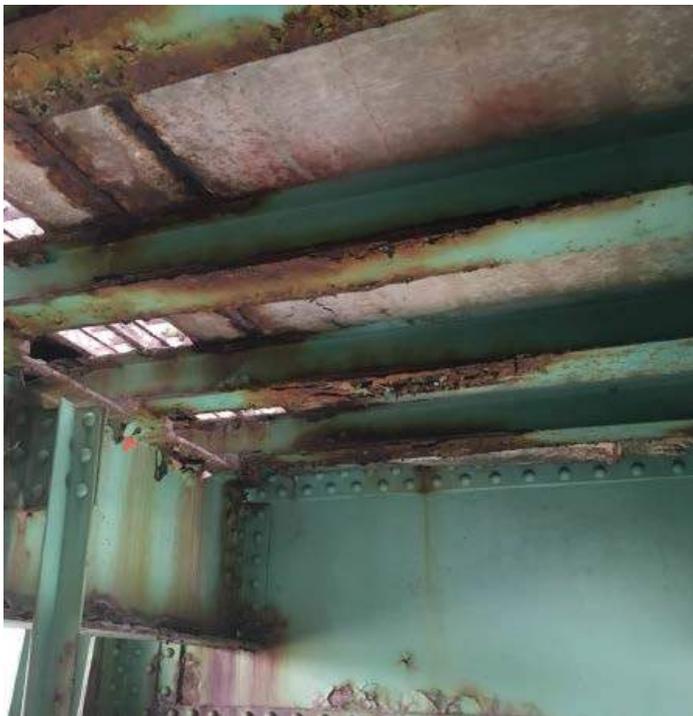
Photo #42: Typical view of cross beams (needle beams) in the exterior bay between S3 & S4, S7 & S8 similar (8/1/16)

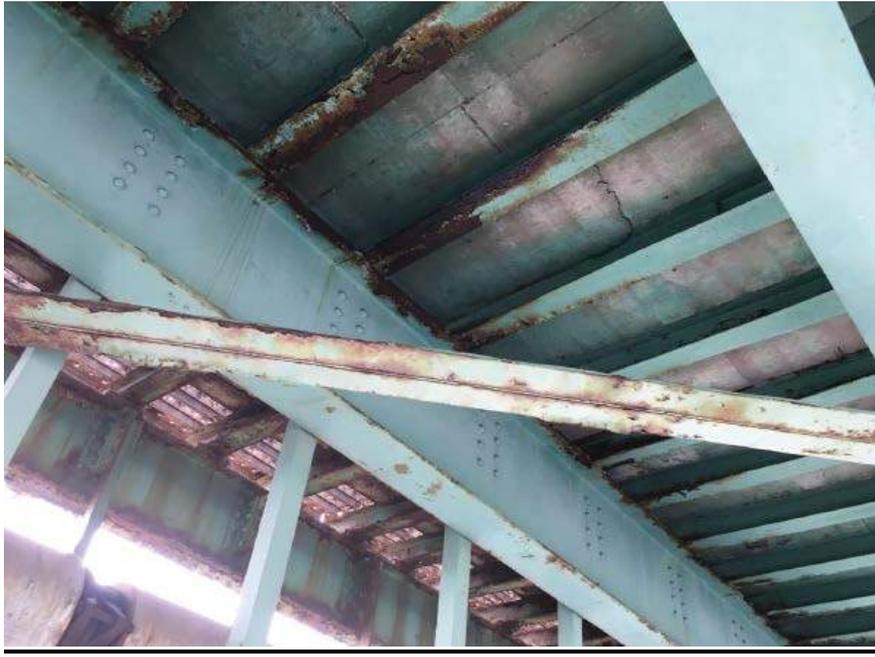
Photo #43: Typical view of cross beams (needle beams) in the first interior bays from S4 through S7 (8/1/16)

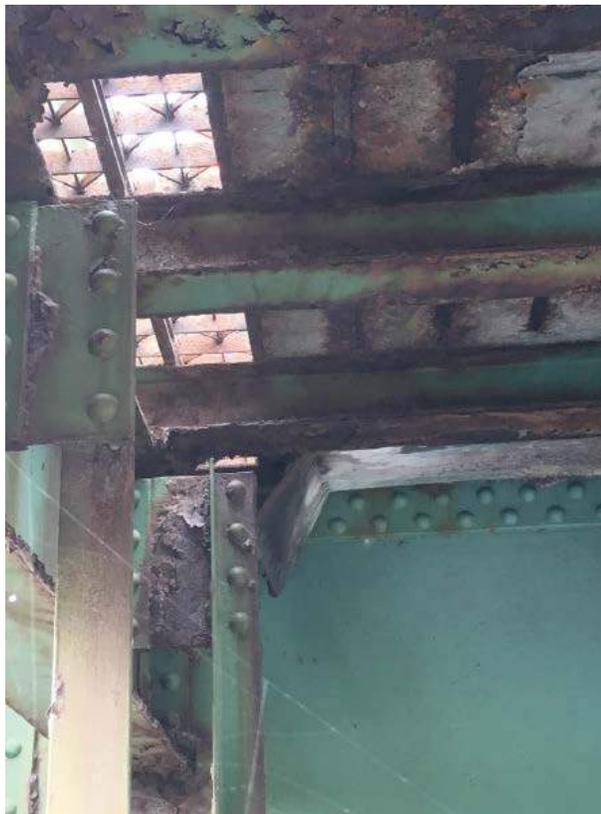
Photo #44: Moderate corrosion to cross beams (needle beam) (Typ.) (8/1/16)

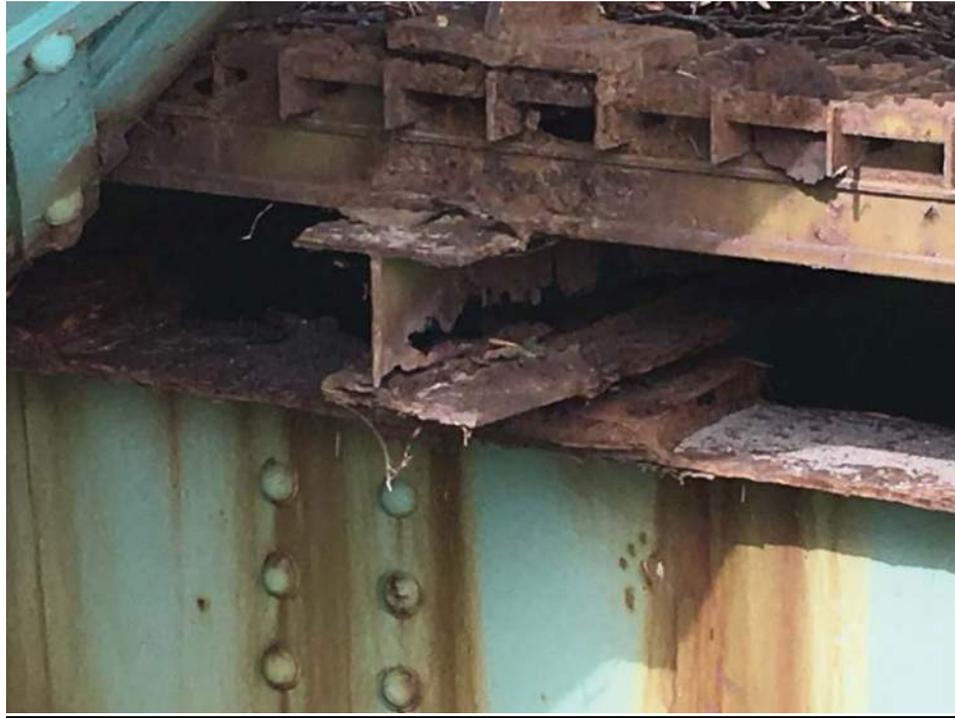
Photo #45: Severe corrosion to a cross beam (needle beam) near FB 1 in span 1 of non-sidewalk (eastern) truss (8/1/16)

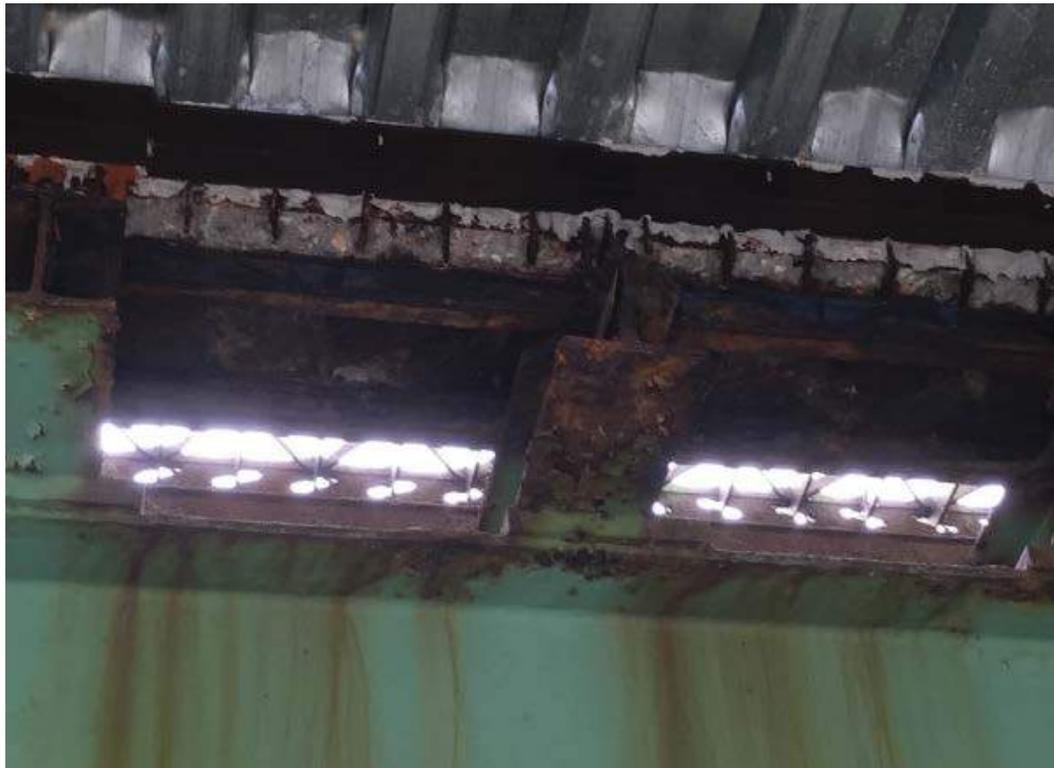
Photo #46: Severe corrosion to a cross beam (needle beam) on the sidewalk (western) truss (8/1/16)

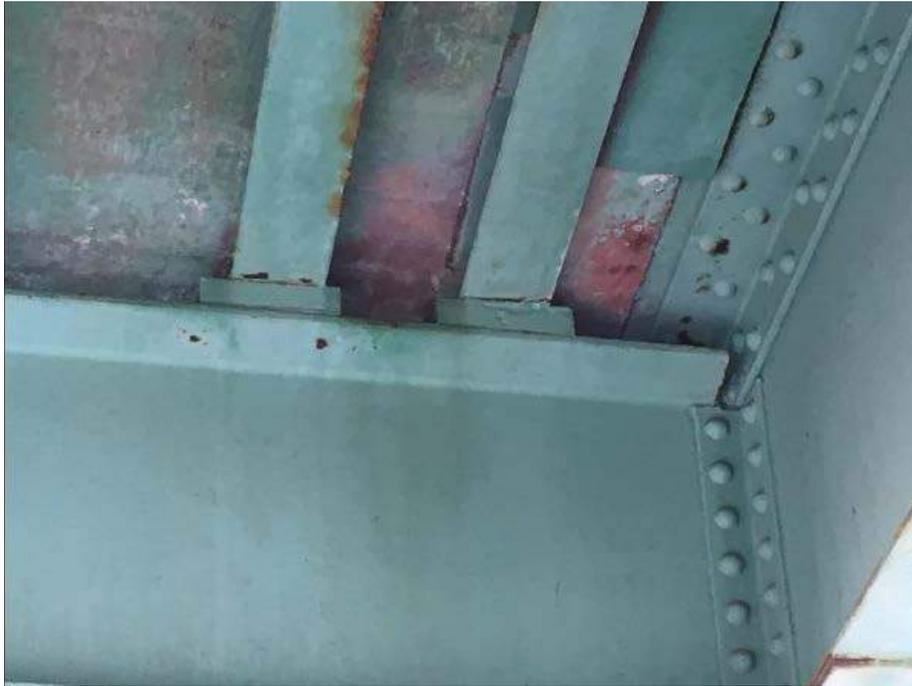
Photo #47: Failed weld between needle beam and an interior stringer in span 1 (8/1/16)

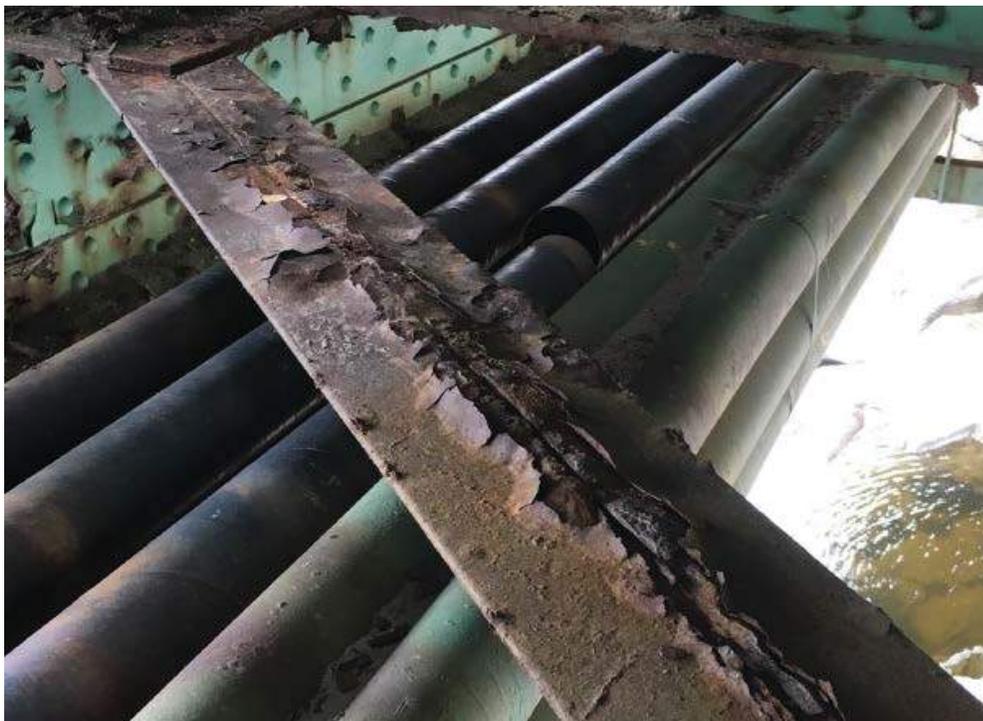
Photo #50: Severely corroded lateral bracing member view from top of double angle in spans 1 & 2 (8/1/12)

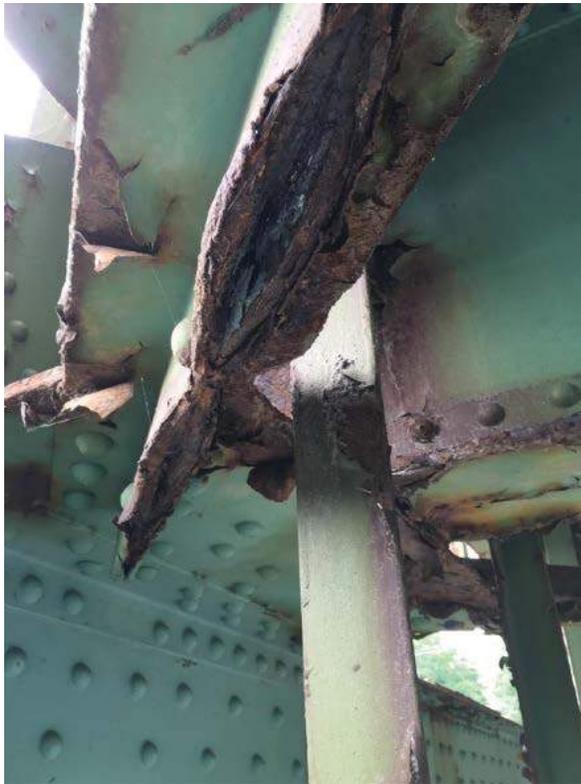
Photo #51: Severely corroded lateral bracing member, view from the bottom of the double angle connections in Spans 1 & 2 (8/1/12)

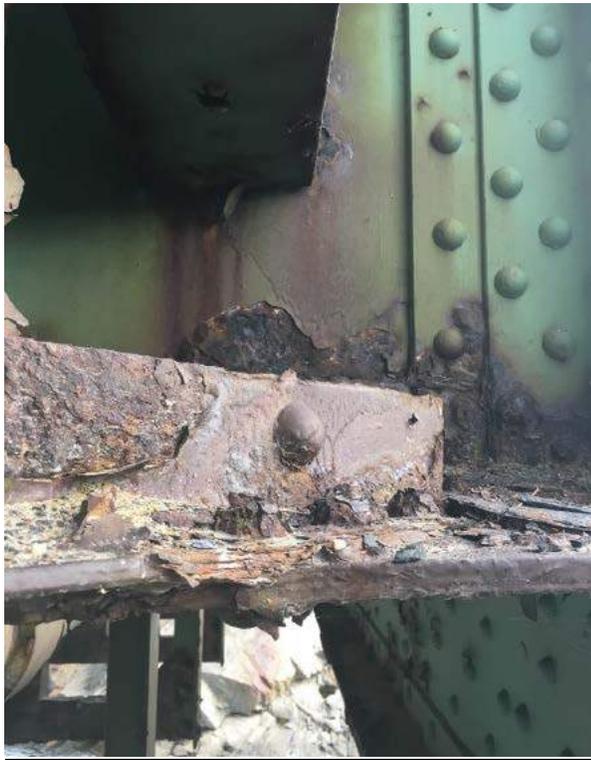
Photo #54: Corroded lateral bracing end at its connection to the horizontal plate at FB8 span 2 (8/2/16)

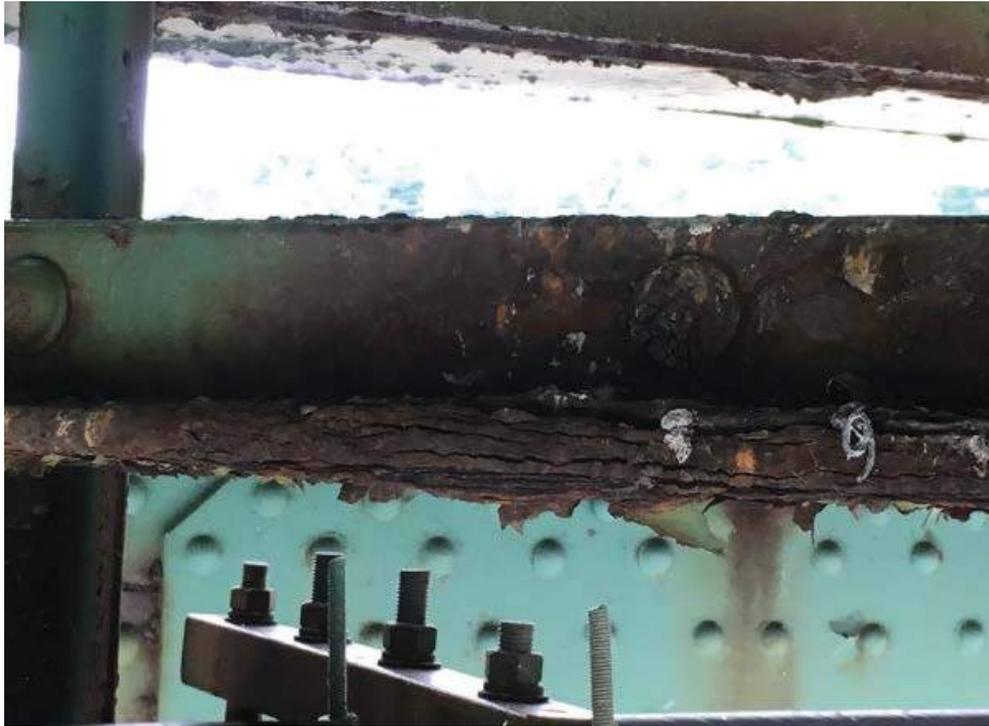
Photo #55: Pack rust and section loss to the lateral bracing near FB6 in span 1 (8/1/16)

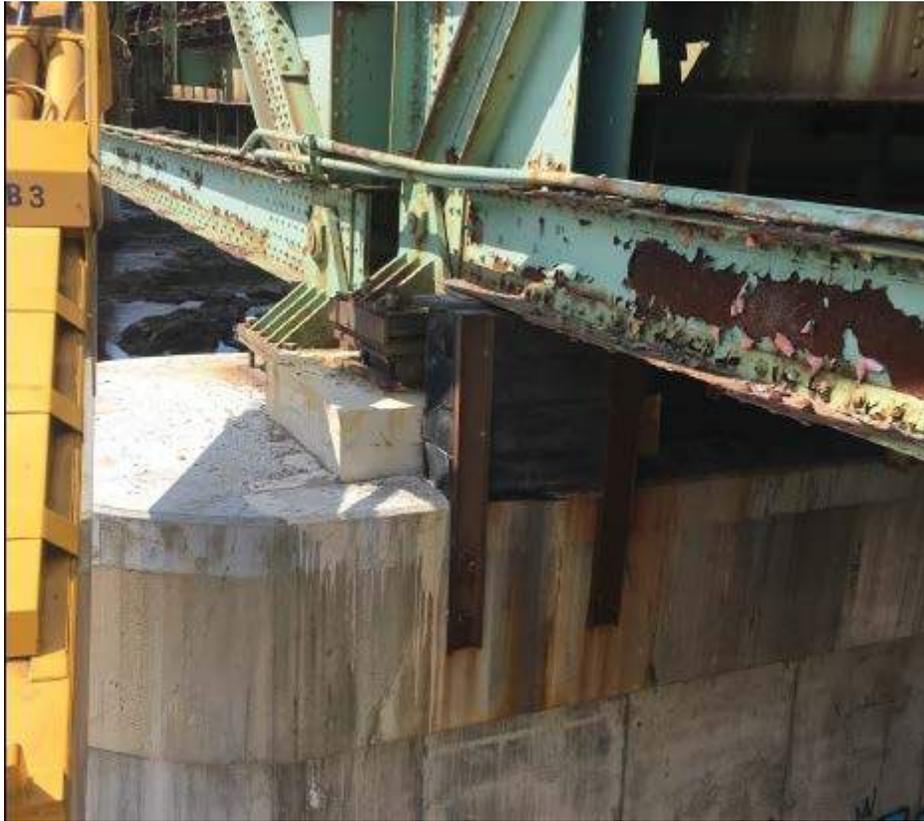
Photo #57: Shoring of non-sidewalk bearing, pier 2, span 3 (looking southwest) (8/2/16)

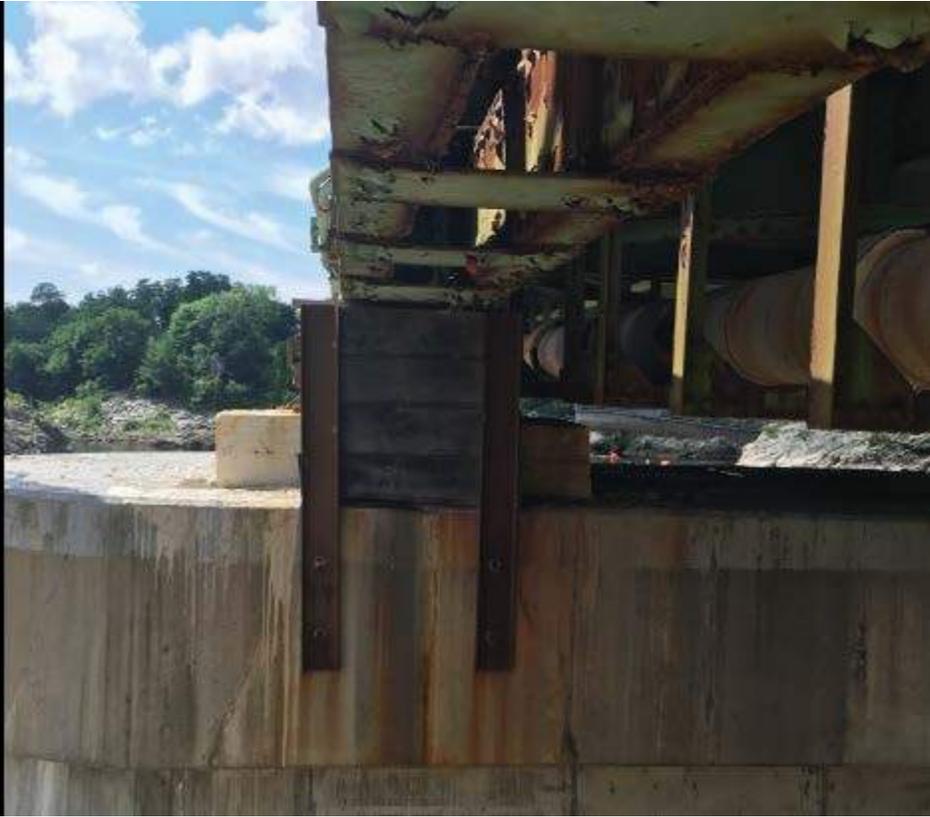
Photo #58: Shoring of non-sidewalk bearing, pier 2, span 3 (looking south) (8/2/16)

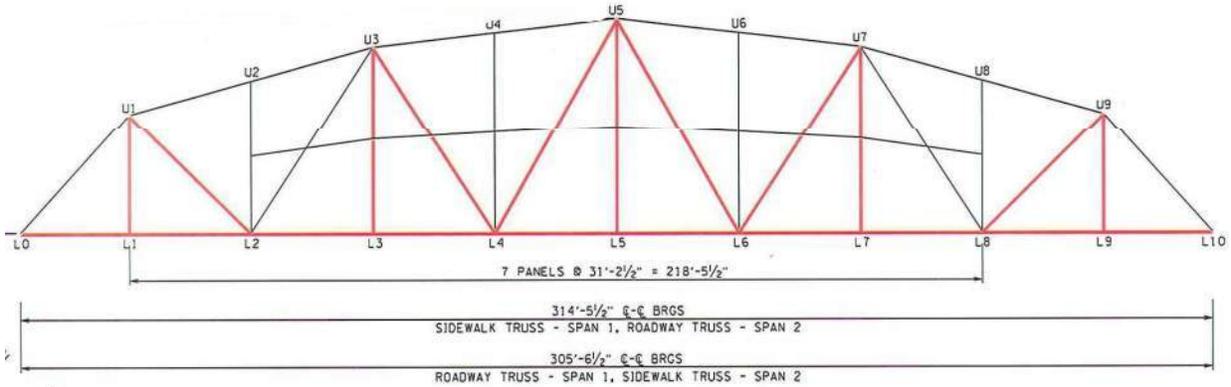
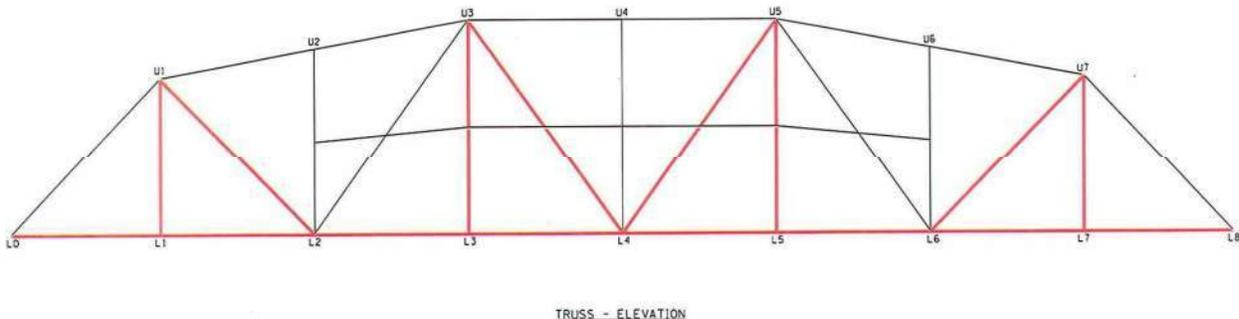
The sidewalk truss verticals and diagonals have welded plates added at the sidewalk level which are intended to partially block the openings at the sidewalk penetrations. These welded plates represent fatigue-sensitive details in FCM's wherever the base members are FCM's. The end floorbeams have partial height welded stiffeners and full height jacking stiffeners which represent fatigue-sensitive details in FCM's. In addition the north face of the Span 1 end floorbeam FB0 has a welded plate stringer bearing stiffener below S3 which constitutes a fatigue-sensitive detail in a FCM.

Fracture Critical tension Members shown in **Bolded Red** linestyle (per original contract plan design loads)

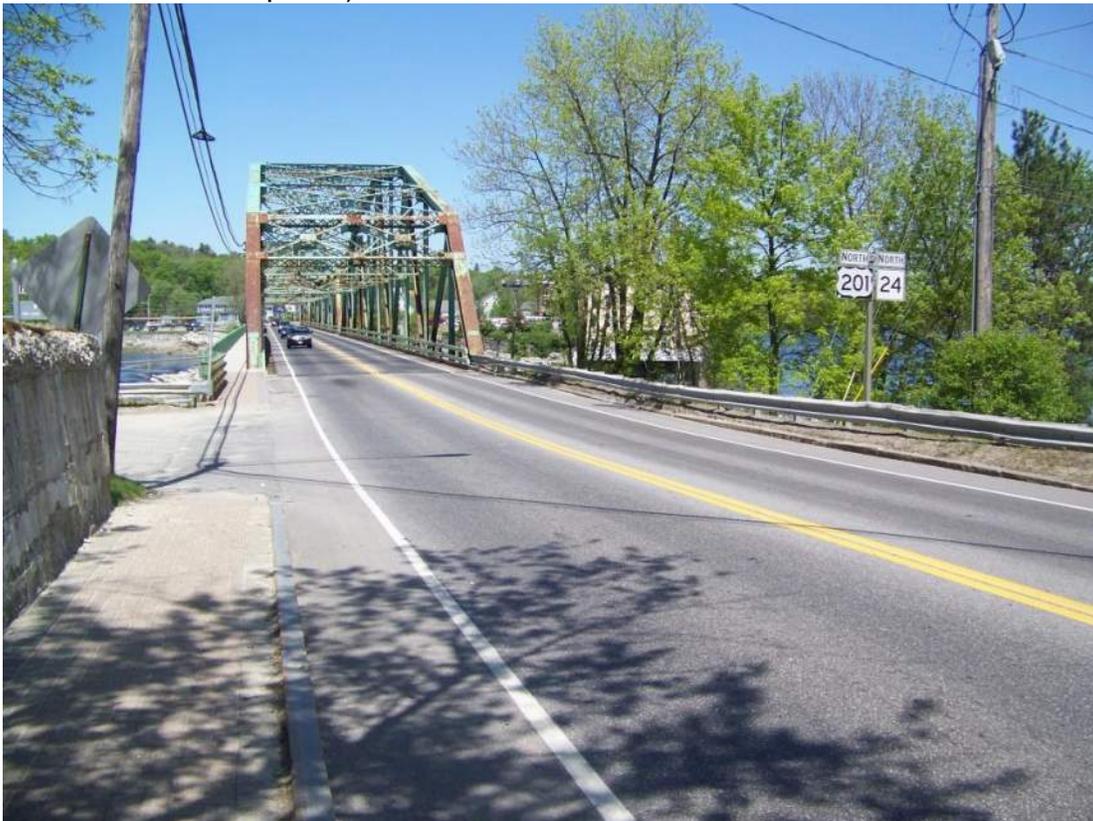
Photo 2 – View of bridge looking north from the south approach roadway. Note minor impact damage to southeast corner guiderail at right.

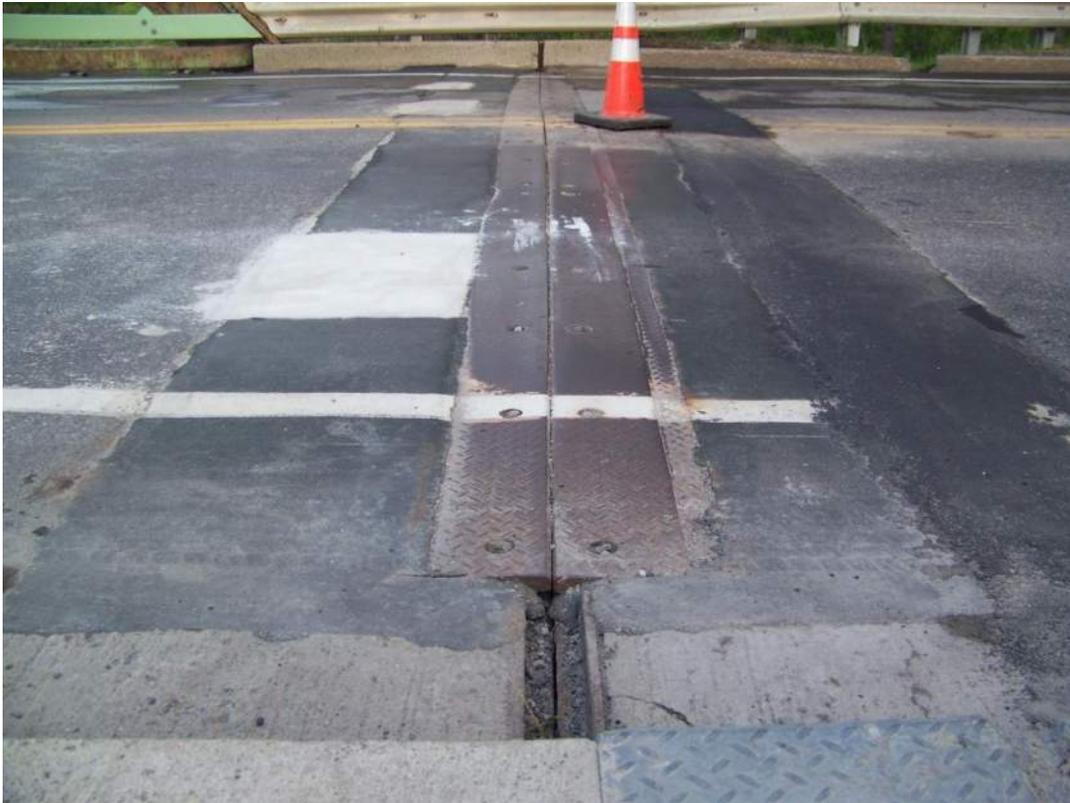
1. All four deck joints have previous bituminous patch repairs and more recent concrete patch repairs (Photos 7-10). The south abutment joint has required emergency repairs on two separate occasions in the last two years. The transverse cross-beam at the south abutment exhibits severe advanced corrosion with section loss and perforation below the northbound lane. Between stringers S6 and S8, there are 2 locations of extensive section loss. A three inch width of the bottom flange south edge is missing over a 4 foot length between S7 and S8 (Photo 59). Within this same zone there is also section loss to the opposite north bottom flange edge with loss of up to 2 inches in width over a length of 12 to 18 inches. The lower two inches of the web was also perforated in a portion of this 4 foot length. A similar condition was observed at a separate location along the same member located between S6 and S7.

Photo 7 – South abutment open plate deck joint was previously patched with bituminous material; additional bituminous and concrete patching and other repairs were being performed during the inspection.

Recommendation: Replace the four deck joints by performing full depth deck removal and replacement of a four foot strip centered at each joint, including reconstruction of the top of the abutment backwalls at each end of the bridge. Replace the severely corroded and perforated south abutment cross-beam in conjunction with the deck joint reconstruction.

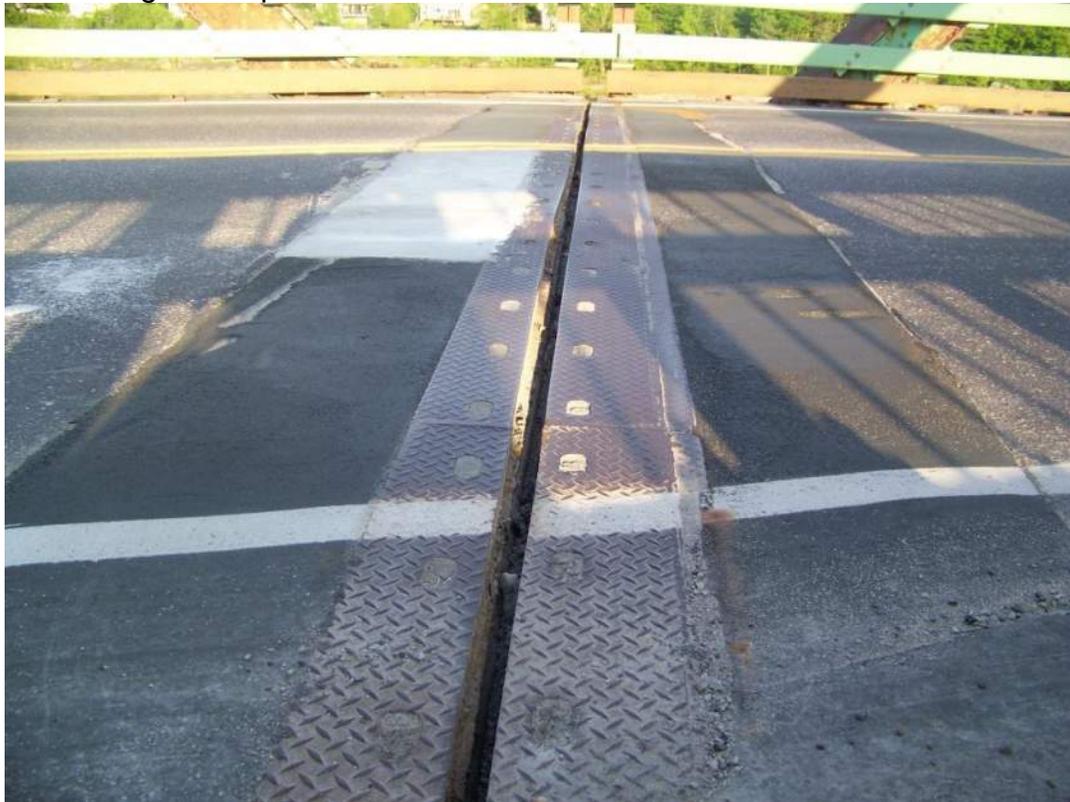
Photo 8 – The south pier strip seal type deck joint was previously patched with bituminous material and a concrete patch was placed during the inspection.
