Preliminary Design Report

Frank J. Wood #2016

Brunswick-Topsham, Maine

August 4, 2017

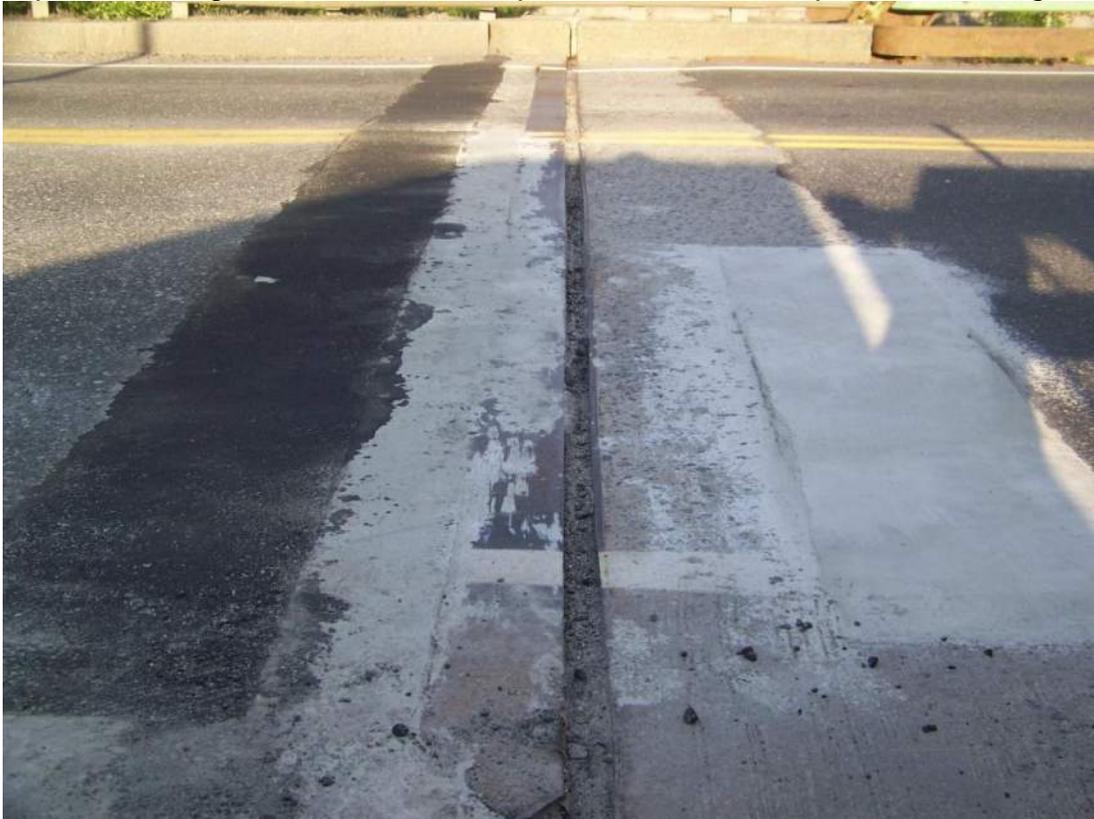
Photo 10 – The north abutment compression seal type deck joint is filled with debris and the concrete headers were patched with quick-setting concrete during the inspection.

Recommendation: Replace the four deck joints by performing full depth deck removal and replacement of a four foot strip centered at each joint, including reconstruction of the top of the abutment backwalls at each end of the bridge. Replace the severely corroded and perforated south abutment cross-beam in conjunction with the deck joint reconstruction.

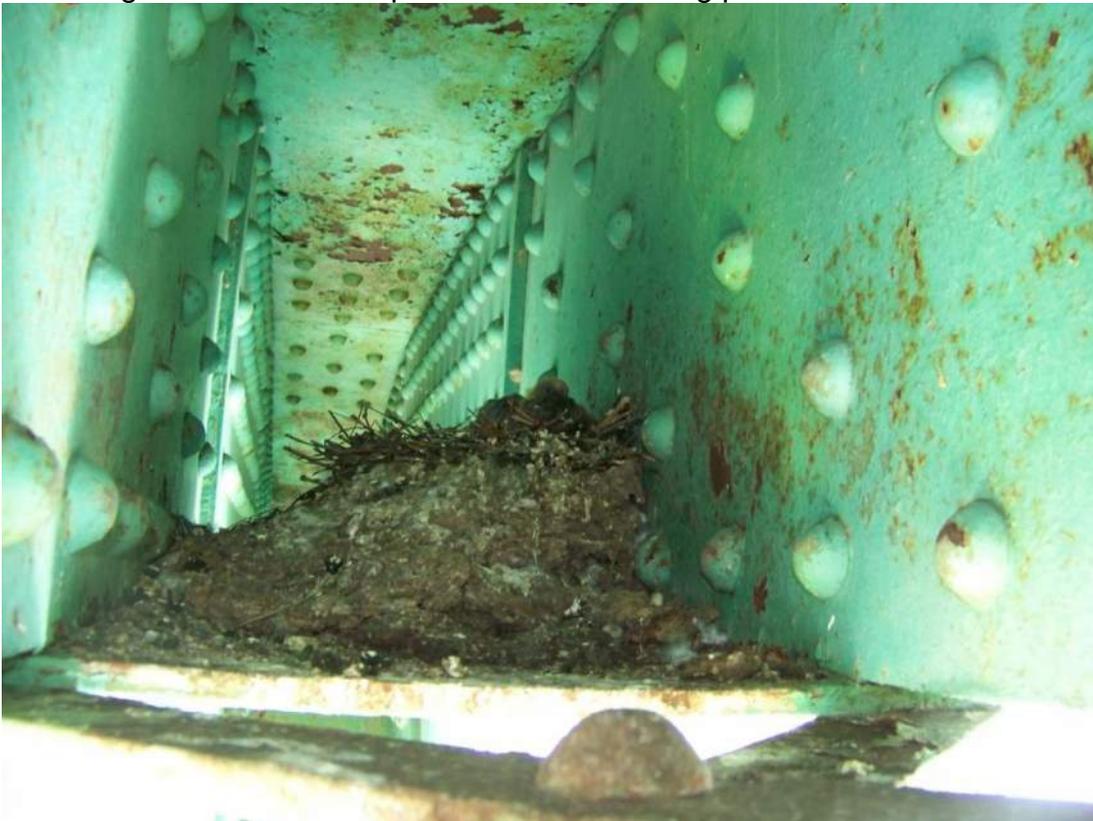
Photo 14 – The interior surfaces of upper chords exhibit paint failure rates averaging 10% and there are bird nests present on top of nearly all of bottom face batten plates.

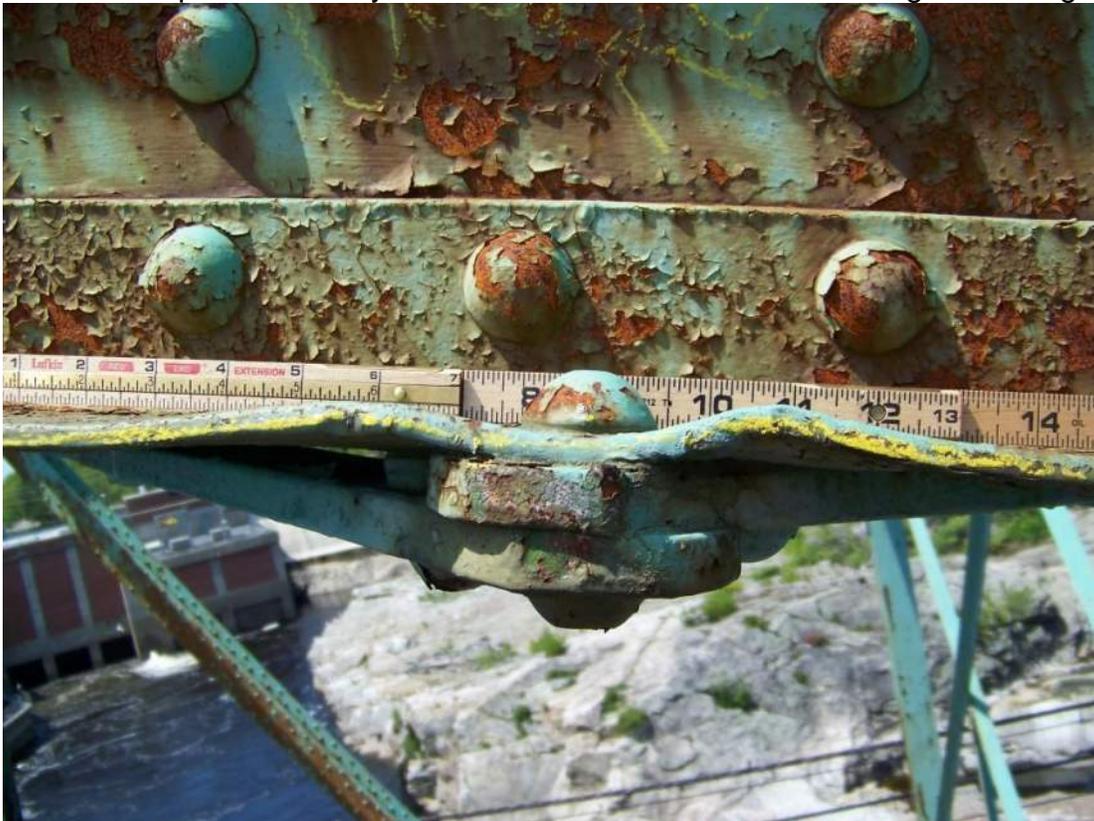
Photo 16 – Slight vertical distortion was noted in the bottom flange angles at and/or between the lacing bars at various locations. View at Span 1 U7-U8 sidewalk truss.

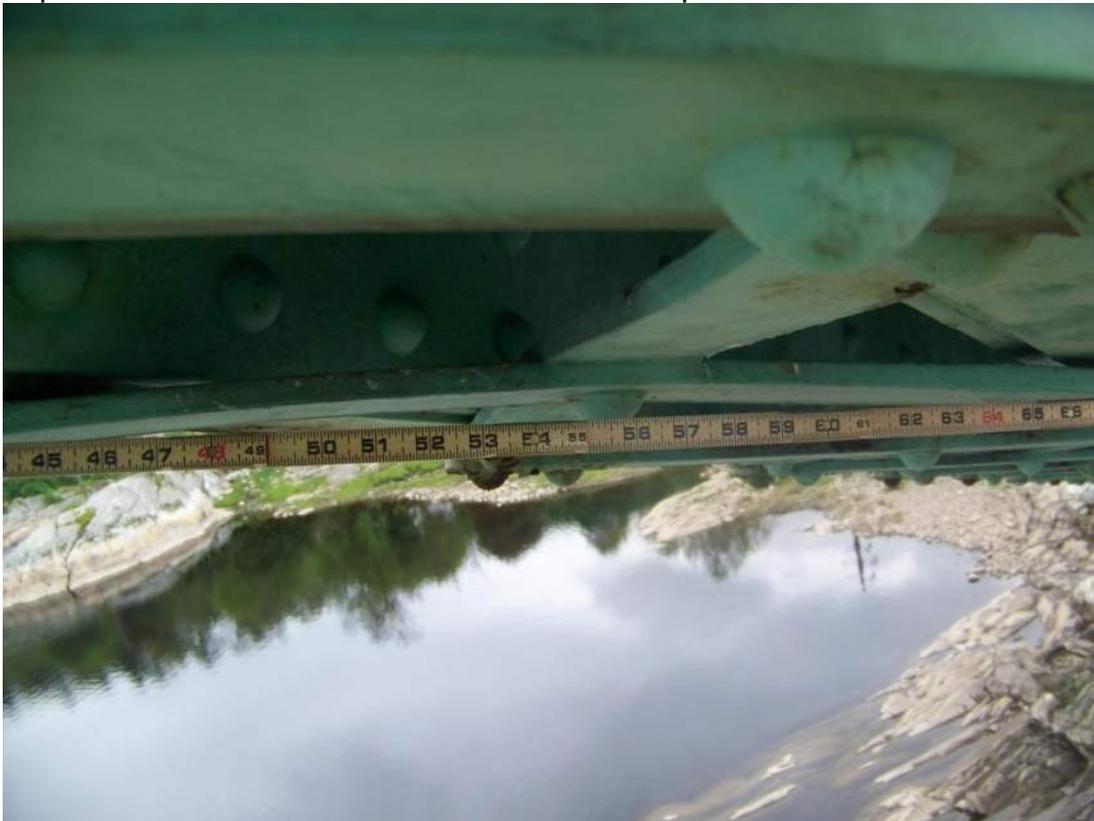
Photo 18 – The double lattice lacings bars in the Span 2 sidewalk truss U7-U8 upper chord have noticeable upward deflection. View is looking west.

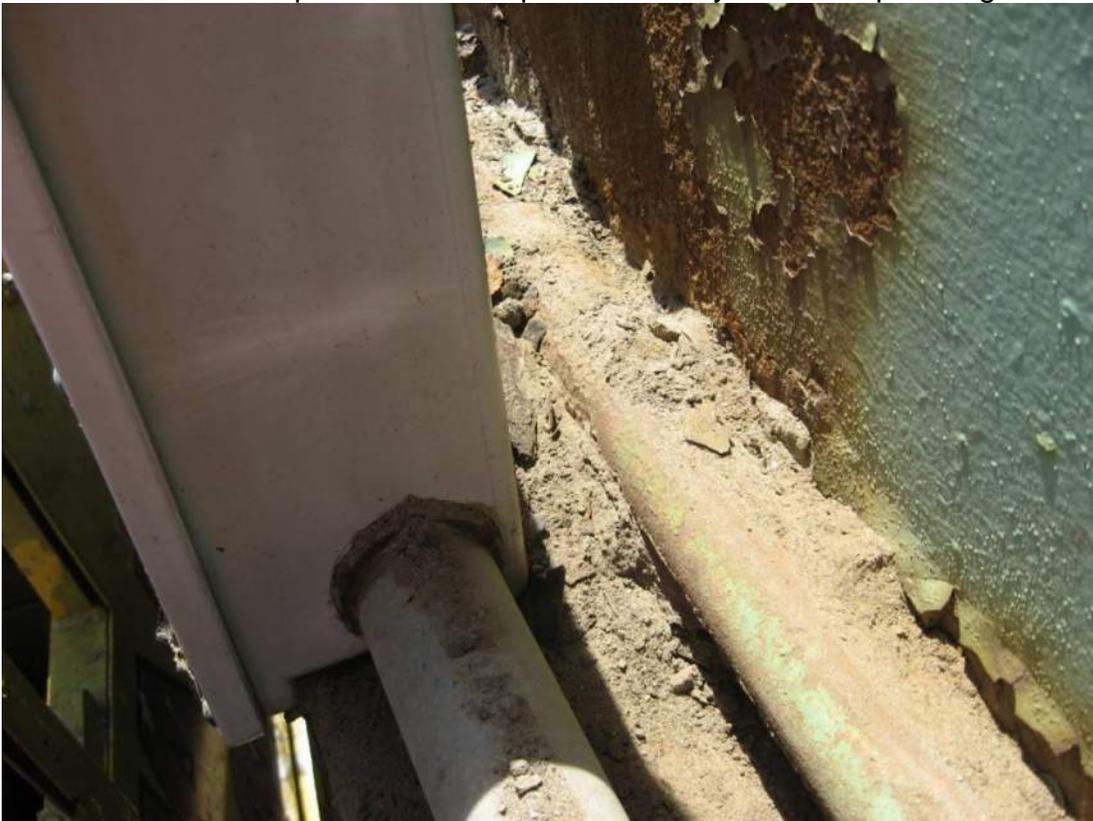
Photo 20 – Packed debris up to two inches deep on top of Span 1 roadway truss L2 lower chord outboard channel where electrical conduits and junction box trap and collect dirt.

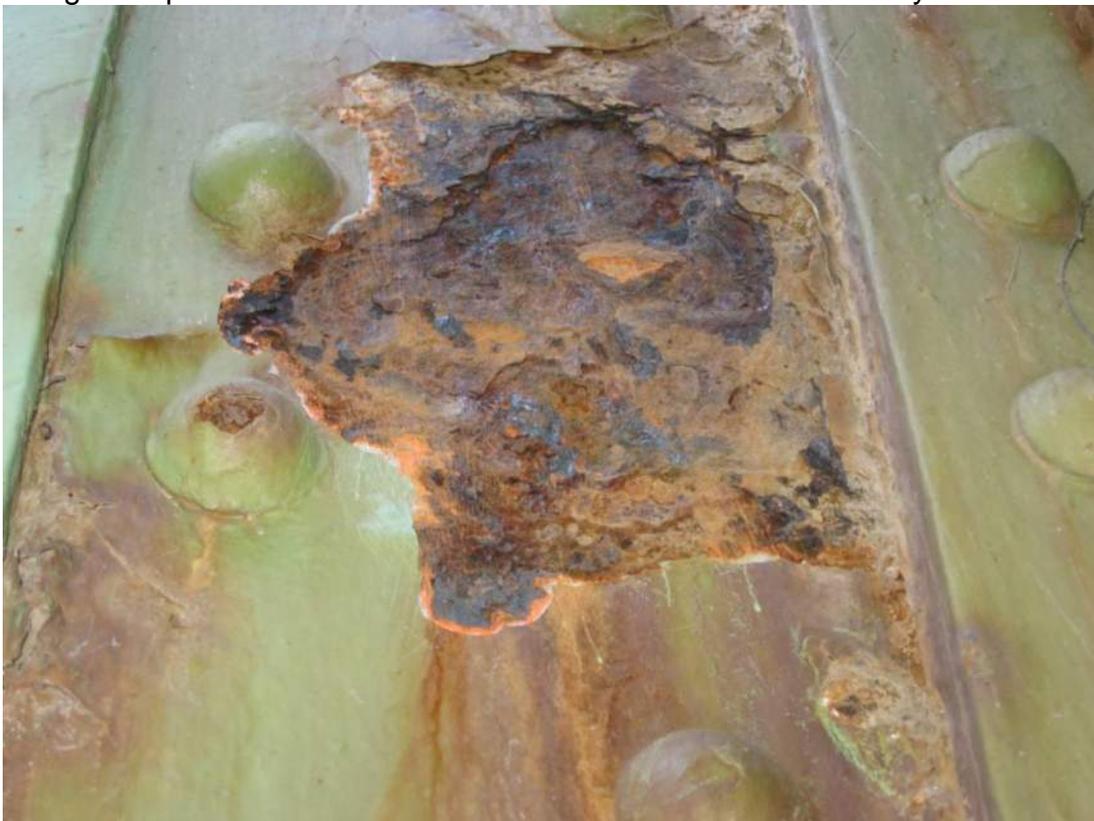
In the Span 1 roadway truss at L4 section loss of 1/16 inch depth was observed over a 4 inch long by 8 inch high area on the east face of the L3-L4 chord west side channel cover plate immediately adjacent to the vertical edge of the U4-L4 vertical (Photo 22). Minor negligible section loss to three of five total rivets heads in the lower chord bottom face on the north side of the outboard side channel was observed in the Span 1 roadway truss splice at L4.

Photo 22 – In Span 1 roadway truss at L4 section loss of 1/16 inch depth was observed over a 4” long by 8 “ high area on east face of L3-L4 chord west side channel cover plate.

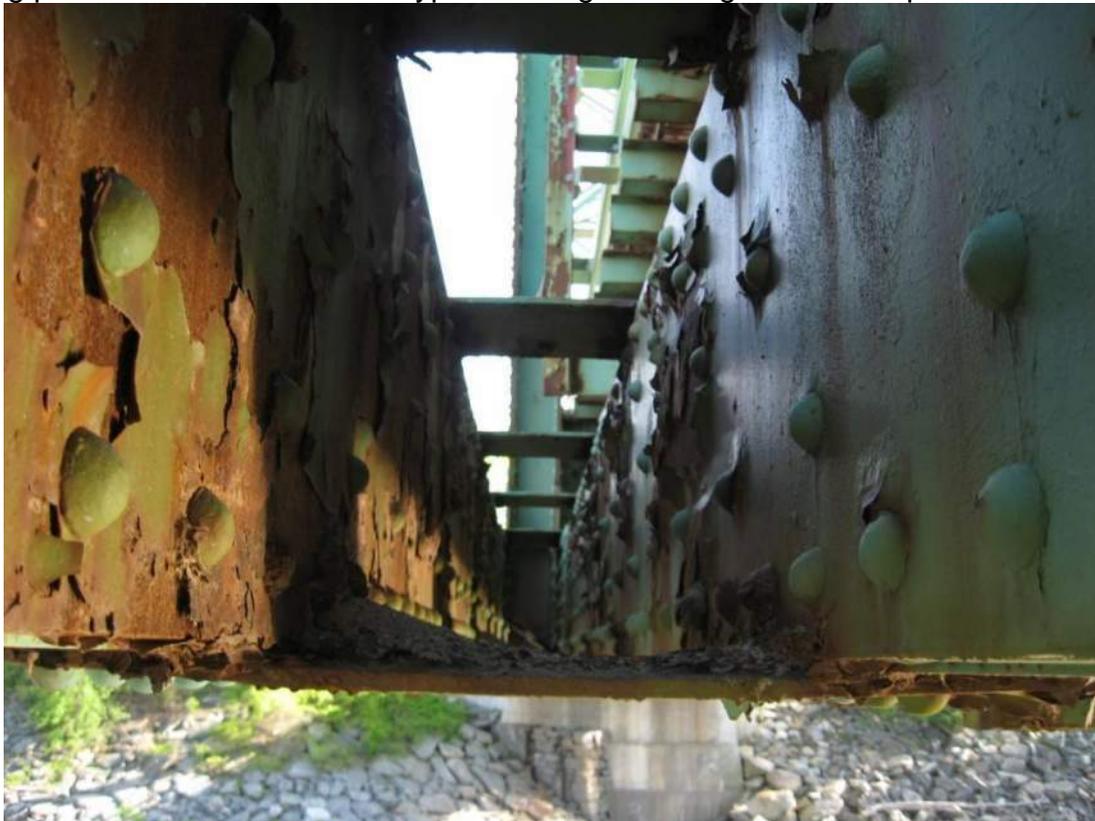
The roadway truss lower chord top face exhibits poor paint condition with missing paint and active corrosion typical throughout the bridge length (Photo 23). The overall typical upper chord paint condition is characterized as 30-40% paint loss. The interior vertical faces of the roadway truss lower chord also exhibits poor paint condition with missing paint and active corrosion typical throughout the bridge length (Photo 24). The east face of the Span 1 roadway truss between L8 and L9 exhibits missing paint and active corrosion over a 15 foot length (Photo 25). In Span 3 the entire length of the east face of the roadway truss has severe paint failure with active corrosion (Photo 26).

Photo 24 – The interior vertical faces of the roadway truss lower chord also exhibit poor paint condition with missing paint and active corrosion typical throughout. Span 1, L6-L7.

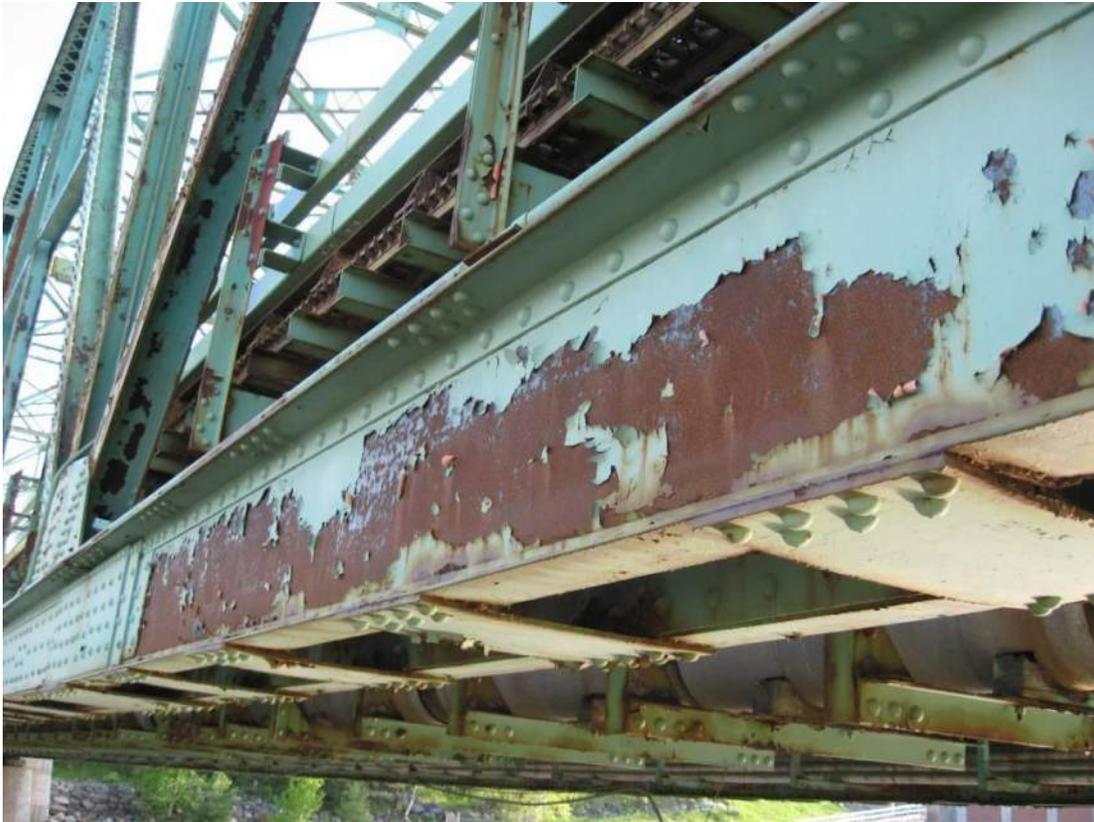
Photo 25 – The east face of the Span 1 roadway truss between L8 and L9 exhibits missing paint and active corrosion over a 15 foot length.

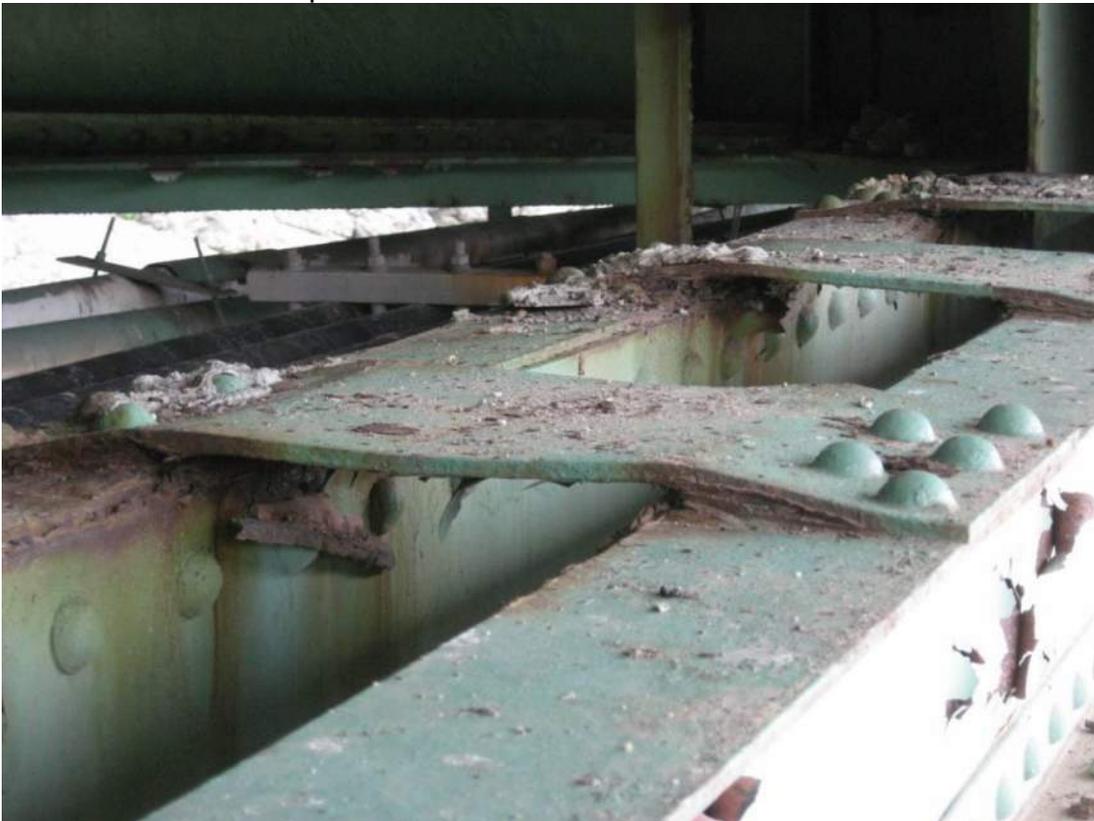
Photo 30 – The most severe instance of bowing of the top face lower chord tie plates was observed at Span 3 sidewalk truss at the third tie plate north of L0.

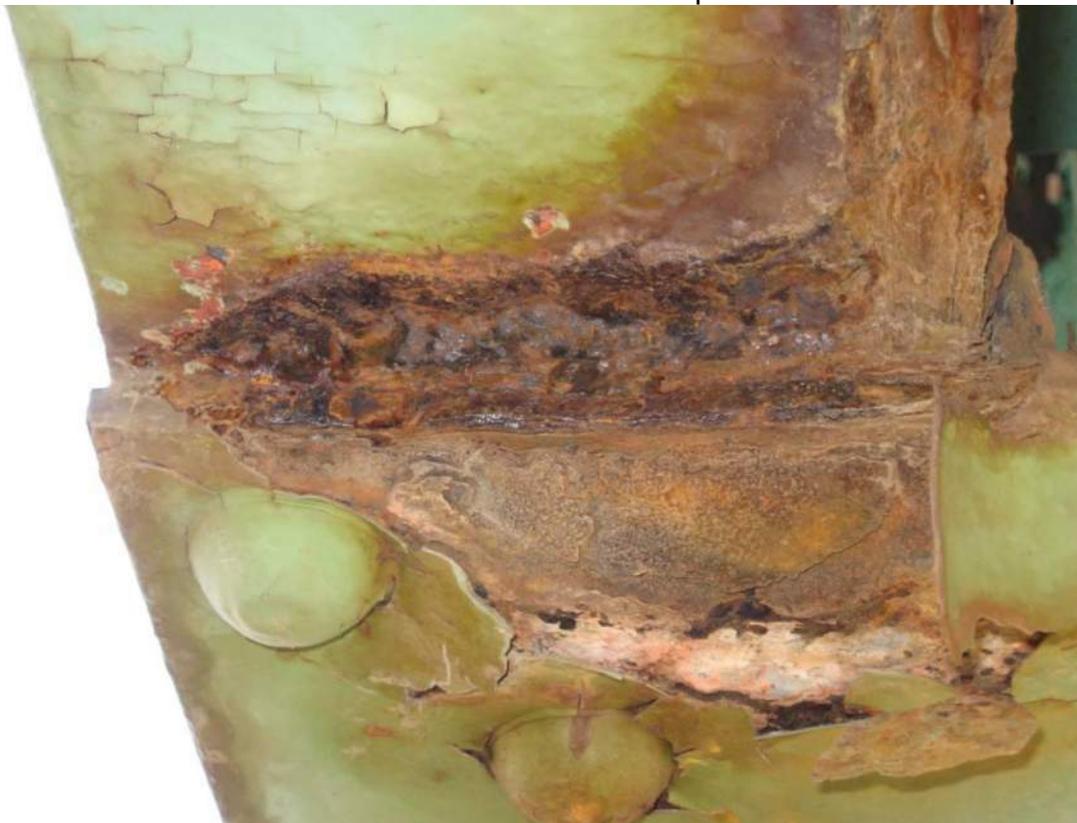
There is a localized zone of 1/8 inch deep by 3 inch wide section loss to underside of the Span 3 sidewalk truss lower chord outboard side channel located at the corner of the first tie plate south of the center splice in the L4-L5 (Photo 31). There is similar section loss to both side channels of the Span 3 roadway truss lower chord at the second tie plate north of L6. At this location the east side channel has 1/4 inch of section loss over a 4 inch width at the edge of the tie plate and the west side channel has 1/8 inch section loss over a 4 inch width (Photo 32). The interior vertical side channel faces of the Span 3 roadway truss L3-L4 exhibit large areas of failed paint with active corrosion along with raised expansive delamination/exfoliation similar to pack rust (Photo 33).

Photo 32 – Span 3 roadway truss L6-L7 has 1/4 inch of section loss over 4 inch width on east side channel and 1/8 inch section loss over a 4 inch width to west side channel.

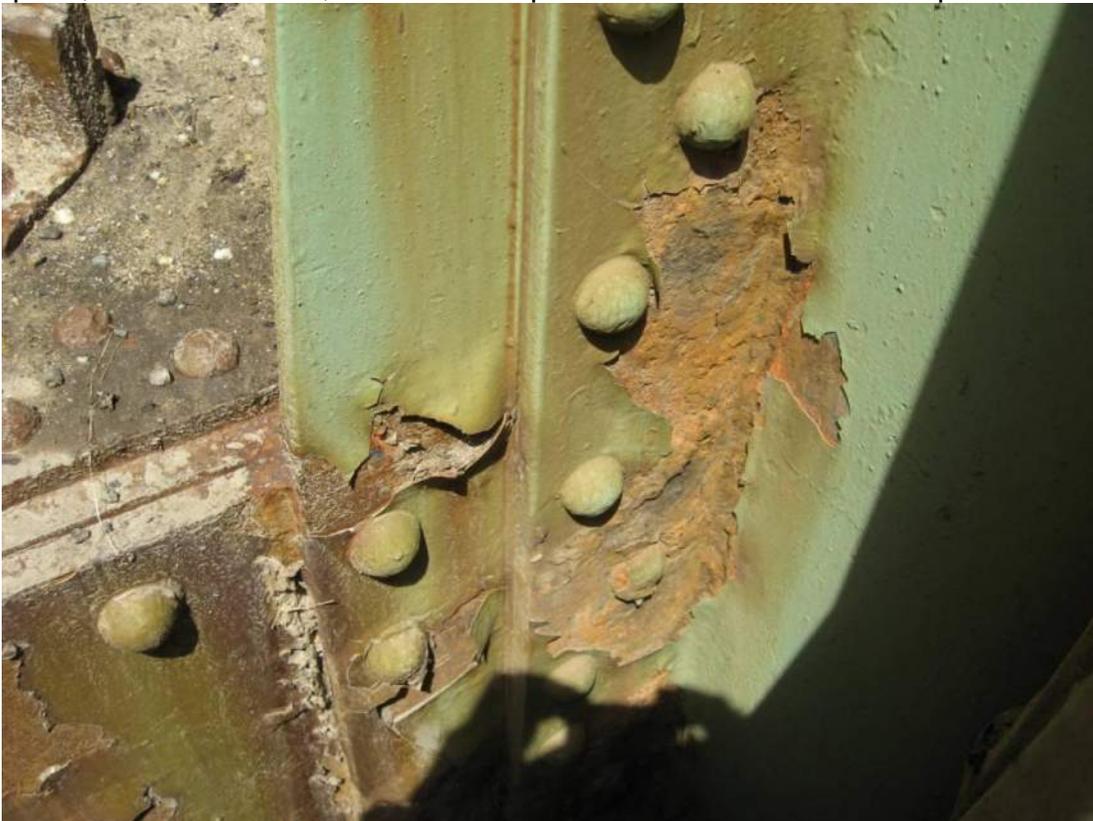
Vertical and Diagonal Members: Active corrosion with delamination and rust exfoliation was observed at the Span 1 roadway truss U1-L1 where there is estimated section loss of 1/16 inch to the east face of the vertical west flange over the half of the flange width to the south of the vertical web (Photo 34). The section loss extends over a height of about 3 feet and is roughly centered on the top of the lower chord.

Photo 34 – Span 1 roadway truss U1-L1 has section loss of 1/16 inch to the east face of the vertical west flange over the half of the flange width south of the vertical web.

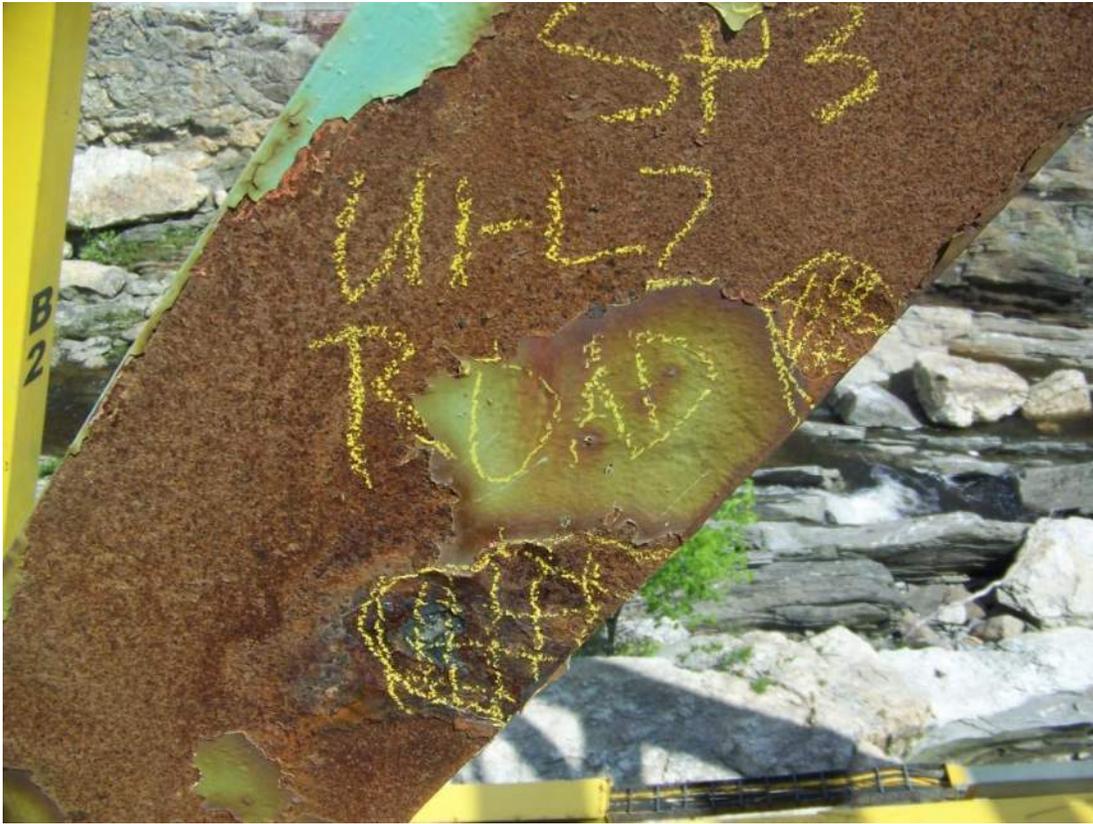
At approximately 5 feet above the deck in the Span 3 roadway truss U1-L2 there is a zone of 1/8 inch section loss to the west face of the flange over an area measuring approximately 5 inches square (Photo 35). The Span 3 roadway truss U4-L4 vertical has a 7/16 diameter hole in the west flange located approximately 3'-6" above the deck level.

Photo 35– At 5 feet above the deck in Span 3 roadway truss U1-L2 there is a zone of 1/8 inch section loss to west face of flange over an area approximately 5 inches square.

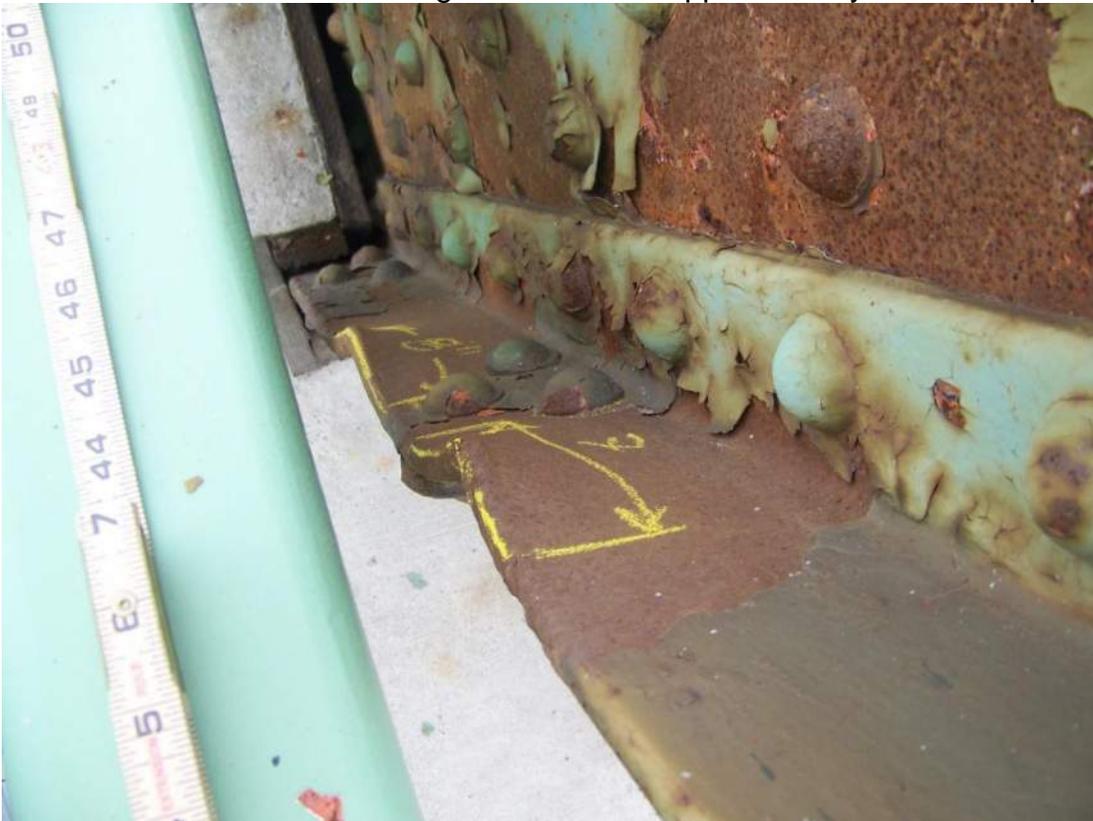
Impact damage to the Span 3 sidewalk truss L0-U1 end post was observed which has caused two bends of 3/4 to 1 inch to the northeast corner angle (Photo 36). Similar impact damage was observed to the Span 3 roadway truss U7-L8 end post at approximately 8 feet above the deck.

Photo 36 – Impact damage to the Span 3 sidewalk truss L0-U1 end post was observed which has caused two bends of $\frac{3}{4}$ to 1 inch to the northeast corner angle.

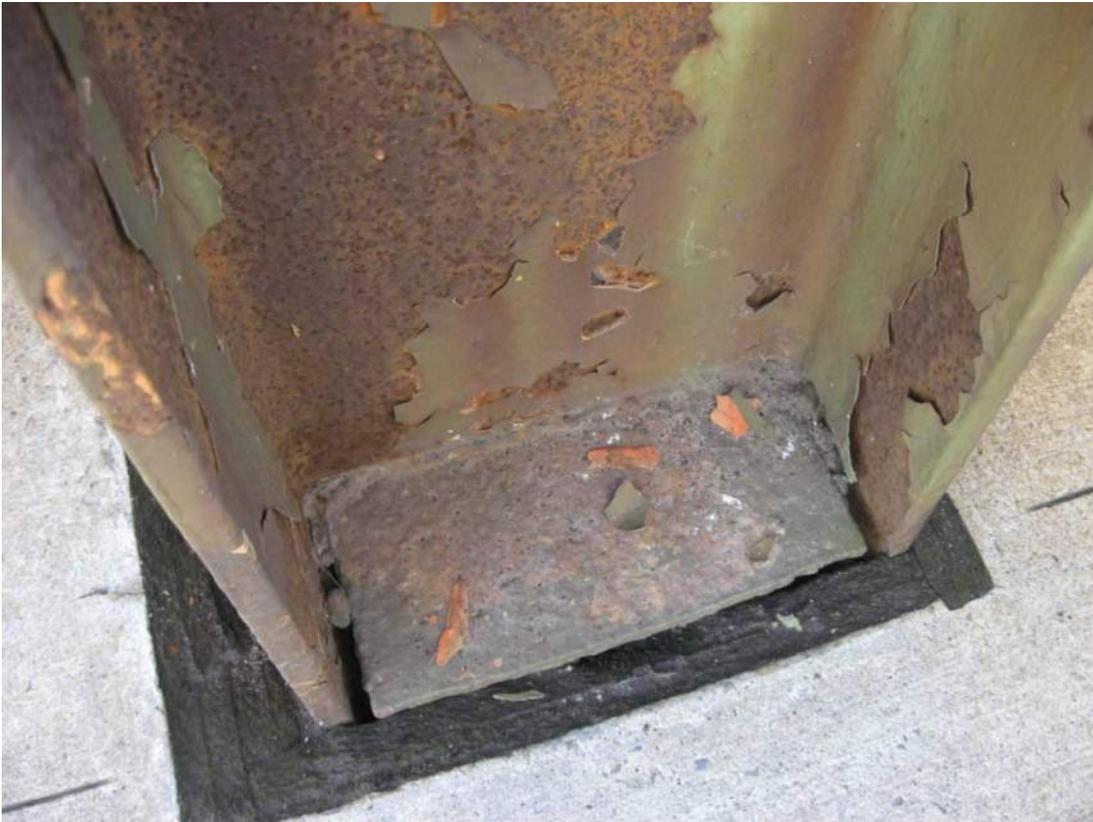
The sidewalk truss verticals and diagonals have welded plates added at the sidewalk level which are intended to partially block the openings at the sidewalk penetrations (Photos 37). These welded plates represent fatigue-sensitive details in FCM's wherever the base members are FCM's. Even though some of these plates are no longer in place the weld remnant is still present, so the location remains as an FSD in a FCM.

Photo 37– Sidewalk truss verticals and diagonals have welded plates at sidewalk level openings. These plates represent FSD's in FCM's (wherever base members are FCM's).

Recommendation: Re-inspect all welded sidewalk penetration plates in the sidewalk truss vertical and diagonal FCM's during future biennial bridge inspection cycles. Check for any indications of fatigue cracking initiation as part of the regularly scheduled bridge inspection cycles.

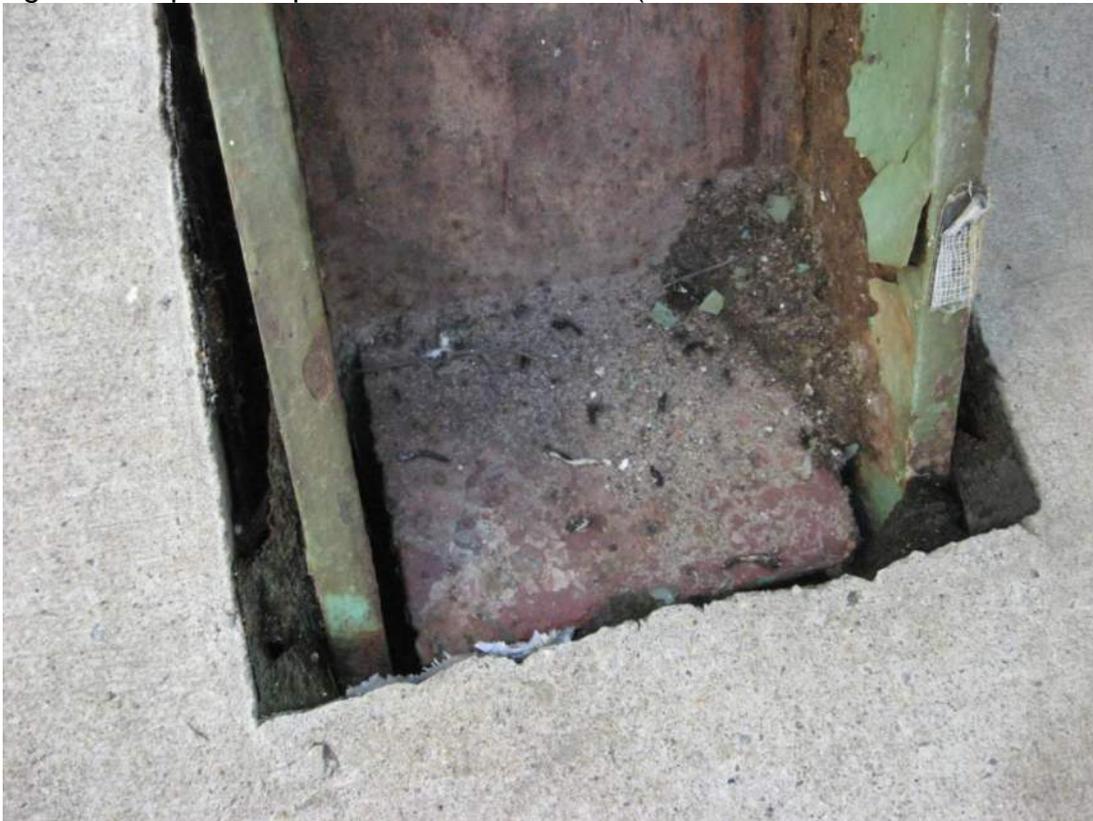
Photo 38 – Sidewalk truss verticals and diagonals have welded plates at sidewalk level openings. These plates represent FSD's in FCM's (wherever base members are FCM's).

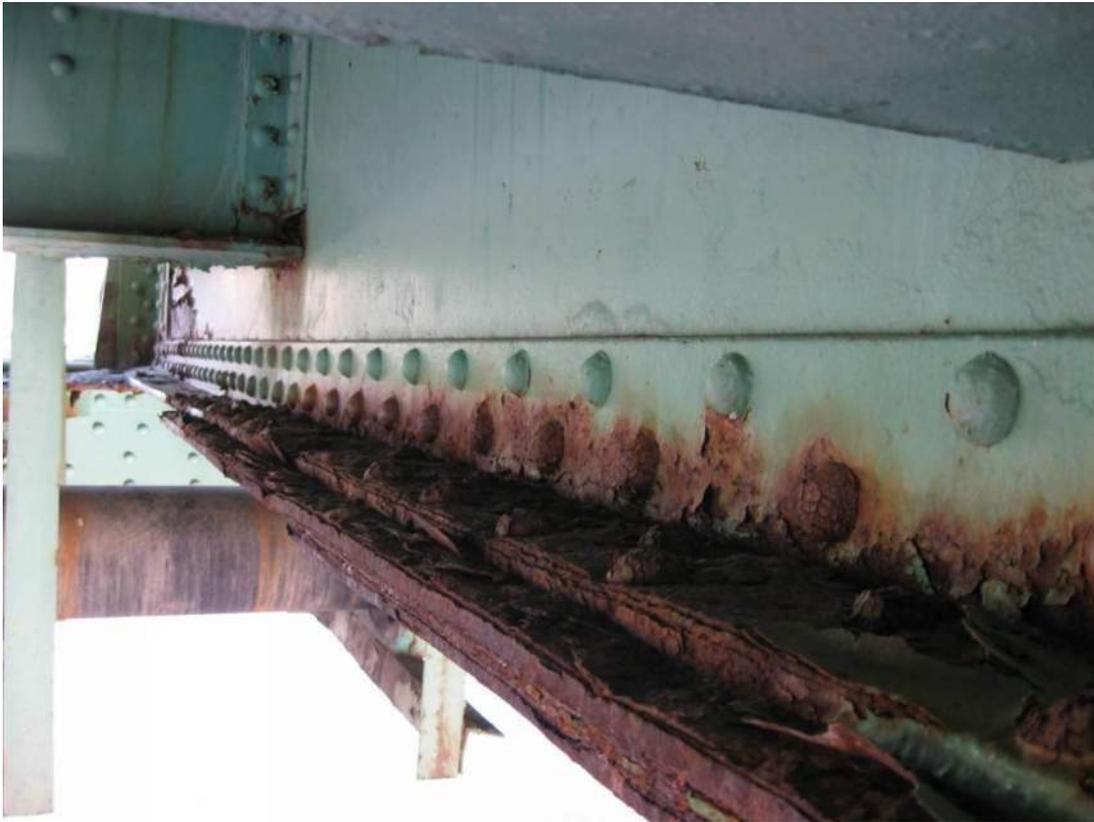
Photo 43– Span 1 FB5 has a zone of significant active corrosion to top of bottom flange on north side of web between S6 and S7 with up to 1/8 inch section loss to rivet heads.

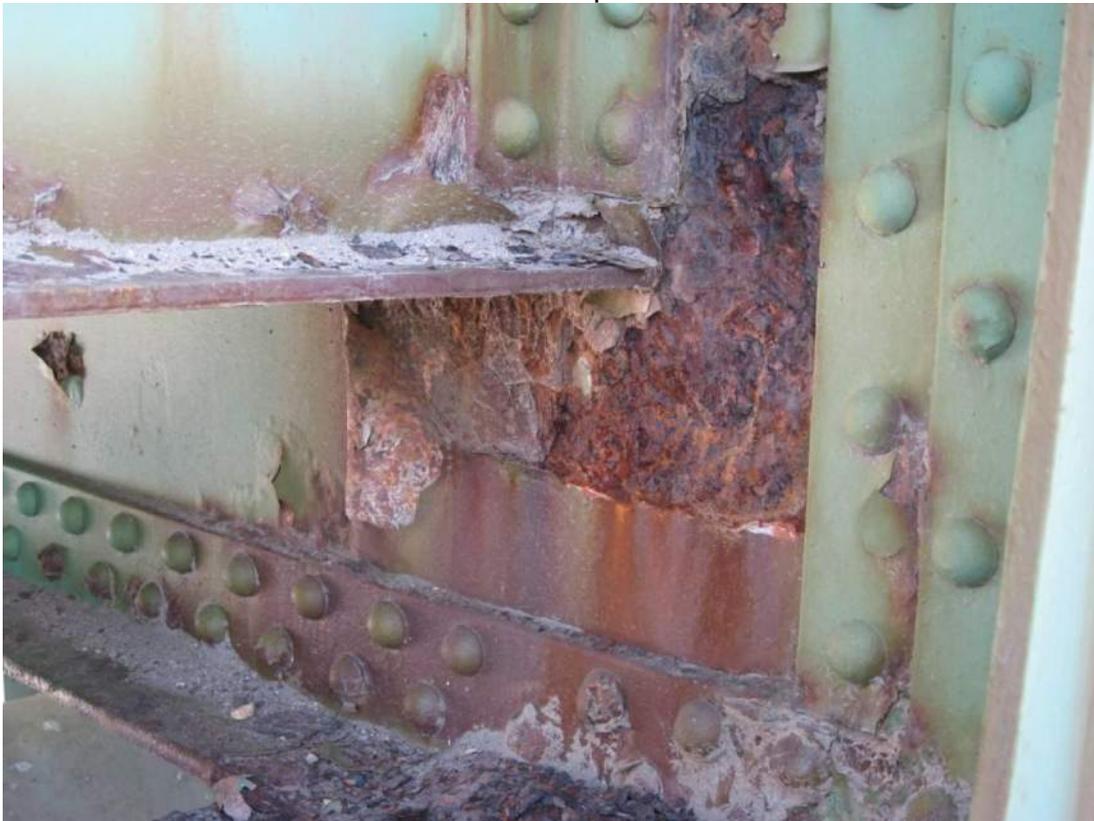
Photo 44 – At Span 1 FB7 below S8 both faces of the web exhibit active corrosion with section loss of 1/8 inch depth over a height of 8 inches and length of 12 inches.

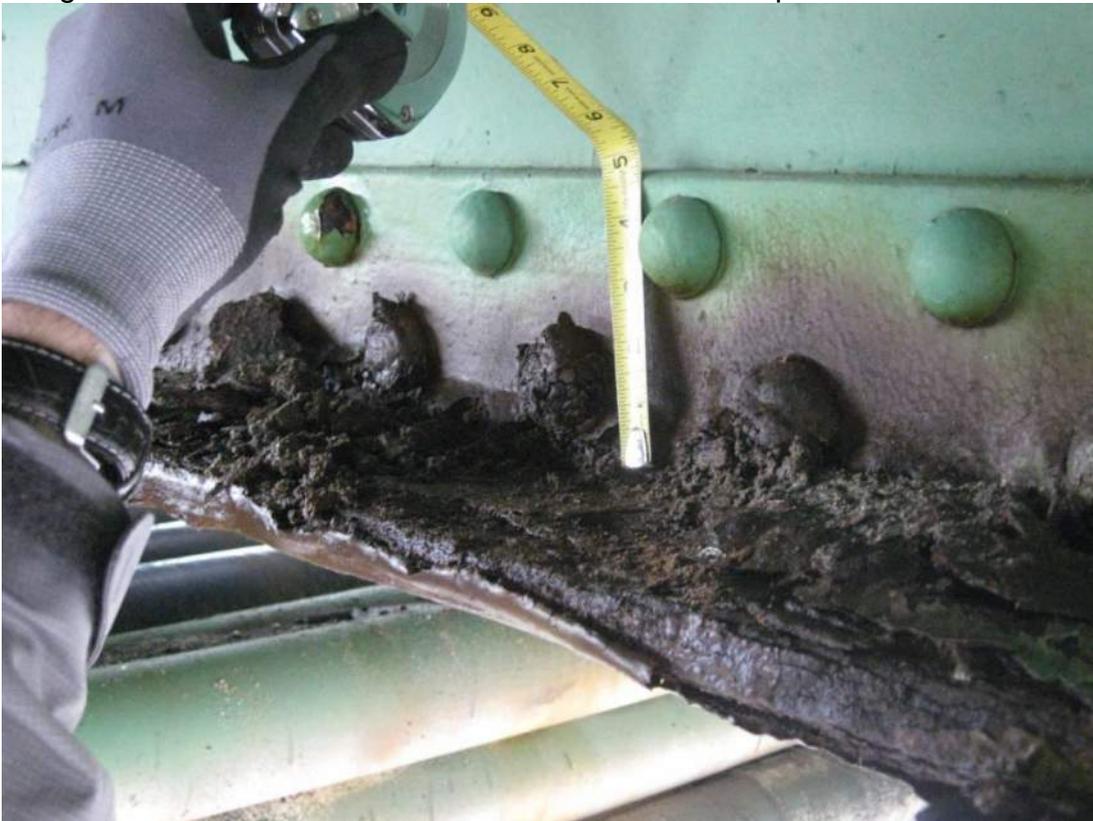
Span 3 roadway truss U4-L4	Approximately 3'-6" above the deck	The vertical has a 7/16 diameter hole in the west flange
Span 3 roadway truss L6-L7	Second tie plate north of L6	Underside of east side channel has 1/4 inch of section loss over a 4 inch width at the edge of the tie plate and the west side channel has 1/8 inch section loss over a 4 inch width (Photo 32).
Span 1 FB7	Below S8	Both faces of web exhibit active corrosion with section loss of 1/8" depth over a height of 8" and length of 12" (Photo 44)
Span 2 FB8	Between S6 and S8 top of the bottom flange on the north side of the web	Delamination to top and edge of bottom flange angle horizontal leg with up to 1/8 inch section loss was observed in the portion of the floorbeam outside the partial length cover plate (Photo 45).
Span 2 FB6	Between S3 and S4 south half of bottom flange only	Zone of 1/8 inch section loss to the top of the bottom flange on south side of web (Photo 46).

Photo 46 – Span 2 FB6 has a zone of significant active corrosion and 1/8 inch section loss to the top of the bottom flange on the south side of the web between S3 and S4.

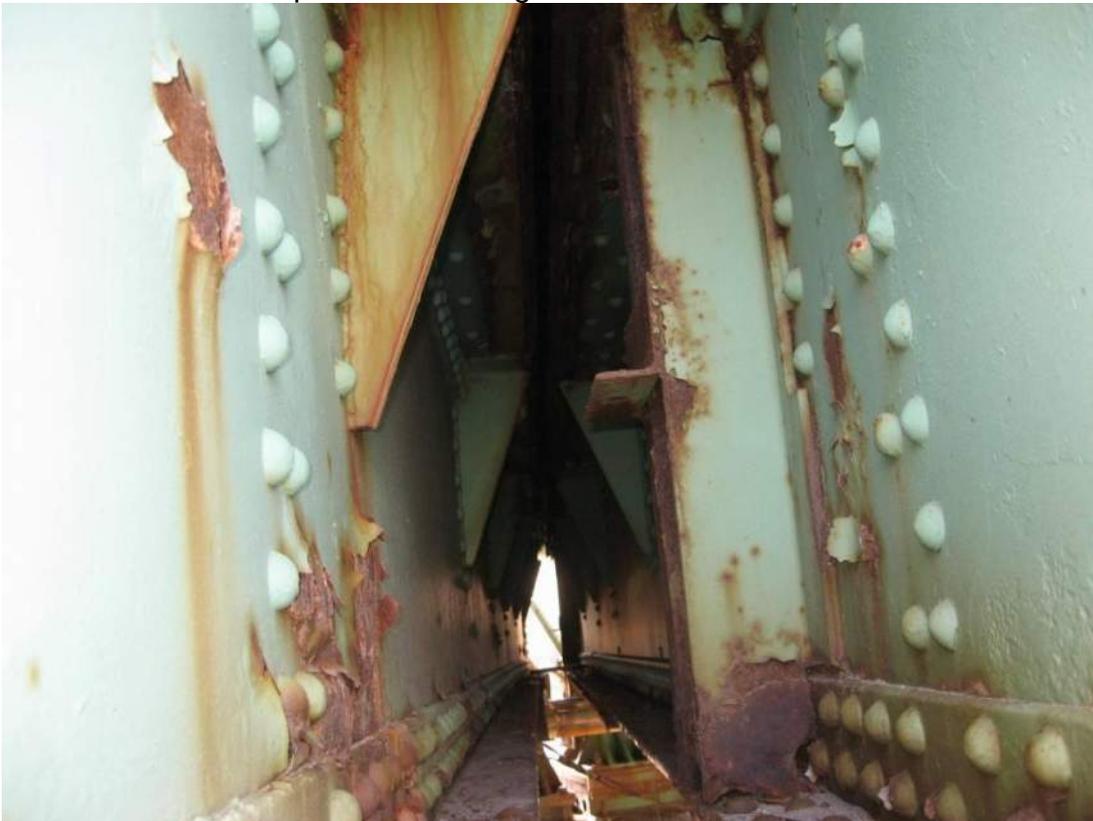
Photo 48 – The end floorbeams over Pier 1 have partial height welded stiffeners on face of web below deck joint, which constitutes a number of fatigue-sensitive details in FCM's.

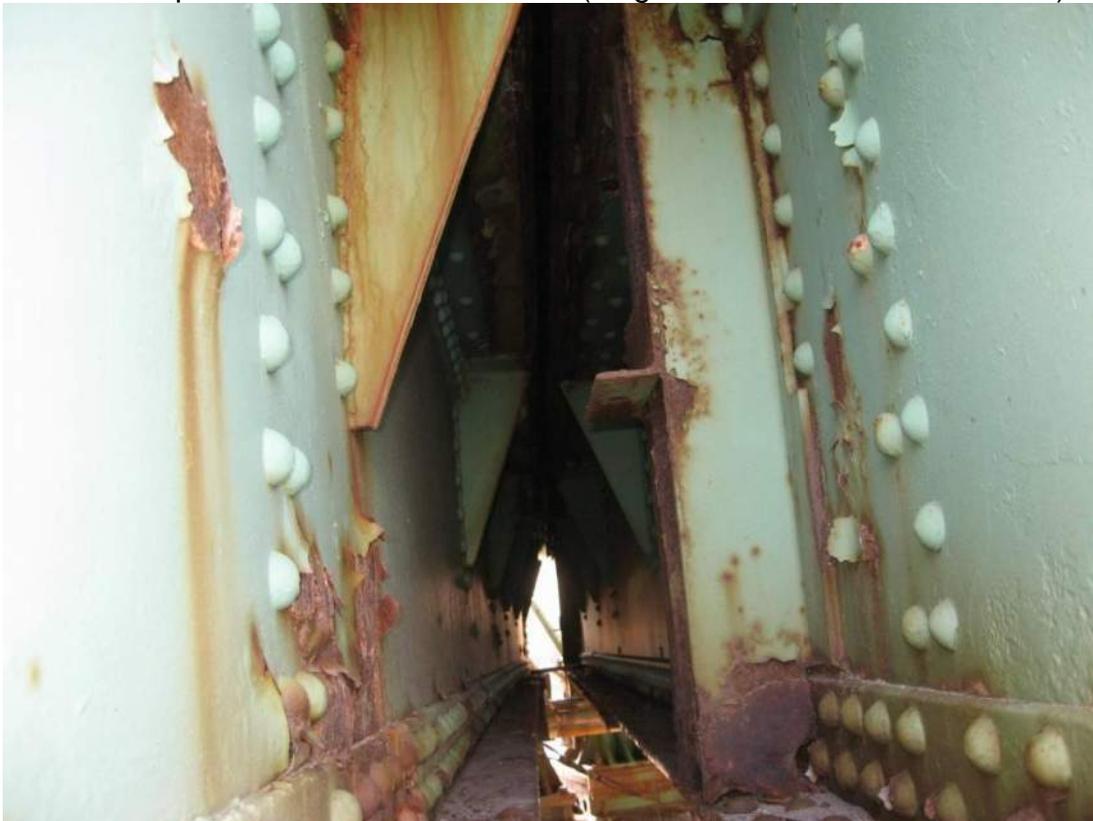
Photo 50 – Span 2 FB0 on right also has full height welded jacking stiffeners at both ends (FSD's in FCM's). Jacking stiffeners are also present on opposite face of web.

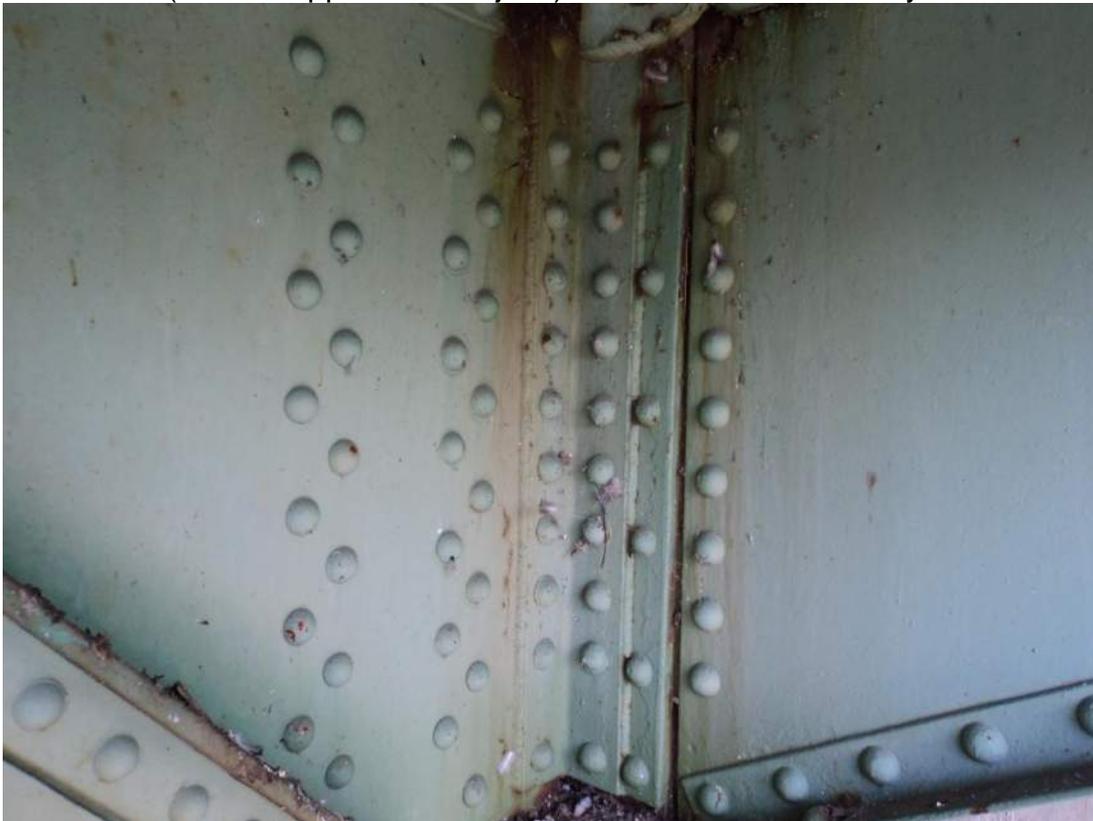
Photo 52 – Sidewalk cantilever bracket clip angles were observed to be welded full height to the gusset plate and to the web fill plate on the bracket web at Span 1 L0.

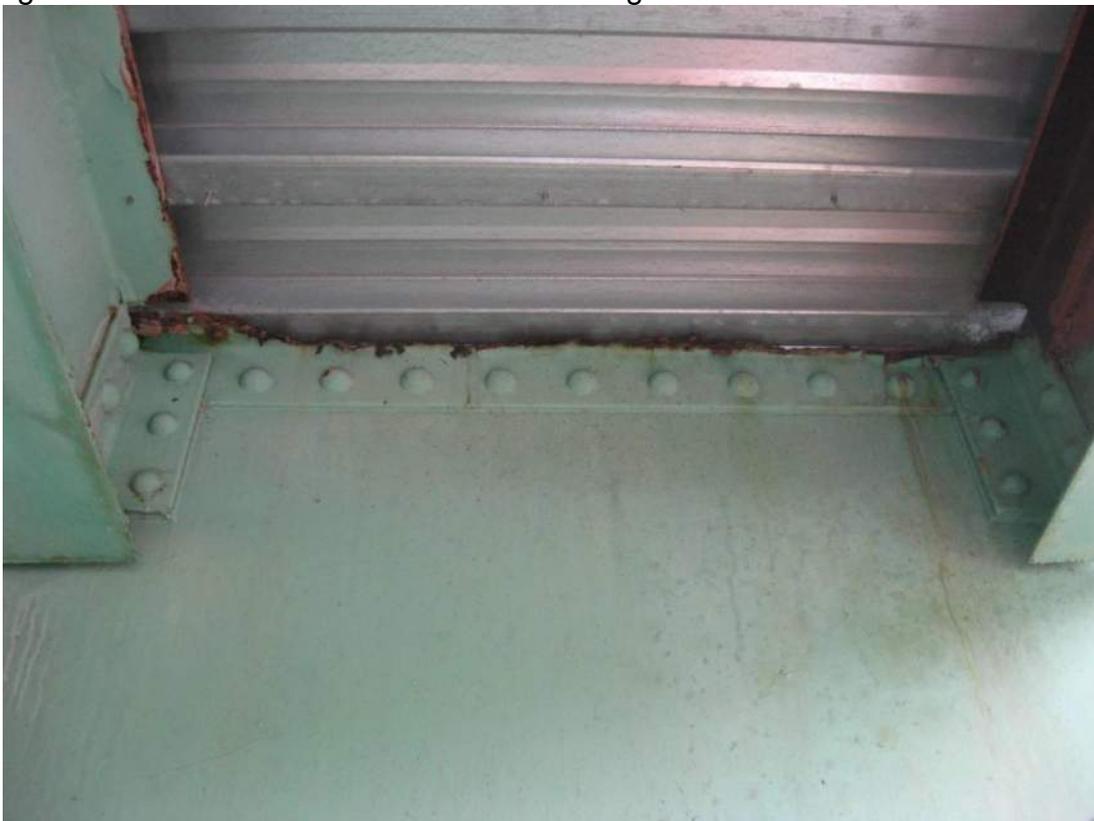
Span 2 FB4	Bottom flange on north side of web at 2 feet west of S4	4" wide by 8" long zone of 1/8 inch section loss to top of bottom flange on north side of the web at 2 feet west of S4 (Photo 47).
Spans 1-3, (all flrbm. cantilever brackets)	Floorbeam sidewalk cantilever brackets between S1 and S2	Top flange angles exhibit severe section loss throughout. In most severe locations, 100% of horizontal legs of top flange angles on both sides of web are lost (Photo 54)

Photo 54 – Top flange angles of floorbeam cantilever brackets exhibit severe section loss, amounting to 100% of horizontal legs on both sides of the web between S1 and S2.
