Preliminary Design Report

Frank J. Wood #2016

Brunswick-Topsham, Maine

August 4, 2017

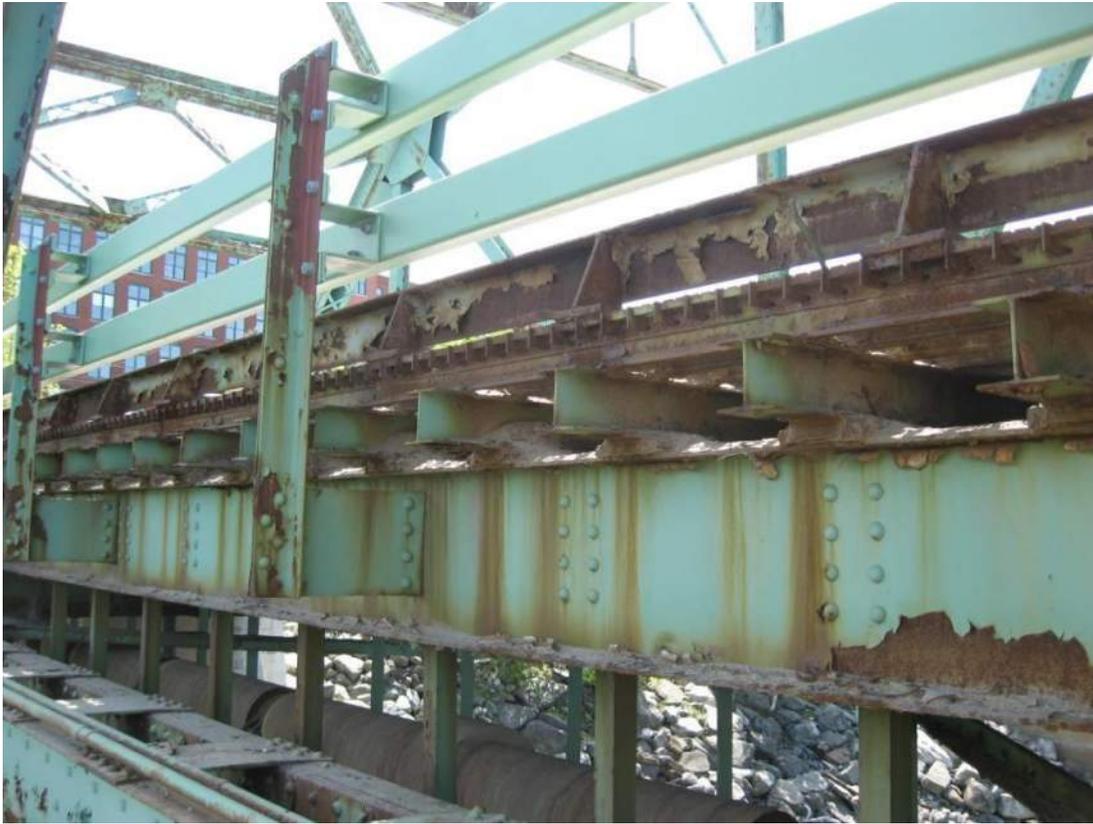
Photo 55– Stringer S8 in Span 1 has heavy debris accumulations along the top flange at each of the grid deck cross beams between L2 and L3.

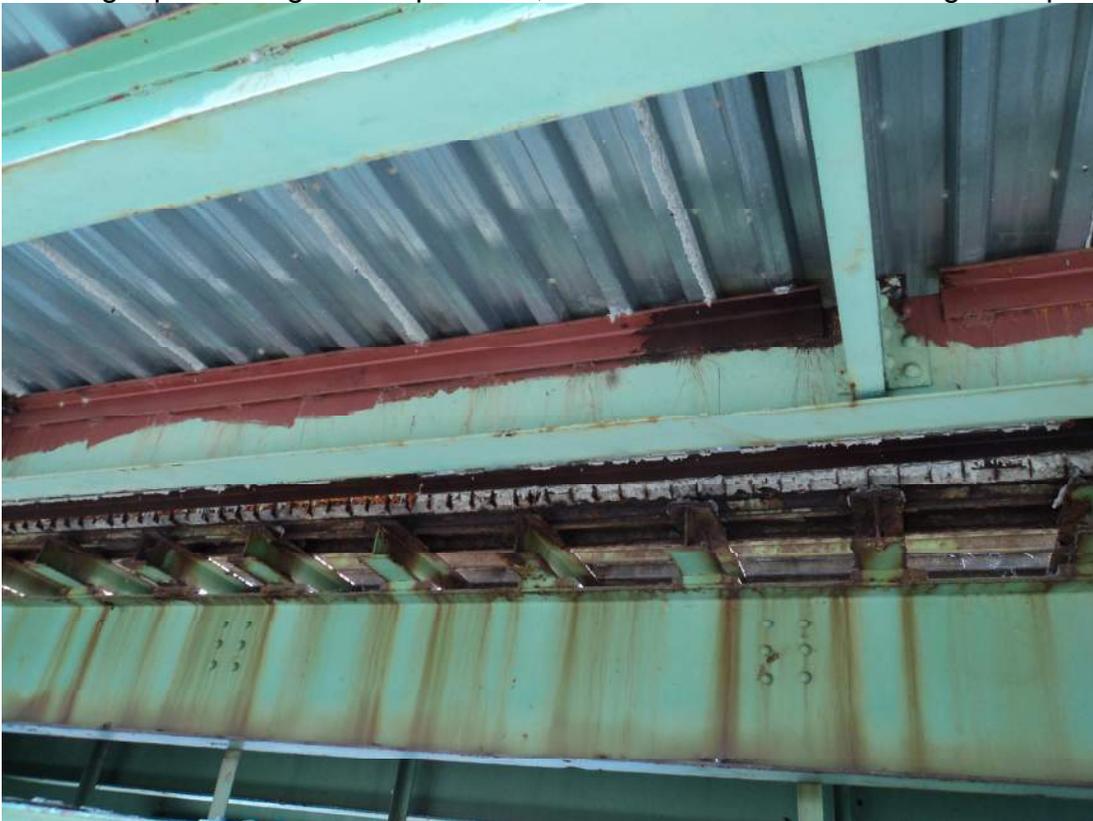
Photo 58 – Similar repairs were also observed on sidewalk stringer S2 where the top flange angle repair was left prime-painted only on both sides of the stringer.

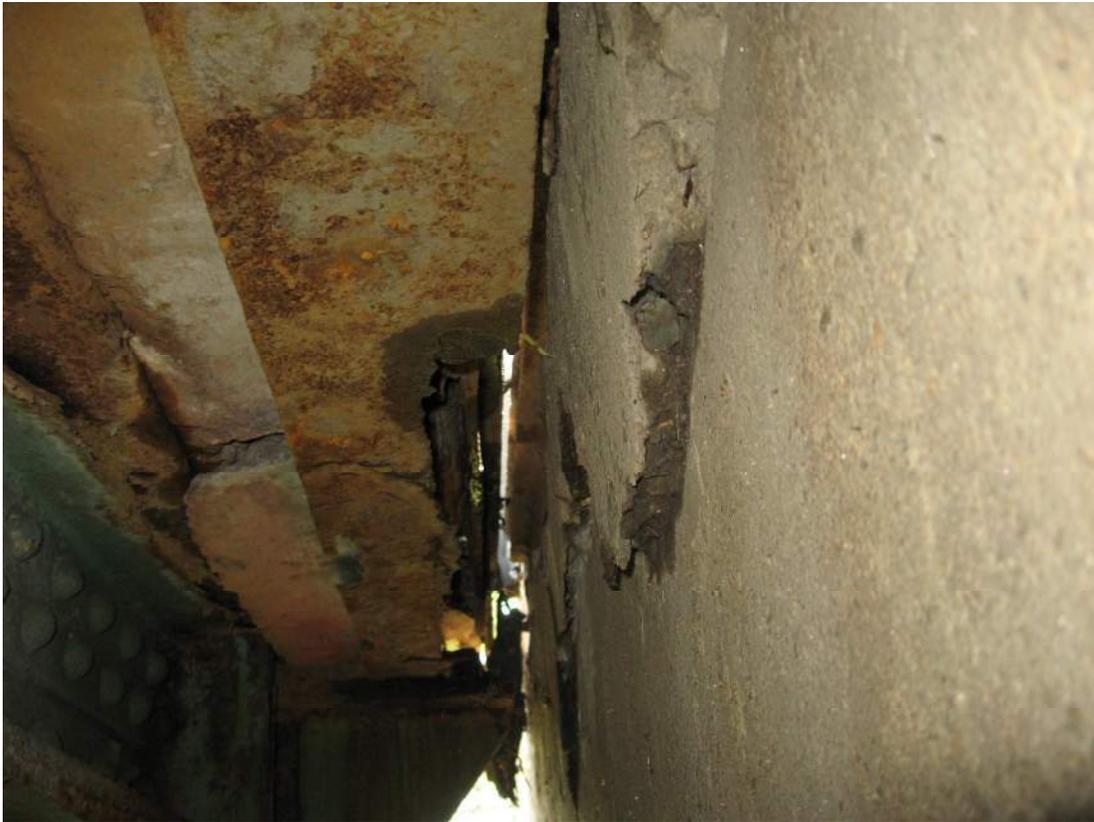
Photo 59– A three inch width of the bottom flange south edge is missing from the south abutment transverse cross-beam over a 4 foot length between S7 and S8.

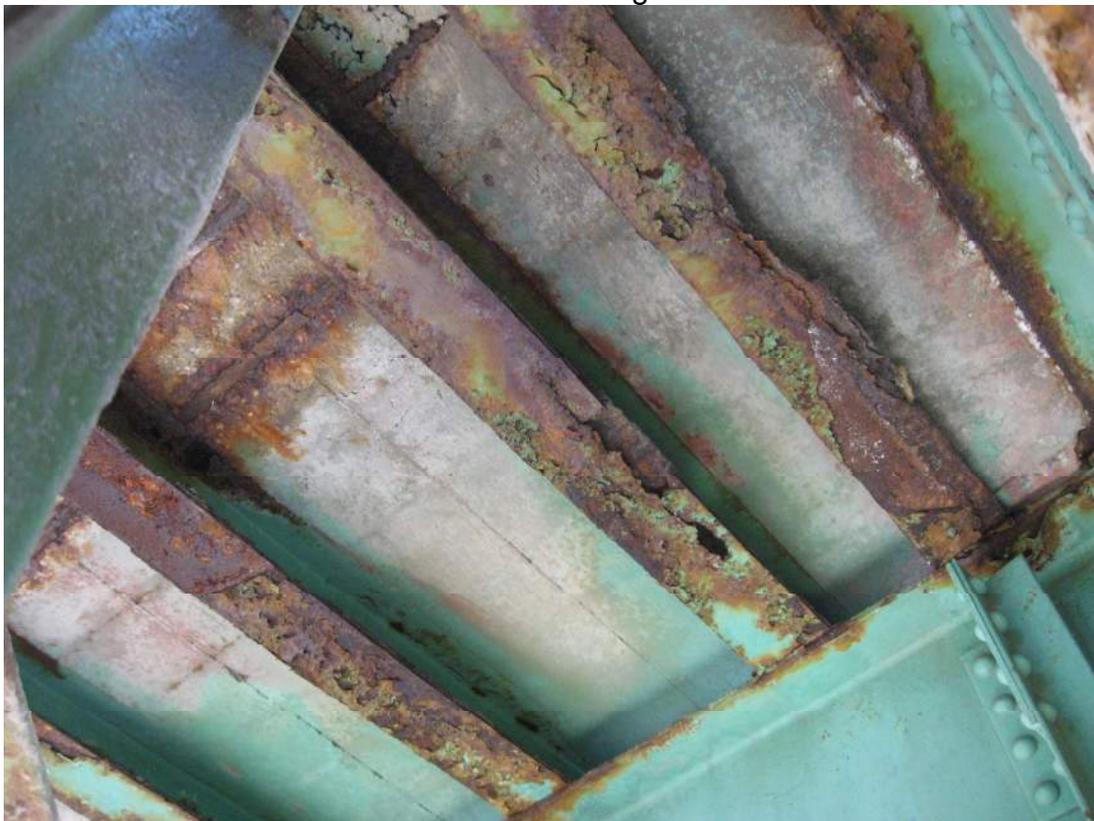
Photo 60 – Section loss and perforation to two cross-beams in Span 1 near FB2 between S7 and S8 where bottom flange has up to 3/16" section loss over 2 inches along edge.

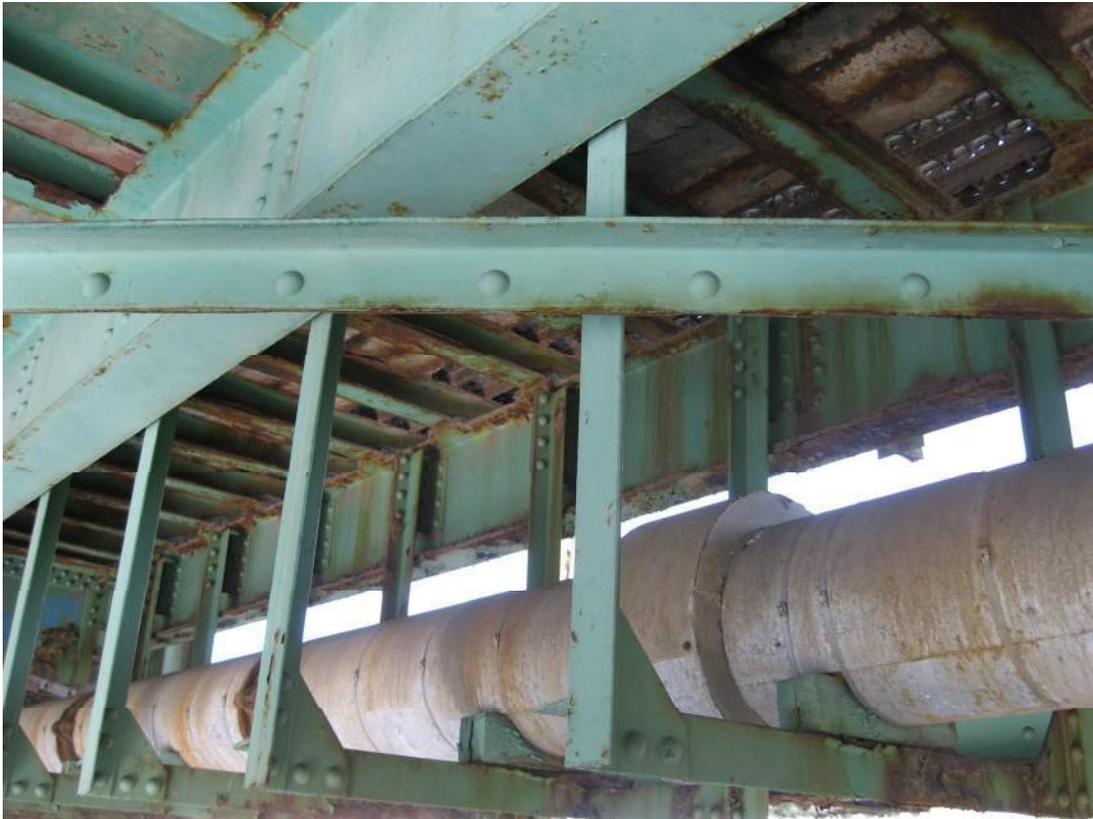
Photo 61– The typical paint condition on grid deck cross-beams between S7 and S8 is poor throughout the bridge length with active corrosion on most cross-beams this bay.

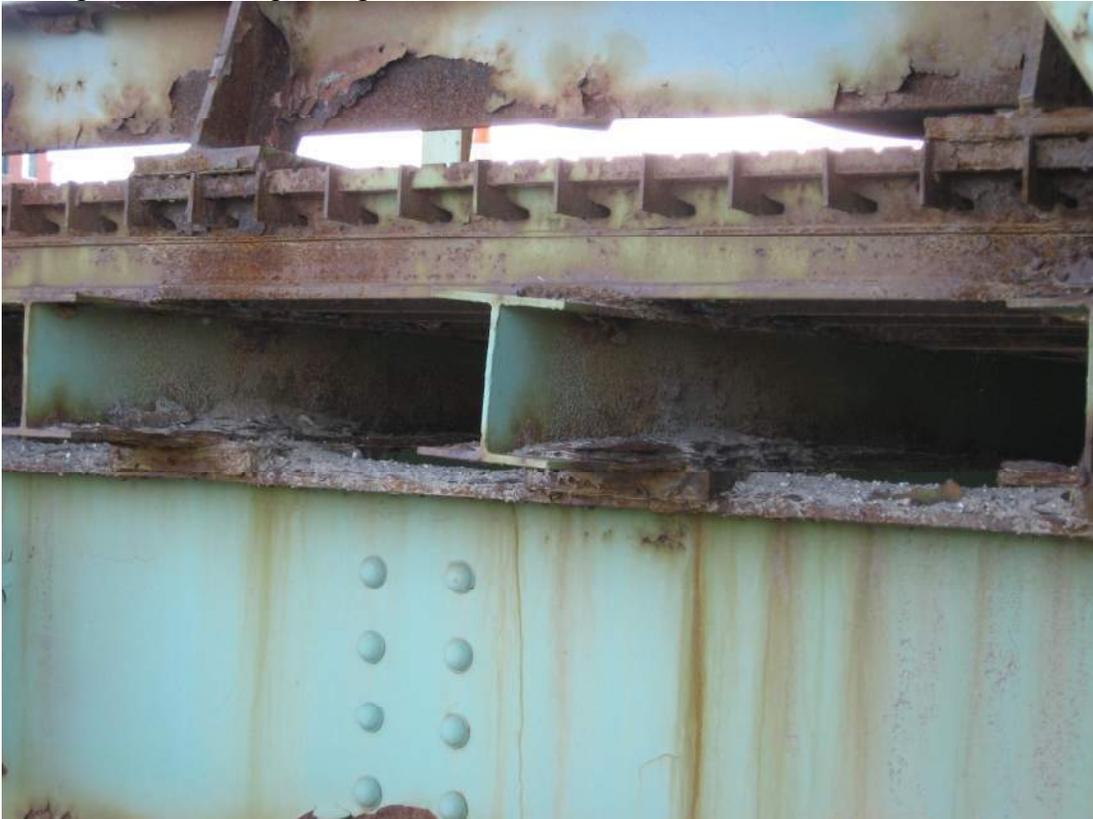
Photo 62 – The east end of a grid deck cross-beam above S8 between L7 and L8 was observed to be twisted around cross-beam axis due to pack rust at the S8 connection.

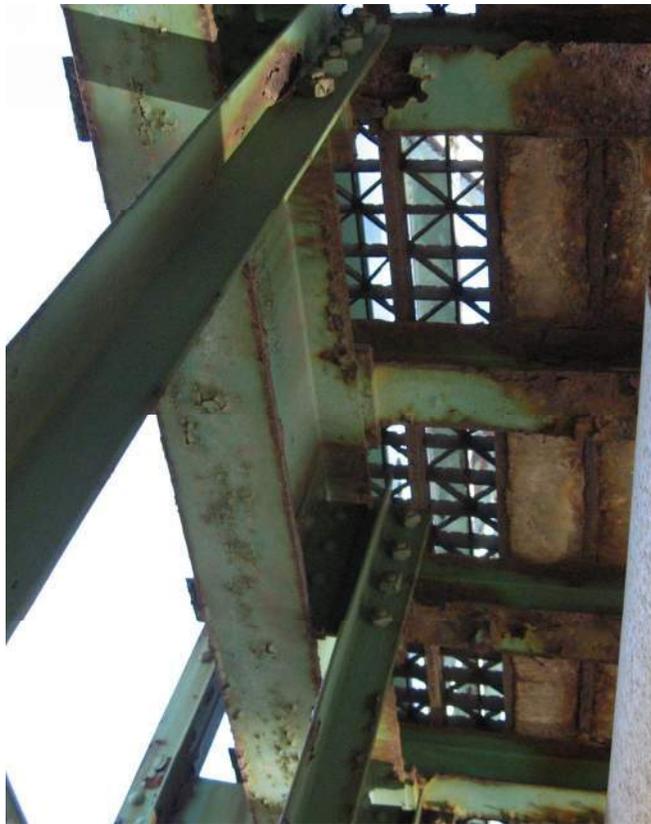
Photo 63– Perforations at the flange edges and in the bottom flange of the cross-beams was observed in Span 3 near L6 in the ends of the cross beams.

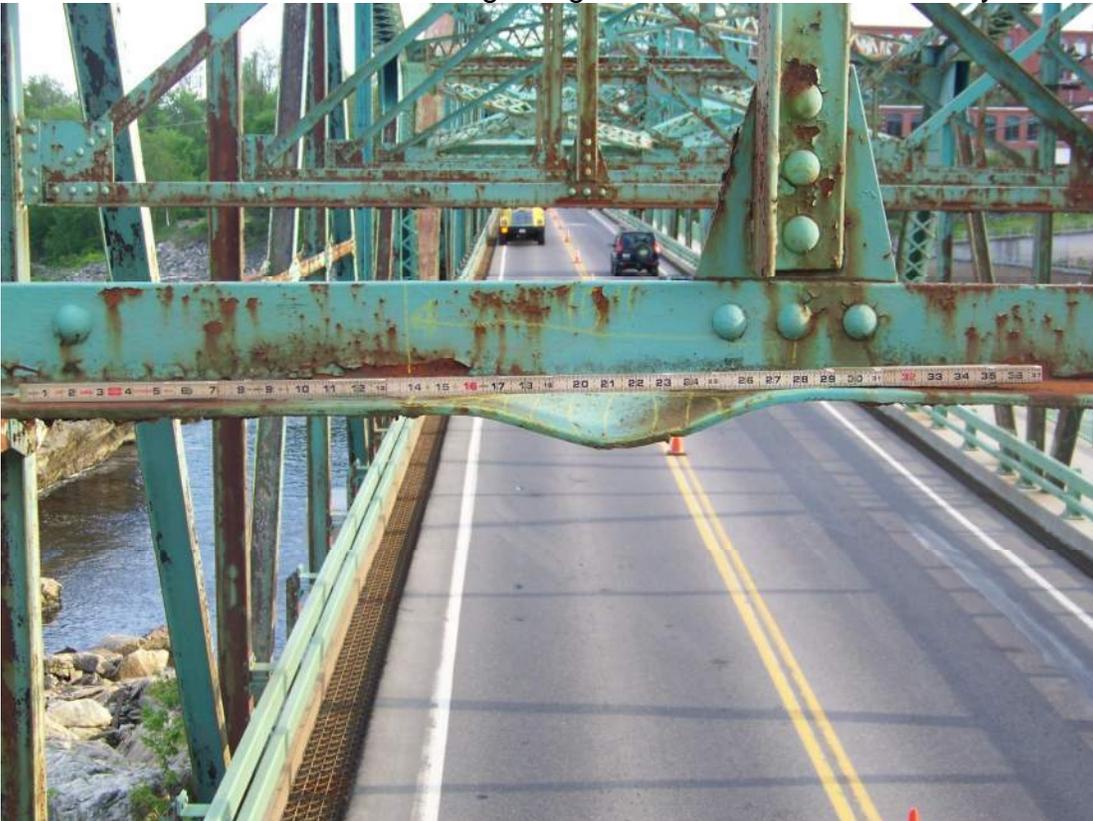
The Span 3 U6 sway frame lower strut has sustained impact damage in a 15 inch long zone which has deflected the north horizontal leg downward by $1\frac{1}{4}$ inches over the northbound lane just east of the bridge centerline (Photo 70).

Photo 70 – Span 3 U6 sway frame strut has impact damage which has deflected the north horizontal leg downward by $1\frac{1}{4}$ " over northbound lane just east of bridge centerline.

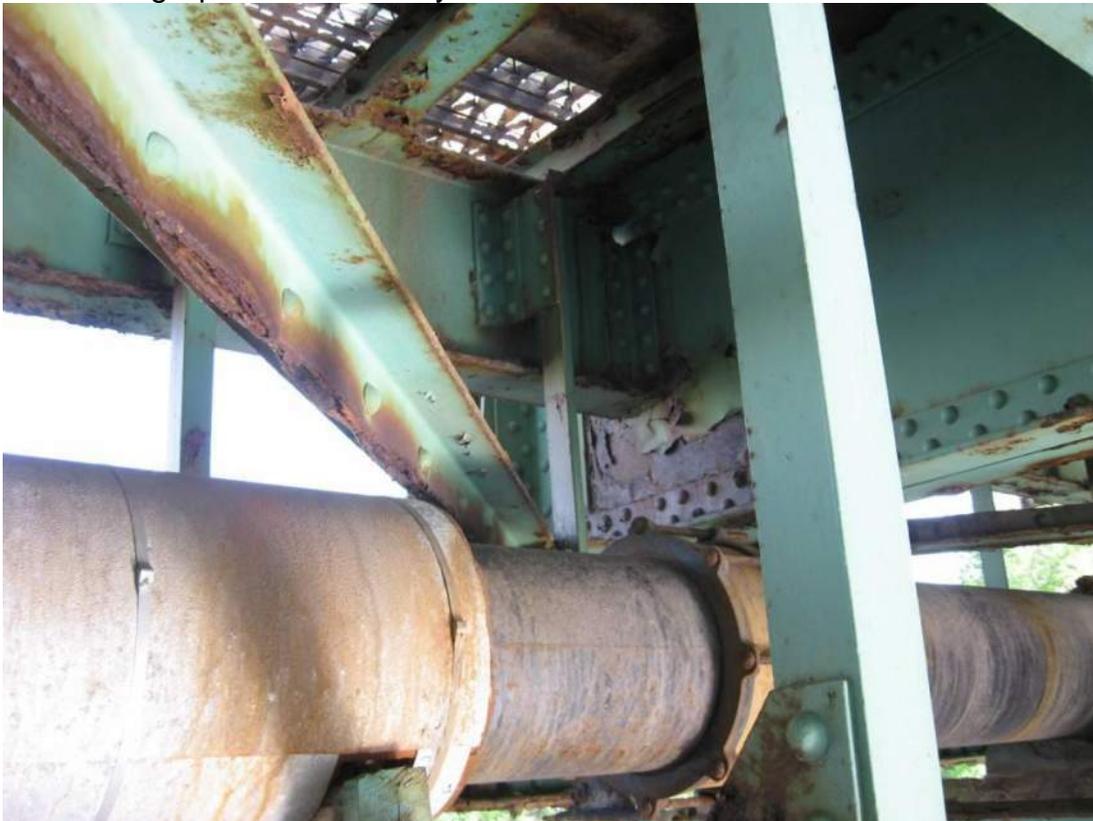
Lower Chord Lateral Bracing- Severe pack rust with active corrosion was observed over a four foot length of the lower lateral bracing angle connecting Span 1 L3 roadway truss and L4 sidewalk truss at the L3 end of the member (Photo 71). A similar condition was observed over a four foot length of the lower lateral bracing angle connecting Span 2 L4 sidewalk truss and L3 roadway truss at the L4 end of the member. Severe pack rust with active corrosion was also observed between the back to back vertical angles over a ten foot length of the lower lateral bracing angle connecting Span 1 L5 roadway truss and L6 sidewalk truss at the L5 end of the member (Photo 72).

Photo 72 – Severe pack rust with active corrosion between back to back angles of lower lateral bracing connecting Span 1 L5 roadway truss and L6 sidewalk truss at L5 end.

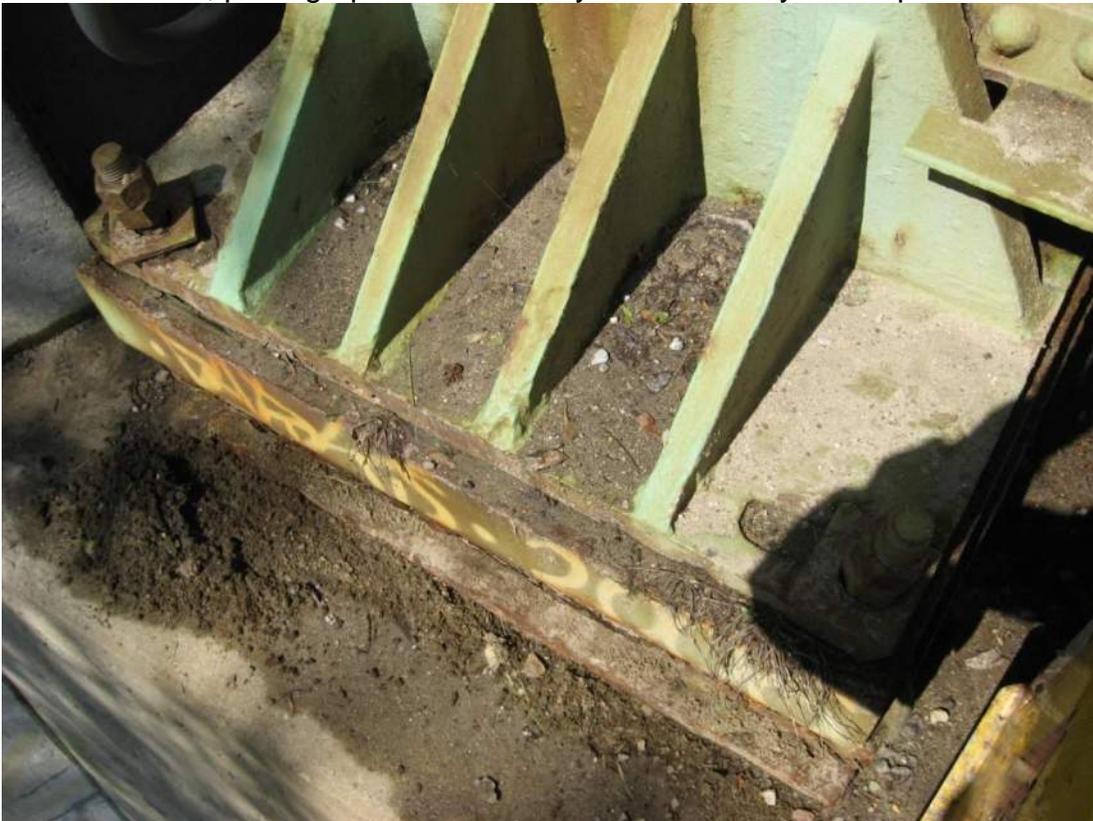
Photo 74 – Expansion slots in the south abutment roadway truss bearing upper shoe are completely filled with debris accumulations which preclude normal thermal movement.

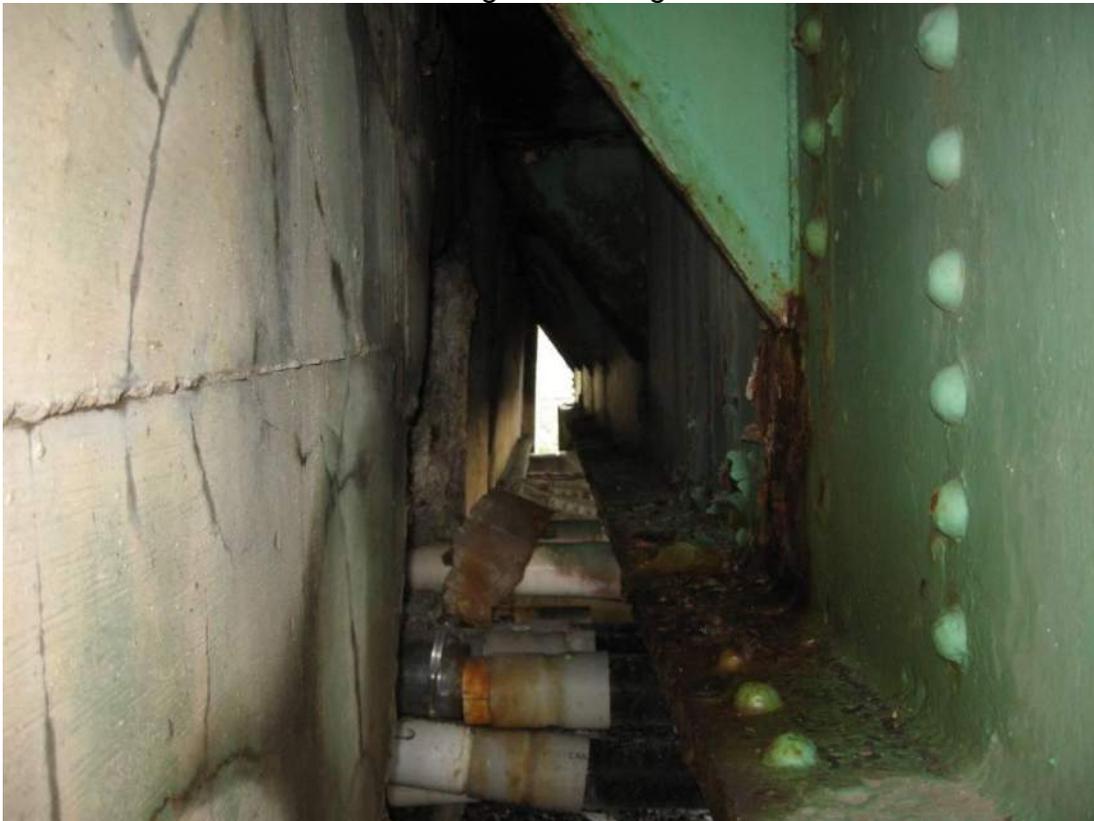
The north abutment backwall has numerous medium diagonal cracks in the portion below the sidewalk (Photo 79). A previous large spall repair was observed in the upper and middle portion of the north abutment backwall located roughly in line with the sidewalk truss. There is a large 3 foot by 3 foot by 3 inch deep spall in the lower portion of the backwall around the edges of the utility conduit penetration and extending behind the sidewalk truss (Photos 80 & 81).

Photo 80 – There is a large 3 foot by 3 foot by 3 inch deep spall in lower portion of backwall around edges of utility conduit penetration and extending behind sidewalk truss.

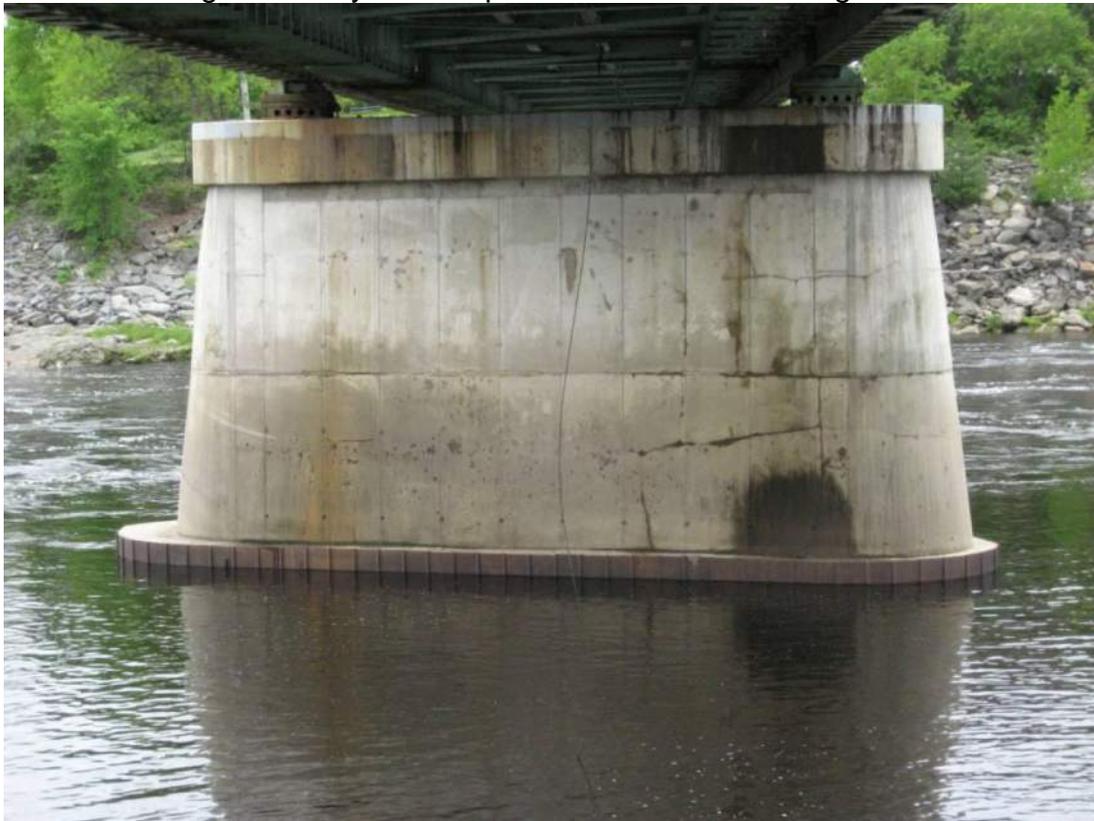
Piers: Both piers are in satisfactory condition with no significant visible defects (Photos 82 and 83). Pier 2 has a wide diagonal crack in the southwest corner of the sidewalk truss bearing pedestal which extends for the full height of the concrete pedestal (Photo 84).

Photo 82– Piers are in satisfactory condition with no significant visible defects. View looking south at north face of Pier 1.

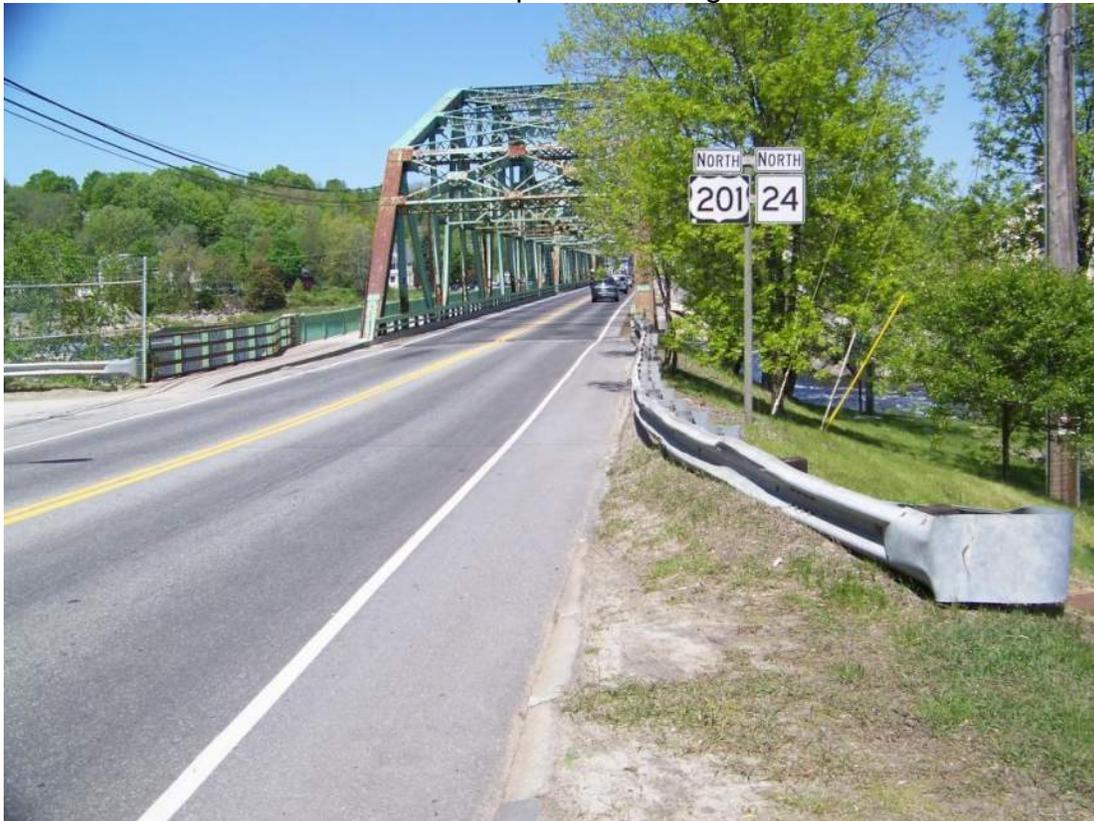
Approach Guiderails: There are approach guiderails at the southeast, northeast, and northwest corners which appear to meet standards. The existing guiderails are stiffened in the transition zones at these three bridge corner connections to the bridge railings (Photo 85). No guiderail is present at the southwest bridge corner because there is a section of railing attached to the U-shaped retaining wall/wingwall extension at this location (Photo 86). The approach guiderail at the northwest corner of the bridge is aligned with the outboard edge of the sidewalk and connected to the west pylon (Photo 87). The end of the southeast corner approach guiderail has impact damage (Photo 86). The end terminal on the northeast guiderail also has minor impact damage.

Photo 86 – No guiderail is present at southwest bridge corner (at left) because there is a section of railing attached to the U-shaped wingwall. Also note guiderail impact damage.

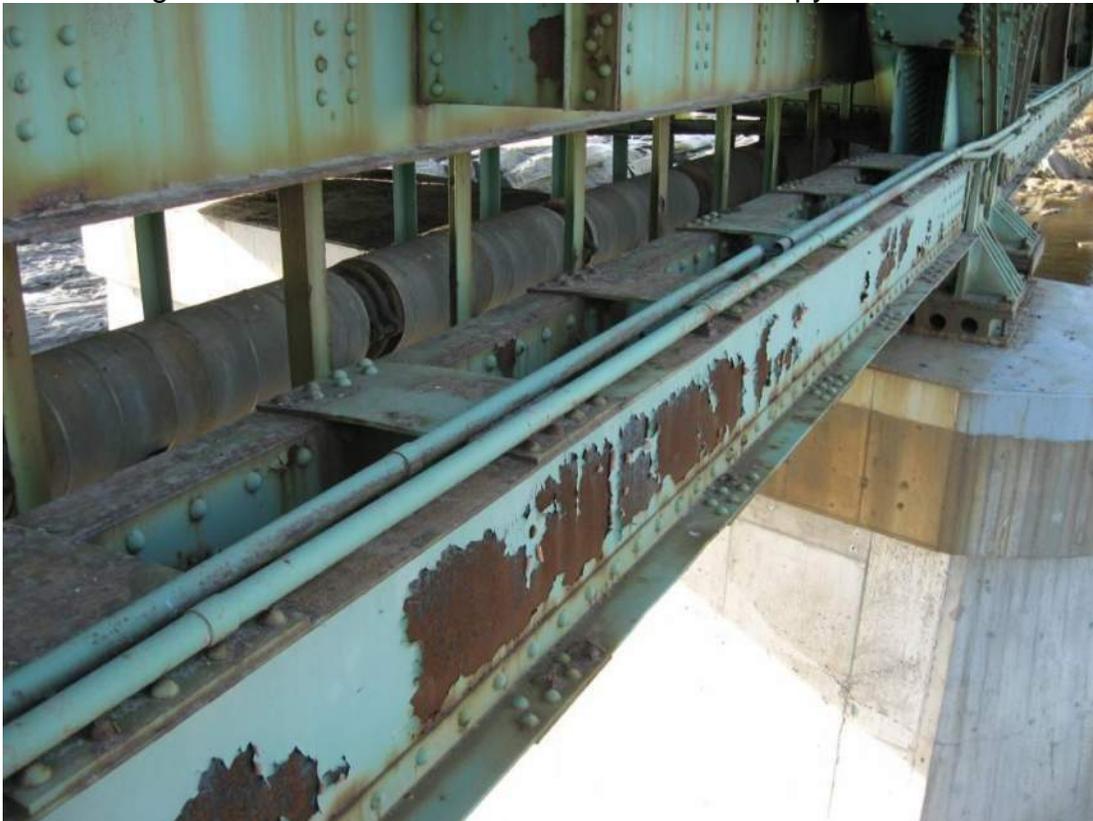
Conduits: Two conduits presumed to supply power for bridge lighting were observed to have a three inch separation in the conduit in Span 1 along the top face of the roadway truss between L9 and L10 which results in exposed electrical cables (Photo 88).

Photo 88 – Two conduits for bridge lighting have a 3" separation in one conduit in Span 1 along top face of roadway truss between L9 and L10 with exposed electrical cables.

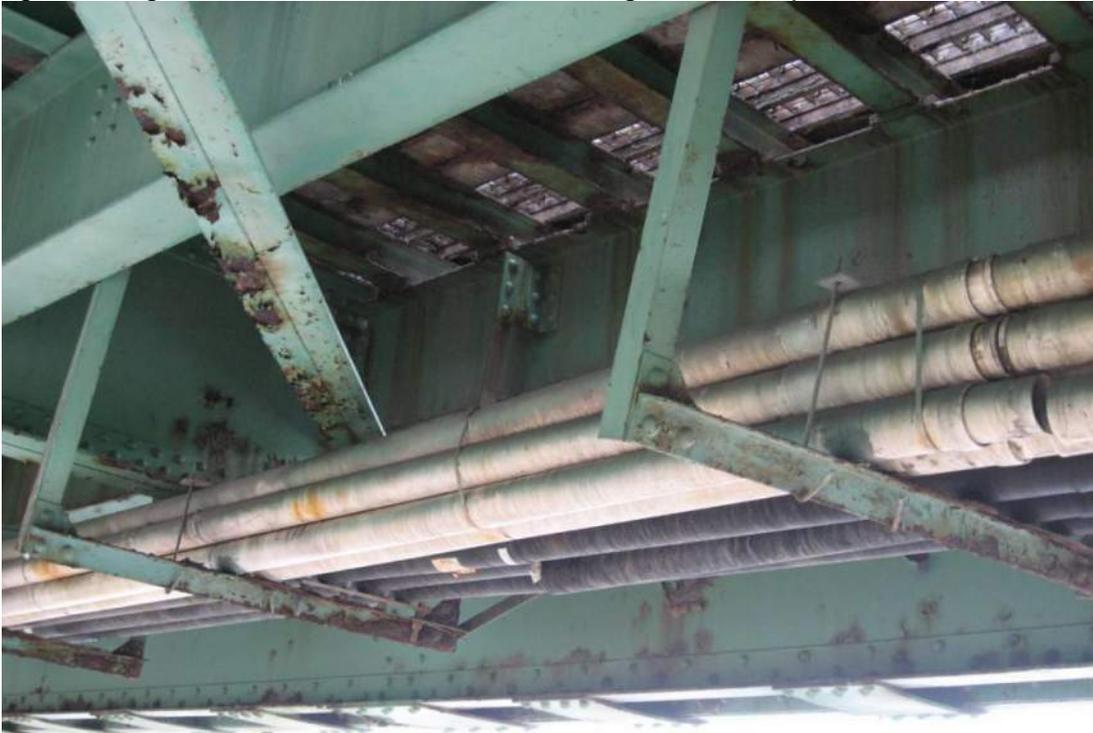
There are two separate banks of six conduits each located just inboard of the east roadway truss which are suspended from utility support brackets which are attached to the S3 and S4 stringers. In Span 2 between L9 and L10 both conduit banks were observed to have open one inch gaps in the conduits along with two consecutive twisted support hangers (Photo 90). In Span 2 between L2 and L3 a repair was observed consisting of additional angles installed due to perforations in the horizontal leg of the original utility support hanger. In Span 2 at FB0 the western bank of conduits have an open gap, are mis-aligned, and the vertical hanger angle is missing. It appears this bank may be empty as there were no exposed contents visible at the gap. Two small quarter size perforations were noticed in the horizontal lower angle of the Pier 1 utility conduit hanger support.

Photo 90 – In Span 2 between L9 and L10 both conduit banks have open one inch gaps in the conduits along with two consecutive twisted support hangers.
