STATE OF MAINE PARKING GARAGE RESTORATION-2014

93 SEWALL STREET
AUGUSTA, MAINE

WALKER PROJECT NUMBER: 16-2559.00

STATE OF MAINE PROJECT NUMBER: 1803

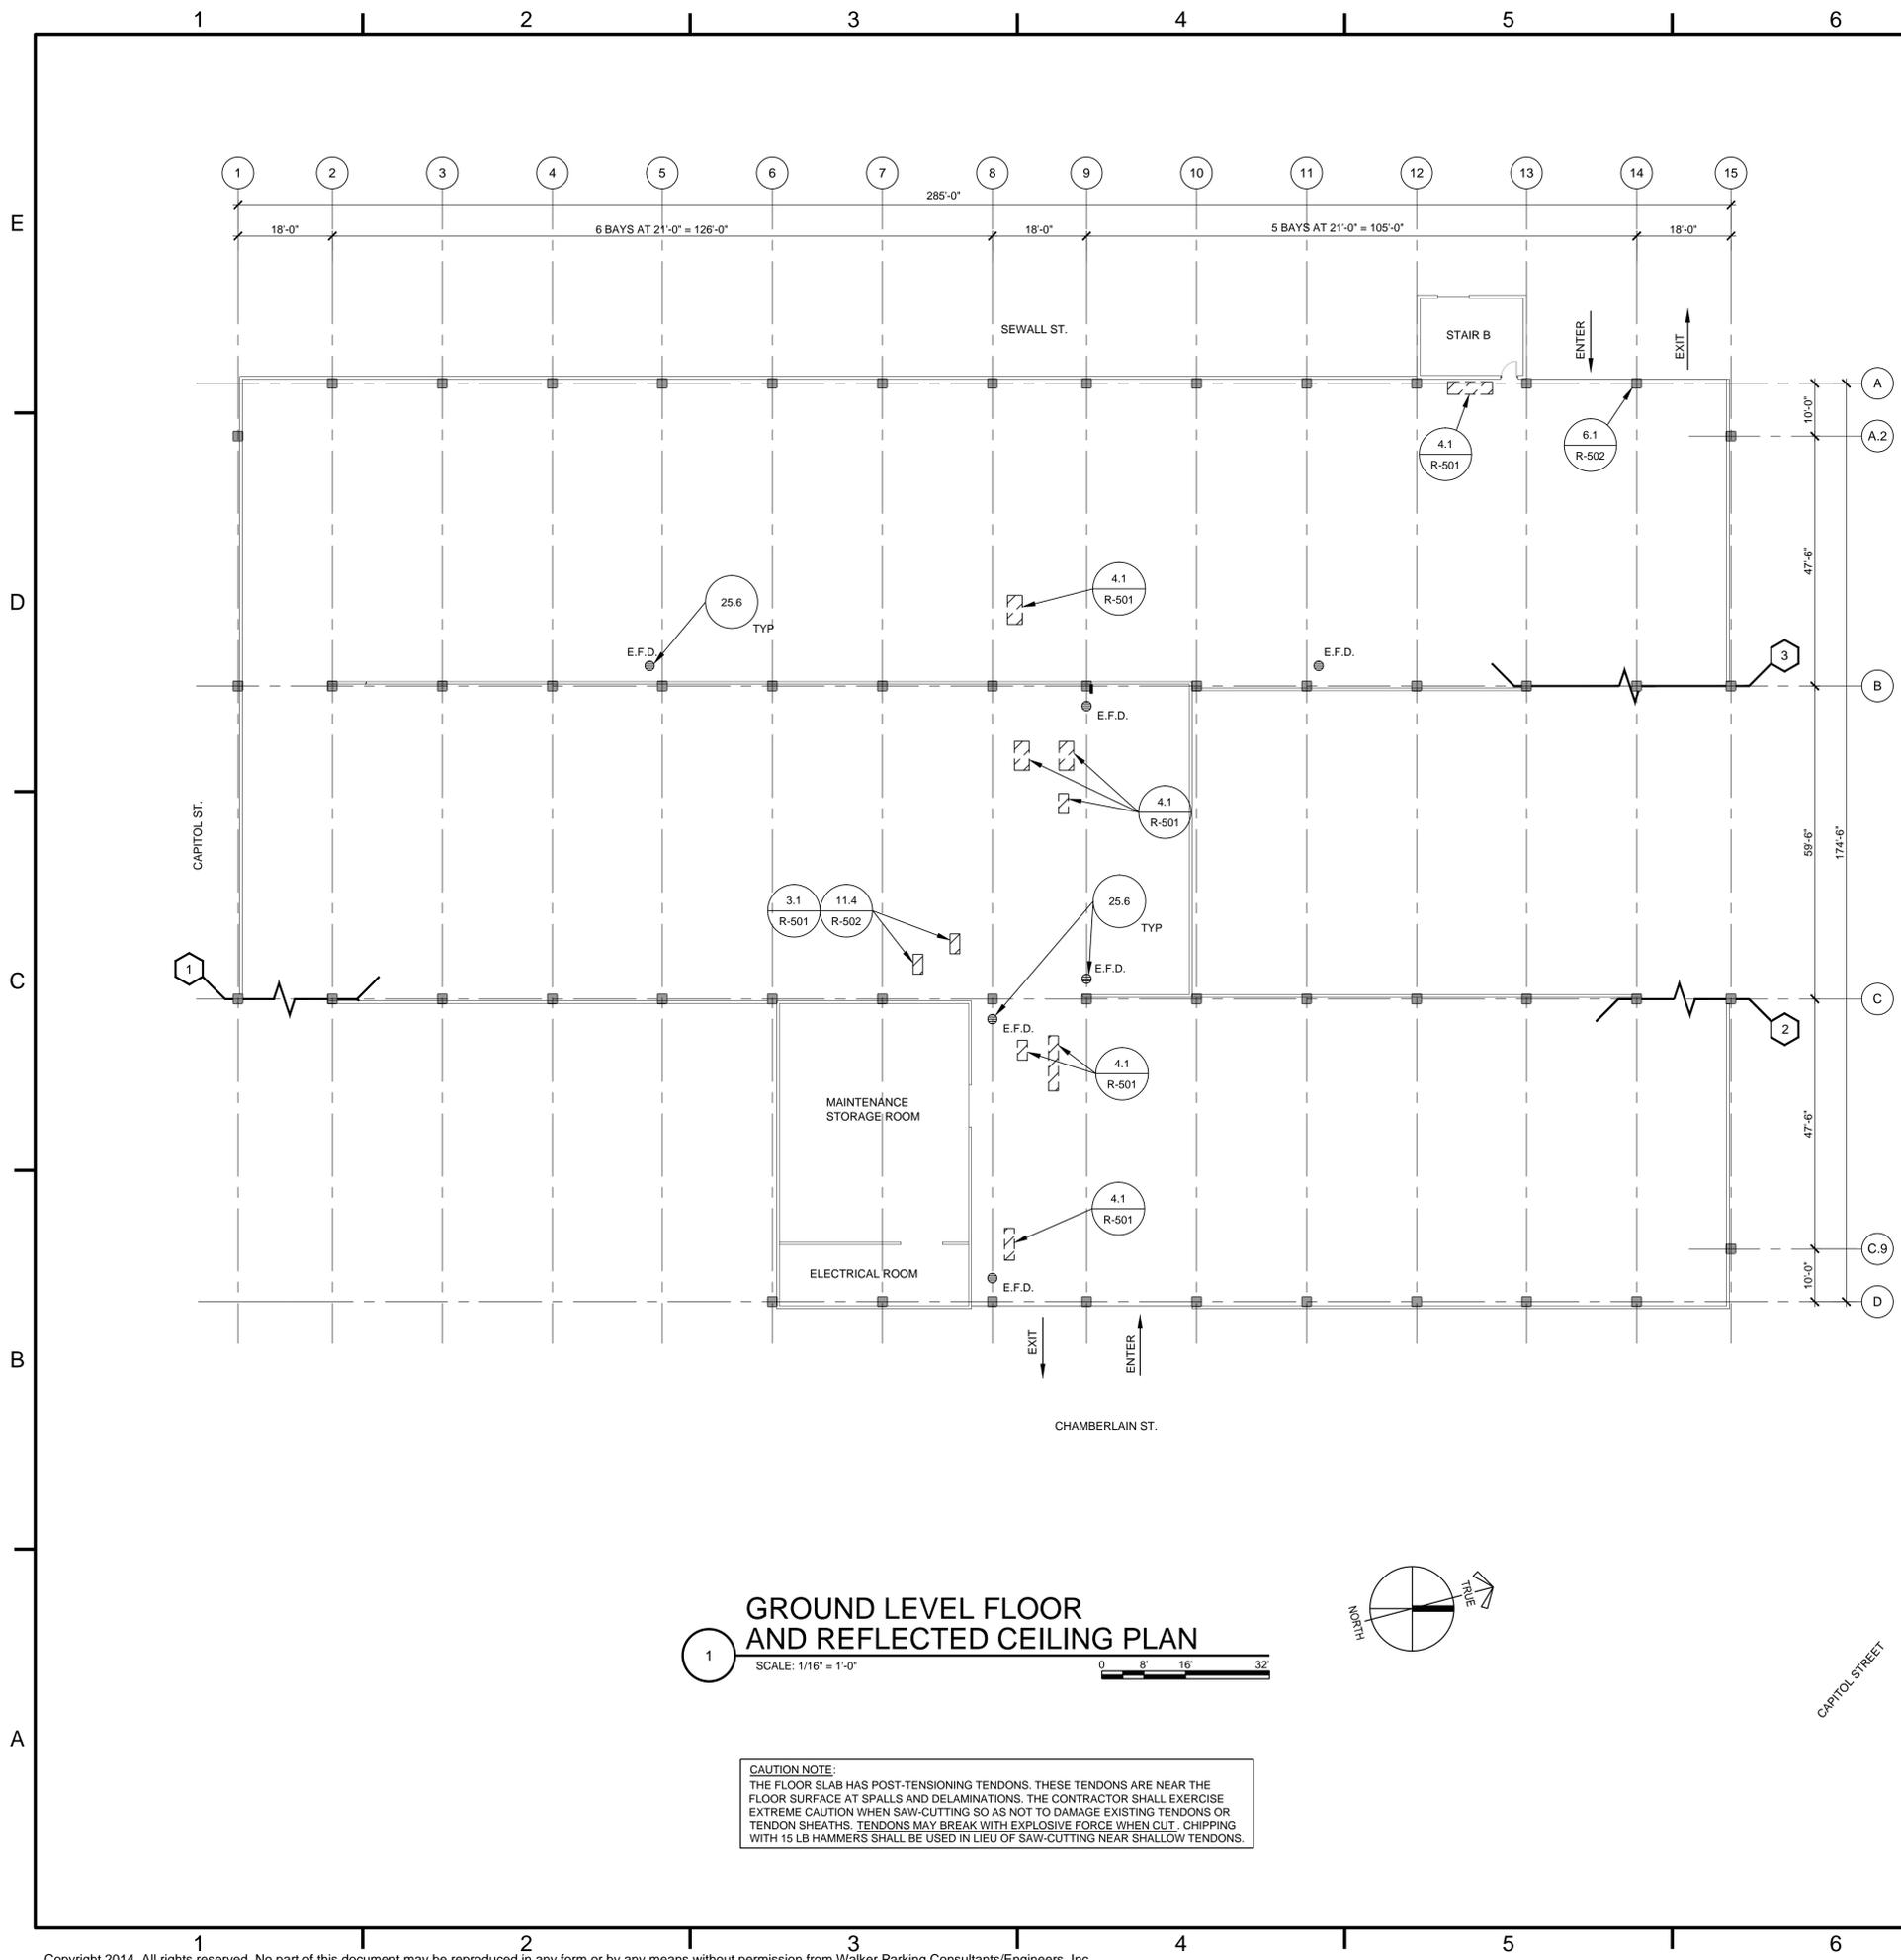
GROUND LEVEL FLOOR AND REFLECTED CEILING PLAN
 SCALE: 1/16" = 1'-0"

SHEET NOTES:
 1. LOCATIONS OF REPAIRS SHOWN ARE FOR GRAPHICAL REPRESENTATION ONLY. CONTRACTOR RESPONSIBLE FOR FINDING AND MARKING ACTUAL REPAIR LOCATIONS BY MEANS OF A VISUAL AND SOUNDING SURVEY. ALL REPAIR AREAS TO BE APPROVED BY ENGINEER PRIOR TO DEMOLITION OPERATIONS.
 2. CONTRACTOR IS RESPONSIBLE FOR DETERMINING ACTUAL EXTENT AND LOCATIONS OF REPAIR AREAS IN ACCORDANCE WITH THE SPECIFICATIONS. WORK ITEM IS SHOWN ONLY TO REPRESENT THE TYPES OF DETERIORATION.

CAUTION NOTE:
 THE FLOOR SLAB HAS POST-TENSIONING TENDONS. THESE TENDONS ARE NEAR THE FLOOR SURFACE AT SPALLS AND DELAMINATIONS. THE CONTRACTOR SHALL EXERCISE EXTREME CAUTION WHEN SAW-CUTTING SO AS NOT TO DAMAGE EXISTING TENDONS OR TENDON SHEATHS. TENDONS MAY BREAK WITH EXPLOSIVE FORCE WHEN CUT. CHIPPING WITH 15 LB HAMMERS SHALL BE USED IN LIEU OF SAW-CUTTING NEAR SHALLOW TENDONS.

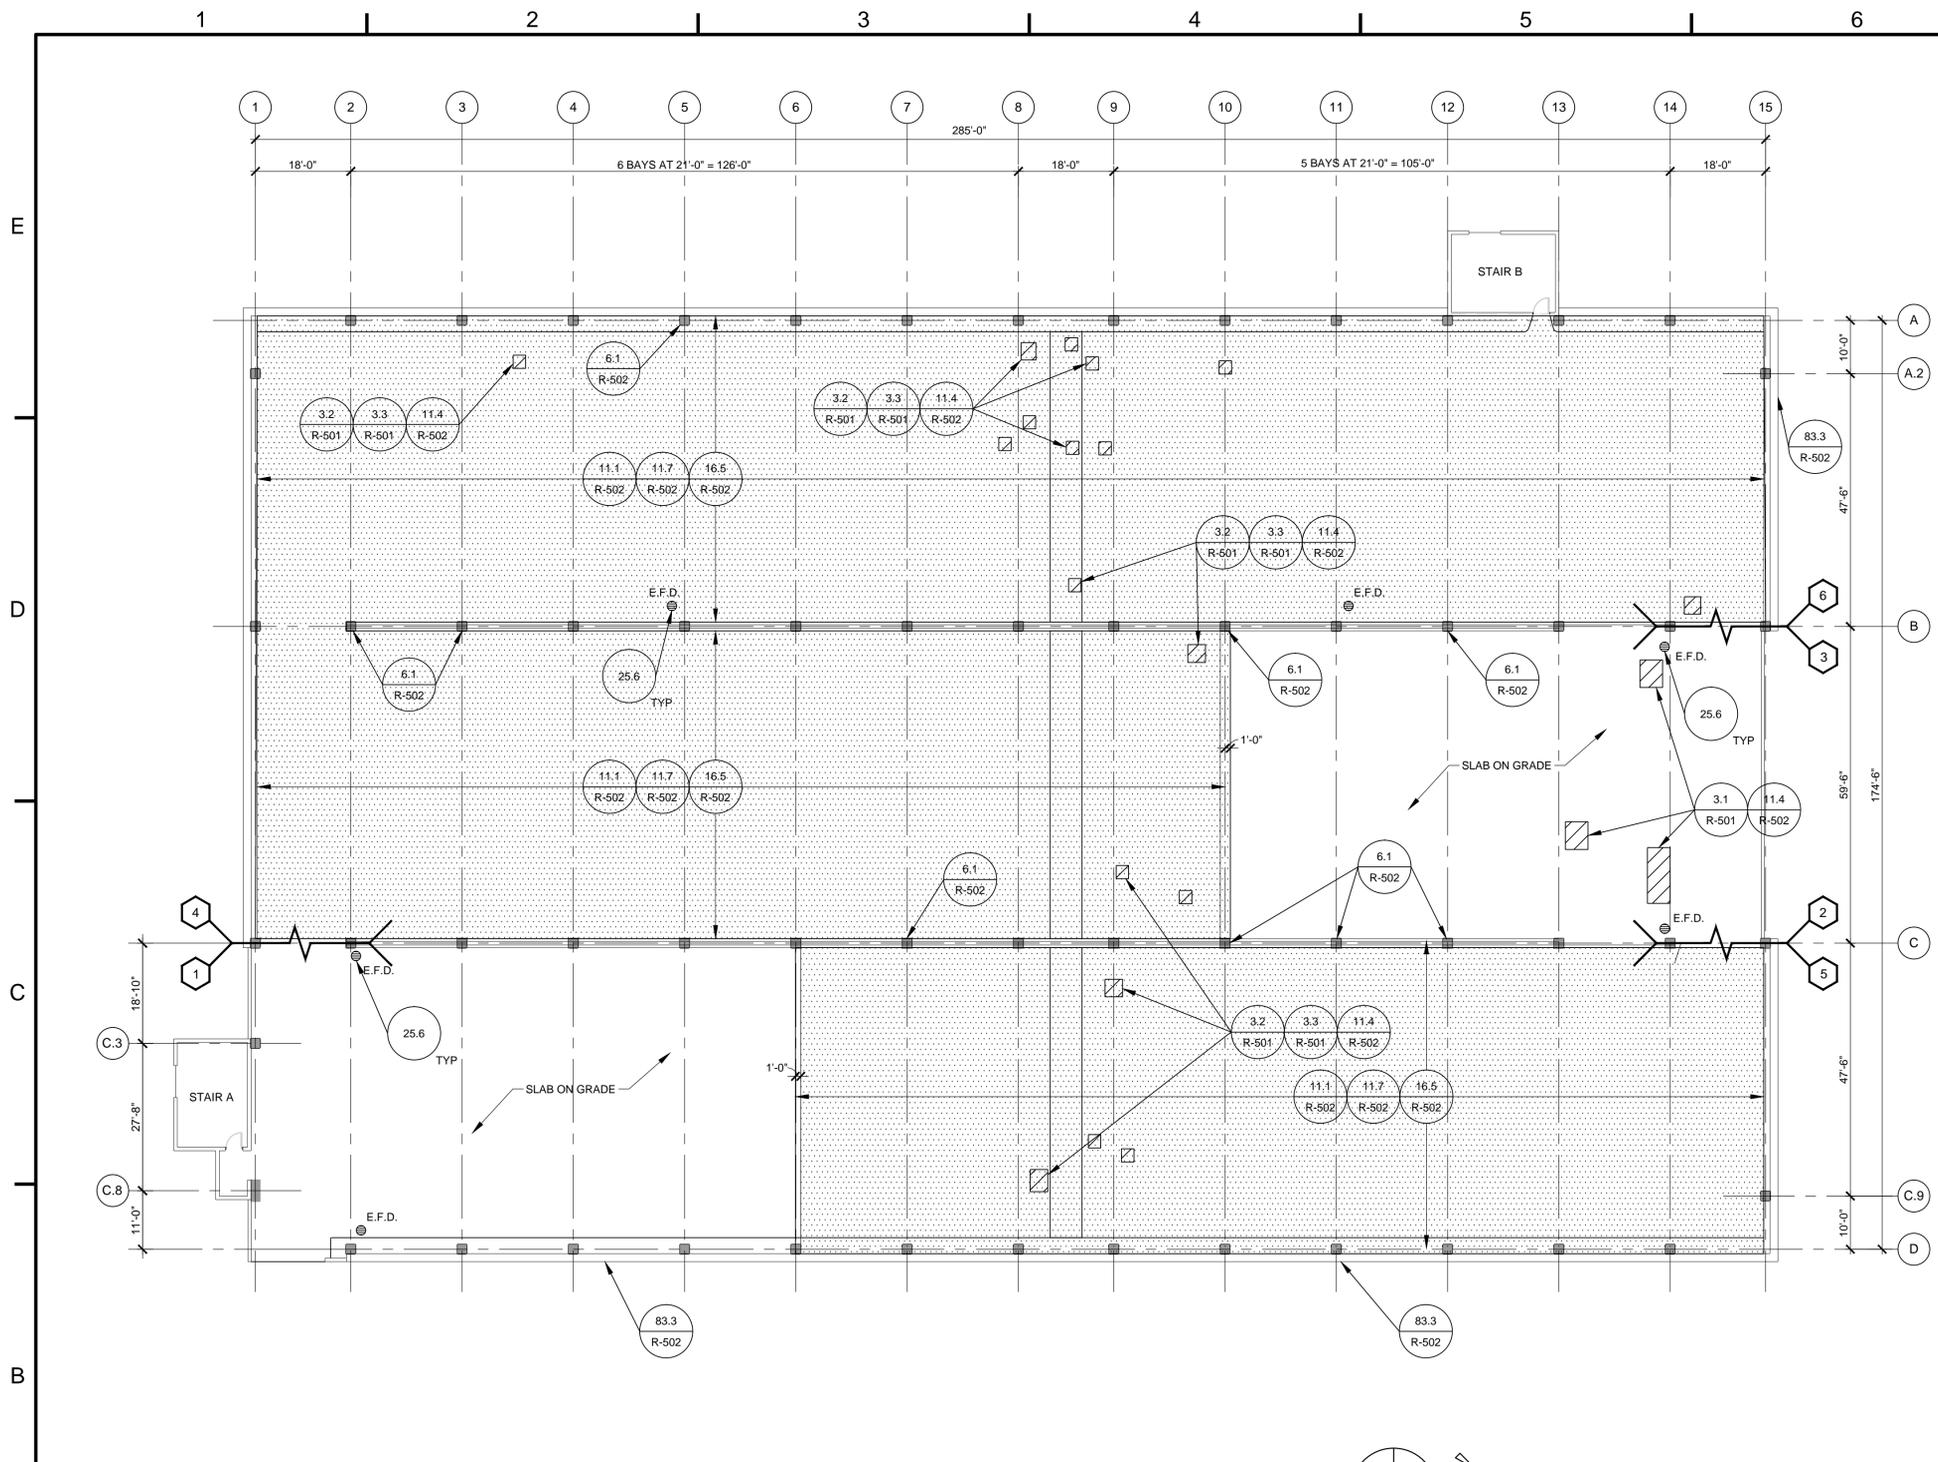
1
SECOND LEVEL FLOOR AND REFLECTED CEILING PLAN
 SCALE: 1/16" = 1'-0"
 0 8' 16' 32'

CAUTION NOTE:
 THE FLOOR SLAB HAS POST-TENSIONING TENDONS. THESE TENDONS ARE NEAR THE FLOOR SURFACE AT SPALLS AND DELAMINATIONS. THE CONTRACTOR SHALL EXERCISE EXTREME CAUTION WHEN SAW-CUTTING SO AS NOT TO DAMAGE EXISTING TENDONS OR TENDON SHEATHS. TENDONS MAY BREAK WITH EXPLOSIVE FORCE WHEN CUT. CHIPPING WITH 15 LB HAMMERS SHALL BE USED IN LIEU OF SAW-CUTTING NEAR SHALLOW TENDONS.

- SHEET NOTES:**
- LOCATIONS OF REPAIRS SHOWN ARE FOR GRAPHICAL REPRESENTATION ONLY. CONTRACTOR RESPONSIBLE FOR FINDING AND MARKING ACTUAL REPAIR LOCATIONS BY MEANS OF A VISUAL AND SOUNDING SURVEY. ALL REPAIR AREAS TO BE APPROVED BY ENGINEER PRIOR TO DEMOLITION OPERATIONS.
 - CONTRACTOR IS RESPONSIBLE FOR DETERMINING ACTUAL EXTENT AND LOCATIONS OF REPAIR AREAS IN ACCORDANCE WITH THE SPECIFICATIONS. WORK ITEM IS SHOWN ONLY TO REPRESENT THE TYPES OF DETERIORATION.
 - ALL CAULKING, IF REQUIRED IN EXISTING TRAFFIC TOPPING AREA, IS INCIDENTAL TO WORK ITEM 16.5.

- LEGEND**
- [Hatched Box] AREA OF CONCRETE SPALLING/ DELAMINATION (WORK ITEM 3.2 OR 3.3)
 - [Dotted Box] EXISTING TRAFFIC TOPPING RECOAT (WORK ITEM 16.5)
 - [Circle with 'E.F.D.'] EXISTING FLOOR DRAIN

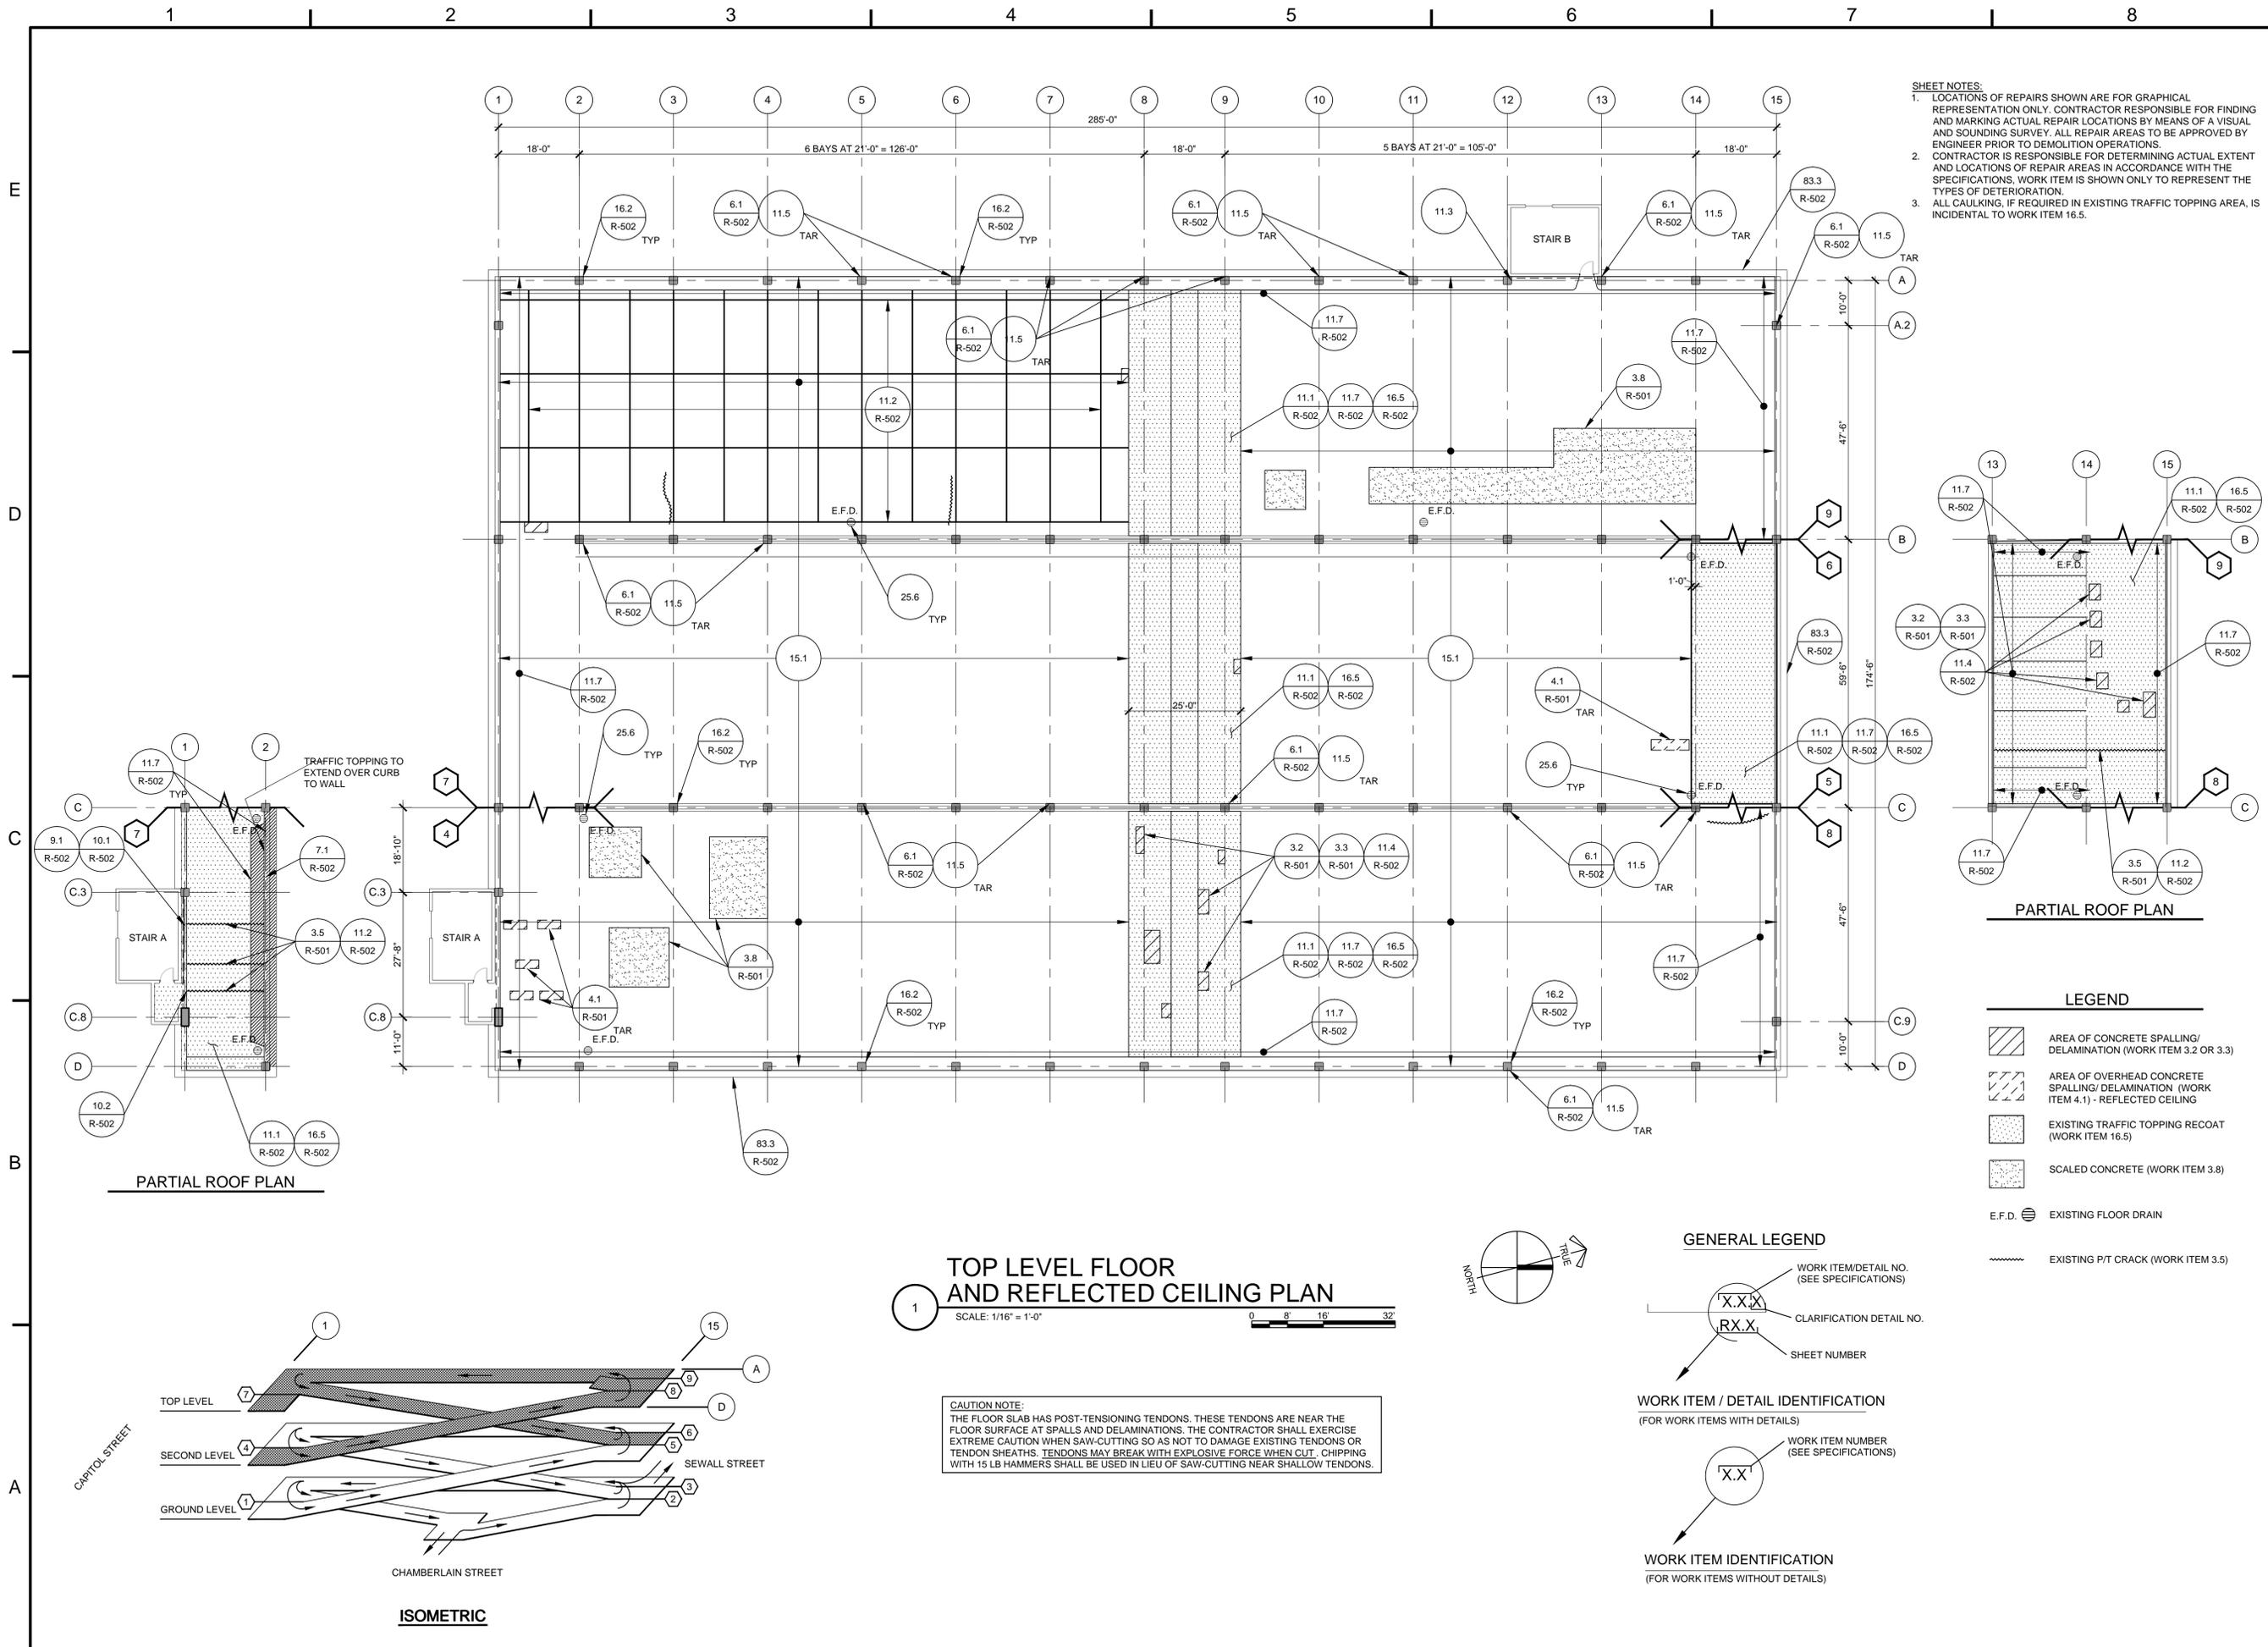
SHEET TITLE:
TOP LEVEL PLAN

SHEET NOTES:
 1. LOCATIONS OF REPAIRS SHOWN ARE FOR GRAPHICAL REPRESENTATION ONLY. CONTRACTOR RESPONSIBLE FOR FINDING AND MARKING ACTUAL REPAIR LOCATIONS BY MEANS OF A VISUAL AND SOUNDING SURVEY. ALL REPAIR AREAS TO BE APPROVED BY ENGINEER PRIOR TO DEMOLITION OPERATIONS.
 2. CONTRACTOR IS RESPONSIBLE FOR DETERMINING ACTUAL EXTENT AND LOCATIONS OF REPAIR AREAS IN ACCORDANCE WITH THE SPECIFICATIONS. WORK ITEM IS SHOWN ONLY TO REPRESENT THE TYPES OF DETEIORATION.
 3. ALL CAULKING, IF REQUIRED IN EXISTING TRAFFIC TOPPING AREA, IS INCIDENTAL TO WORK ITEM 16.5.

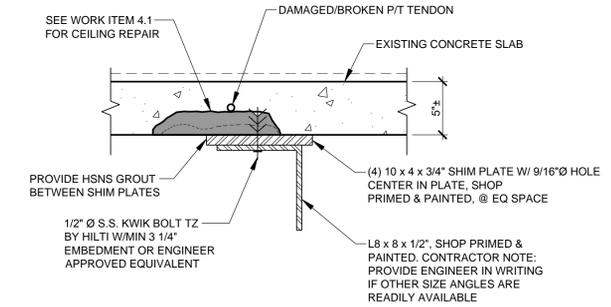
3.5 FLOOR REPAIR - CONCRETE P/T SLAB

NOTES:
1. CONTRACTOR TO EXERCISE CAUTION SO AS NOT TO DAMAGE TENDON.
2. CONTRACTOR TO EXERCISE CAUTION SO AS NOT TO DAMAGE P/T BUTTON HEADS, SHIM PLATES AND WIRES. CLEAN AND EPOXY COAT ALL EXPOSED STEEL.

3.3	Floor Repair - Full Depth	S.F.	10
3.4	Floor Repair - Curbs / Walks	S.F.	25
3.5	Floor Repair - Concrete P/T Slab	E.A.	5
3.8	Floor Repair - Concrete Scaling	S.F.	2,000

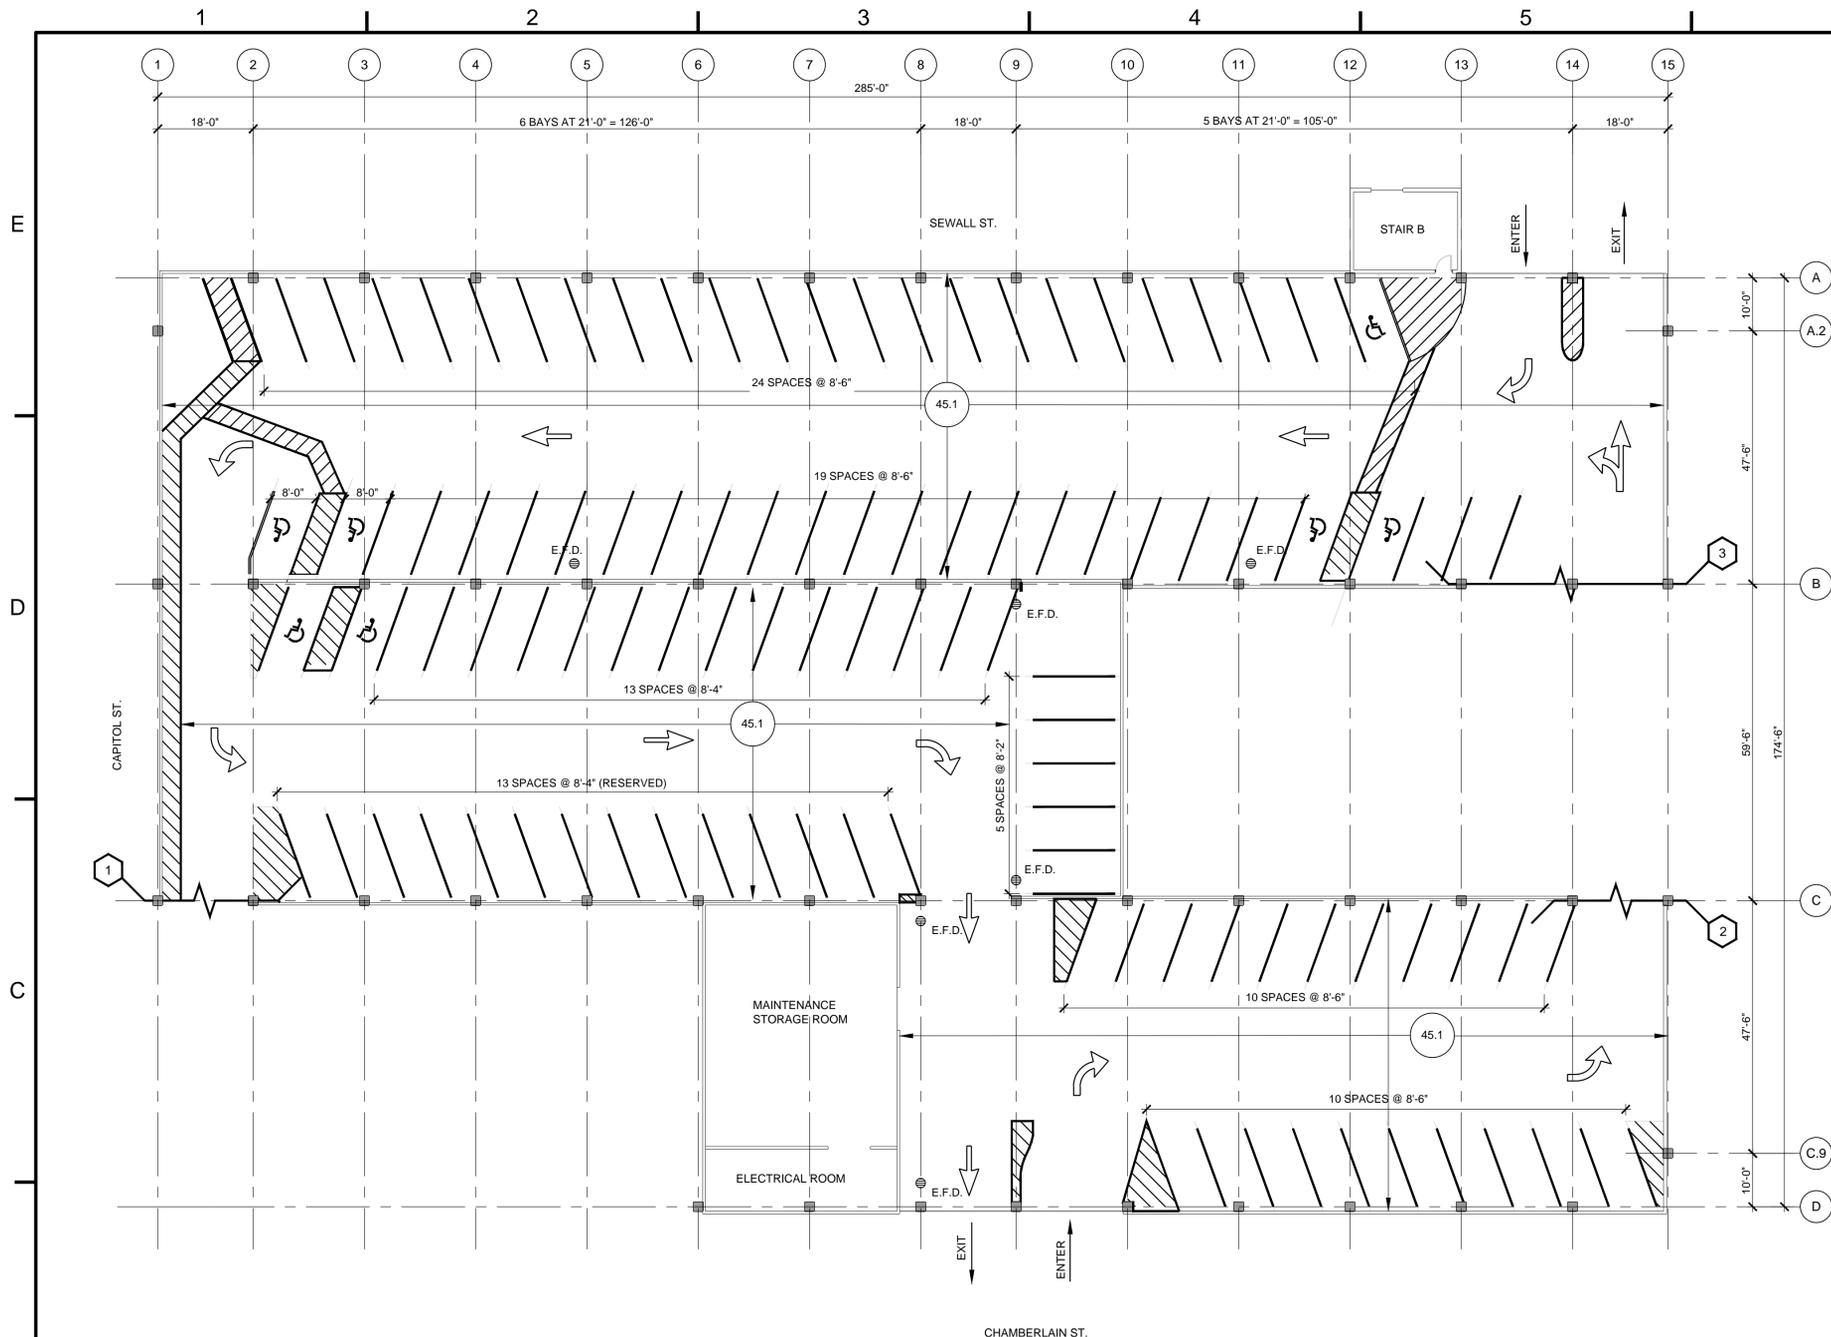
1 GROUND LEVEL STRIPING PLAN
SCALE: 1/16" = 1'-0"

NOTE:
1. CONTRACTOR SHALL SHOT-BLAST CLEAN FLOOR SURFACE PRIOR TO RE-STRIPING.

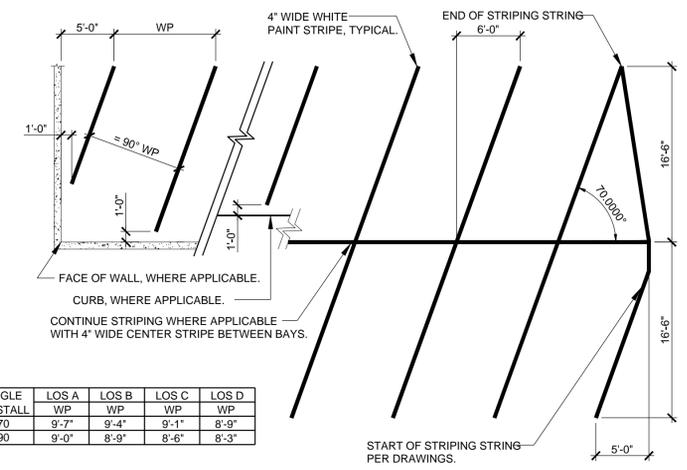
2 70° STRIPING DETAIL

ANGLE OF STALL	LOS A WP	LOS B WP	LOS C WP	LOS D WP
70	9'-7"	9'-4"	9'-1"	8'-9"
90	9'-0"	8'-9"	8'-6"	8'-3"

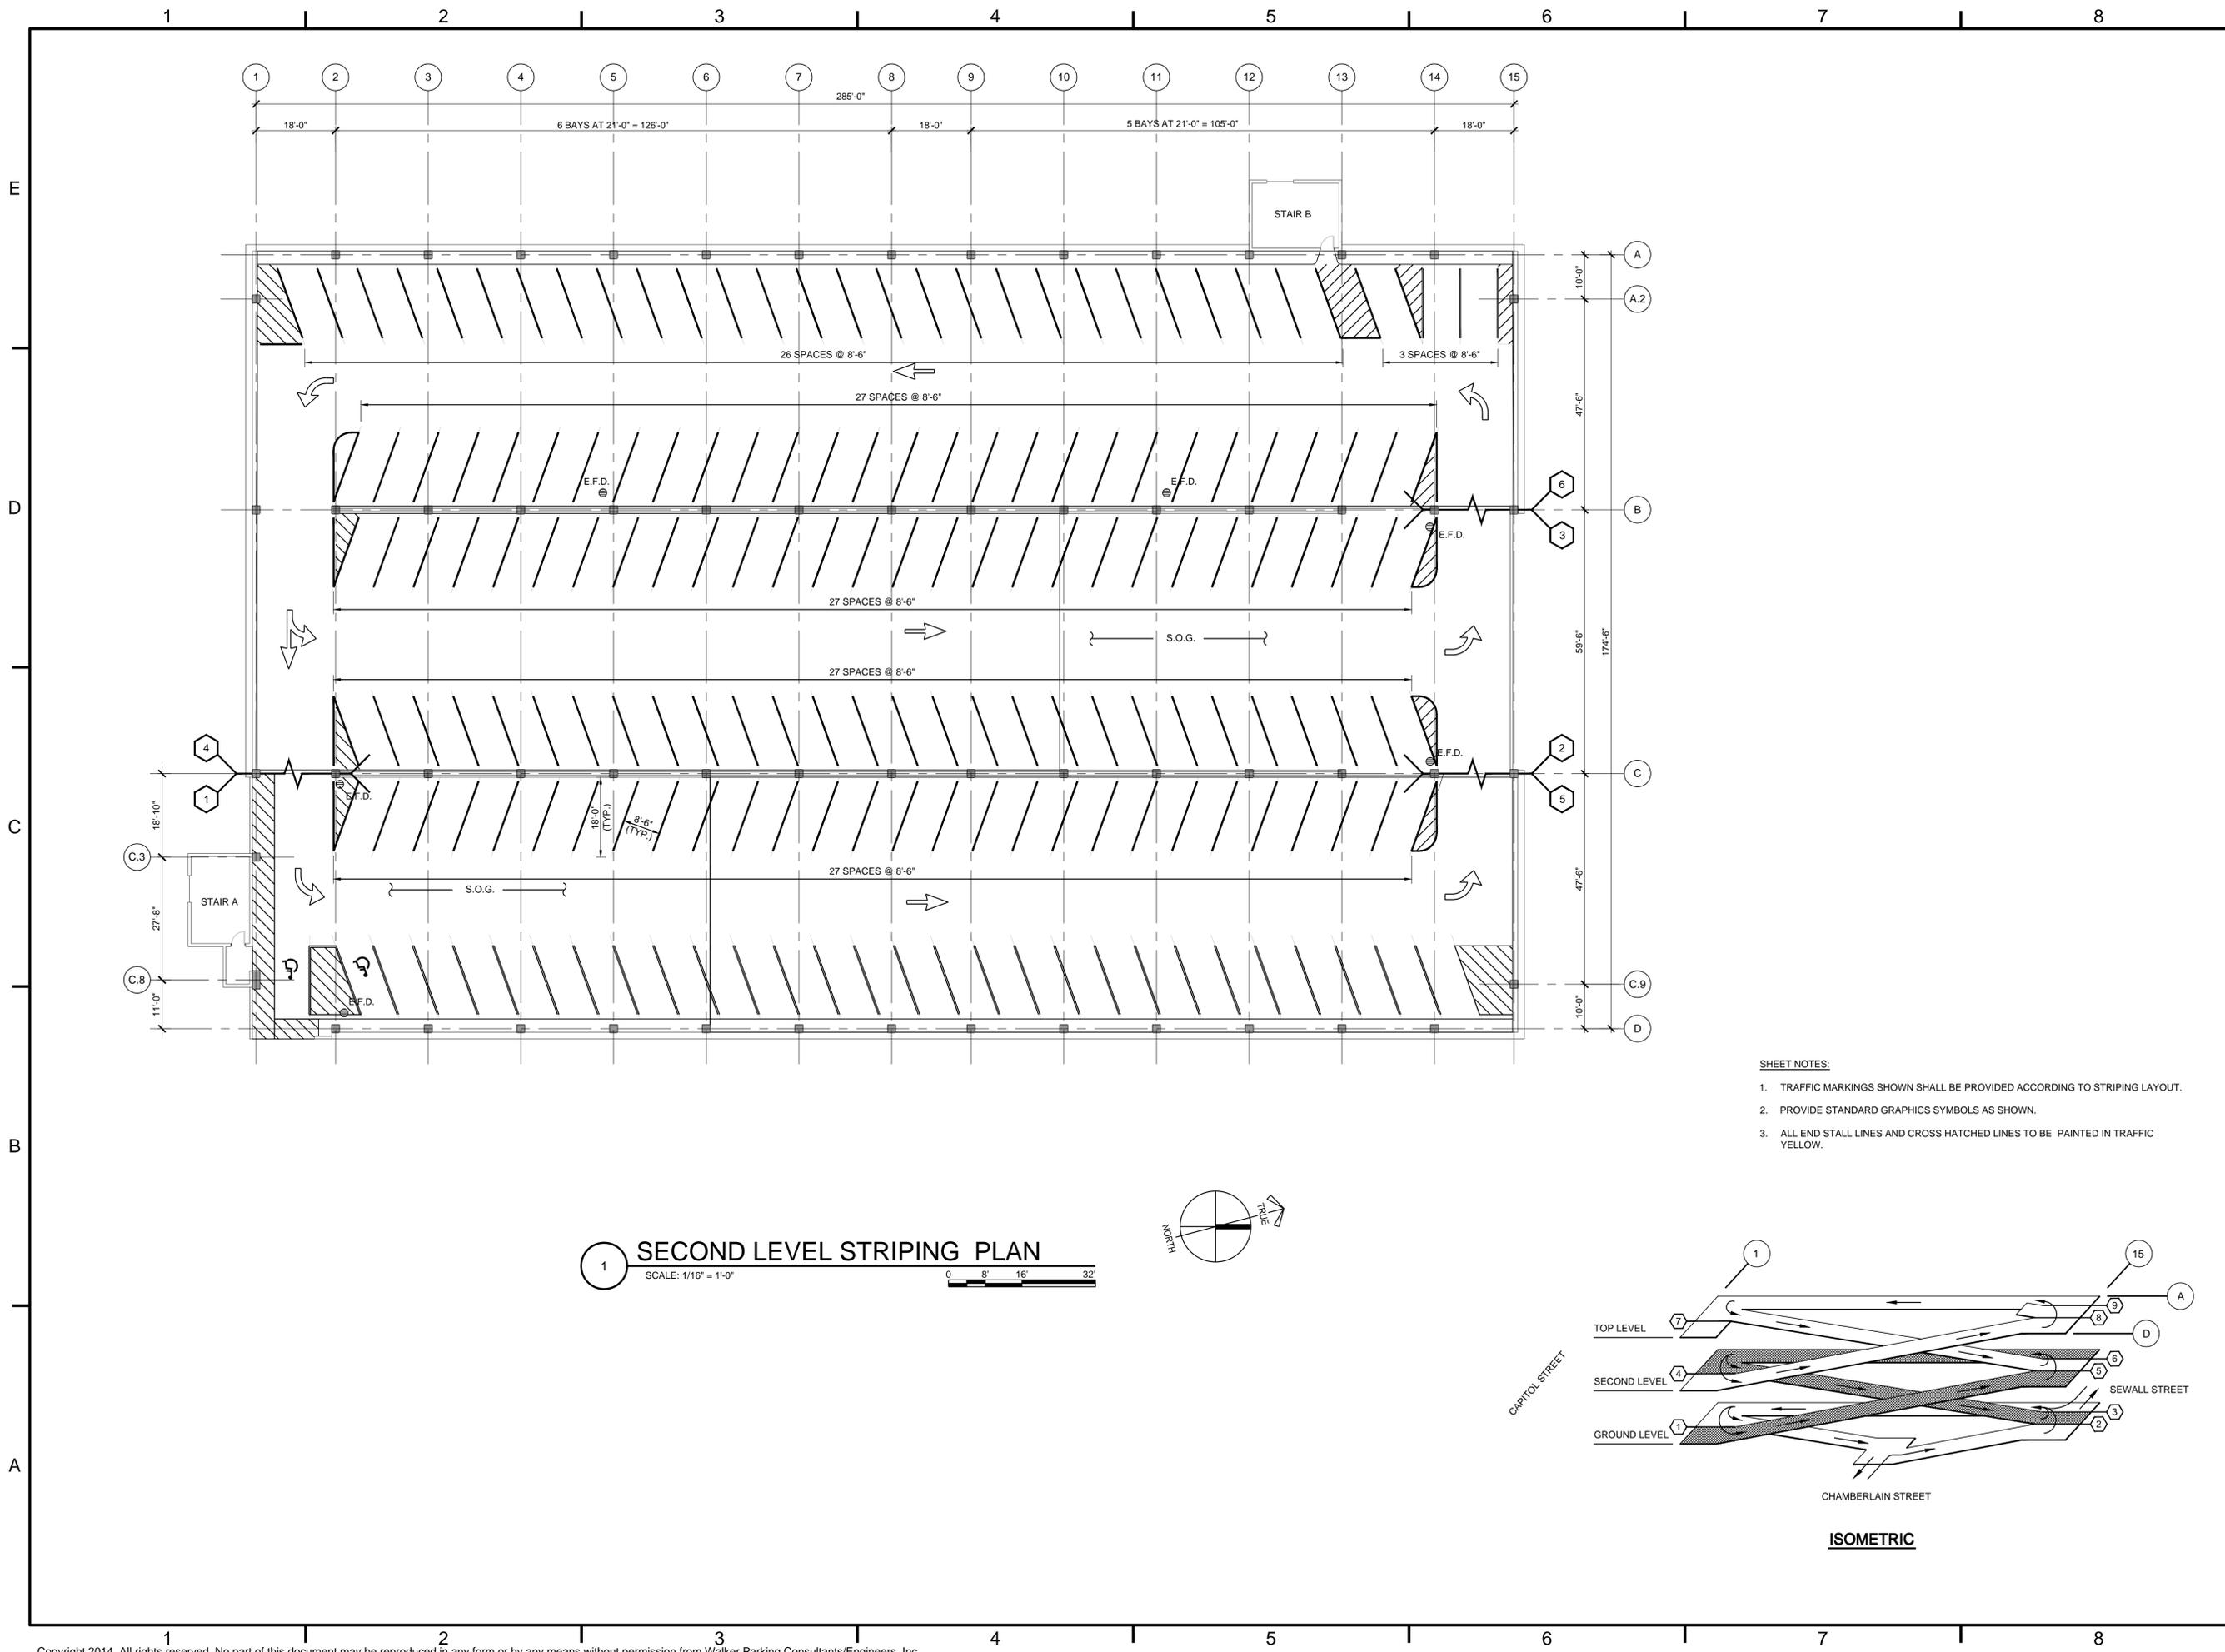
1 SECOND LEVEL STRIPING PLAN
SCALE: 1/16" = 1'-0"
0 8' 16' 32'

- SHEET NOTES:**
1. TRAFFIC MARKINGS SHOWN SHALL BE PROVIDED ACCORDING TO STRIPING LAYOUT.
 2. PROVIDE STANDARD GRAPHICS SYMBOLS AS SHOWN.
 3. ALL END STALL LINES AND CROSS HATCHED LINES TO BE PAINTED IN TRAFFIC YELLOW.

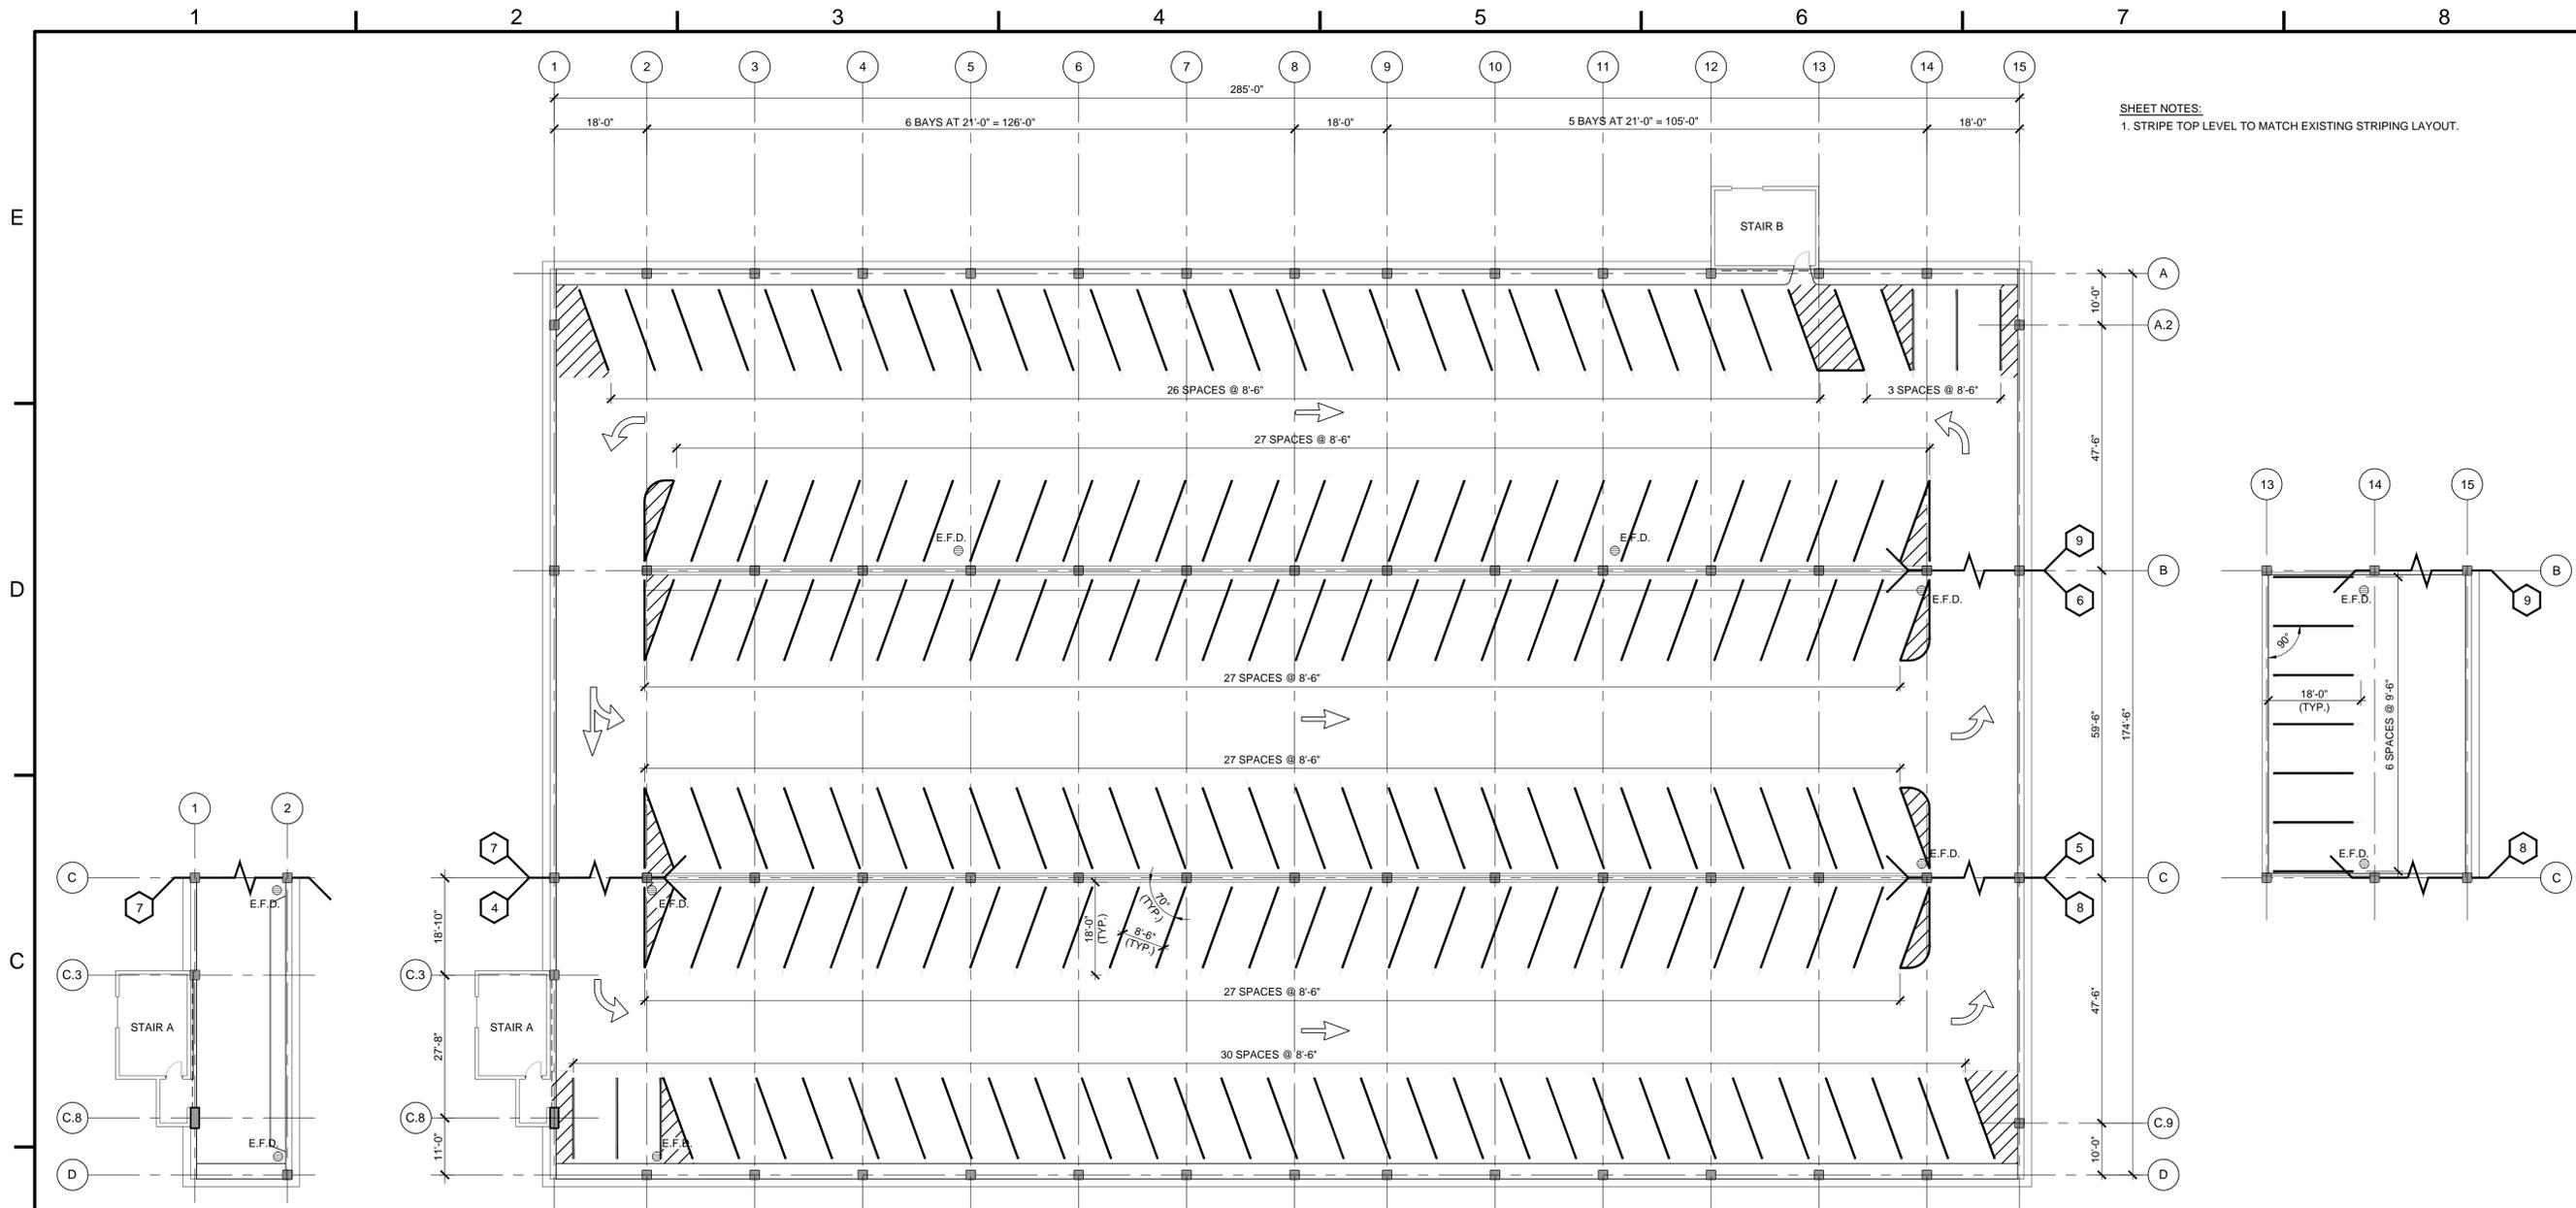
1 TOP LEVEL STRIPING PLAN
SCALE: 1/16" = 1'-0"

SHEET NOTES:
1. STRIPE TOP LEVEL TO MATCH EXISTING STRIPING LAYOUT.
