FOR CONSTRUCTION

EAST AND WEST ELEVATIONS

ILDING ENVELOPE REPAIRS
AT THE IF&W BUILDING
DIX PSYCHIATRIC CENTER CAMPUS
BANGOR, ME 04401

BUILDING ENVELOPE REPAIRS
AT THE IF&W BUILDING
DOROTHEA DIX PSYCHIATRIC CENTER CAMPI
BANGOR, ME 04401

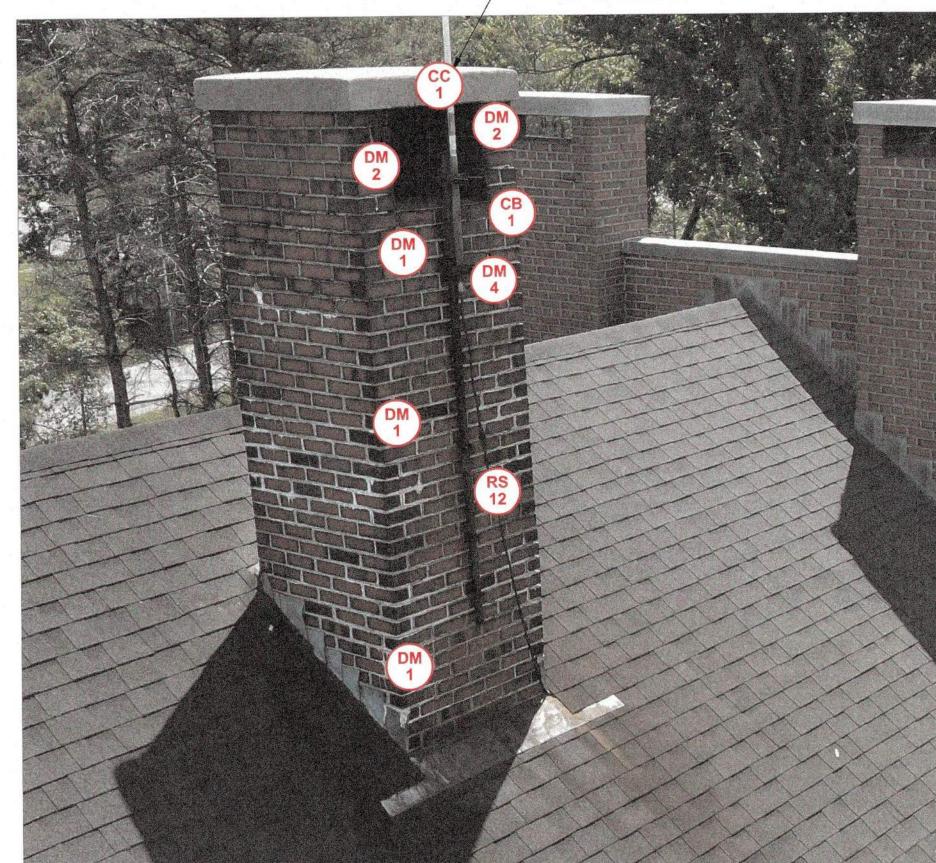
CHIMNEY ELEVATION A204 SCALE: NOT TO SCALE

- CONTRACTOR TO TEMPORARILY REMOVE, STORE, AND REINSTALL ANTENNA AS REQUIRED TO PERFORM MASONRY REPAIR WORK.

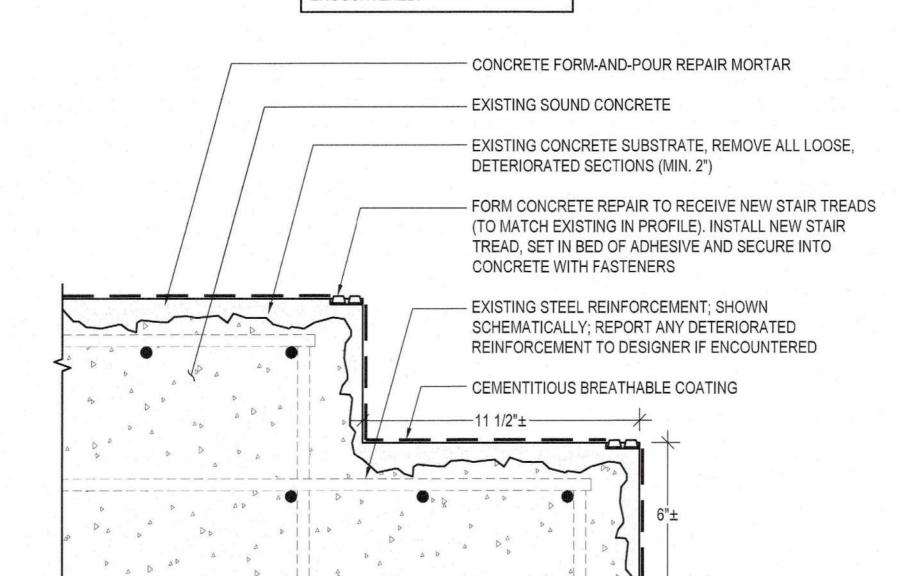
TYPICAL SPALL REPAIR SCALE: NOT TO SCALE (ALL ITEMS ARE NEW UNLESS DESIGNATED AS EXISTING) TYPICAL CONCRETE STAIR TREAD REPAIR

GENERAL PROCEDURES FOR SPALL REPAIR

- BACK-ANGLE SAWCUT PERIMETER POLYGON SHAPE (DO NOT CUT REINFORCEMENT)
- CHIP OUT ALL DETERIORATED CONCRETE, EXTENDING 3/4" MINIMUM AROUND REBAR (OR MINIMUM AGGREGATE SIZE, IF NECESSARY: AS INDICATED IN NOTES BELOW SECTION).

- CLEAN ALL EXPOSED REINFORCING STEEL TO BARE METAL CONDITION. (SSPC - SP11).
- REMOVE ADDITIONAL SUBSTRATE TO EXPOSE AND CLEAN CORRODED STEEL WHICH HAS SCALED RUST (BARS WITH ONLY LIGHT SURFACE RUST AND SOLID CONCRETE COVER MAY BE LEFT ALONE.)

- EXAMINE REBAR AND DETERMINE SECTION LOSS. BARS WITH 25% OR GREATER LOSS SHALL RECEIVE SUPPLEMENTARY REINFORCEMENT. (REFER TO DETAIL). REMOVAL OF ADDITIONAL SOUND CONCRETÈ TO ALLOW PLACÉMENT OF SUPPLEMENTAL STEEL SHALL NOT BE INCLUDED IN SPALL REPAIR QUANTITIES. EXAMINE SUBSTRATE FOR CRACKS, REFER TO CRACK REPAIR AS

- SCARIFY SUBSTRATE TO 1/8" MINIMUM SURFACE PROFILE (ICRI-CSP 8 OR 9). WASH SUBSTRATE AND LEAVE SSD (SATURATED SURFACE DRY) CONDITION.
- APPLY EPOXY MODIFIED CEMENTITIOUS PRIMER/ BOND AGENT TO ALL CONCRETE SUBSTRATE (1 COAT) AND EMBEDDED STEEL OR REBAR (2 COATS).

- AT VERTICAL SPALLS WITH A DEPTH GREATER THAN 1-1/2", DRILL AND EPOXY 1/4" MIN. DIAMETER STAINLESS STEEL PINS INTO SUBSTRATE OF REPAIR AREA. MAINTAIN 2" MIN. EDGE DISTANCE FOR EACH PIN. SPACE PINS 6" O.C. EACH WAY. DRAPE PINS WITH 2" x 2"x 14 (MIN.) GAUGE STAINLESS STEEL OR EPOXY COATED WIRE MESH WITH 1-1/2" COVER. MESH IS REQUIRED AT EACH 1-1/2" DEPTH OF REPAIR. TIE ALL MESH TO EACH PIN. PINNING IS ALSO REQUIRED AT CORNER AND PANEL PERIMETER SPALL REPAIRS, REGARDLESS OF SPALL DEPTH.

- WHERE CORRODED STEEL IS EVIDENT, OR WHEN MORE THAN HALF OF THE REBAR DIAMETER IS EXPOSED, SUBSTRATE SHALL BE CHIPPED 3/4" MINIMUM TO 1-1/2" MAXIMUM BEHIND REBAR.

- CONCRETE SECTION SHOWN SCHEMATICALLY.

SPALLED CONCRETE TO BE REPAIRED, REFER TO DETAIL 4/A701; # INDICATÉS SQUARE FEET

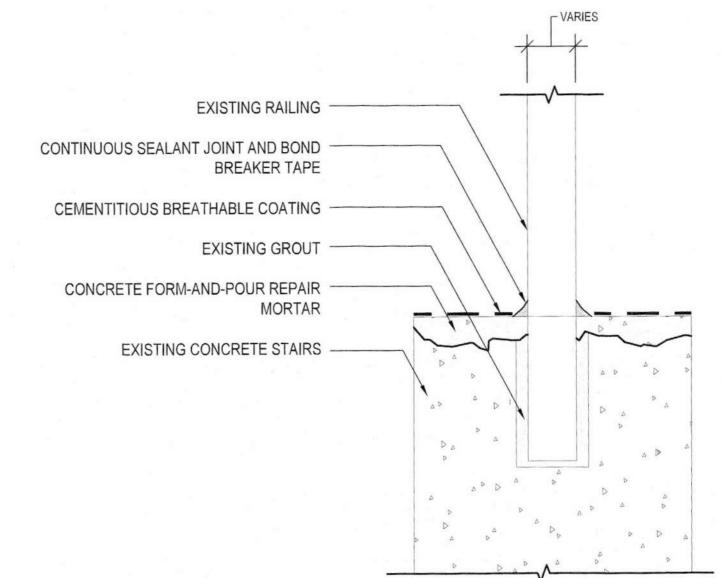
TYPICAL RAILING BASE REPAIR

THIS DETAIL SHALL BE UTILIZED AT ALL EMBEDDED RAIL BASE PENETRATIONS.
