THE
ELLSWORTH DAM

Ambursen hydraulic construction company.

ELLSWORTH, MAINE

Height of Rollway	65 feet
Height of Bulkhead	72 feet
Length of Rollway	275 feet
Length of Dam over all	500 feet

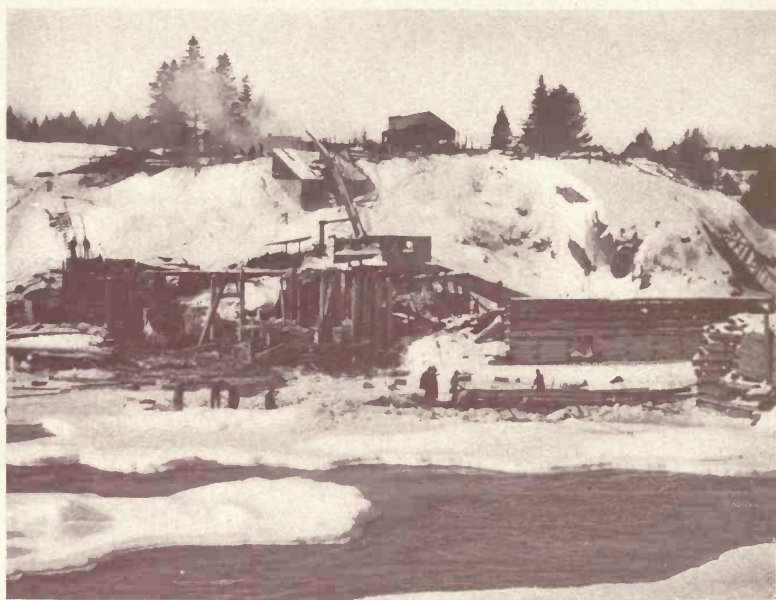
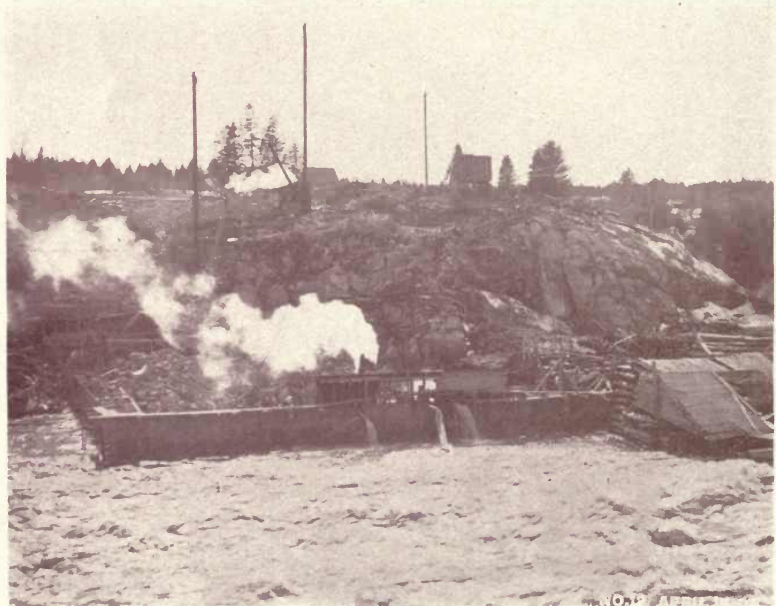
April 15, 1907

These photographs show the building of the cofferdam and that portion of the site where the power house is to be erected at about the point covered by the building shown in the preceding picture.

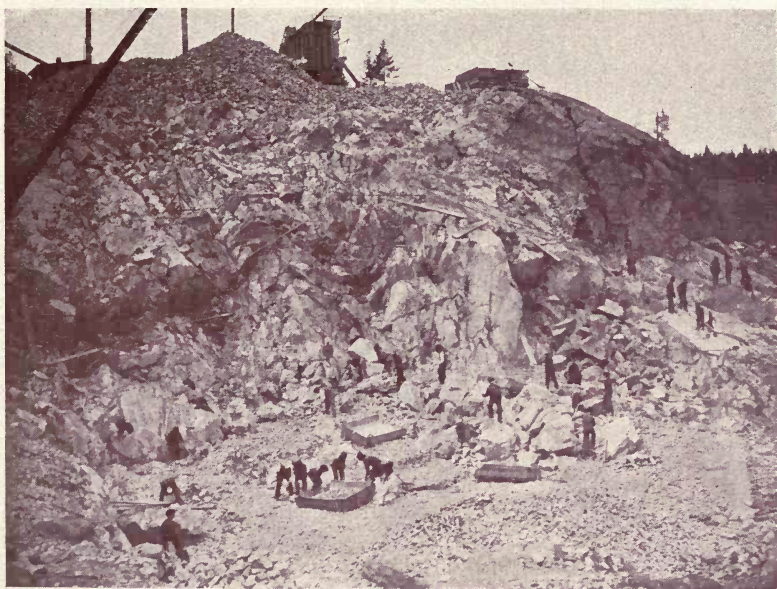
May 15, 1907

FROM April 15th the work was concentrated on the foundations for the power house where it was necessary to excavate 3,000 yards of solid rock before any concrete could be laid. This work proceeded by day and night, the stone being broken and piled up for use in future concrete.

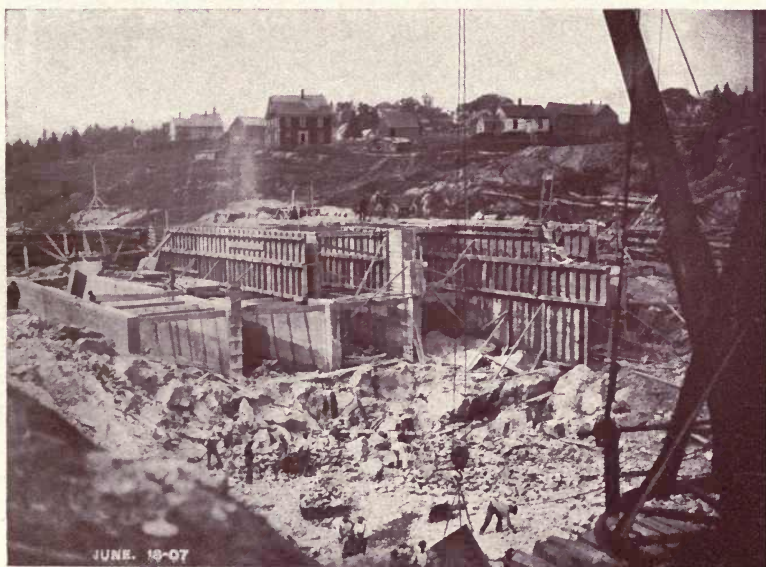
June 9, 1907

HERE is shown the condition of the work on June ninth. On this day the excavation for the power house being complete and the preparations of the foundations for the dam being in order, concreting was begun.

Notice upon the hill and on the downstream side of the cofferdam, the piles of broken rock which are stored ready for the crusher. A reference to the ground plan of this work on page 3 will show how narrow and constricted was the site, there being little opportunity for convenient storage elsewhere. These stone piles are directly upon that portion of the site where later the forebay must be excavated.

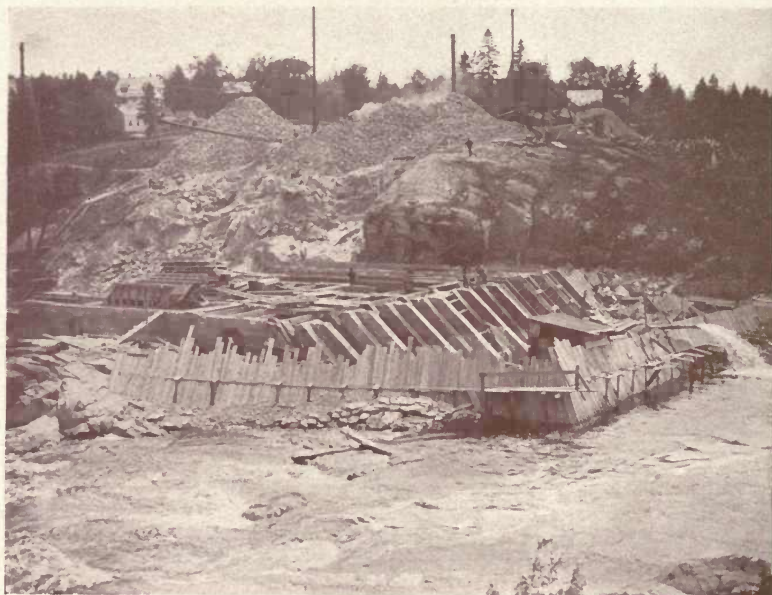
June 18, 1907

NINE days ago the first concrete was laid. Today we show the work completed to this stage, both views being taken inside the cofferdam; No. 1 looking downstream and No. 2 looking upstream. Both of these pictures show the movable sectional forms in place and No. 1 shows the enlargement of the buttresses into haunches, supporting the deck plate, which is put on later.

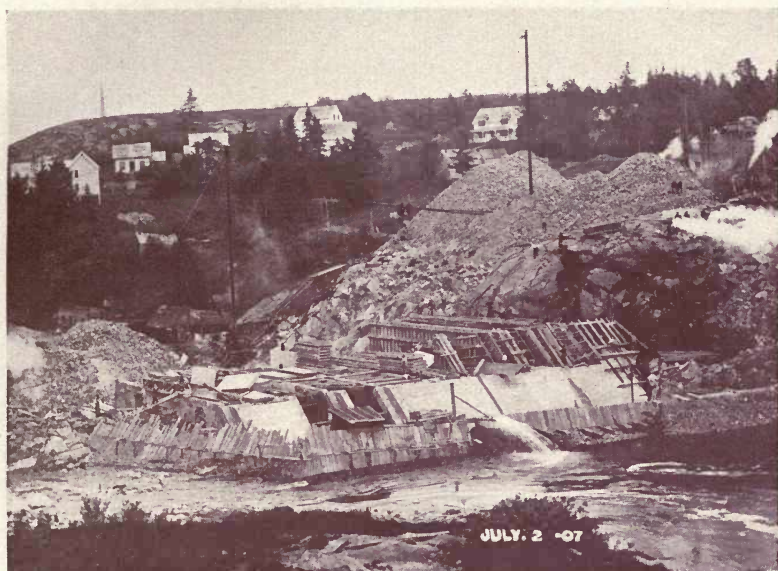
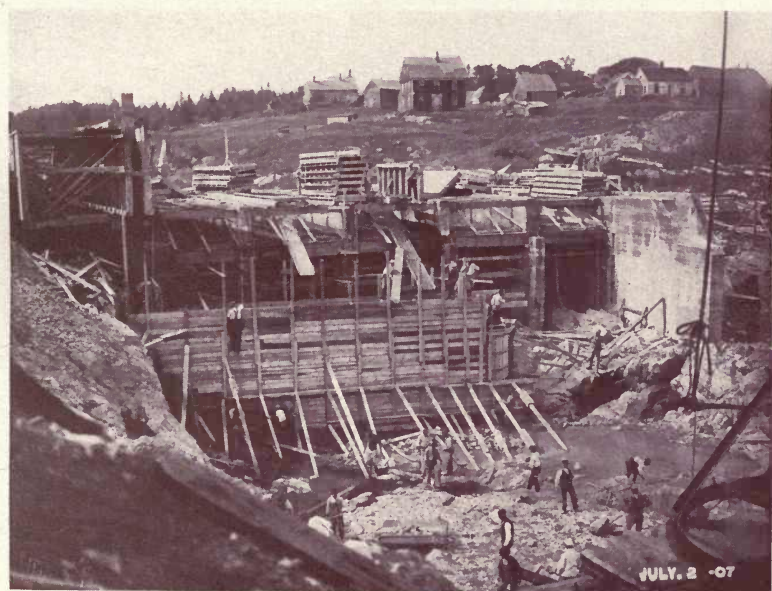
July 2, 1907

THIS section of the dam is now 32 feet in height and the deck slab has been put in place for 20 feet above the bottom. In the upper picture 10 feet of the bottom of the dam is hidden behind the cofferdam.

The lower picture is taken within the cofferdam, and shows one of the piers of the power house being put in place in front of the bulkhead section of the dam.

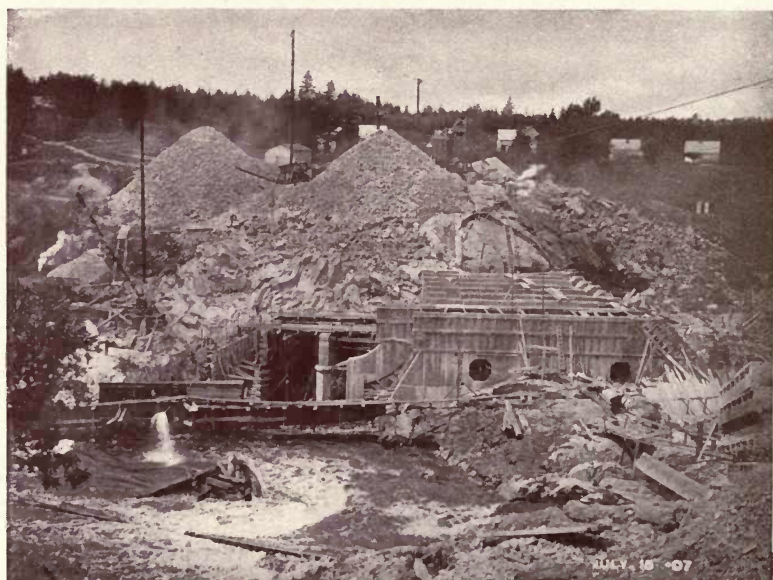
July 15, 1907

THE finished work is now to the 42.5 level but all of the concrete is not in the dam itself. The power house foundation piers are progressing and two of them are shown completed and on the third the forms are ready to be filled.

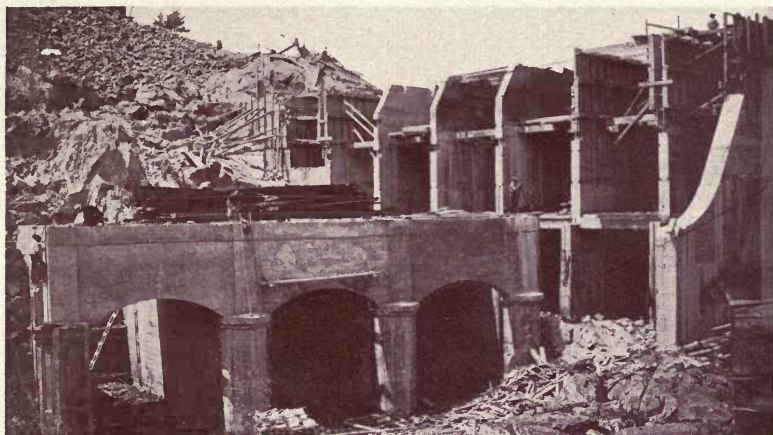
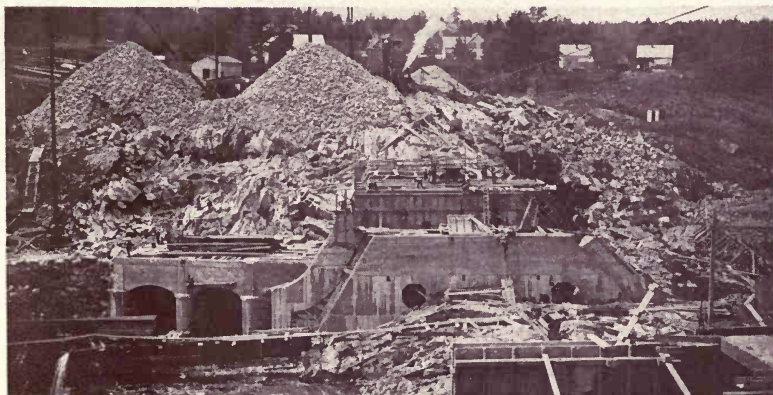
September 7, 1907

On September first the condition of the eastern section was shown in the first picture.

Seven days later the buttresses are up to their first level as shown in the second picture.

The entire dam is shown in the third picture looking upstream.

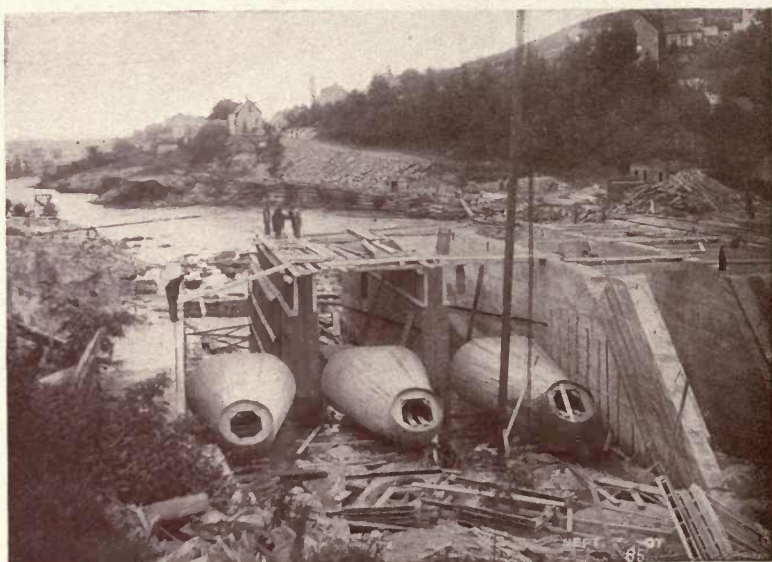
September 15, 1907

TWO views looking up stream showing the forms for waste way near the eastern bank. In No. 1 you will notice that there is a rabbet in the buttresses to receive a floor over the waste way, in order that when the gates are open the waste water can not interfere with the passage-way through the dam, which is seen above the floor level.

In the second view the forms are partially embedded in the concrete and the guides for the waste gates are in place.

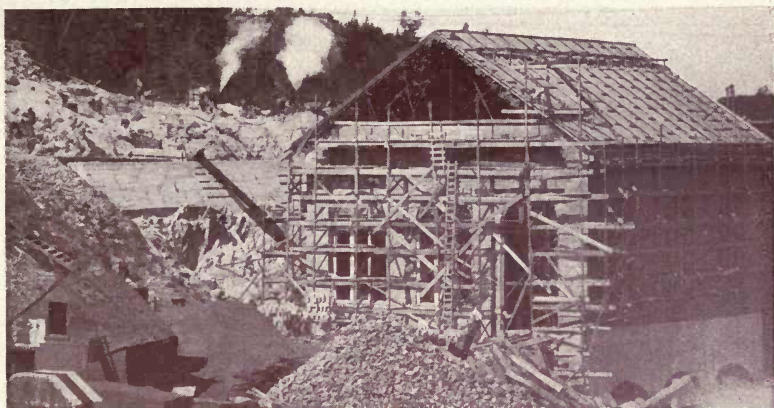
September 20, 1907

THESE three views taken together show the entire structure. In the first one note that the foundations for the canal wall are completed. 1500 yards of concrete were used here.

The power house, which is built of concrete blocks on a steel frame, is nearly completed and the concrete roof is being put on.

The bulkhead behind the power house is at 62.5 and the lower slope of the rollway section shows the curve of the bucket.

The extreme eastern section shows the reinforcing steel in place and a little of the crest shows at the extreme right.

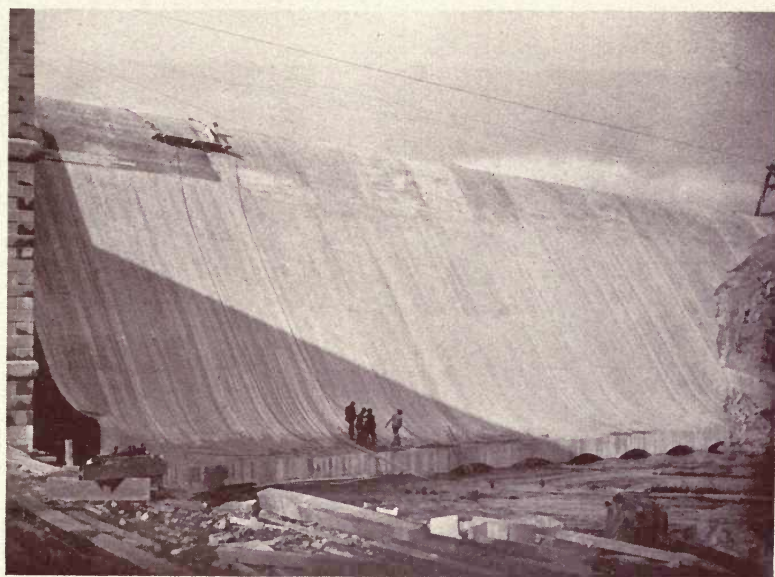
November 1, 1907

AN extended view showing power house and completed rollway looking upstream. The water is coming through the dam in the first two sections of the bulkhead and work is now proceeding on the bulkhead and on the canal.

Observe the sectional forms still in place near the crest; — these forms have been in continuous use since the beginning of the work and are still in good condition.

Note that two of the headgate piers at the entrance to the canal on the extreme left are completed.

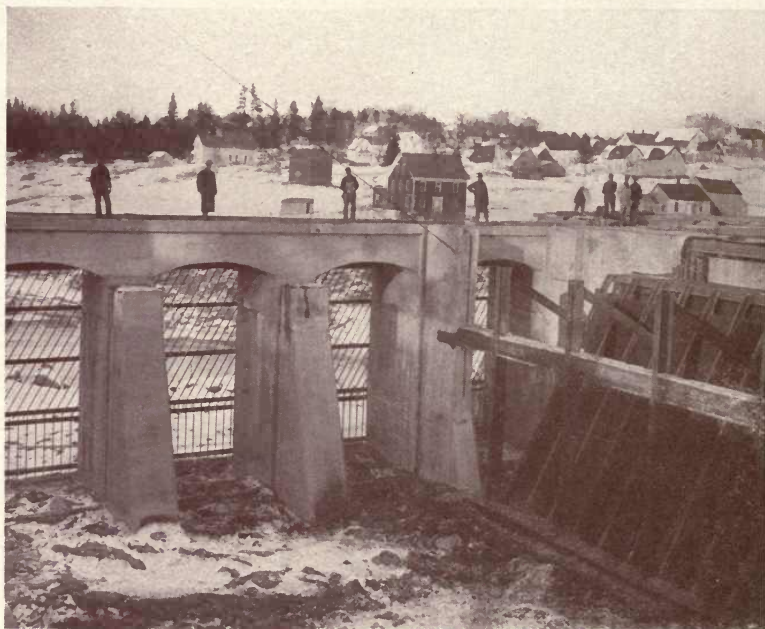
December 1, 1907

TWO views of the interior of the forebay above the power house with some detail of the racks and the temporary spillway. The first picture is looking up the river through the coarse racks. The fine racks and the penstock gates are on the right of the picture.

The second photograph shows more details of the fine racks and gates. The gate hoists are just being put in place. At the right of the picture is seen the temporary spillway at the end of the forebay. This is merely a wooden crib dam which will be removed at some future day when the forebay and power house are enlarged.
