PHOTOSIMULATION 3: ROCK POND, T5 R6 BKP WKR

PHOTOSIMULATION 3: ROCK POND, T5 R6 BKP WKR, Structure 731-735 Visibility Analysis

PHOTOSIMULATION 3A: ROCK POND, T5 R6 BKP WKR

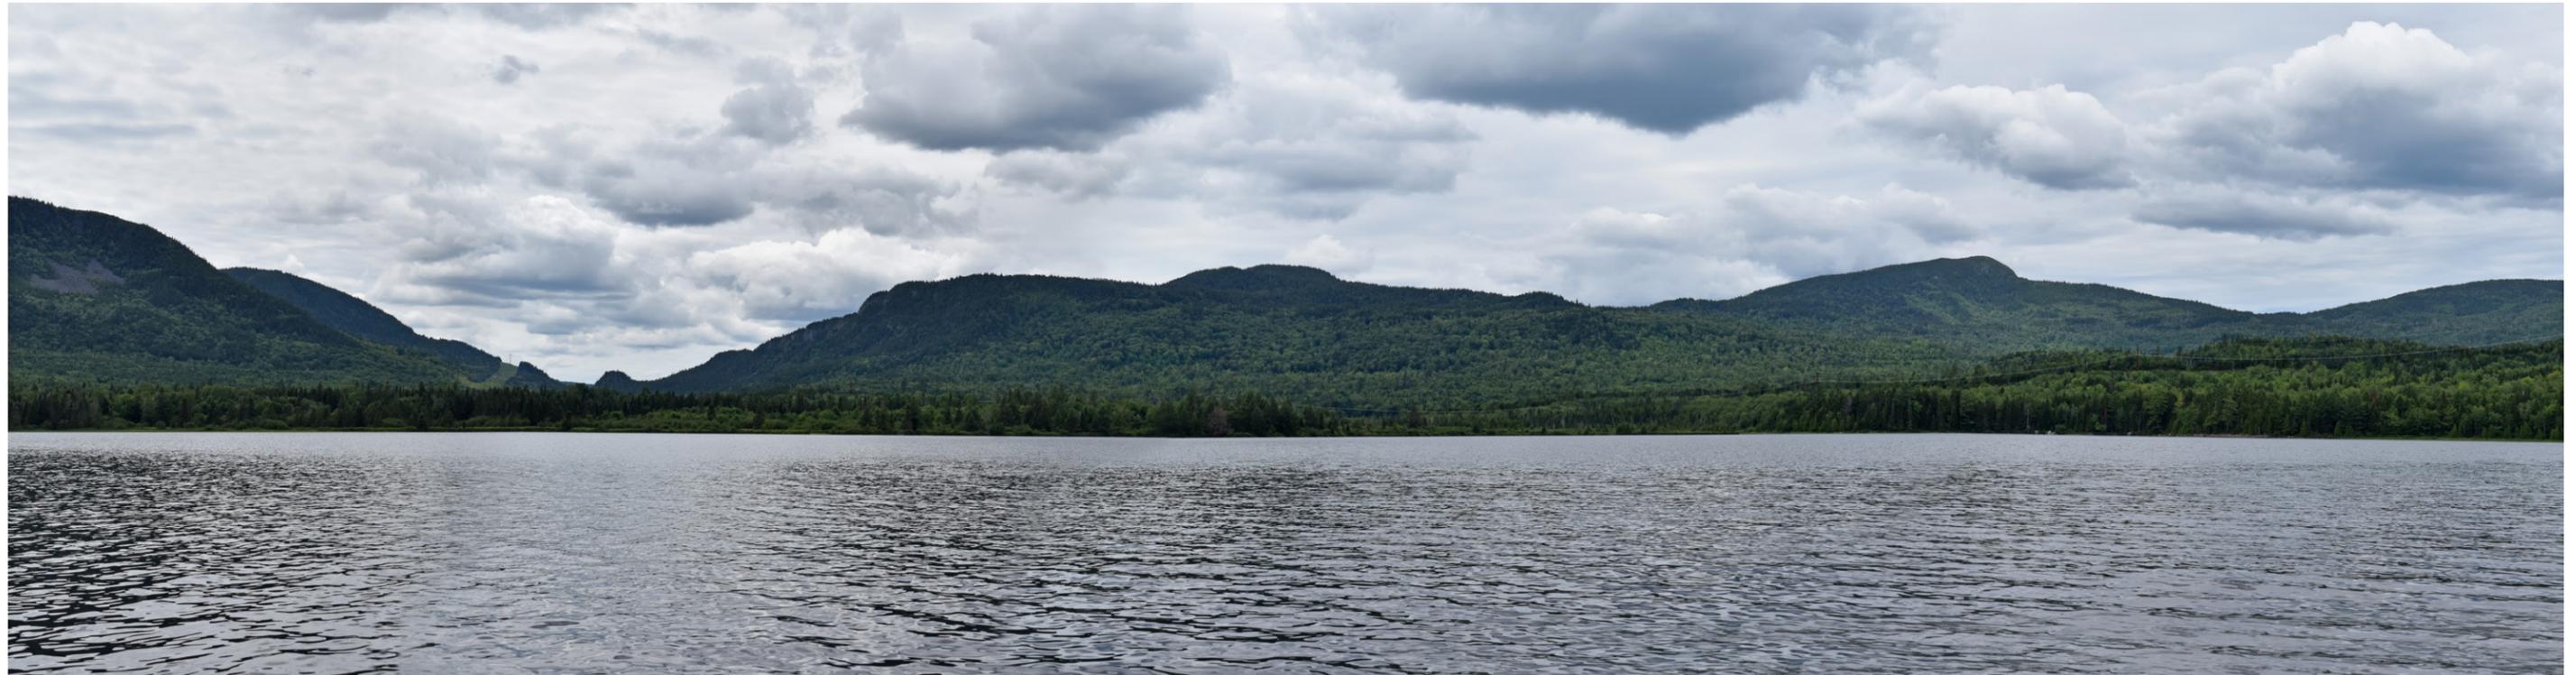
Proposed Conditions: Panoramic view looking west to north from the southeast end of Rock Pond toward the proposed HVDC transmission line. Approximately twelve structures, conductors, and portions of the cleared corridor will be visible at distances of 0.7 to 2.5 miles from this viewpoint. As previously submitted, a portion of the cleared corridor would have been visible as a 'notch' between Three Slide and Greenlaw Mountains. Visible mountains from left to right: Three Slide Mountain, Greenlaw Mountain, No. 6 Mountain, and No. 5 Mountain.

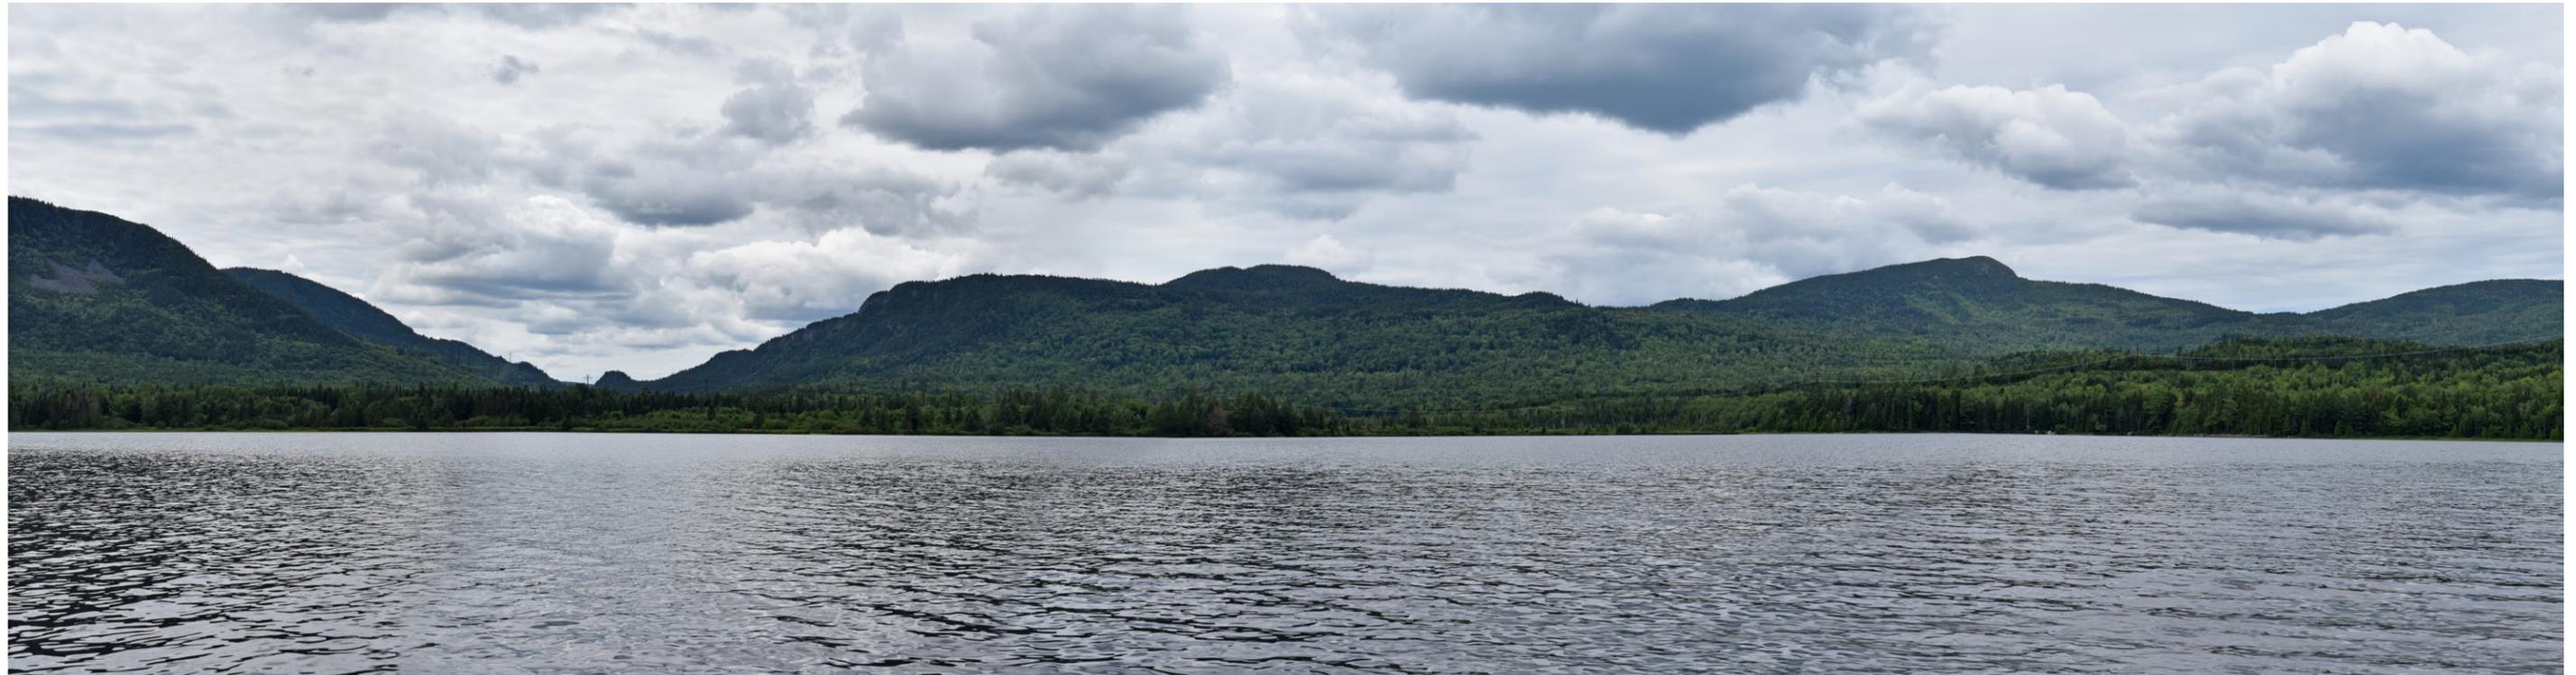
Proposed Conditions: Panoramic view looking west to north from the southeast end of Rock Pond toward the proposed HVDC transmission line. Approximately twelve structures, conductors, and portions of the cleared corridor will be visible at distances of 0.7 to 2.5 miles from this viewpoint. Visible mountains from left to right: Three Slide Mountain, Greenlaw Mountain, No. 6 Mountain, and No. 5 Mountain.

This simulation reflects a change in height for five structures in proximity to Gold Brook on the northern shoulder of Three Slide Mountain. Full vegetation height will be preserved for approximately 4,269 feet of corridor to maintain habitat. An additional 2,059 feet of corridor would be maintained using a tapering vegetation management technique which allows vegetation at heights ranging from 15 feet to 35 ft to be preserved along both sides within the corridor. This mitigation would minimize the visual 'notch' potentially viewed from Rock Pond.

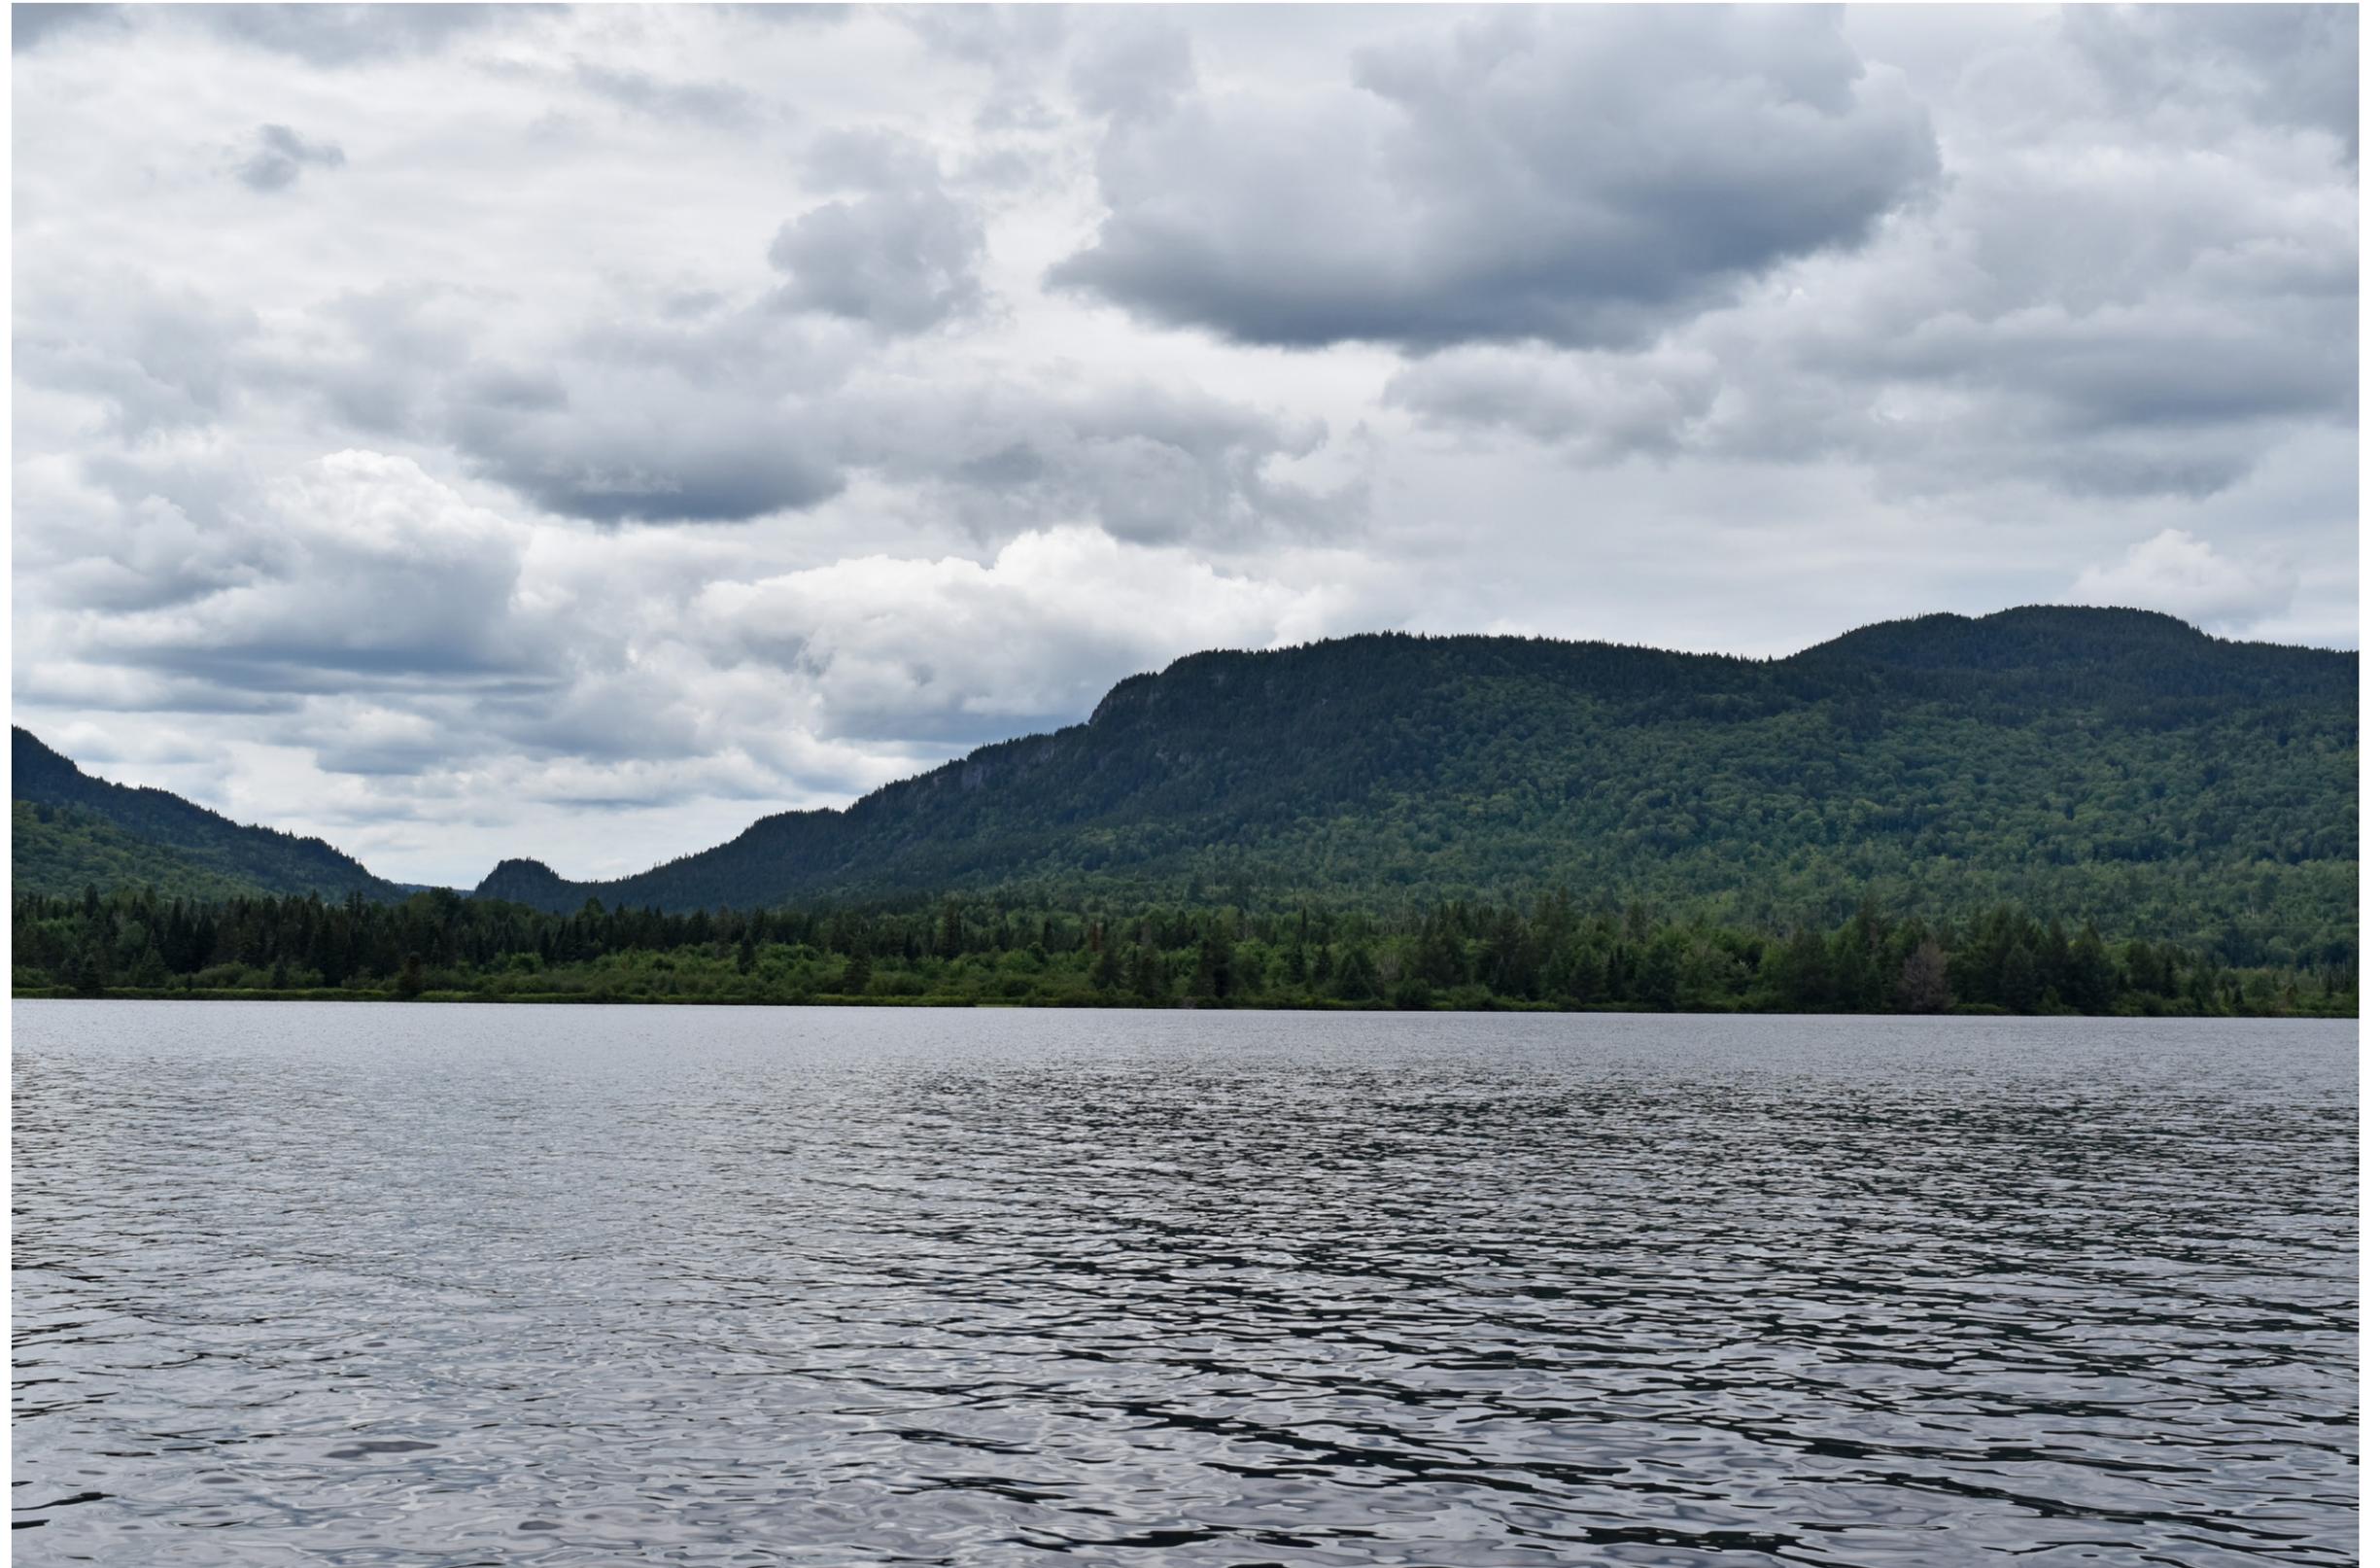
Existing Conditions: Normal view looking northwest from the southeast end of Rock Pond. Three Slide Mountain is visible on the left side of the image. Greenlaw Mountain is visible on the right side of the image.

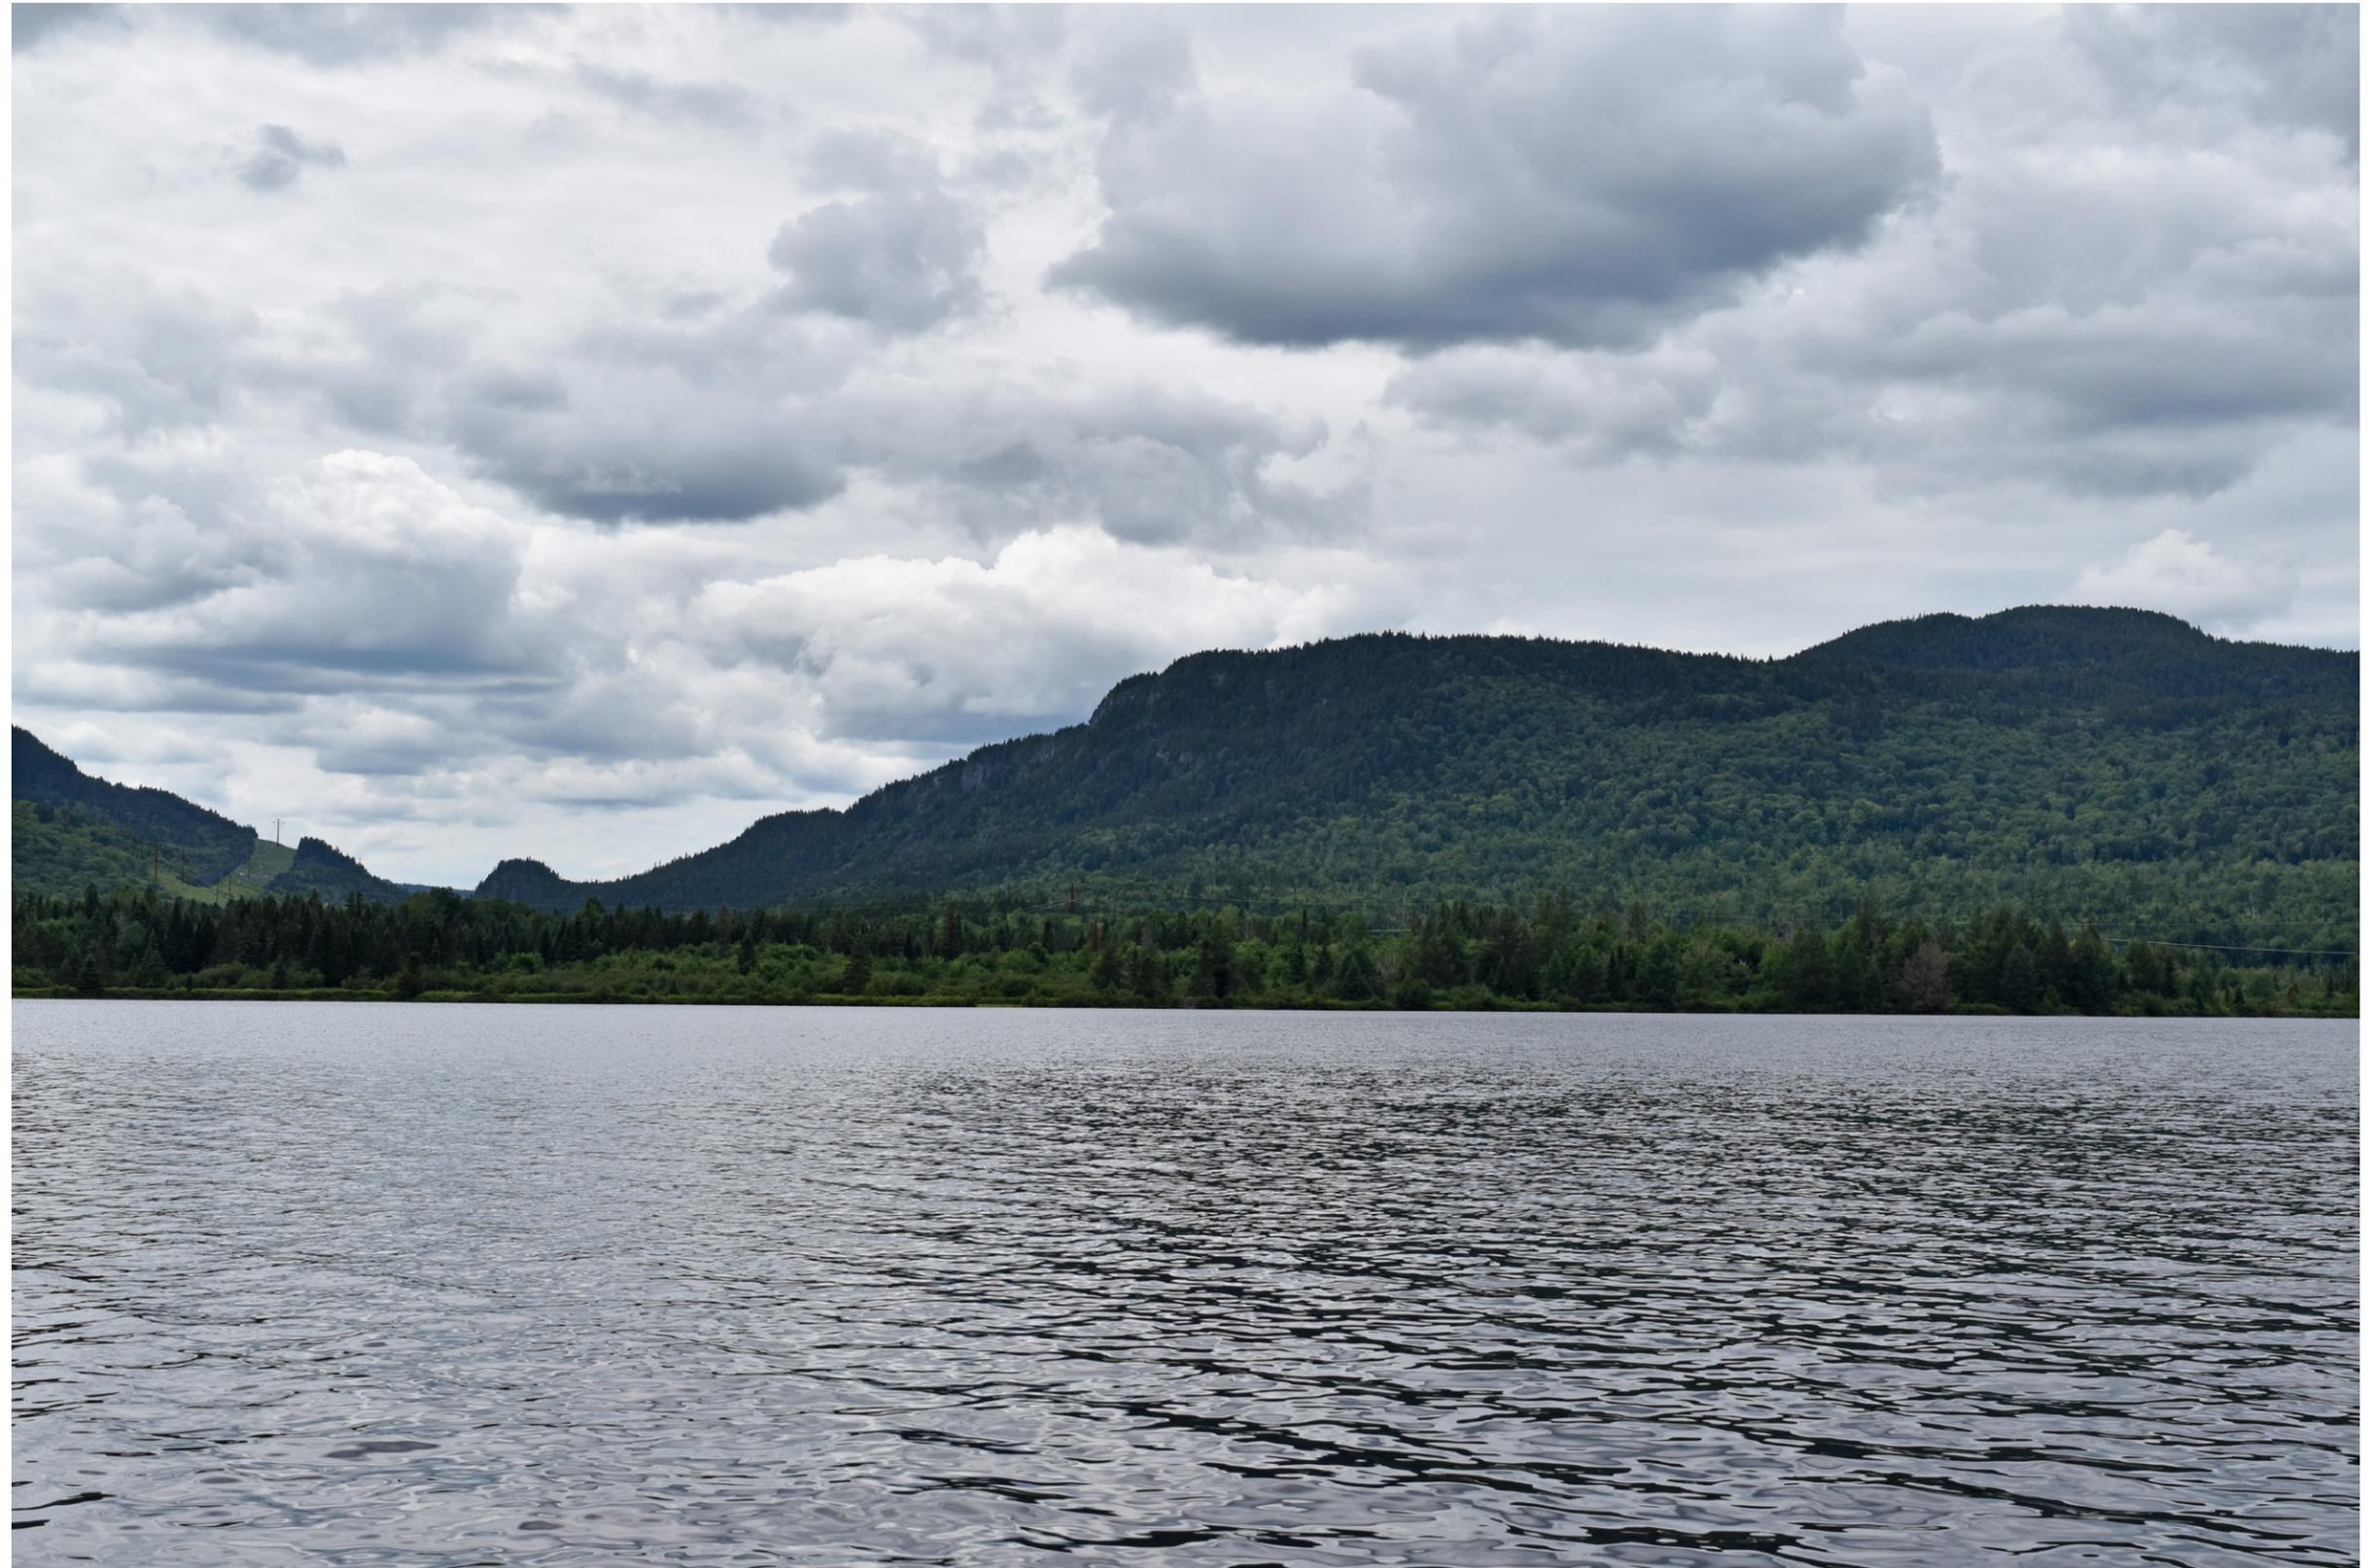
Proposed Conditions (Submitted September 2017): Normal view looking northwest from the southeast end of Rock Pond toward the proposed HVDC transmission line. Approximately six structures and conductors will be visible in the cleared corridor in the valley between Three Slide and Greenlaw Mountains. Additionally, the tops of three structures and conductors will be visible above the tree tops from this viewpoint.

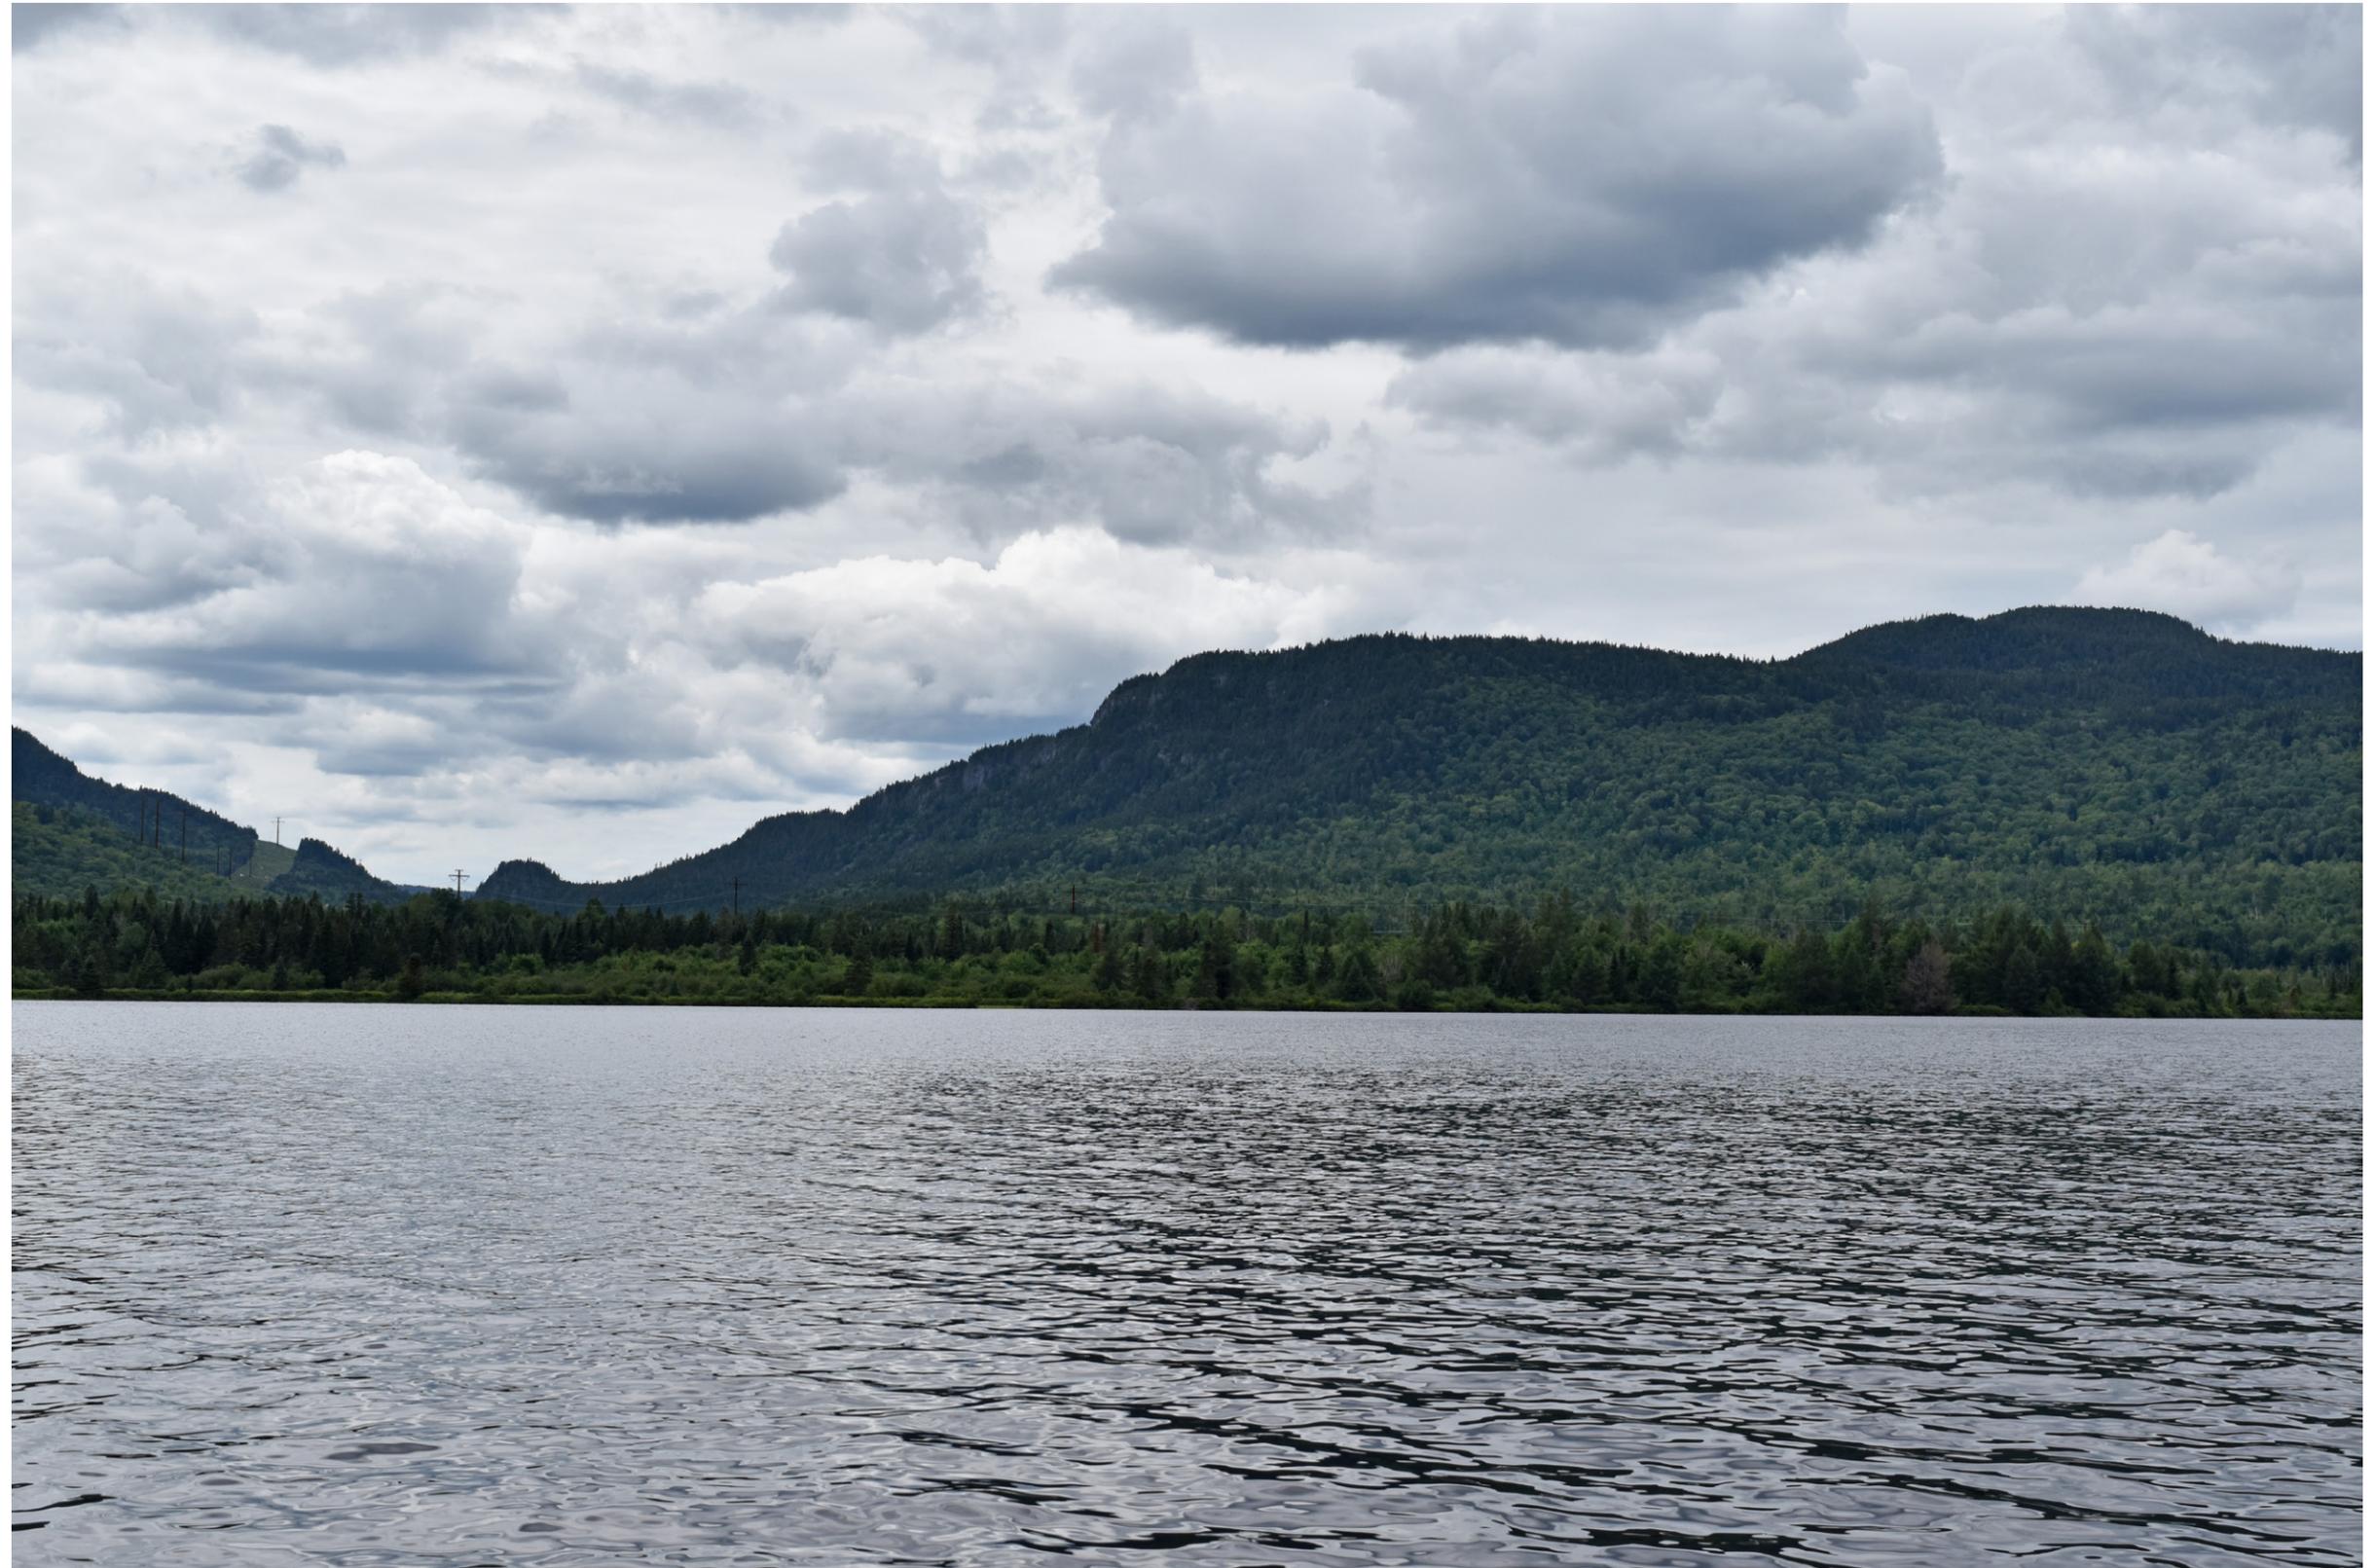
Proposed Conditions: (Revised 12.7.18) Normal view looking northwest from the southeast end of Rock Pond toward the proposed HVDC transmission line. Approximately six structures and conductors will be visible in the partially cleared corridor in the valley between Three Slide and Greenlaw Mountains. A portion of the corridor on three slide mountain will include taller structures and allow full vegetation growth.

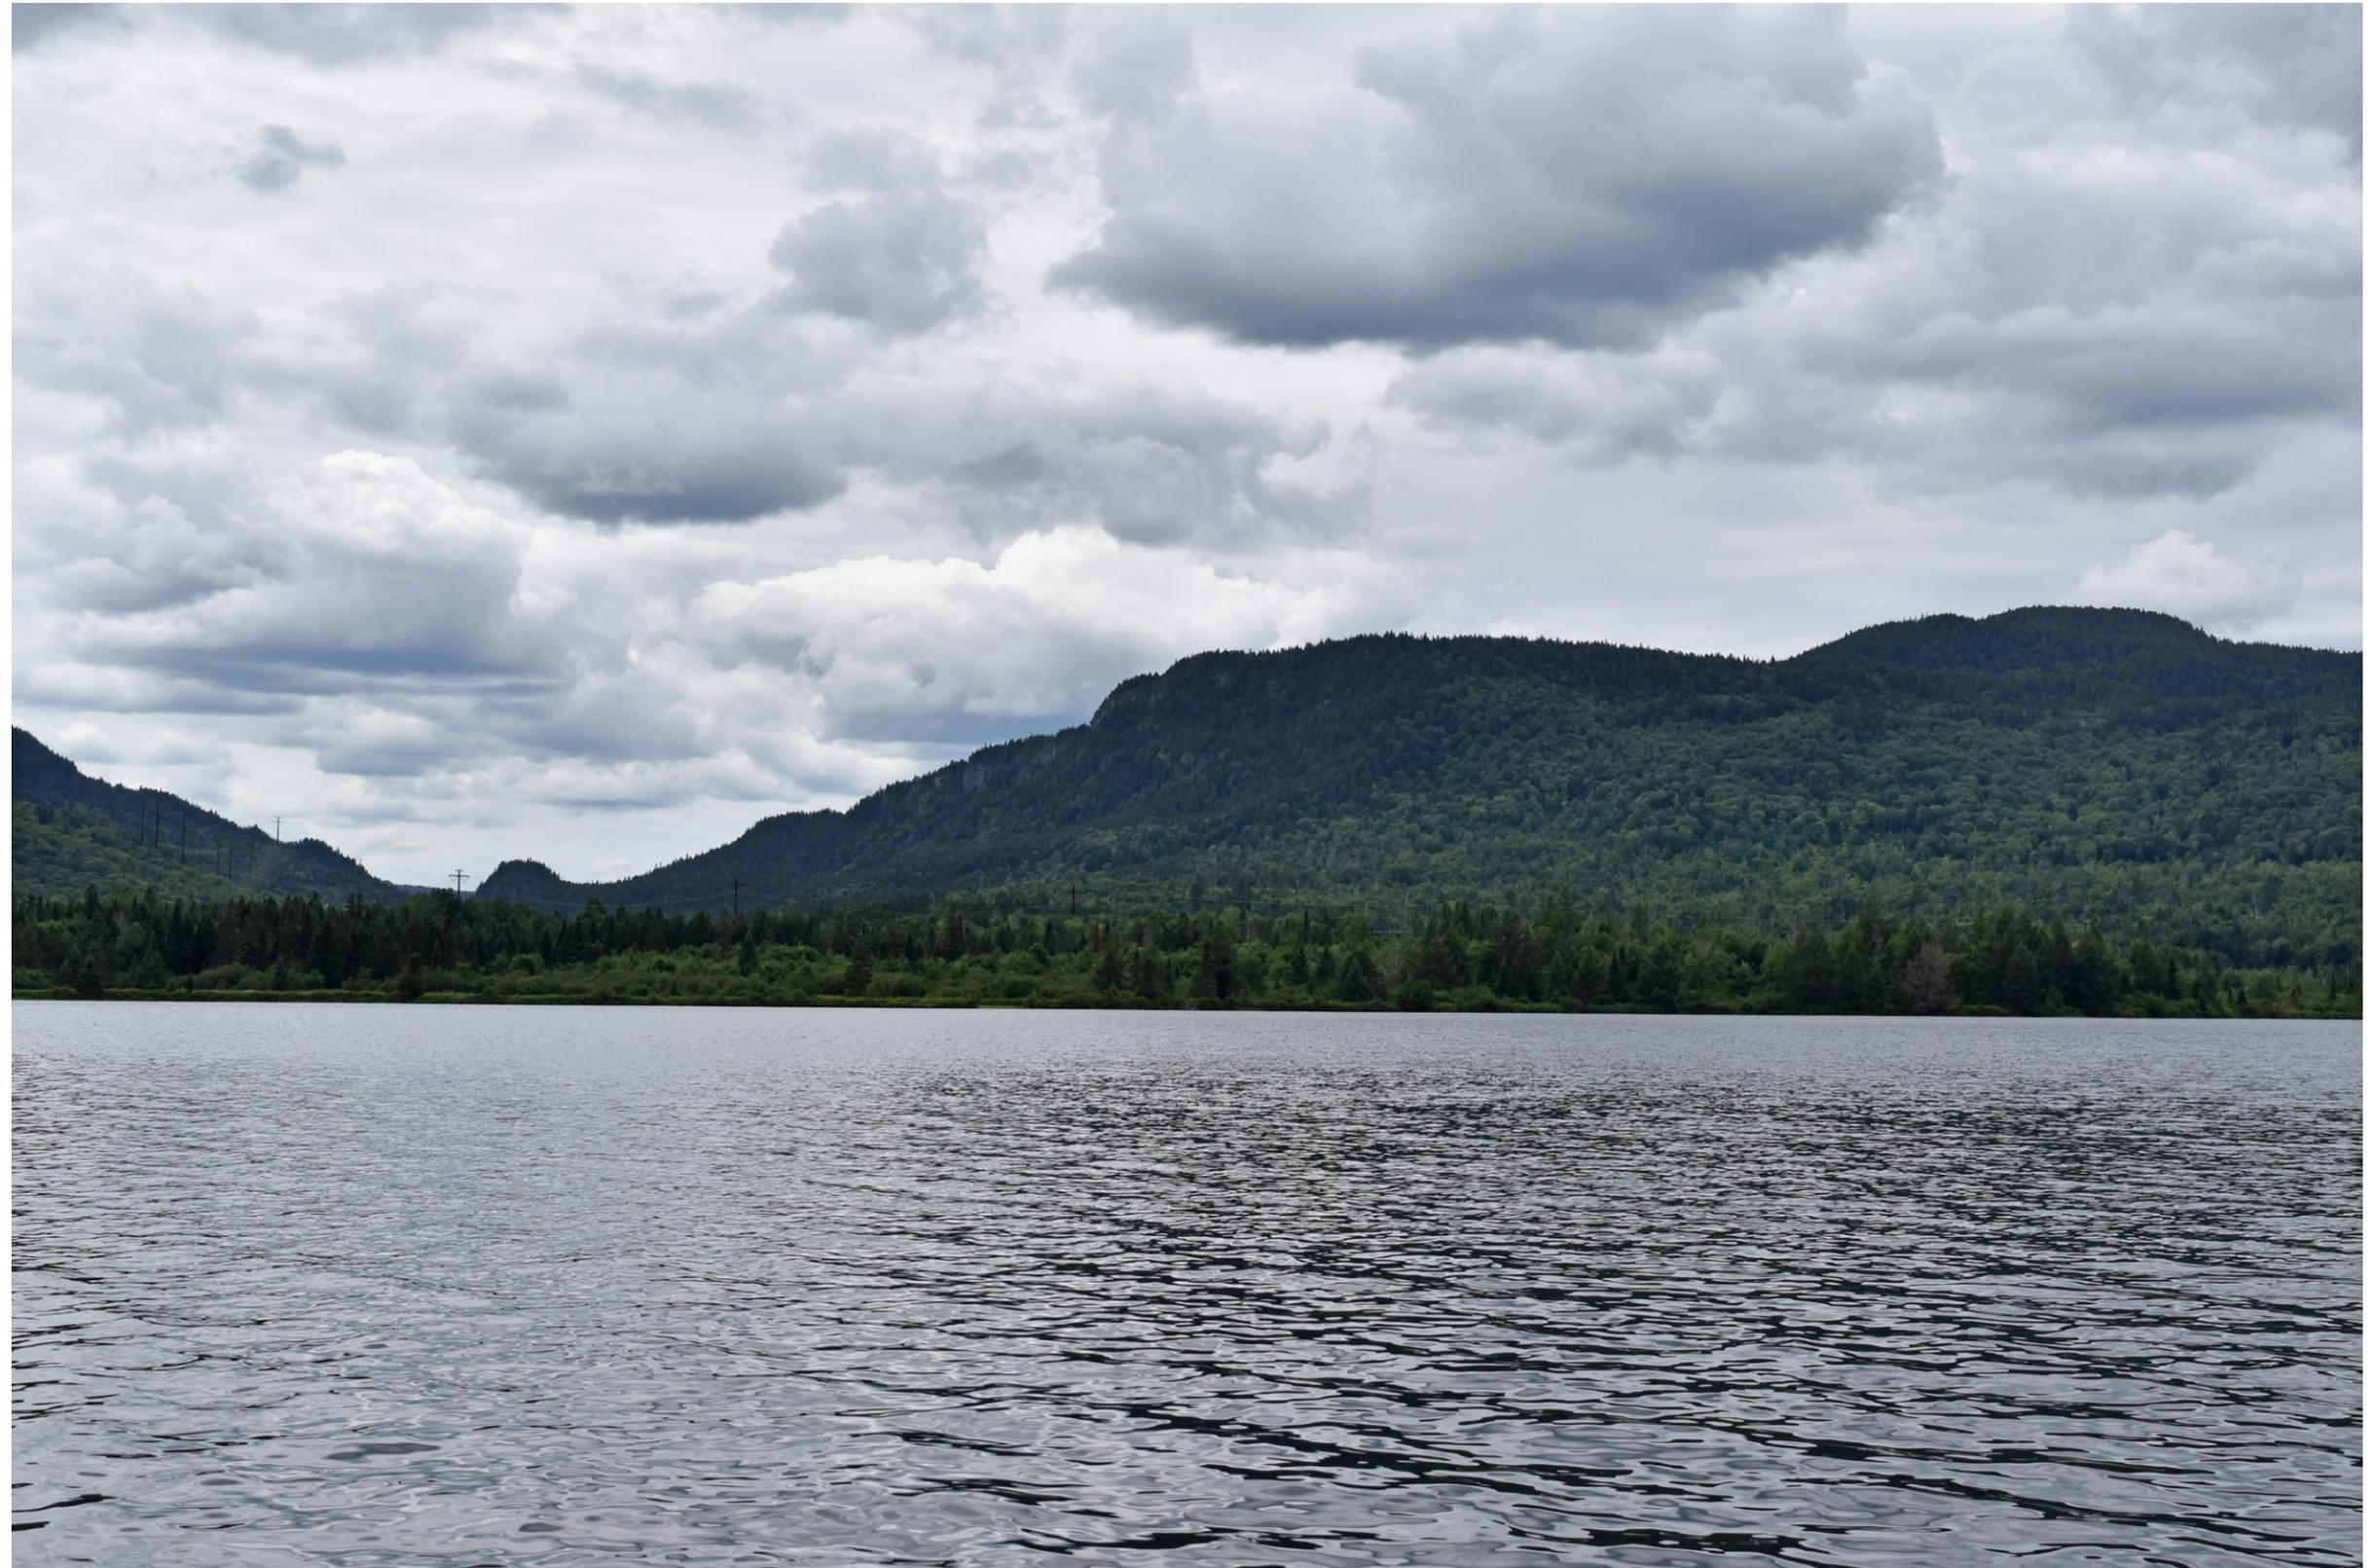
Proposed Conditions: (Revised 12.7.18) Normal view looking northwest from the southeast end of Rock Pond toward the proposed HVDC transmission line. Approximately six structures and conductors will be visible in the partially cleared corridor in the valley between Three Slide and Greenlaw Mountains. A portion of the corridor on Three Slide Mountain will include taller structures and allow full vegetation growth. The remainder of the visible corridor will be maintained with a tapered vegetation management technique to minimize the visual notch affect as viewed from Rock Pond.

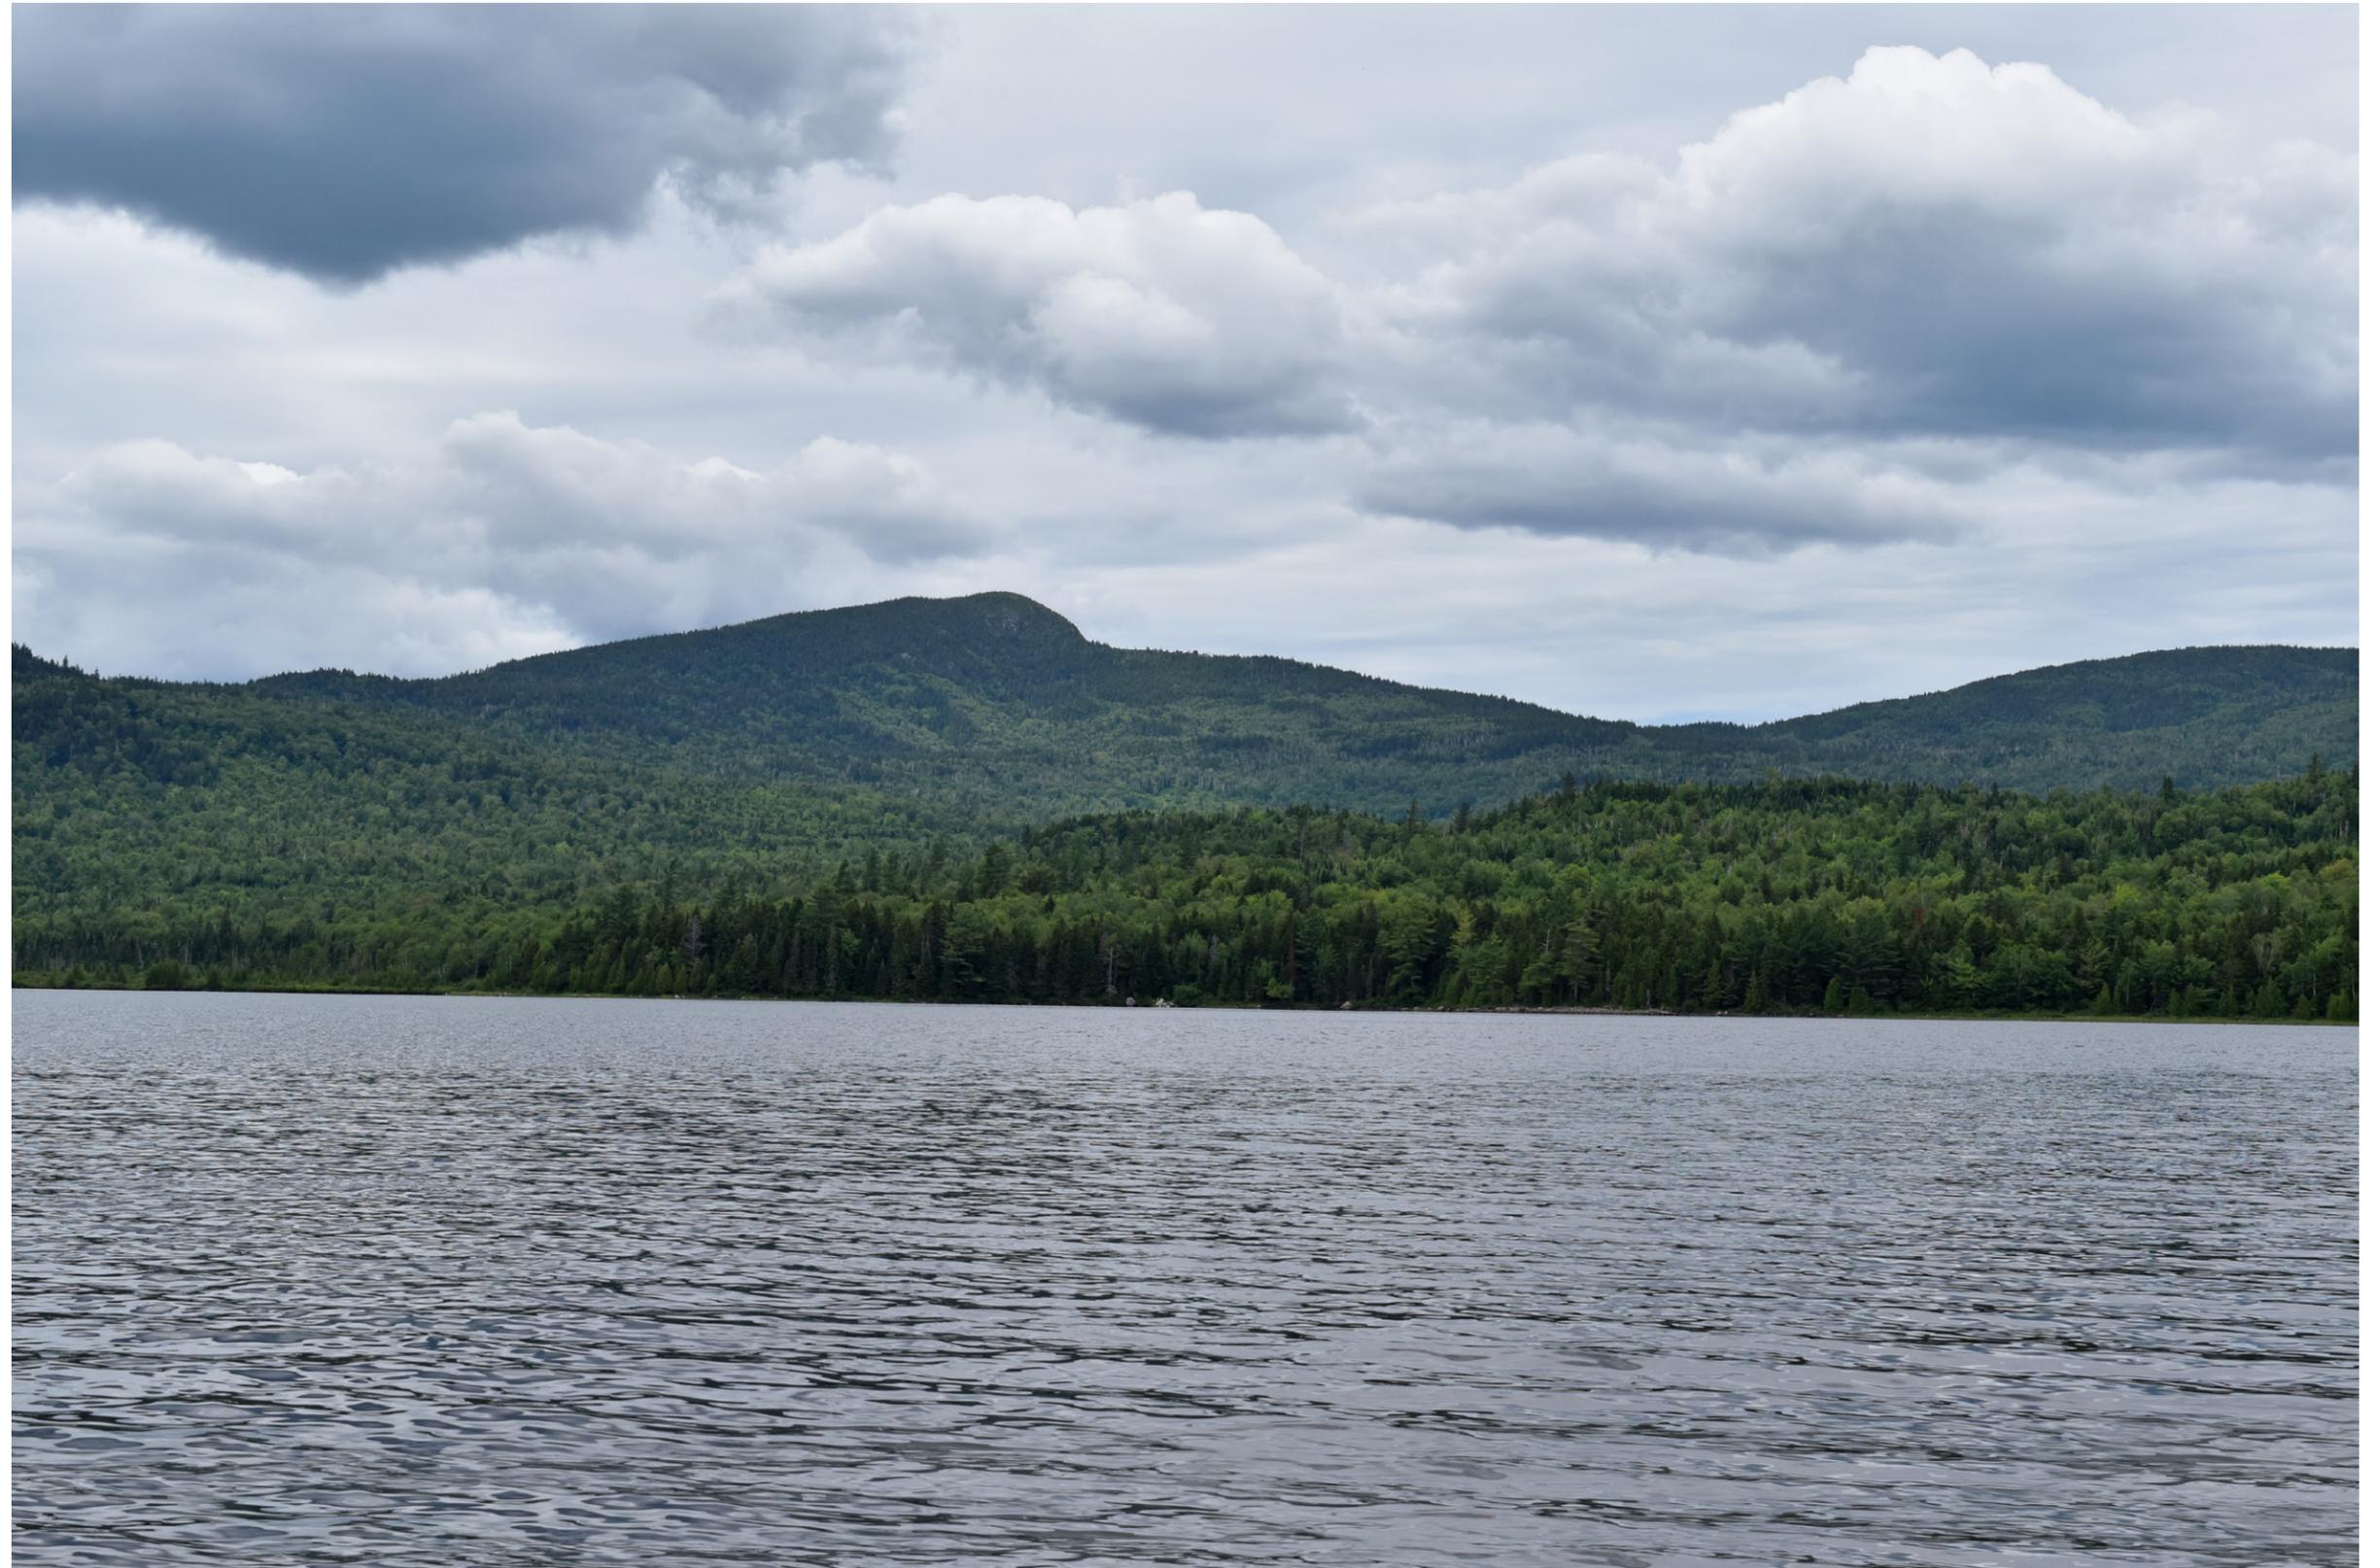
Existing Conditions: Normal view looking north from southeast end of Rock Pond. Greenlaw Mountain is visible on the left side of the image. No. 6 Mountain is visible on the right side of the image.
