PHOTOSIMULATION 3: ROCK POND, T5 R6 BKP WKR

PHOTOSIMULATION 3: ROCK POND, T5 R6 BKP WKR, Structure 731-735 Visibility Analysis

PHOTOSIMULATION 3A: ROCK POND, T5 R6 BKP WKR

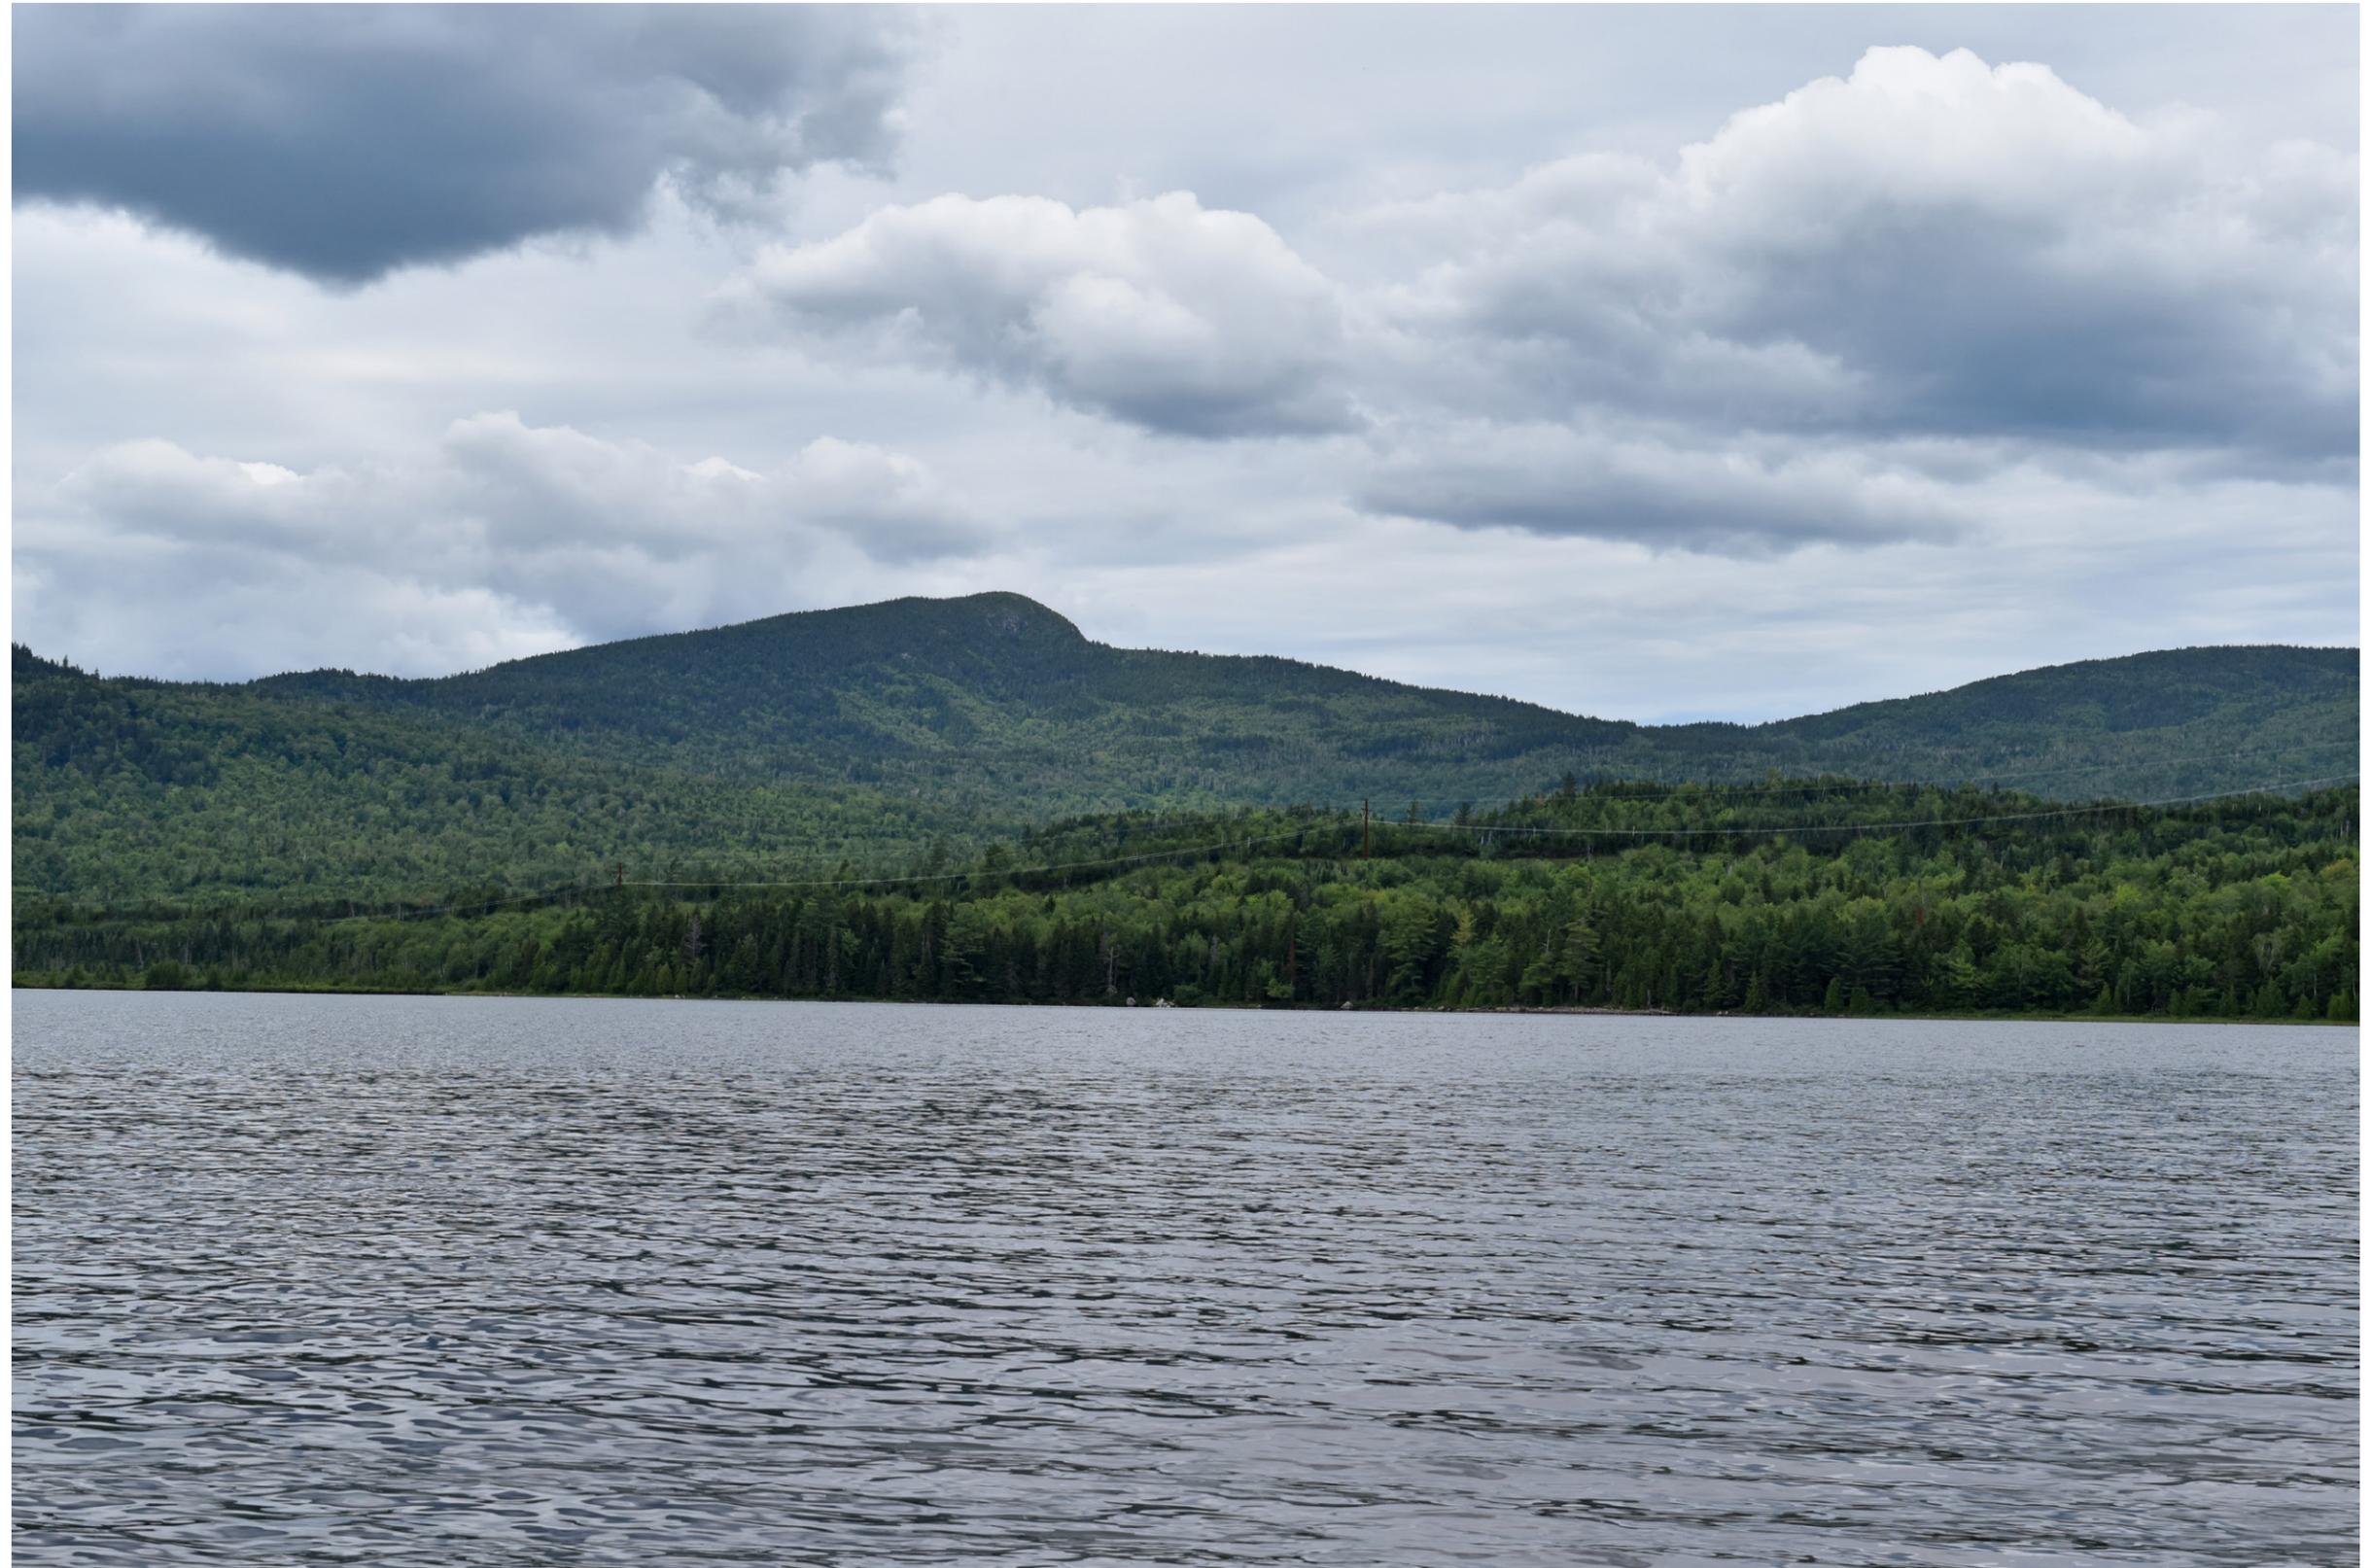
PHOTOSIMULATION 3B: ROCK POND, T5 R6 BKP WKR

Proposed Conditions: Normal view looking north from southeast end of Rock Pond toward the proposed HVDC transmission line. Three structures, conductors, and portions of the cleared corridor will be visible at distances of 0.6 to 0.8 miles. The structure height for these structures has remained the same.
